DAMAGE TO THE HISTORIC TOWN OF STAUFEN (GERMANY) CAUSED BY GEOTHERMAL DRILLINGS THROUGH ANHYDRITE-BEARING FORMATIONS

Ingo SASS¹ & Ulrich BURBAUM²

Ingo Sass & Ulrich Burbaum: Damage to the historic town of Staufen (Germany) caused by geothermal drillings through anhydrite-bearing formations

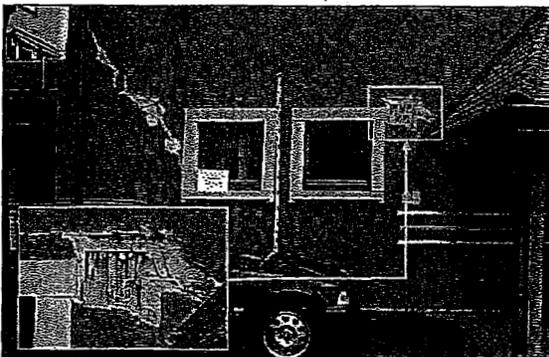
Fig. 2: Uplift cracks in building Kirchstraße, inner courtyard, distance to the well field approx. 20 m to the east. Destruction of the supporting masonry, March 2009 (Photo: U. Burbaum).

The differential uplift affects buildings as well as infrastructure by inducing stresses which exceed the tension and shear strengths of the structural components, producing tension and shear cracks (Figs. 2 and 3). In addition, the deformations also cause tilting, which in turn puts compressive stress on bearing elements. The uniaxial compressive strength of construction components is locally exceeded, and they fail. Damages to the local infrastructure (Fig. 4) are severe. For example, gas and water utilities require expansion bends (Fig. 5) to prevent future disasters. The damage patterns are dependent upon the tectonic setting, the lithologic conditions, hydrogeological heterogeneity, and the BHE drilling geometry as well as varying BHE construction quality.

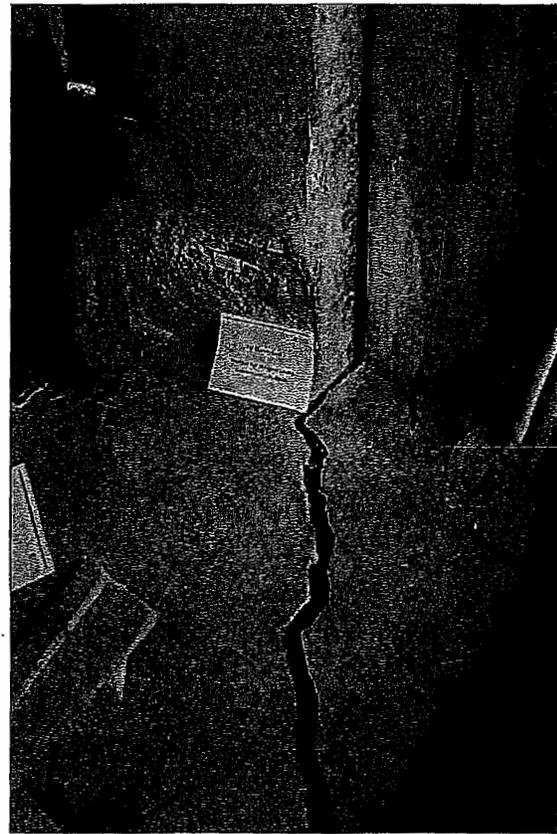
Fig. 3: Tension crack in a baseplate, building Jägergasse, distance to the well field approx. 70 m to the northeast, March 2009 (Photo: U. Burbaum).

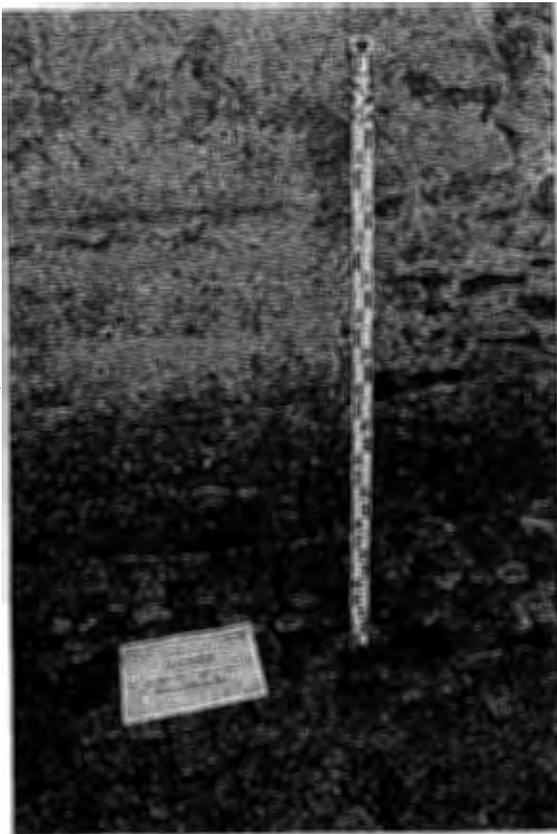
Fig. 4: Crack in the street "Jägergasse", distance to the wellfield approx. 80 m to the NE, March 2009 (Photo: U. Burbaum).

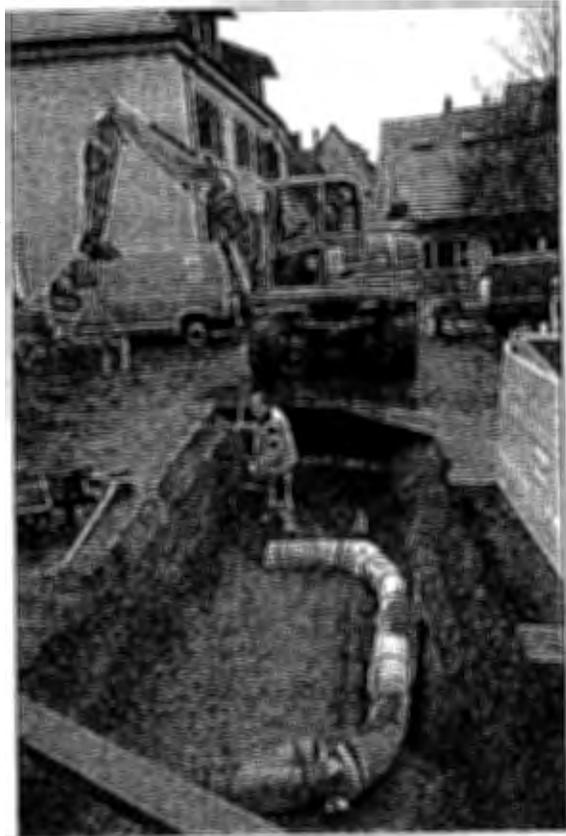
Fig. 5: Installation of an expansion bend in a PE-HD gas pipe, Meiergasse, distance to the well field approx. 80 m in northnortheast direction, March 2009 (Photo: U. Burbaum).

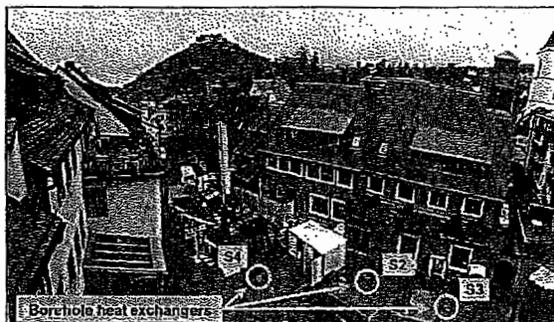
Fig. 12: Borehole heat exchanger field at Rathausgasse with drill rig for the first exploration boring for determining the cause of damage (March 2009). Photo taken from the tower of the town hall by U. Burbaum.

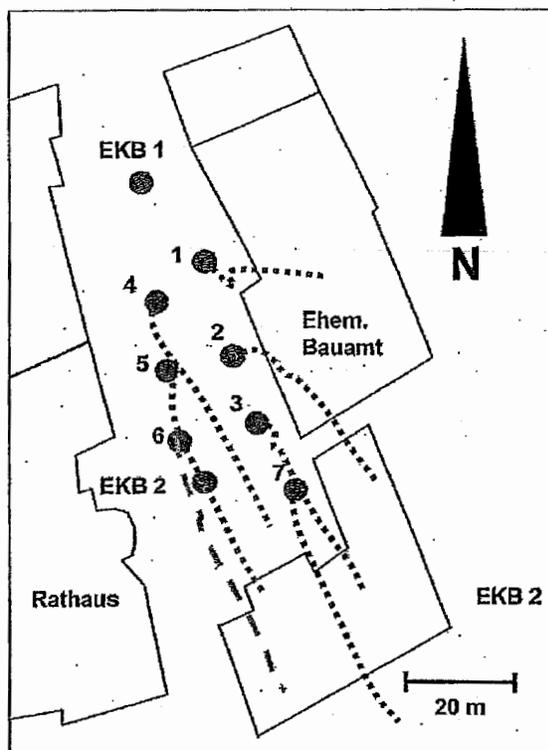
Fig. 13: Deviation of drillings.

An investigation of the inclination of the drillings shows a great horizontal deviation of all drillings up to some 20 m (LGRB 2010). This is shown in Fig. 13. The main deviation occurs in a depth of approx. 60 to 70 m. The depth correlates with the lower end of the temporary drilling casings.

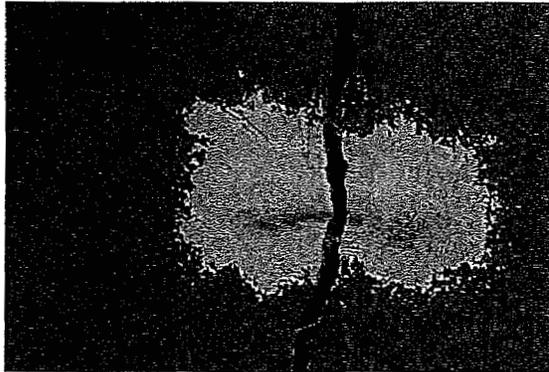
In November 2007, only 6 to 8 weeks after finishing the installation of the BHE, the first cracks were noticed in buildings. Cracks were quite small at first, and were

not linked to the drilling operations. From 12/2007 to 01/2008 cracks were marked with gypsum markers (Fig. 14).

Fig. 14: Gypsum markers on a crack, building Rathausgasse 3, with logs of the fracture spacing since December 2007 (Photo from March 2009 by I. Sass & U. Burbaum).

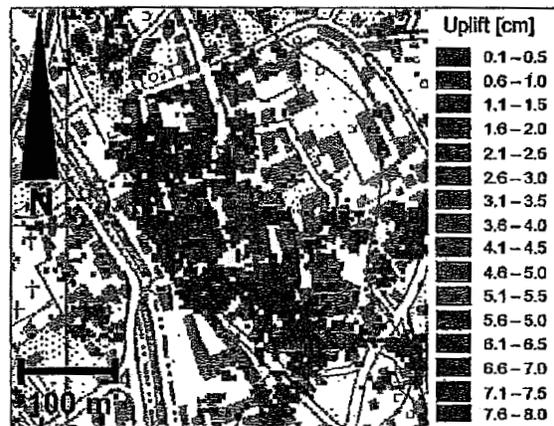
Fig. 15: Analysis of satellite-based ground level uplift monitoring by radar interferometry, a) July 2008 to 29. October 2008, b) July 2008 to 3. January 2009, c) July 2008 to 25. January 2009.

In general, results of the geodetic surveillance and satellite-based radar images (Fig. 15a-c) of the uplifted zone show an elliptical dome with a NNE-SSW axis (Fig. 16). This position coincides well with the bedding of the Jurassic, Keuper and Muschelkalk series.

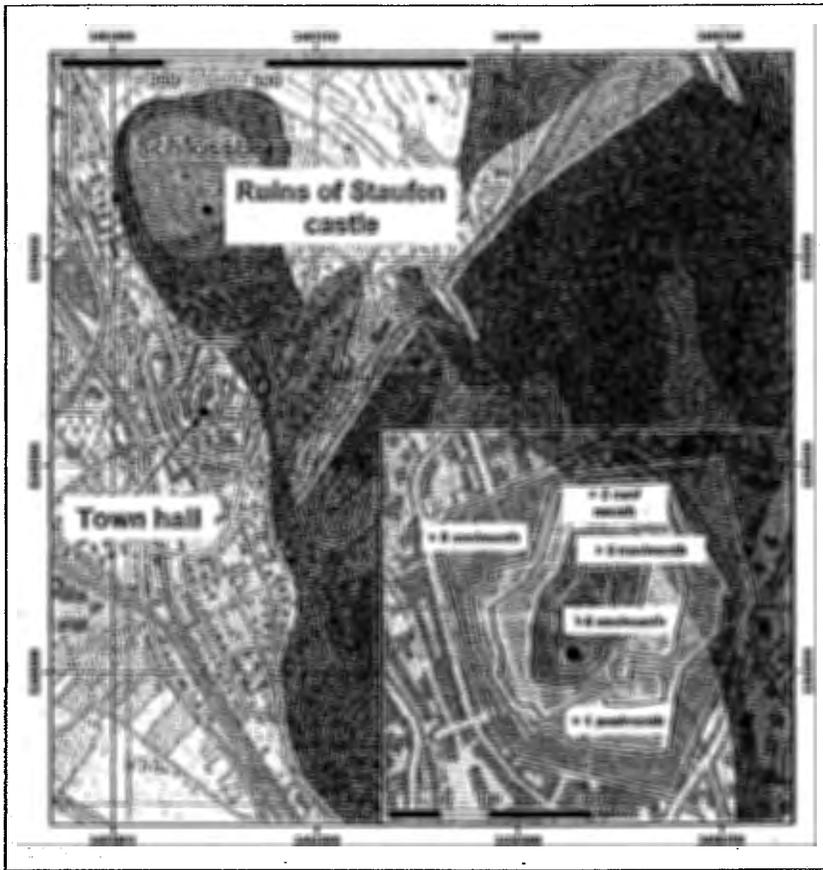
Fig. 16: Uplift rates in the city centre (LGRB 2009) plotted over the geological map Blatt 8112, Staufen im Breisgau, M 1:25.000.

2. The contour lines of the uplift are elliptical around the well field (Figs. 15 and 16), which is an indication that the contact between water and Gipskeuper is located in the centre of the ellipse.

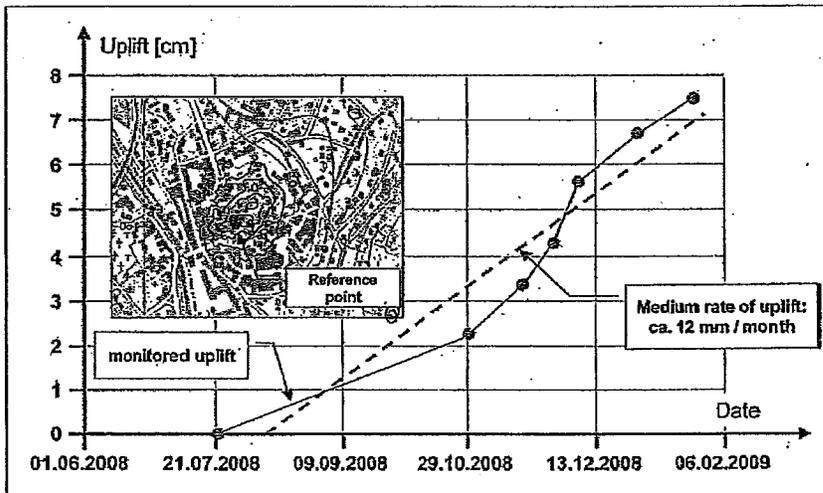
Fig. 17: Chronological development of the uplift of the town centre.

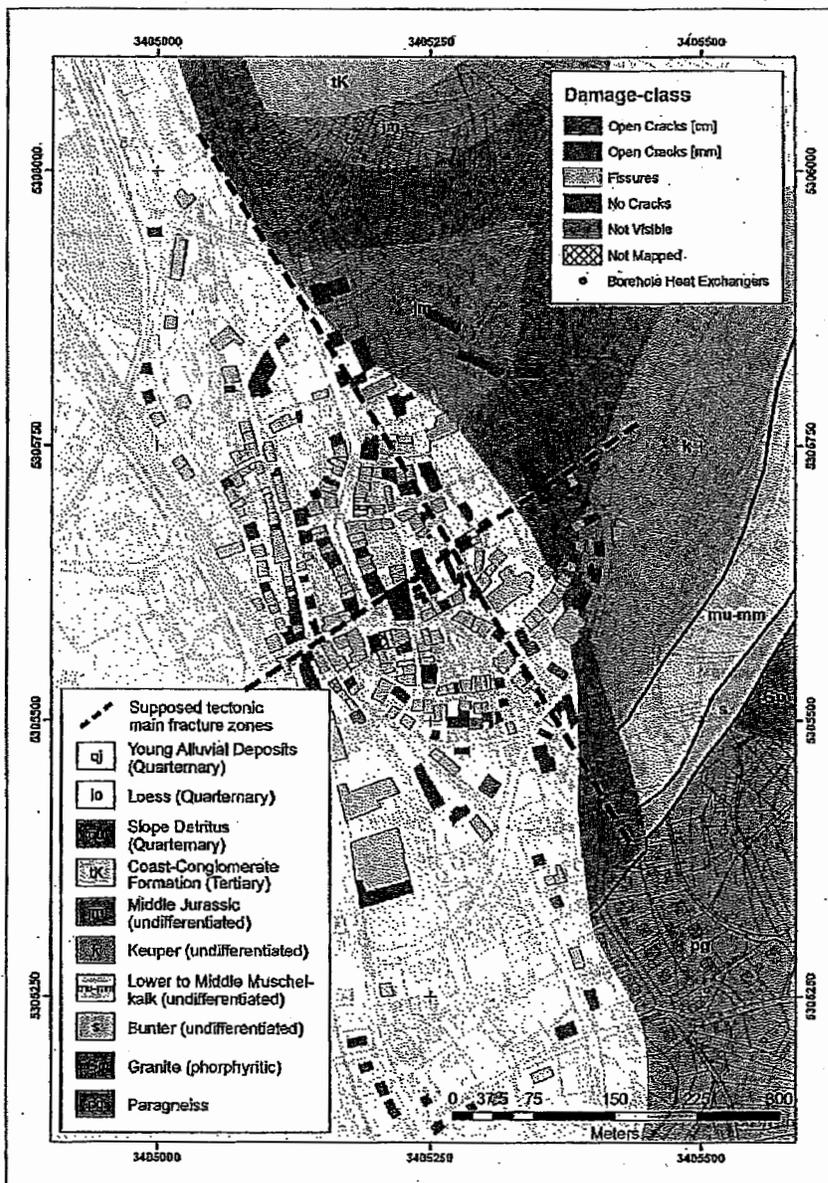
The zone of the most damaged buildings is consistent with the main orientation of geological fault structures, which is NNW-SSE and WSW-ESE (Fig. 18).

The orientation of building damages corresponds to the orientation of the discontinuities (Figs. 18 and 19) that were obtained by a field study in October 2009. It can be concluded that groundwater not only flows through drillings but now through discontinuities, too. The swelling process therefore cannot be stopped by sealing the BHE-Drillings. A larger area remediation approach must be found.

Fig. 18: Mapping of damages and geology.
