**Appendix J**  
**Site Photos – July/August 2009**

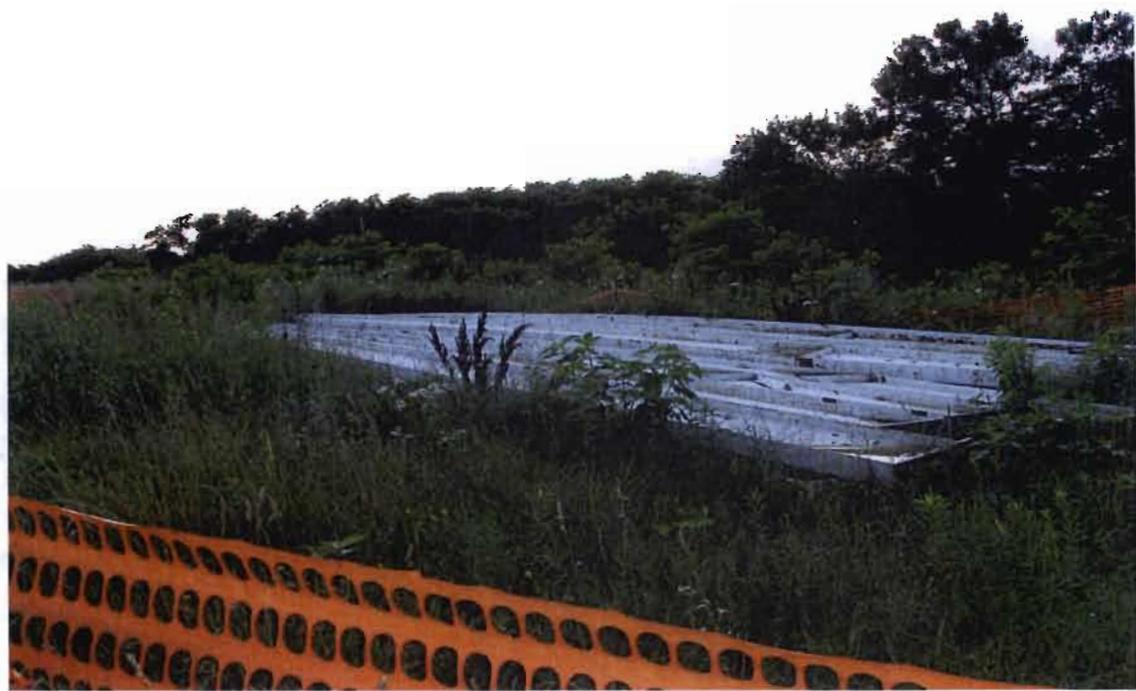
**View of Typical 35' - 45' Length Roof Trusses in Metal Beam Stockpile B on West Side of SIM Property (7/22/09)**

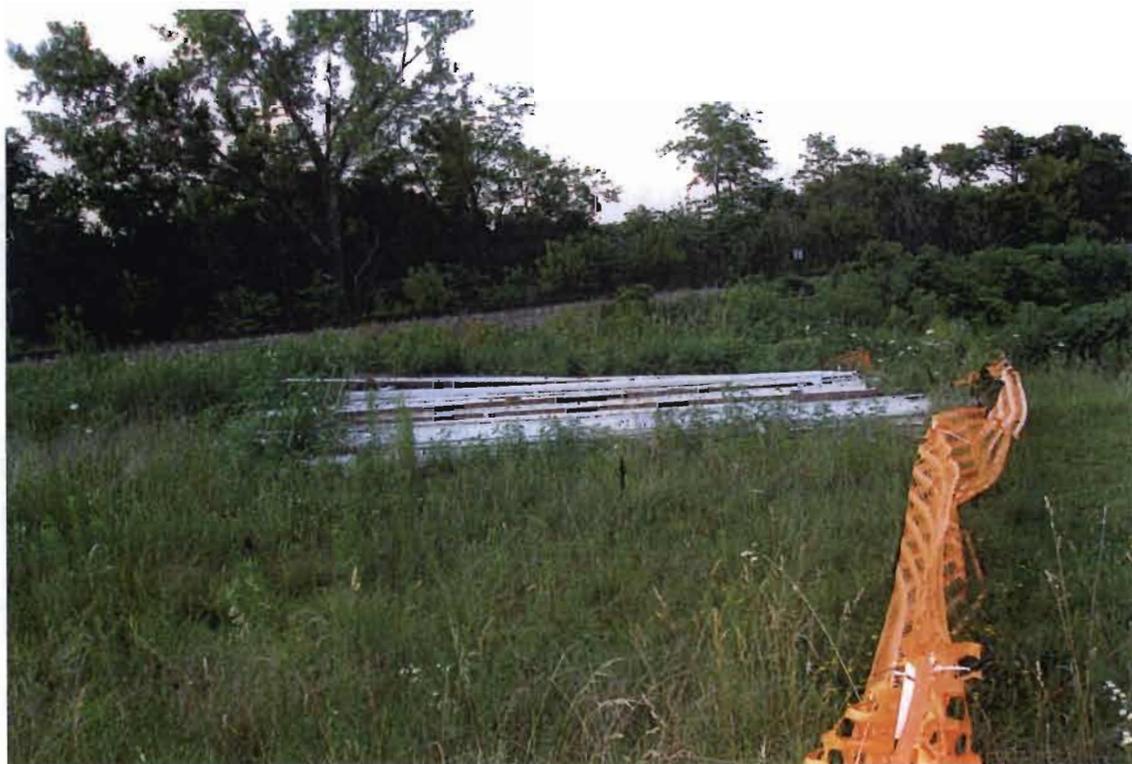
**View of Typical 12' - 25' Length Girts & Purlins in Metal Beam Stockpile A on West Side of SIM Property (7/22/09)**

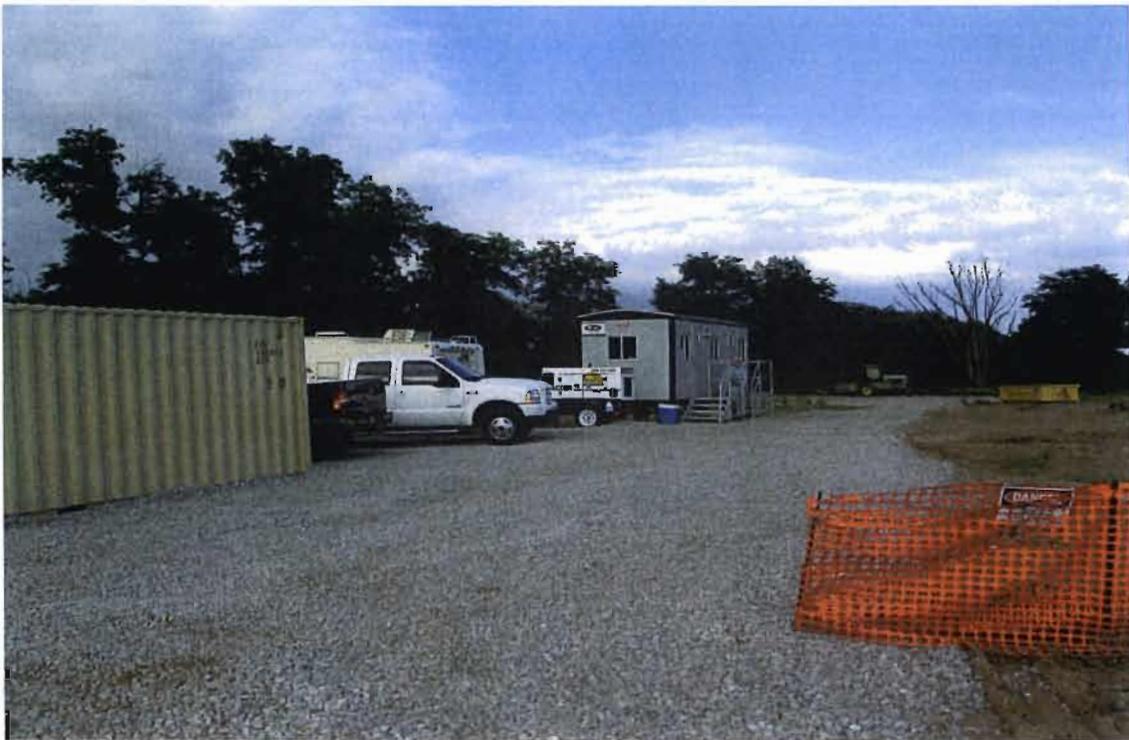
**Support Zone on East Side of SIM Property (7/16/09)**

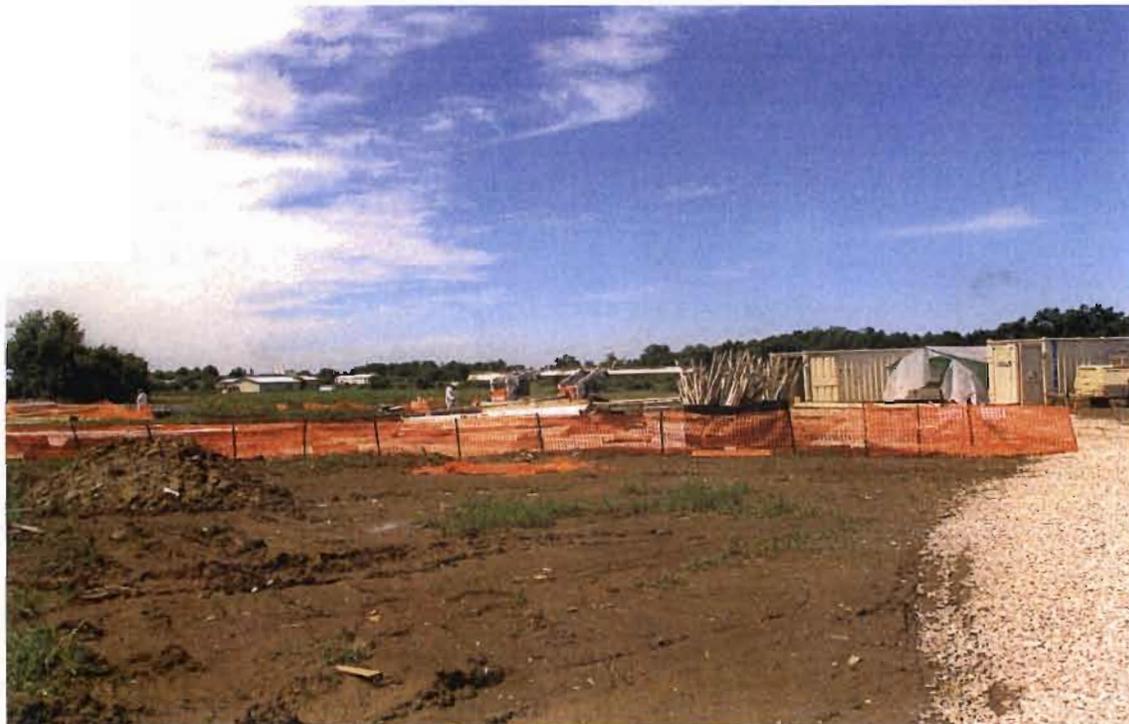
**Exclusion Zone on West Side of SIM Property; Background shows material handling logistics of typical 35' - 45' Length Roof Truss being relocated (7/16/09)**

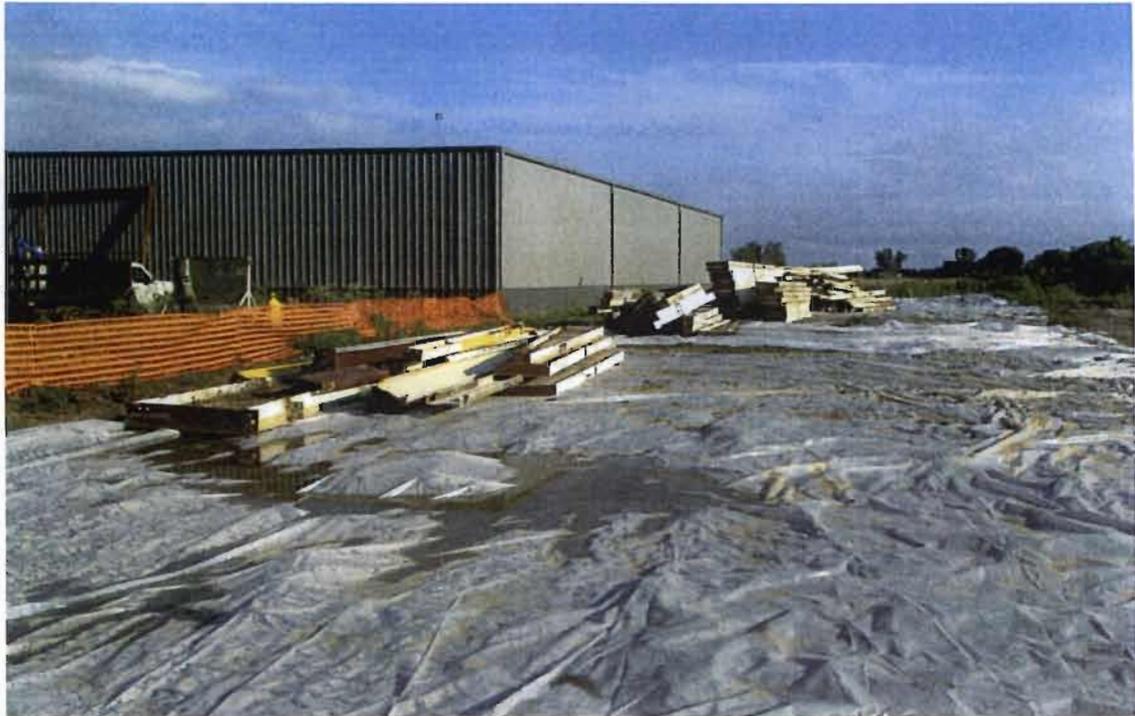
**Typical Metal Beam Segregation & Sampling Staging Areas (7/16/09)**

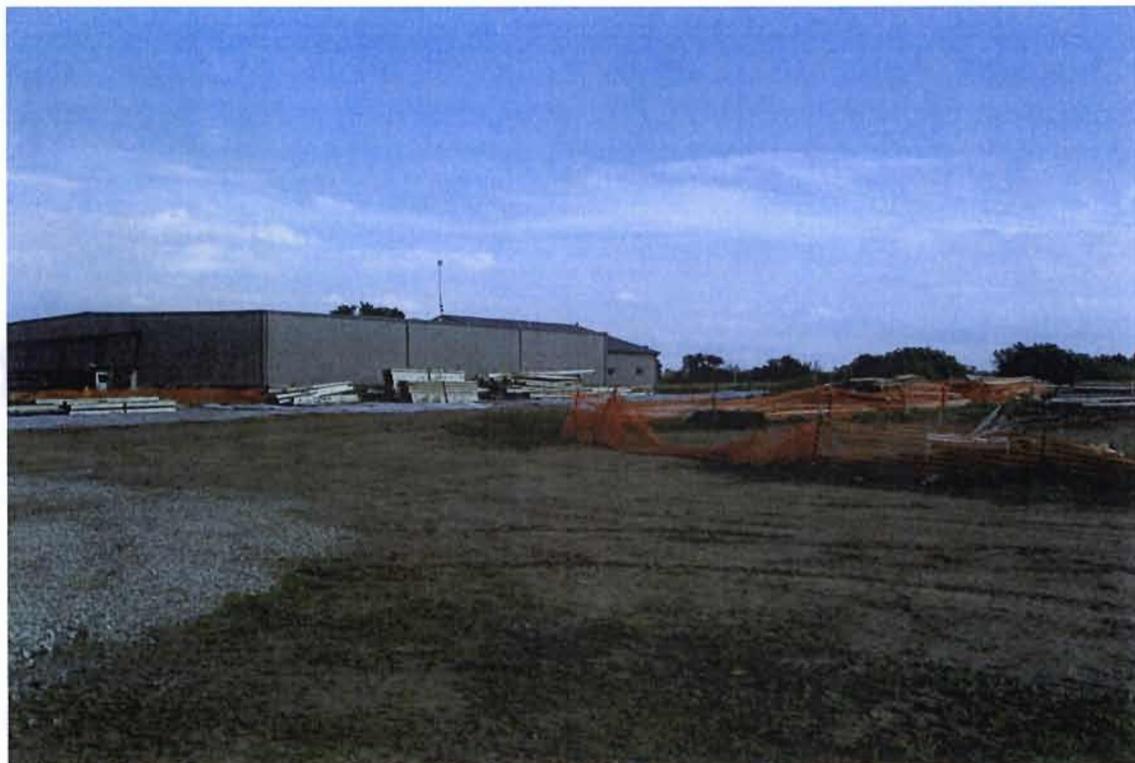
**Metal Beams Inspected & Segregated from Stockpile C (7/16/09)**

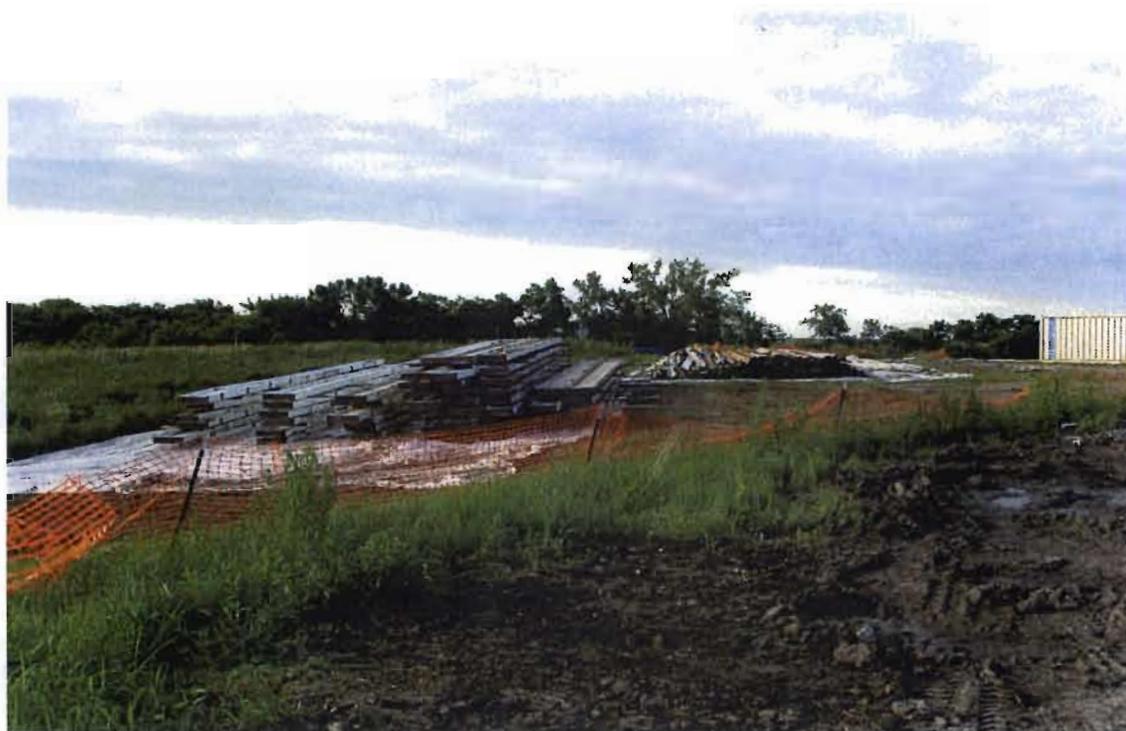
**Typical 35' - 45' Length Roof Trusses (foreground) and 12' - 25' Length Girts & Purlins (background) Inspected & Segregated from Stockpile C (7/16/09)**

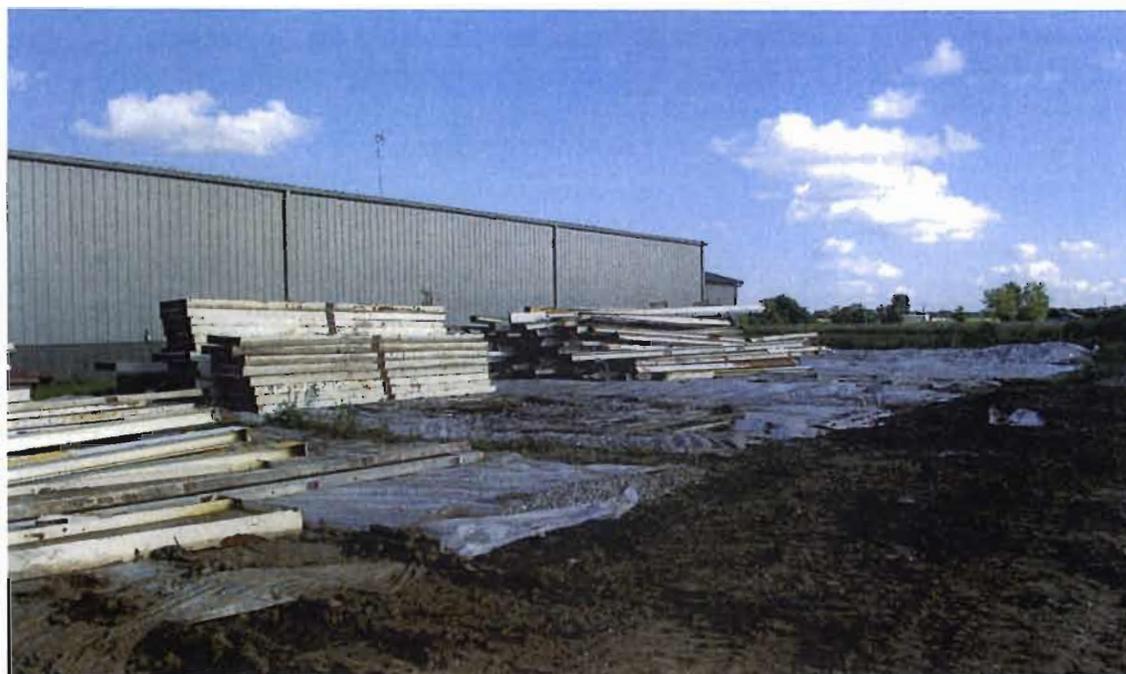
**Typical 10' - 12' Length Roof Truss Column Supports & Tails (Middle of photo) Inspected & Segregated from Stockpile C (7/22/09)**

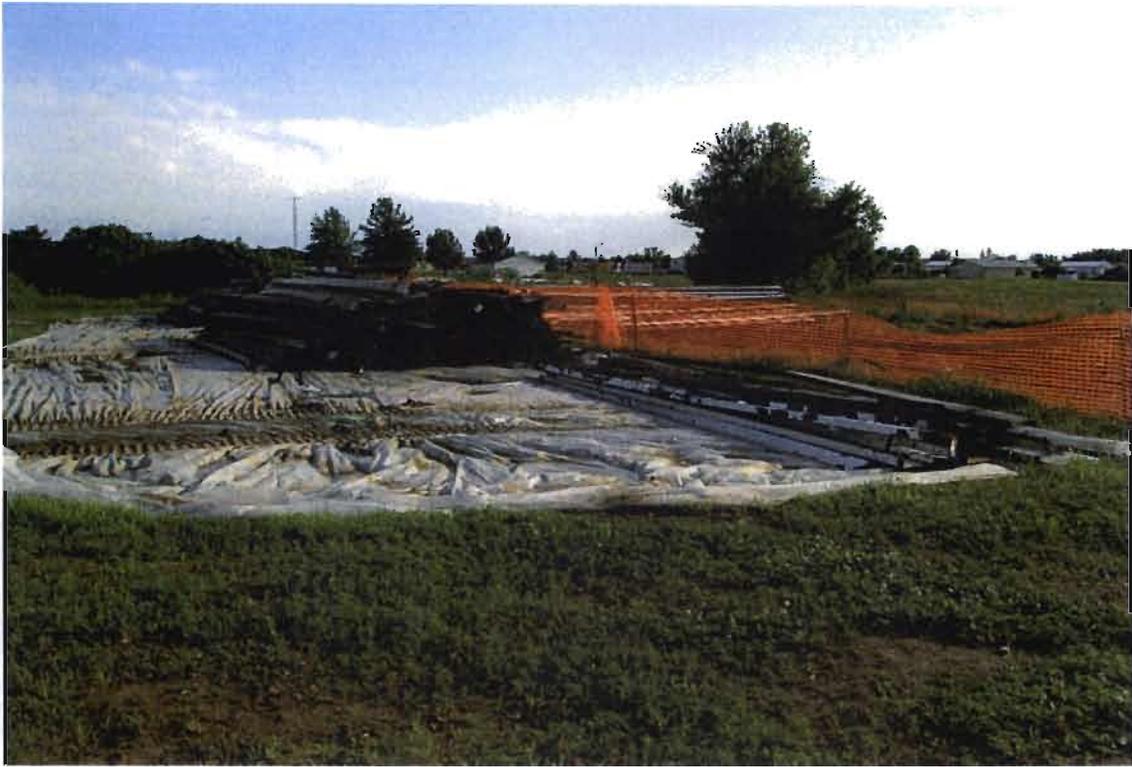
**Typical 12' – 25' Length Girts & Purlins Inspected & Segregated from Stockpile C  
(7/16/09)**

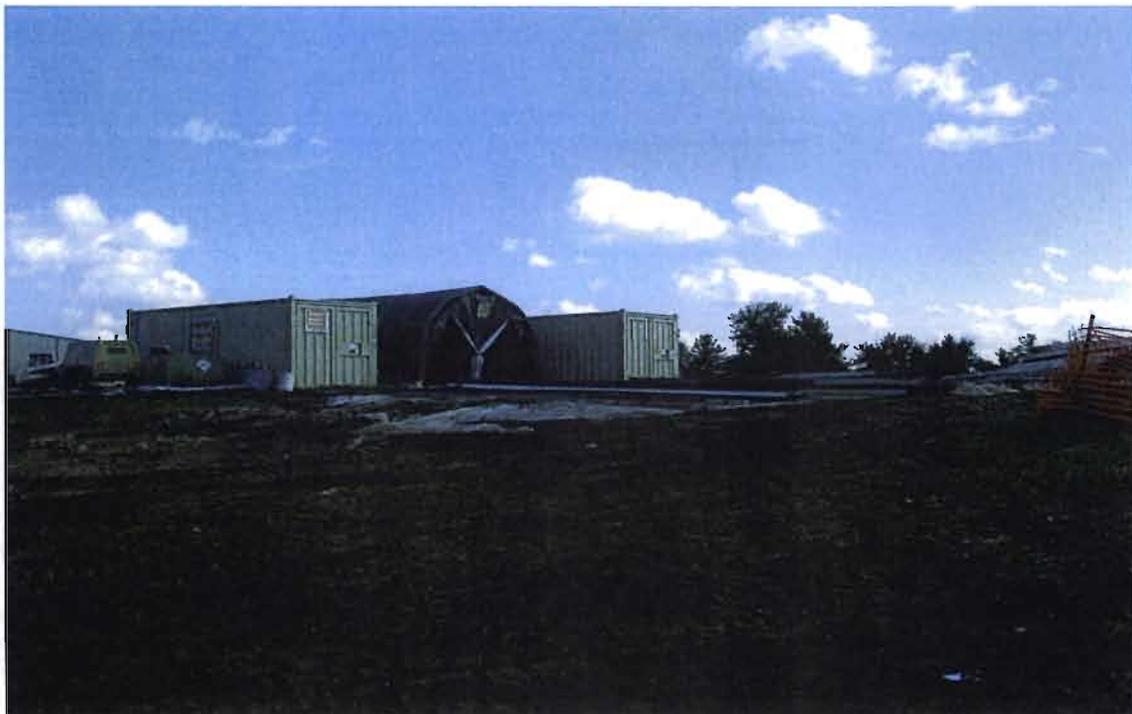
**Metal Beam Decontamination Tent (7/22/09)**

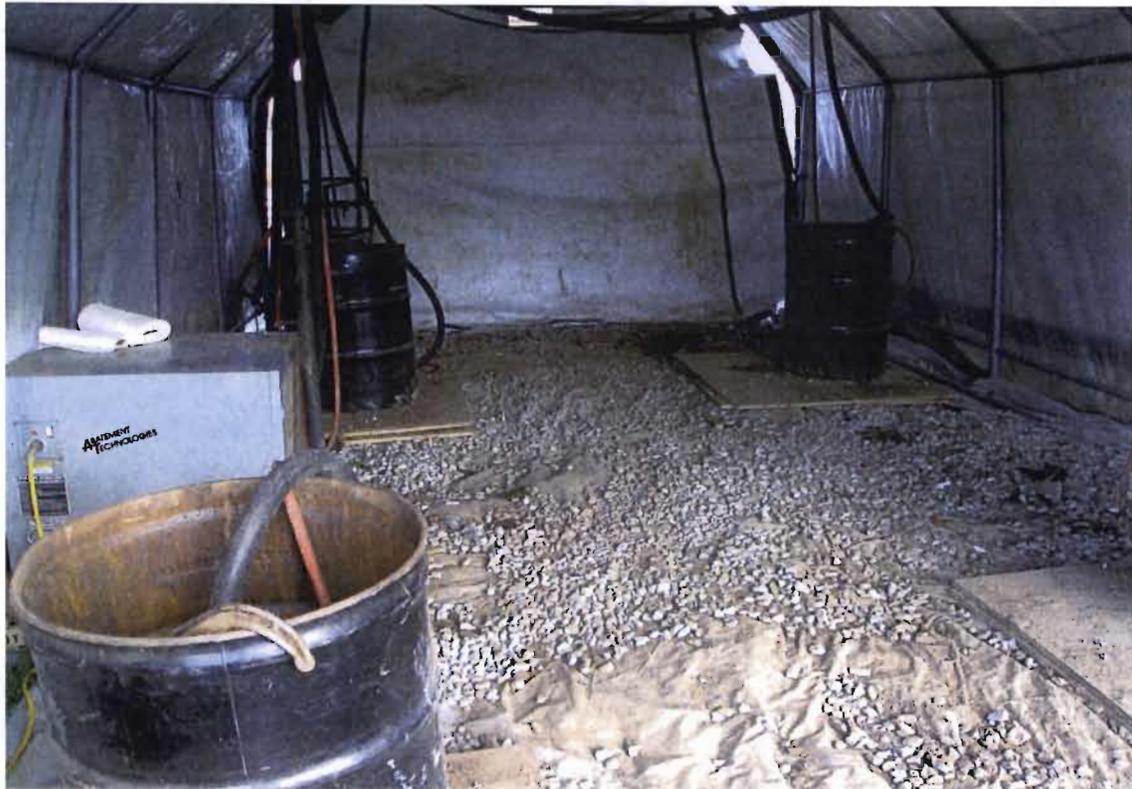
**Inside Metal Beam Decontamination Tent (7/22/09)**

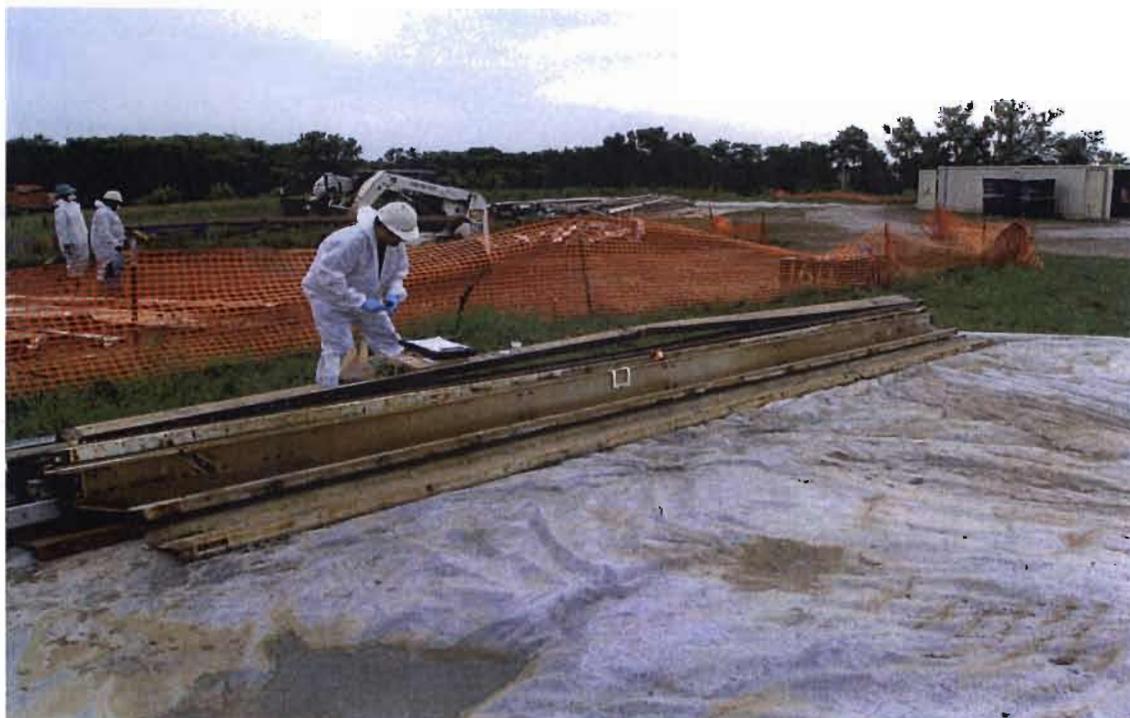
**Stockpile Area C – Metal Beam Inspection, Segregation (background) & Sampling (foreground) 12' – 25' Length Girts & Purlins (7/14/09)**

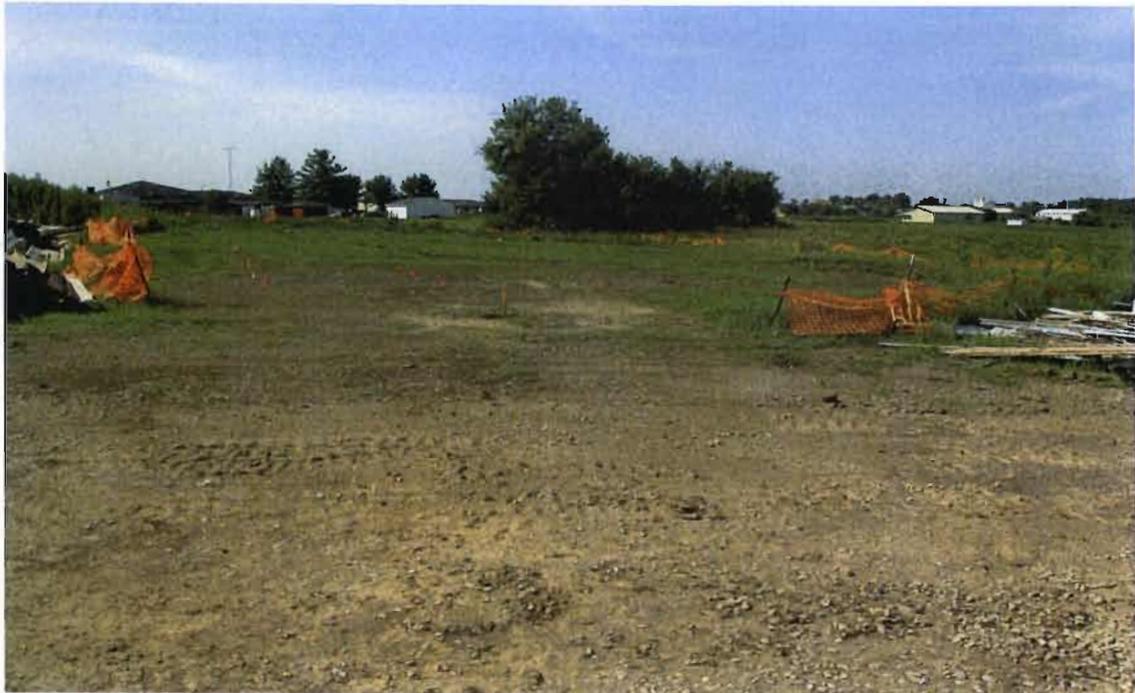
**Metal Beam Stockpile Area C – Inspection, Segregation & Soil Sampling Completed  
(8/24/09)**

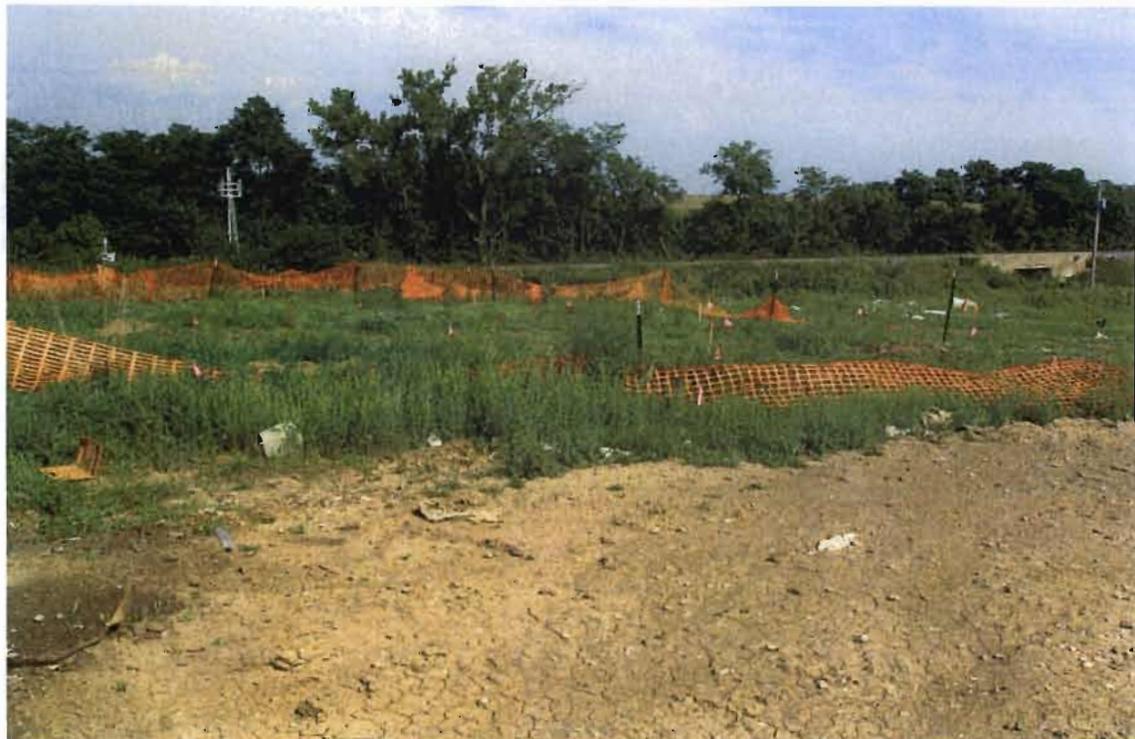
**Metal Beam Stockpile Area B – Inspection, Segregation & Soil Sampling Completed  
(8/24/09)**

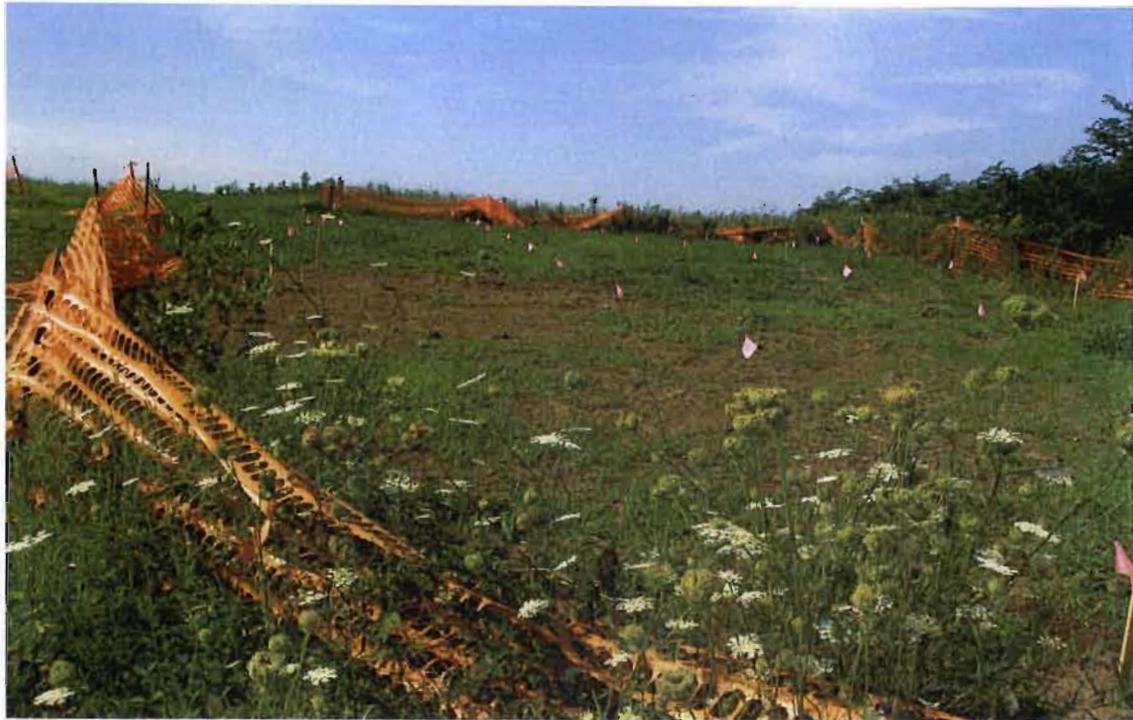
**Metal Beam Stockpile Area A – Inspection, Segregation & Soil Sampling Completed  
(8/24/09)**

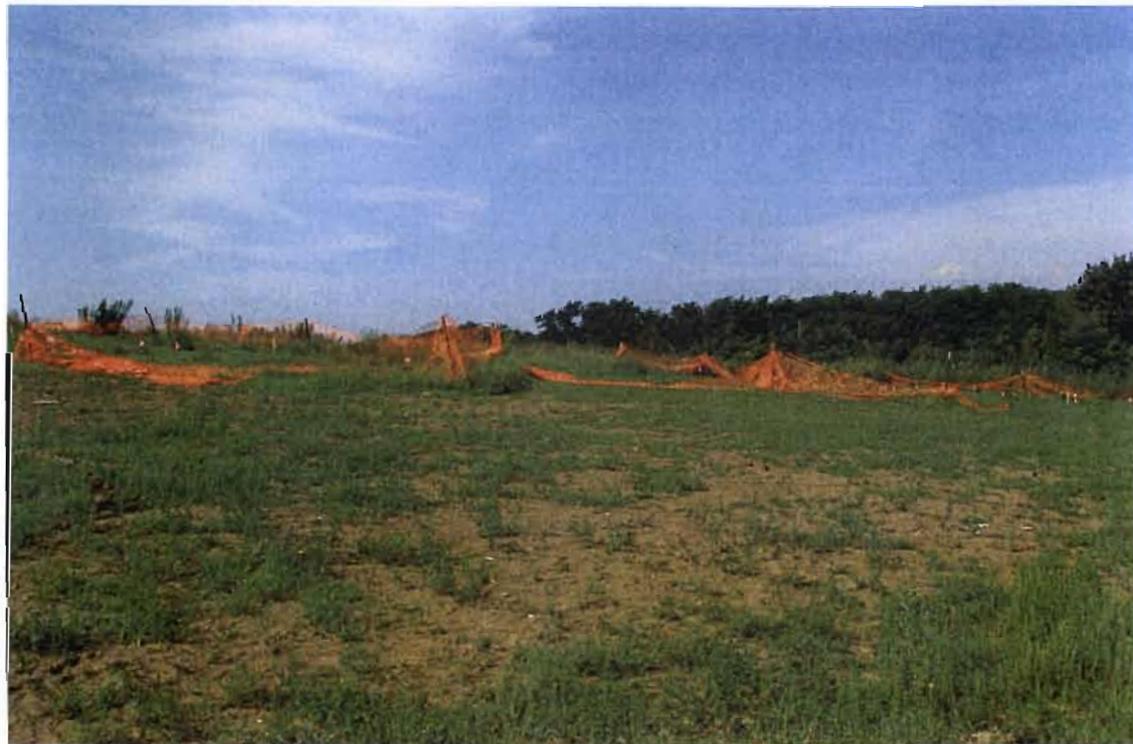
**Metal Beam Stockpile Area B & A – Inspection, Segregation & Soil Sampling Completed  
(8/24/09)**

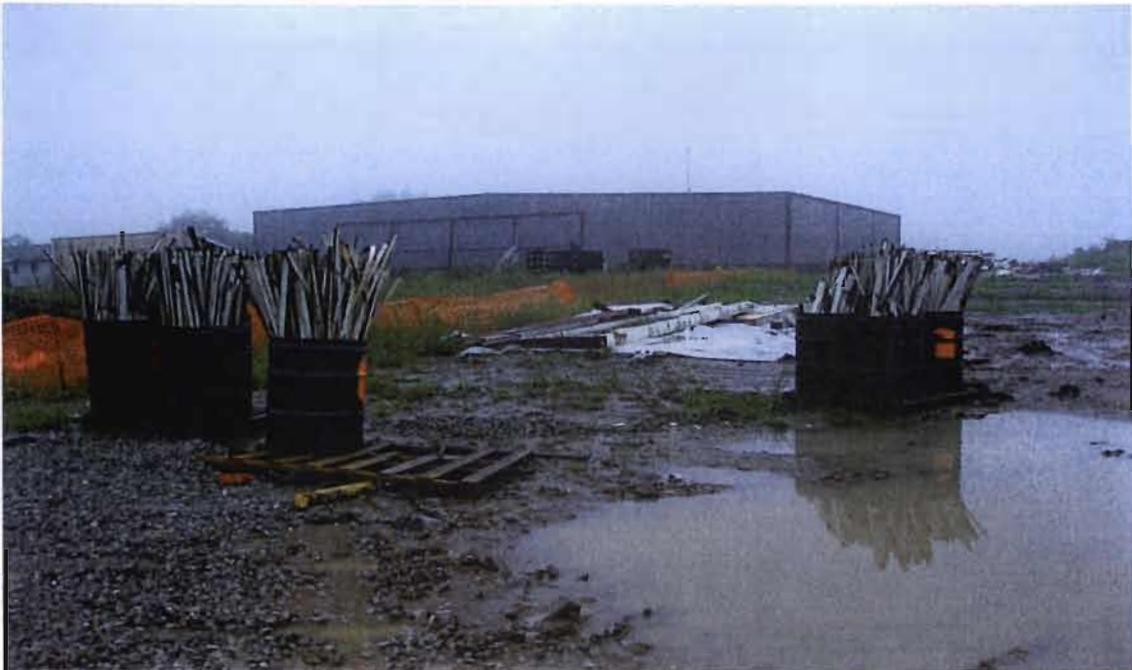
**Site ready for demobilization - photo of EZ entrance facing south; this photo also depicts typical inclement weather, high winds and above normal heavy rainfalls that caused long workday delays and several Site shutdowns (8/27/09)**

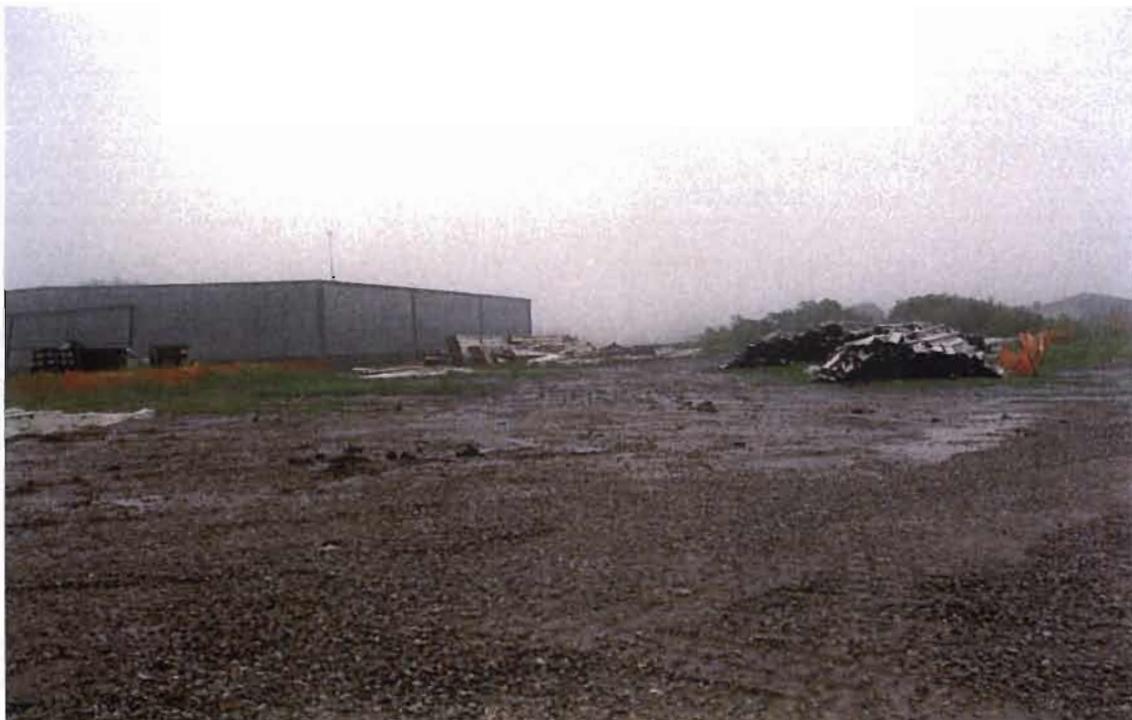
**Site ready for demobilization - photo of EZ, looking south (stockpile C area- right edge). Photo also depicts typical inclement weather, high winds and above normal heavy rainfalls that caused long workday delays and several Site shutdowns (8/27/09)**

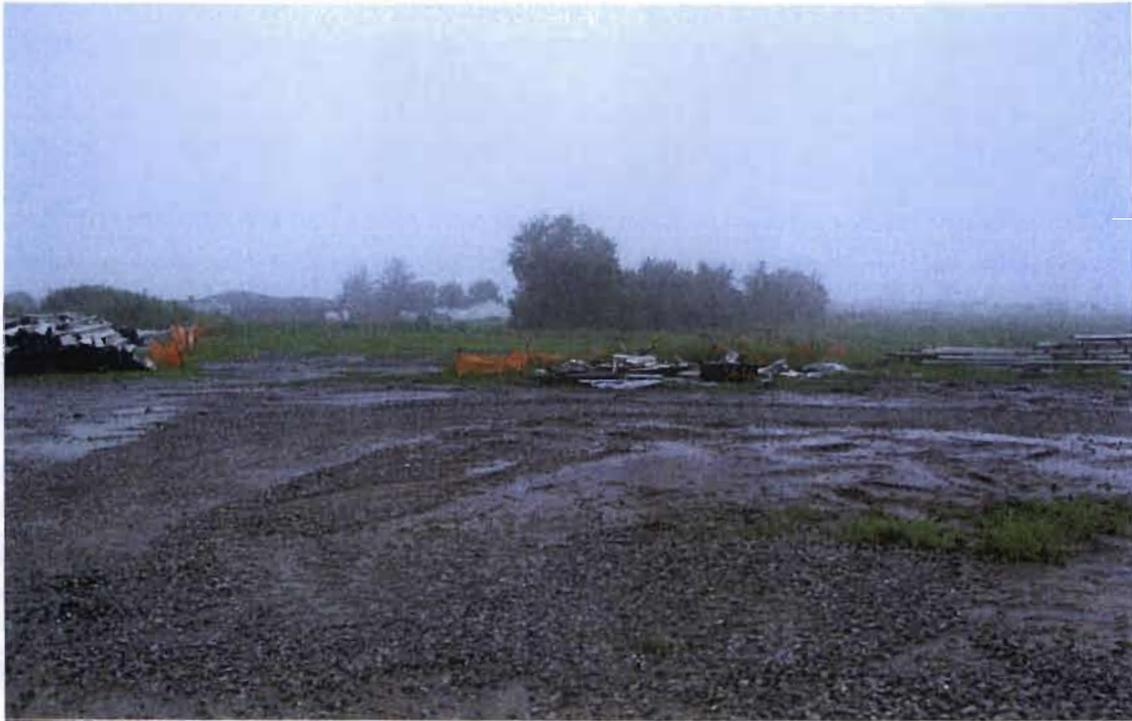
**Site ready for demobilization - photo of EZ, looking south towards stockpile C area. Photo also depicts typical inclement weather, high winds and above normal heavy rainfalls that caused long workday delays and several Site shutdowns (8/27/09)**

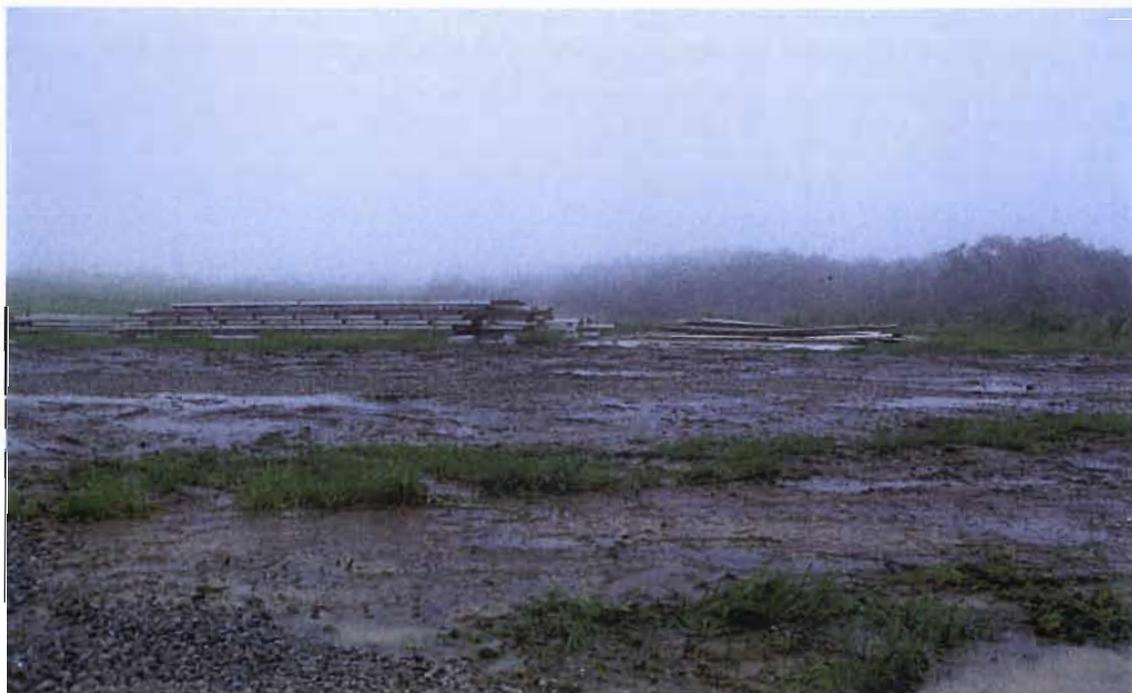
**Site ready for demobilization - photo of EZ, looking west. Photo also depicts typical inclement weather, high winds and above normal heavy rainfalls that caused long workday delays and several Site shutdowns (8/27/09)**

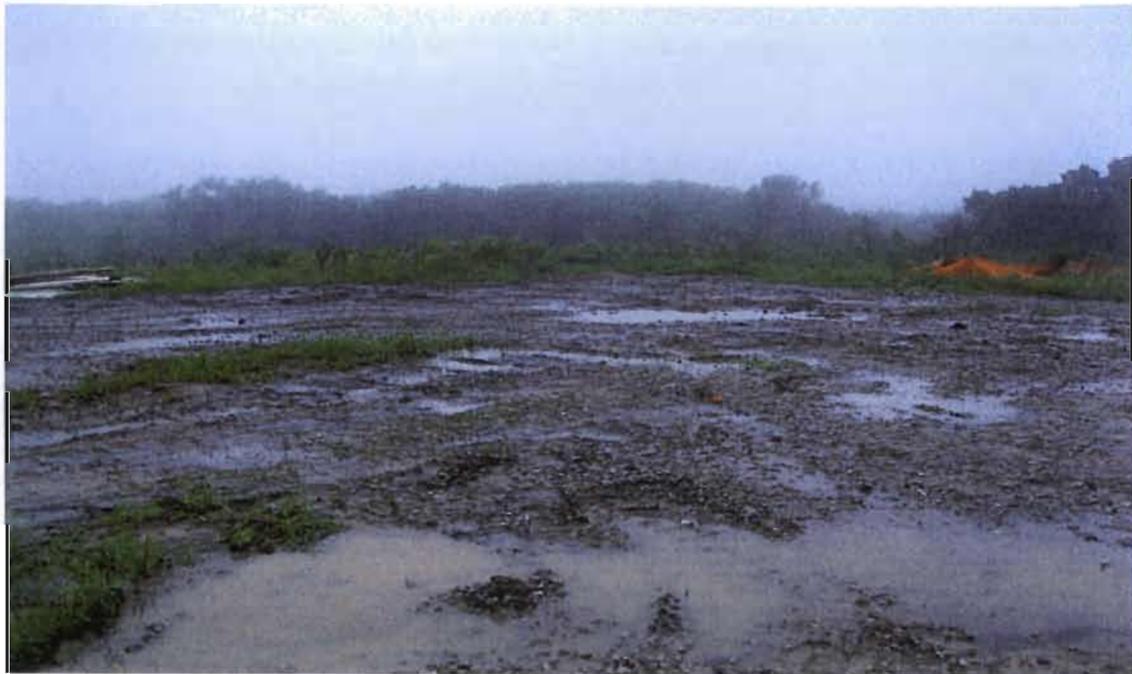
**Site ready for demobilization - photo of EZ looking west at former decontamination tent area. (stockpile B area- right edge). Photo also depicts typical inclement weather, high winds and above normal heavy rainfalls that caused long workday delays and several Site shutdowns (8/27/09)**

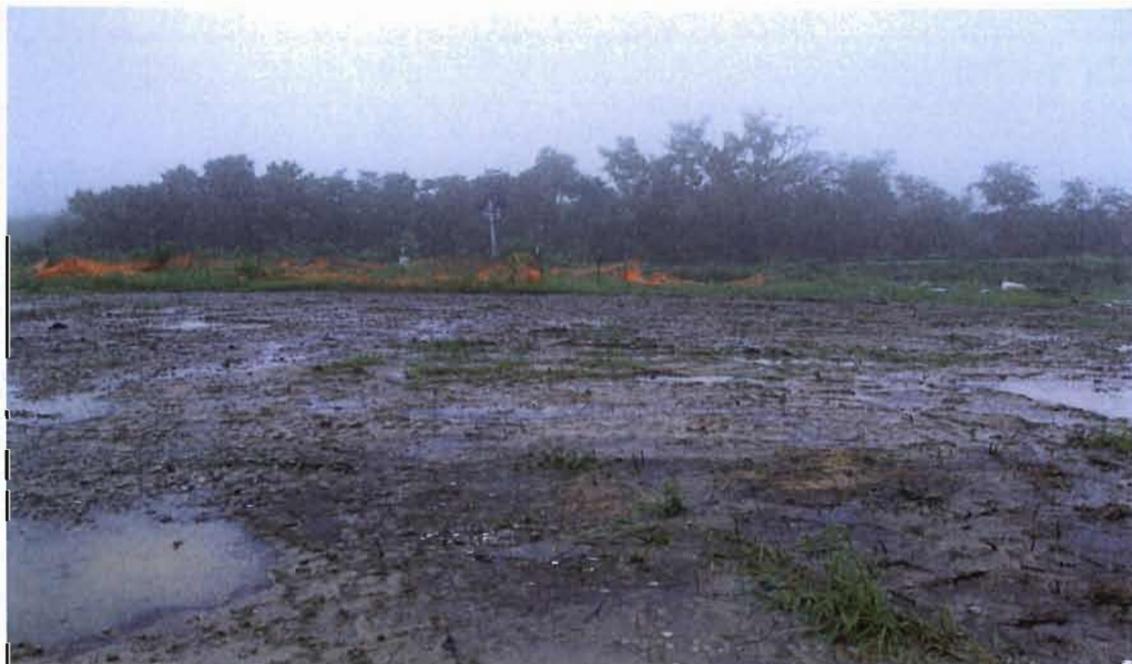
**Site ready for demobilization - photo of EZ looking northwest at former stockpile B area (foreground) & A (background). Photo also depicts typical inclement weather, high winds and above normal heavy rainfalls that caused long workday delays and several Site shutdowns (8/27/09)**

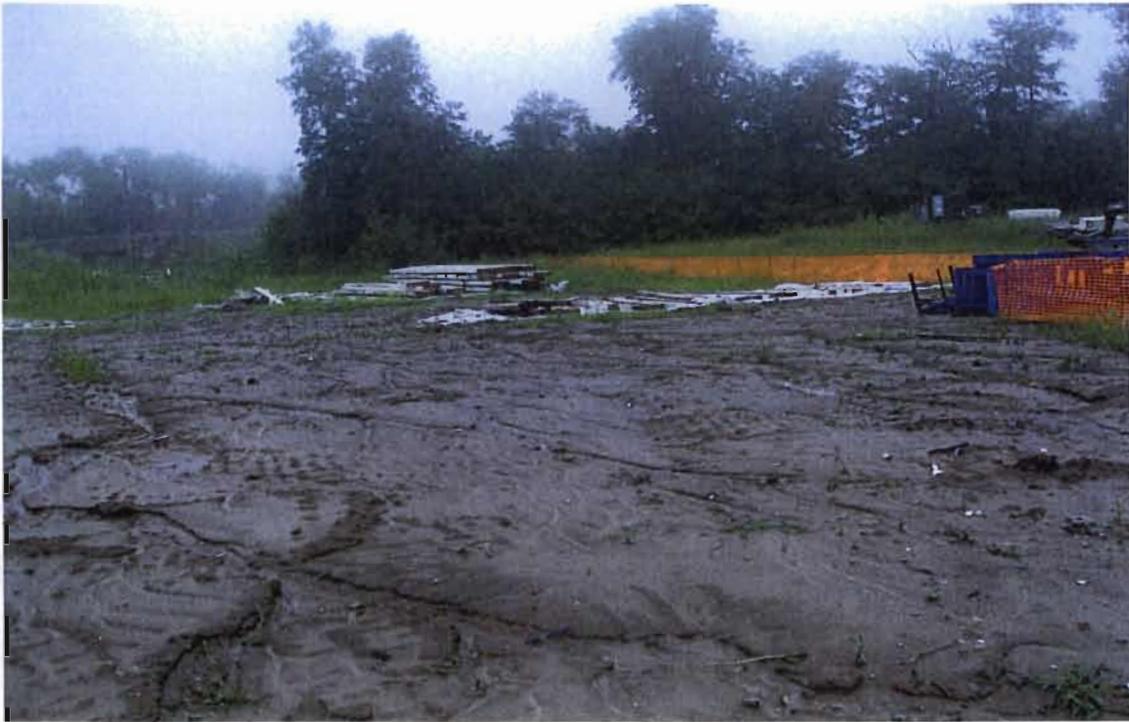
**Site ready for demobilization - photo of EZ looking north. Photo also depicts typical inclement weather, high winds and above normal heavy rainfalls that caused long workday delays and several Site shutdowns (8/27/09)**

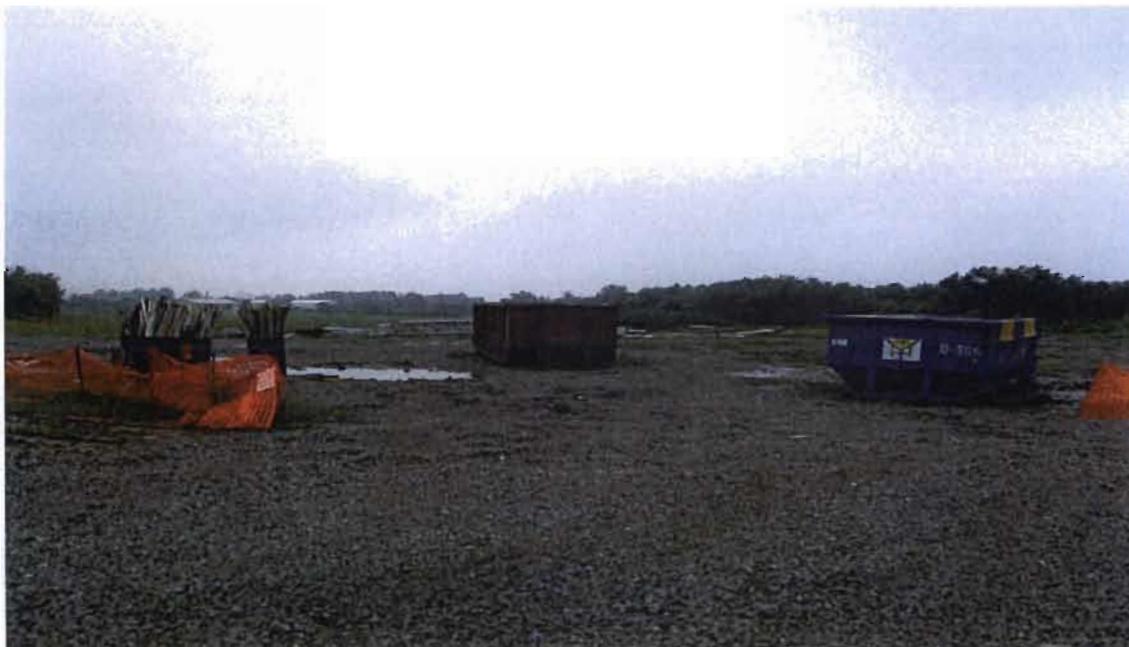
**Photo at EZ entrance showing site ready for demobilization; decontamination tent & storage containers demobilized. Soil and Debris rolloffs ready for transportation to Metro Waste Authority Landfill (8/27/09)**

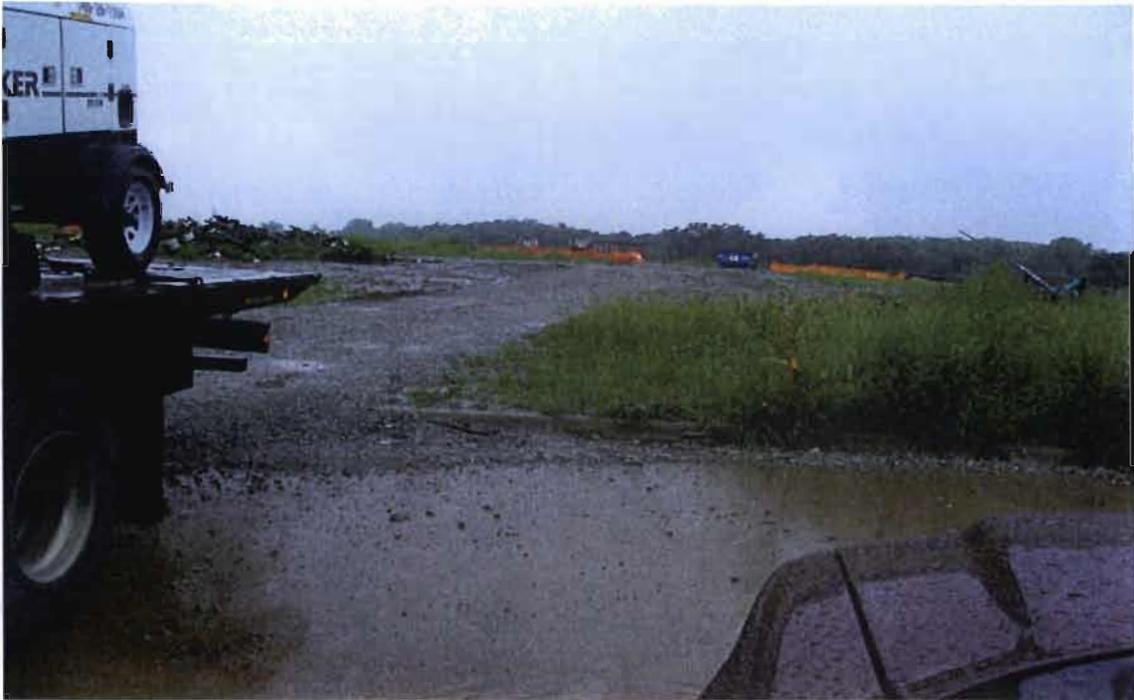
**Photo from cul-de-sac showing site ready for demobilization; support zone trailers, storage containers & equipment demobilized. (Stockpile in left edge of photo from SIM activities on east side of property) (8/27/09)**
