Colorado NPDES Storm Water Inspection - Construction

NATIONAL DATABASE INFORMATION	
Inspection Date: 3/11/11	Inspection Type: Stormwater Construction
Entry Time: 9:20am	Exit Time: 12:20pm
NPDES ID Number: COR03H278	
Inspector: Natasha Davis	EPA/State/Contractor
Inspector: Stephanie Gieck	EPA/State/Contractor

Facility Location Information:(Name/Location/ Mailing Address)	
Site/Facility Location: Arkansas River Trail Phase 2 4th Street to Clark Street along the south side of the Arkansas River Pueblo, CO	Mail Report to: Michael Brown Langston Concrete Inc. 2335 N Interstate 25 Pueblo, CO 81008

Photographs for Arkansas River Trail 2 - COR03H278

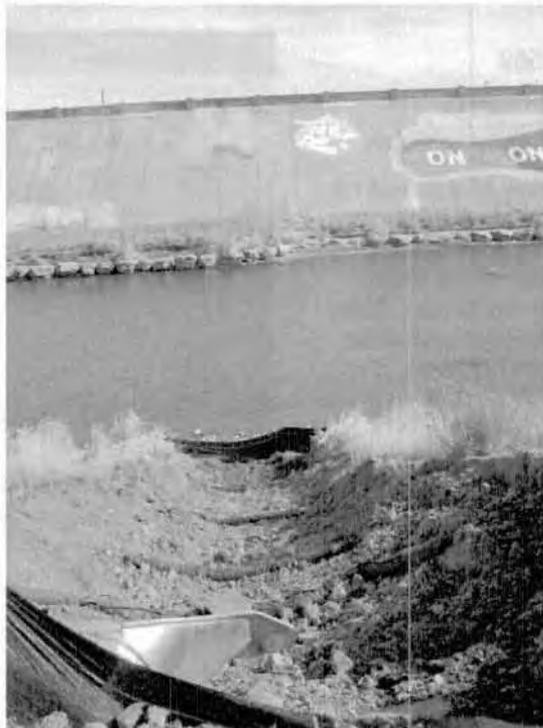
Photo Number 1560

Equipment/maintenance area	Y			Y			The equipment storage area east of the Main Street Bridge was not indicated on the site map.
Concrete washout area	Y			Y			Photo 1587
Port-o-lets	Y				N		The site was inactive at the time of the inspection. A port-o-let will be used when activity resumes.
Existing vegetation		N		Y			Existing vegetation on the slope from the trail to the river was seen on site but not indicated as a vegetative buffer BMP in the SWMP or site map. Photo 1568
Seeding	Y				N		Seeding will be used during final stabilization.
Filter Fabric		N		Y			Erosion control matting was seen on site. Photos 1562, 1583
Culverts		N		Y			The culvert partially constructed east of Main Street has the potential to discharge a significant amount of sediment. Photos 1560, 1584, 1585, 1586

Are stabilization practices properly applied in a timely manner and adequately maintained?	<p><i>(e.g., indicate "yes" or "no"; if "yes", how long without stabilization measures?)</i></p> <p>No, see explanation above. Additionally, the culvert constructed east of Main Street (Photos 1560, 1584, 1585, 1586, 1589) had not been completed but could have been completed in a timely manner, as specified in the SWMP, or additional correctly installed BMPs put in place to prevent direct discharges (Photos 1584, 1586) into the Arkansas River. LCI plans to complete the culvert by installing rip rap.</p>
Are structural controls properly installed and maintained?	<p><i>(e.g., indicate "yes" or "no"; explain if necessary)</i></p> <p>No, there were several areas where the silt fence was not trenched or replaced when damaged, as seen in photos 1563, 1573, 1576, and 1582. There were areas where silt fence was found in the river, as seen in photos 1565, 1566, and 1575. Below the culvert near Main Street, the silt fence could easily be bypassed, as seen in photo 1584. In addition, the culvert installed near the railroad bridge, just west of Clark Street, had filter fabric that had been washed from above the culvert through the pipe (Photo 1583).</p>

Discuss how the structural controls are, or are not appropriate for the site.	<p><i>(e.g., silt fence installed in a live stream)</i></p> <p>LCI plans to install rip rap in the culvert located at the Main Street bridge (photos 1560 and 1585), but delay in construction has prevented this from occurring and allowed sediment erosion into the Arkansas River. Furthermore, the silt fence installed at the base did not surround the area where potential erosion could occur as seen in photo 1584.</p>

Description View to the north of a new culvert outlet and drainage into Arkansas River from the trail east of Main Street bridge.

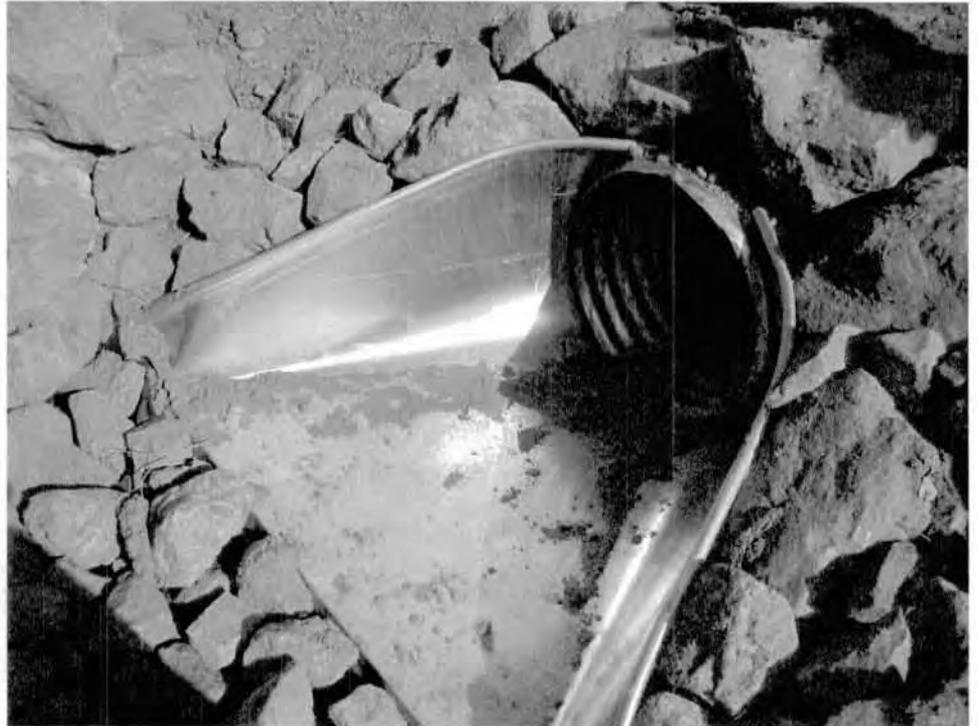
Photo Number 1561
Inspection Date 3/11/2011
Photographer Stephanie Gieck
Description View of the culvert outlet of Photo 1560.

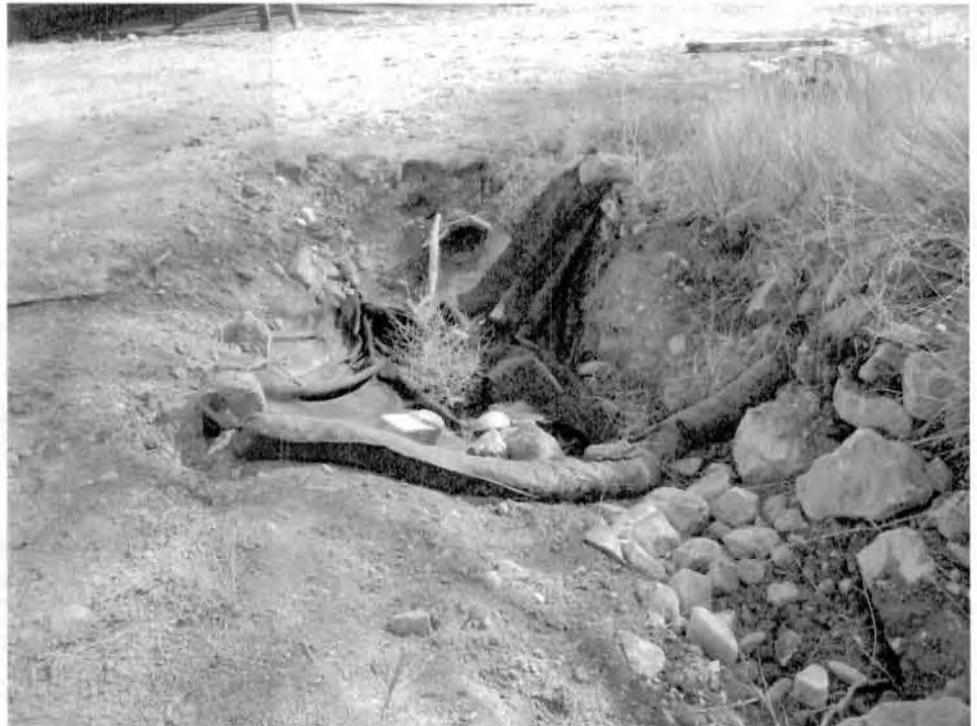
Photo Number 1562
Inspection Date 3/11/2011
Photographer Stephanie Gieck
Description View of a culvert at the construction site entrance located east of the Main Street bridge. Note the inlet protection has not been maintained.

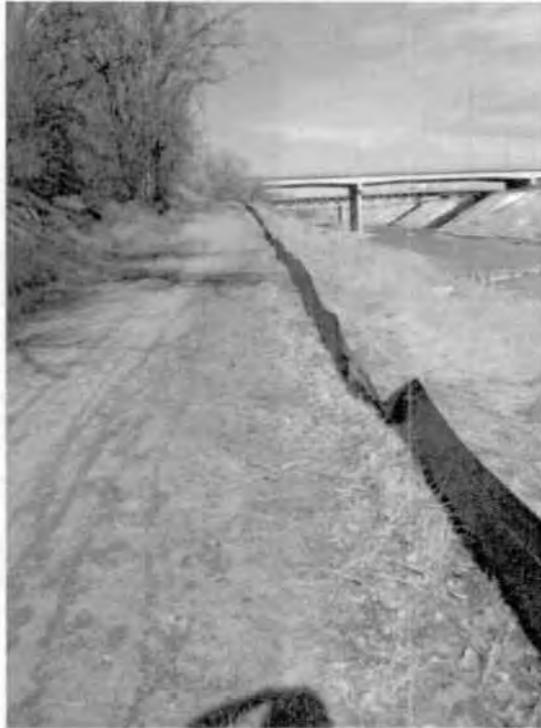
Photo Number 1563

Description View of the project looking west toward Main St. Note the disturbance on both sides of the silt fence and the damage to the silt fence.

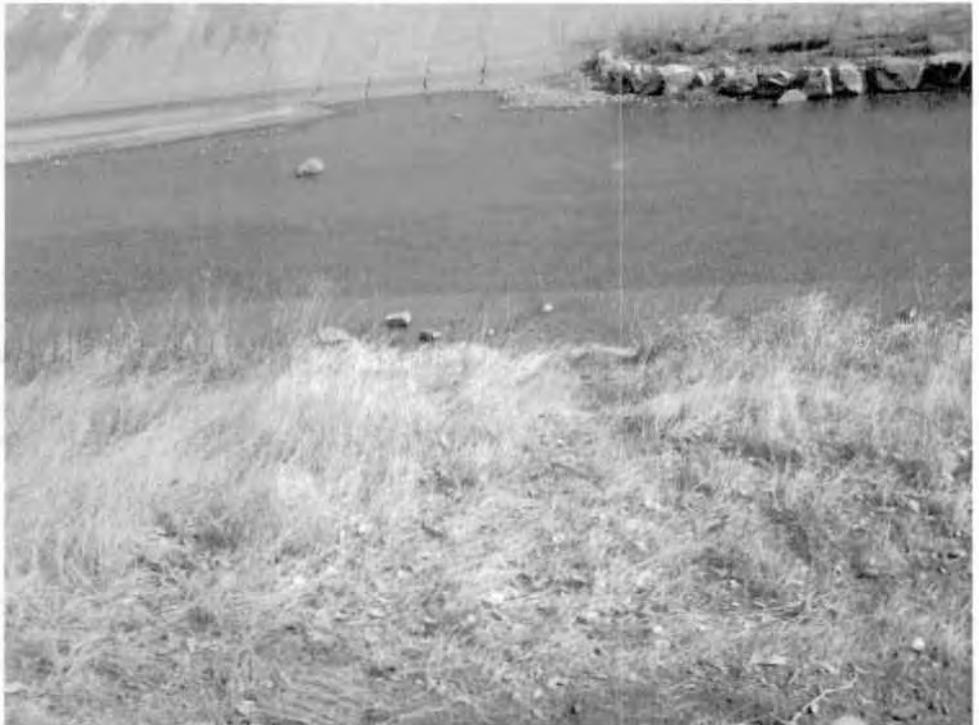
Photo Number 1564

Description View down the hill from the trail toward the Arkansas River. Note the vegetation in the center of the photo is matted down in the same direction toward the river.

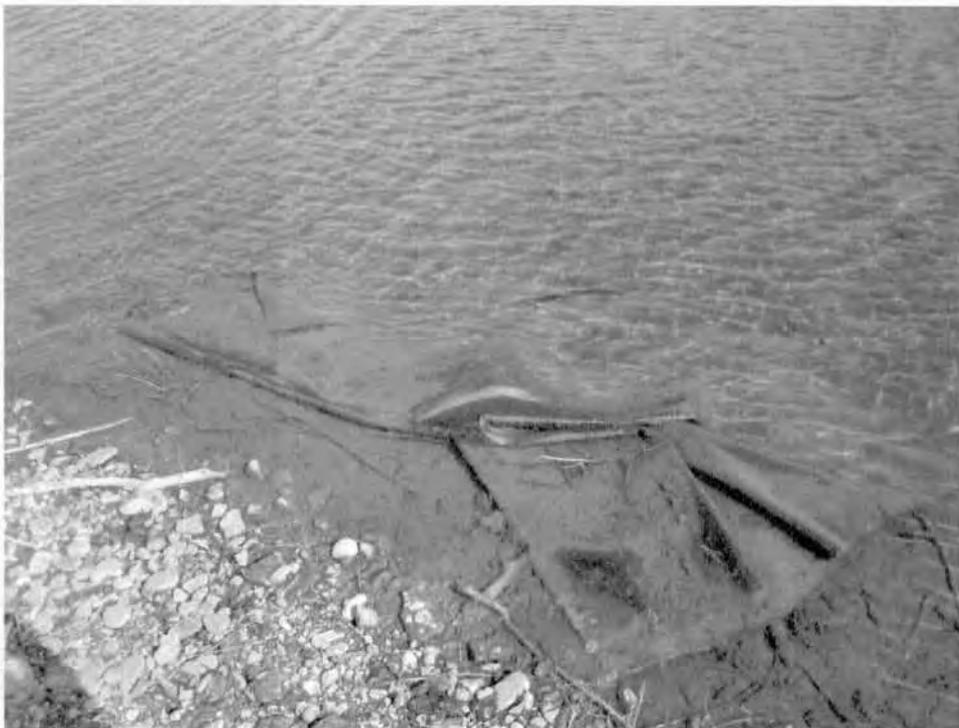
Photo Number 1565

Description Down silt fence in the Arkansas River along the project site.

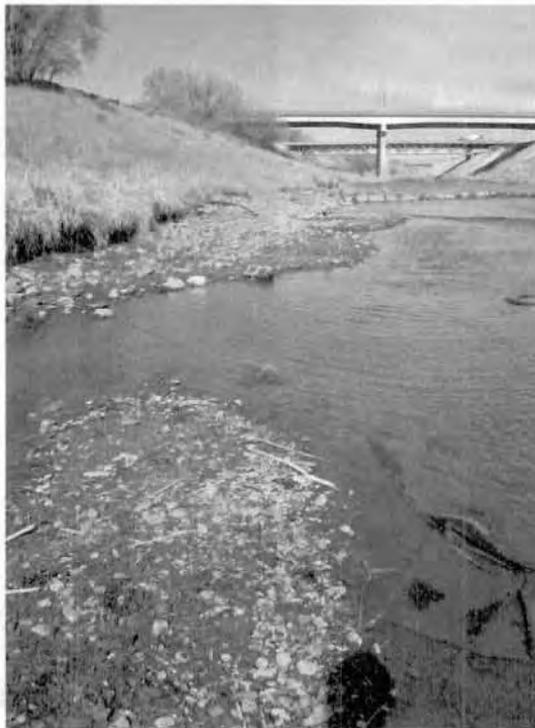
Photo Number 1566

Description View of the Arkansas River along the project site looking west toward Main St. Note the down silt fence in the lower right corner of the photo.

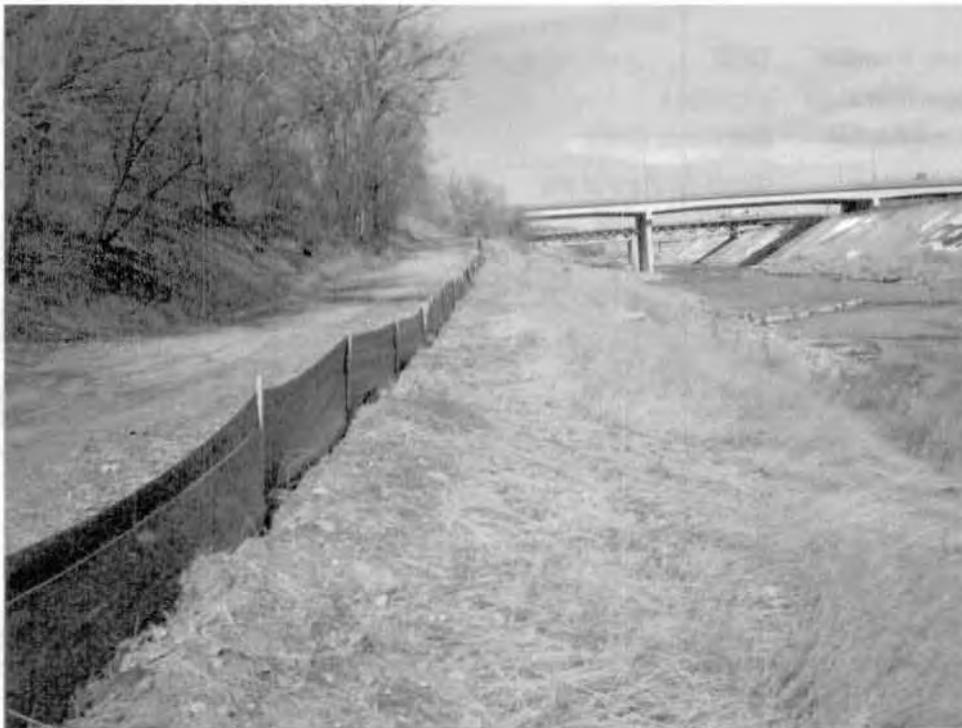
Photo Number 1568

SWPPP Implementation (Site Review)	
Structural and Stabilization Practices	
Any unprotected/exposed slopes/areas without vegetation mulch or matting after construction activity has ceased?	<p><i>(e.g., indicate "yes" or "no"; if "yes", how long without stabilization measures?)</i> <i>(Note: for information only in Colorado)</i></p> <p>Yes, there was one location along the trail approximately 3/4 of the way between Main Street and Clark Street where an approximate five foot wide section of soil was disturbed from the trail down the hill to the river prior to the inspection. The cause of the disturbance is unknown. No BMPs, mulch or matting were in place to control erosion from this area as seen in photo 1577.</p> <p>The unvegetated trail was bordered by silt fence, but there was unprotected disturbed soil on the downhill side of the silt fence (Photo 1568); Mr. Brown stated that LCI had not planned to manage this disturbed area.</p>

Description View of the project looking west toward the Main Street bridge. Note the disturbance on both sides of the silt fence.

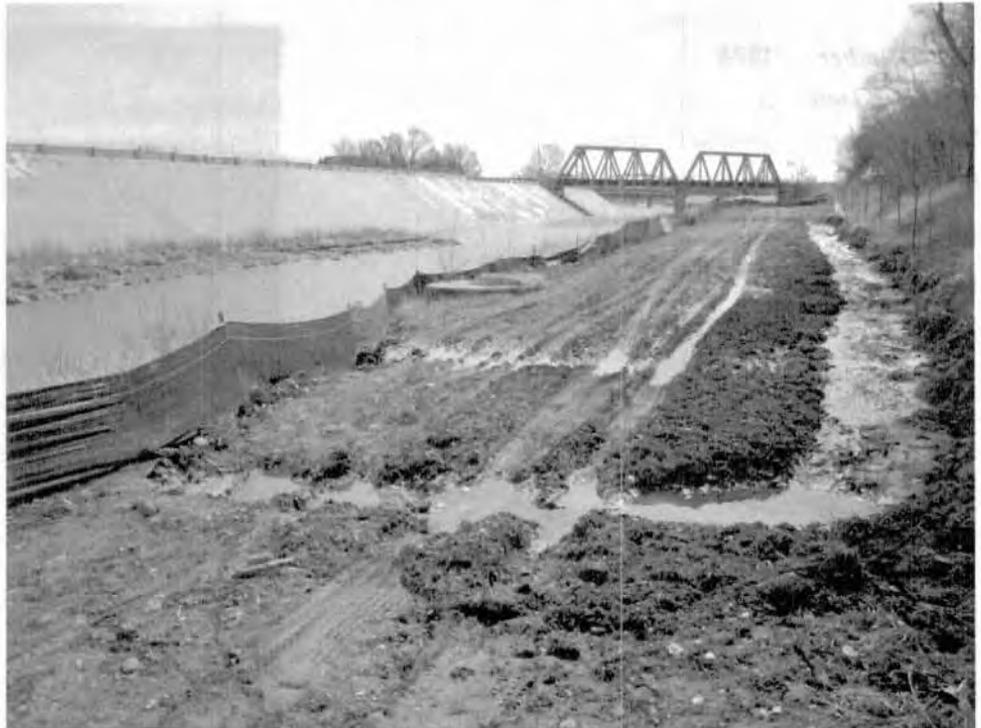
Photo Number 1572

Description View to the east of water flowing from the hillside, along the path, and then under the silt fence to the Arkansas River.

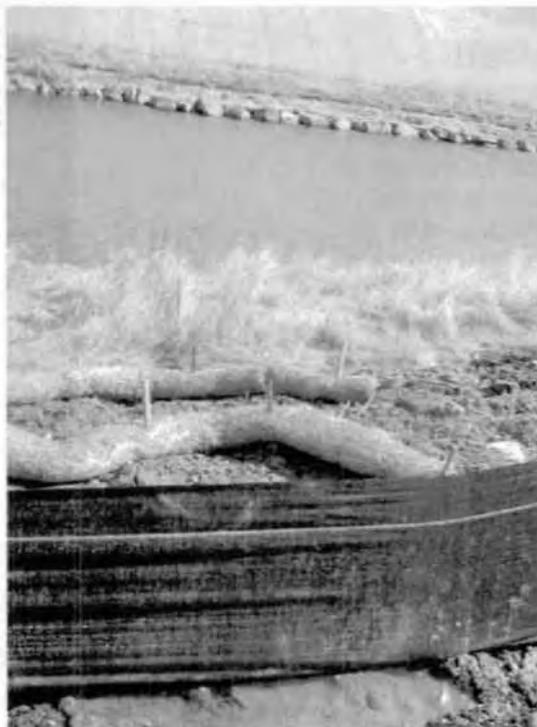
Photo Number 1573

Description View of the water from Photo 1572 flowing under the silt fence toward the Arkansas River. Note the silt fence is not trenched.

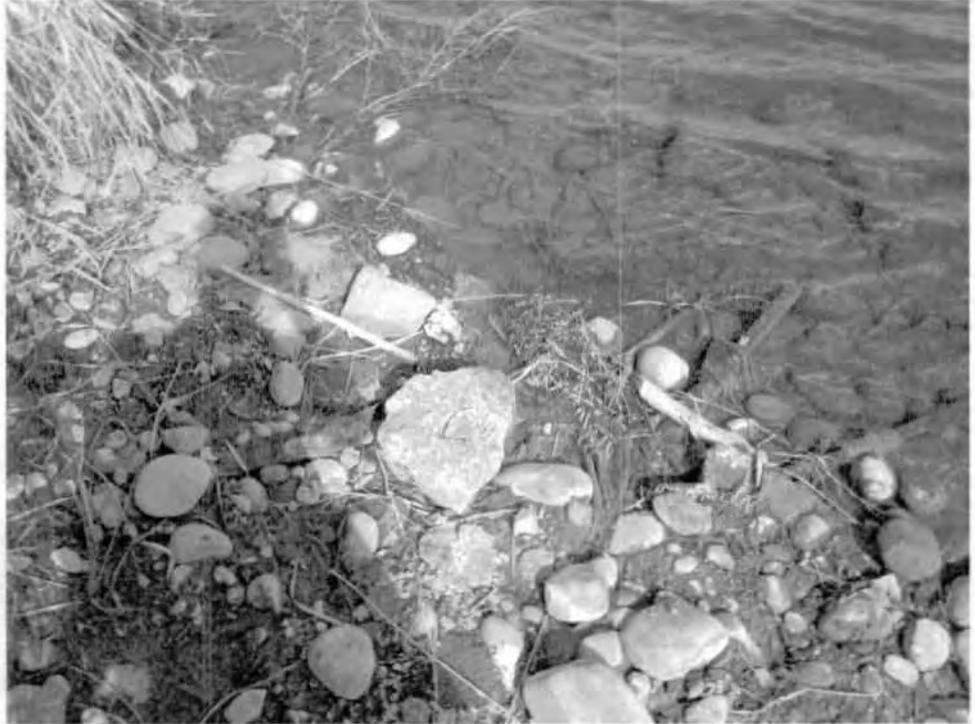
Photo Number 1575

Description View of silt fence in the river below the area of Photos 1572-1574.

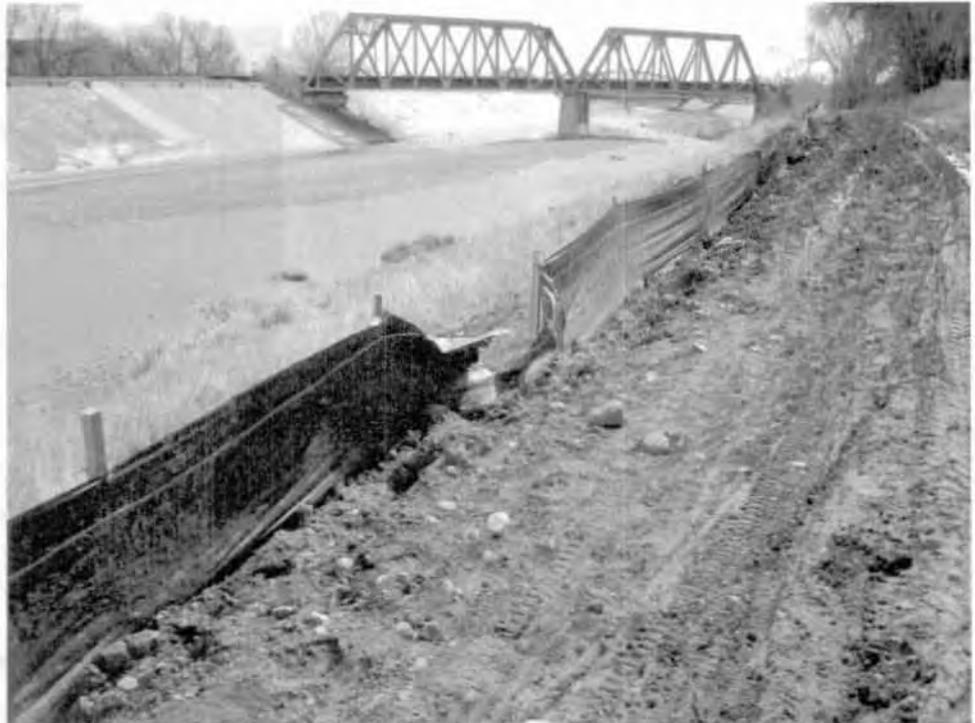
Photo Number 1576

Description View to the east showing damaged silt fence.

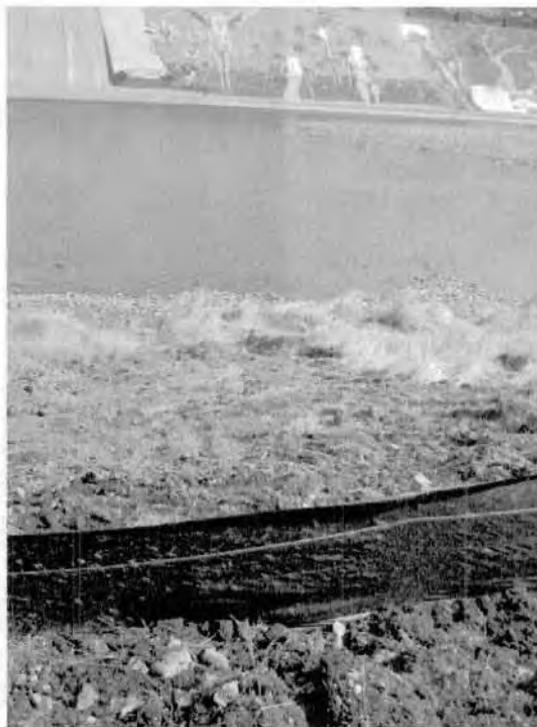
Photo Number 1577

<u>Miscellaneous</u>	
Evidence of Sediment Deposition to Surface Waters	<p><i>(e.g., significant turbidity observed in a receiving water body)</i></p> <p>Yes, the Arkansas River below the Main Street bridge culvert contained excessive sediment downhill from the disturbed area explained above and seen in photo 1577. The sediment seen in photo 1579 and 1580 was deposited below the disturbed strip as compared to a shoreline below an undisturbed area in photo 1581.</p>
Pollution prevention measures for non-storm water discharges?	<p><i>(provide brief description)</i></p> <p>Silt fence around the concrete wash out was installed to prevent discharges (Photo 1587).</p>
Has implementation of additional/modified BMPs been completed before next anticipated storm event?	<p><i>(provide brief description)</i></p> <p>The BMPs on site were installed, inspections ceased, and modified BMPs or the need for additional BMPs has not been evaluated.</p>

Description View to the north of disturbance along the hillside below the trail to the Arkansas River.

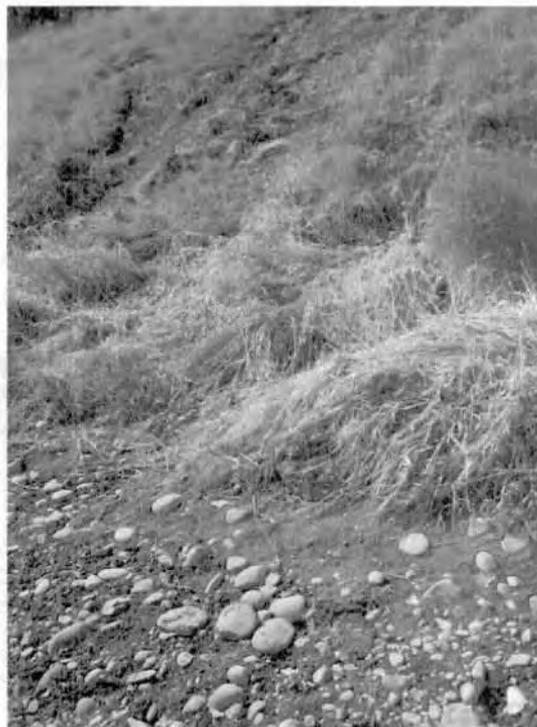
Photo Number 1578

Description View from the river looking uphill to the south of down vegetation and sediment below Photo 1577.

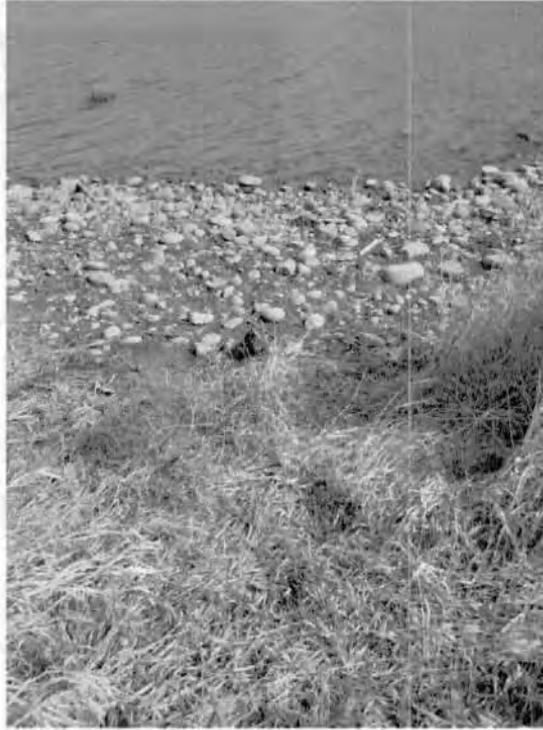
Photo Number 1579

Description View to the north, toward the river, of down vegetation and sediment along the Arkansas River bank below Photos 1577 and 1578.

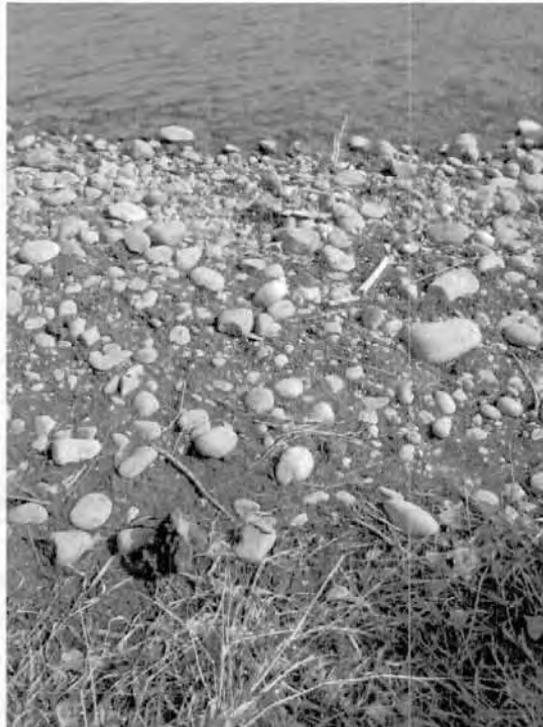
Photo Number 1580

Description Close-up view of sediment along the bank shown in Photo 1579.

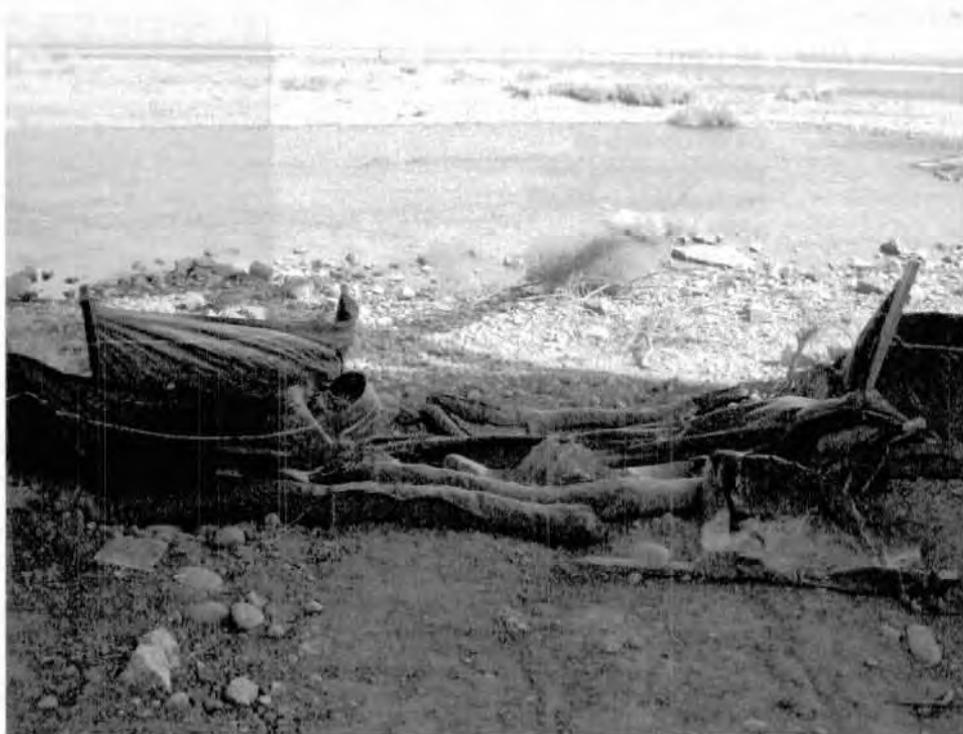
Photo Number 1582
Inspection Date 3/11/2011
Photographer Stephanie Gieck
Description View to the north toward the Arkansas River of damaged silt fence on the east side of the project site under the railroad bridge, near Clark St.

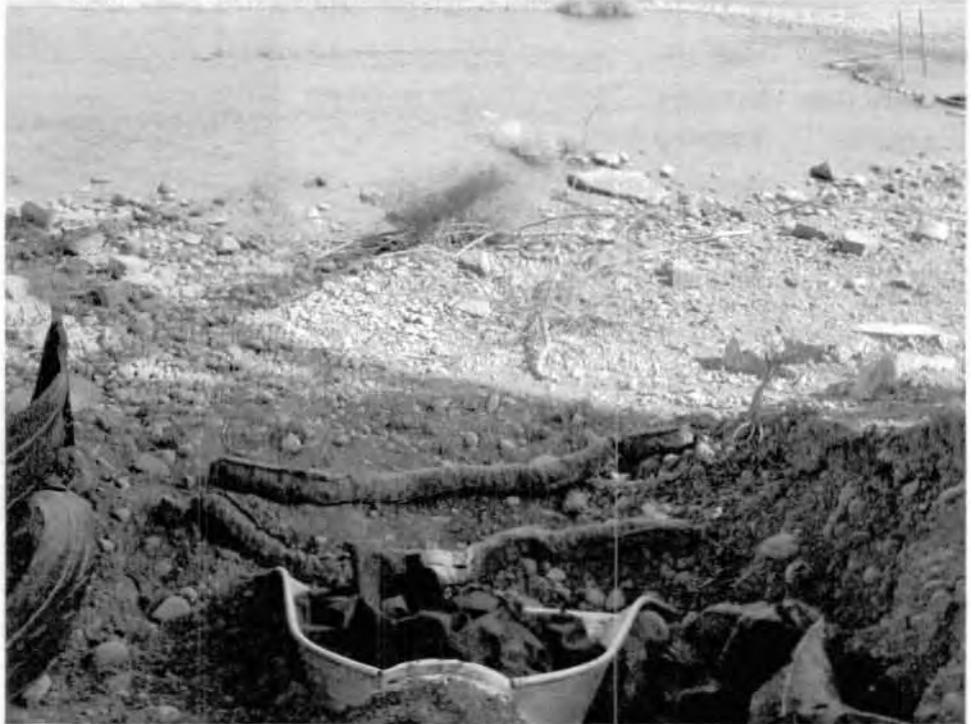
Photo Number 1583

Description View to the north toward the Arkansas River of sediment just below a culvert outlet at the east end of the project site near Clark St. Note the fabric that has been pushed through the culvert from above.

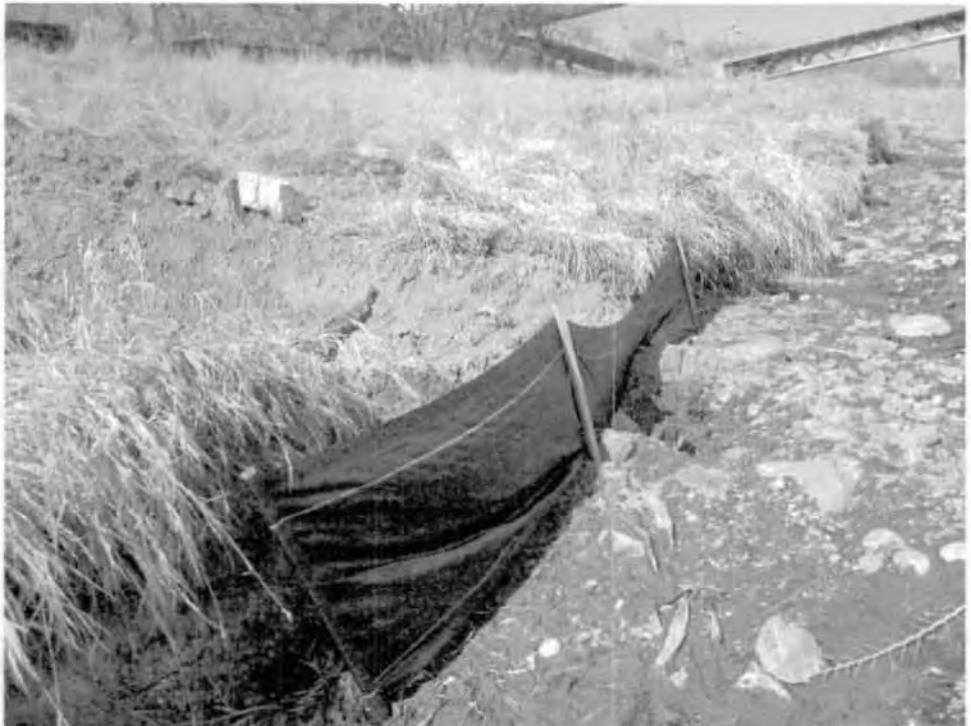
Photo Number 1584

Description View along the river looking southwest toward Main St. below the drainage shown on Photo 1560. Note that stormwater could flow around either side of the silt fence.

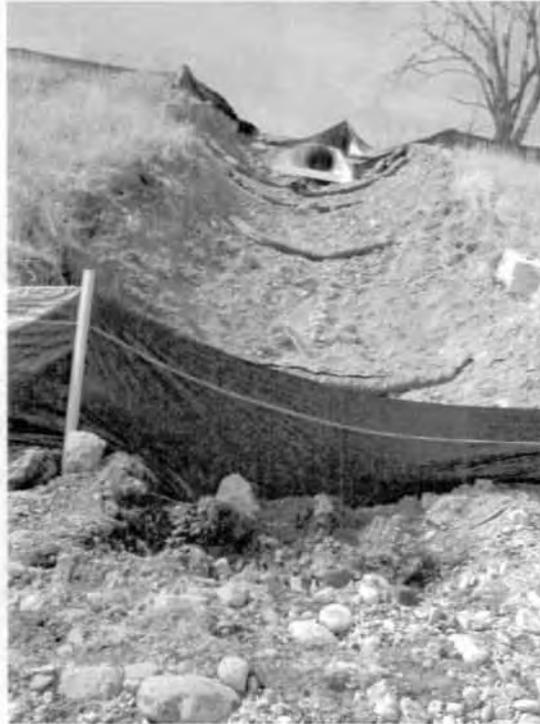
Photo Number 1585
Inspection Date 3/11/2011
Photographer Stephanie Gieck
Description View uphill to the south of the drainage shown in Photo 1560 showing the same silt fence as in Photo 1584.

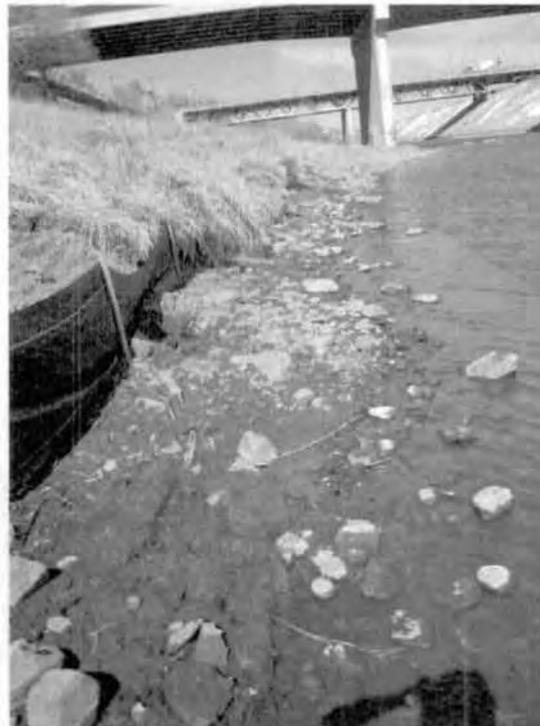
Photo Number 1586
Inspection Date 3/11/2011
Photographer Stephanie Gieck
Description Second view along the river looking southwest toward Main St. below the drainage shown on Photo 1560. Note the difference in the sediment near the silt fence compared to the area near the first bridge (Main St.).

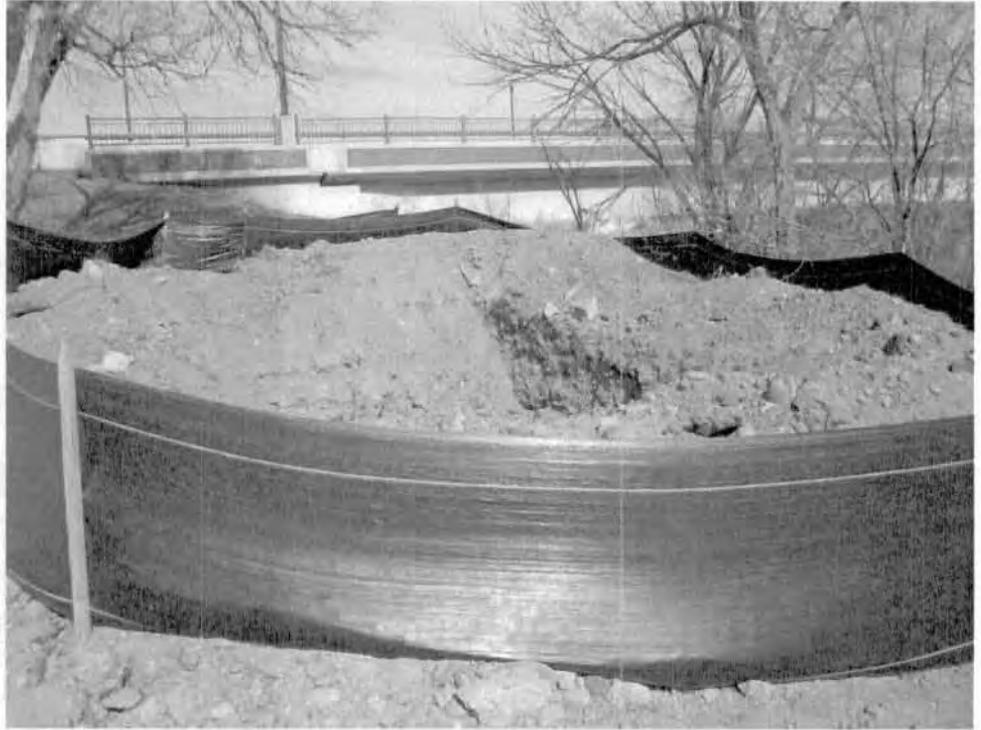
Photo Number 1587
Inspection Date 3/11/2011
Photographer Stephanie Gieck
Description Concrete washout located near the equipment storage area and the construction site entrance near Main Street.

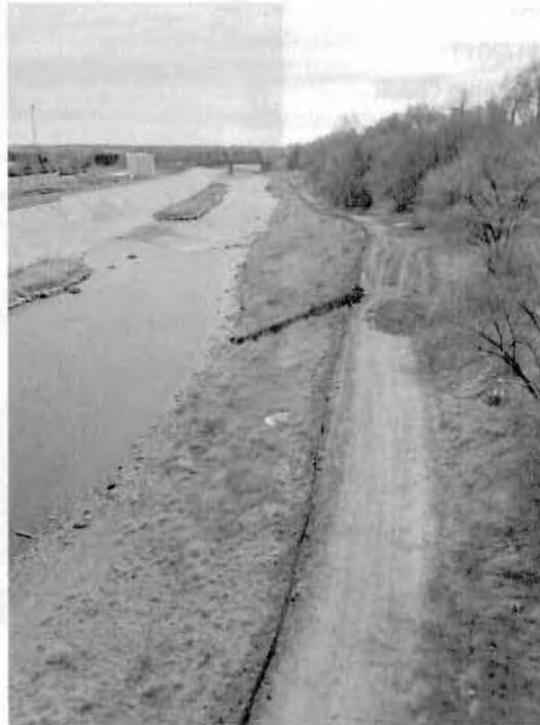
Photo Number 1589

Description Overview of the project site from Main St. looking east. The culvert outlet drainage shown in Photo 1560 is visible in the center of the photo.
