Re: Response to United States Environmental Protection Agency Expedited Information Request for Fulton Fuel Crude Oil Release into Fred and George Creek, Toole County, Montana

Figure 1
Fulton Fuel Company: Fred & George Creek Crude Release Site Location Map
 Latitude: 48° 57.5783' N Longitude: 111° 26.1601' W
 Project Area: Township 37 North, Range 2 E, Section 14

PHOTOGRAPHIC LOG

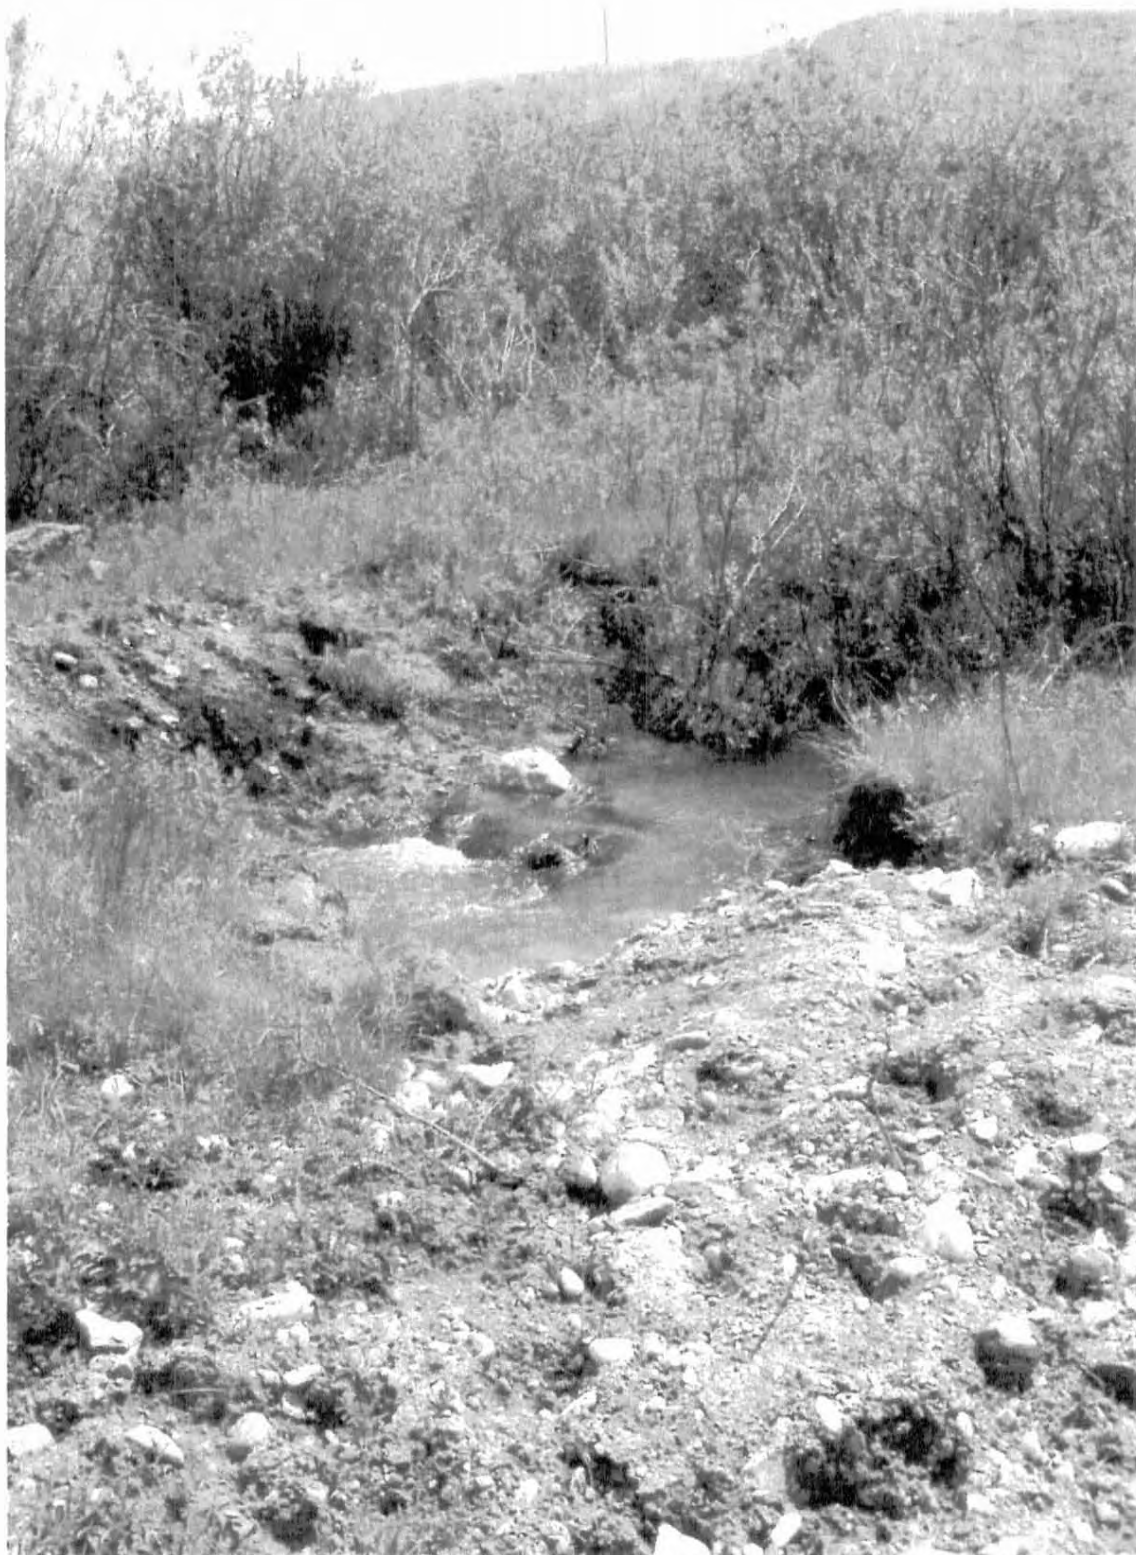
Photo taken: June 17, 2004

View to the south of the flowing stream at the approximate southern end of the planned excavation area. The ground disturbance (center left) was caused by the excavation of the fiberglass pipe in order to seal off the ends to prevent further release.

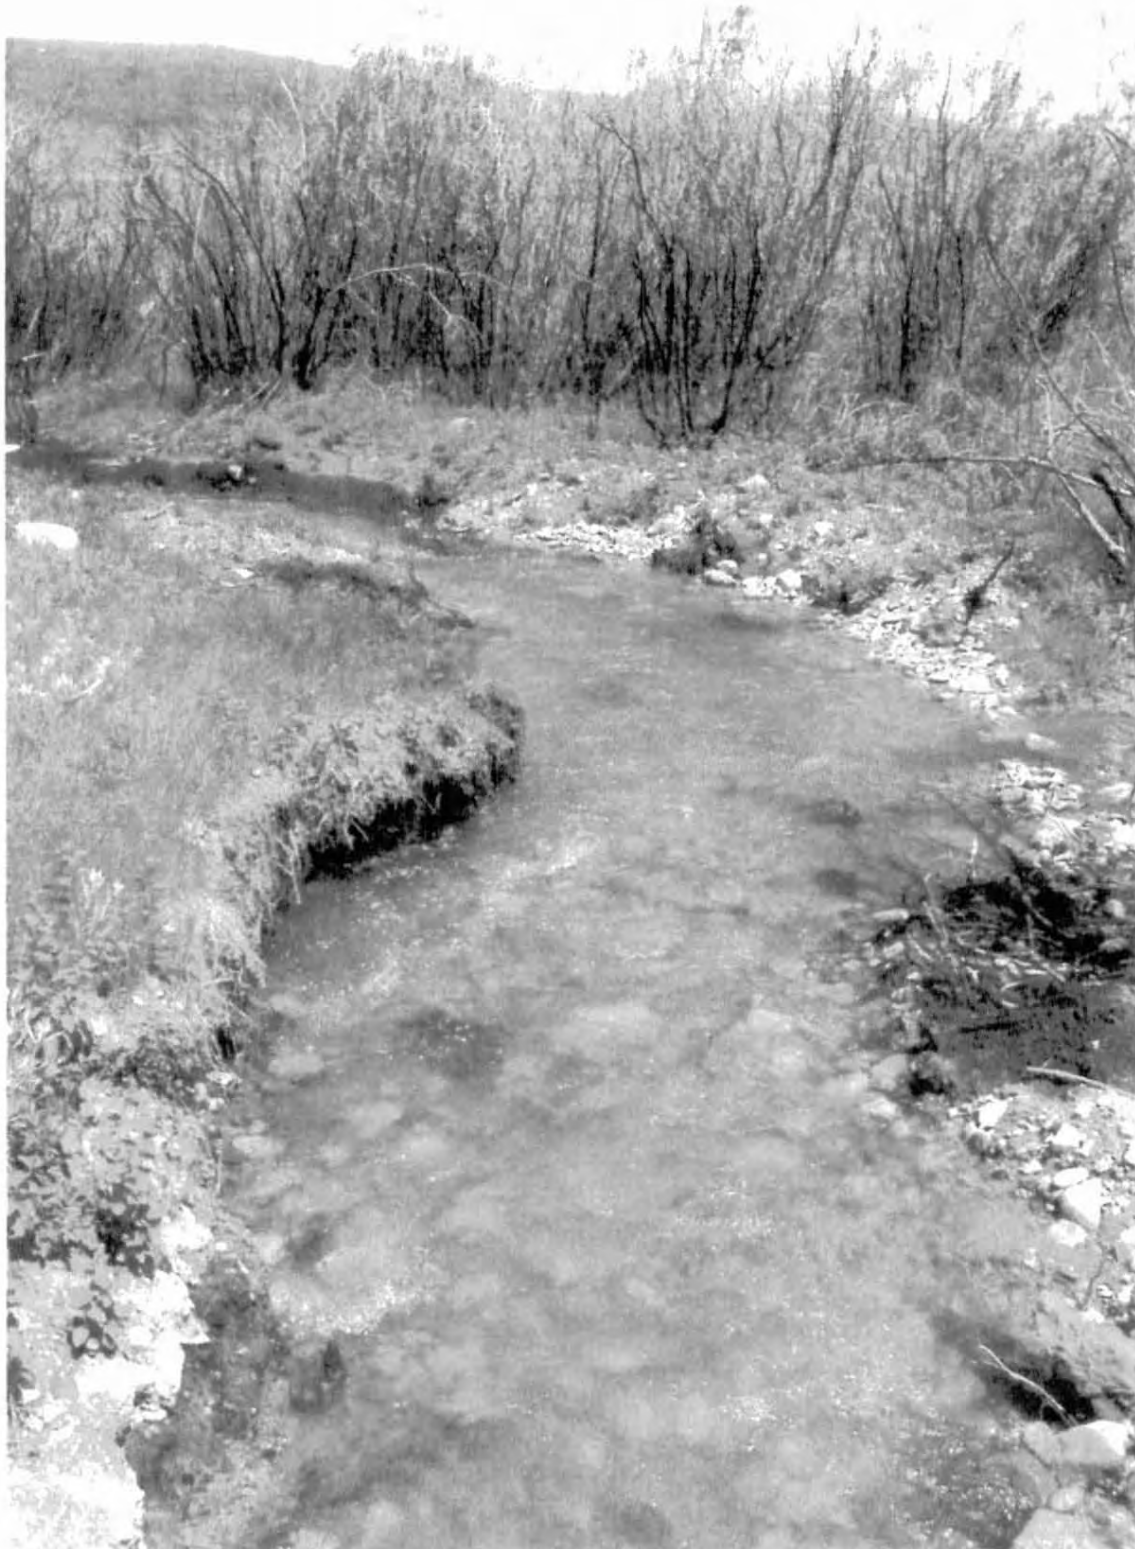
Photo taken: June 17, 2004

View to the northeast of the flowing stream at the approximate mid-point of the planned excavation area. Crude 'staining' is also visible along the bank immediately above the water line (far right and bottom left of photo).

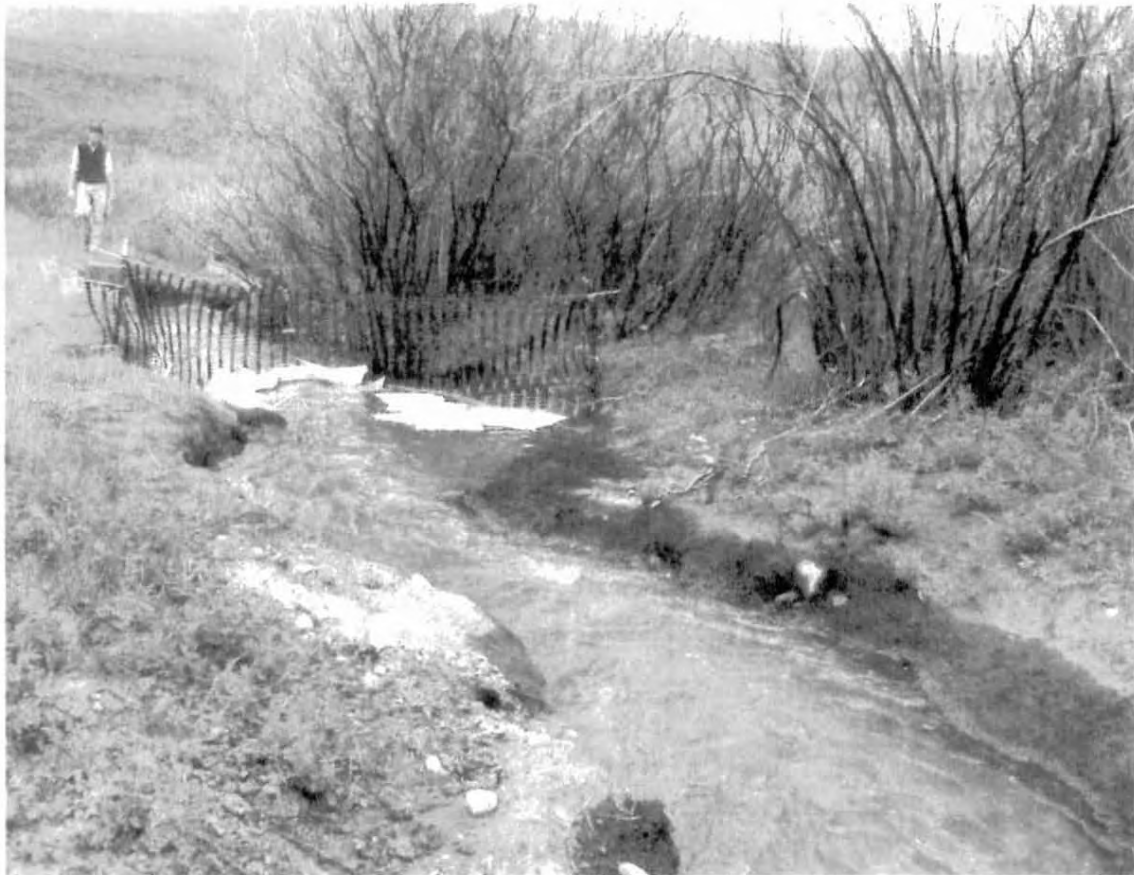
Photo taken: June 17, 2004

View to the north of the flowing stream at the north end of the planned excavation area. Note the padding in place as countermeasure to the crude release. Crude 'staining' is also visible along the bank immediately above the water line.

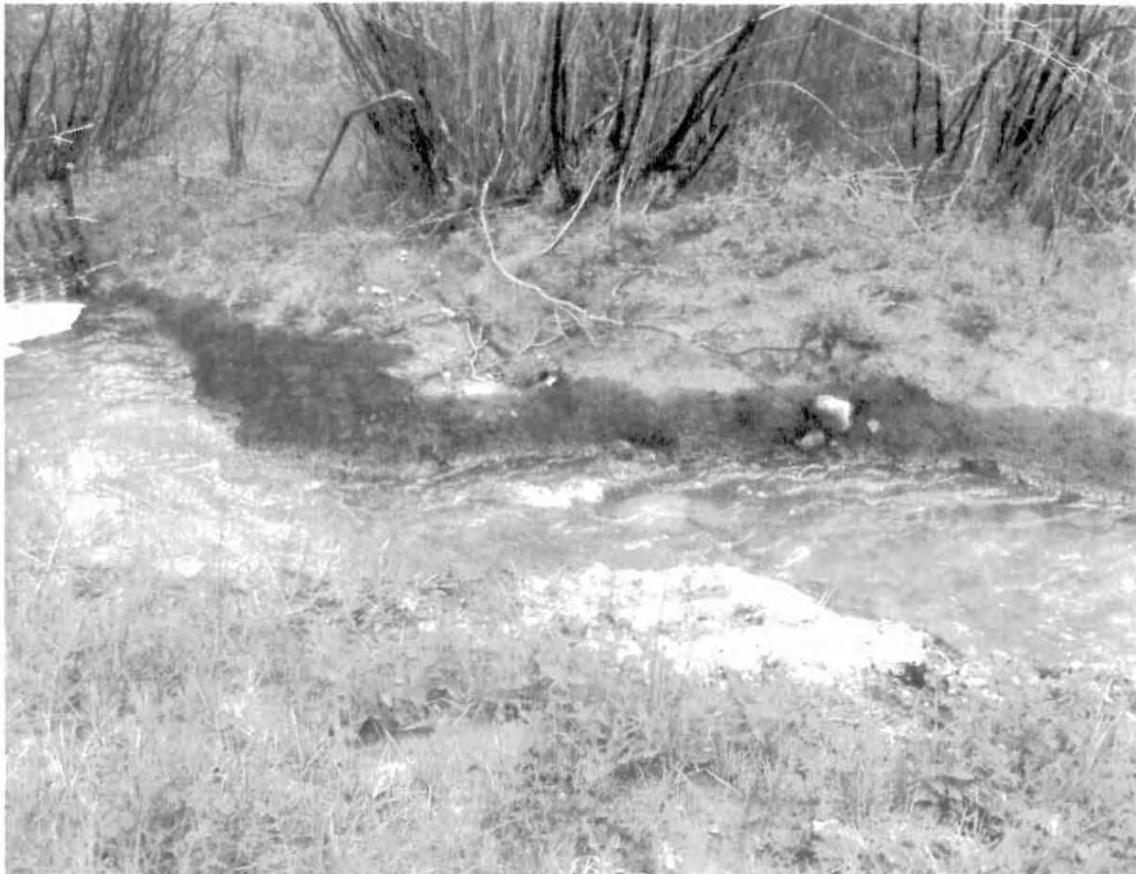
Photo taken: June 17, 2004

View to the east of the flowing stream at the north end of the planned excavation area. Note the padding in place (far left of photo) as countermeasure to the crude release. Crude 'staining' is also visible along the bank immediately above the water line.

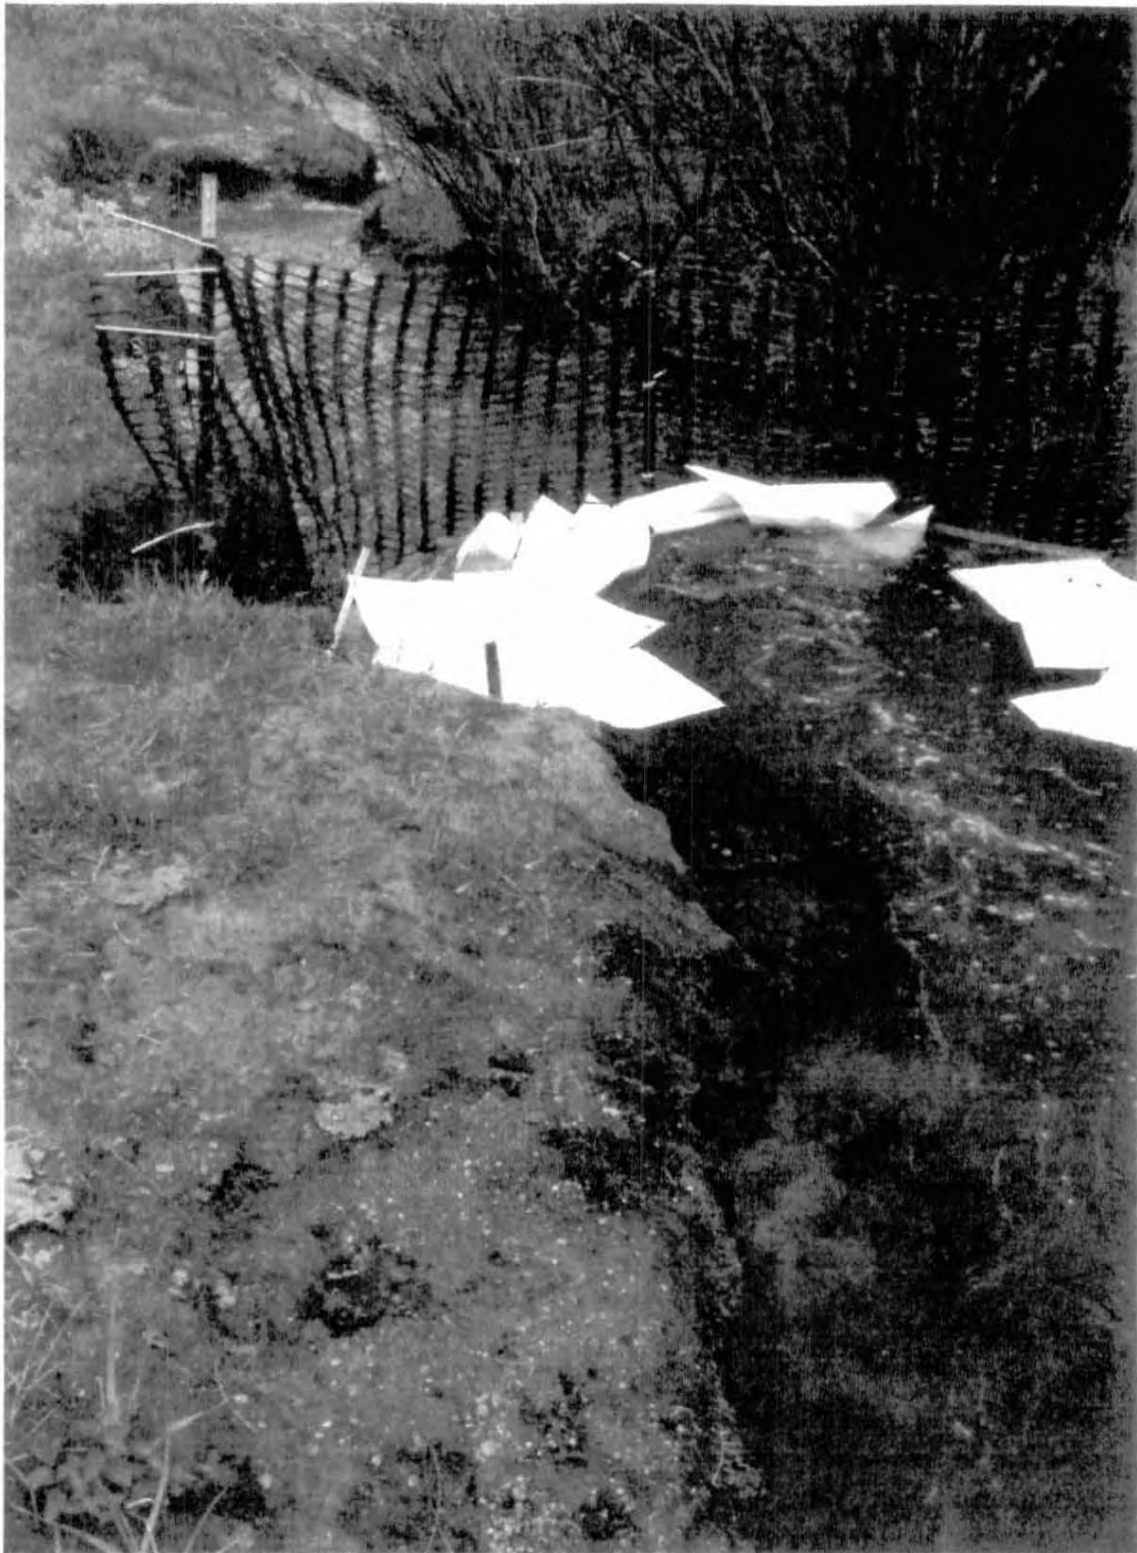
Photo taken: June 17, 2004

View to the north of the flowing stream at the north end of the planned excavation area. Note the padding in place as countermeasure to the crude release. Crude 'staining' is also visible along the bank immediately above the water line.

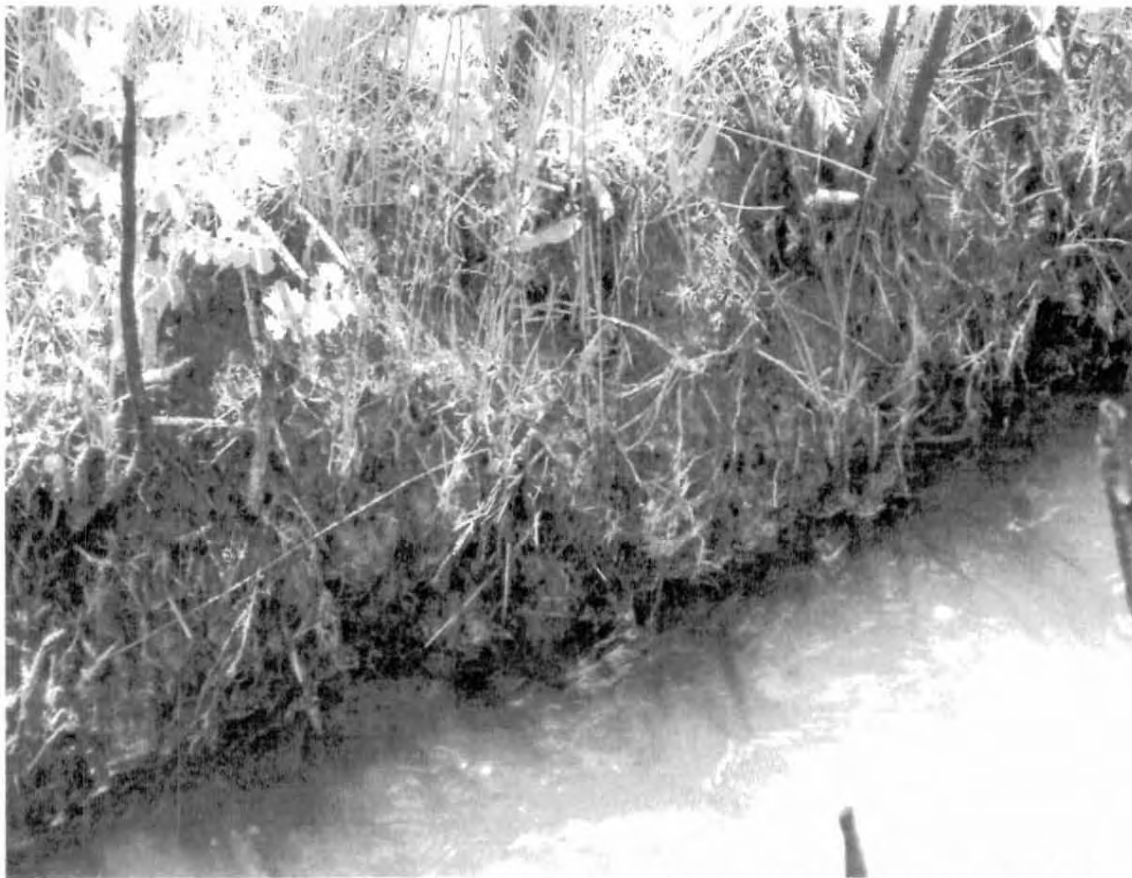
Photo taken: June 17, 2004

View of the flowing stream to the west of the planned excavation area. Note some residual evidence of the crude release along the banks just below the grass line.

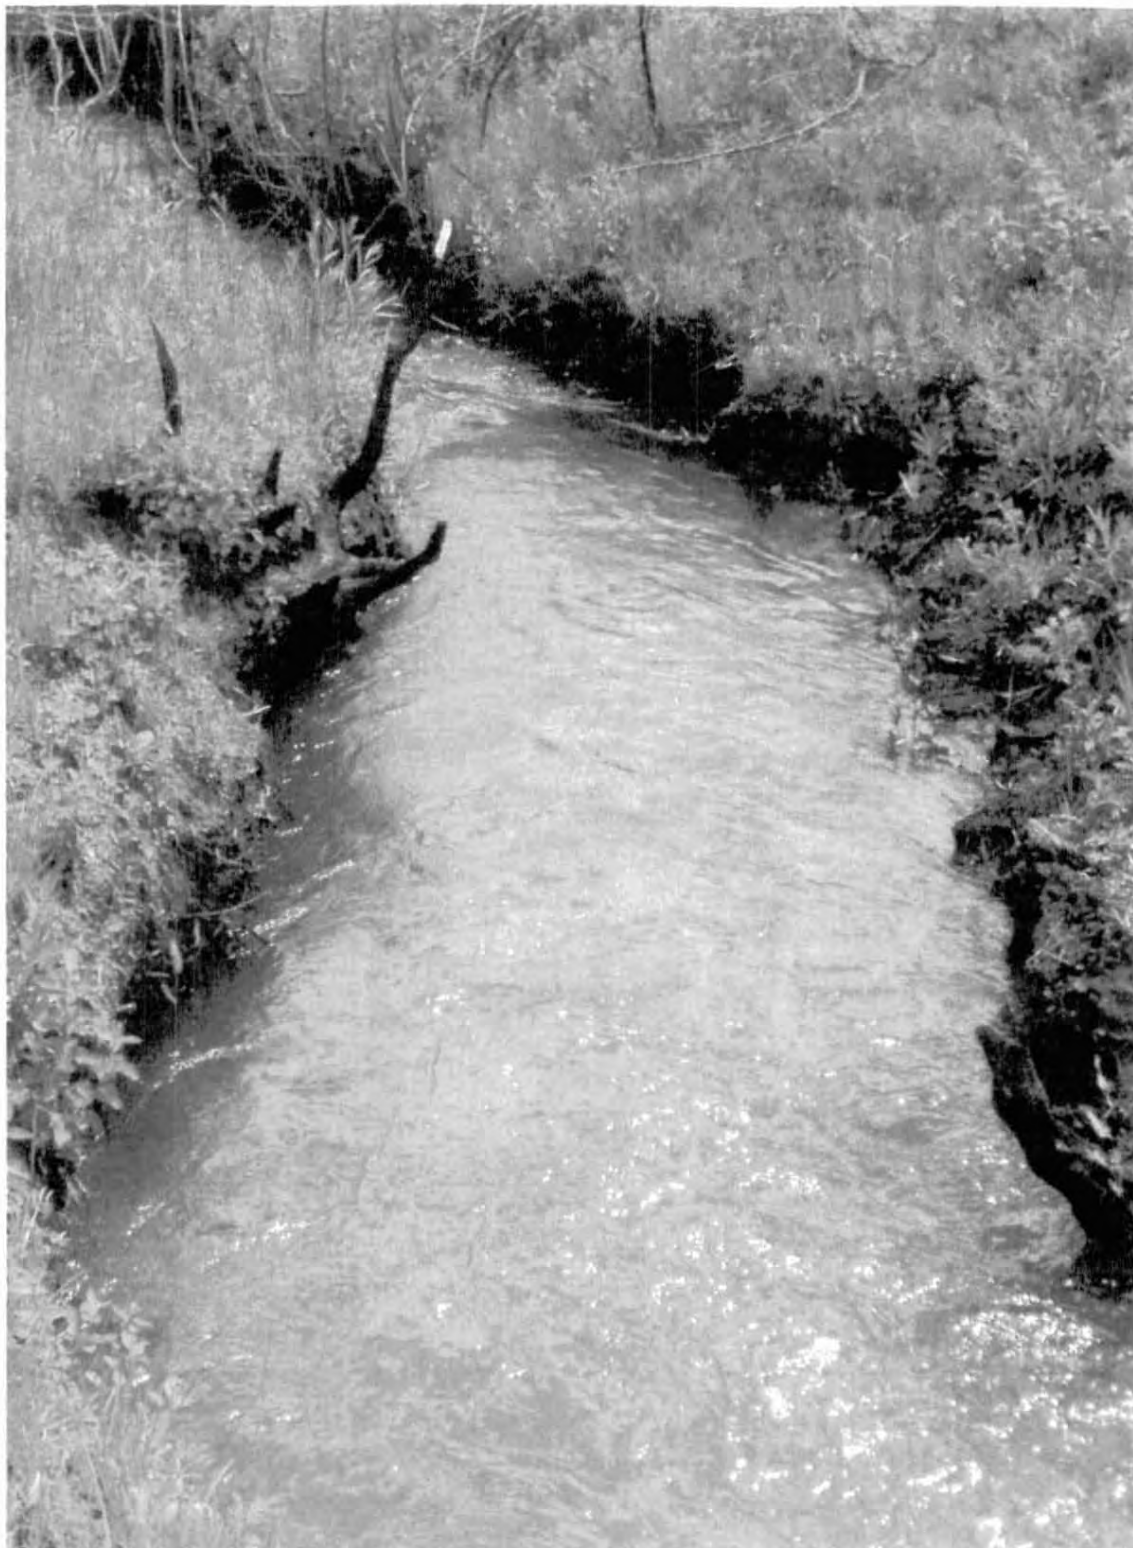
Photo taken: June 17, 2004

View to the east of the flowing stream to the north of the planned excavation area. Note some residual evidence of the crude release on the surface along the banks just below the grass line.

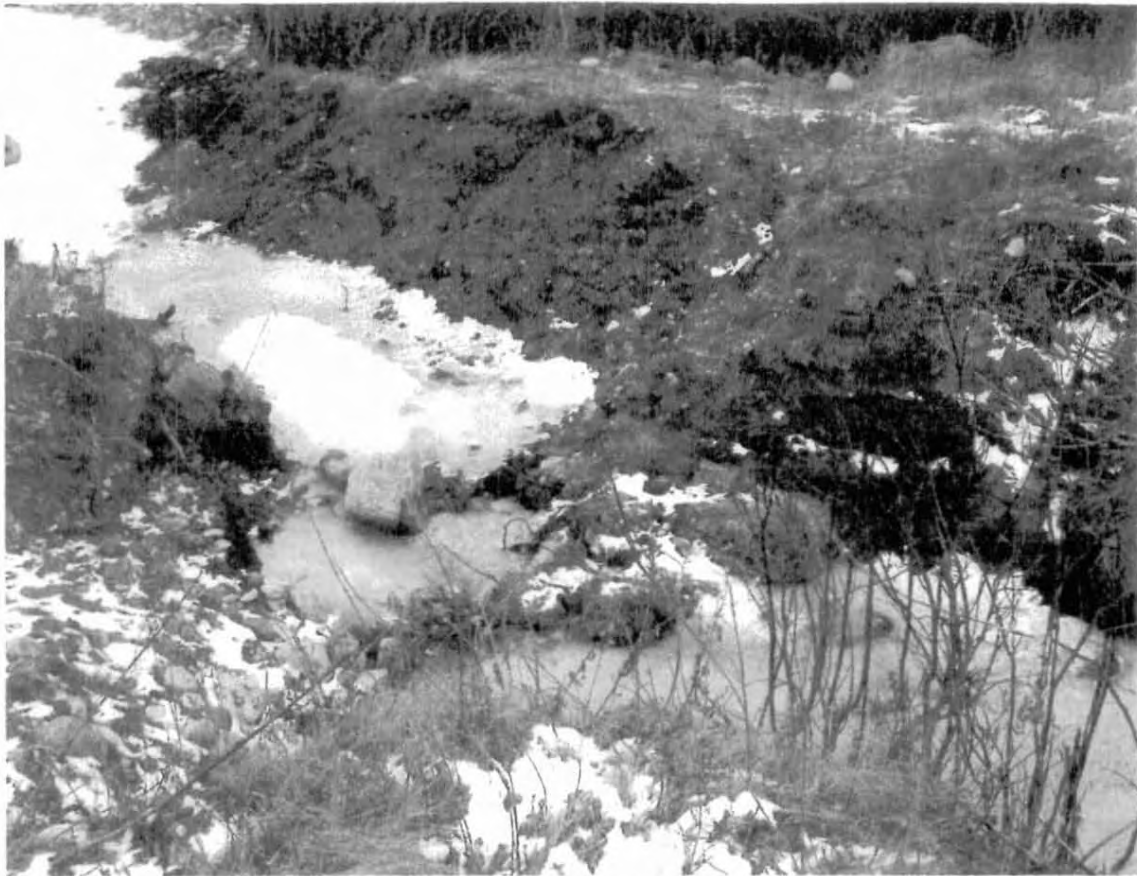
Photo taken: December 10, 2004

View to the southeast of the stream bed and banks, pre-excavation. The disturbed area of the banks is where the fiberglass pipeline was excavated and capped on either end to prevent any additional release from residual crude in the lines.

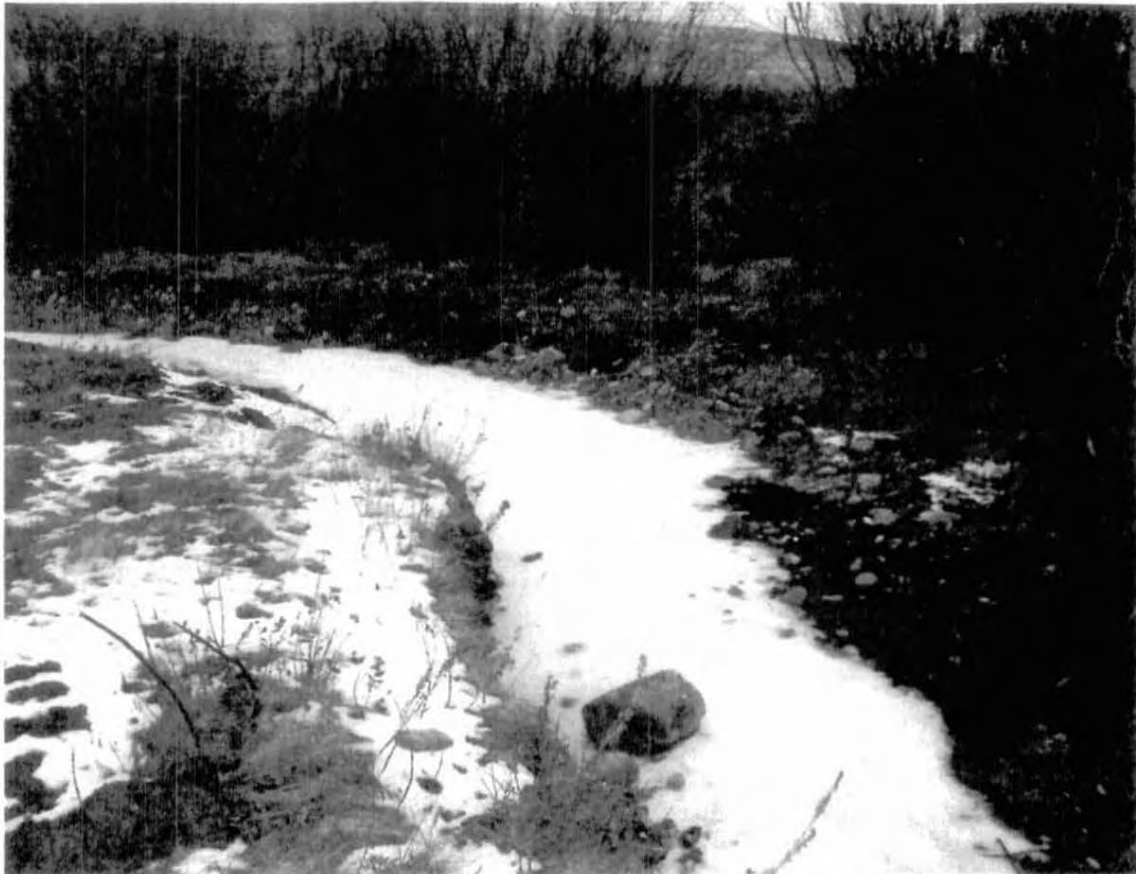
Photo taken: December 10, 2004

View to the east of the stream bed and banks, pre-excavation. This photo was taken on the south end of the expected area of excavation. Note some residual evidence of the crude release on the surface along the banks just above the snow.

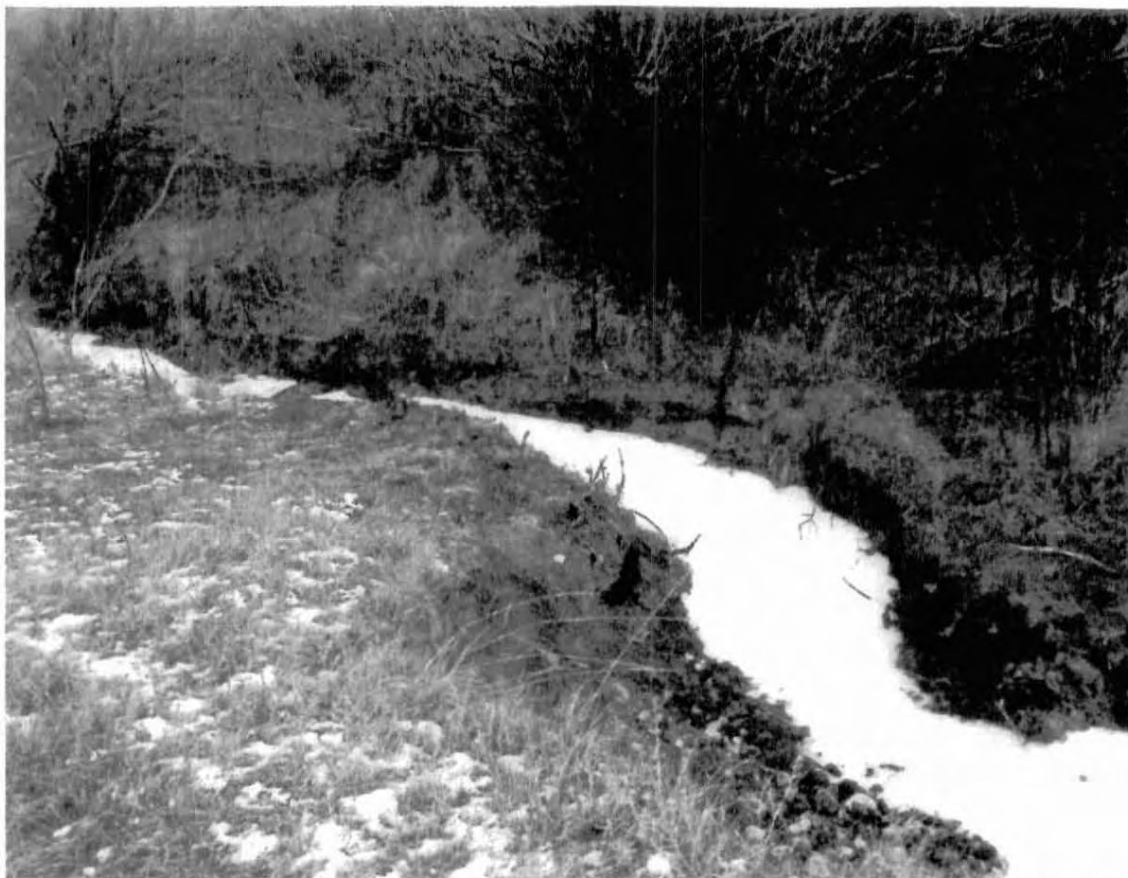
Photo taken: December 10, 2004

View to the east of the stream bed and banks, pre-excitation. This was taken on the extreme north end of the area that was selected to be excavated. Note some residual evidence of the crude release on the surface along the banks just above the snow.

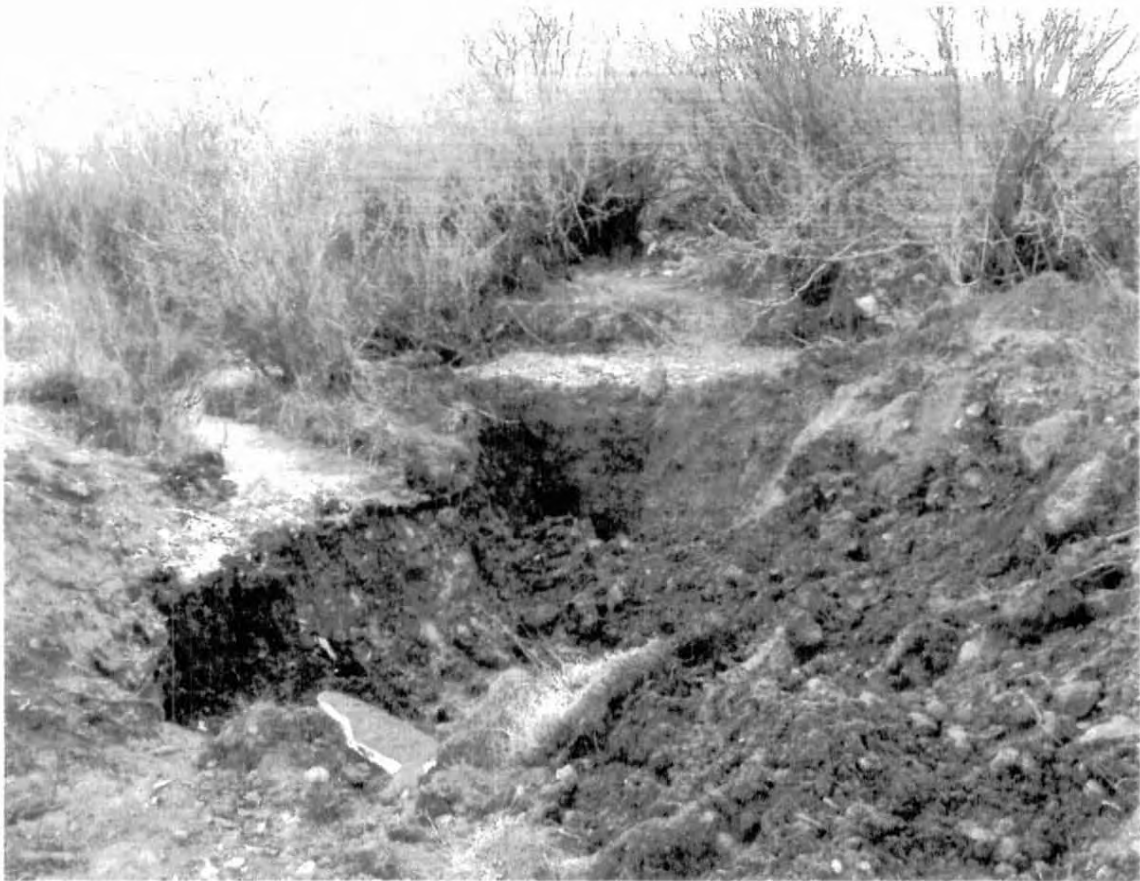
View of the south end of the excavation during remediation activities. Note the crude-impaired zone of soils. The crude material generally reached a depth of approximately 6 to 7 feet.
Photo taken: December 10, 2004

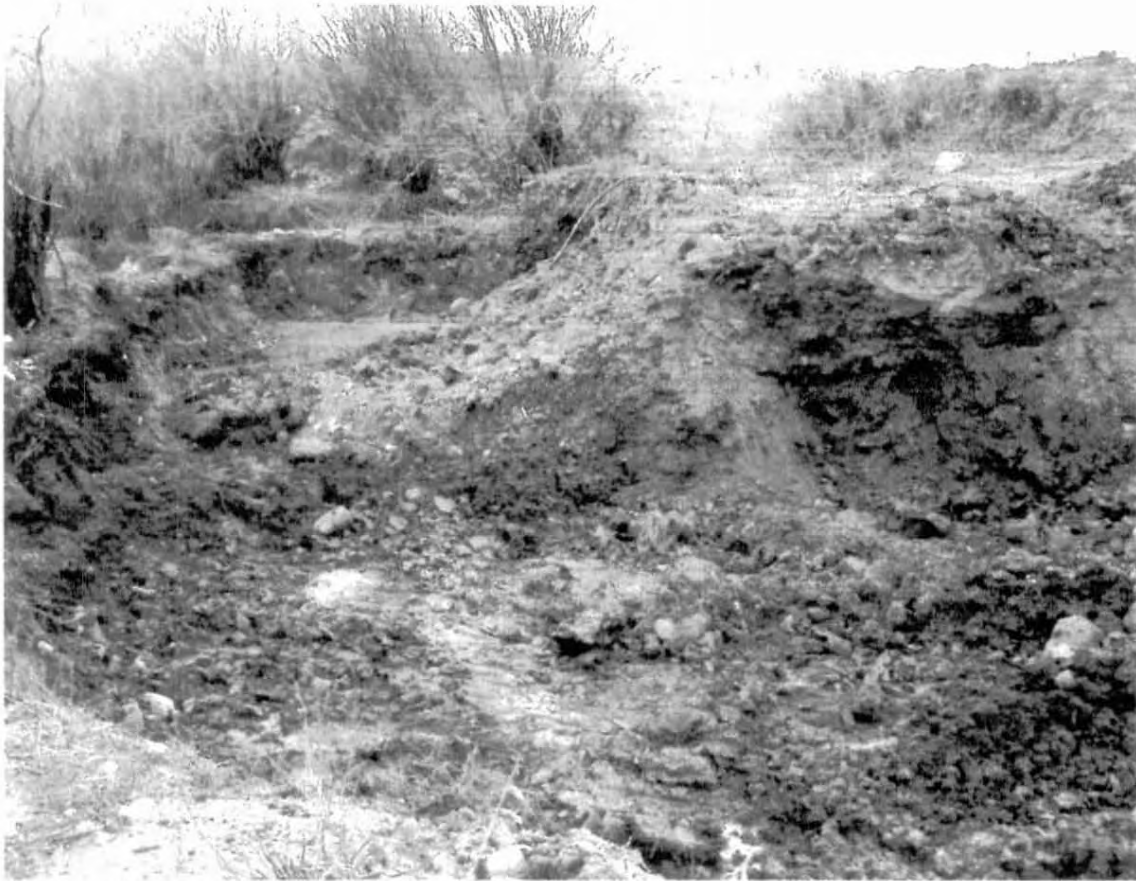
Photo taken: December 10, 2004

View of the southwest walls of the excavation during remediation activities. Note the crude-impaired zone of soils. All visible remnants of crude were removed from the west side of the stream's banks and bed to a depth of approximately 8 feet.

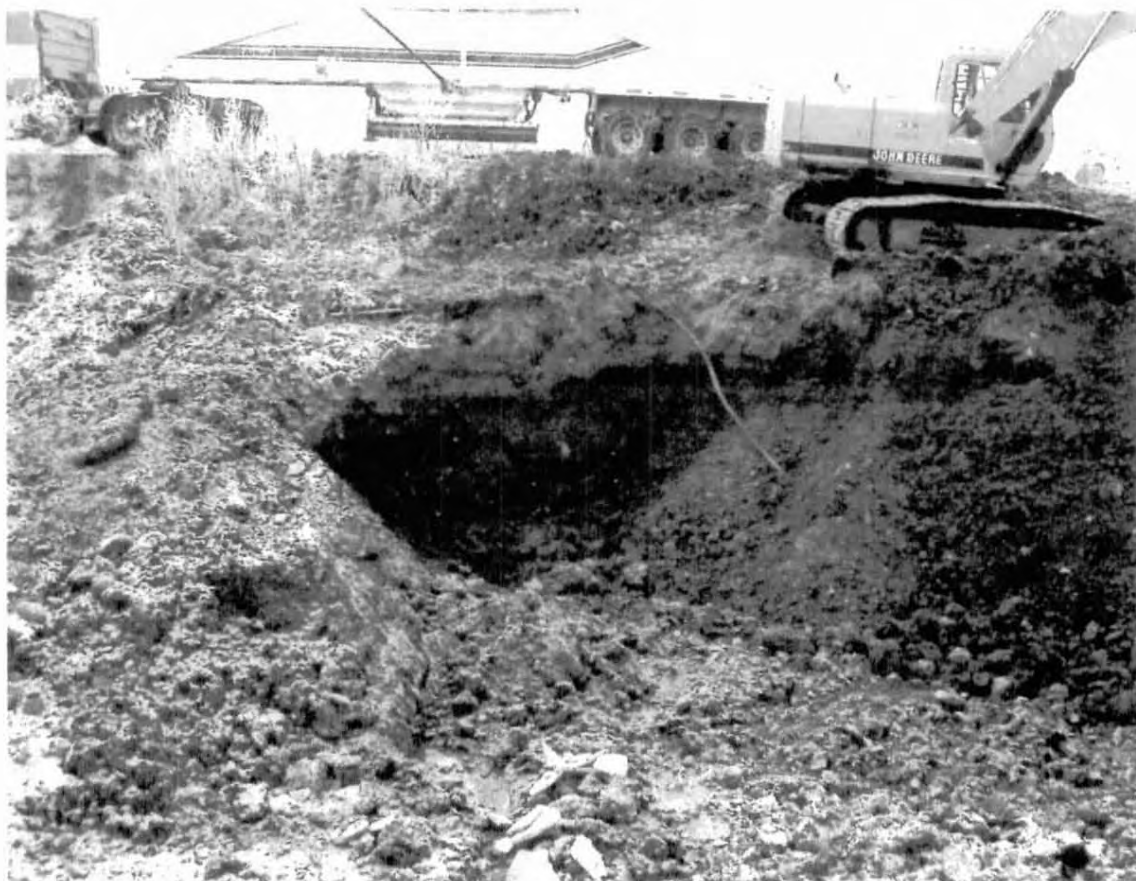
Photo taken: December 10, 2004

View of the west wall of the excavation during remediation activities. Note the crude-impaired zone of soils. All visible remnants of crude were removed from the west side of the stream's banks and bed to a depth of approximately 8 feet.

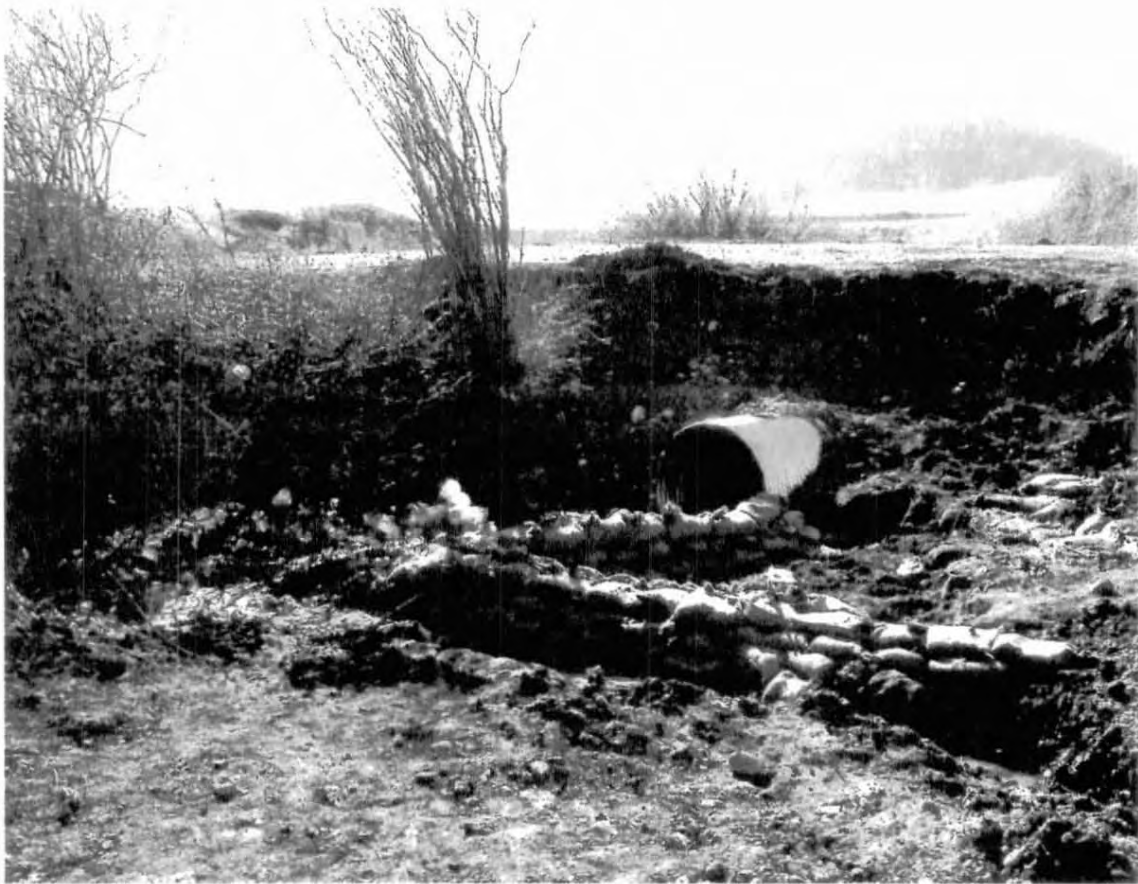
View to the west showing the pre-vegetation state following bank reconstruction. Sandbags on the northwest bank of the stream were placed in March 2005.
Photo taken: March 15, 2005

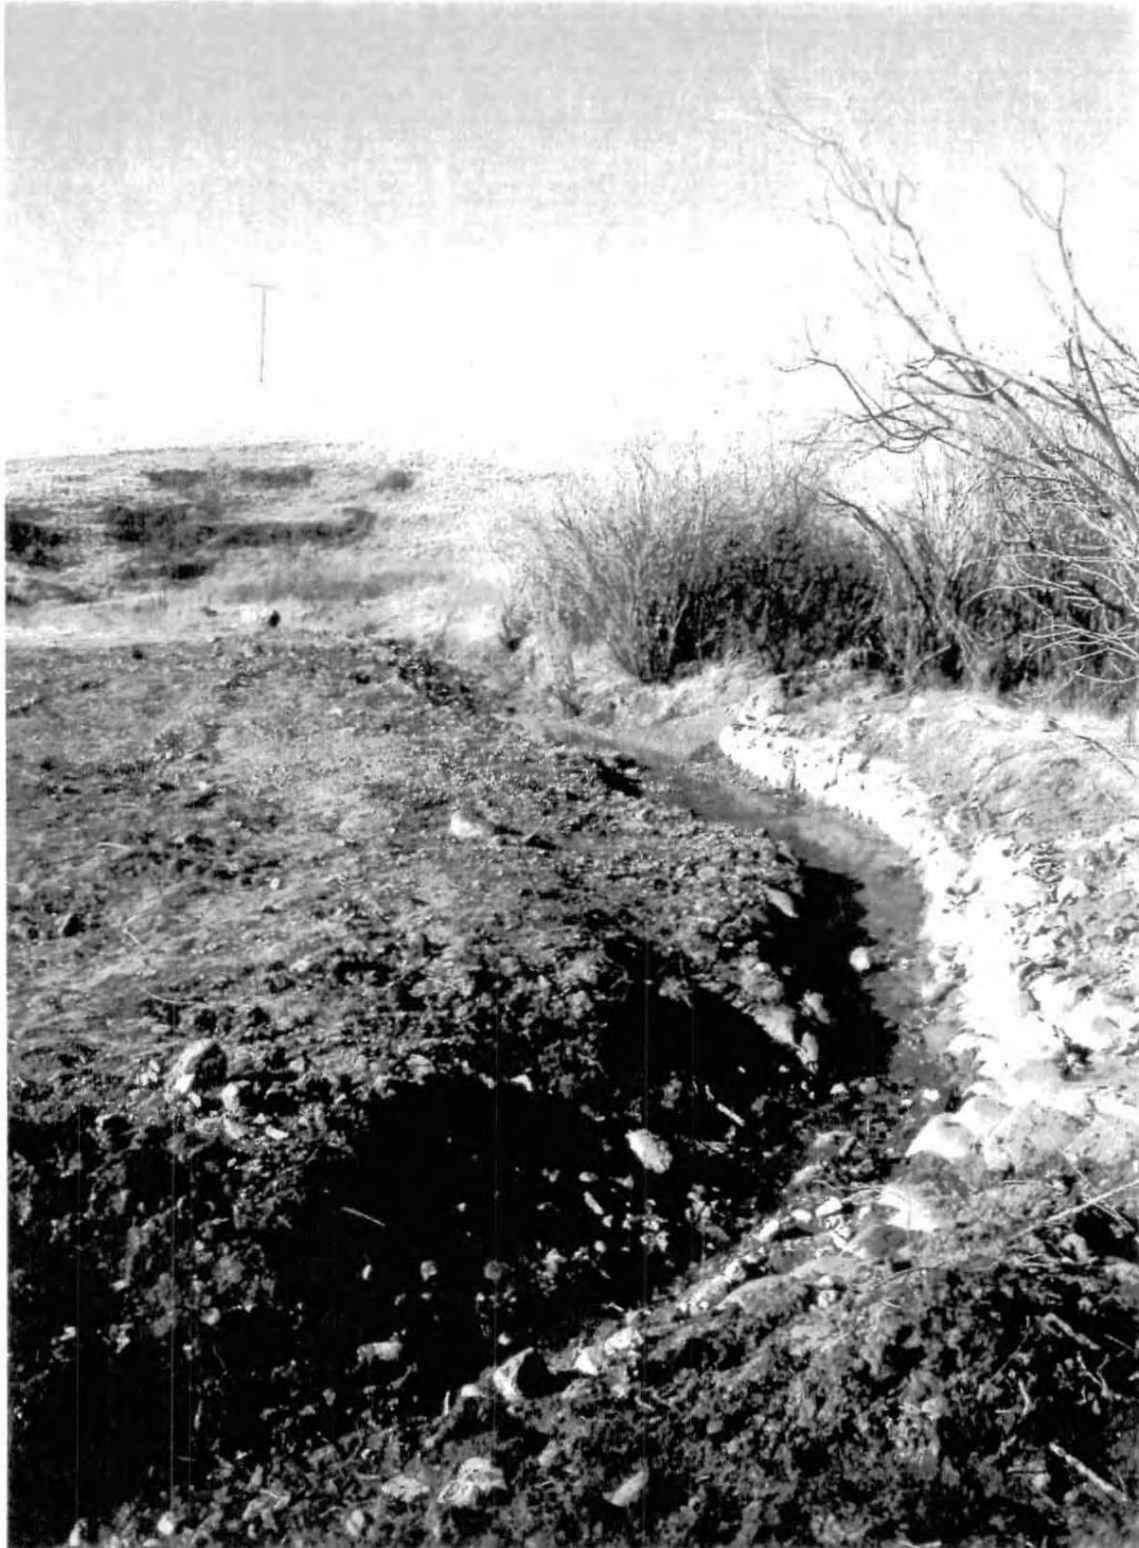
Photo taken: March 15, 2005

View to the north showing the pre-vegetation state following bank reconstruction. Sandbags on the east bank of the stream were placed in March 2005.

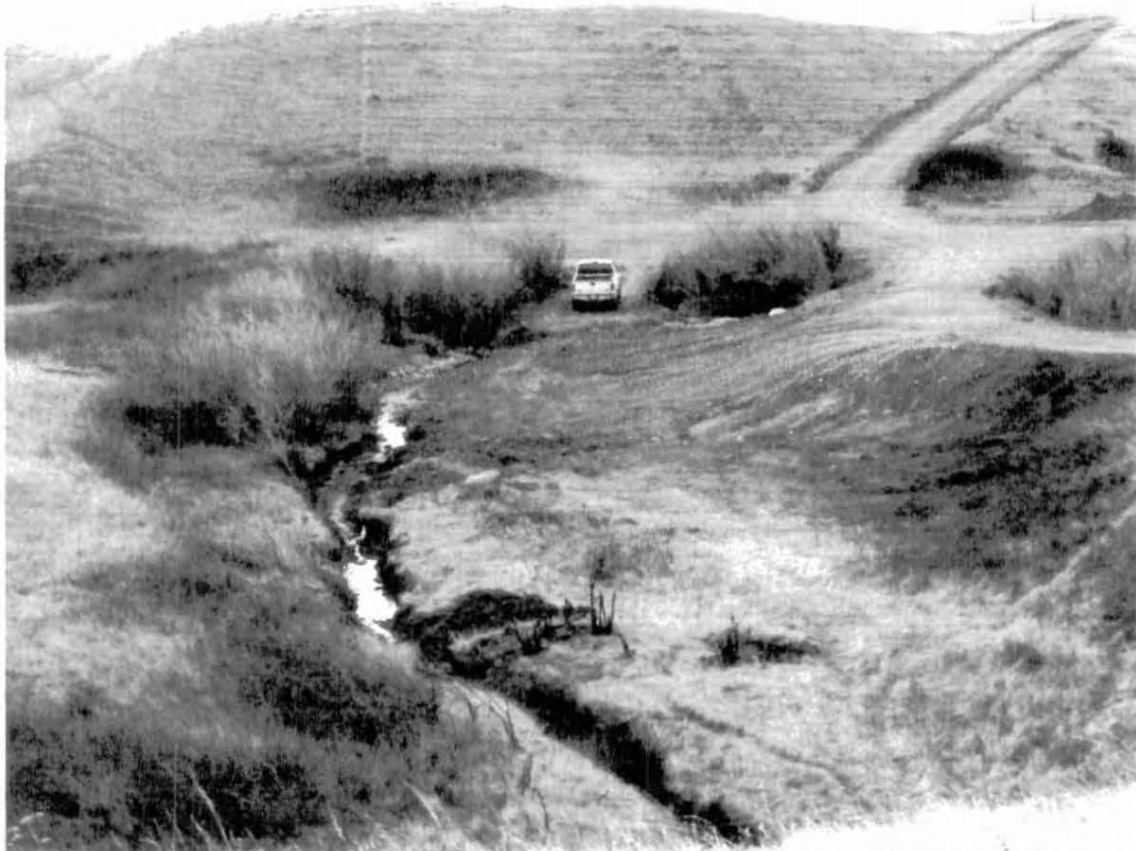
View to the south showing the pre-vegetation state following bank reconstruction. Sandbags on the east bank of the stream were placed in March 2005.
Photo taken: March 15, 2005

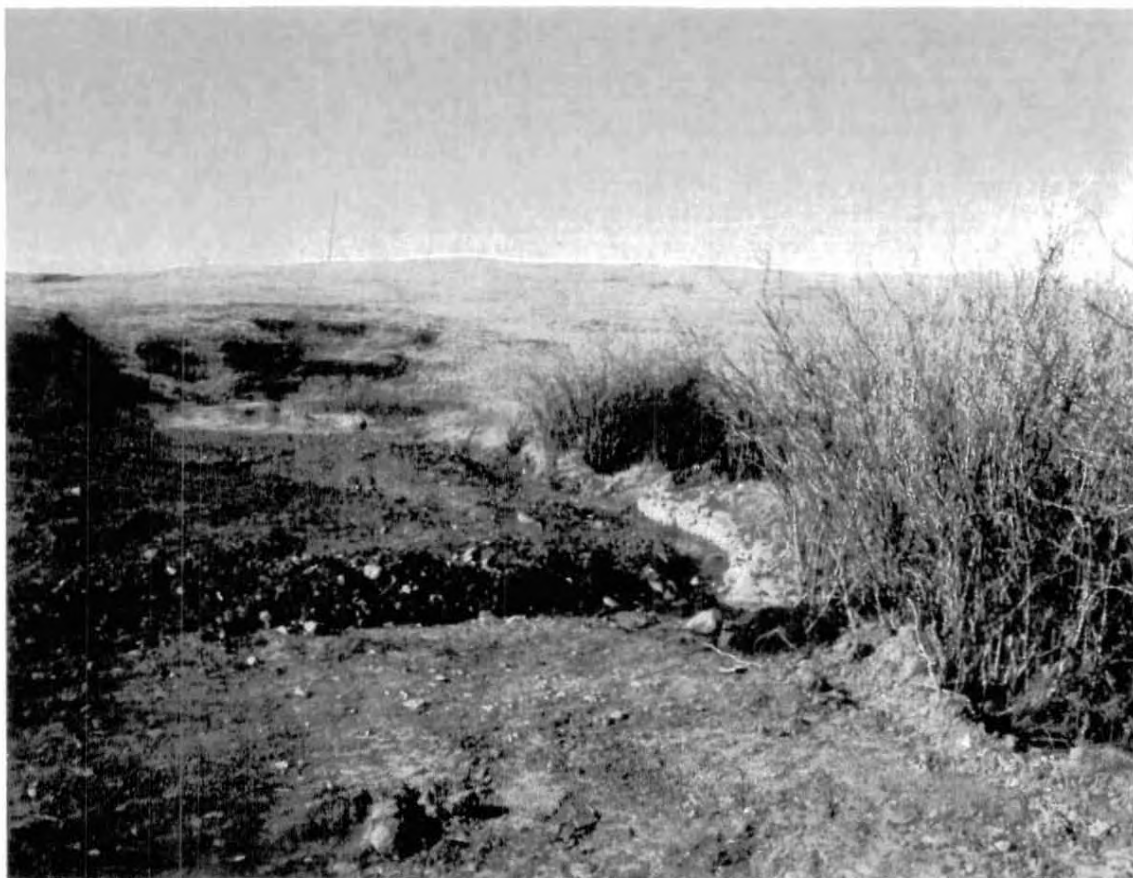
Photo taken: March 15, 2005

View to the north showing the pre-vegetation state following bank reconstruction. Sandbags on the east bank of the stream were placed in March 2005.

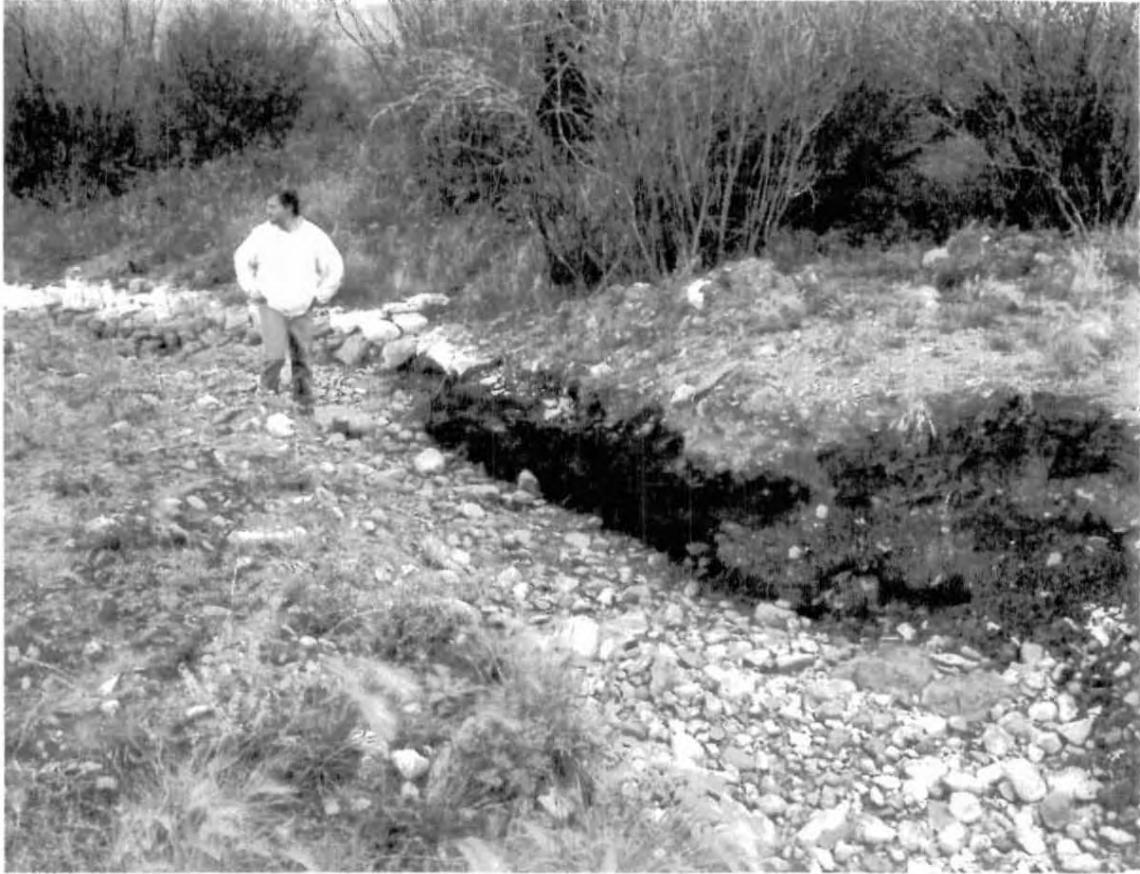
Photo taken: September 29, 2005

View to the east showing the bank and the pre-vegetation state following bank reconstruction. Sandbags on the east bank of the stream were placed in March 2005. Residual crude deposition was noted to have occurred between the time of the bank reconstruction and the September 2005 field review.
