Re: Response to United States Environmental Protection Agency Expedited Information Request for Fulton Fuel Crude Oil Release into Fred and George Creek, Toole County, Montana

Figure 1
Fulton Fuel Company: Fred & George Creek Crude Release Site Location Map
 Latitude: 48° 57.5783' N Longitude: 111° 26.1601' W
 Project Area: Township 37 North, Range 2 E, Section 14

PHOTOGRAPHIC LOG

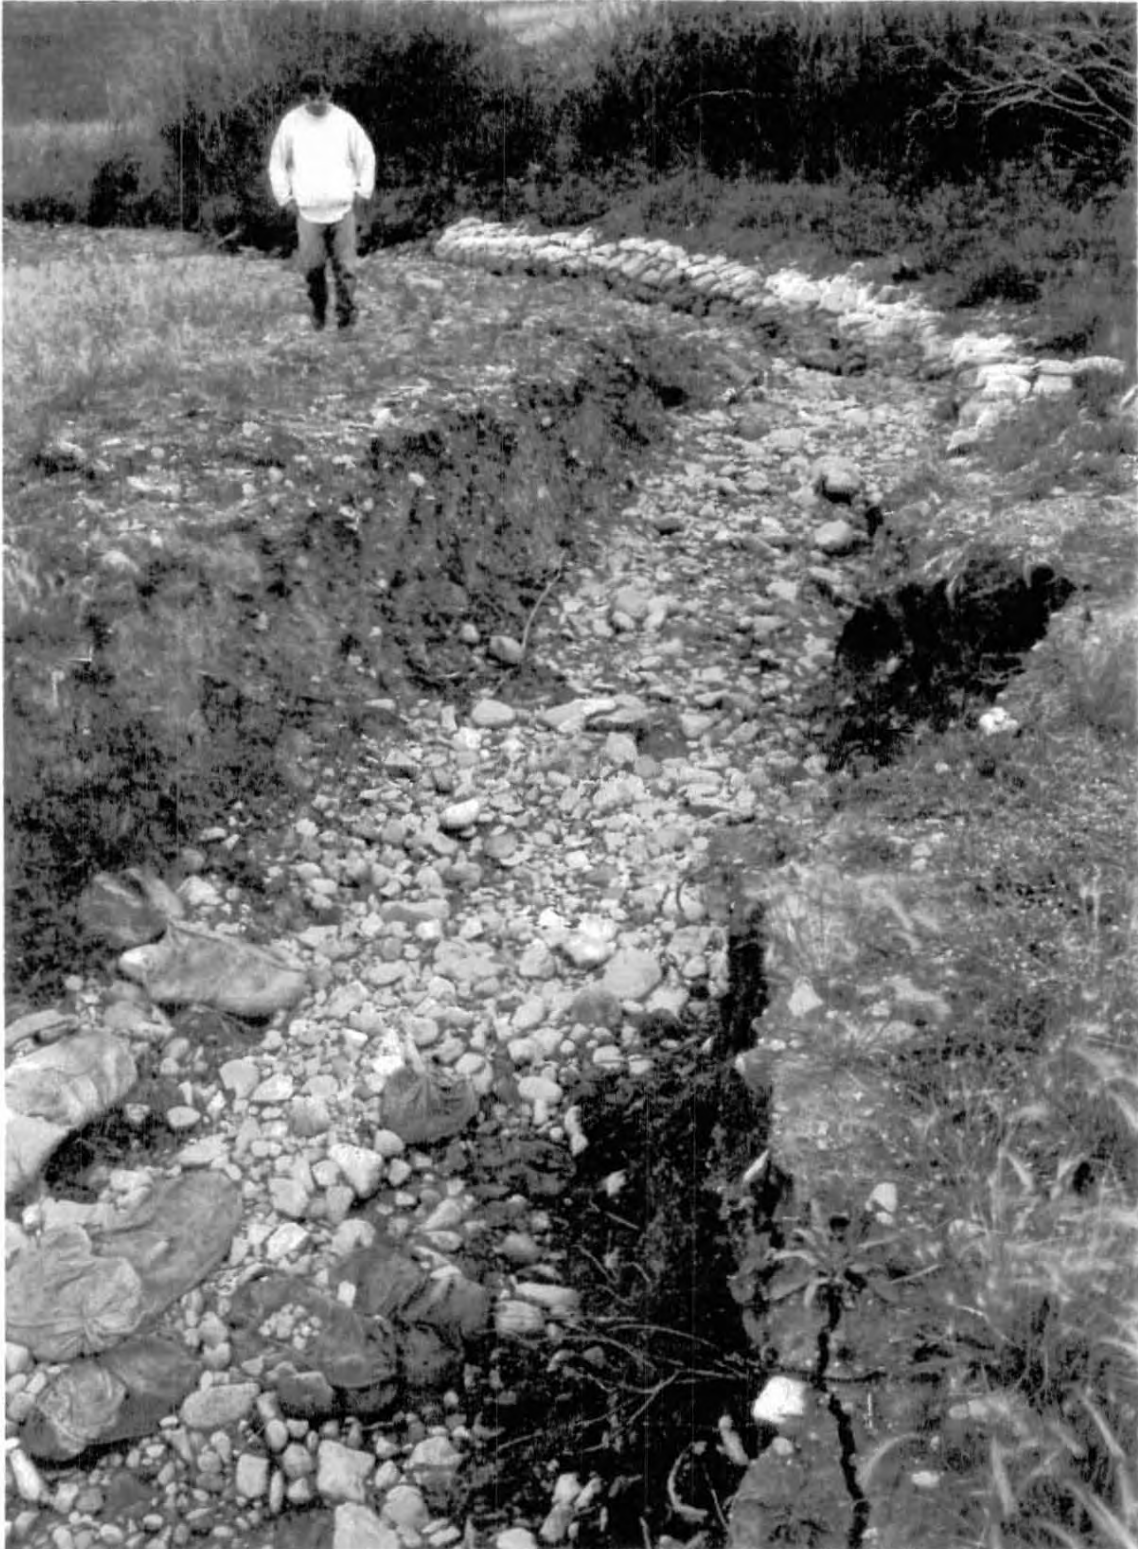
View to the northeast showing the bank and the pre-vegetation state following bank reconstruction. Sandbags on the east bank of the stream were placed in March 2005.
Photo taken: September 29, 2005

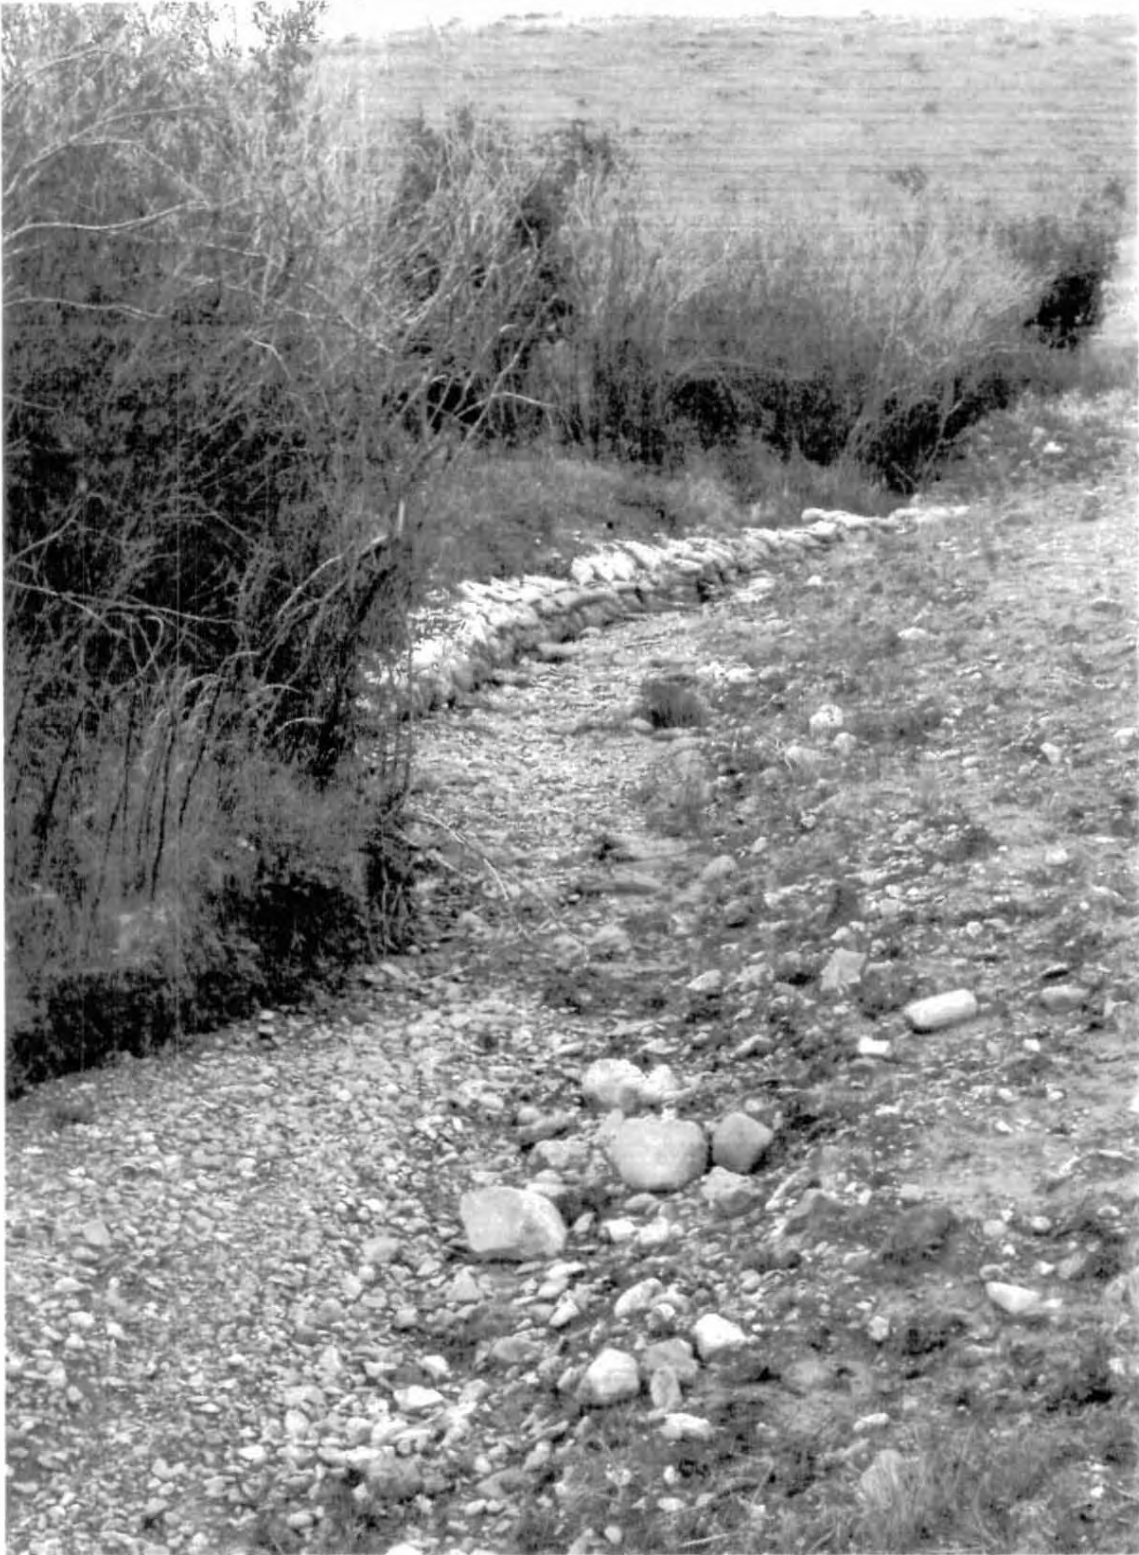
View to the south showing the stream channel following stream and bank reconstruction.
Sandbags on the east bank of the stream were placed in March 2005.
Photo taken: September 29, 2005

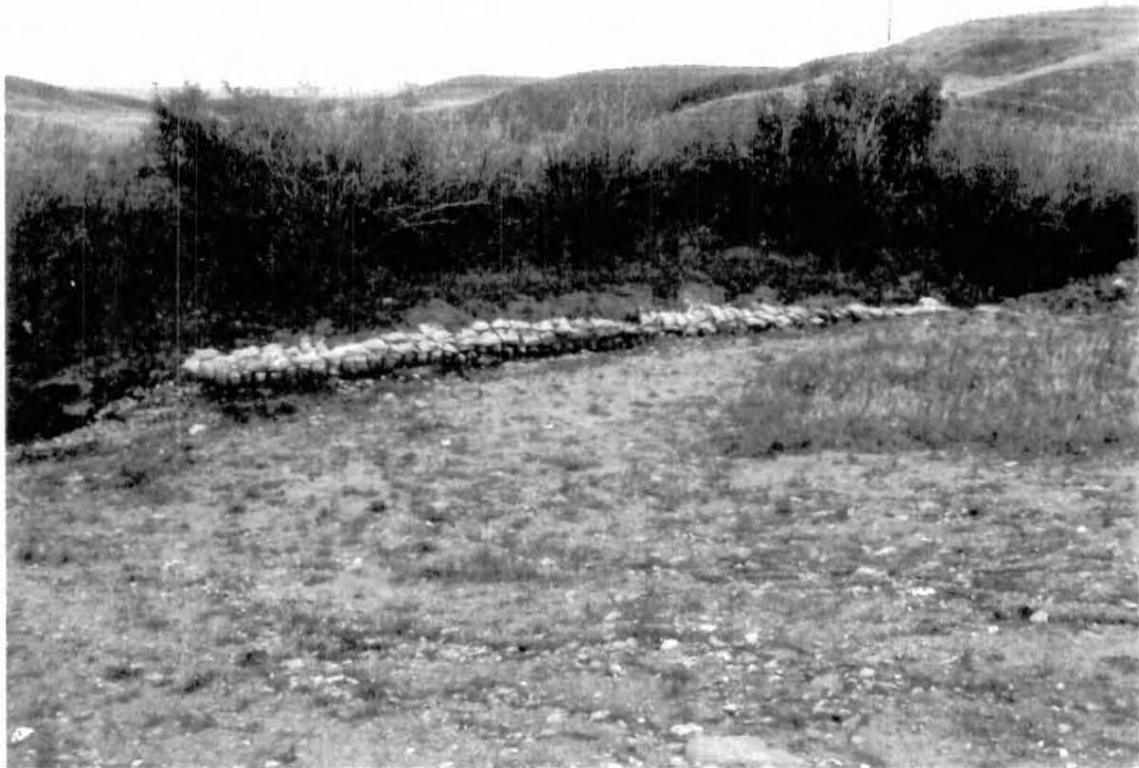
View to the east showing west slope of the bank and the pre-vegetation state following bank reconstruction. Sandbags on the east bank of the stream were placed in March 2005.
Photo taken: September 29, 2005

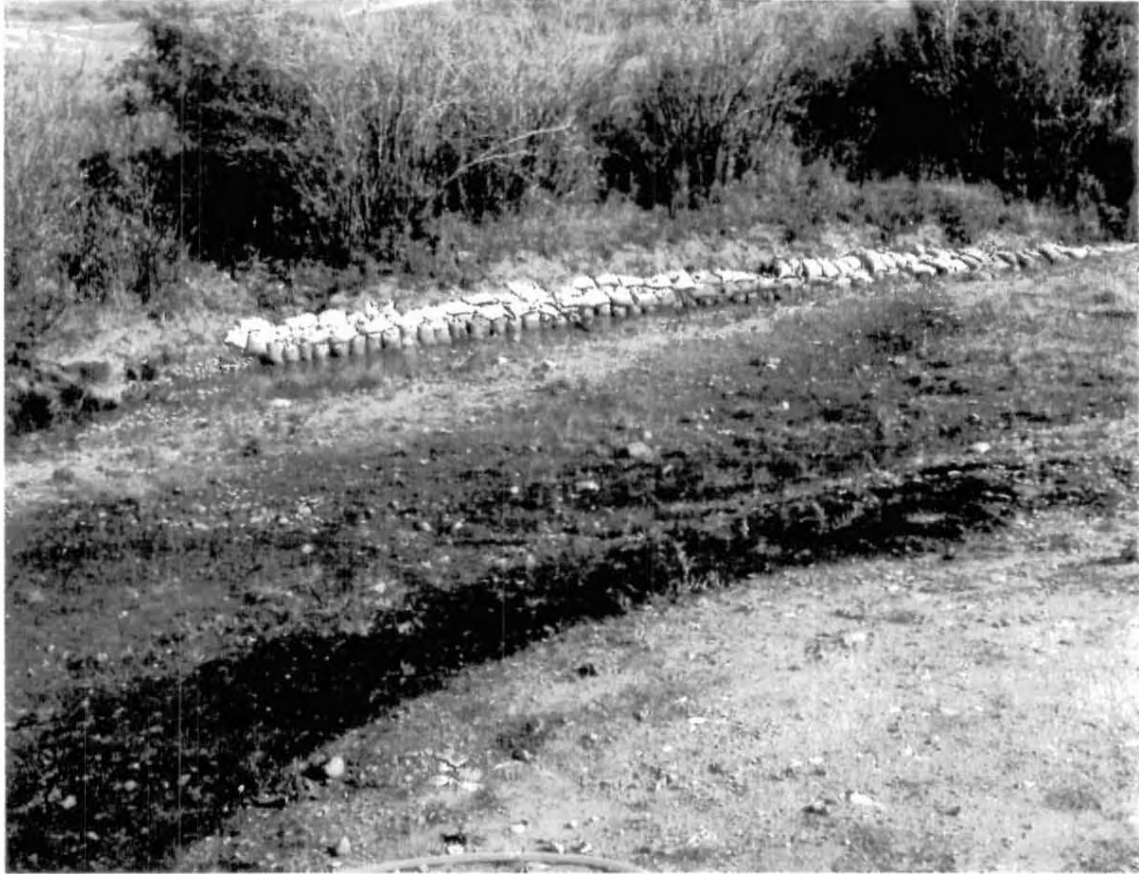
View to the east showing remediated area and newly seeded, reconstructed slope. Sandbags on the far east bank were placed in March of 2005.
Photo taken: September 29, 2005

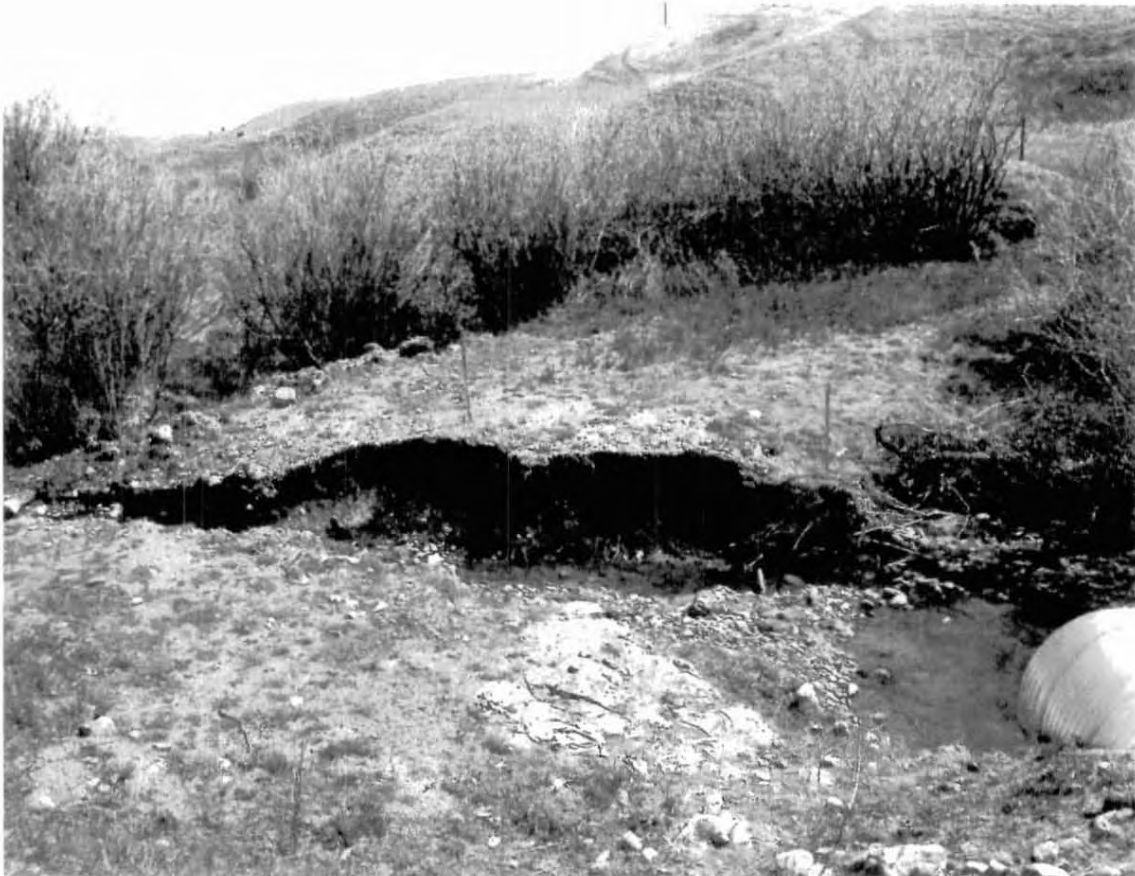
Photo taken: May 4, 2006

View to the southeast showing remediated area just below culvert. Note that vegetation on both banks (north and south) is beginning to fill in where topsoils were replaced after the excavation and bank reconstruction. Also note the stream cuts beginning to develop.

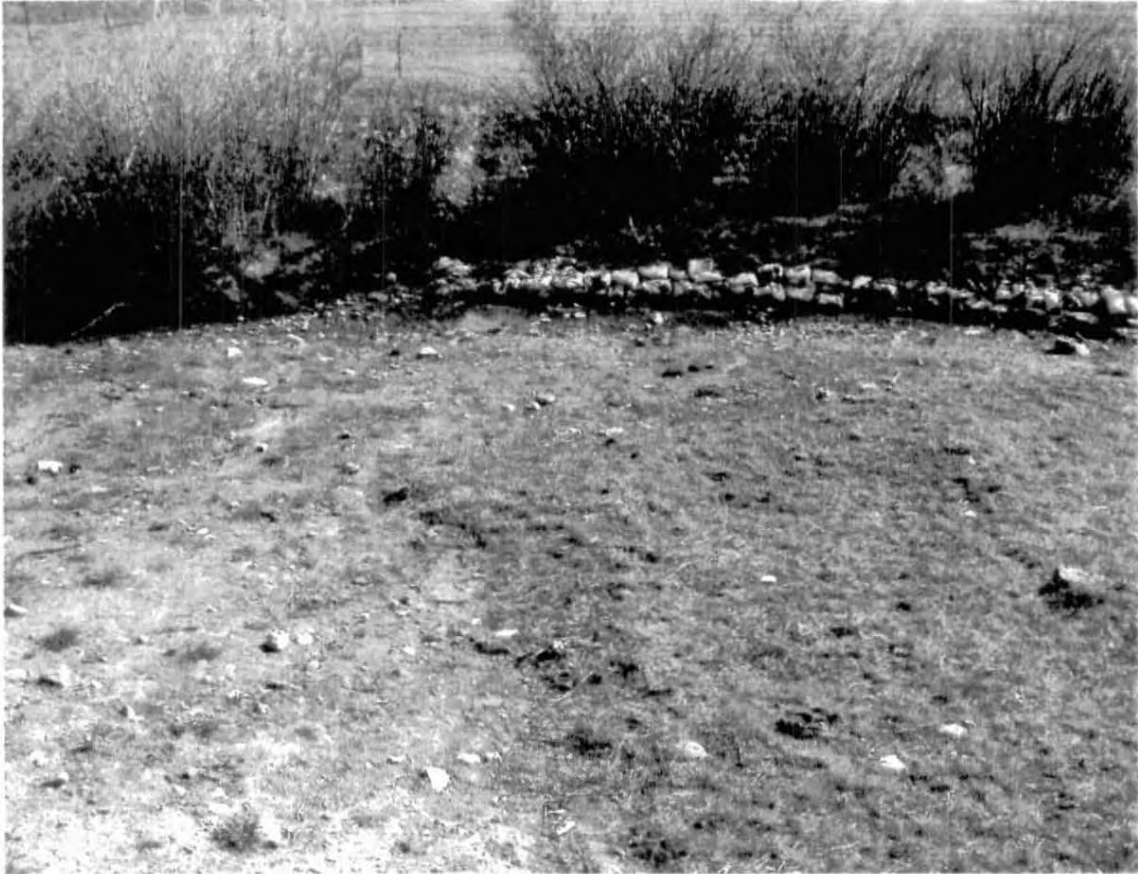
View to the southeast showing remediated area. Note that vegetation on the north bank is beginning to fill in where topsoils were replaced after the excavation and bank reconstruction.
Photo taken: May 4, 2006

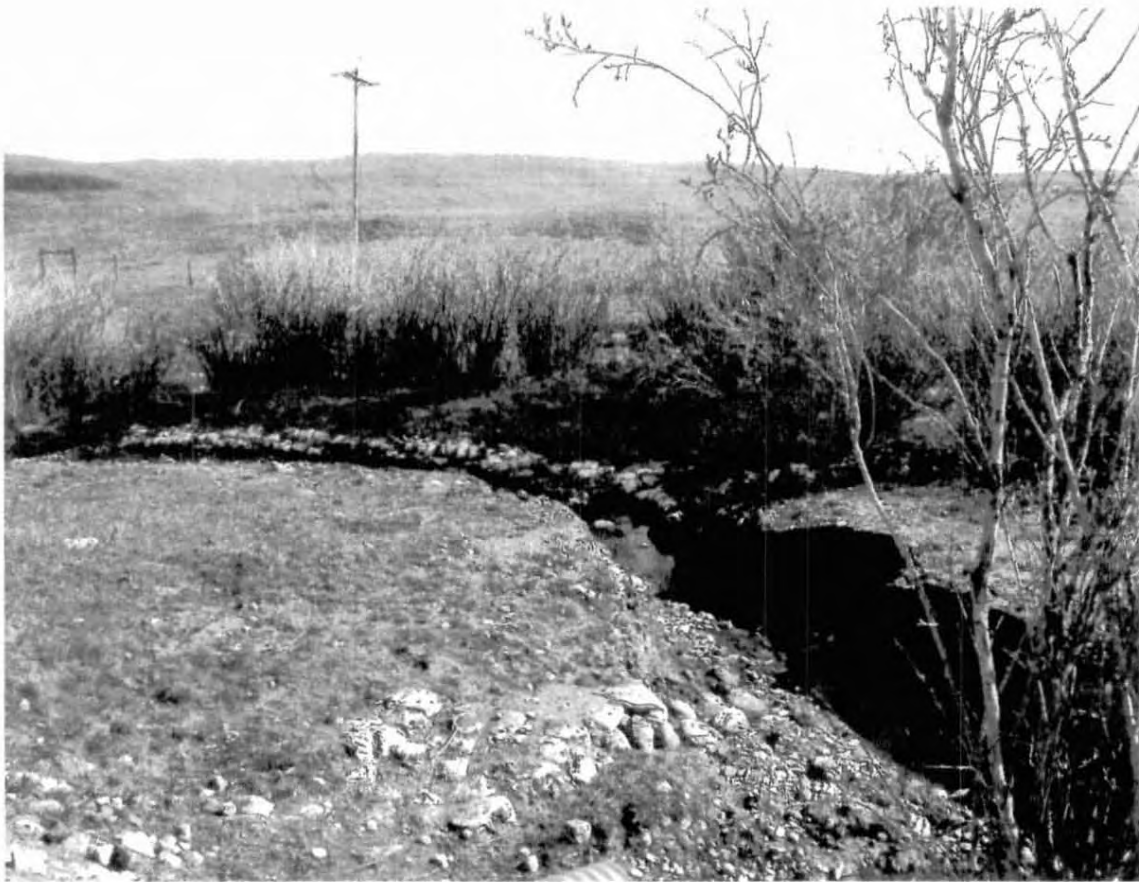
Photo taken: May 4, 2006

View to the east showing remediation area just east of the culvert. Note that vegetation is filling in on the north bank after the excavation and bank reconstruction.

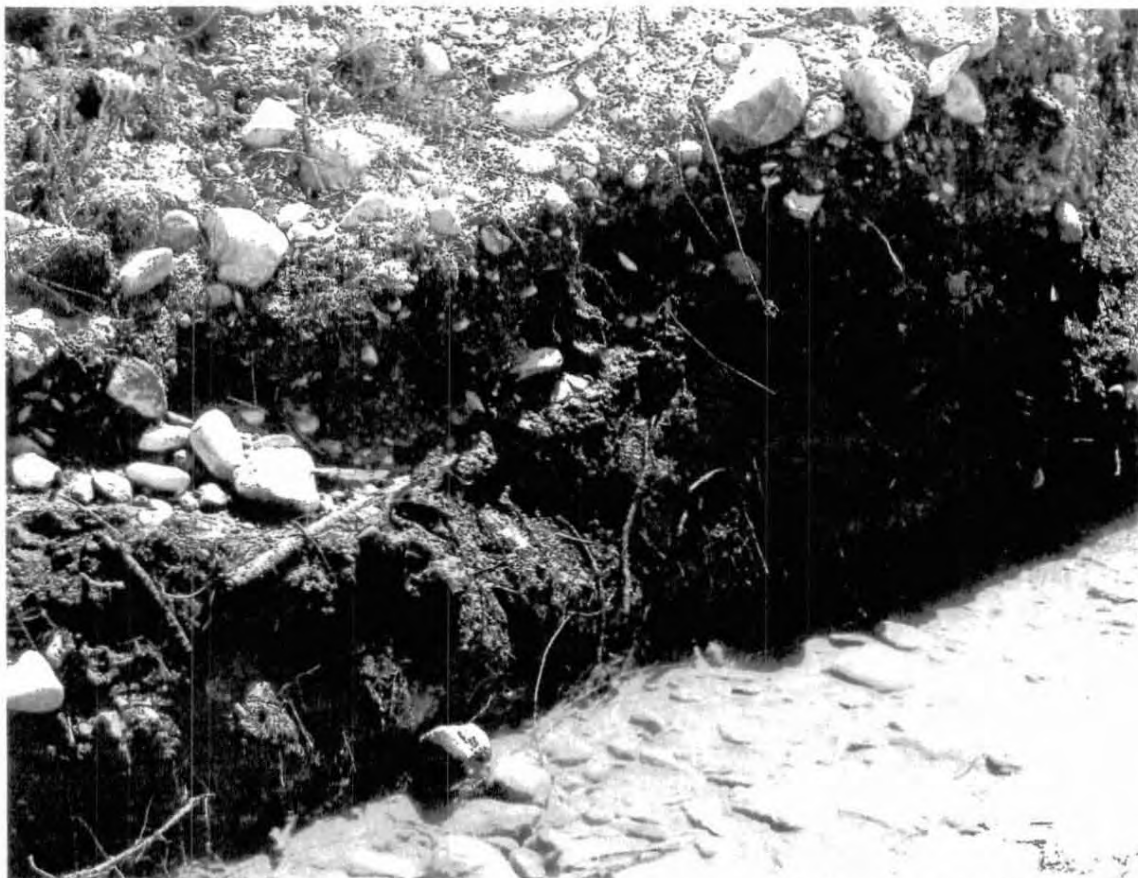
View of the southeast bank of the stream, showing remaining residual crude in remediated area.
Photo taken: May 4, 2006

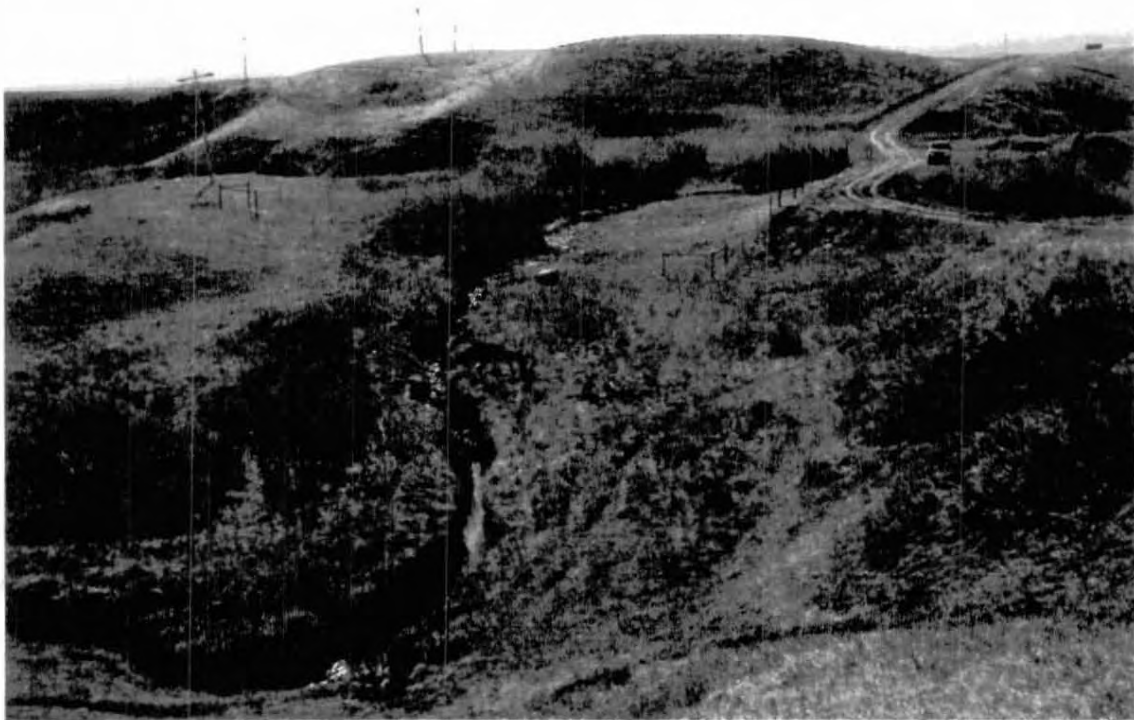
Photo taken: May 4, 2006

View to the south showing remediation area. Note that vegetation is beginning to fill in where topsoils were replaced after the excavation and bank reconstruction.
