Aguakem Caribe, Inc.

Docket No. RCRA-02-2009-7110

**COMPLAINANT'S SUPPLEMENTAL PREHEARING EXCHANGE**

Set of 13 Color Photos substituting the black and white photos part of Complainant's Exhibit 3, RCRA Compliance Evaluation Inspection, Port of Ponce Authority, Attachment III.

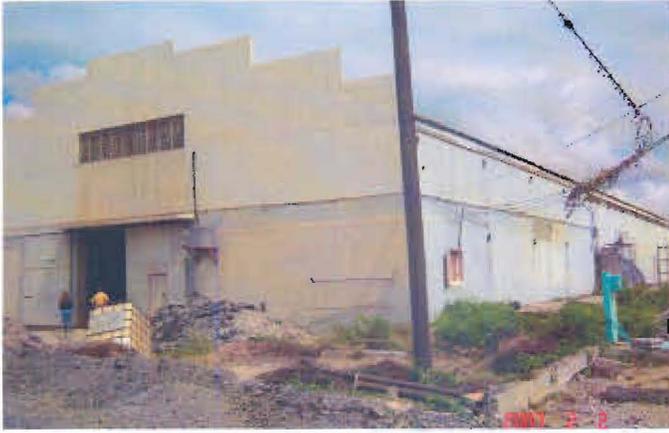
1. View of facility-Building #6.

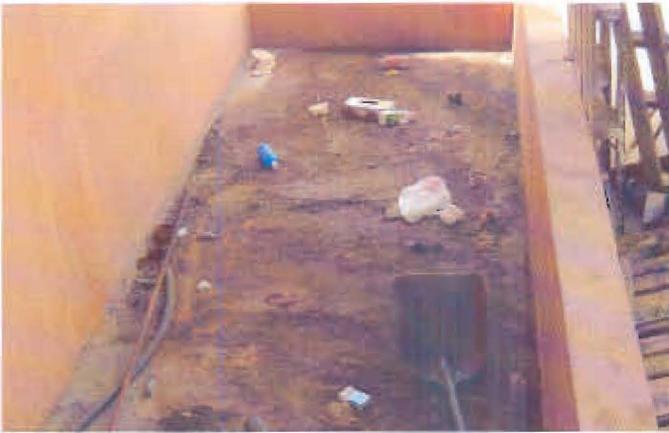
2. Concrete containment unit located at the north-west section of the facility.

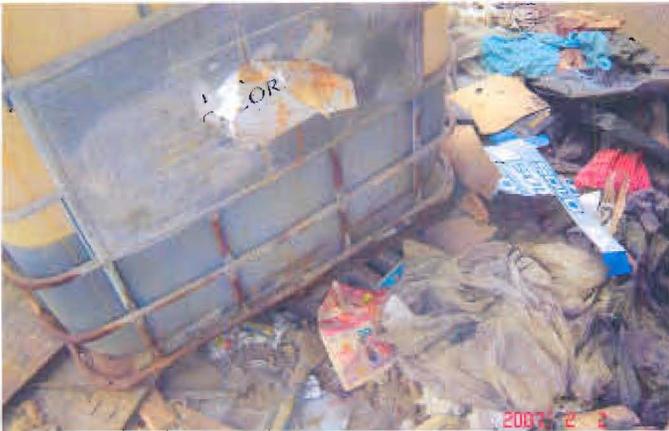
3. Stormwater catch basin obstructed by 150 yd<sup>3</sup> container labeled as FERROUS CHLORIDE and garbage.

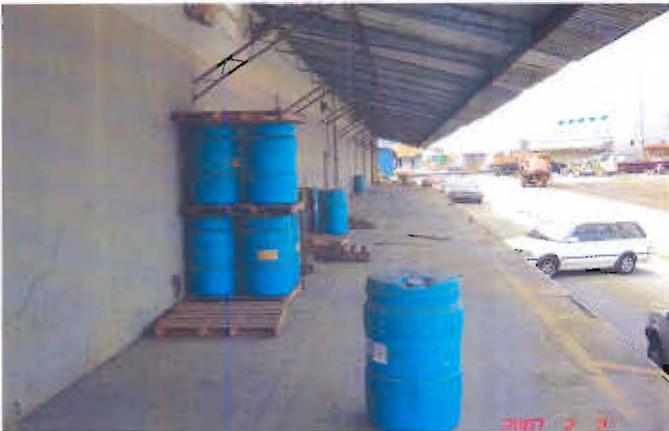
4. Empty drums at the loading/unloading dock of the building (North).

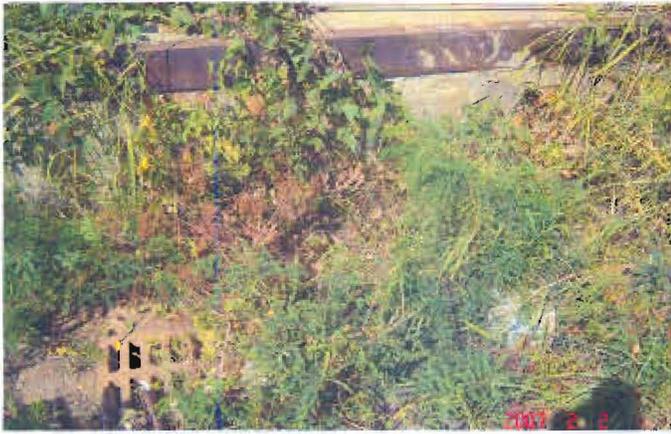
5. Concrete ditch at the south side of the facility.

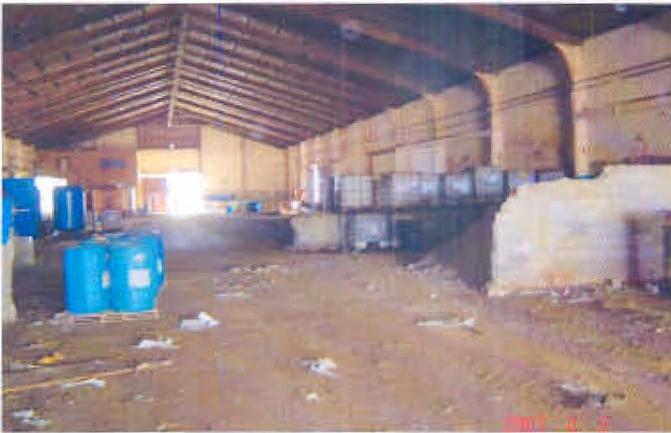
6. View of stacked 150 yd3 containers located at the north side of the facility.

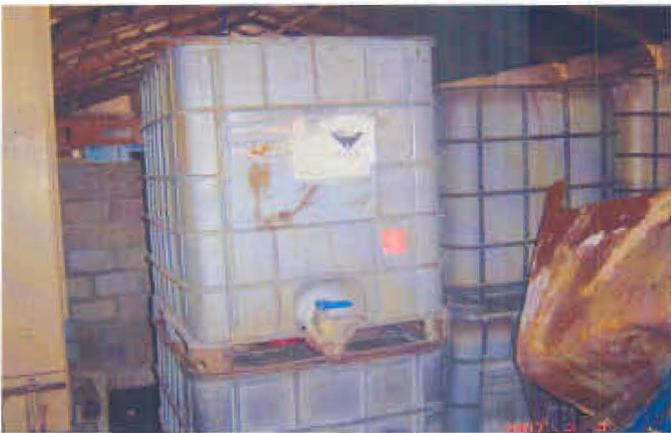
7. Stacks of 150 yd3 tanks.

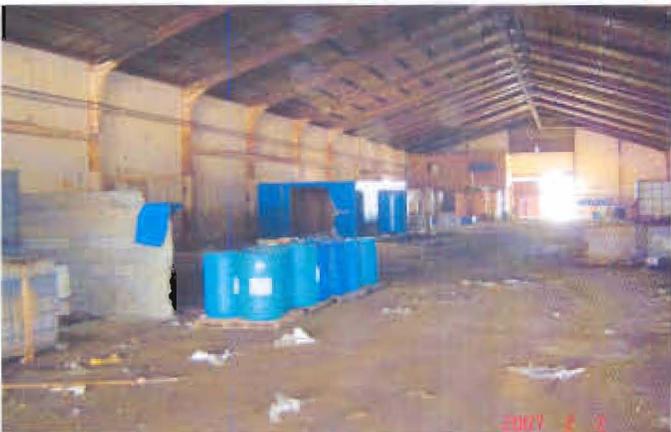
8. Partial view of the southeast side of the facility.

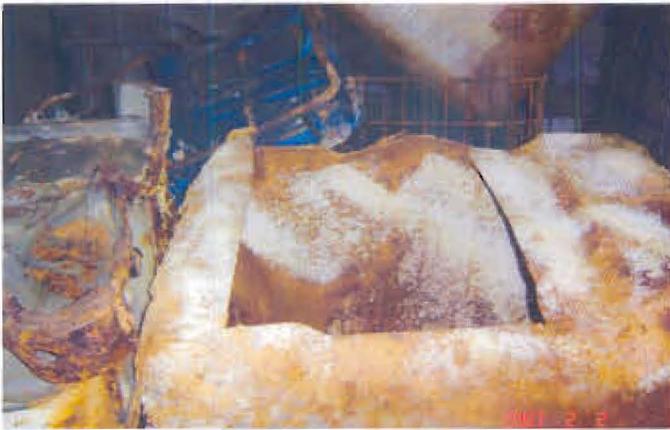
9. Unidentified 1yd3 container with its top portion removed.

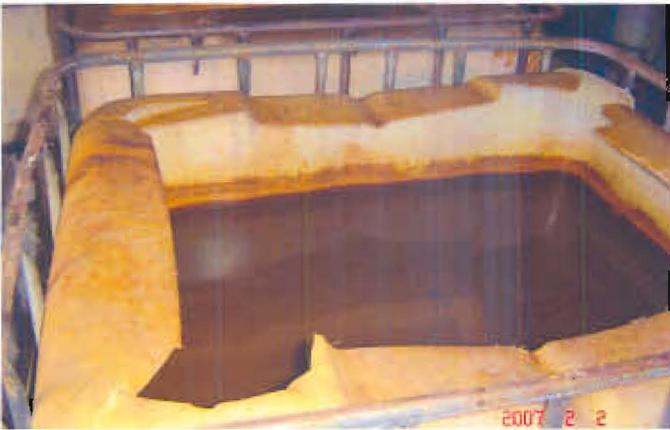
10. Unidentified 1 yd3 container.

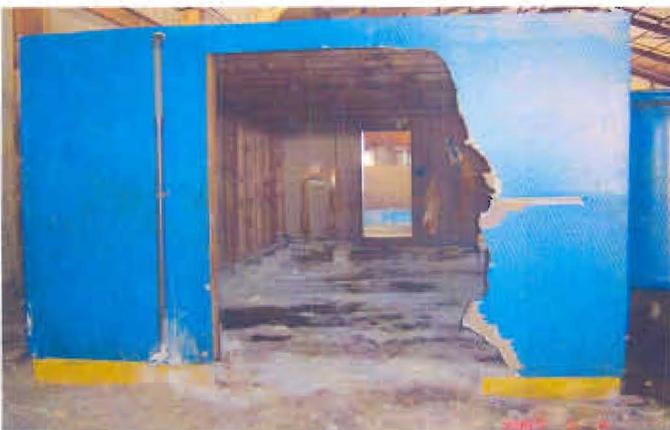
11. Demolished structure and related debris that were found at the south-central section of the facility.

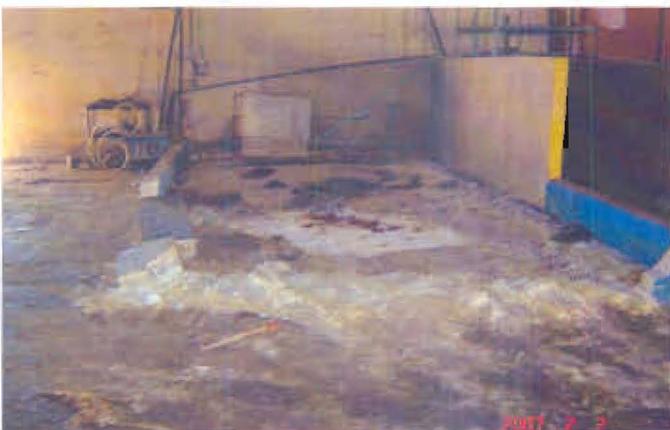
12. White granular material spreaded on the surface of a partially demolished secondary containment unit.

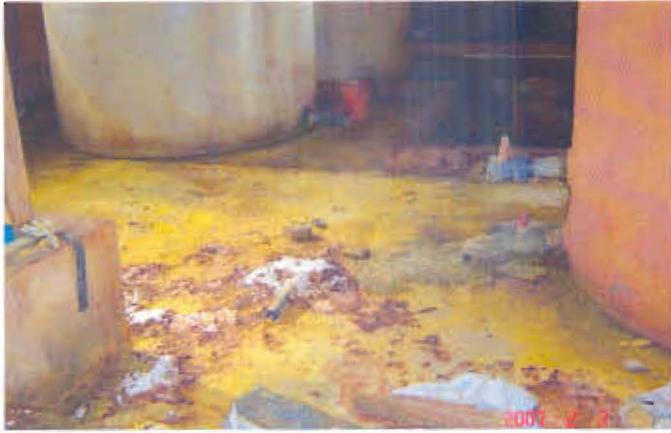
*13. Yellow-brown granular material at secondary containment unit.*
