**Re: Corrective Action Completion – OGI Survey Findings
Trecora Hydrocarbons, LLC – Silsbee Facility
Docket No. CAA-06-2025-3431**

Tank 61 Follow-up OGI Data

Tank 61 Follow-Up OGI Pictures

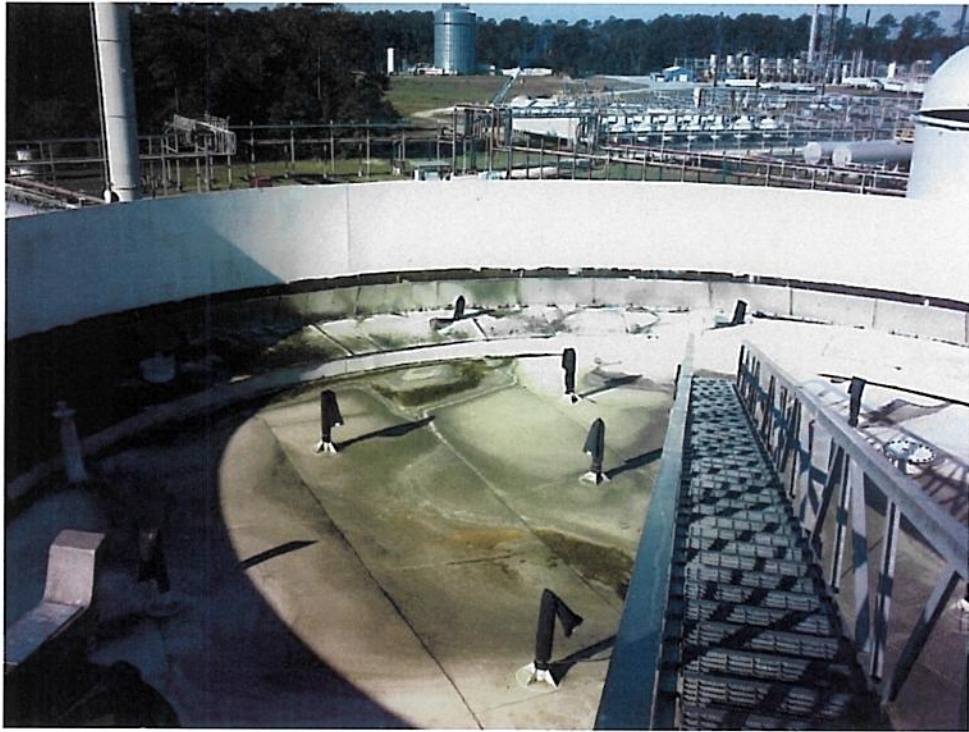
DC_0080

All repairs have been completed, and the November 14 verification demonstrates that the tank is operating with no visible emissions. The corresponding survey logs, videos, and repair documentation have been included in this submission.
