UNITED STATES ENVIRONMENTAL PROTECTION AGENCY
REGION 8

Re: Inspection Reports for Wastewater Treatment Facilities Operated by the Northern Cheyenne Utilities Commission

NPDES Inspection Report – POTW

Facility Location Information	
Site/Facility Name & Location: Lame Deer Wastewater Treatment Facility 45.628889, -106.673611 Lame Deer, Montana	Mail Report to: Sheri Bement, General Manager Northern Cheyenne Utilities Commission P.O. Box 747 Lame Deer, Montana 59043

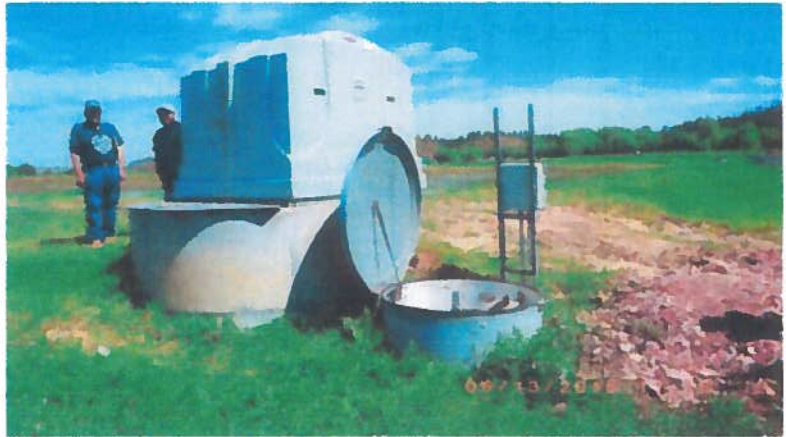
The grinder and lift station at the lagoon were not functional.

During the inspection, the grinder and lift station were not functional (Photograph 167), meaning influent could not be pumped to the fermentation pits and flowed through Cell 1. Mr. Pierce indicated the grinder had not been sufficiently reducing the size of solids to prevent interference with the lift station pumps. As the lift station could not be operated without a properly functioning grinder, both units had been shut-off to prevent continued lift station failure. The lift station was located adjacent southeast of the berm between Cell 1 and Cell 2 and sewage was discharging via the lift station emergency overflows directly into Cell 2 (Photographs 169 and 170), bypassing the fermentation pits and Cell 1. As the grinder was not in operation, all solids in the influent, including rags, wipes, gloves, and other trash and debris, were entering Cell 2 without being reduced in size. Mr. Pierce indicated the grinder and lift station had been out of service for at least several months.

Overview of the grinder and lift station. Both units were not functional.

Ensure the grinder and lift station at the lagoon are properly functioning, ensure solids which could interfere with treatment processes are not entering the lagoon, and ensure that flow can be directed through the fermentation pits and Cell 1, if desired. In a response to EPA, provide a written narrative describing the steps taken to implement this corrective action and indicate the date this corrective action was completed.

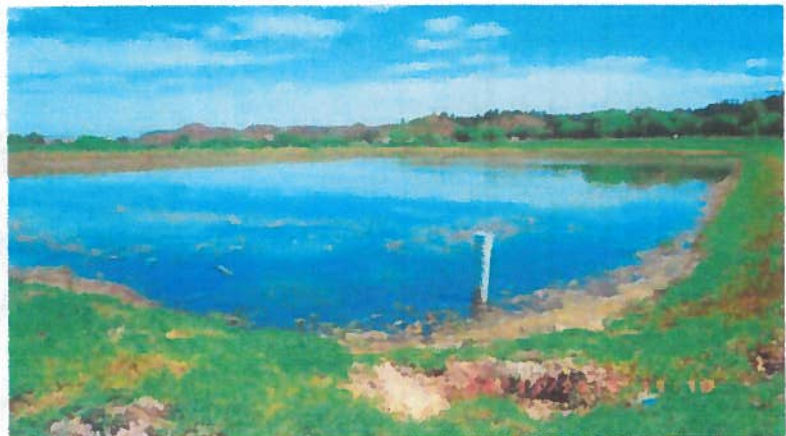
Photo number 168 taken by Emilio Llamozas on 6/13/2018.

The southern corner of Cell 1 was eroded, potentially impacting berm integrity.

In the southern corner of Cell 1, historical septic dumping had eroded a portion of the berm (Photograph 168), potentially impacting berm integrity. Facility representatives indicated the practice of emptying septic trucks directly onto the berm had been discontinued.

Overview of Cell 1. Note erosion from septic pumping in the southern corner. Note wastewater was not flowing into the cell because the lift station was not operating at the time of the inspection. Note the wastewater depth in cell 1 was approximately 3 feet.

Repair the berm erosion in the southern corner of Cell 1. In a response to EPA, provide a photograph and written narrative indicating this corrective action has been completed and indicate the date this corrective action was completed.

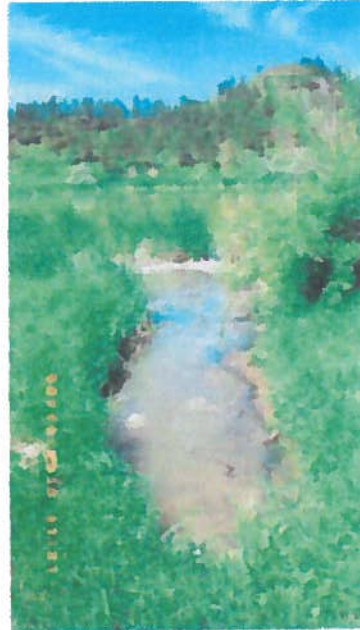
Influent flowing from the lift station emergency overflow flowing directly into Cell 2. Note the deposition of large solids into the cell.

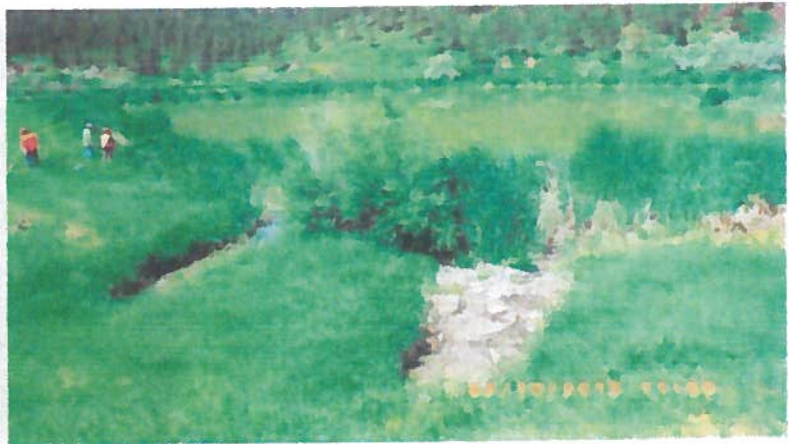
Photo number 170 taken by Emilio Llamozas on 6/13/2018.

Overview of influent from both lift station emergency overflows flowing directly into Cell 2. Wastewater was primarily flowing through the overflow on the left side of the photo. The overflow on the right side of the photo was obstructed by a crust of floating solids which had formed inside the lift station.

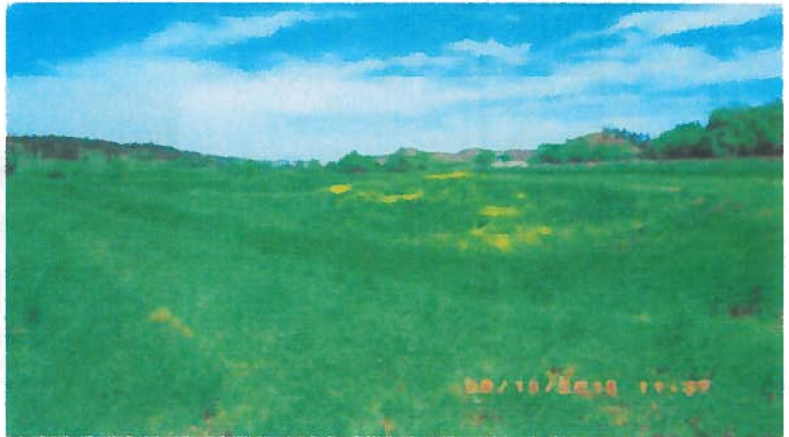
Overview of excavation pit northwest of the fermentation ponds (see 2014 aerial imagery).

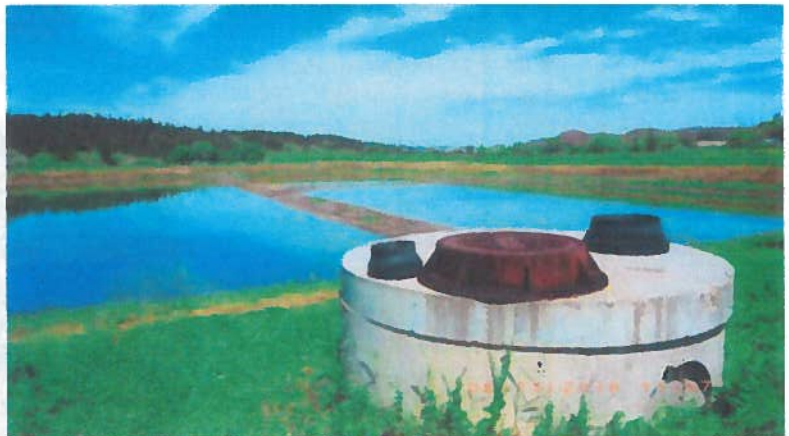
Photo number 172 taken by Emilio Llamozas on 6/13/2018.

Overview of a manhole along the line from the lift station to the fermentation pits, with the fermentation pits (right) and Cell 1 (left) in the background.

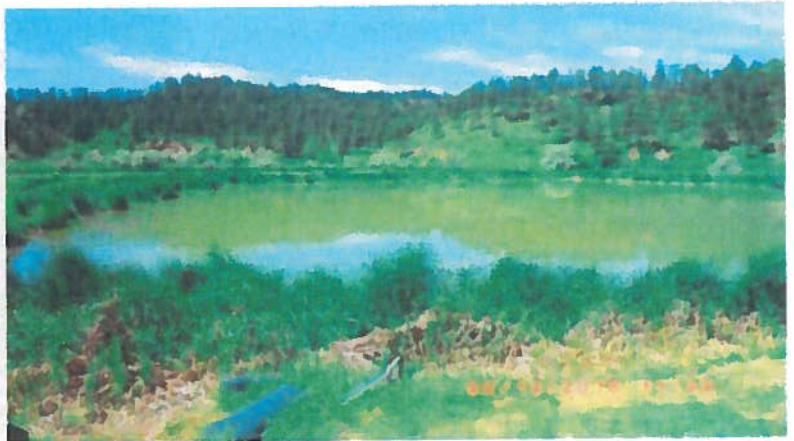
Overview of Cell 2. Note the color was a brown green opaque color. Floating aerators (foreground) had been removed from the cell in preparation for the upcoming sludge removal and Bio-Dome installation.

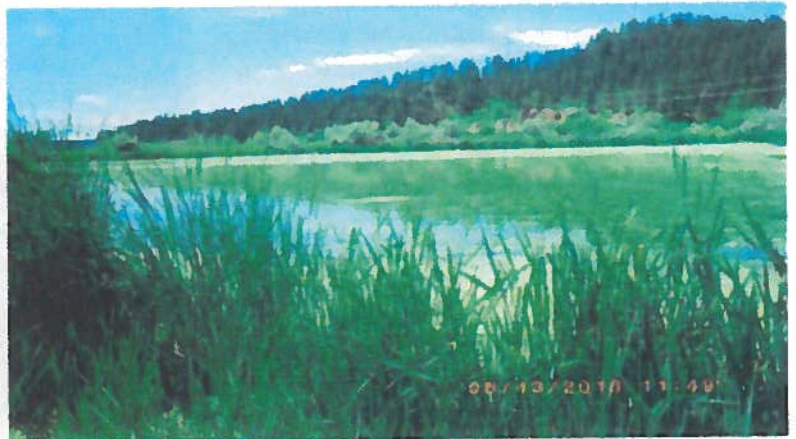
Photo number 174 taken by Emilio Llamozas on 6/13/2018.

Overview of Cell 3, as seen from the northern corner of the cell.

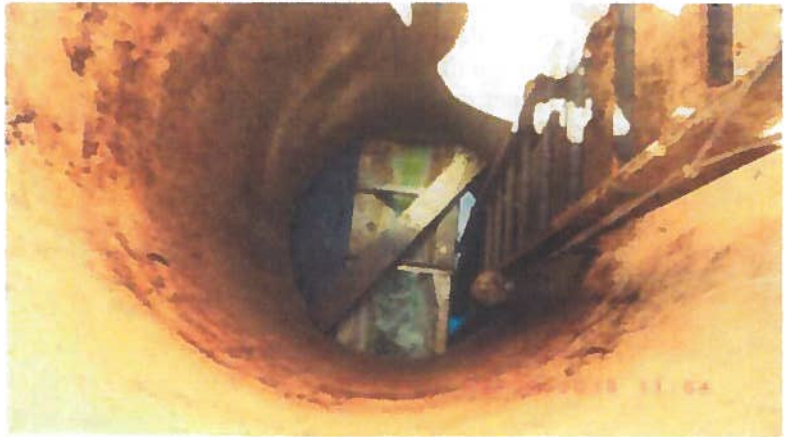
Interior of the manhole sampling location at the southwestern corner of Cell 3, immediately ahead of Outfall 001. Note the effluent was light green in color.

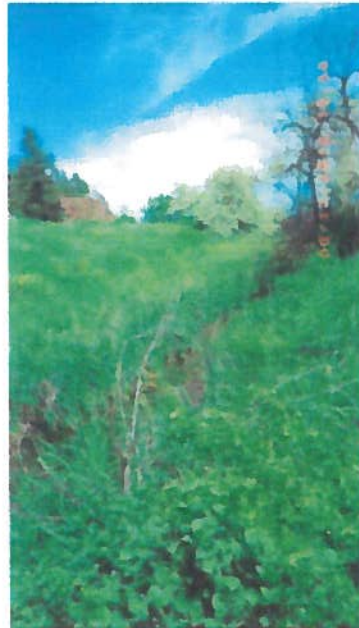
Photo number 176 taken by Emilio Llamozas on 6/13/2018.

Tall vegetation was present on the berms around Cell 2 and Cell 3 and the path to the outfall from Cell 3 was obscured (Photograph 176).

Overview of Lame Deer Creek at the outfall location from Cell 3. Note dense vegetation obscured the outfall location.

Ensure vegetation on the lagoon berms is reduced and maintained at a level such that the berms and outfall can be inspected for leakage, animal burrows, and erosion. In a response to EPA, provide a photograph and written narrative indicating this corrective action has been completed and indicate the date this corrective action was completed.

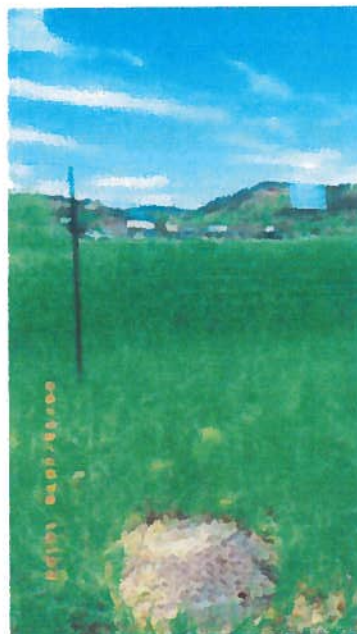
A manhole associated with unknown subsurface infrastructure along the northeastern berm of Cell 3, downgradient of the influent lift station was identified during the inspection (45.627961, -106.673186) (Photograph 177). It was unknown if any water flowed through the manhole and, if it did, where it flowed from or to.

We were not able to remove the manhole cover during the inspection. It is possible the manhole could be directing sewage or stormwater directly into Cell 3, bypassing a portion of the treatment system.

A manhole associated with unknown subsurface infrastructure along the northeastern berm of Cell 3, downgradient of the influent lift station (45.627961, -106.673186). We were not able to remove the manhole cover during the inspection. It was unknown if any water flowed through the manhole and, if it did, where it flowed from or to.

Ensure the manhole identified along the northeastern berm of Cell 3 is not conveying water directly into Cell 3. In a response to EPA, provide a photograph and written narrative indicating this corrective action has been completed and indicate the date this corrective action was completed.

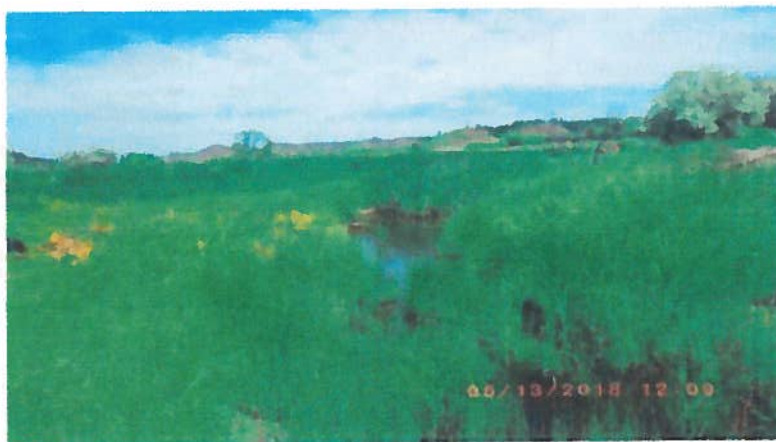
Photo number 178 taken by Emilio Llamozas on 6/13/2018.

Adjacent northeast of Cell 3 and southeast of Cell 2, surface water was ponding against the outside toe of the berms (Photographs 178 and 179), potentially impacting berm integrity.

Facility representatives indicated this issue had occurred frequently over the years, and it was not discernable whether the water comprised surface water, groundwater, or leakage from the lagoon.

Ponding adjacent southeast of Cell 2 and Cell 3.

Ensure surface water ponding does not occur adjacent northeast of Cell 3 and southeast of Cell 2. In a response to EPA, provide photographs and a written narrative describing the steps taken to implement this corrective action and indicate the date this corrective action was completed.

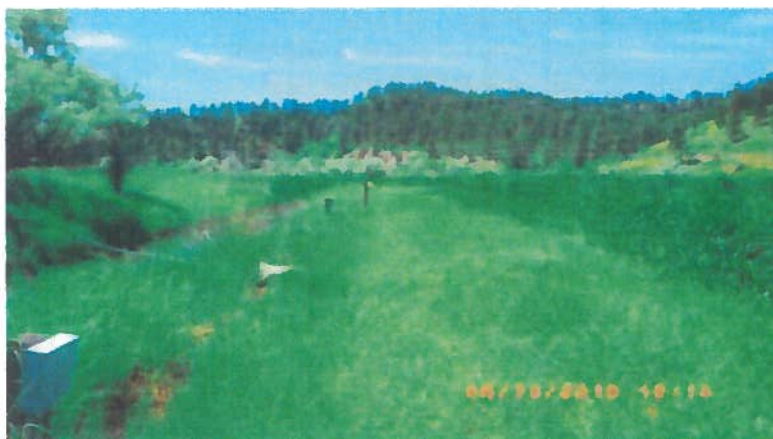
Ponding adjacent southeast of Cell 2 and Cell 3.

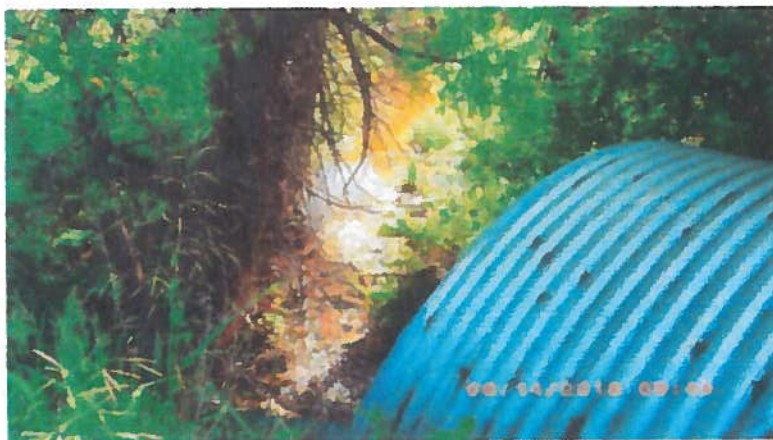
Photo number 191 taken by Emilio Llamozas on 6/14/2018.

Ambient monitoring location, Outfall 001R, was not correctly identified by NCUC personnel.

Erroneous ambient stream monitoring location which was not Outfall 001R.

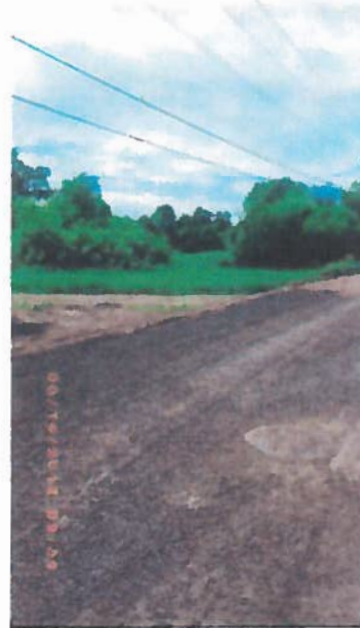
Overview of recent sewer repair work which had been completed to address SSOs from this portion of the collection system flowing into Lame Deer Creek.
