Environmental Survey and Assessment for Asbestos Containing Materials

Work Area at Tallaboa Industrial Park (formerly PR Olefins)
Road 127, Peñuelas, Puerto Rico
(Work Plan Approved by EPA, Reference No. CAA-02-2014-1009)

Carlos E. Ocasio-Feliciano
Best Environmental Consultants, Inc.
Lead-Asbestos-Mold Consultants
PO Box 560180
Guayanilla, PR 00656-0180

January 29, 2019

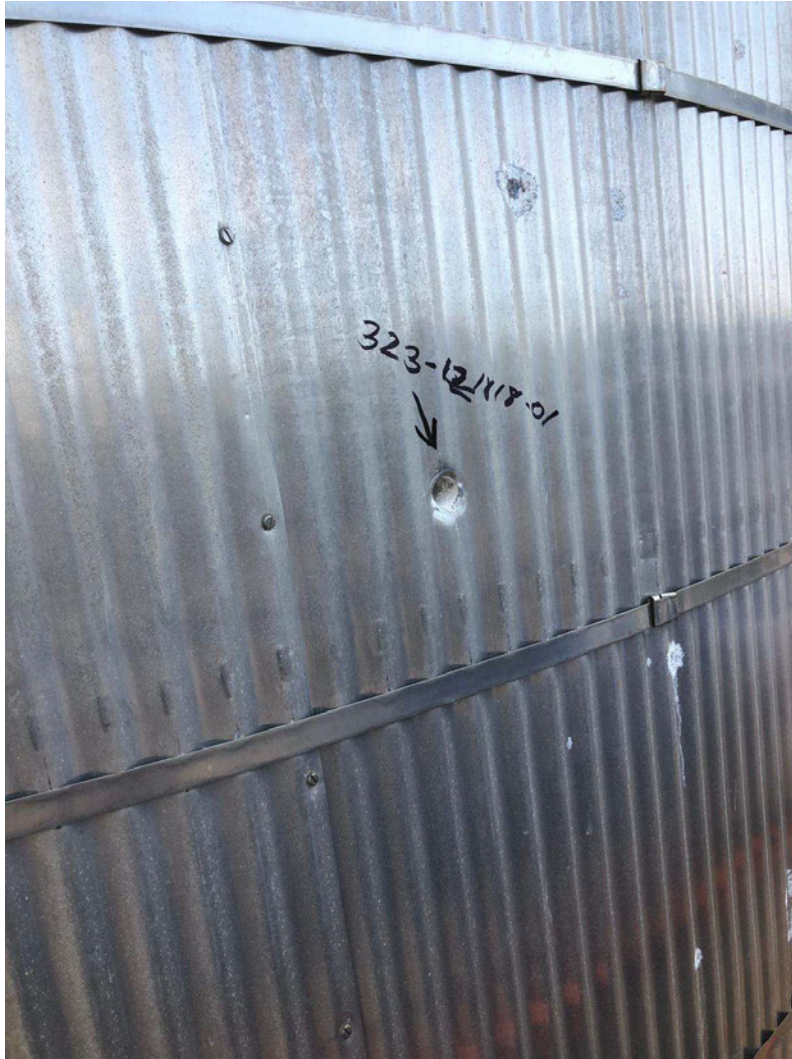
General View Sampling Point #1, TSI Tower #1 South Side

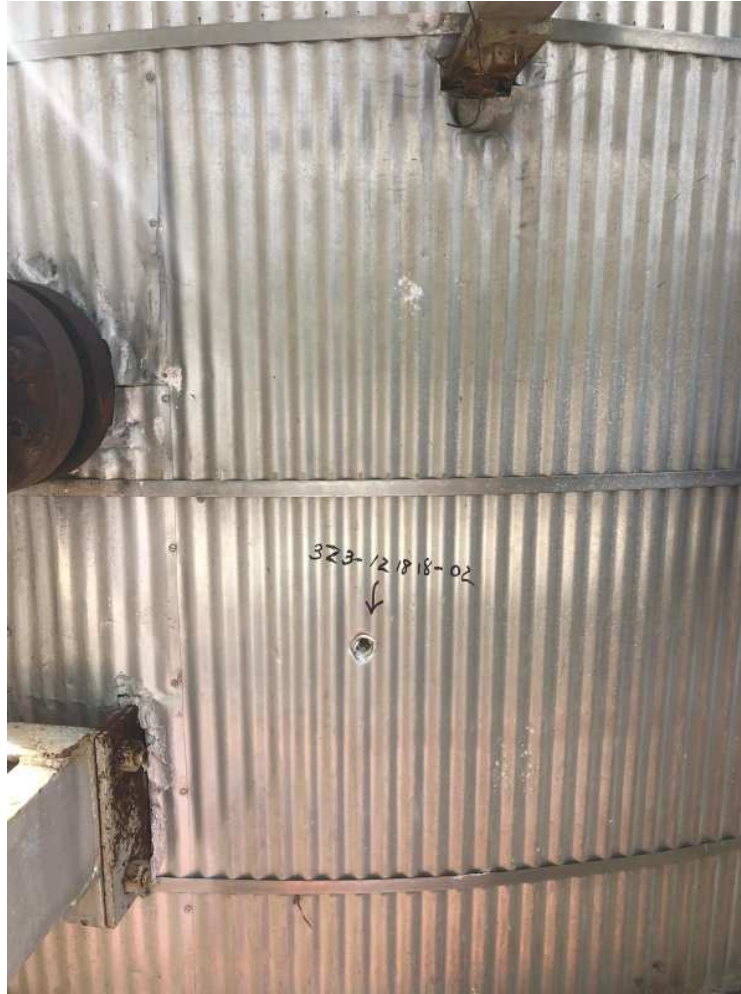
General View Sampling Point #2, TSI Tower #1 East Side

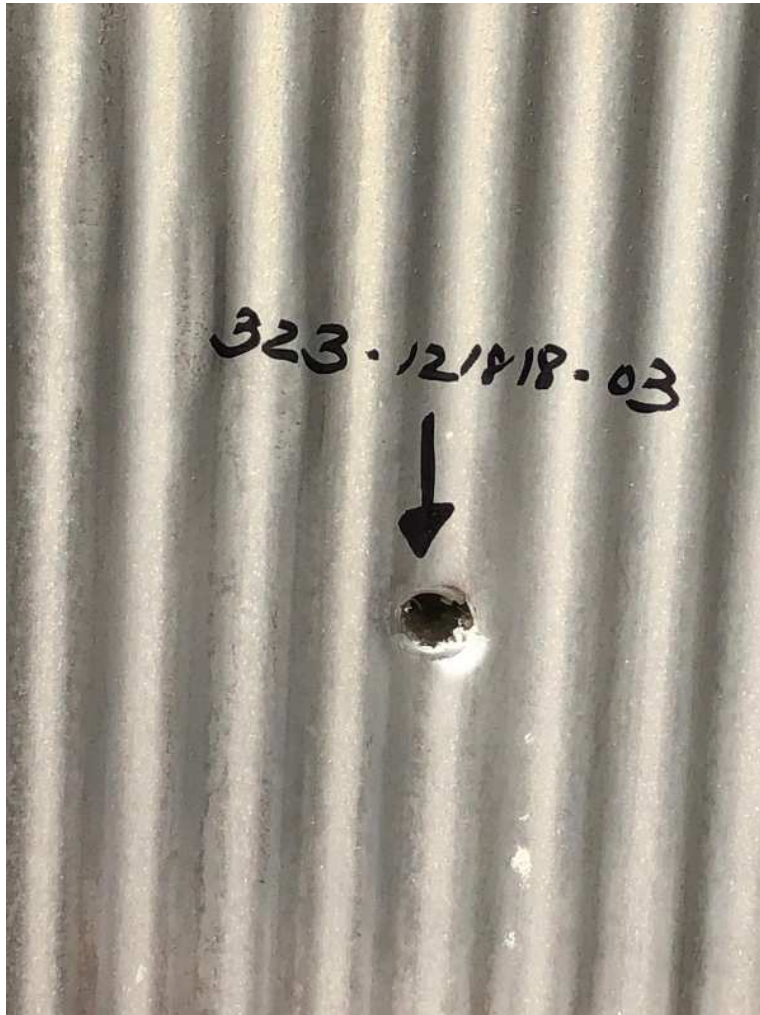
General View Sampling Point #3, TSI Tower #1 North Side

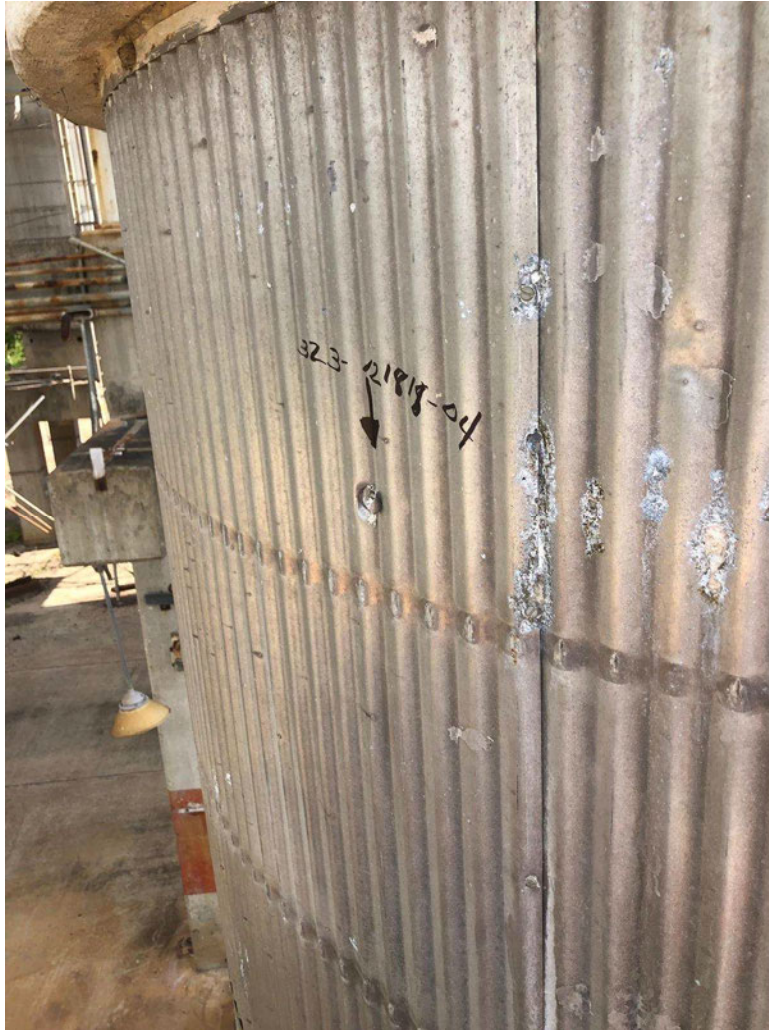
General View Sampling Point #4, TSI Tower #2 South Side

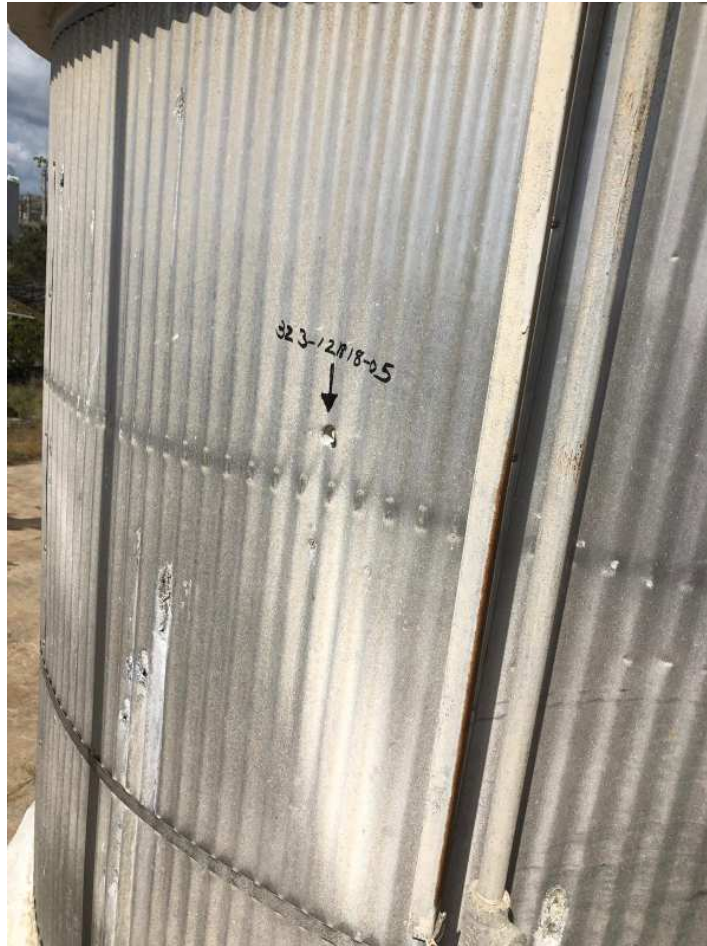
General View Sampling Point #5, TSI Tower #2 East Side

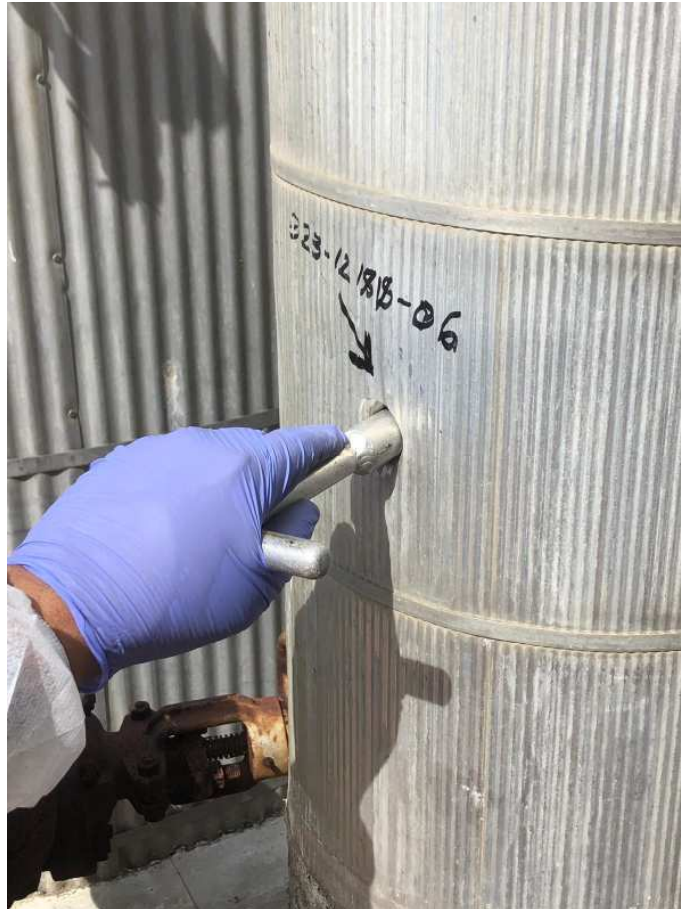
General View Sampling Point #6, TSI Tower #2, 12'' \varnothing Pipe, Northeast Side

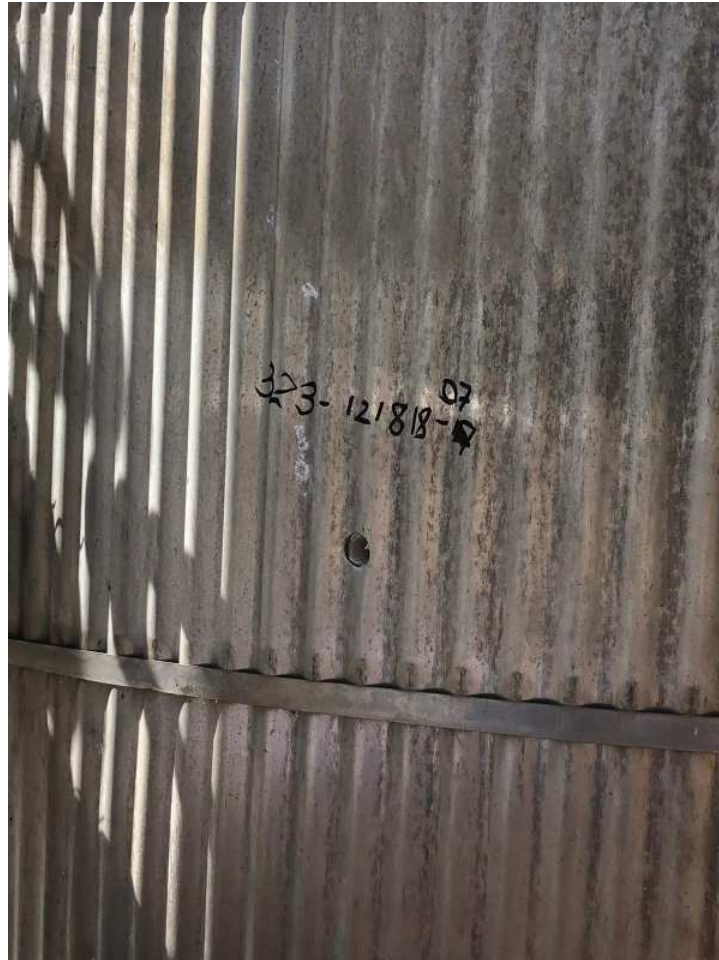
General View Sampling Point #7, TSI Tower #2, North Side.

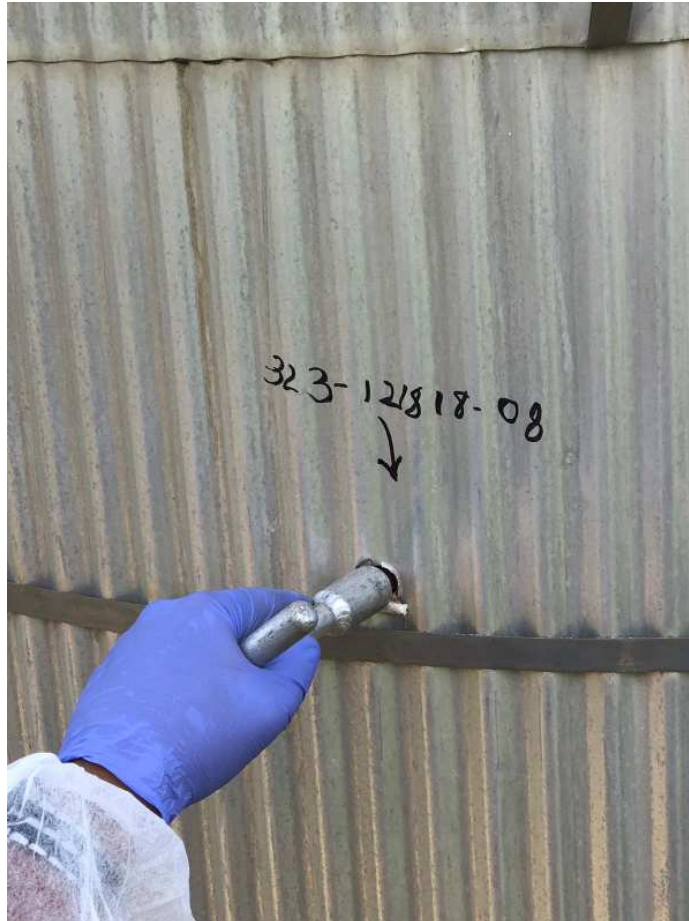
General View Sampling Point #8, TSI Tower #3, North Side.

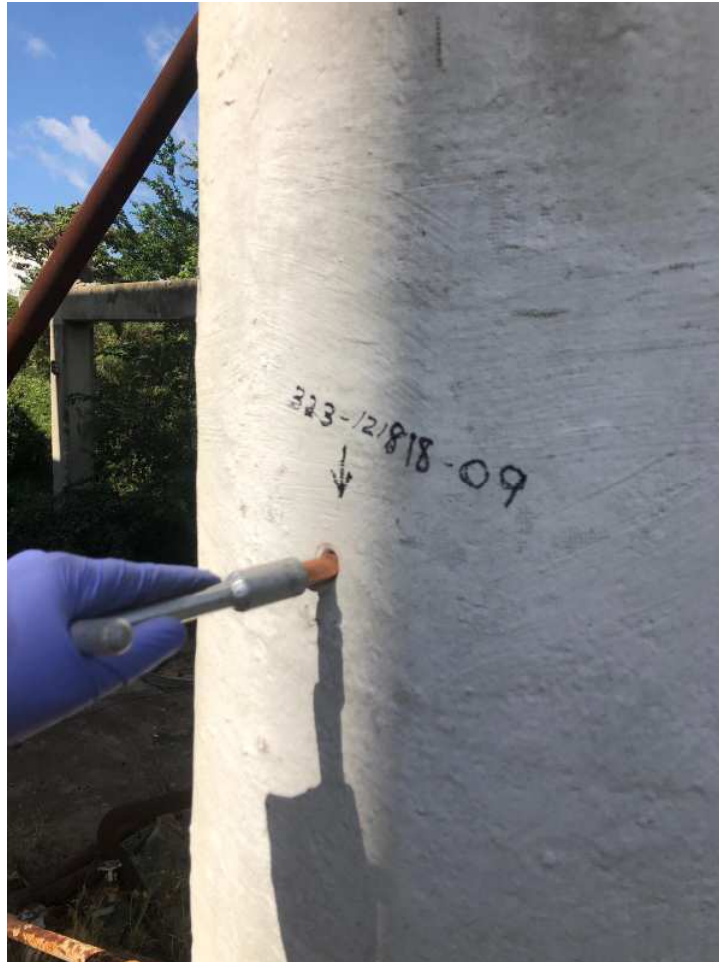
General View Sampling Point #9, TSI Tower #3, Distillation Unit North Side.

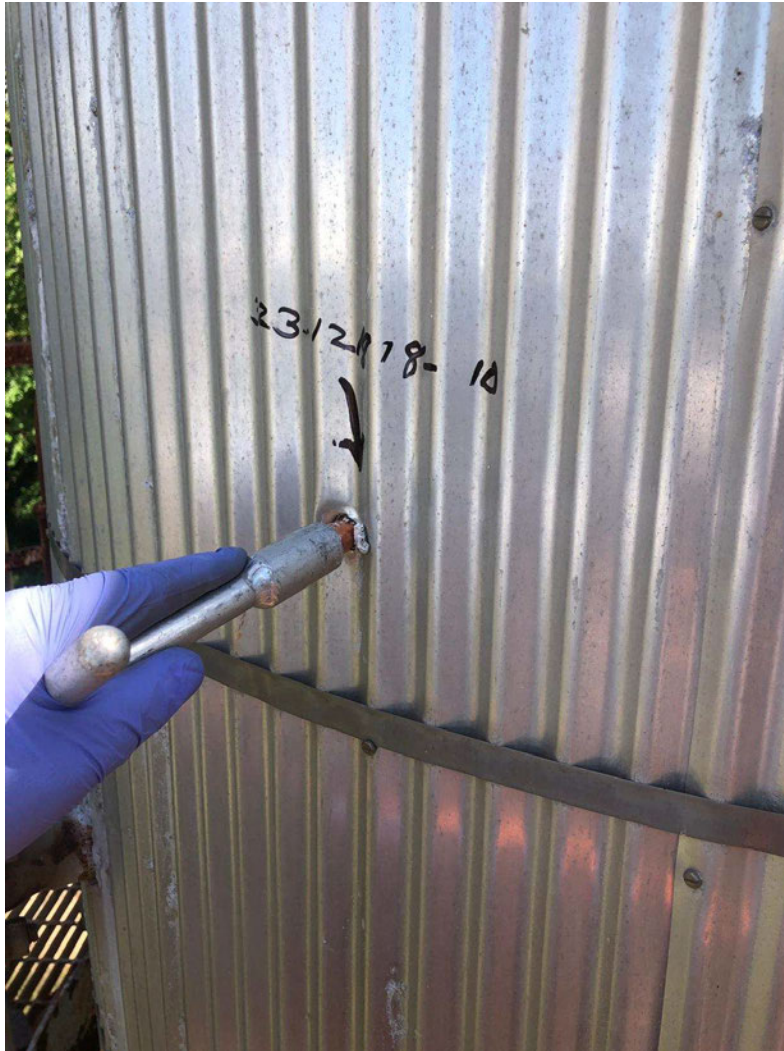
General View Sampling Point #10, TSI Tower #3, South Side

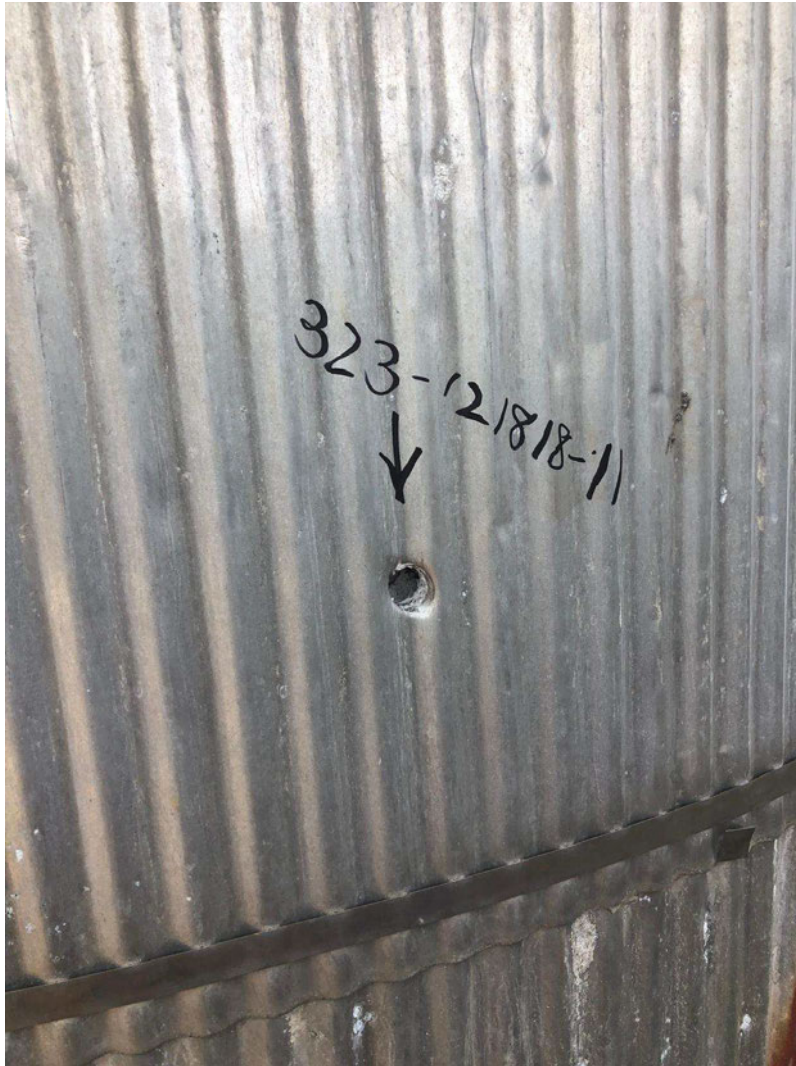
General View Sampling Point #11, TSI Tower #4, North Side

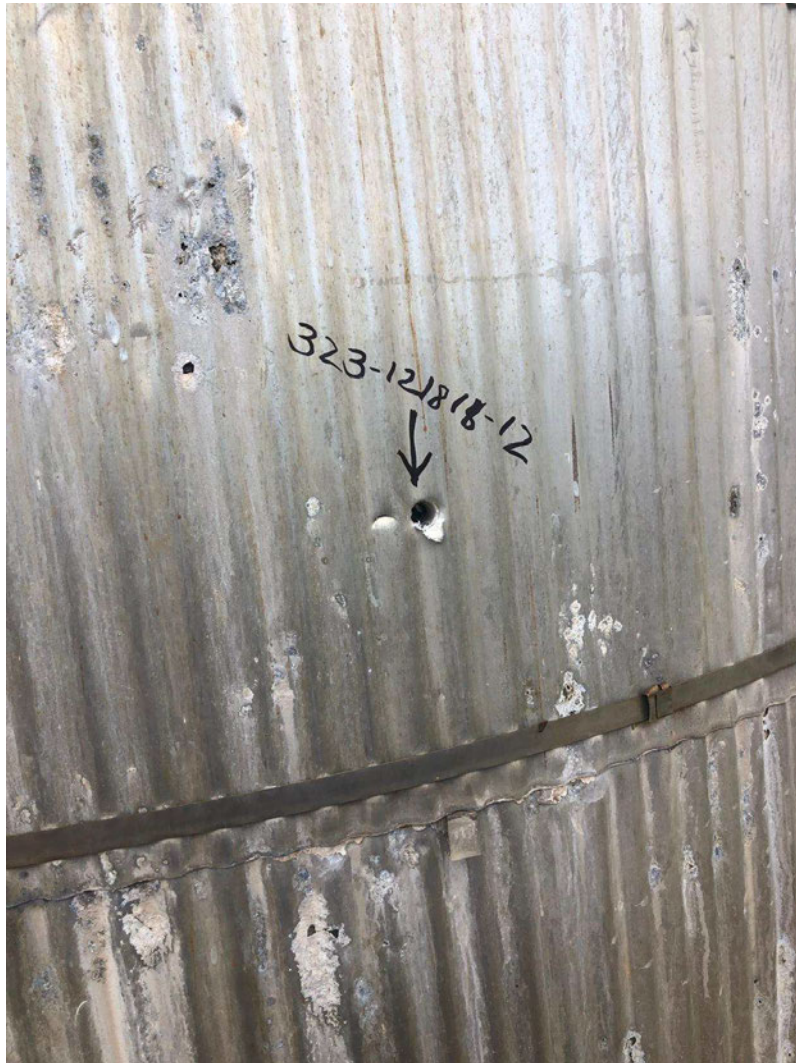
General View Sampling Point #12, TSI Tower #4, South Side

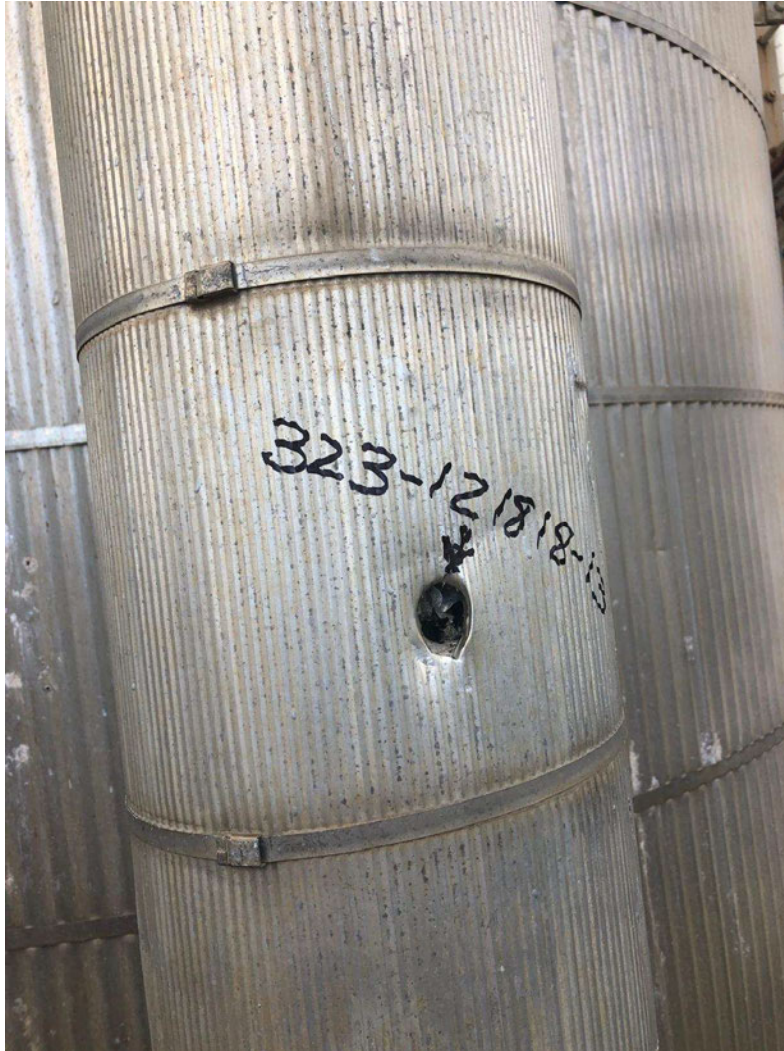
General View Sampling Point #13, TSI Tower #4, Pipe Insulation 10'Ø
South Side.

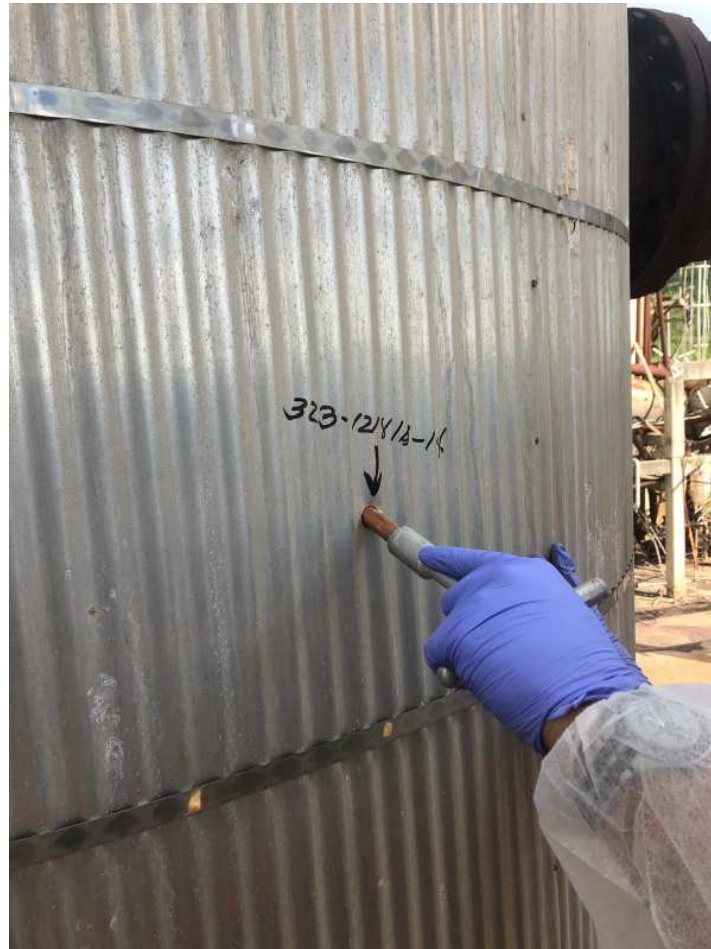
General View Sampling Point #14, TSI Tower #4,
Southwest Side.

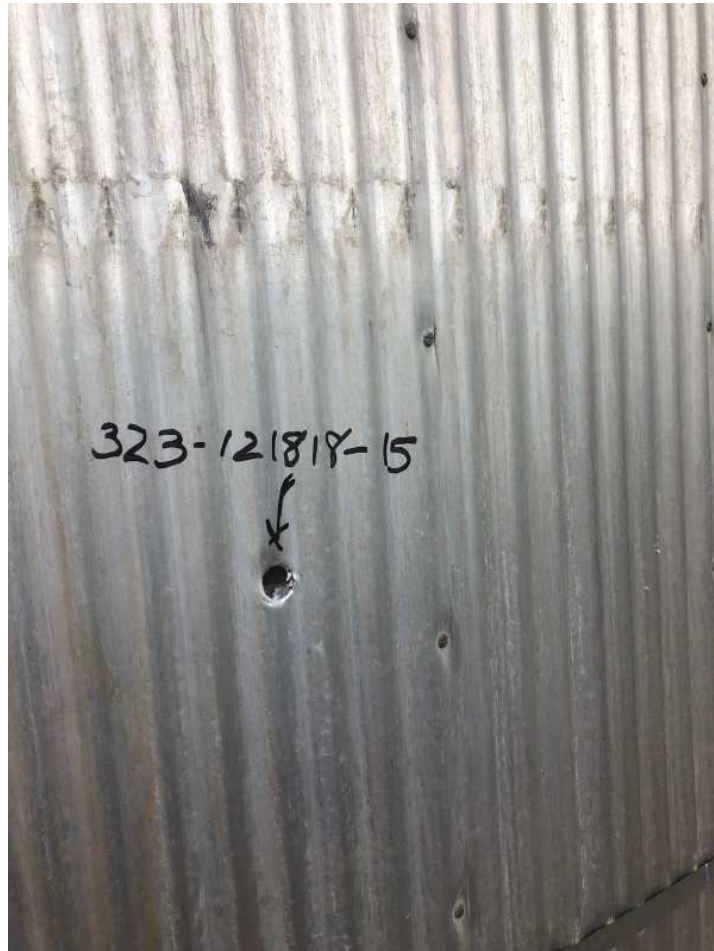
General View Sampling Point #15, TSI Tower #5,
North Side.

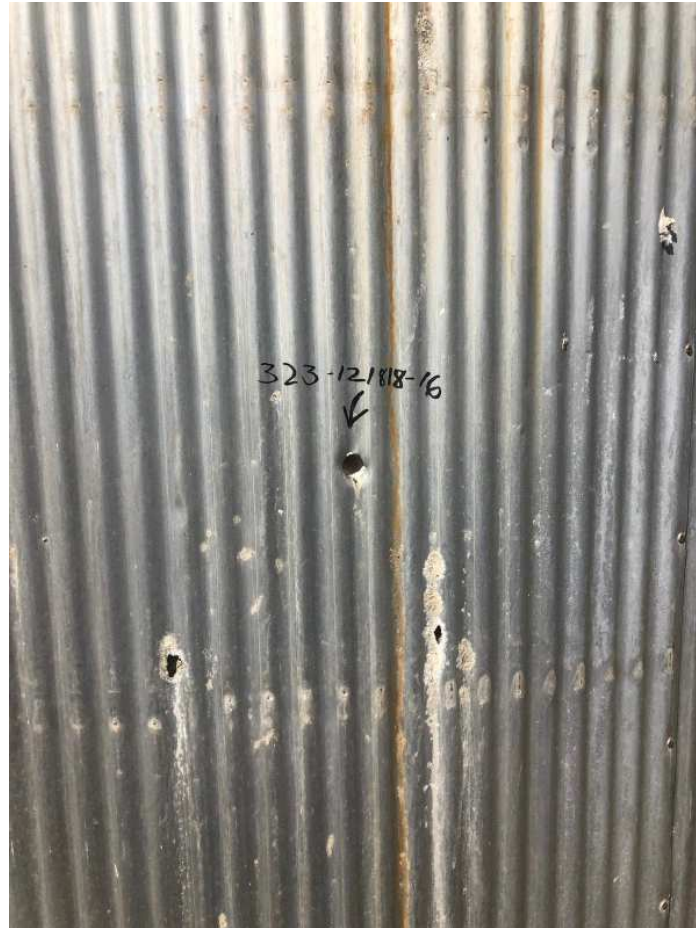
General View Sampling Point #16, TSI Tower #5,
East Side.

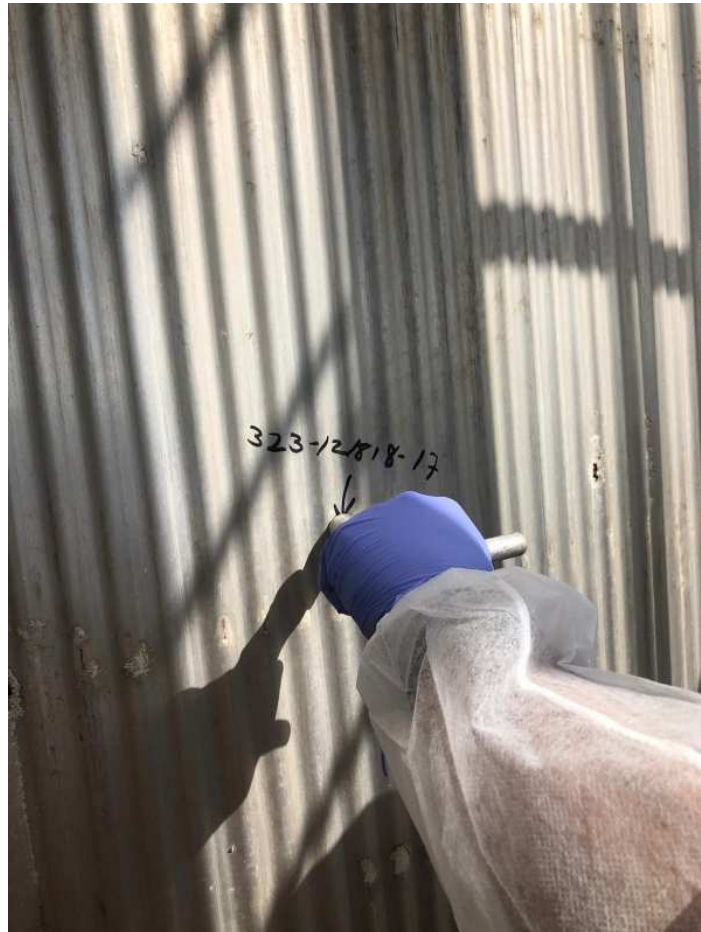
General View Sampling Point #17, TSI Tower #6,
South Side.

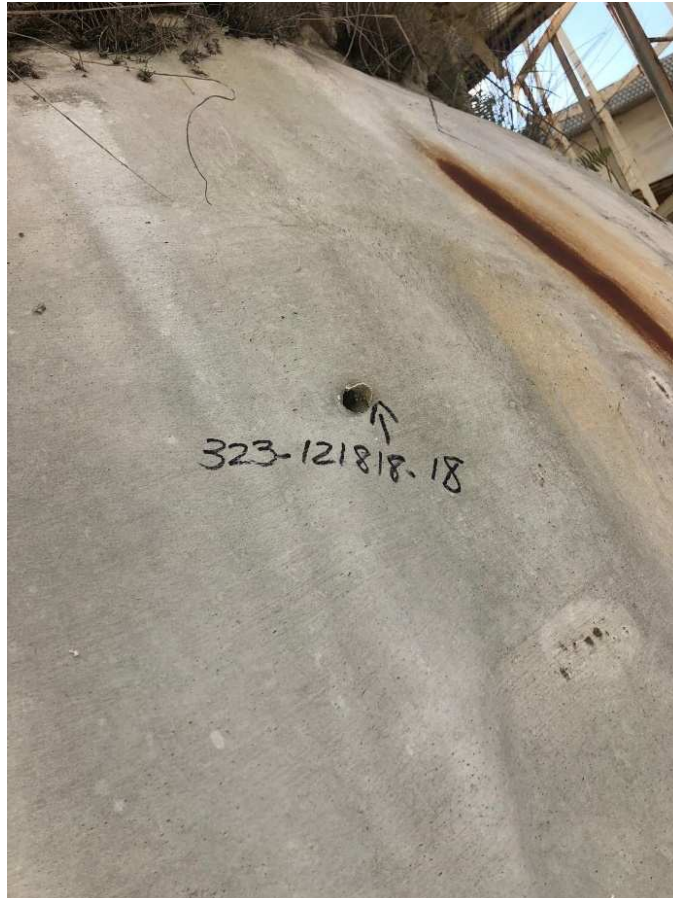
General View Sampling Point #18, TSI Tower #6,
North Side.

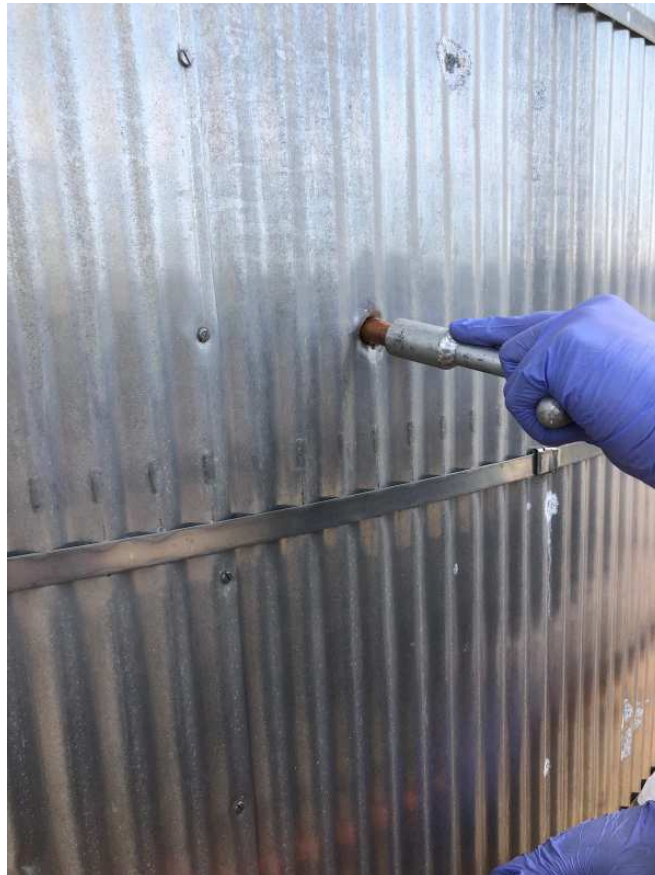
General View Sampling Point #19, TSI Tower #6,
Northeast Side.

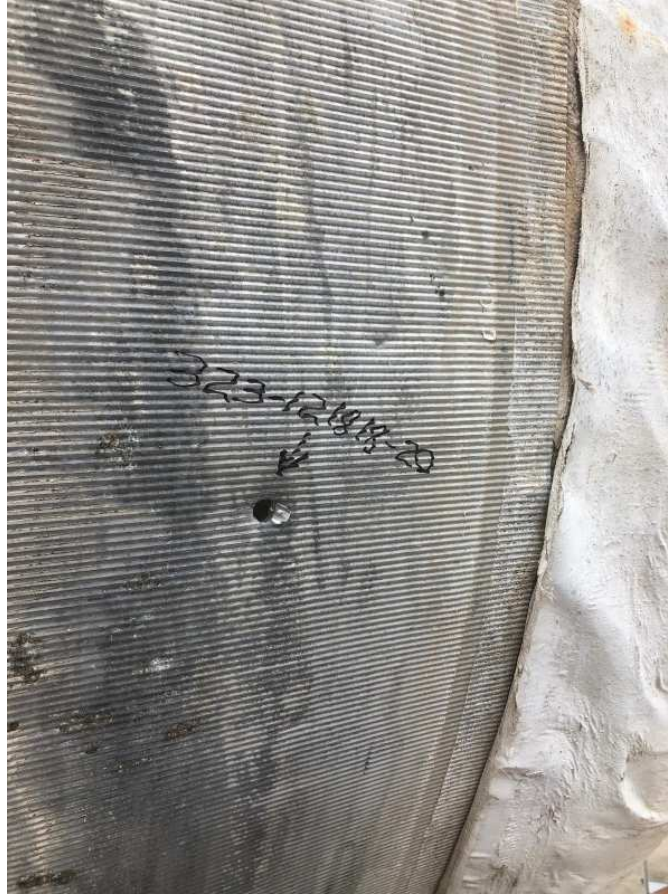
General View Sampling Point #20, TSI Tower #6,
South Side.

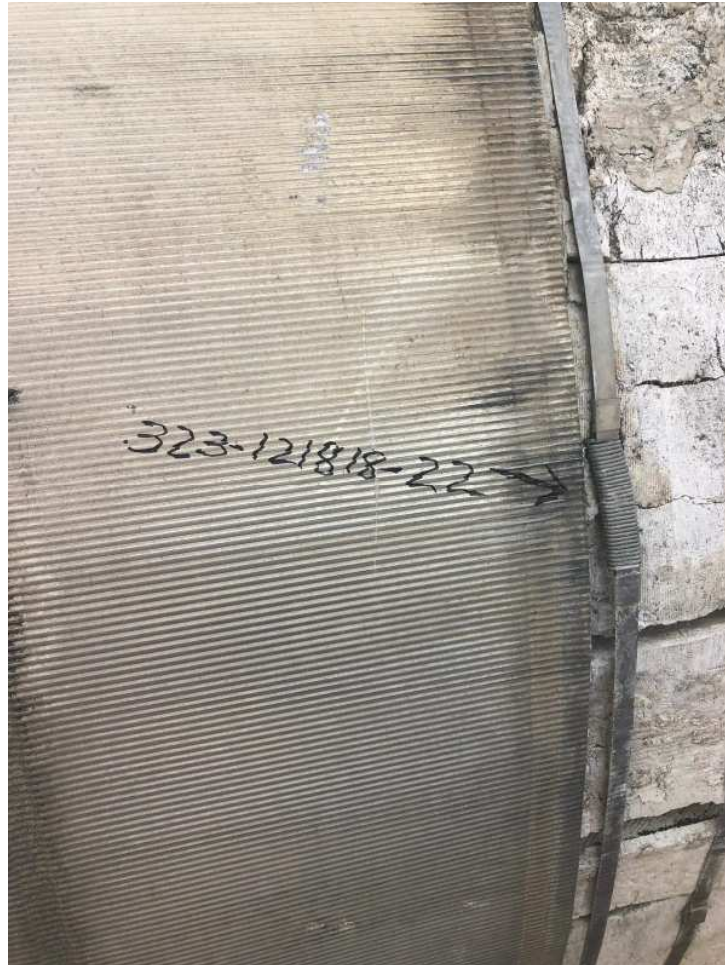
General View Sampling Point #22, TSI Tank #1,
Northeast Side.

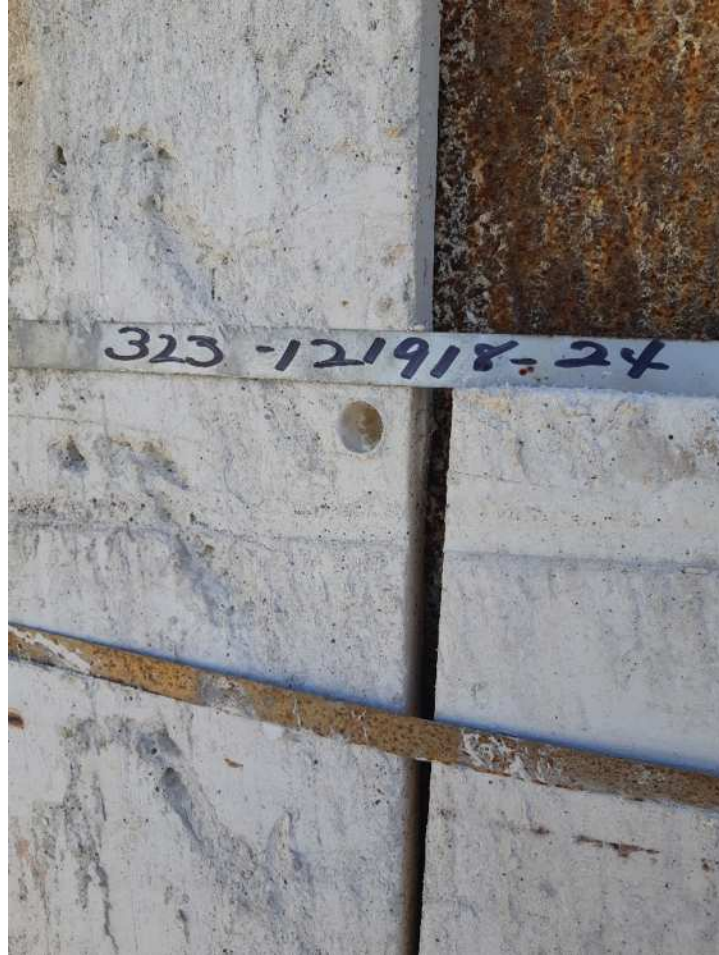
General View Sampling Point #24, TSI Tower 7,
South Side.

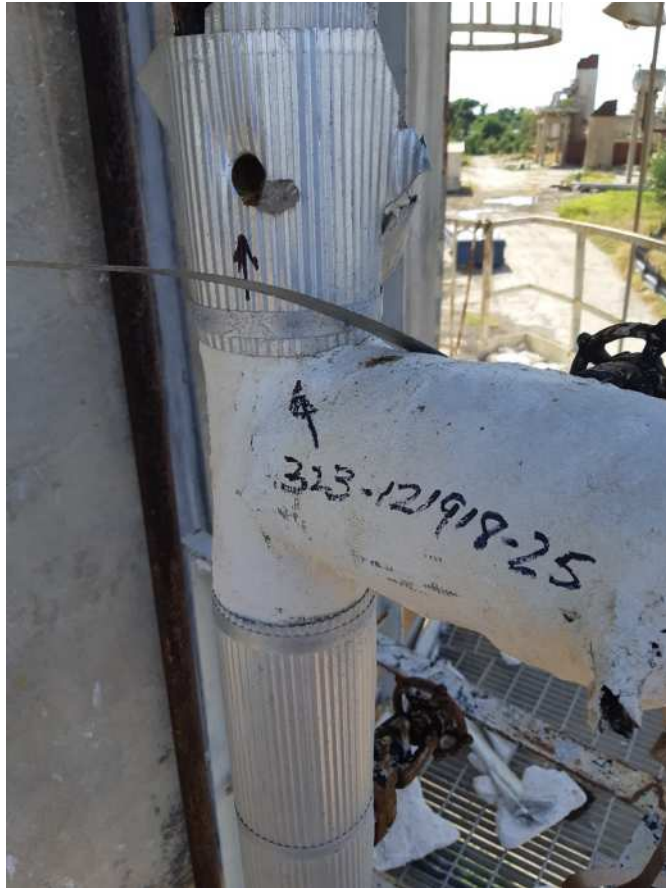
General View Sampling Point #25, TSI Tower 7,
North Side.

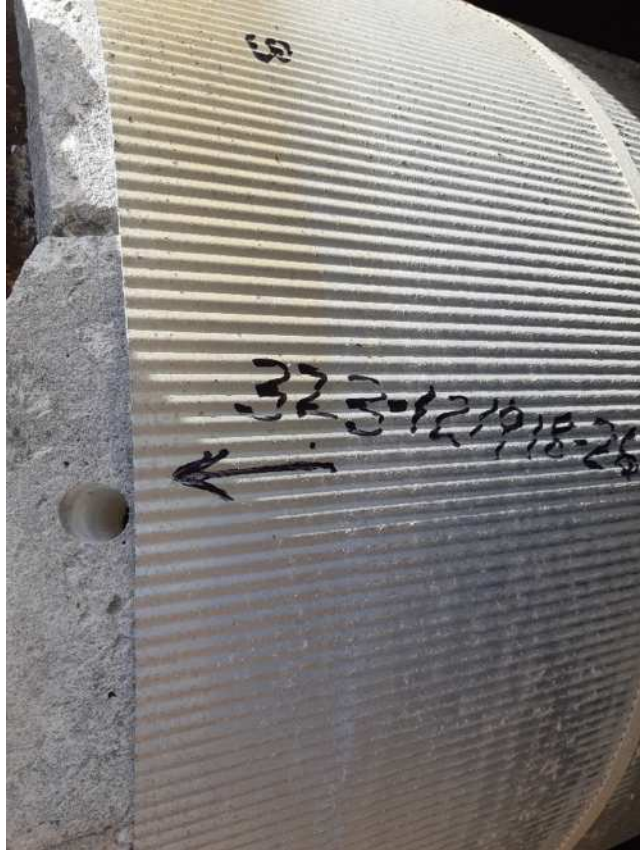
General View Sampling Point #26, TSI Interior Pipe 24'' ϕ ,
Southeast Side.

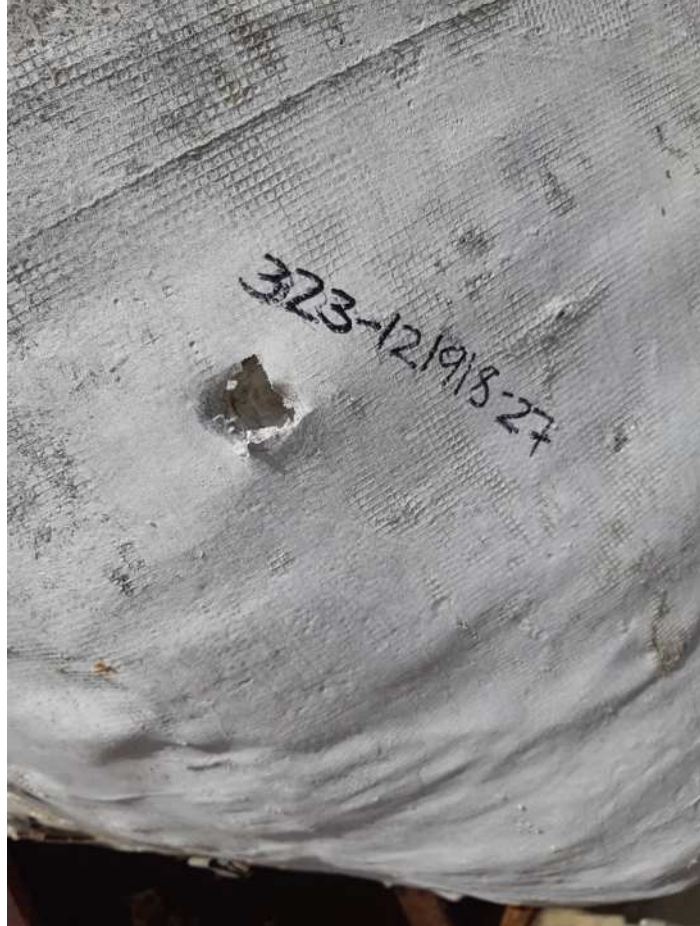
General View Sampling Point #27, Tank 2 TSI,
North Side.

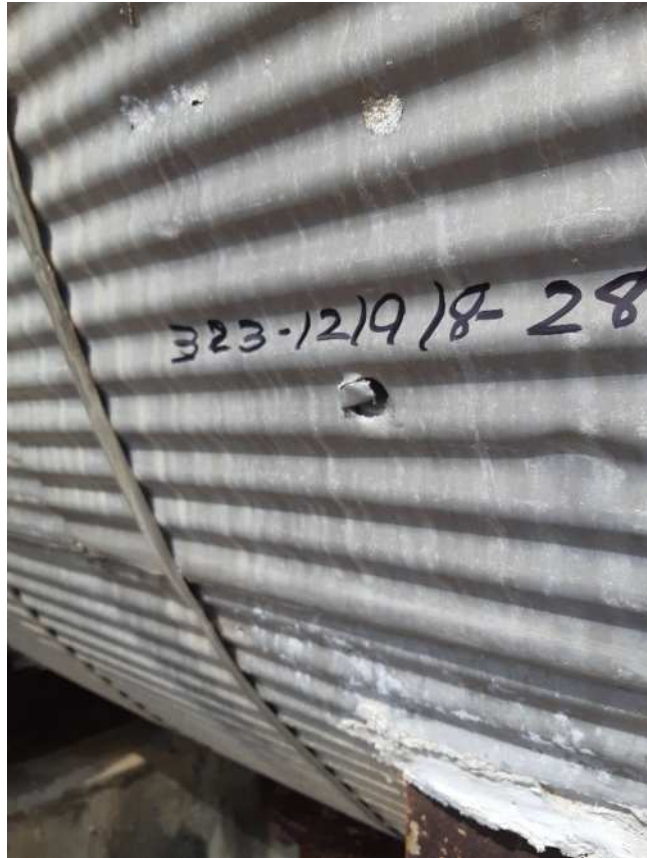
General View Sampling Point #28, Tank 2 TSI,
North Side.

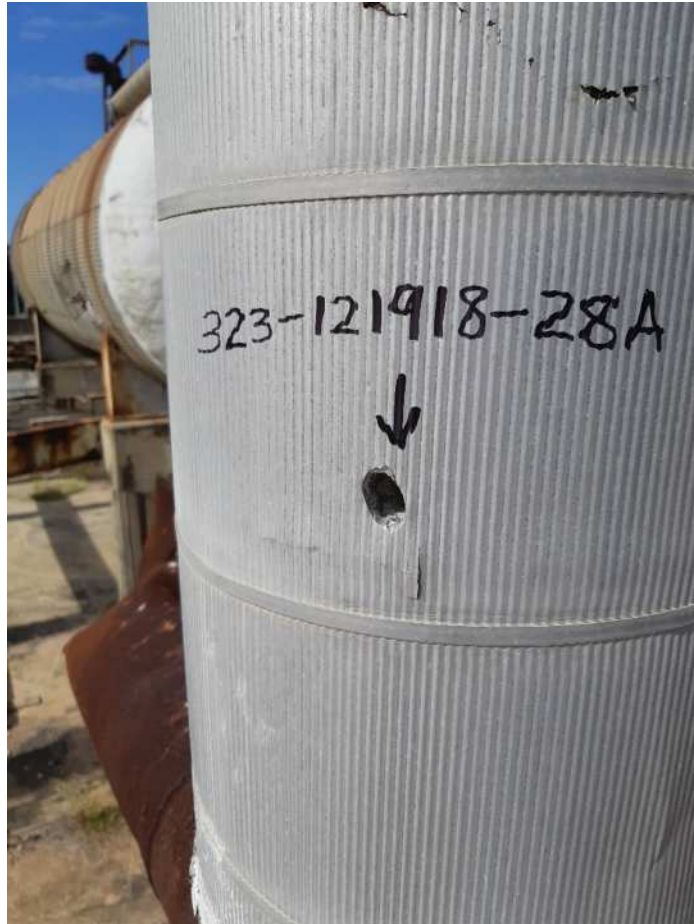
General View Sampling Point #28A, Tank 2, 10' \varnothing TSI,
East Side.

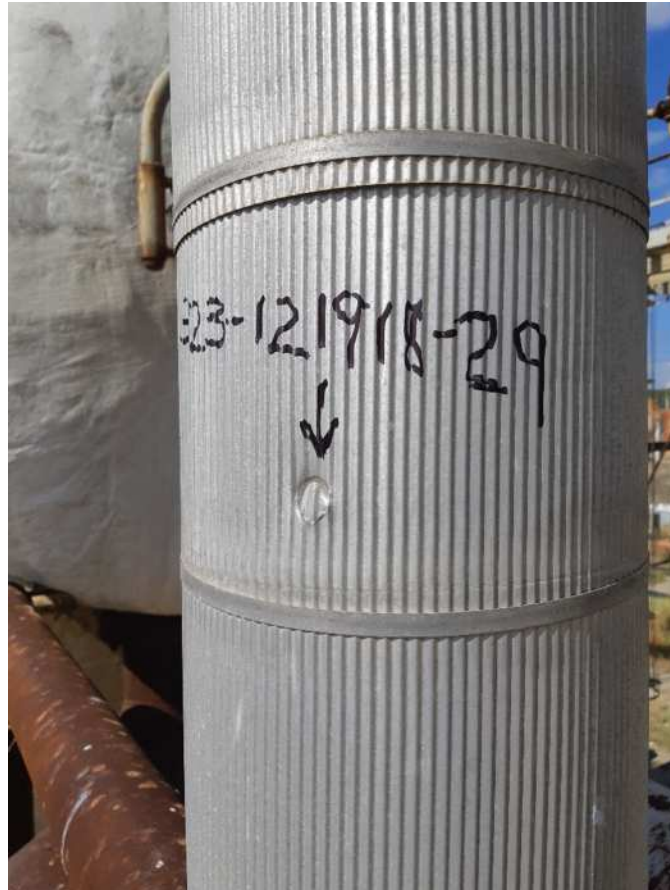
General View Sampling Point #29, Tank 2 TSI,
South Side.

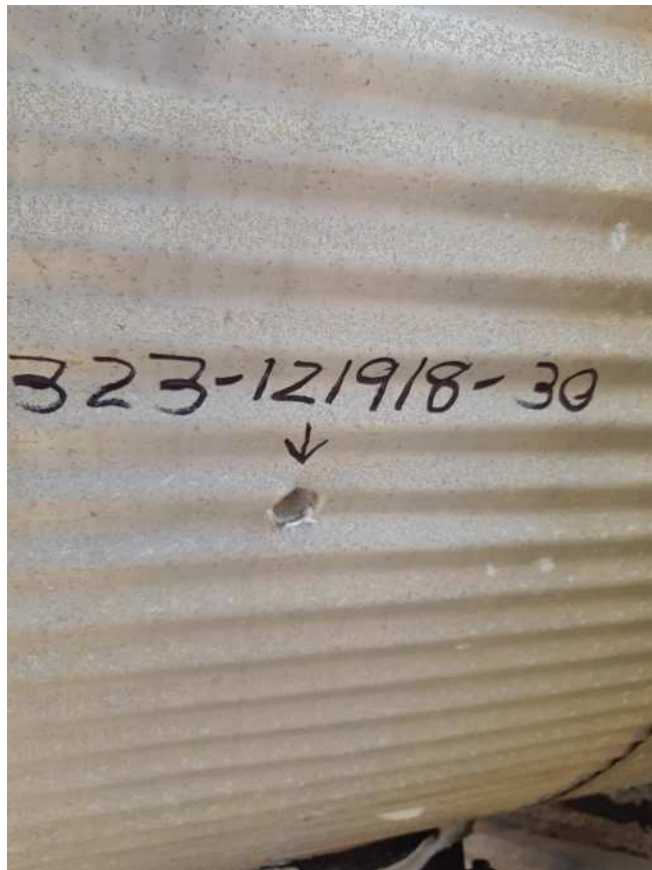
General View Sampling Point #30, Tank 3 TSI,
South Side.

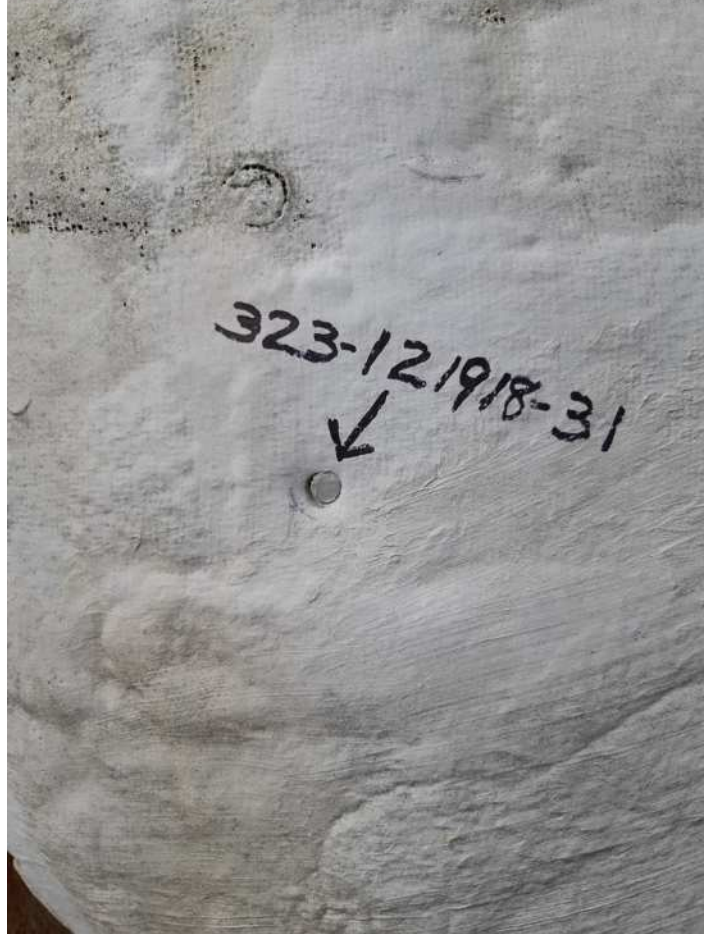
General View Sampling Point #31, Tank 3 TSI,
North Side.

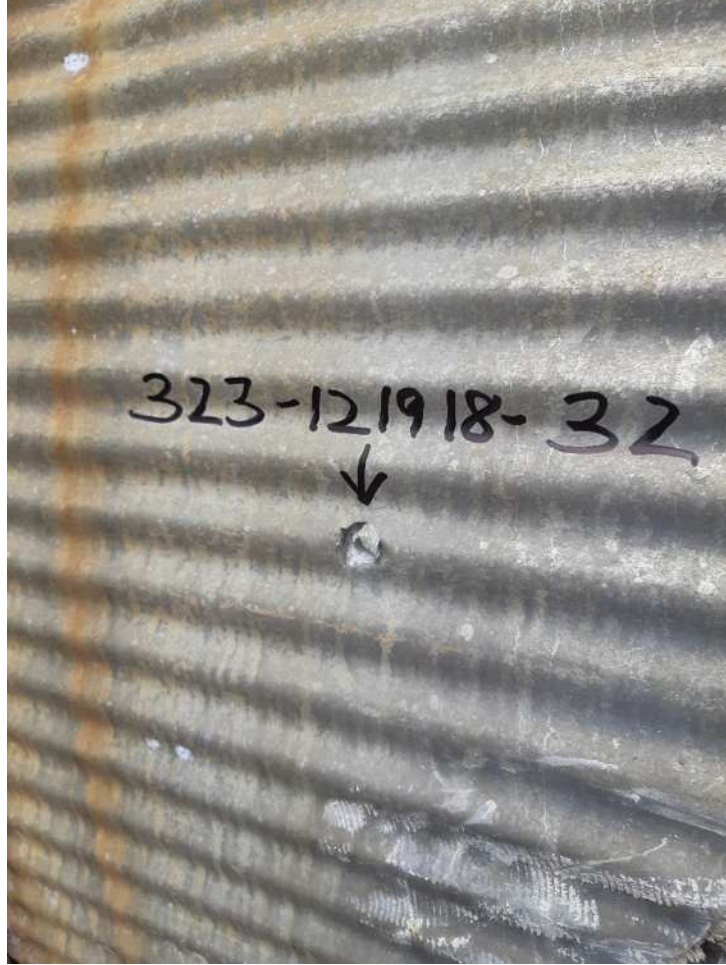
General View Sampling Point #32, Tank 4 TSI,
North Side.

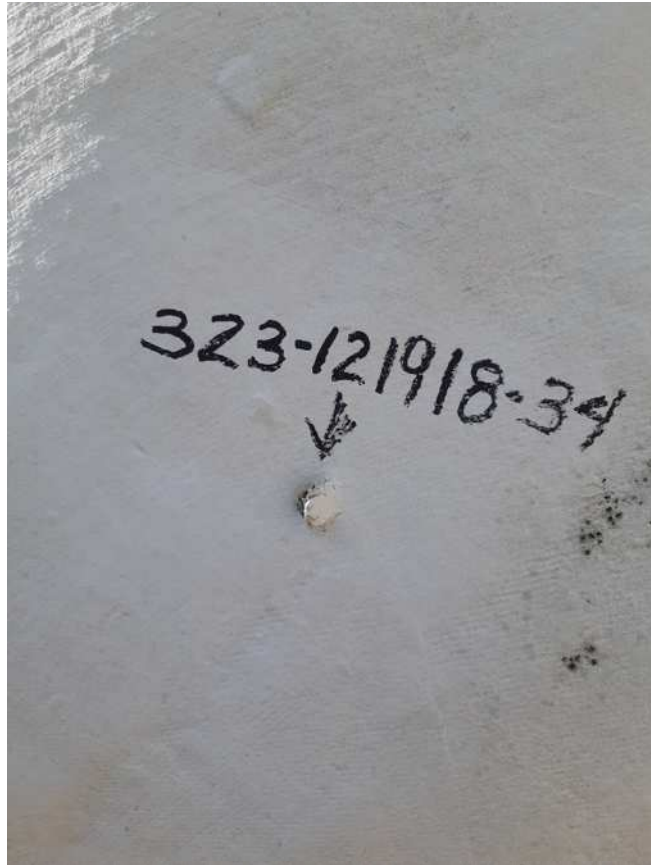
General View Sampling Point #34, Tower 7 TSI, Interior Pipe
24'' ϕ Southeast Side.

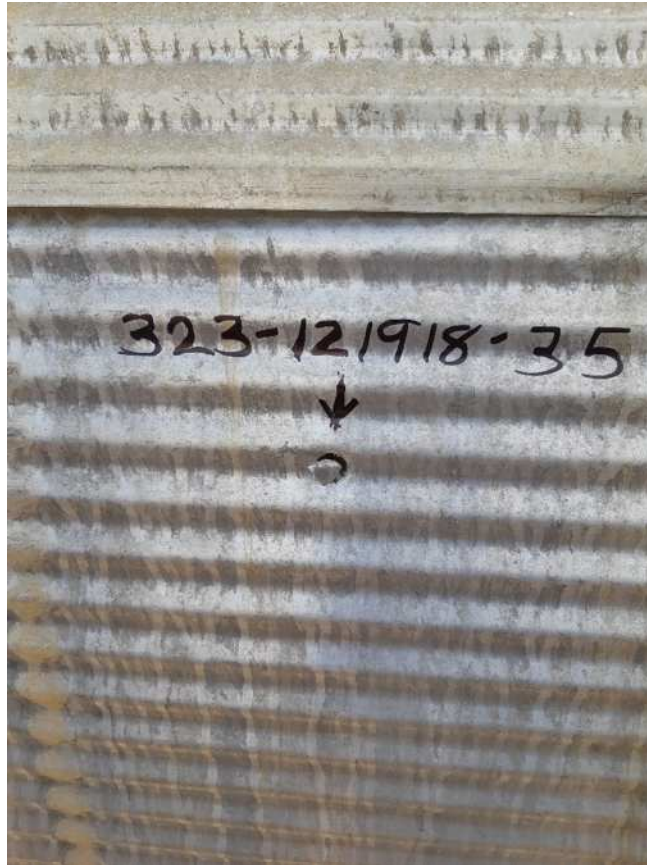
General View Sampling Point #35, Tank 2 TSI, North Side.
(Picture sampling point #36 #37 & 38 not available)
