Environmental Survey and Assessment for Asbestos Containing Materials

Work Area at Tallaboa Industrial Park (formerly PR Olefins)
Road 127, Peñuelas, Puerto Rico
(Work Plan Approved by EPA, Reference No. CAA-02-2014-1009)

Carlos E. Ocasio-Feliciano
Best Environmental Consultants, Inc.
Lead-Asbestos-Mold Consultants
PO Box 560180
Guayanilla, PR 00656-0180

January 29, 2019

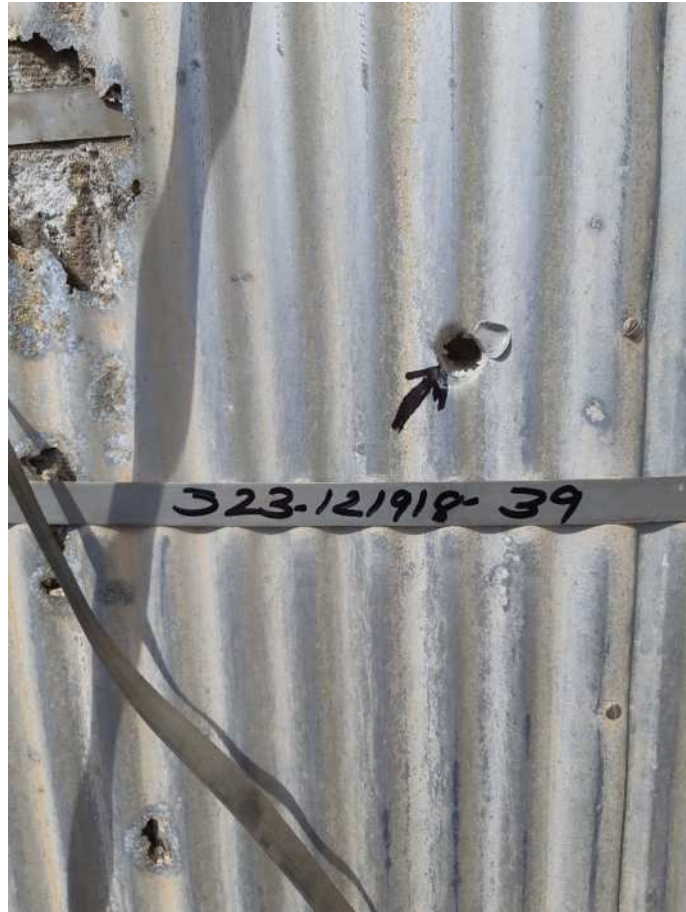
General View Sampling Point #39, Tank 6 TSI, South Side.

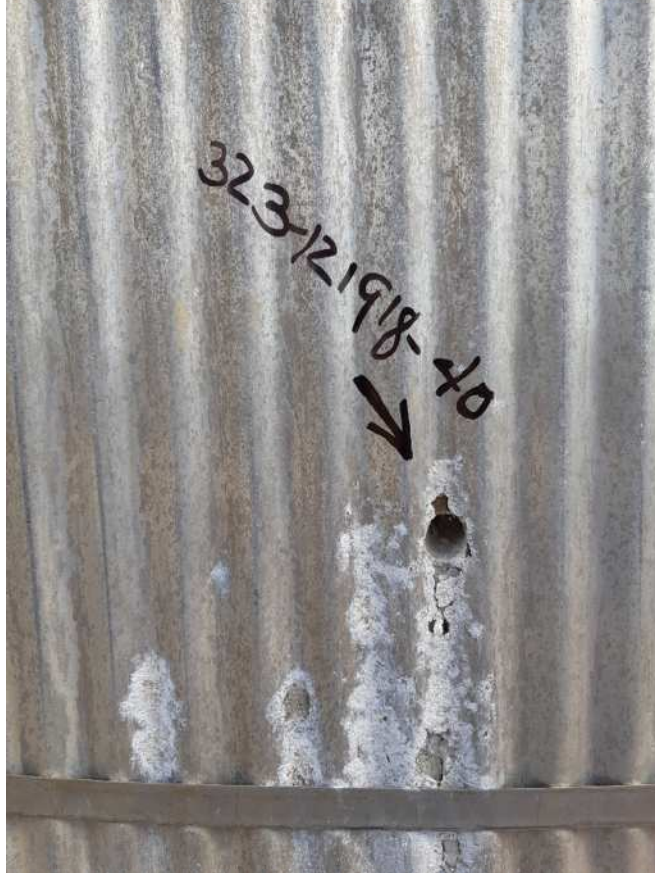
General View Sampling Point #40, Tank 6 TSI, West Side.

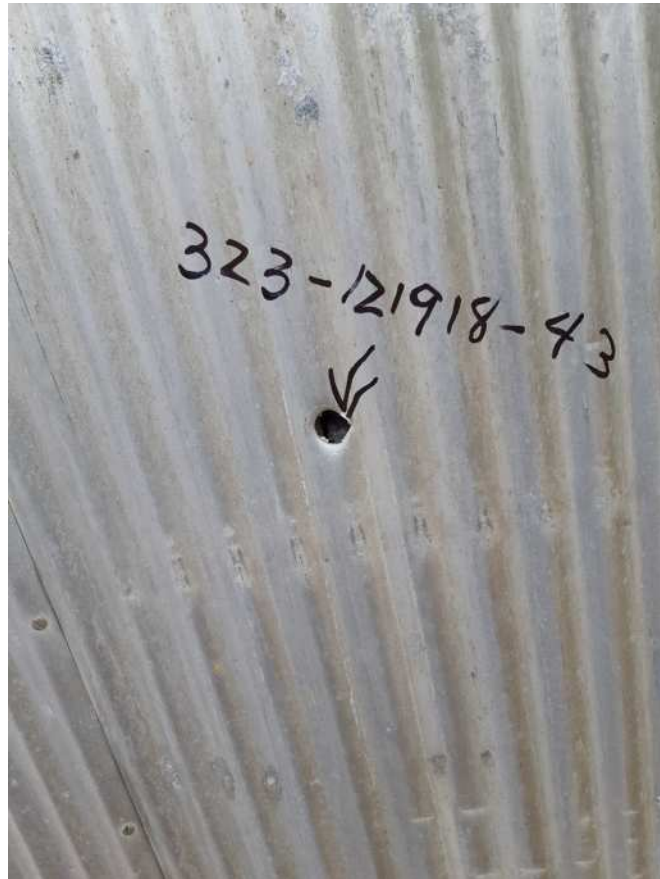
General View Sampling Point #43, Tower 9 TSI, North Side.

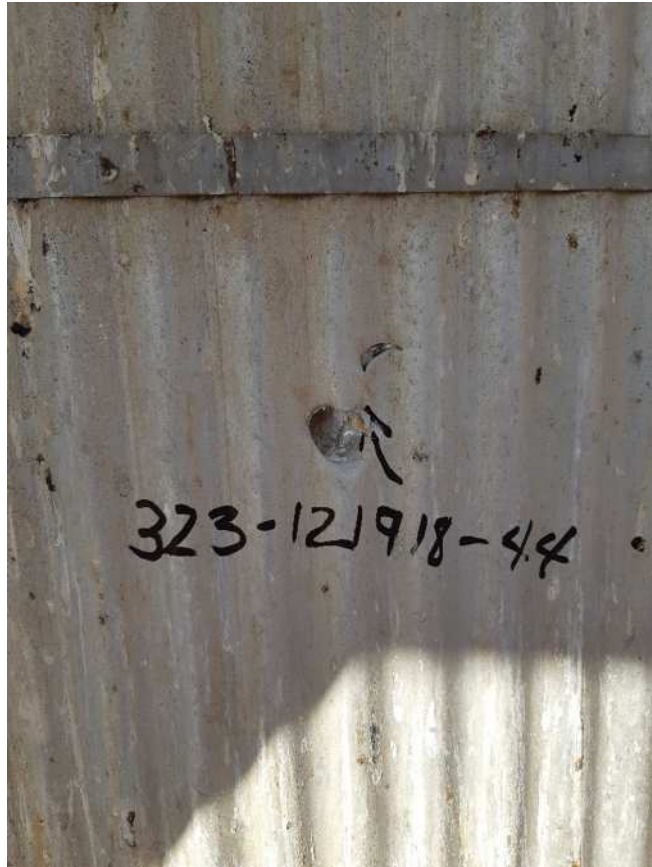
General View Sampling Point #44, Tower 9 TSI, Southeast Side.

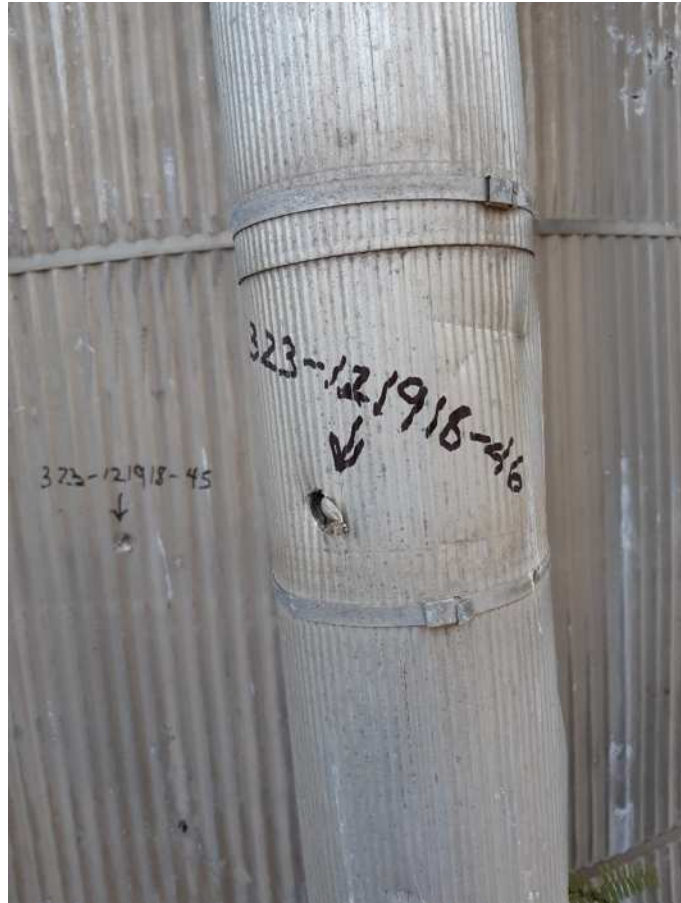
General View Sampling Point #46, 8'' \varnothing Pipe, Tower 10 TSI, Northeast Side.

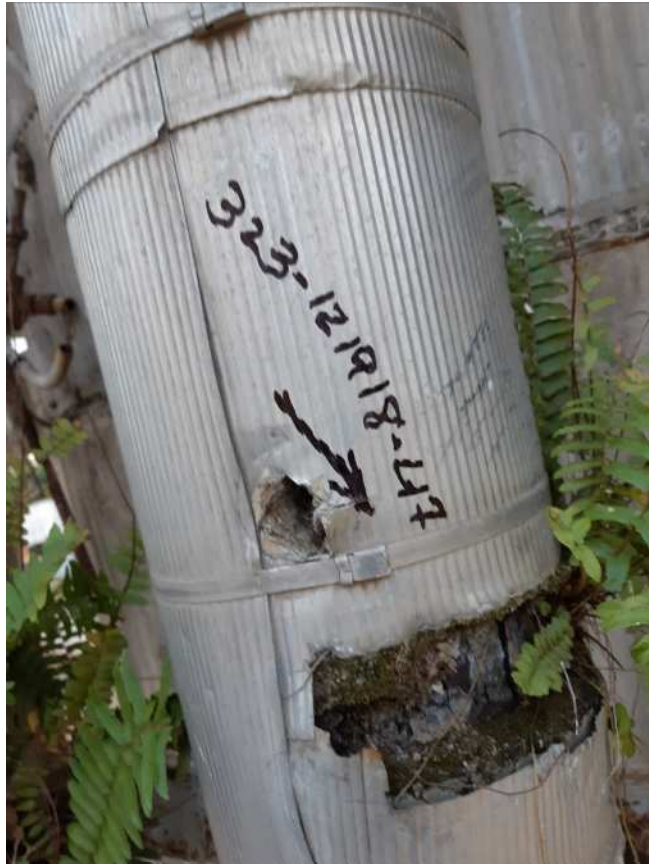
General View Sampling Point #47, 8'' ϕ Pipe, Tower 10 TSI, Northeast Side.

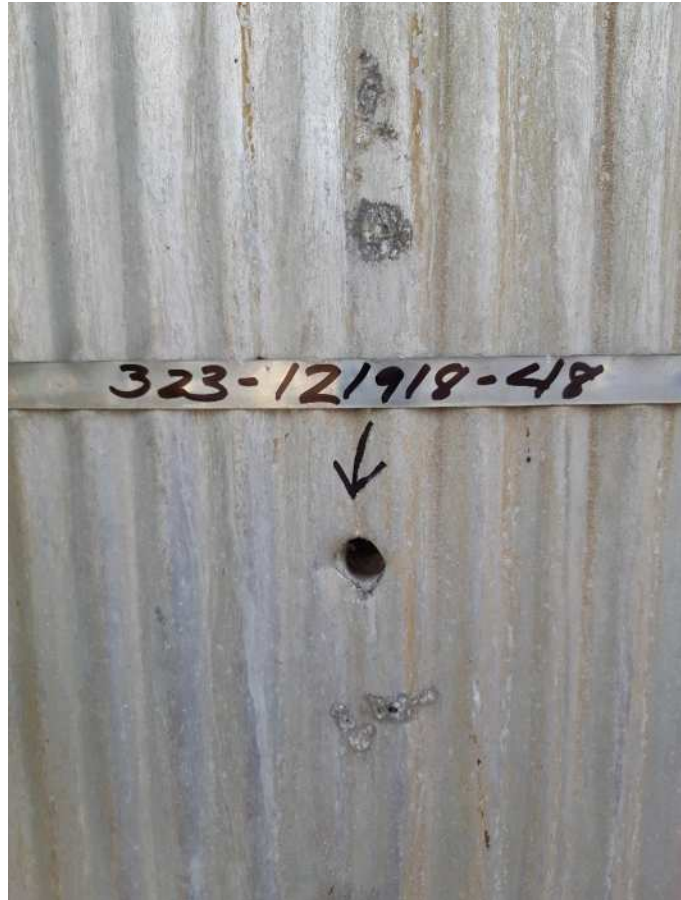
General View Sampling Point #48, Tower 11 TSI, Northeast Side.

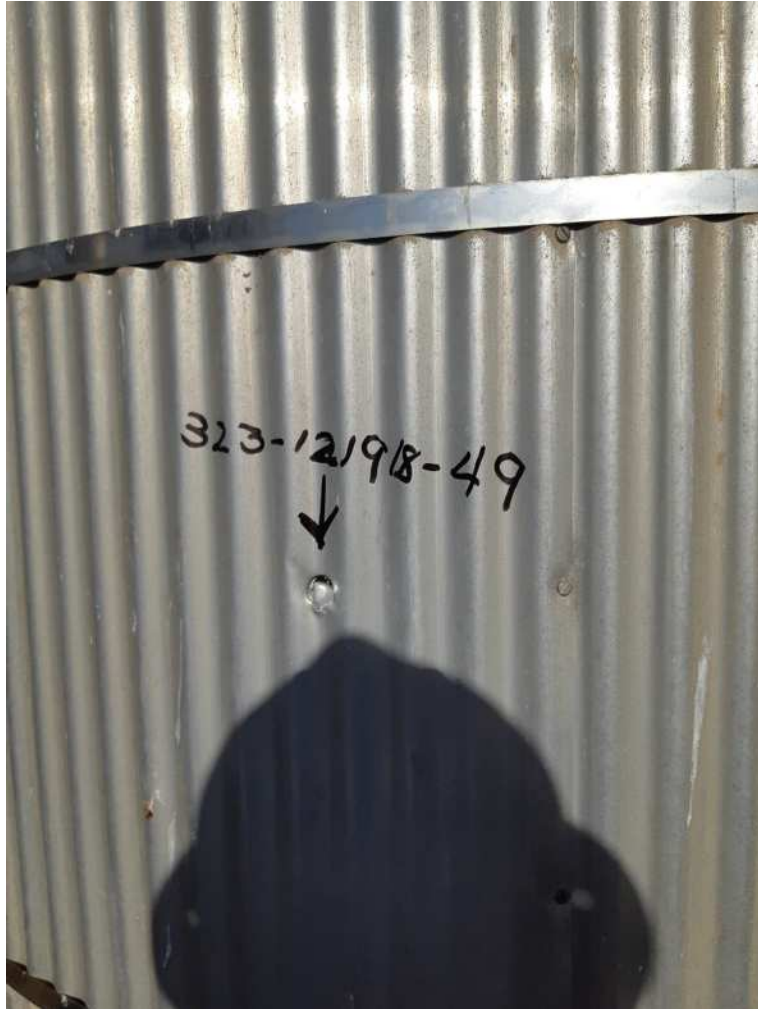
General View Sampling Point #49, Tower 11 TSI, South Side.

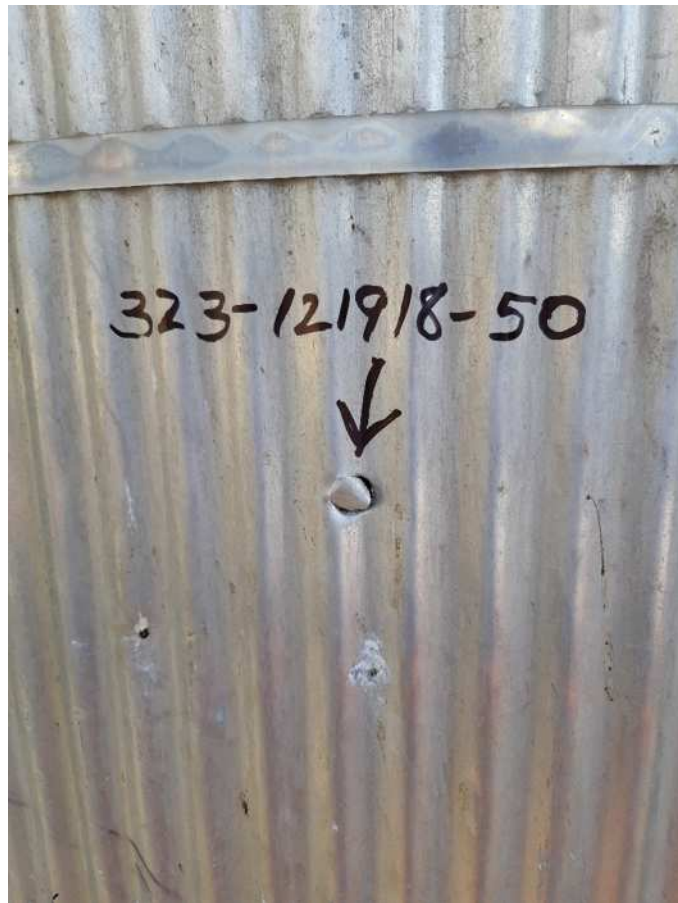
General View Sampling Point #50, Tower 11 TSI, North Side.

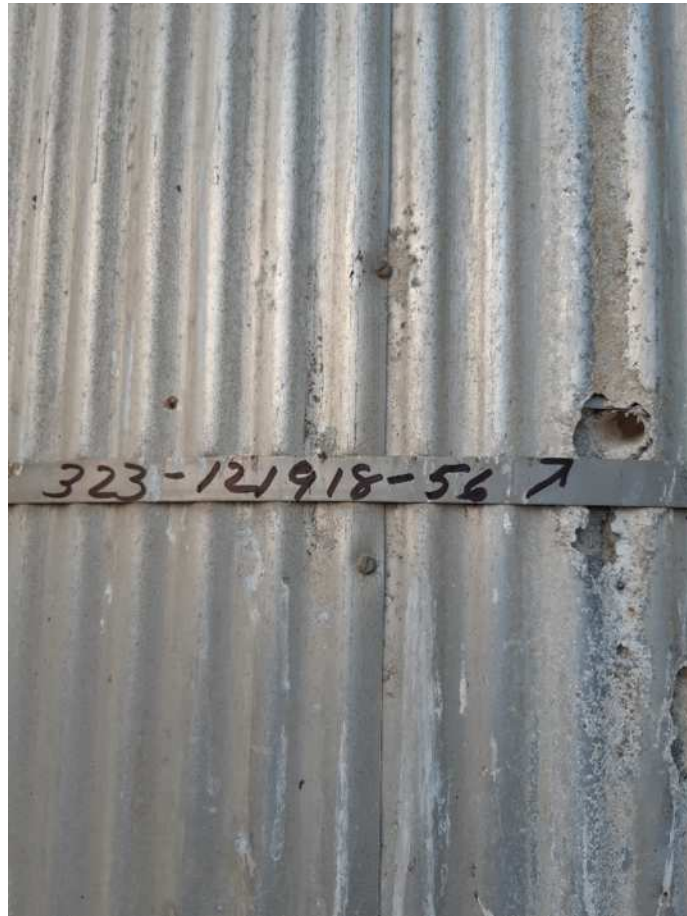
General View Sampling Point #56, Tower 12, West Side

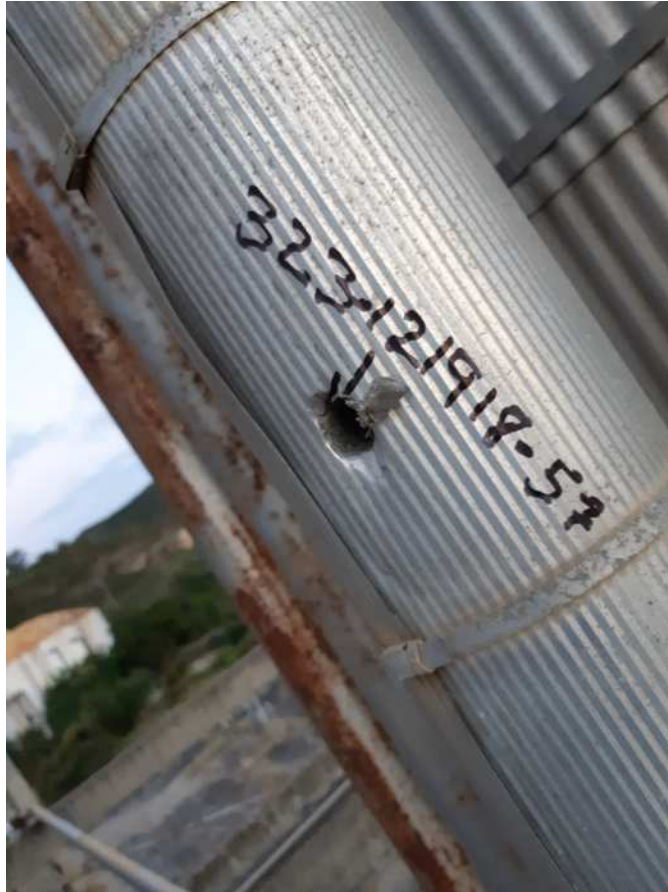
General View Sampling Point #57, TSI 6'ø, Tower 13, North Side

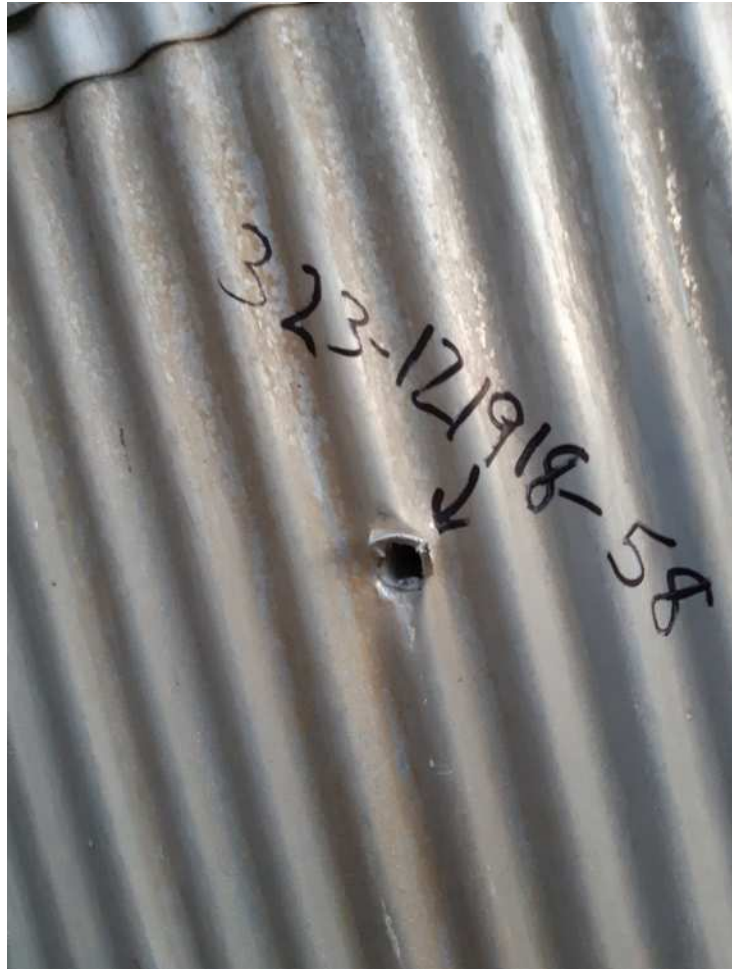
General View Sampling Point #58, Tower 13, West Side

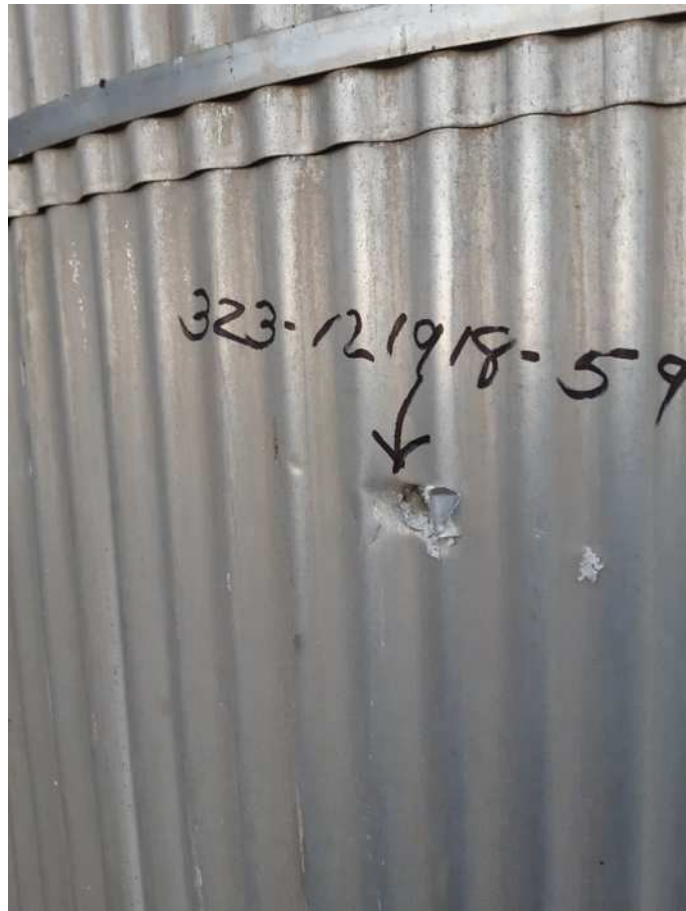
General View Sampling Point #59, Tower 13, South Side

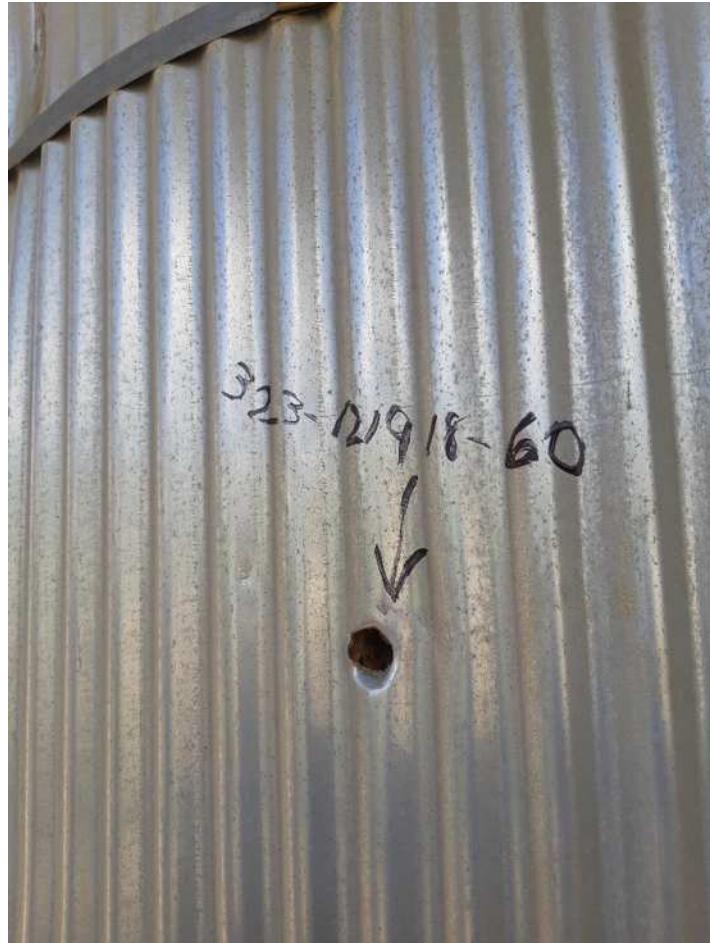
General View Sampling Point #60, Tank 5, South Side

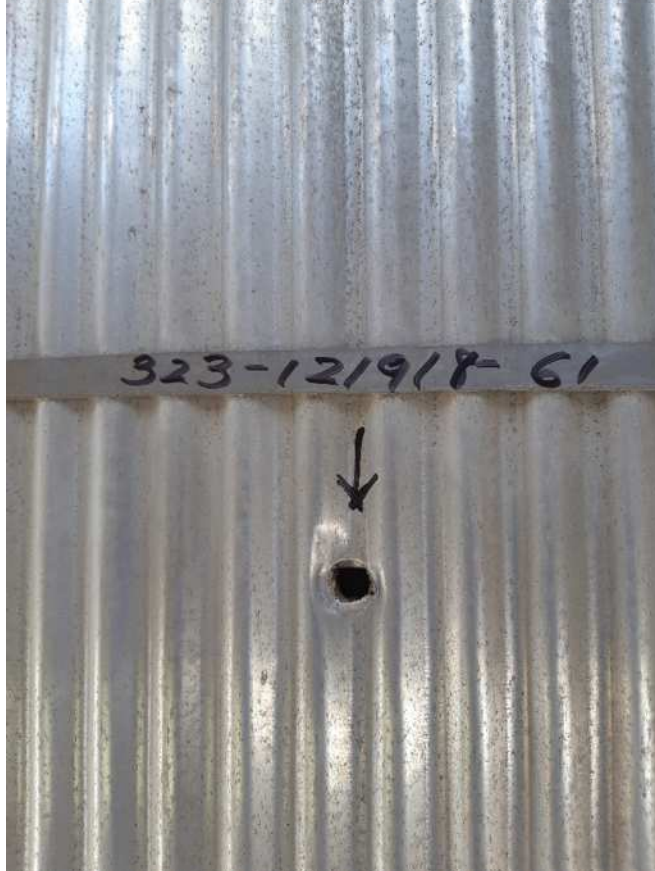
General View Sampling Point #61, Tank 5, North Side

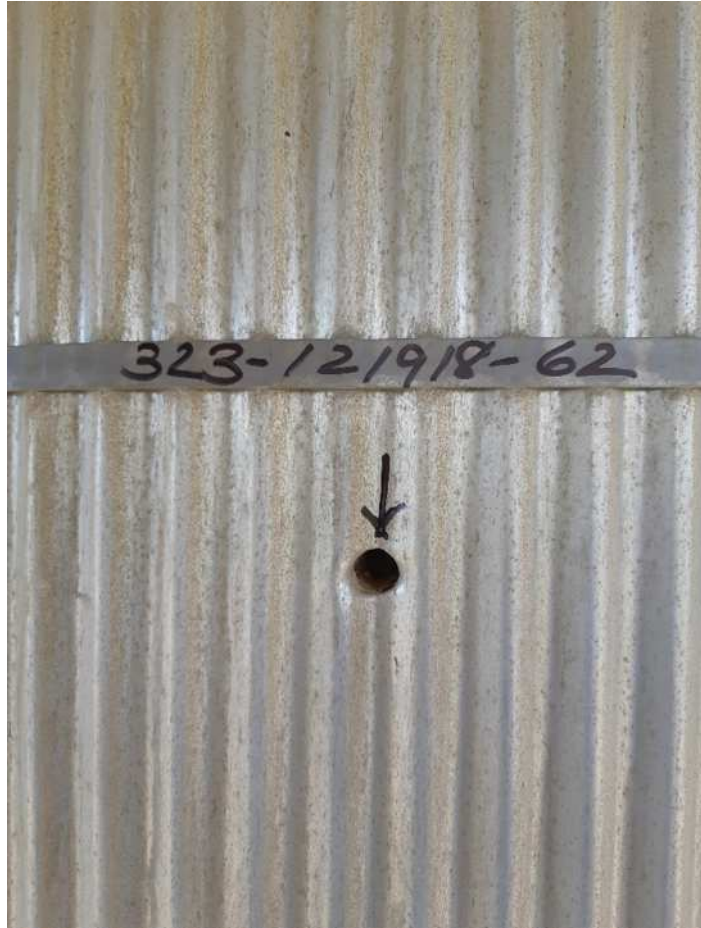
General View Sampling Point #62, Tank 6, Northeast Side

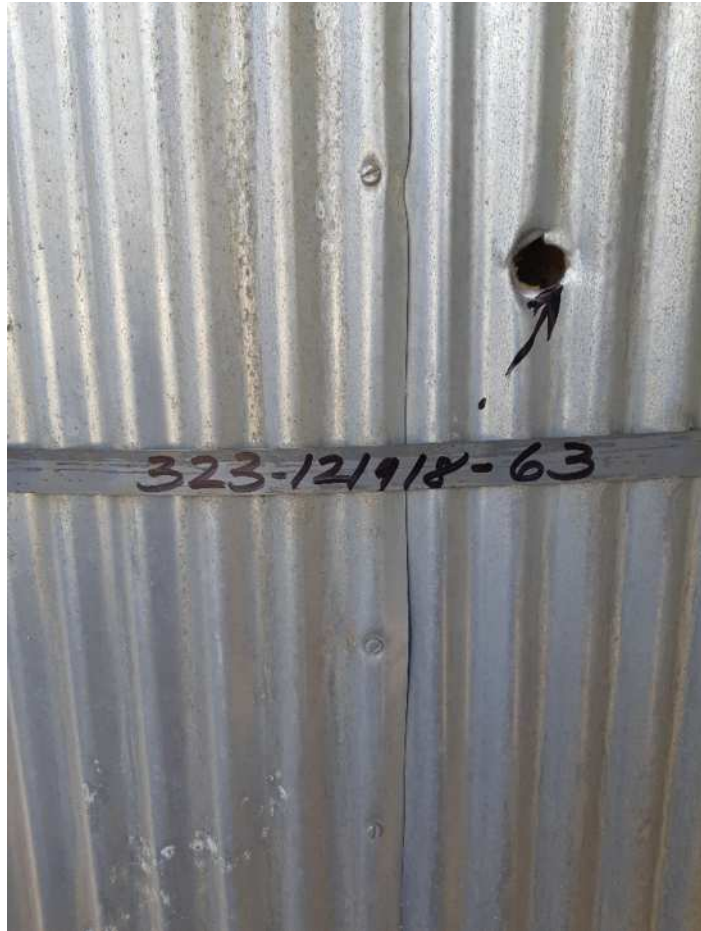
General View Sampling Point #63, Tank 6, North Side

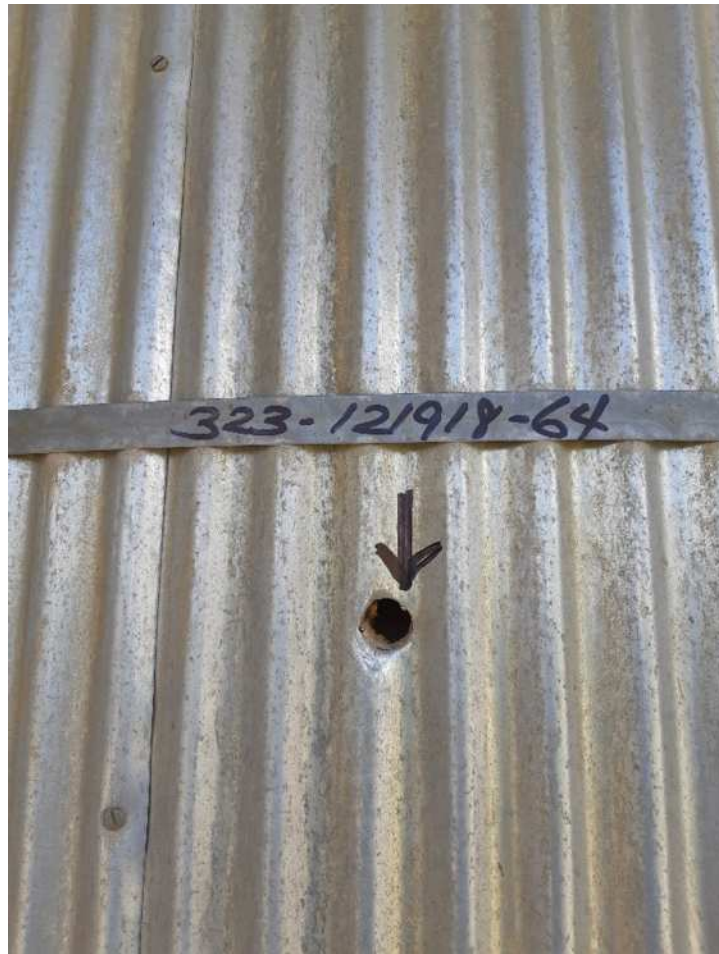
General View Sampling Point #64, Tank 7, Northeast Side

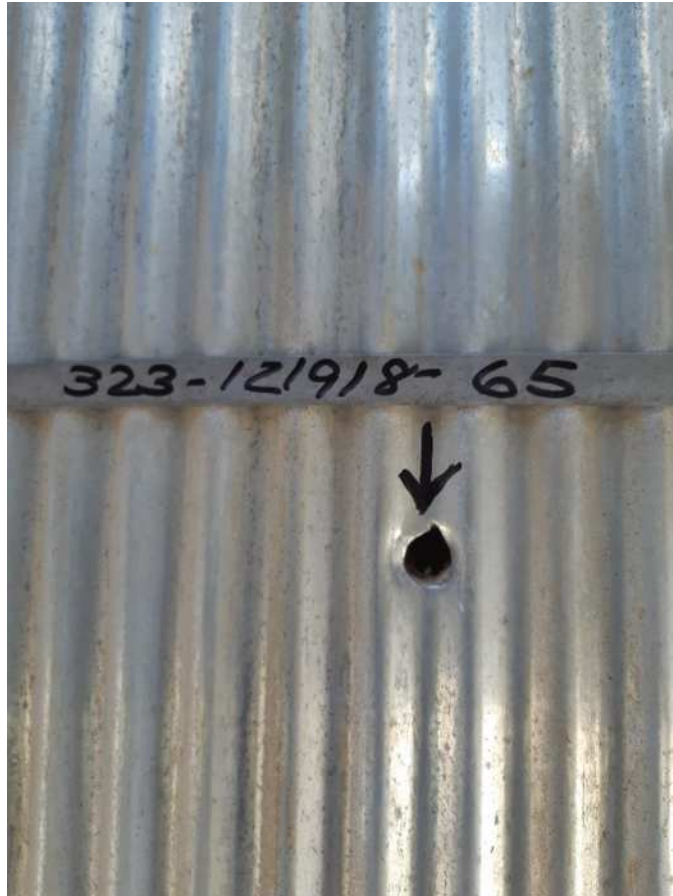
General View Sampling Point #65, Tank 7, North Side

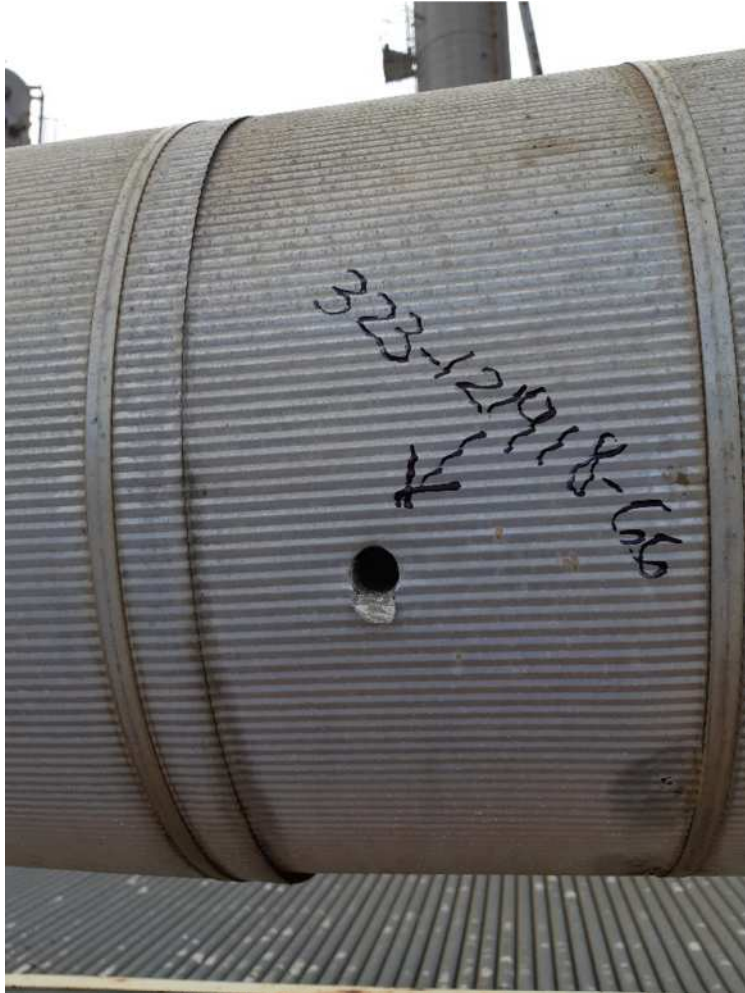
General View Sampling Point #66, Pipe Insulation 12'' ϕ , Fin Fan Air Cooler

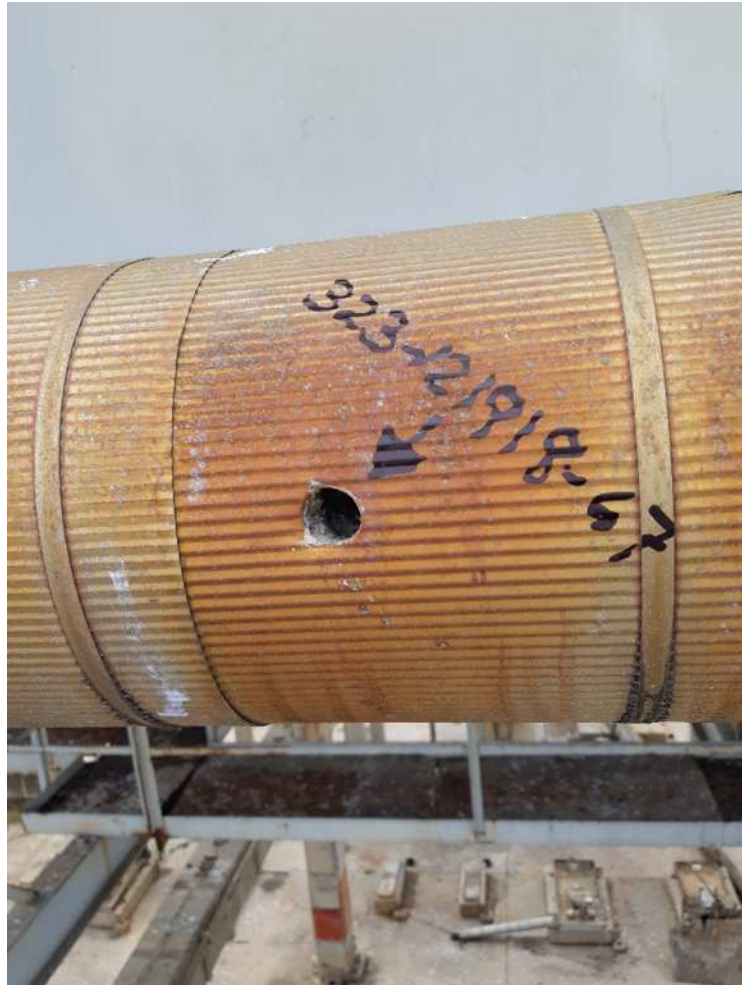
General View Sampling Point #67, Pipe Insulation 10'' ϕ , Fin Fan Air Cooler

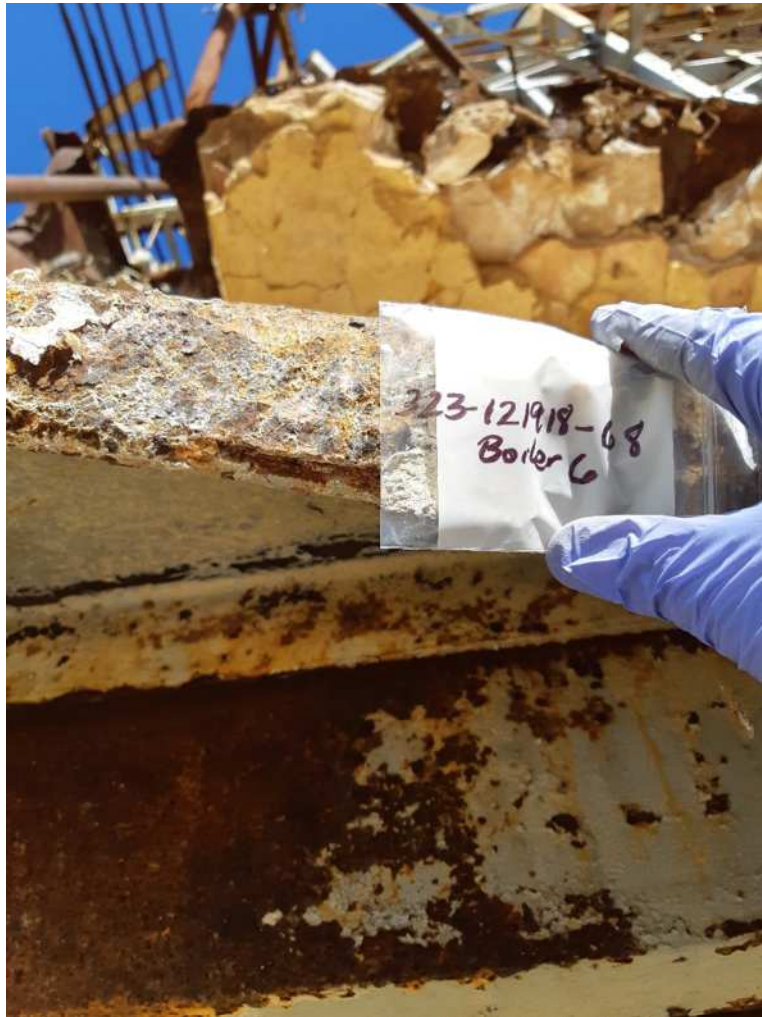
General View Sample # 68, Boiler #6, Fireproofing Cloth Between Metal Walls

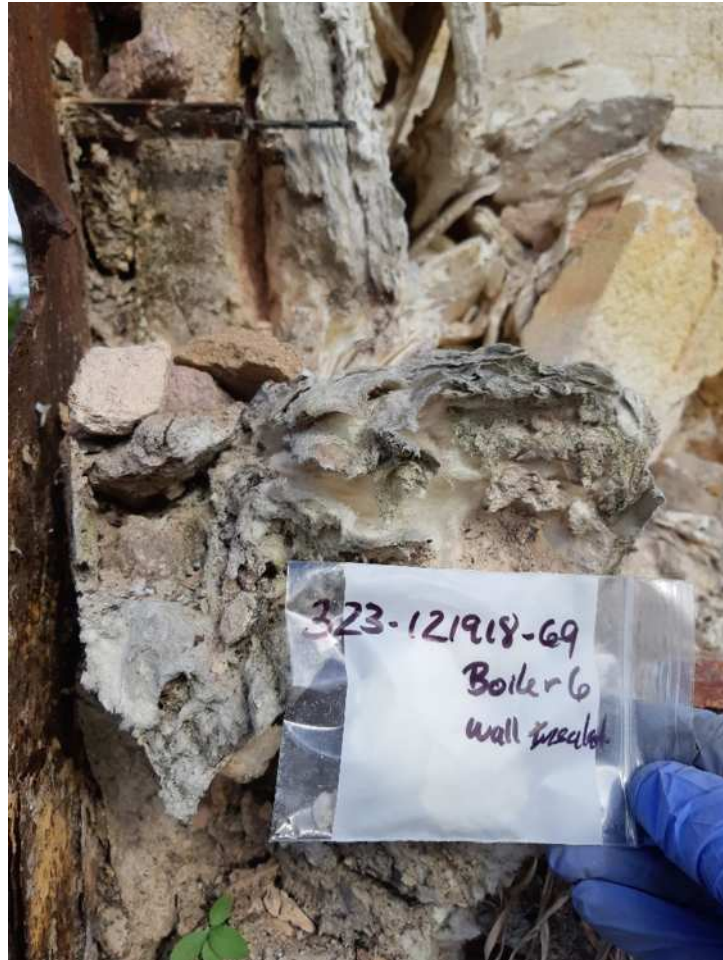
General View Sample # 69, Boiler #6, Inside Insulation Wall(white).

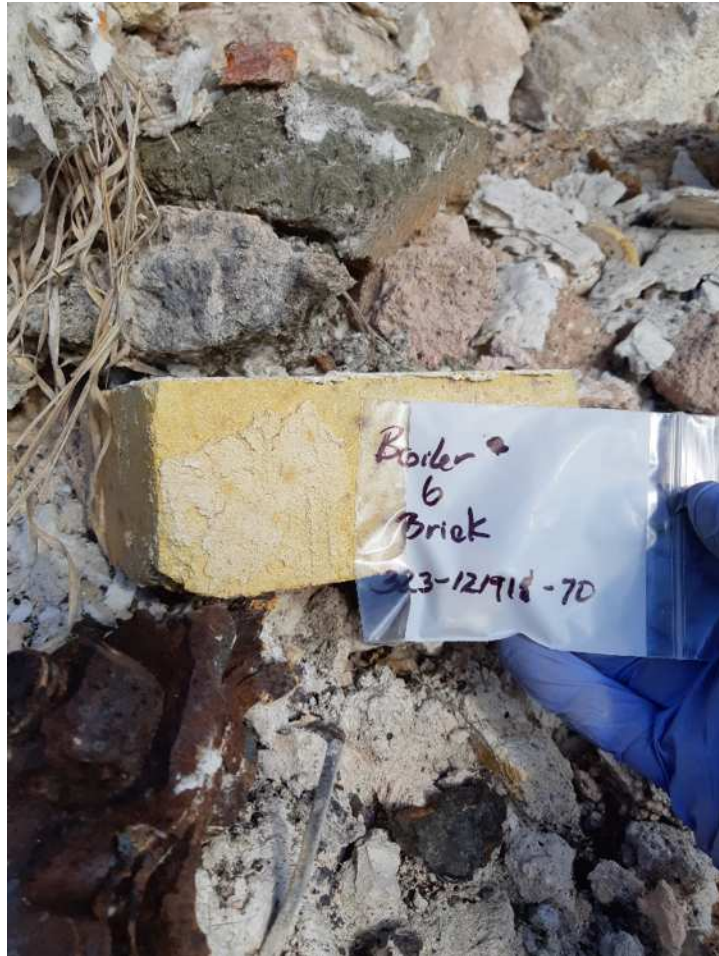
General View Sample # 70, Boiler #6, Inside Brick.

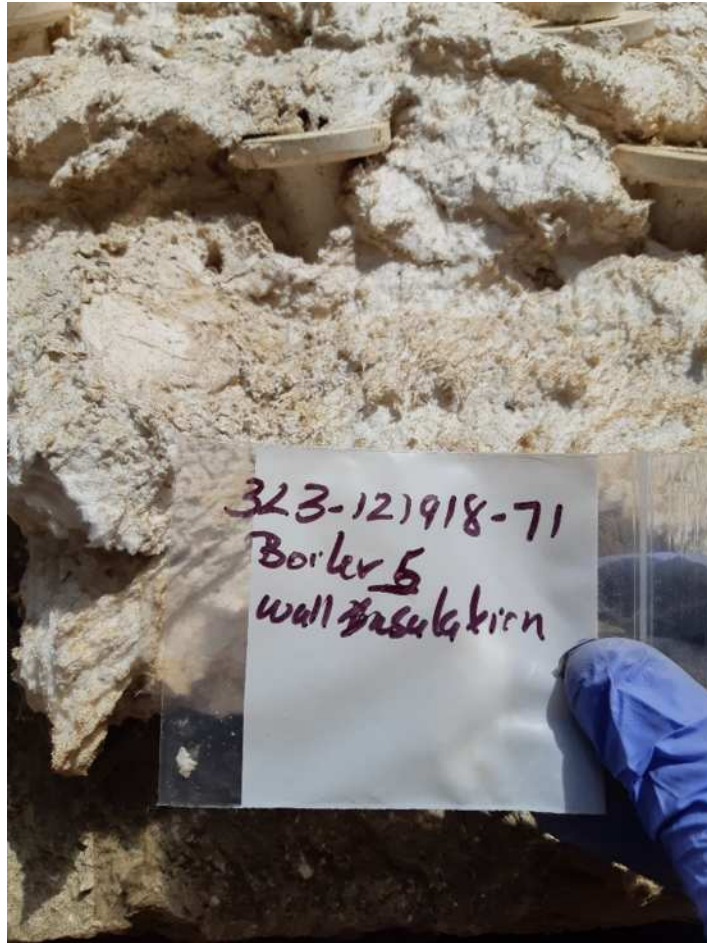
General View Sample # 71, Boiler #5, Inside Insulation Wall(white).

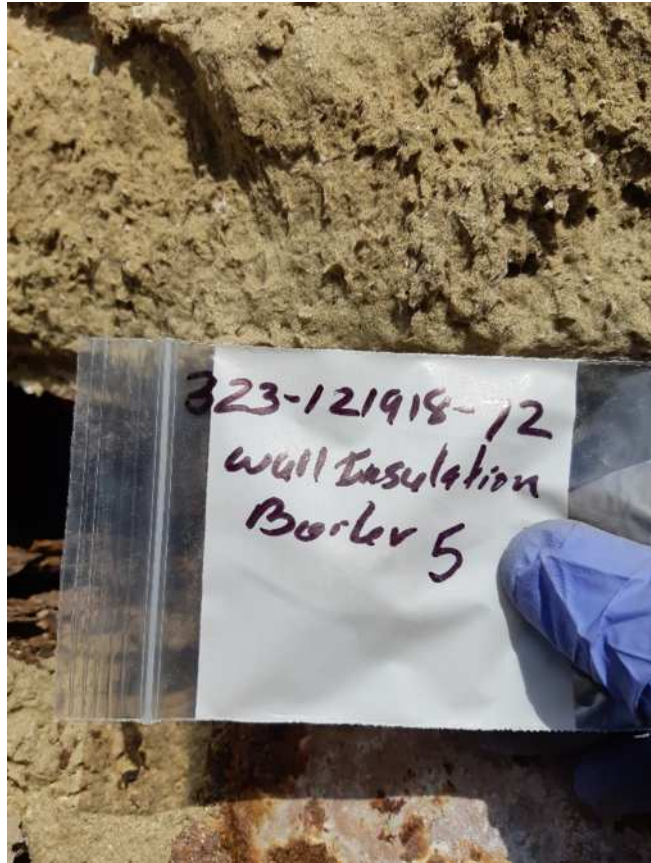
General View Sample # 72, Boiler #5, Inside Wall Insulation (brown).

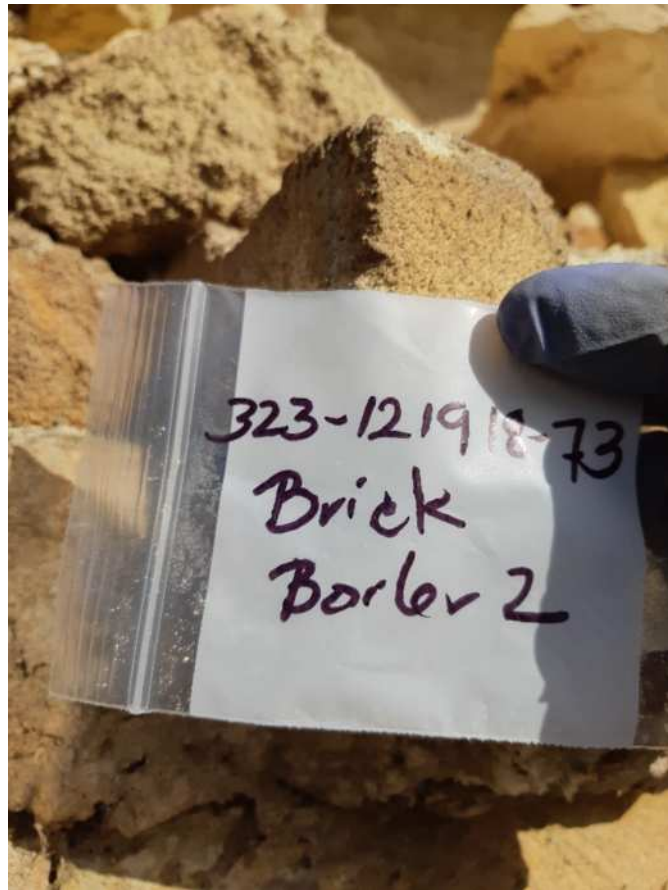
General View Sample # 73, Boiler #2, Inside Brick.

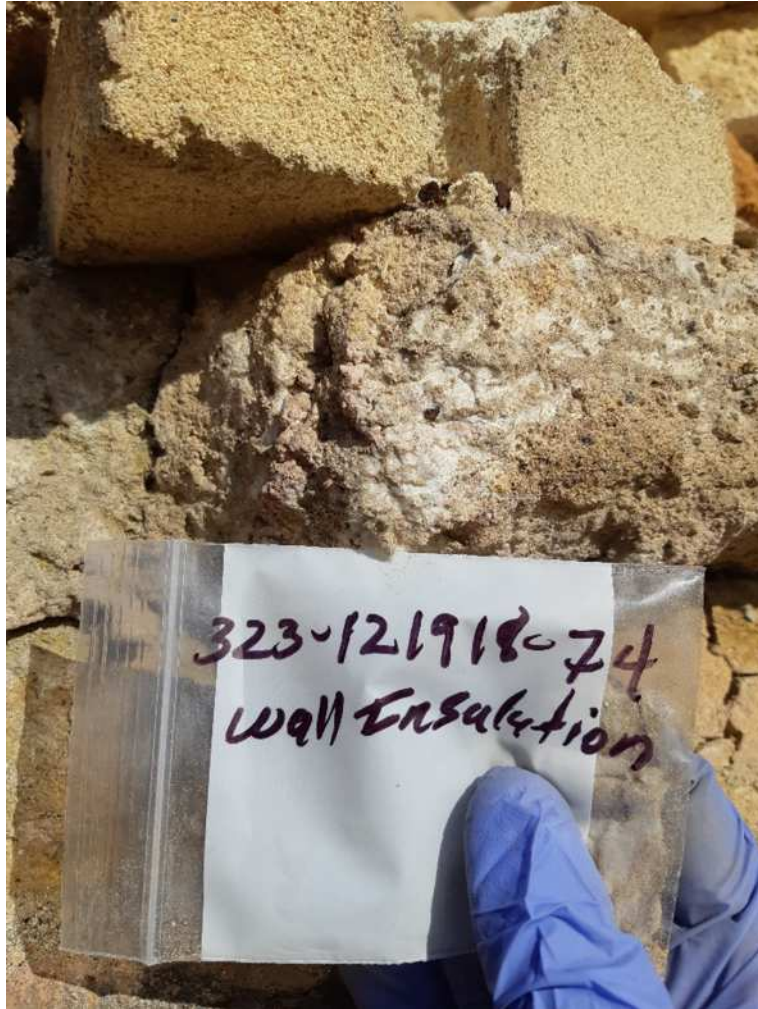
General View Sample # 74, Boiler #2, Inside Wall Insulation (brown).
