Phase I Remedial Action  
Assessment Report  
Operable Unit 2  
Bunker Hill Mining and Metallurgical Complex  
Superfund Site

**October 2007**

Prepared by  
**CH2MHILL**  
Ecology and Environment, Inc.

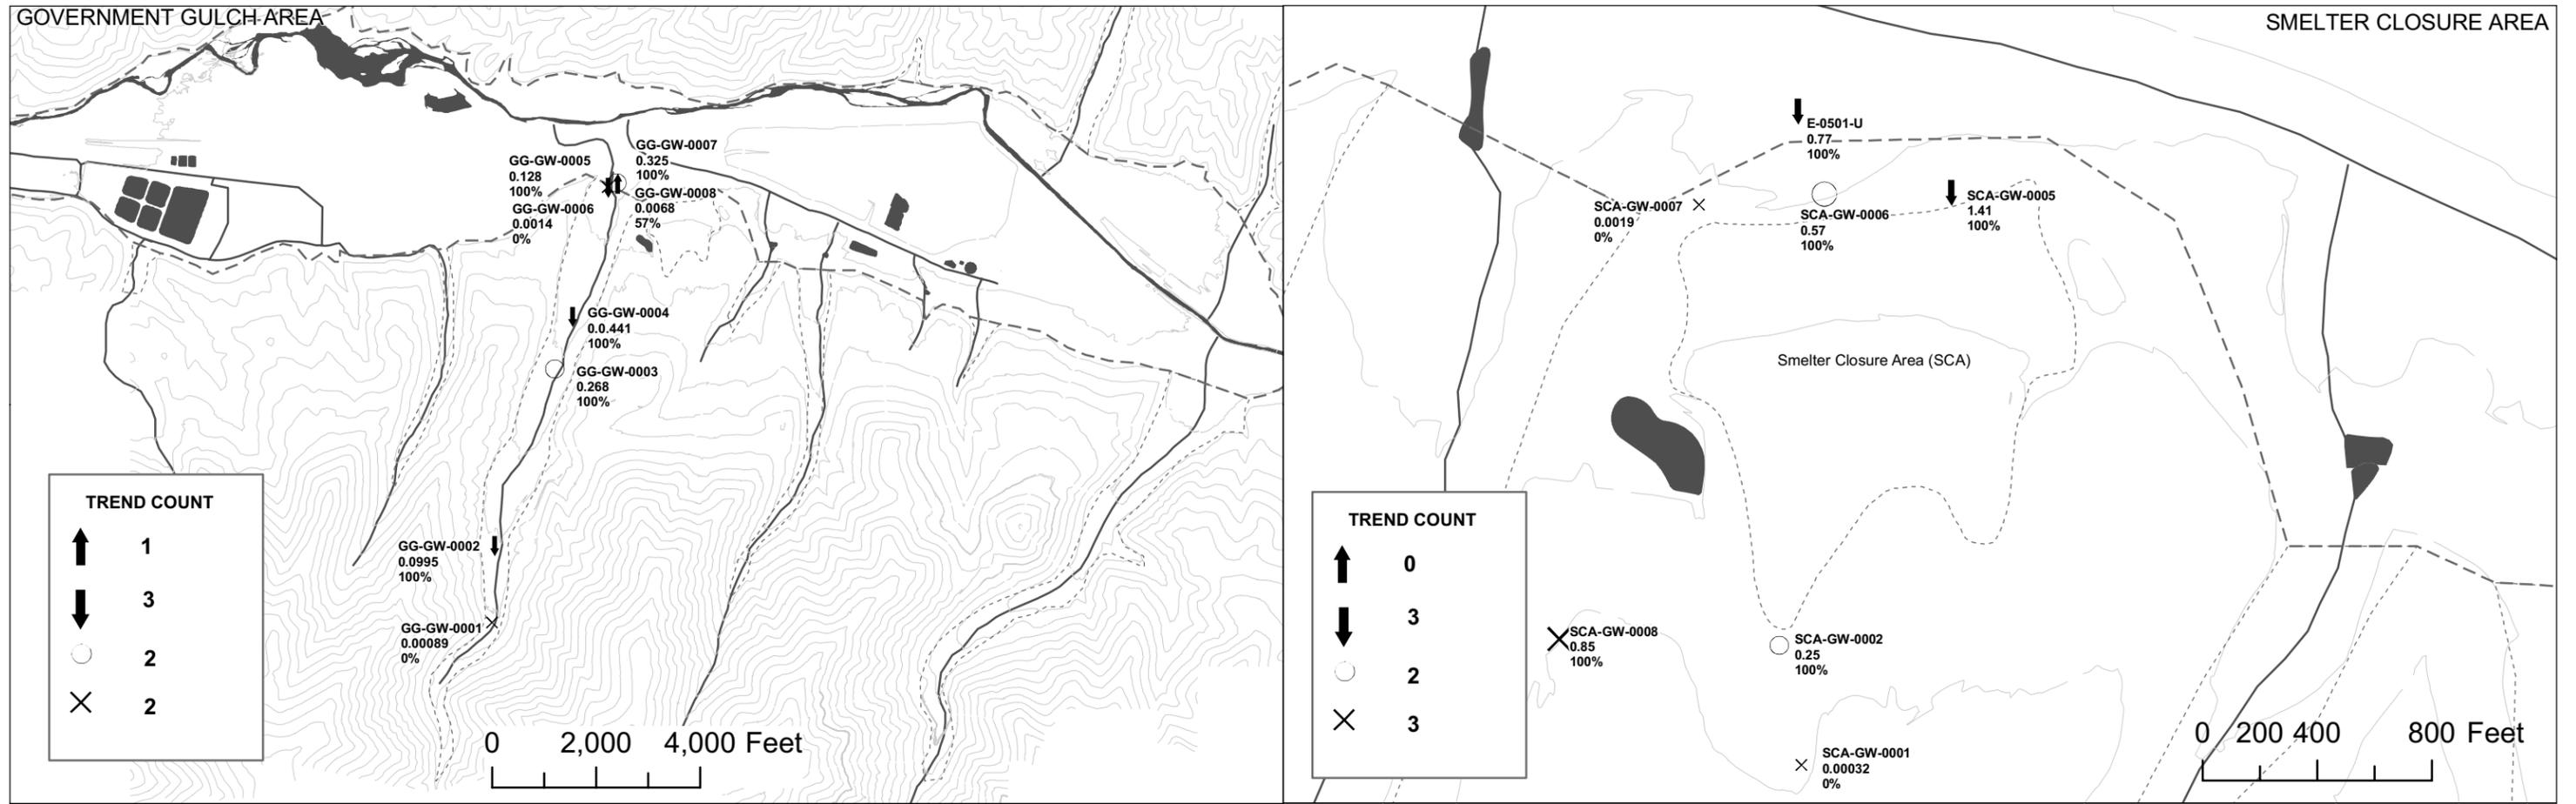
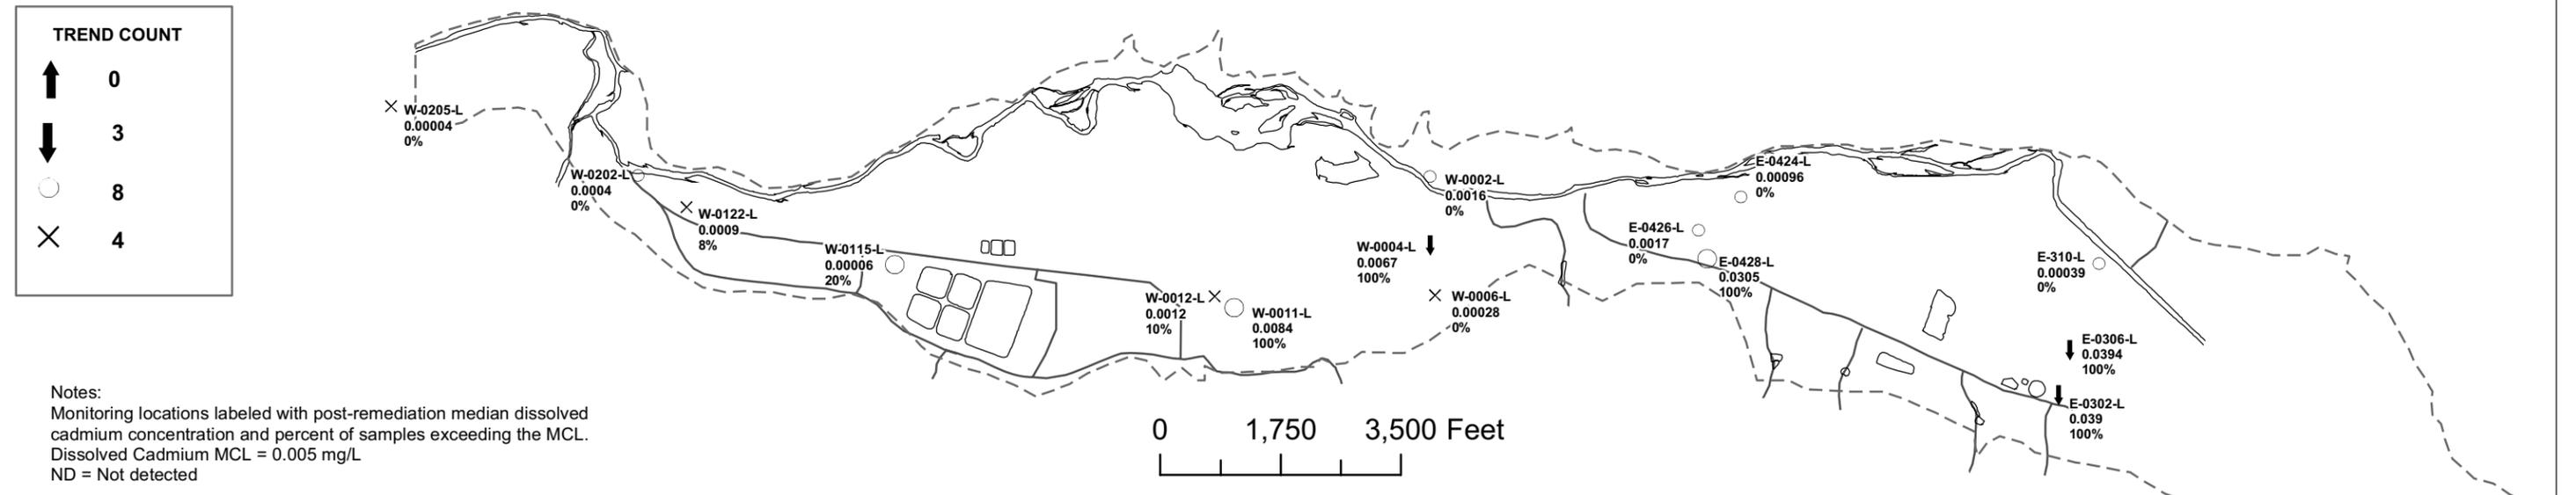
**FIGURE ES-2b**  
**POST-REMEDIAL**  
**DISSOLVED CADMIUM TRENDS**  
**IN GROUNDWATER**  
PHASE I REMEDIAL ACTION ASSESSMENT REPORT  
BUNKER HILL SUPERFUND SITE O2  
**CH2MHILL**

During the post-remediation time period, dissolved cadmium (Figure ES-2b) and dissolved zinc (Figure ES-3b) concentration trends in groundwater are decreasing at the majority of monitoring locations, suggesting that the full positive benefit of the Phase I remedial action on Government Gulch water quality has not yet been fully realized.

Increasing dissolved cadmium and dissolved zinc concentration trends were detected at BH-GG-GW-0008 completed in the lower portion of the Government Gulch aquifer at the mouth of the gulch. Dissolved cadmium concentrations at this location have recently begun to exceed the MCL. Dissolved zinc concentrations at this location remain well below the MCL. Additional investigation of the increasing dissolved cadmium concentration trend at this location will be required.

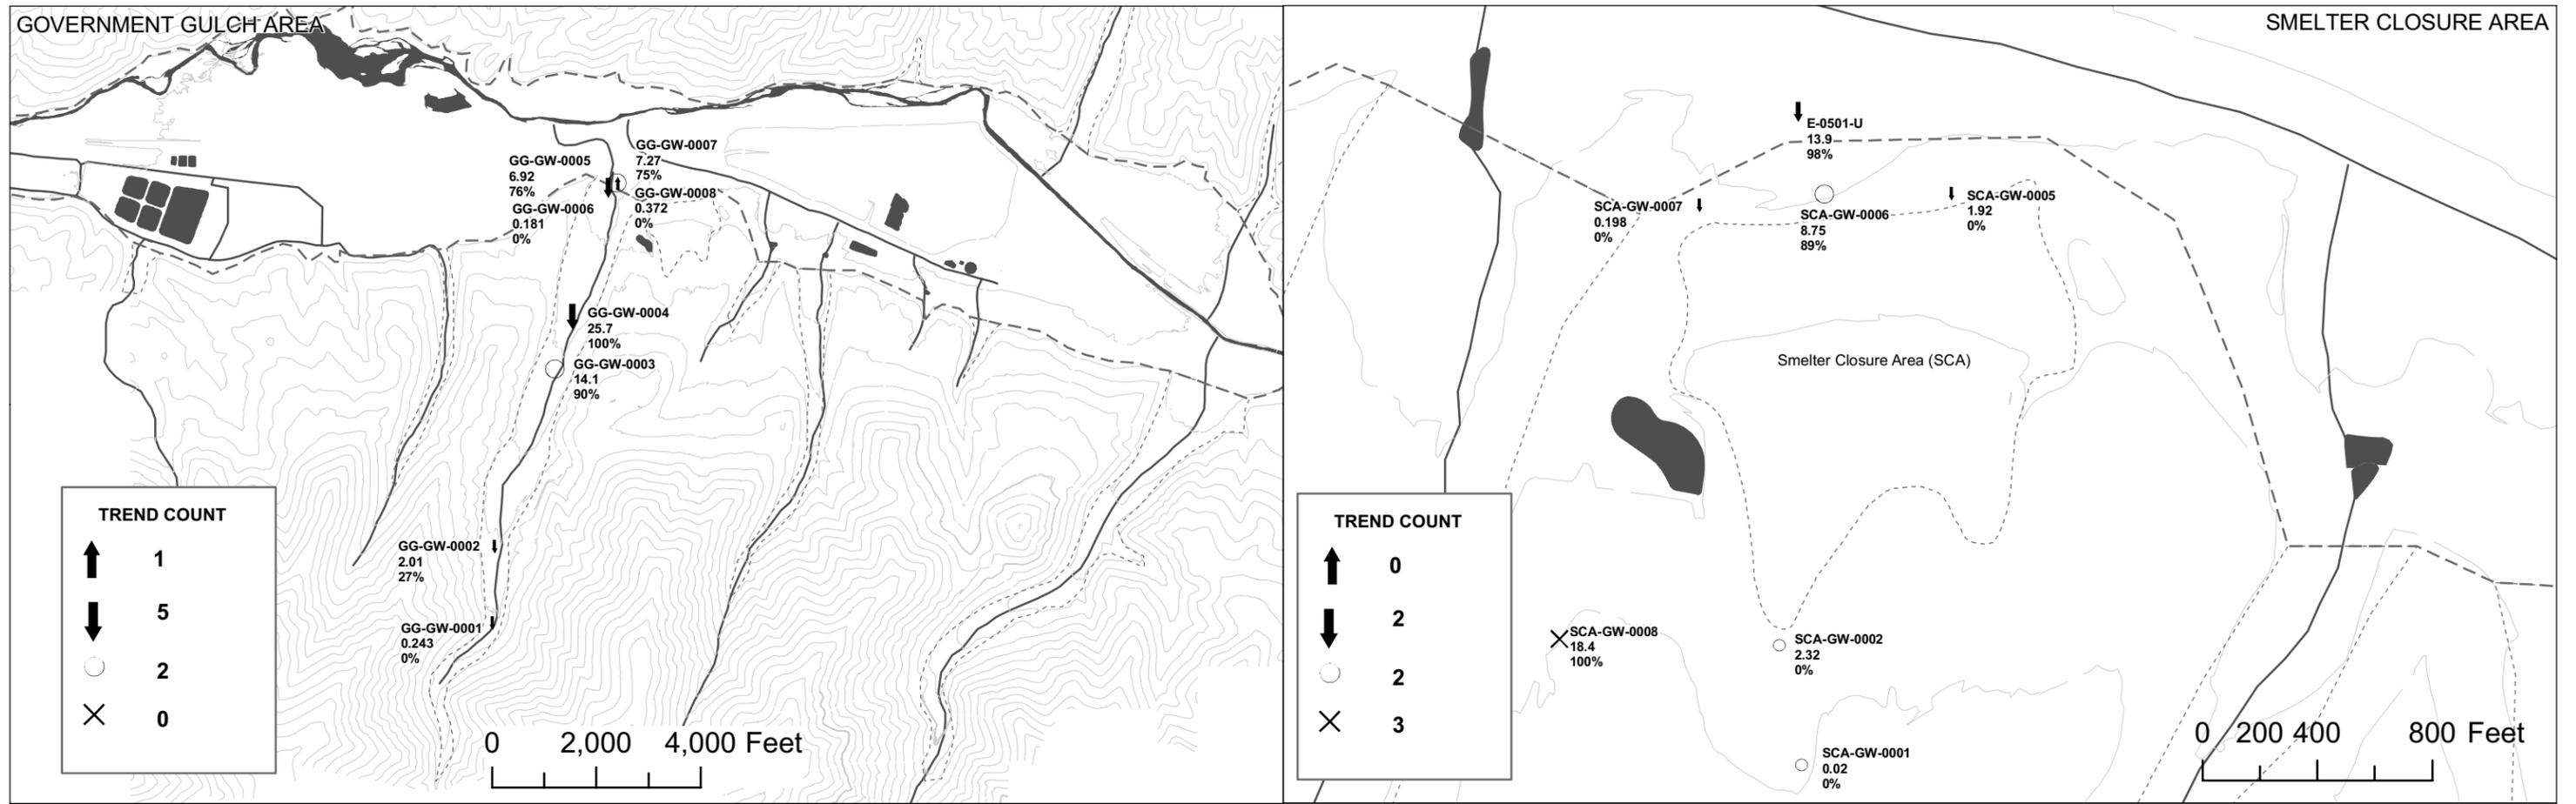
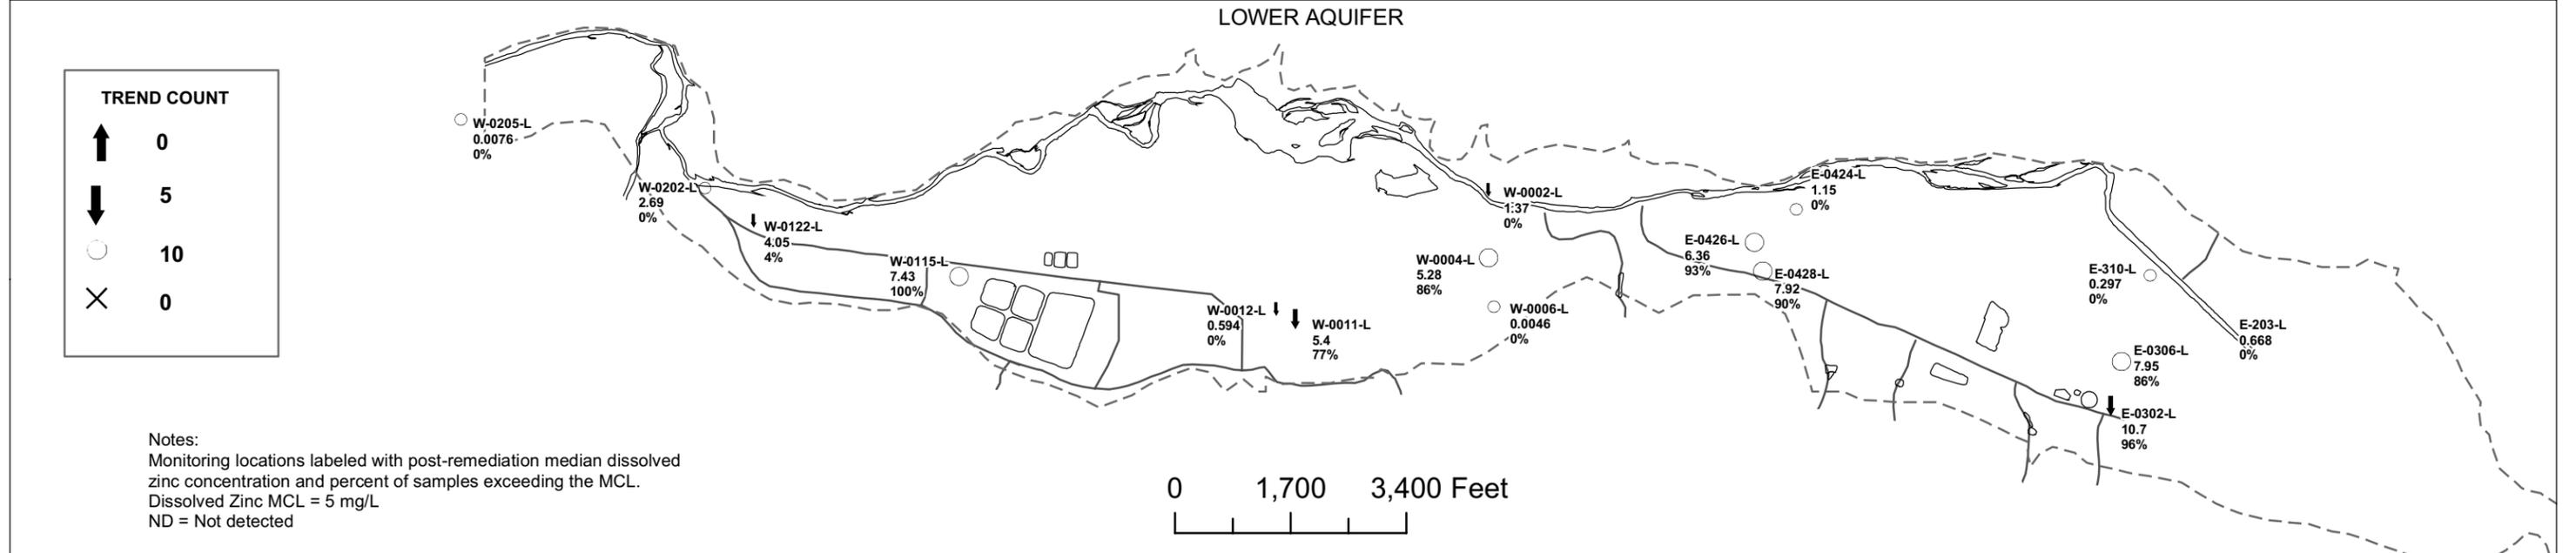
Notes:  
Monitoring locations labeled with post-remediation median dissolved zinc concentration and percent of samples exceeding the MCL.  
Dissolved Zinc MCL = 5 mg/L  
ND = Not detected

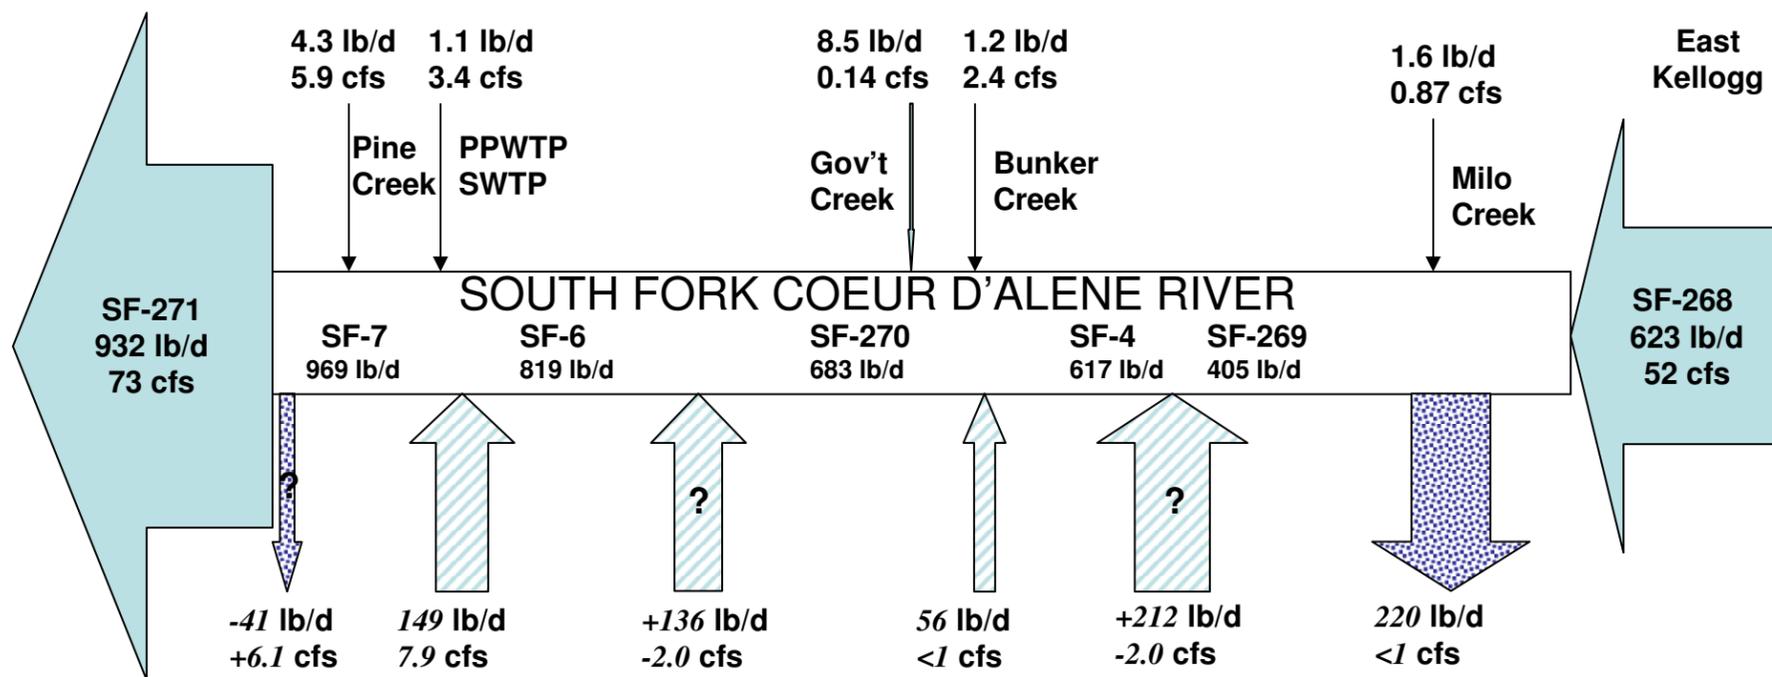
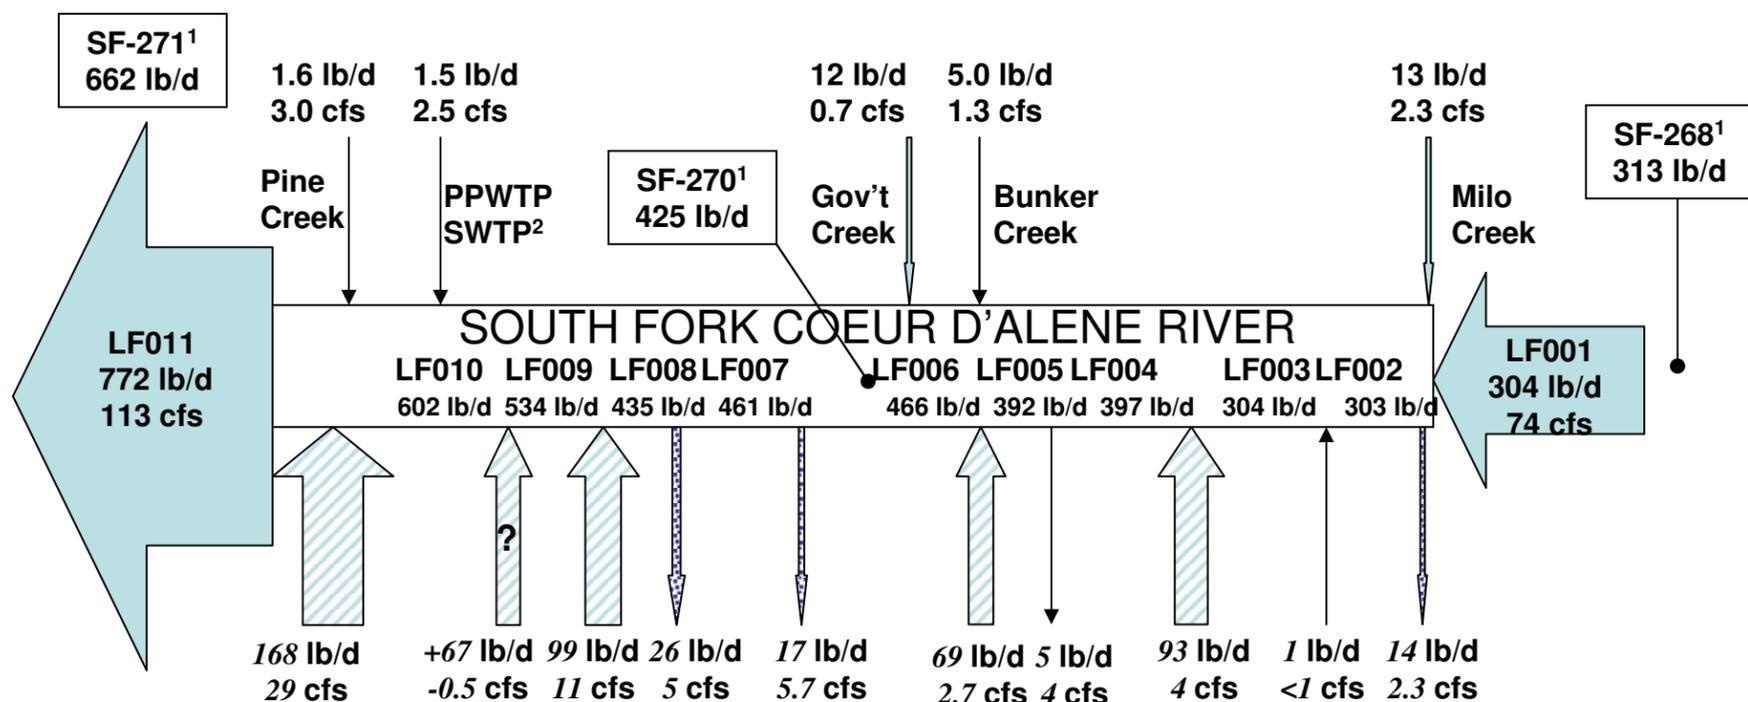
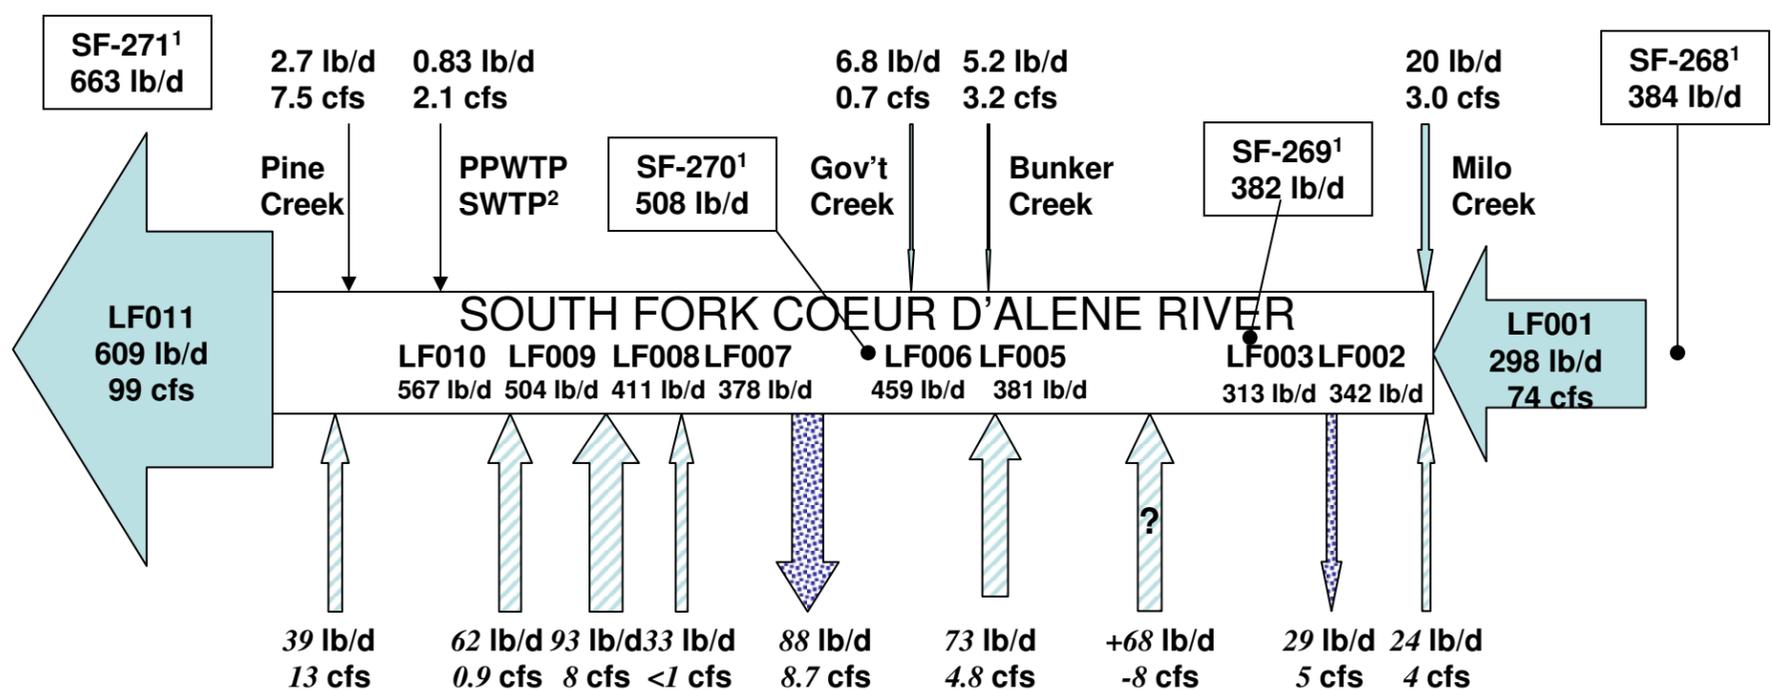
**FIGURE ES-4**  
**SFCDR DISSOLVED ZINC LOADING MASS BALANCE**  
**PRE-REMEDATION (1987) AND**  
**POST-REMEDATION (2003 & 2006)**  
**PHASE I REMEDIAL ACTION ASSESSMENT REPORT**  
**BUNKER HILL SUPERFUND SITE OU2**

Surface water quality in the SFCDR in the vicinity of the CIA has improved significantly following the implementation of the CIA Phase I remedial action. Prior to remediation, the net gain in dissolved zinc loading in this reach of the SFCDR was between 180 and 245 lbs/day under low flow conditions. During the post-remediation time period, the net gain in dissolved zinc loading in this same reach has been between 70 and 90 lbs/day.

The net gain in dissolved zinc load in September 1987 in the SFCDR in the vicinity of the CIA was substantially higher than dissolved zinc loading in this same area in October 2003 and October 2006. As is noted above in the CIA discussion, this is most likely driven by changes in AMD management beginning in 1996 and the capping of the CIA in 2000.

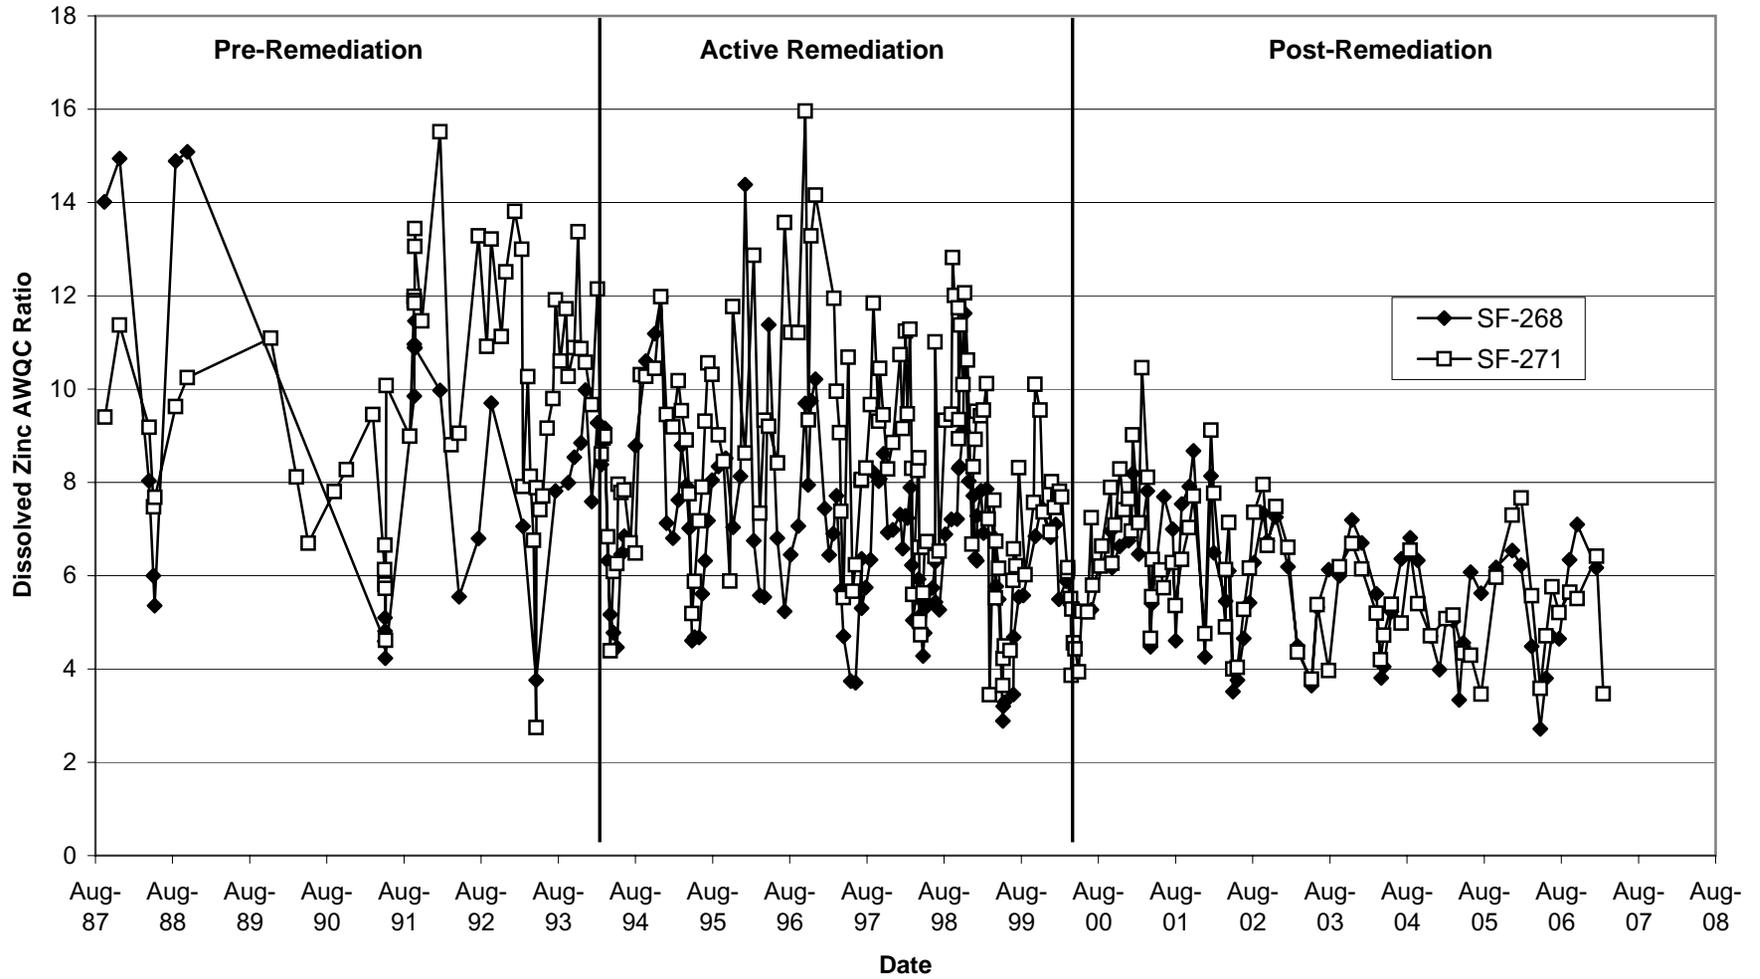
**Figure ES-5**  
**Dissolved Zinc AWQC Ratios Over Time at SF-268 and SF-271**  
*Phase I Remedial Action Assessment Report*  
Bunker Hill Superfund Site OU2

Dissolved zinc AWQC ratios in the SFCDR have decreased substantially between the pre- and post-remediation time periods (Figure ES-5). Decreases in the AWQC ratios occur at both the eastern (SF-268) and western (SF-271) boundaries of OU2. The decreases observed at SF-268 are most likely the result of remedial actions conducted upstream of OU2. Decreases observed at the western boundary of OU2 at SF-271 are also related to some degree to upstream remedial actions. However, the reductions in AWQC ratios at this location would not likely have occurred to the same magnitude without the implementation of Phase I remedial actions within OU2.

Dissolved metal concentrations and AWQC ratios in the SFCDR at SF-268 and SF-271 exhibited decreasing trends for both the full period of record (1987 to 2007) and the post-remediation time period (2000 through 2007). The decreasing trends observed at SF-271 are corroborated by trend evaluations conducted by the U.S. Geological Survey (USGS) (Donato, 2006).
