TS-AMD-82006
JUNE 1982

AERIAL PHOTOGRAPHIC ANALYSIS OF HAZARDOUS WASTE SITES Duwamish Valley, Washington

EPA Region 10

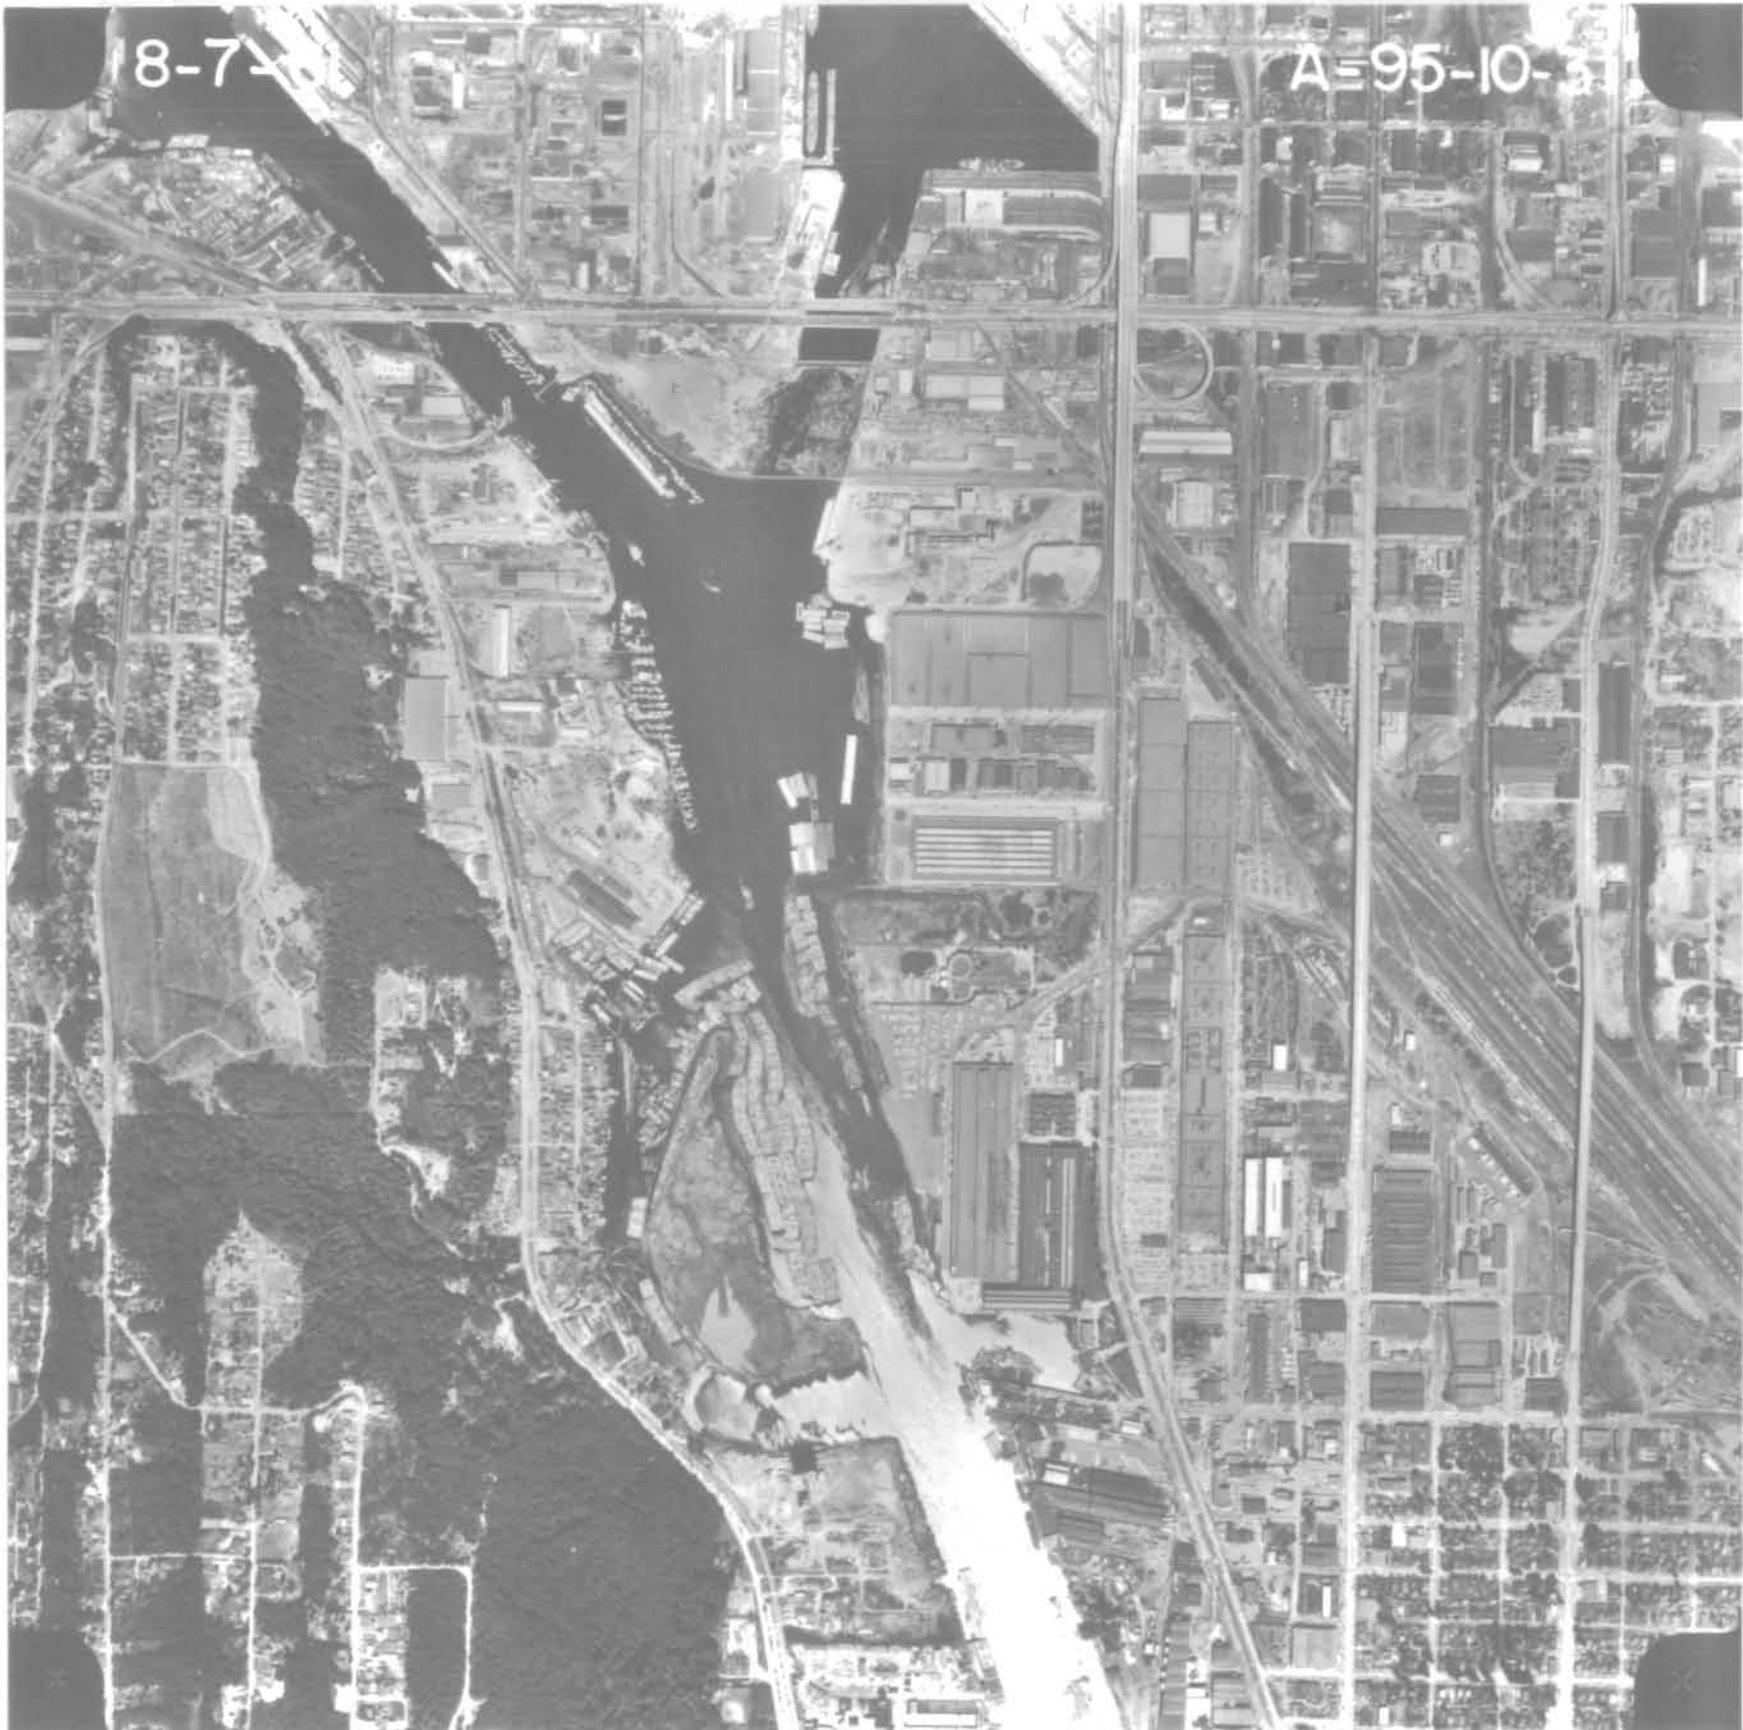
A-95-10-29
FIGURE 18

SITE 21 ('61) - This site is the Reichhold hazardous waste site covered in the EMSL-LV Report AMD 81102 published in September 1981 (Figure 18). Analysis of the 1961 imagery (not used in previous report) reveals the presence of pipelines leading to the three waste pits. All three waste pits drain into the Duwamish Waterway. The dike of the largest pit has been breached and waste material flows directly into the water while discharge pipes are evident for the other two pits. The source of this material cannot be identified from the photography.

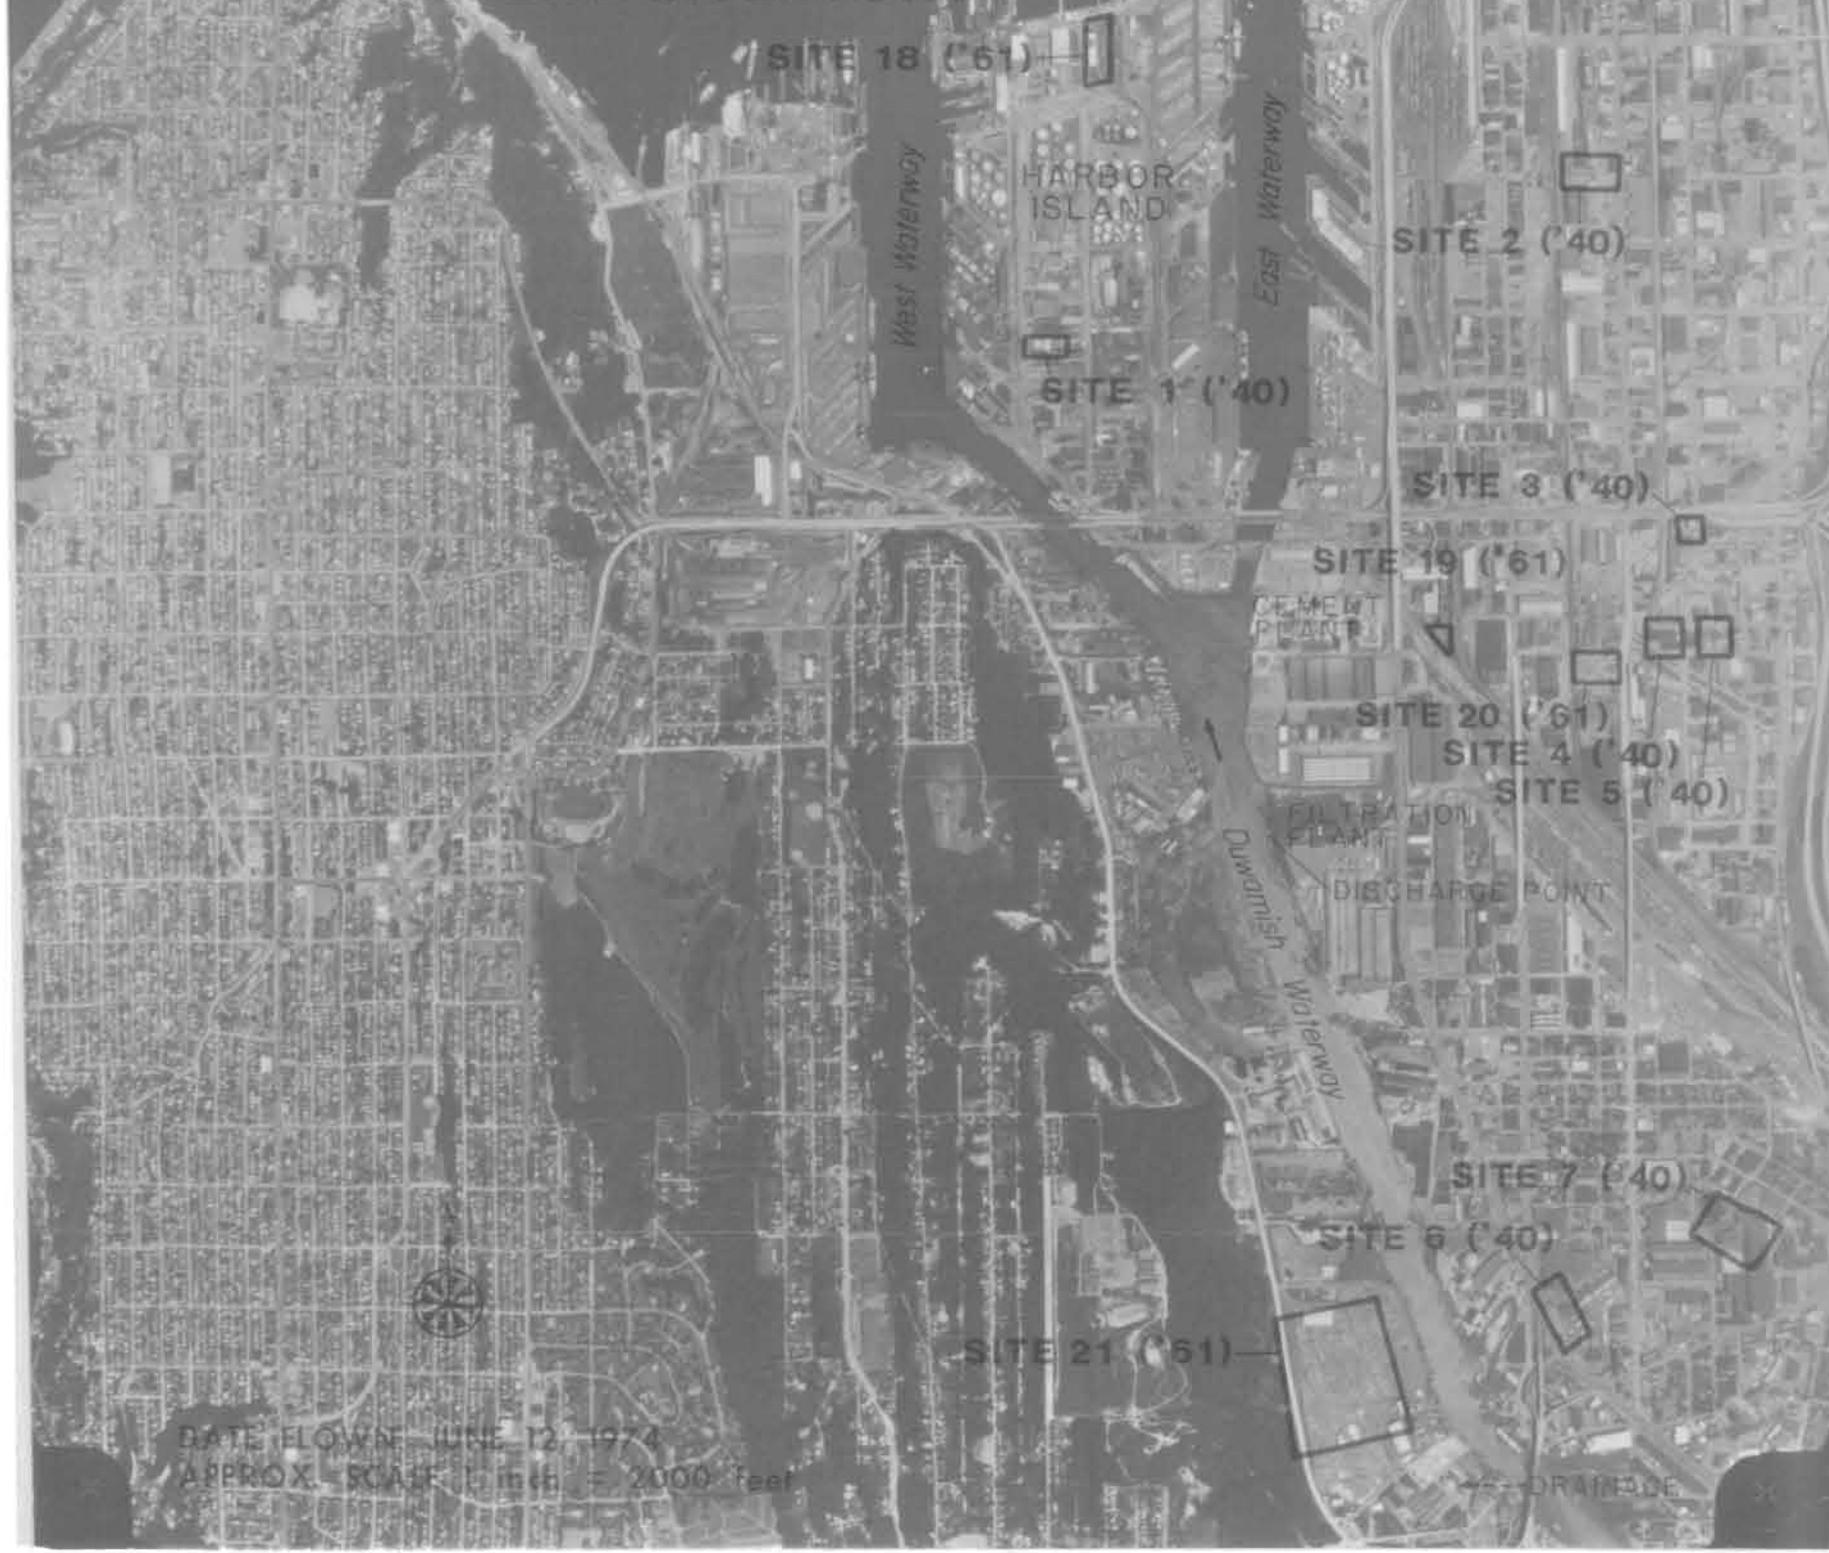
FIGURE 31

SITE 21 ('61) - The entire site has been paved over and there are several thousand cars present (Figures 31 and 32). No evidence of the past hazardous waste site remains.
