Overview of the Historical Site Assessment For Subarea 5D

April 20, 2011

Santa Susana Field Laboratory
Historical Site Assessment

Draft Technical Memorandum - HSA-5D

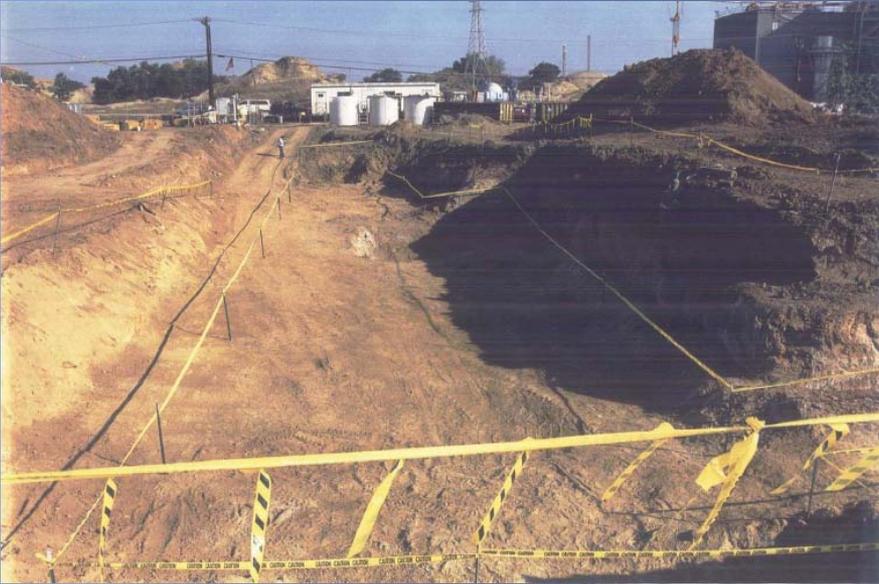
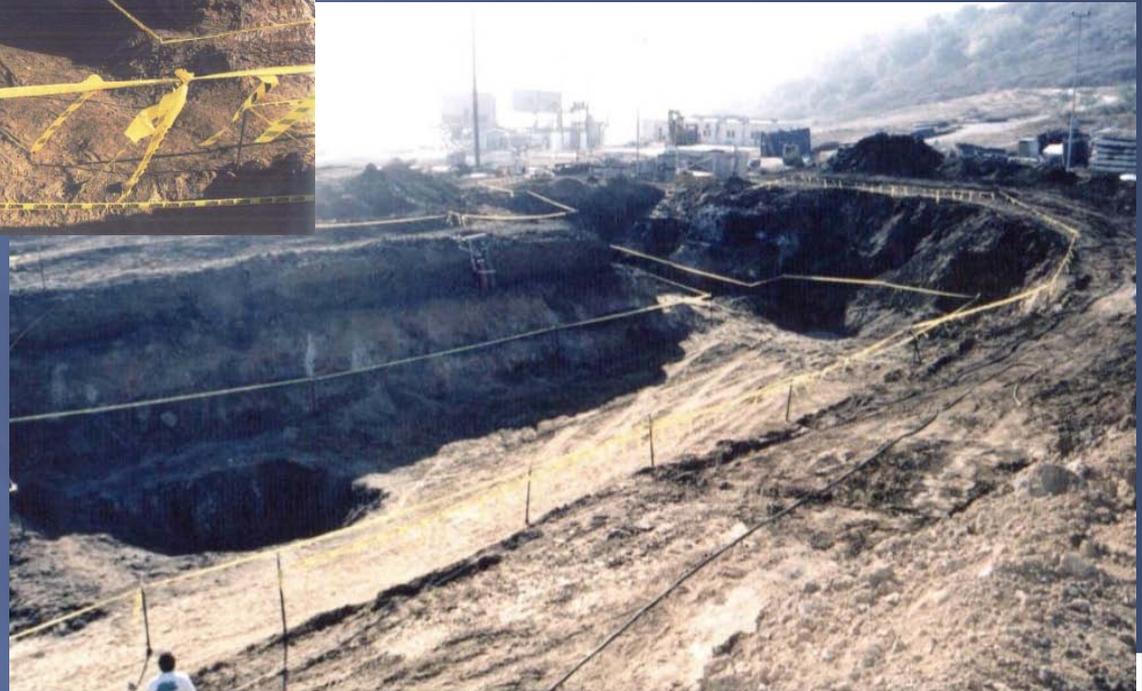
Building 4020 – Excavation

- ▣ Component Development Hot Cell and Hot Laboratory
- ▣ Operations 1959 to 1986
- ▣ Two 500-gallon radioactive holdup tanks in north end of building basement
- ▣ 3,000-gallon tank (Building 4468) replaced two 500-gallon tanks in ~1970
- ▣ 131 documented incidents with 19 involving release to environment
- ▣ Building used for remote handling and examination of highly radioactive materials
- ▣ 1990s – building demolished including foundations, pavement, and Building 4468 – depth of excavation was 18 feet below ground surface

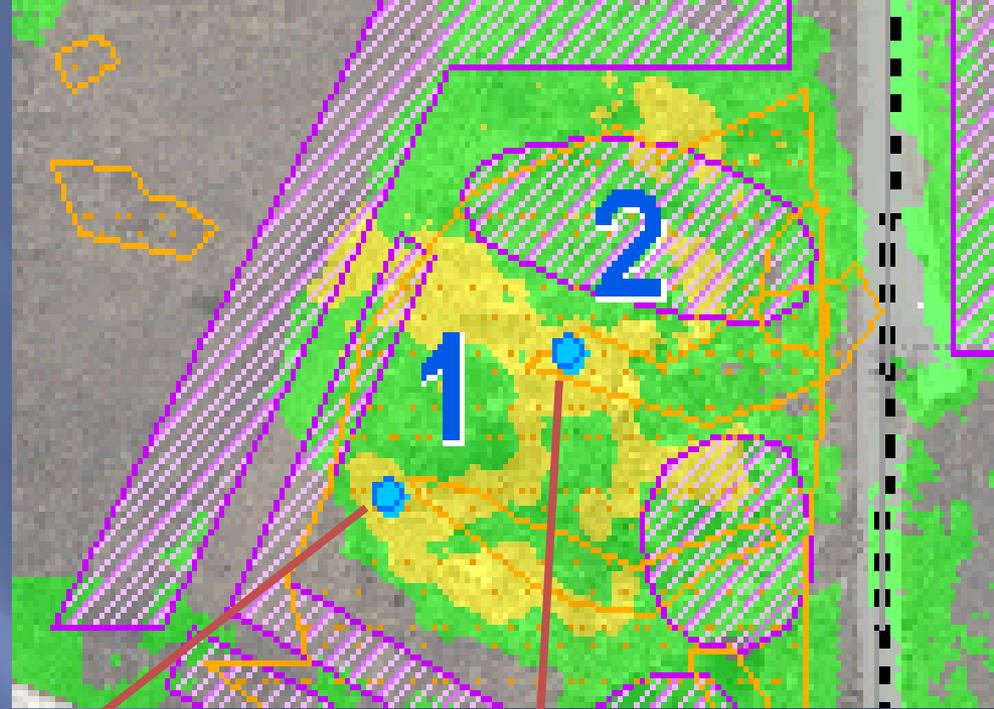
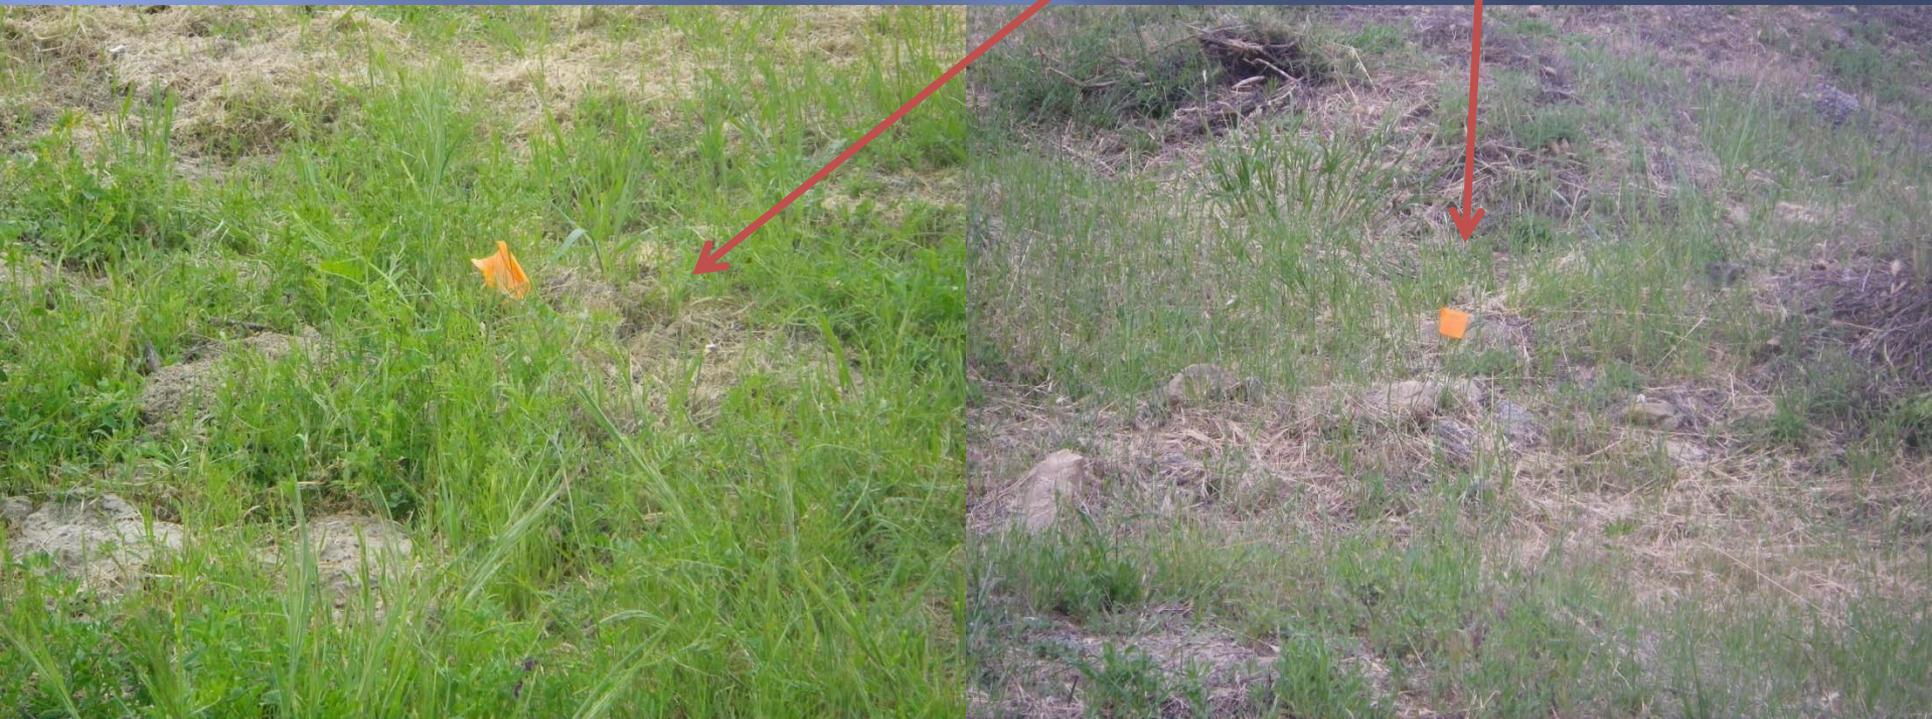
5D N PGRAYS 1 & 2

Potential GRAY	Evaluation
1, 2, 5, 6	Suspect due to another line of evidence at the location
3, 4	NORM
NORM is Naturally Occurring Radioactive Materials (Uranium, Thorium, and Potassium-40)

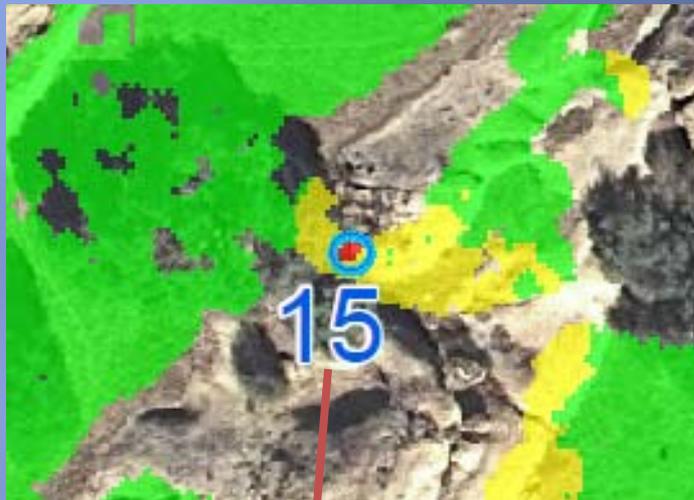
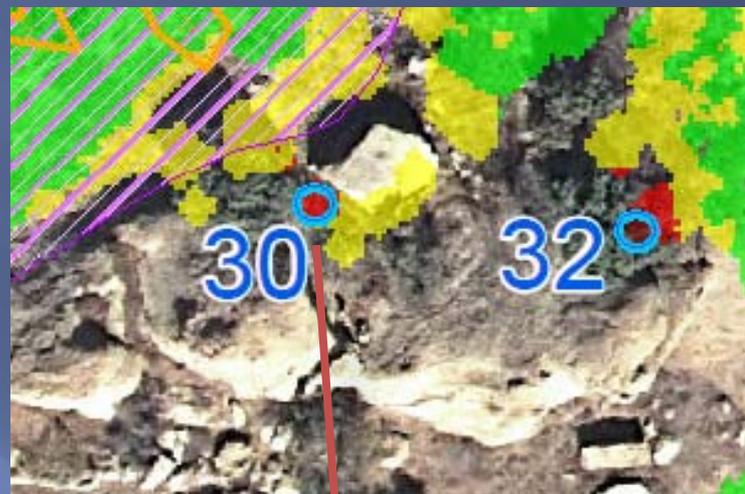
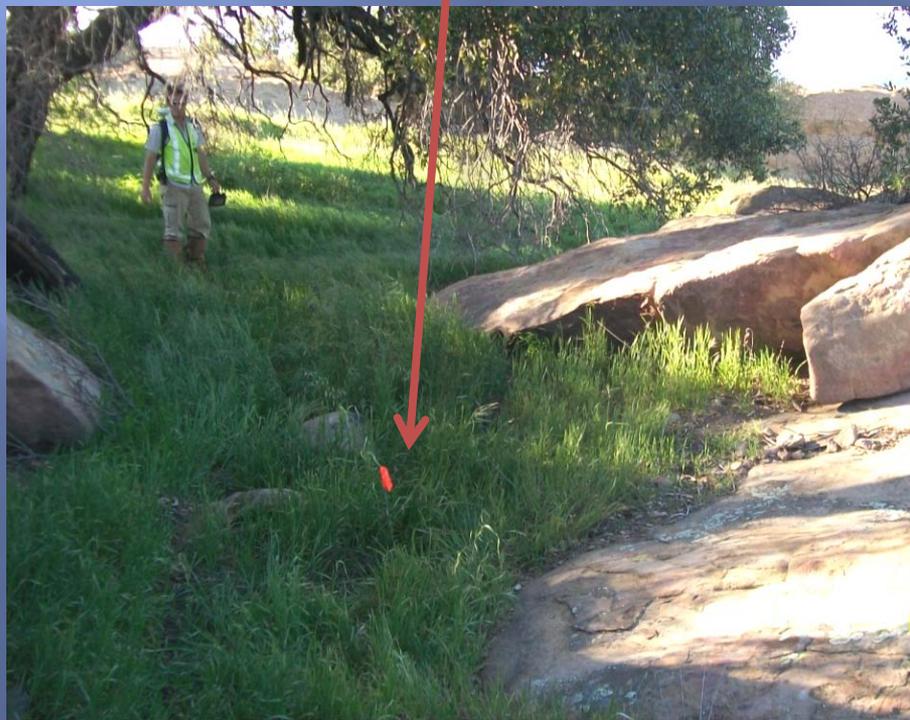
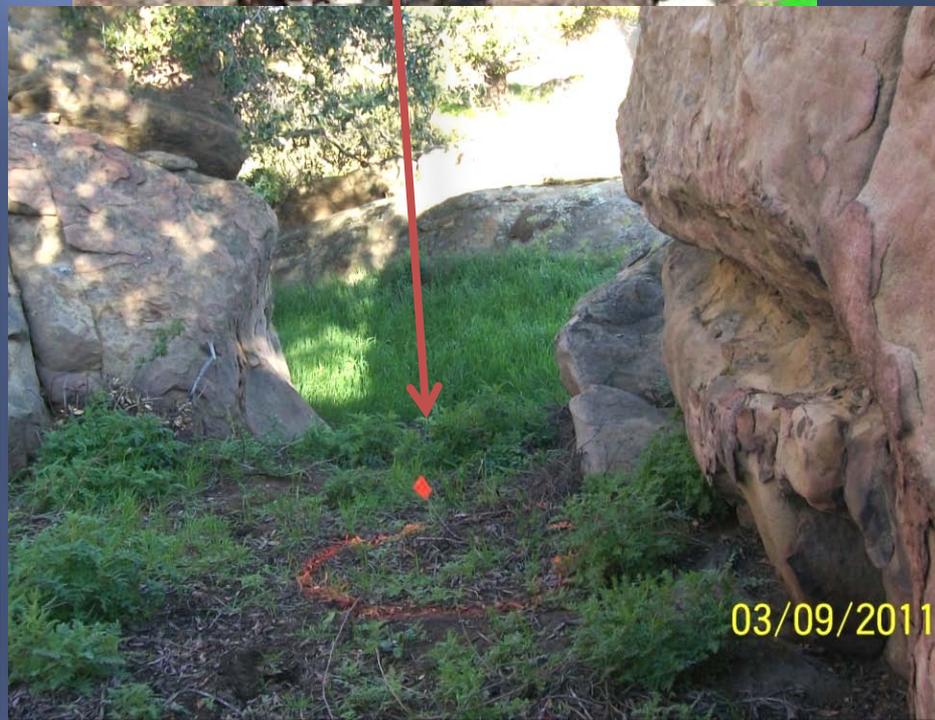
Subarea 8 North PGRAYs 15 & 30

Potential GRAY	Evaluation
15 & 30	NORM
11, 18, 26	Sites too wet to verify
5, 7, 9, 24, 26, 27	Suspect due to another line of evidence at the location
NORM is Naturally Occurring Radioactive Materials (Uranium, Thorium, and Potassium-40)

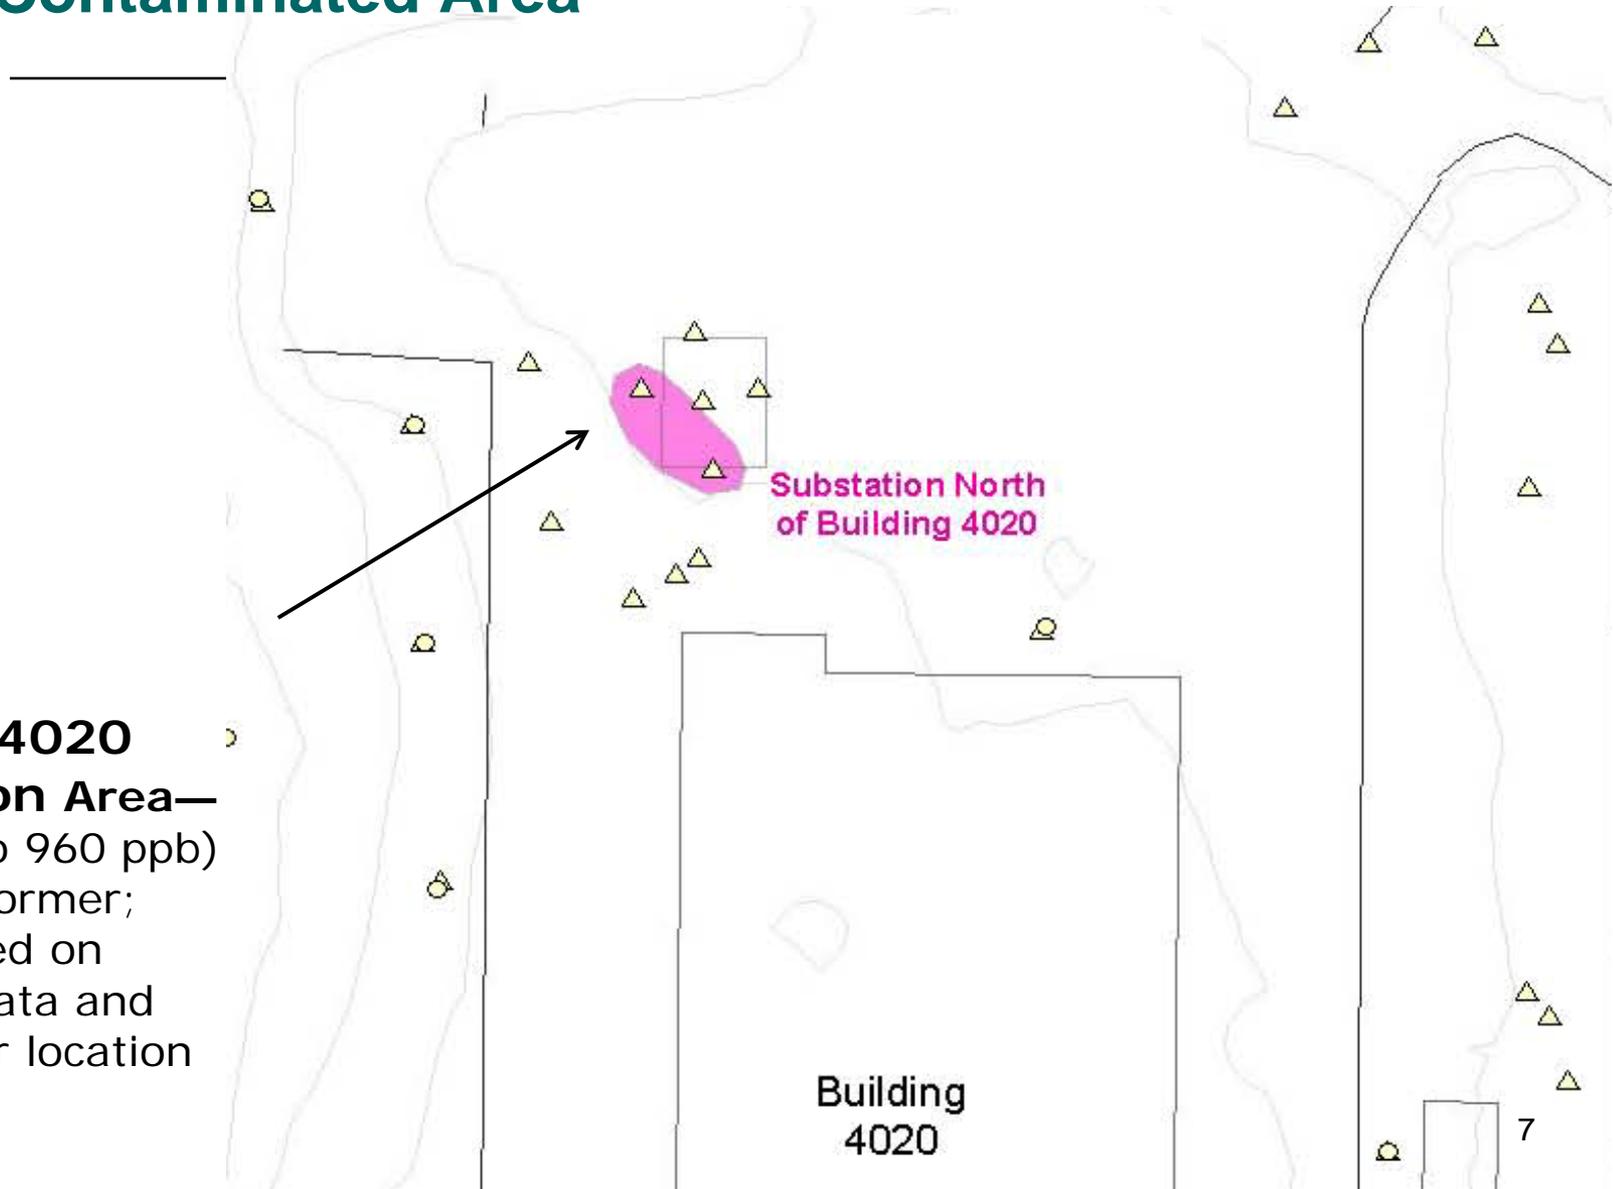
Rockwell International Hot Lab – Clearly Contaminated Area

**Building 4020
Substation Area—**
PCBs (up to 960 ppb)
near transformer;
extent based on
sampling data and
transformer location
