**FOURTH FIVE-YEAR REVIEW REPORT FOR  
MONOLITHIC MEMORIES SUPERFUND SITE (Subunit 2)  
SANTA CLARA COUNTY, CALIFORNIA**

PREPARED BY Army Corps of Engineers Seattle District

# Executive Summary

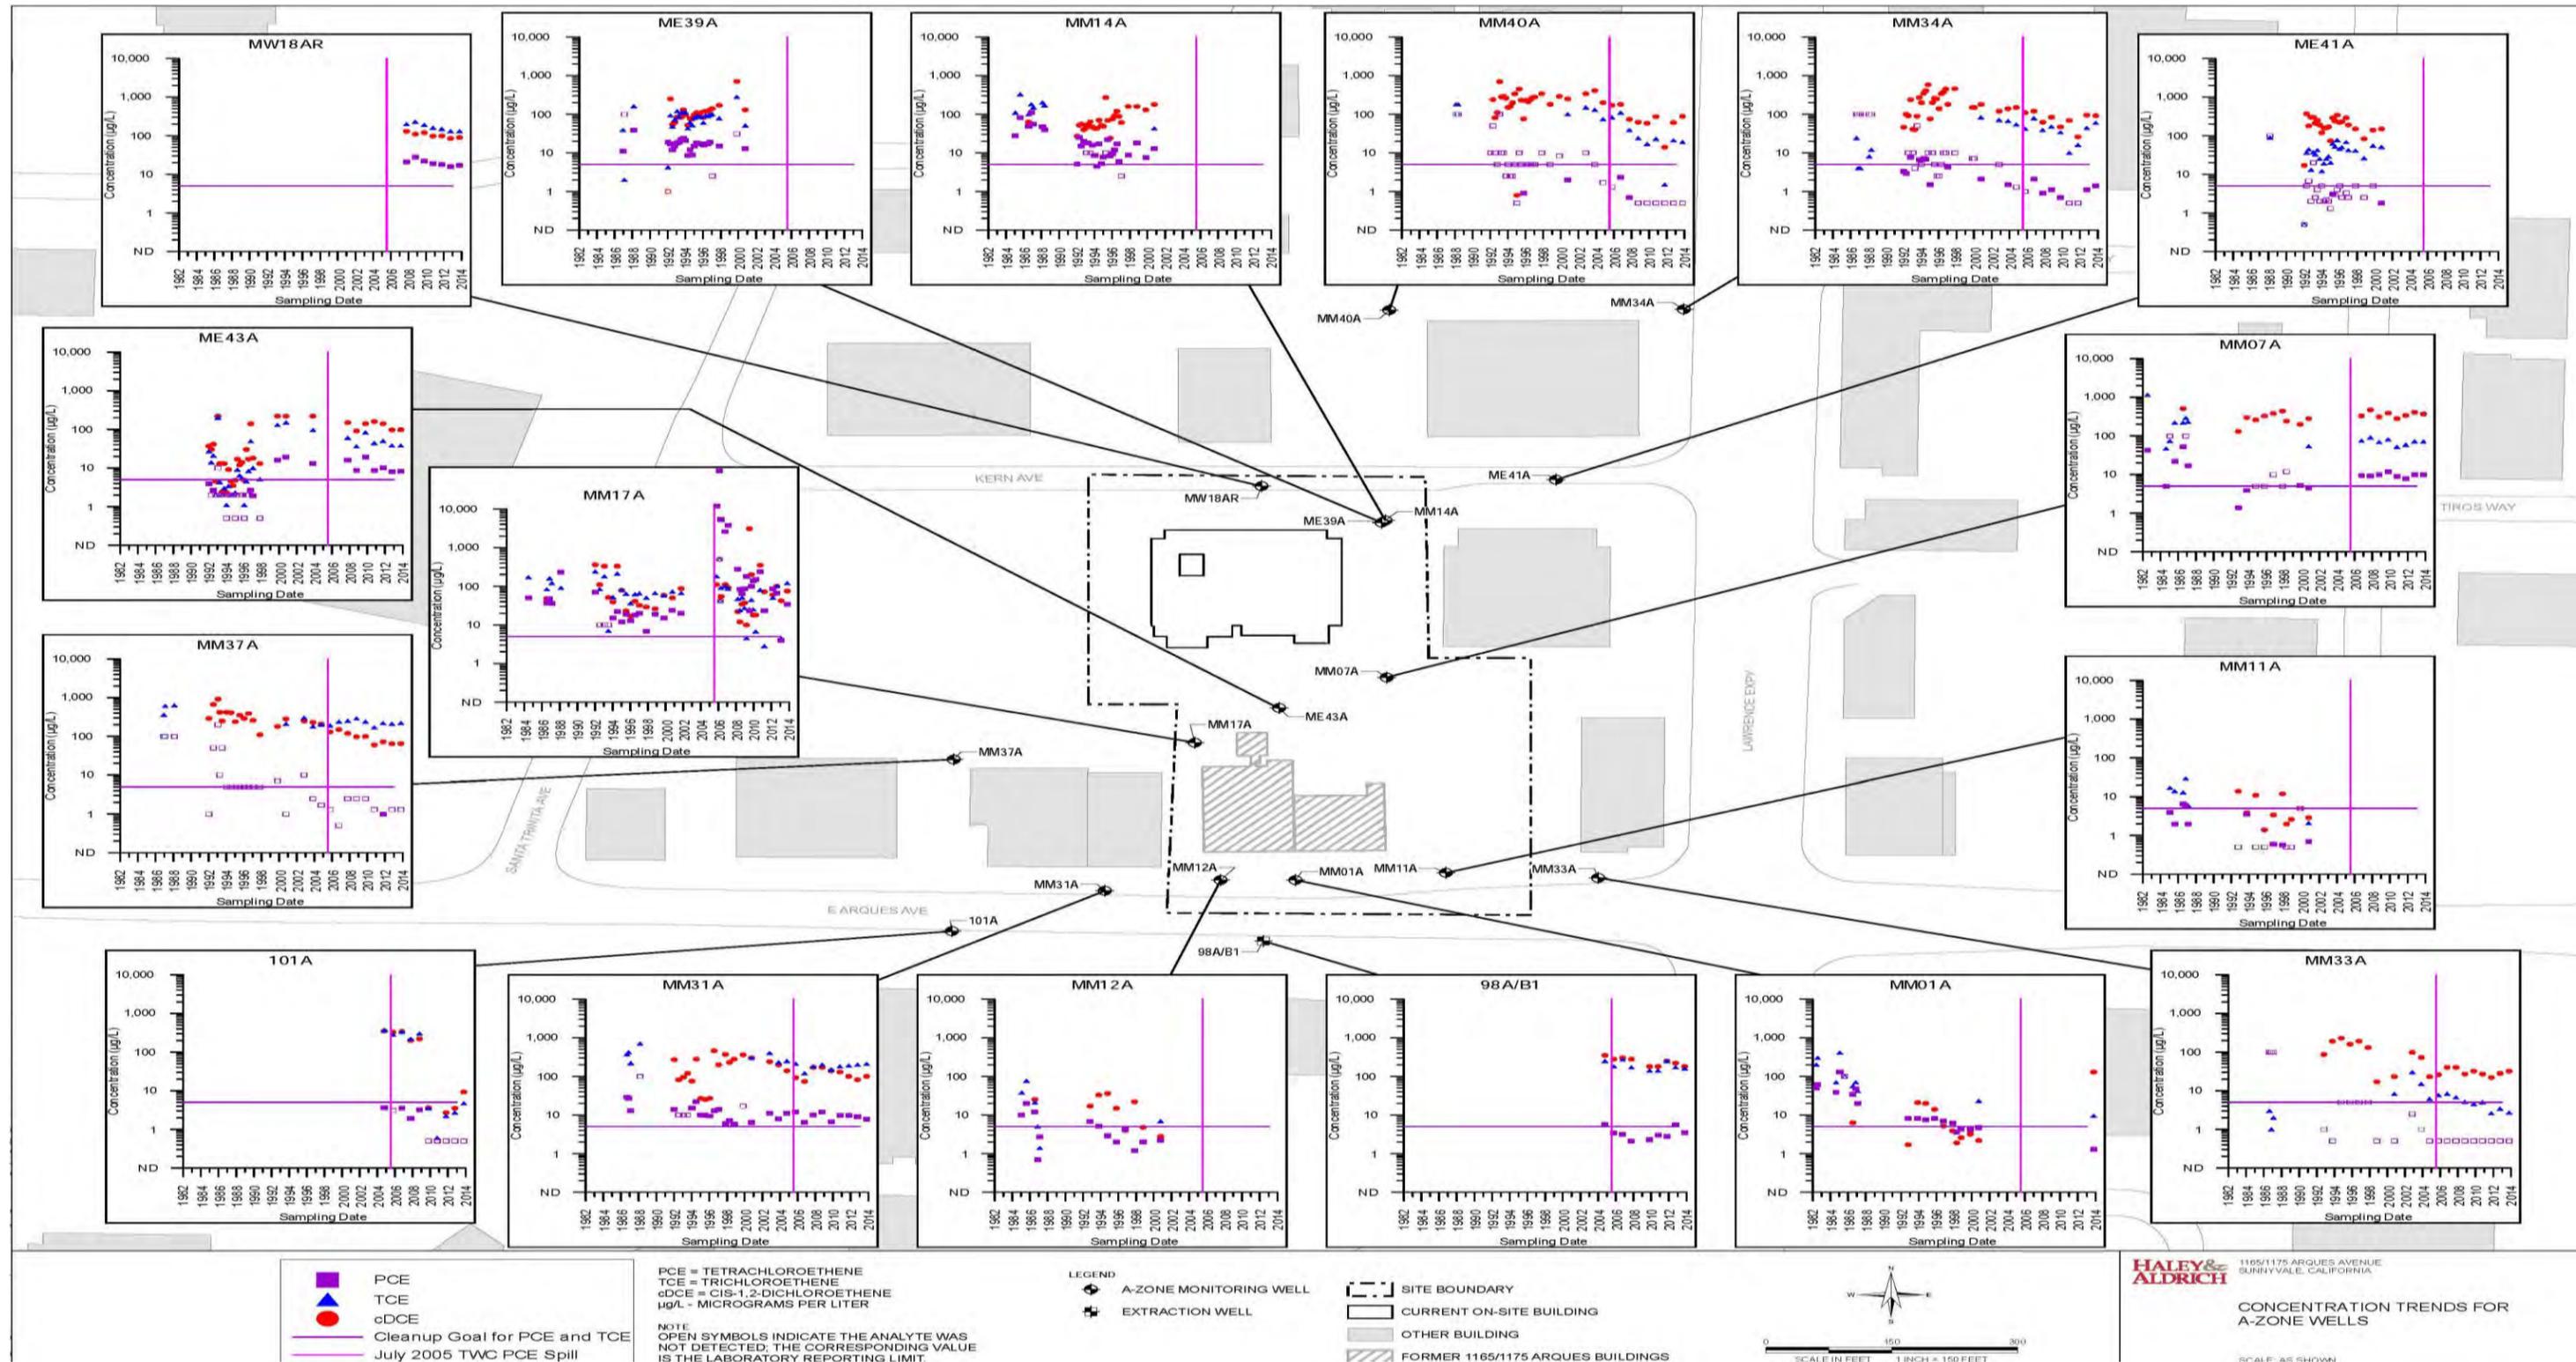
Figure 4. Dissolved PCE and TCE Concentration Trends in 2005 PCE Spill Monitoring Wells

The highest concentration of PCE detected in groundwater samples collected during the 2013 sampling event was 34 g/L in the A-Zone well MM17A. As previously stated, this well has historically been shown to be impacted by PCE from 2005 PCE spill. Generally, the concentrations of PCE in other A Zone monitoring wells are near or below the cleanup goal of 5 µg/L. PCE was not detected in the most recent groundwater samples from B-Zone monitoring wells.

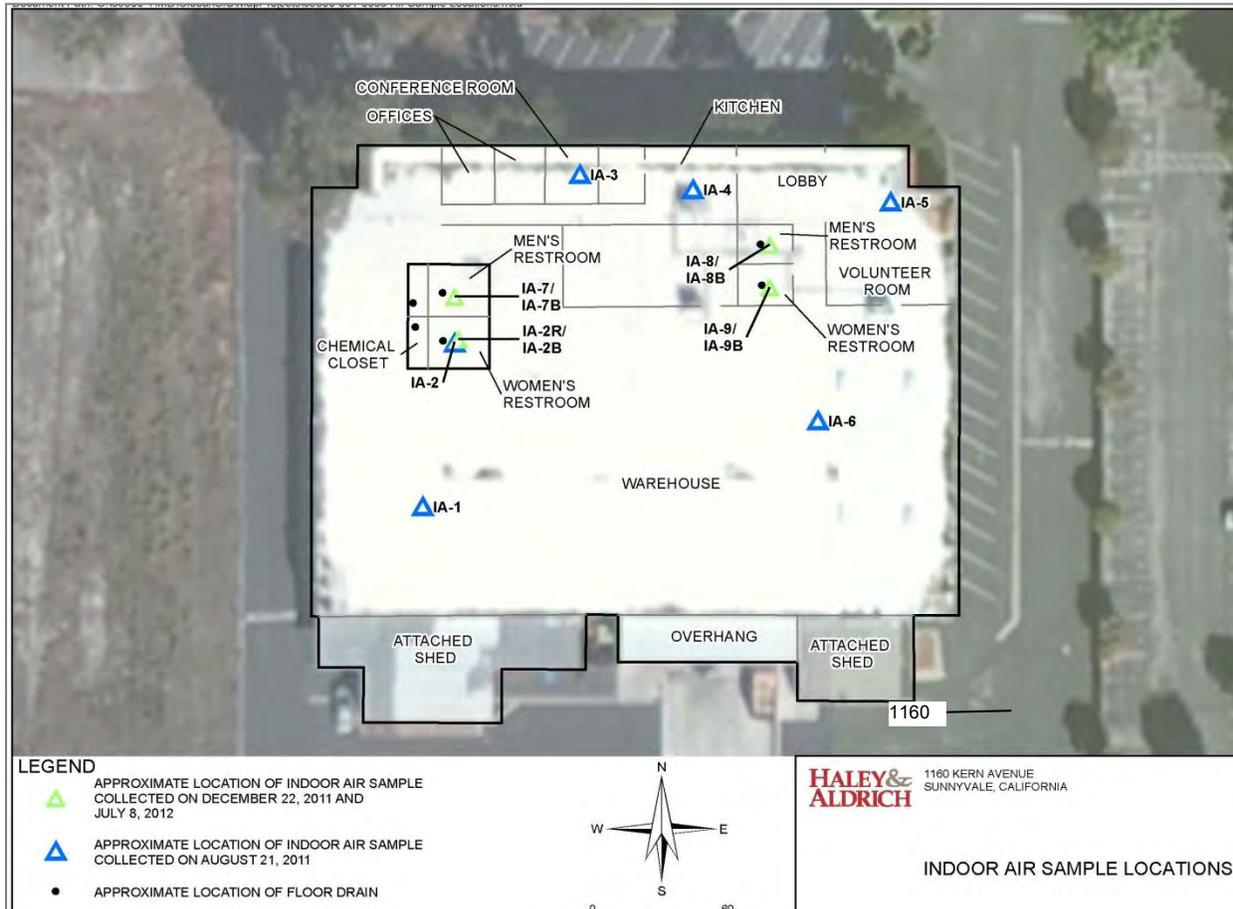
**Figure 5. Air sampling locations at 1160 Kern Drive**

Halogenated volatile organic compounds (HVOCs) including PCE, TCE, cis-1,2-DCE, vinyl chloride, 1,1-DCA, 1,1,1-TCA, and/or Freon 113, were detected in at least one indoor air sample (Table 12) in 2011. Of the HVOCs detected, two (TCE and PCE) were detected at concentrations that exceeded their respective RSL. The highest concentrations of TCE and PCE (27 and 14  $\mu\text{g}/\text{m}^3$ , respectively) were both in sample IA-2 which targeted a preferential pathway (a floor drain) in the warehouse women's restroom.

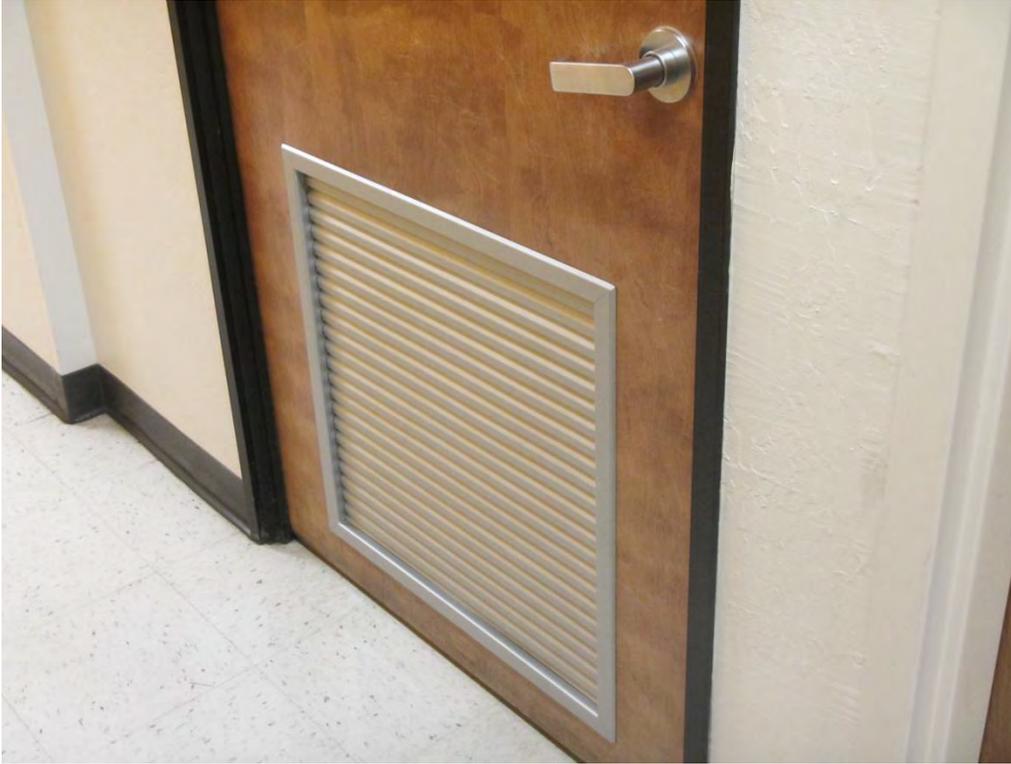
2. Door vents installed on bathroom doors (1160 Kern) (building 3).

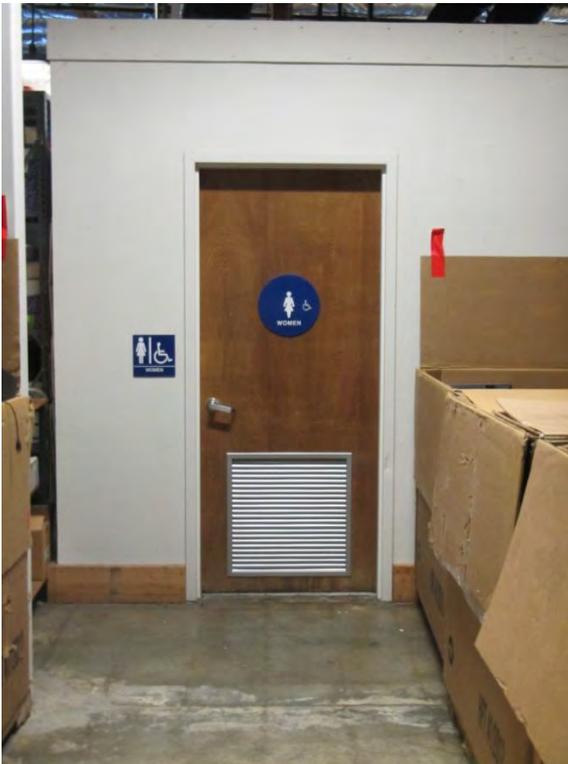
3. Highest VOC detection occurred in this restroom (1160 Kern) (building 3).

Regarding vapor intrusion, the following activities are recommended for the 1160 Kern Avenue building:

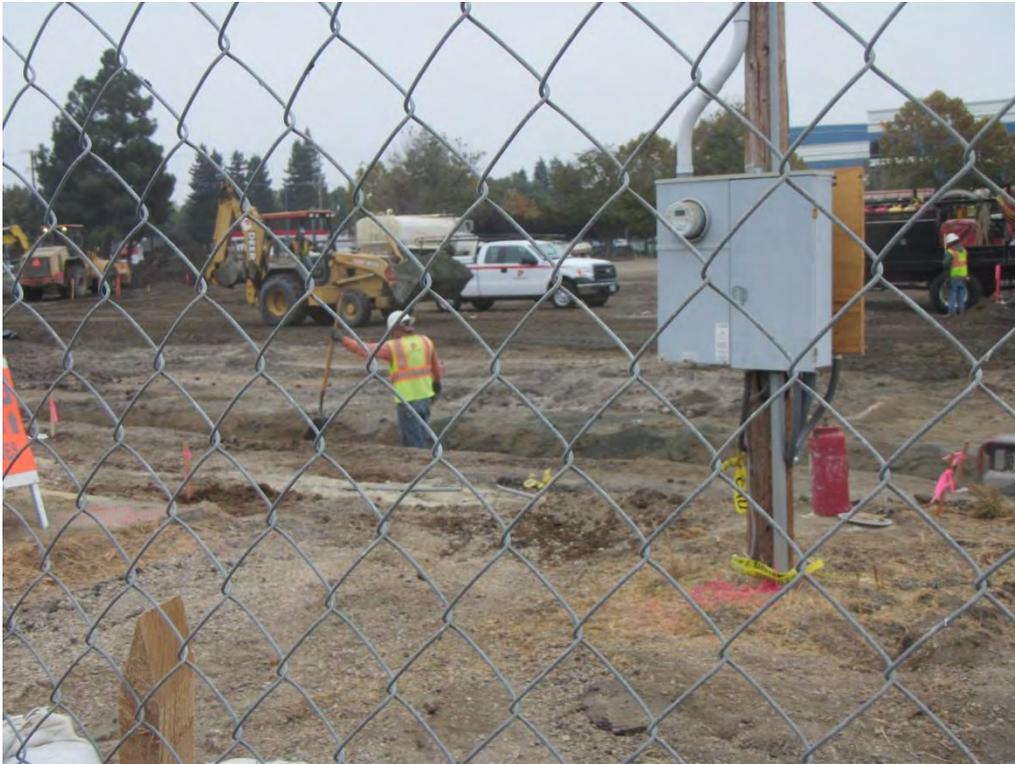
4. Construction activity on 1165/1175 Arques property (former Buildings 1&2).

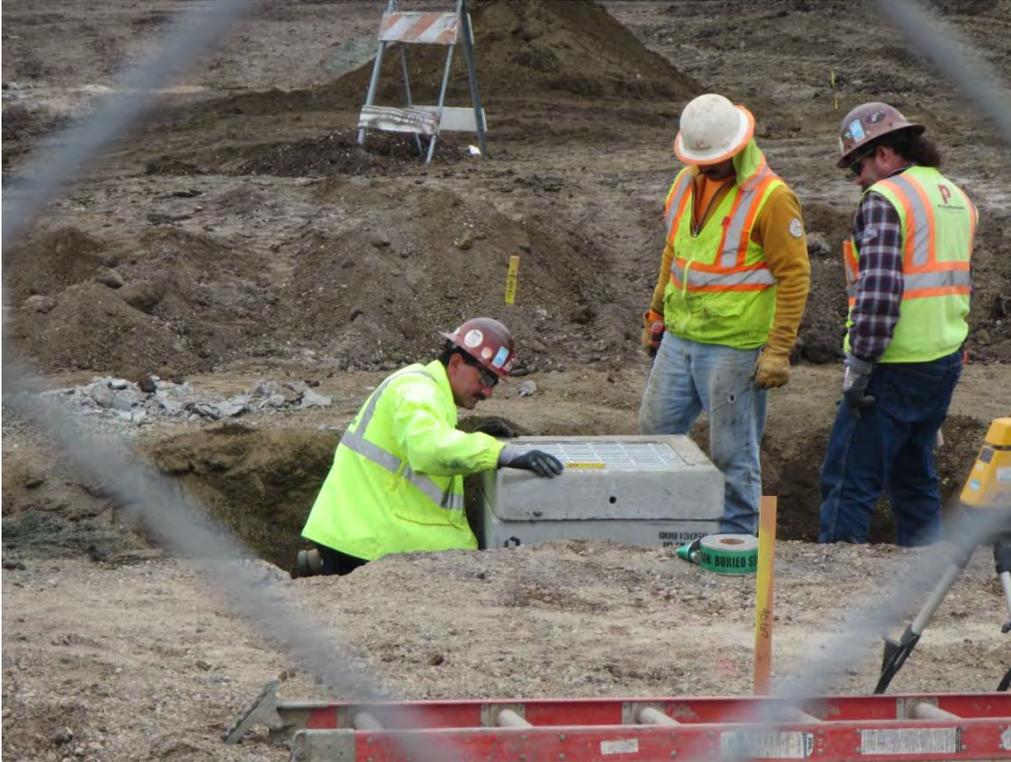
6. Construction at 1175 Arques (former Building 2).

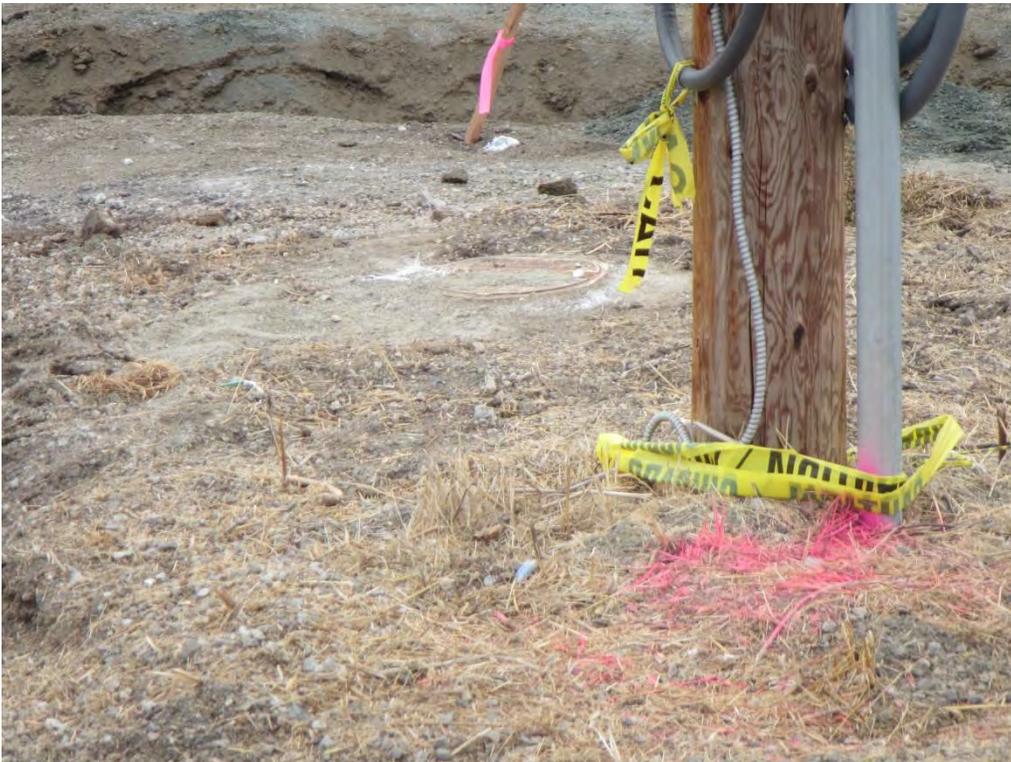
7. Extraction well E44A (sampled, but never used for extraction).

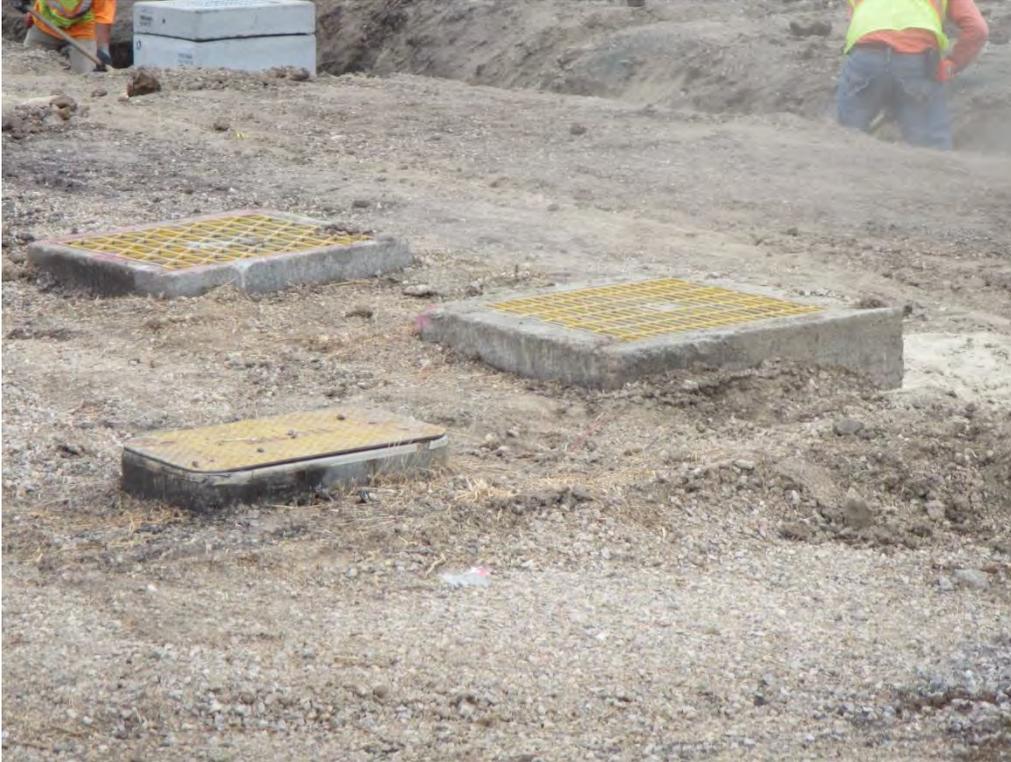
For the paired wells ME43A and ME19B2 (A and B2 aquifer zones, respectively), TCE concentrations have fallen below the cleanup standard in the A aquifer since 2010 but have remained one to two orders of magnitude above it in the B aquifer. Chlorobenzene concentrations in wells ME43A and MW18AR (both in the A aquifer) have decreased to below the cleanup standard since 2010 and have consistently remained below detection limits in well ME19B2.

8. Monitoring wells ME43A and ME19B2.
