CAP REPAIR SUMMARY REPORT

**BROWN & BRYANT, ARVIN FACILITY
SUPERFUND SITE, FIRST OPERABLE UNIT
REMEDIAL ACTION**

ARVIN, CALIFORNIA

October 2015

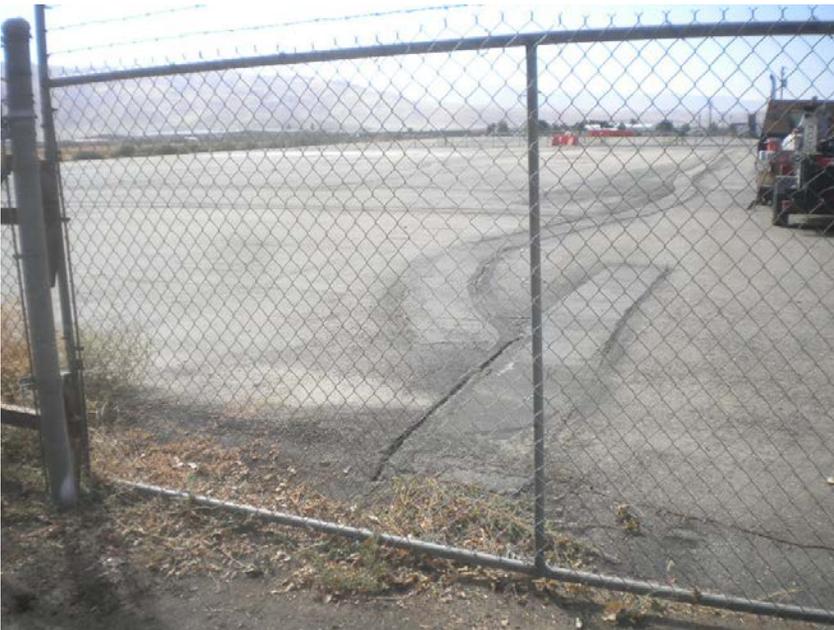
PHOTO NO: PF-1 LOCATION: Perimeter Fence Map Location Number: PF-1 DESCRIPTION: Repaired chain-link fence fabric to eliminate holes.

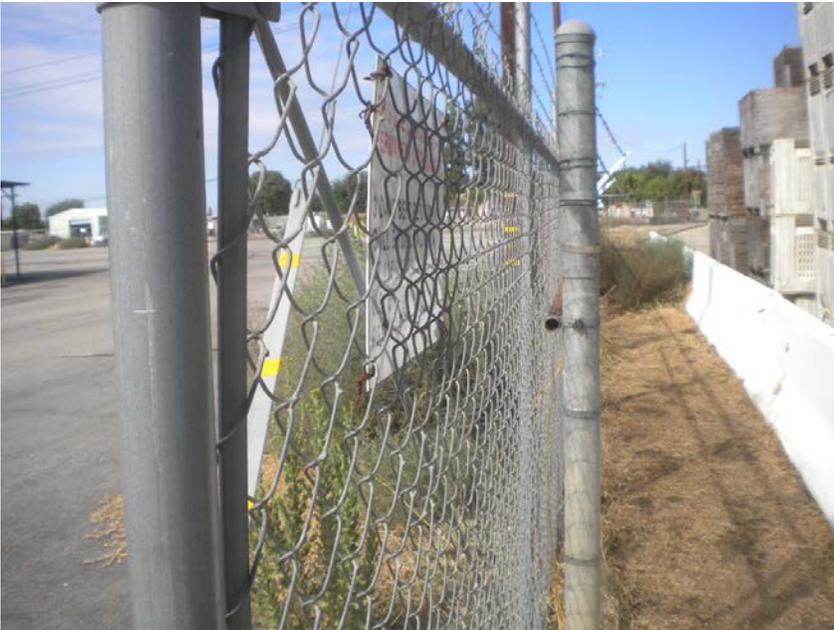
PHOTO NO: PF-2 LOCATION: Perimeter Fence Map Location Number: PF-2 DESCRIPTION: Realigned runner and repaired to ensure smooth operation of sliding gate.

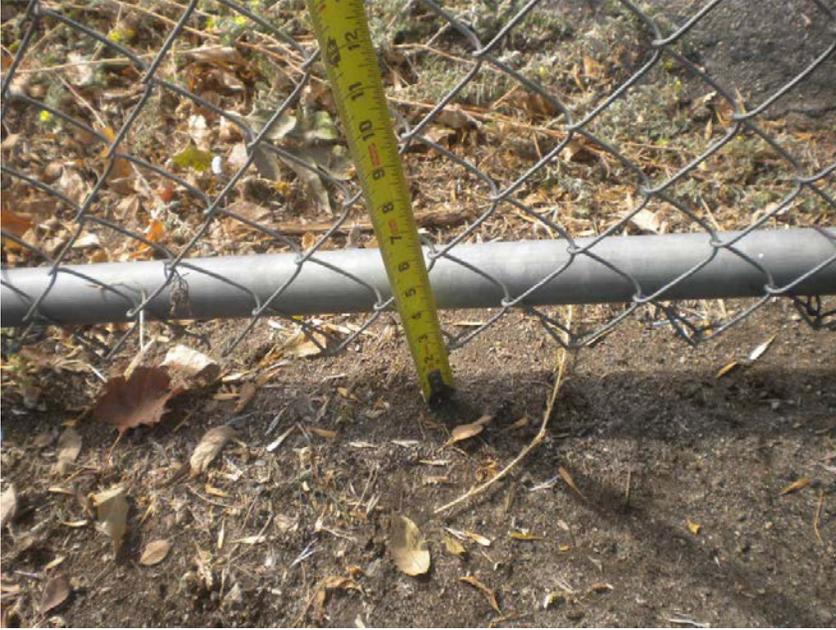
PHOTO NO: PF-3 LOCATION: Perimeter Fence Map Location Number: PF-3 DESCRIPTION: Repaired fabric and adjusted tension wire to ensure clearance is less than 2 inches below fence.

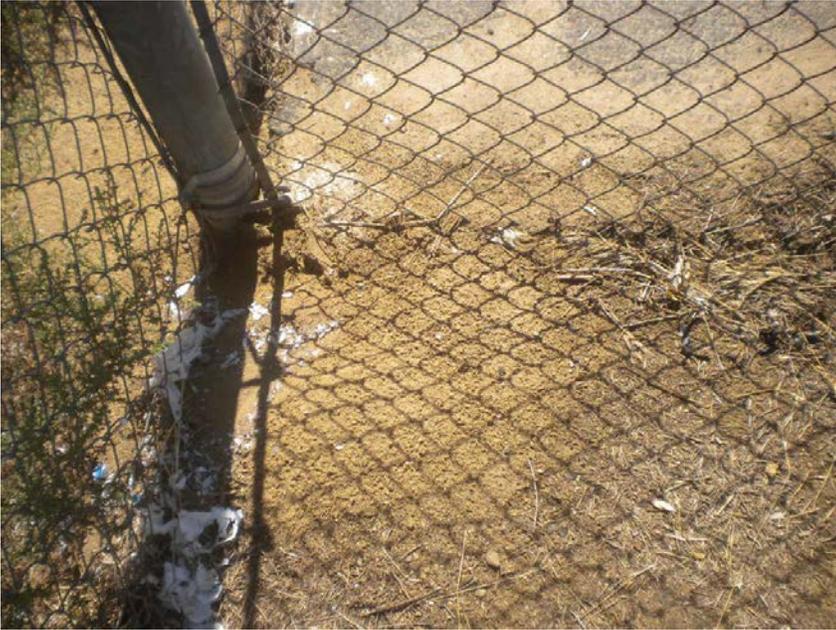
PHOTO NO: PF-4 LOCATION: Perimeter Fence Map Location Number: PF-4 DESCRIPTION: Filled hole with a cement grout.

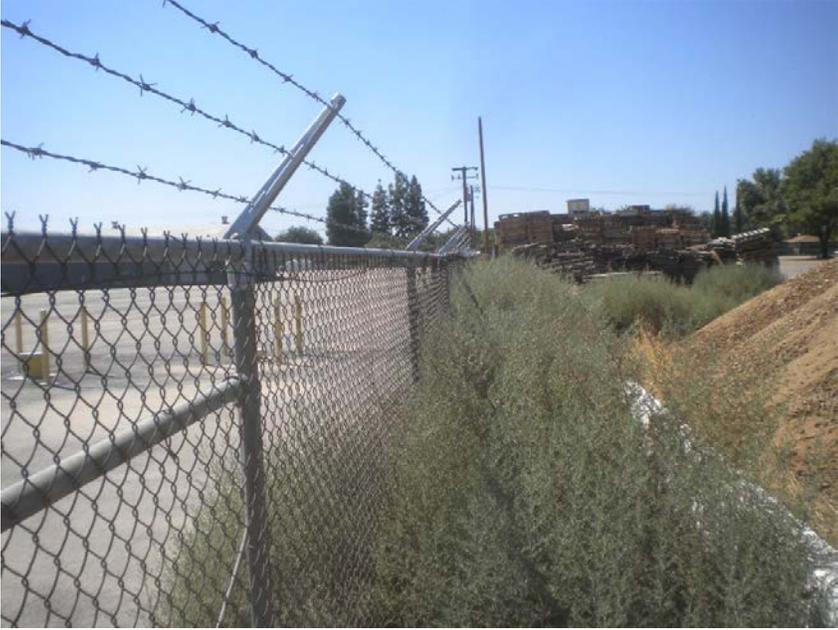
PHOTO NO: PF-5 LOCATION: Perimeter Fence Map Location Number: PF-5 DESCRIPTION: Adjust/replaced poles to plumb.

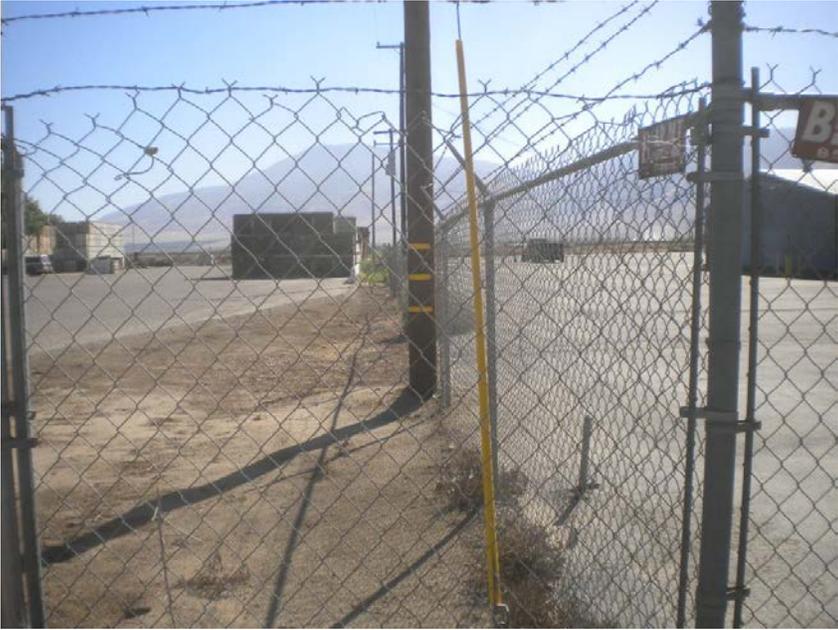
PHOTO NO: PF-6 LOCATION: Perimeter Fence Map Location Number: PF-6 DESCRIPTION: Adjust/replaced poles to plumb.

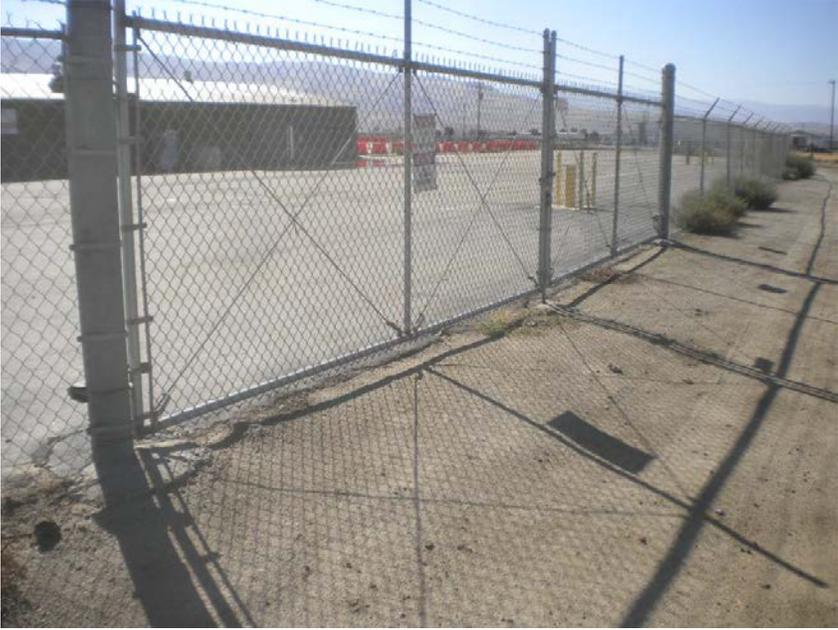
PHOTO NO: PF-7 LOCATION: Perimeter Fence Map Location Number: PF-7 DESCRIPTION: Repaired fabric and adjusted tension wire to ensure clearance is less than 2 inches below fence per City of Arvin specification or equivalent.

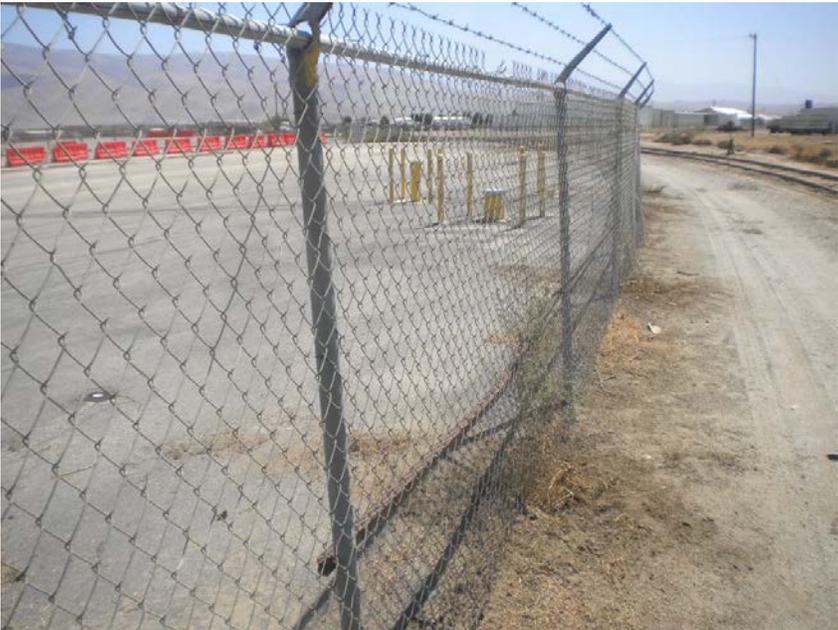
PHOTO NO: PF-8 LOCATION: Perimeter Fence Map Location Number: PF-8 DESCRIPTION: Removed weeds.

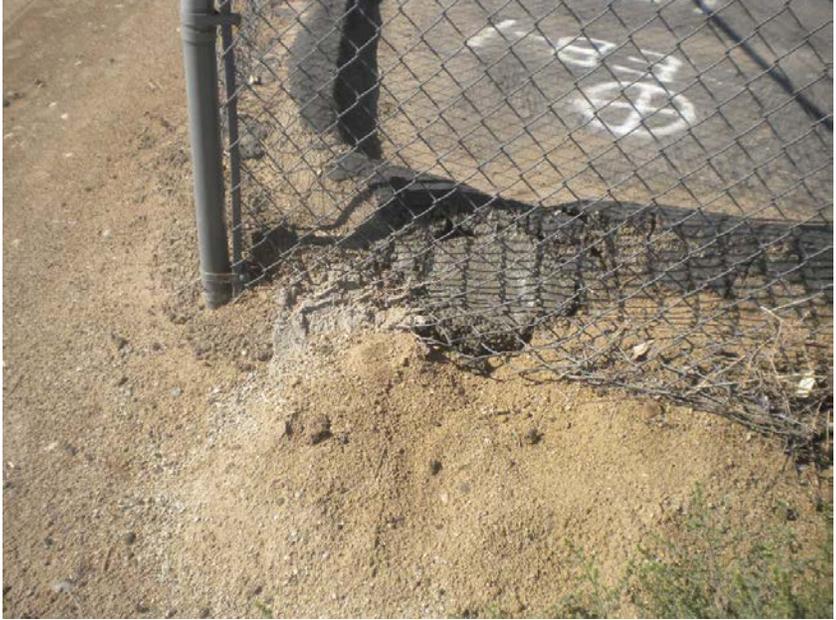
PHOTO NO: PF-9 LOCATION: Perimeter Fence Map Location Number: PF-9 DESCRIPTION: Filled holes with a cement grout.

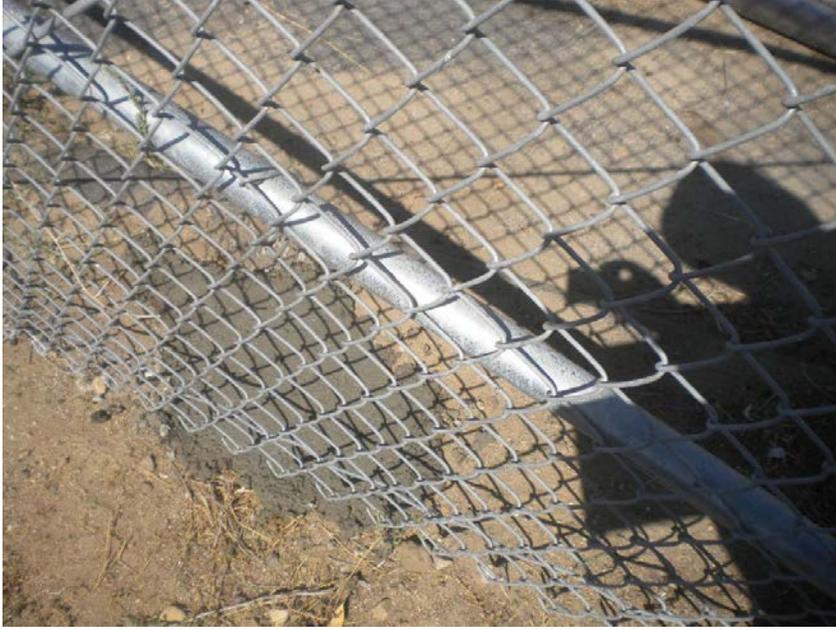
PHOTO NO: PF-10 LOCATION: Perimeter Fence Map Location Number: PF-10 DESCRIPTION: Filled hole with a cement grout. Repaired fabric and adjusted tension wire to ensure clearance is less than 2 inches below fence.

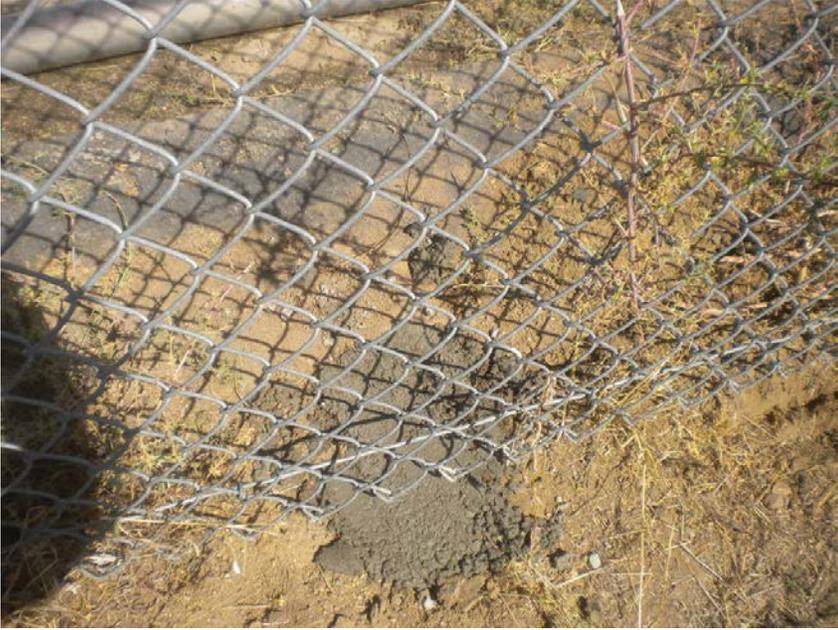
PHOTO NO: PF-11 LOCATION: Perimeter Fence Map Location Number: PF-11 DESCRIPTION: Filled holes with a cement grout.

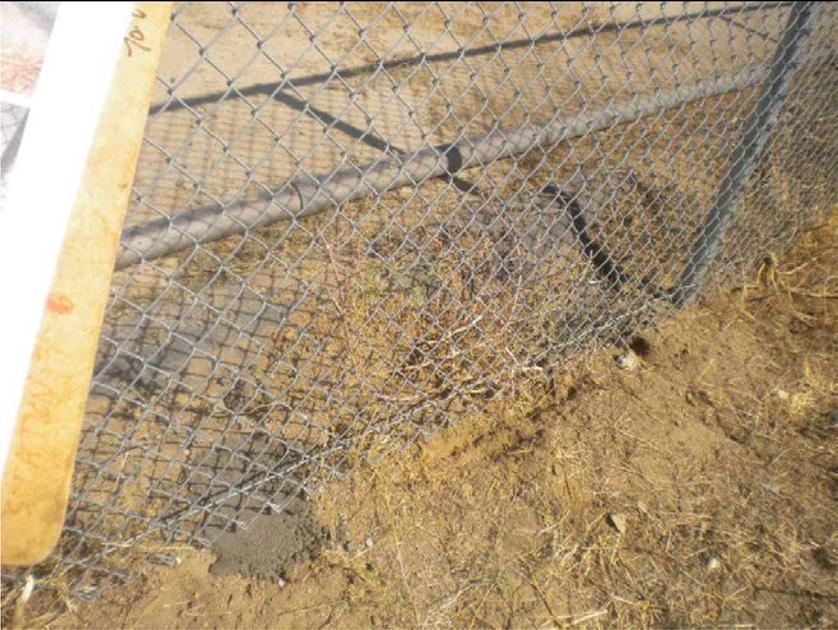
PHOTO NO: PF-12 LOCATION: Perimeter Fence Map Location Number: 12 DESCRIPTION: Three animal burrows under the fence.

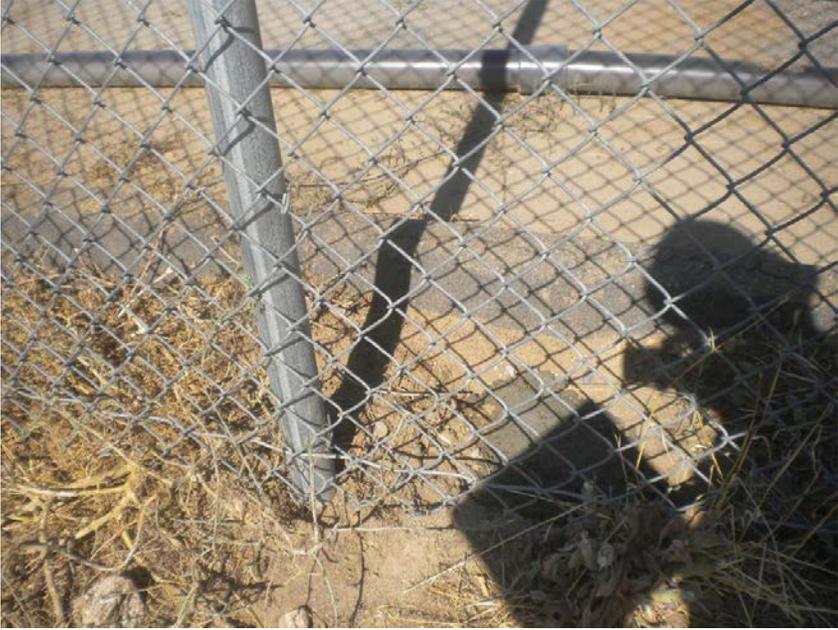
PHOTO NO: PF-13 LOCATION: Perimeter Fence Map Location Number: 13 DESCRIPTION: Filled hole with a cement grout.

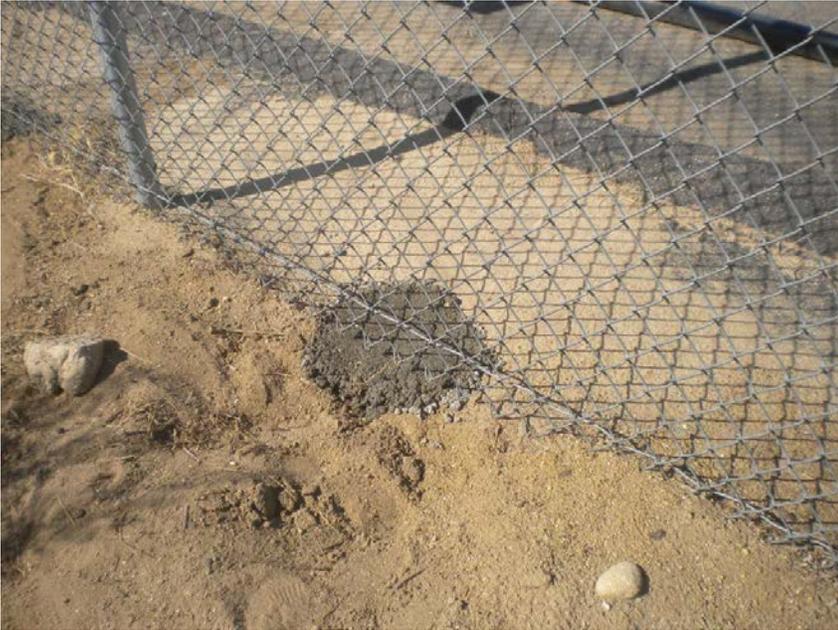
PHOTO NO: PF-14 LOCATION: Perimeter Fence Map Location Number: 14 DESCRIPTION: Repaired fabric and adjusted tension wire to ensure clearance is less than 2 inches below fence per City of Arvin specification. Filled holes with cement grout.

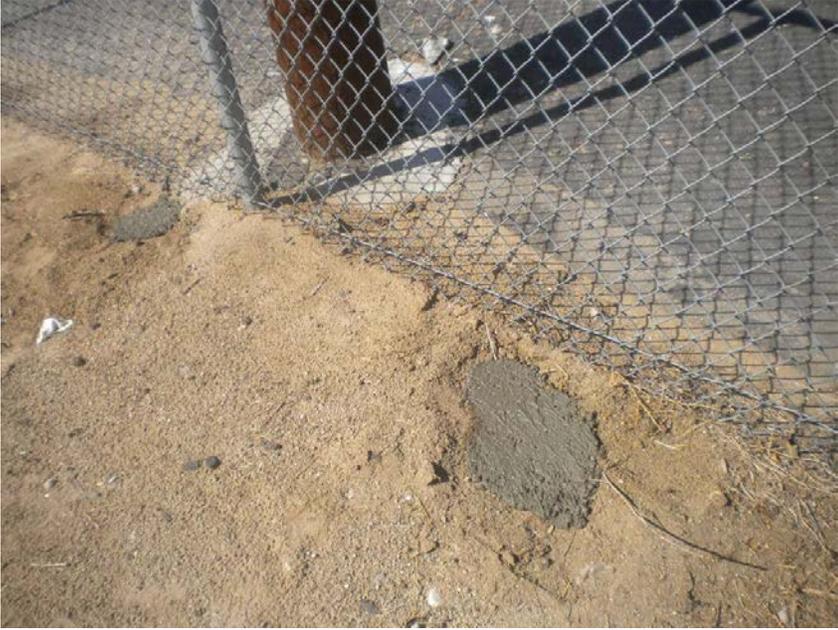
PHOTO NO: PF-15 LOCATION: Perimeter Fence Map Location Number: PF15 DESCRIPTION: Filled holes with cement grout.

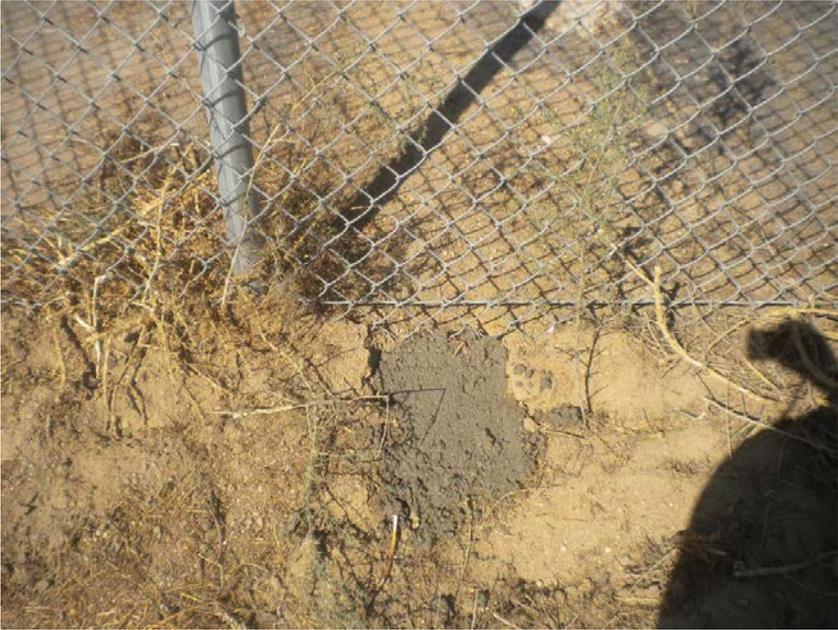
PHOTO NO: PF-16 LOCATION: Perimeter Fence Map Location Number: PF-16 DESCRIPTION: Filled hole with a cement grout.

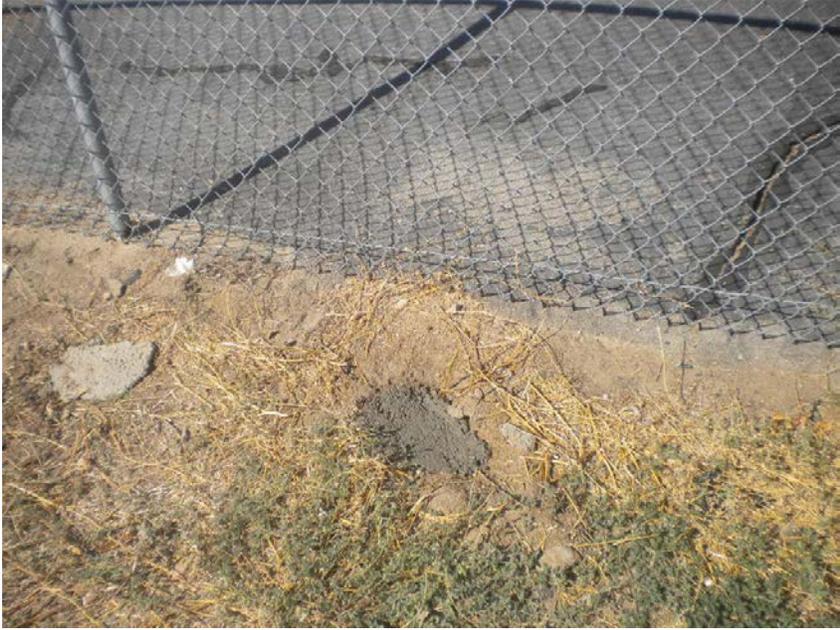
PHOTO NO: PF-17
		LOCATION: Perimeter Fence Map Location Number: PF-17
		DESCRIPTION: Filled hole with a cement grout.

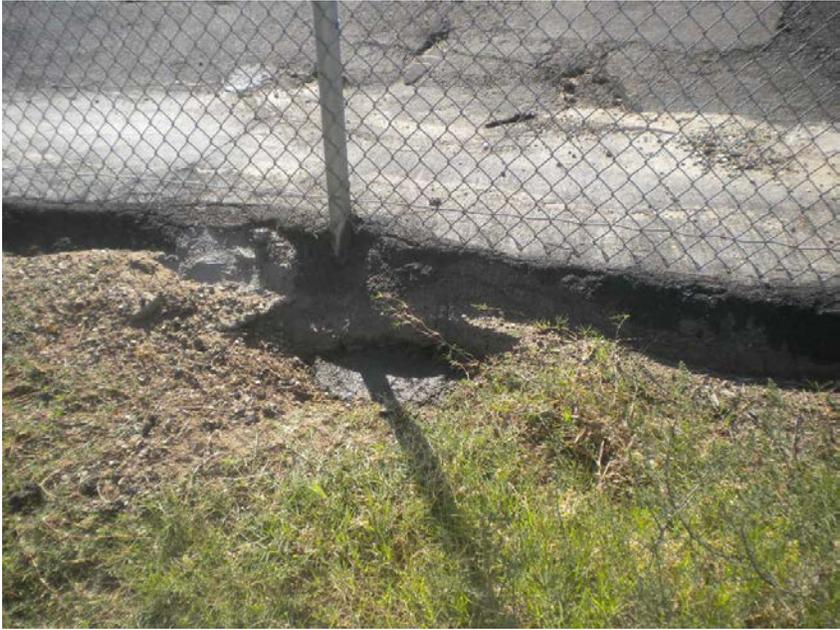
PHOTO NO: PF-18
		LOCATION: Perimeter Fence Map Location Number: PF-18
		DESCRIPTION: Filled hole with a cement grout.

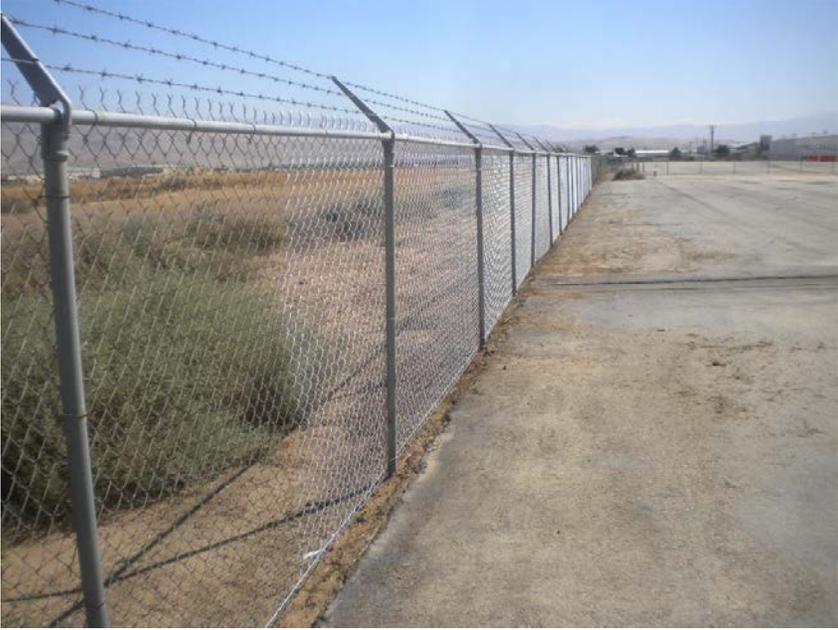
PHOTO NO: PF-19 LOCATION: Perimeter Fence Map Location Number: PF-19 DESCRIPTION: Replaced fabric per City of Arvin specification.

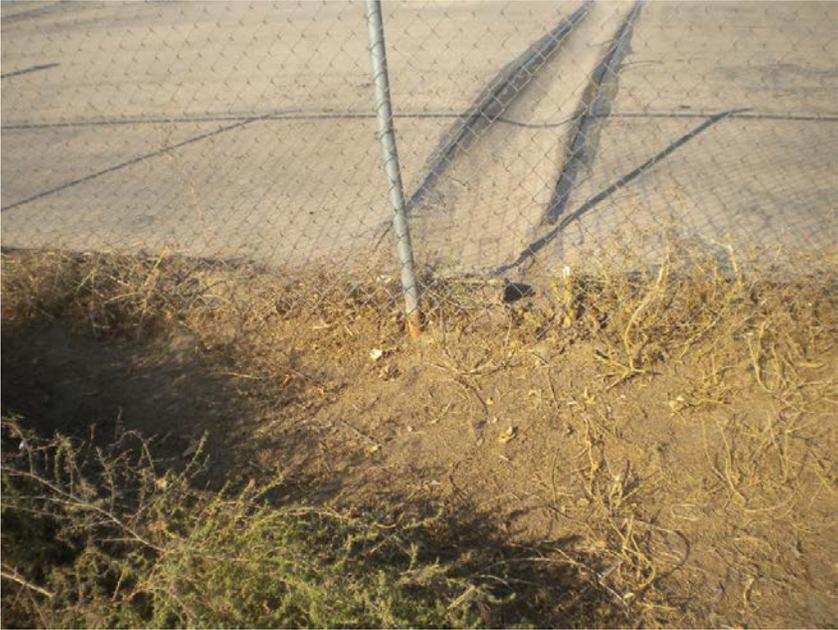
PHOTO NO: PF-20 LOCATION: Perimeter Fence Map Location Number: PF-20 DESCRIPTION: Filled hole with a cement grout.

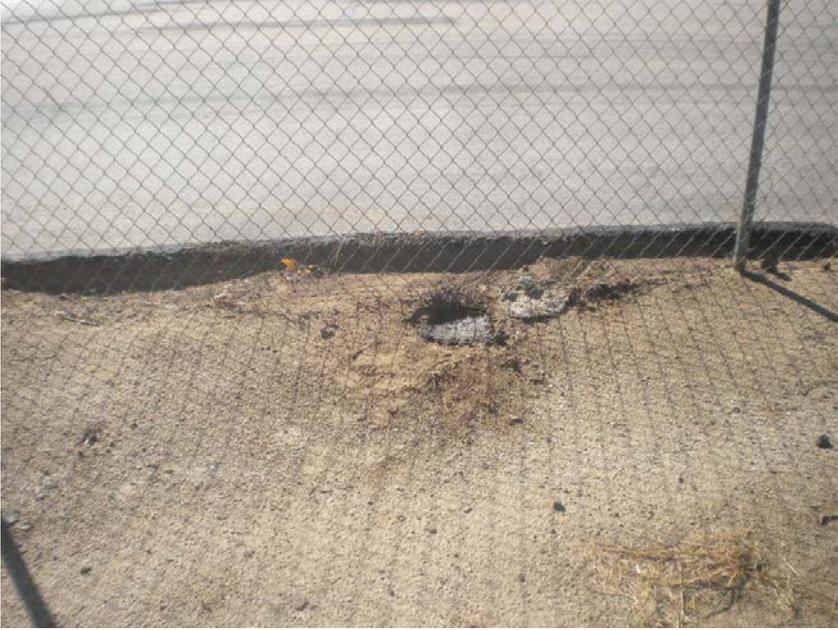
PHOTO NO: PF-21 LOCATION: Perimeter Fence Map Location Number: PF-21 DESCRIPTION: Filled hole with a cement grout.

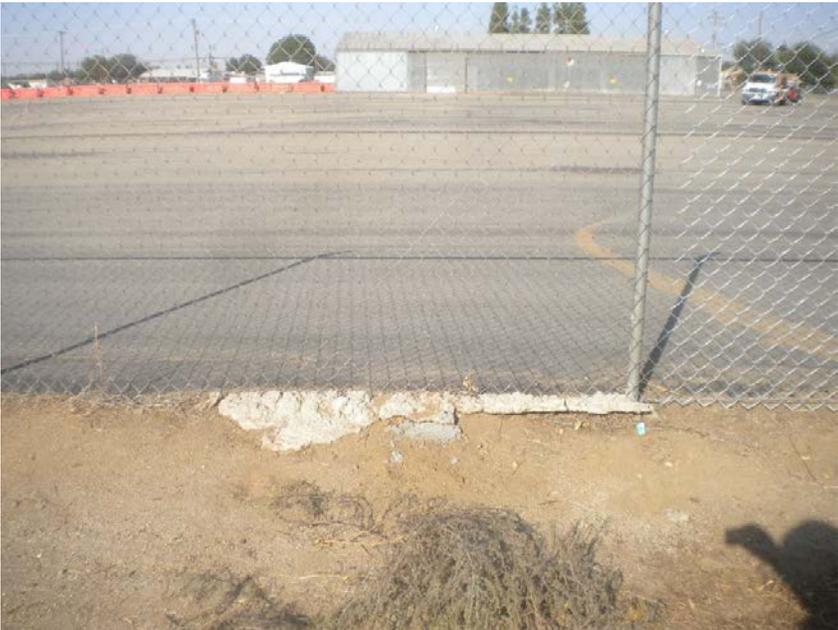
PHOTO NO: PF-22 LOCATION: Perimeter Fence Map Location Number: PF-22 DESCRIPTION: Filled hole with a cement grout.

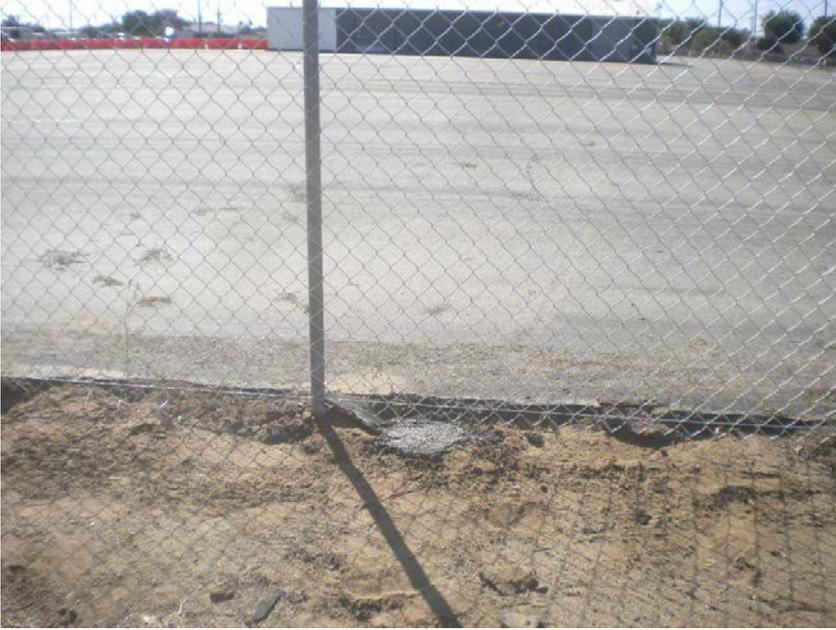
PHOTO NO: PF-23 LOCATION: Perimeter Fence Map Location Number: PF-23 DESCRIPTION: Filled hole with a cement grout.

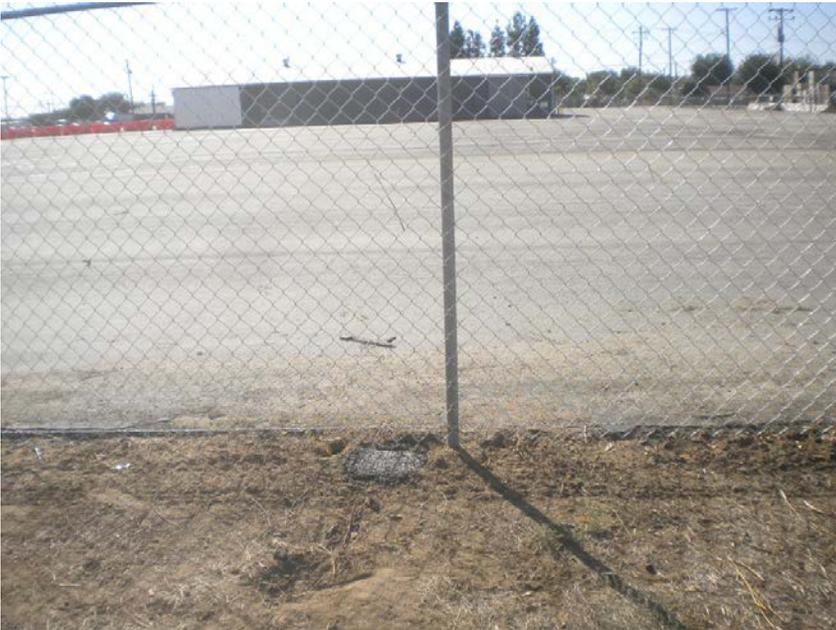
PHOTO NO: PF-24 LOCATION: Perimeter Fence Map Location Number: PF-24 DESCRIPTION: Filled hole with a cement grout.

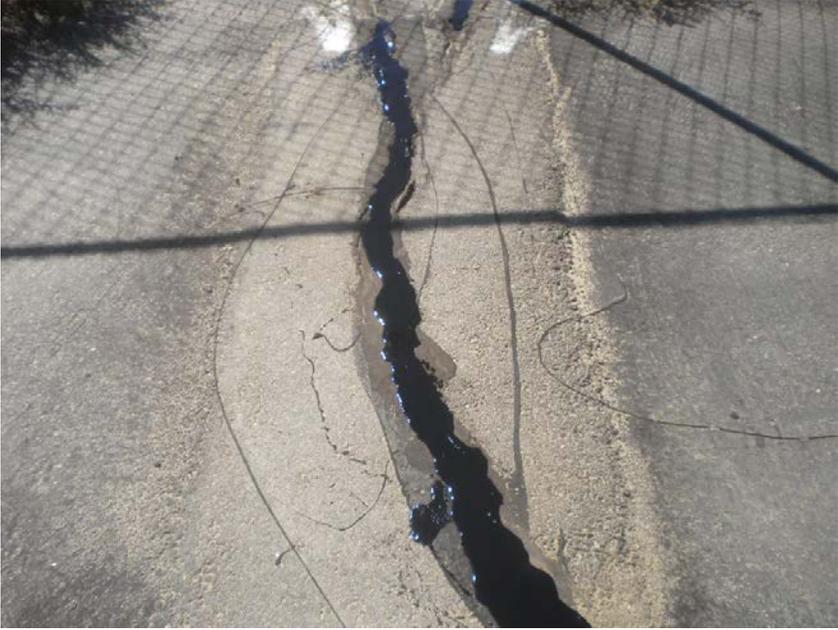
- NRC-1. CRACK 3/8" TO 1/2" AROUND WELL WA-04 AND WEST OF WELL WA-04 APPROXIMATELY 3'.
- NRC-2. CRACKS AROUND WA-03.
- NRC-3. CRACKS 1/4" TO 1/2" AROUND AND BETWEEN TRENCH CUTS FROM NORTH FENCE TO 60' NORTH OF JOG.

PHOTO NO: NRC-1
		LOCATION: Non-RCRA Cap Map Location Number: NRC-1
		DESCRIPTION: Sealed crack.

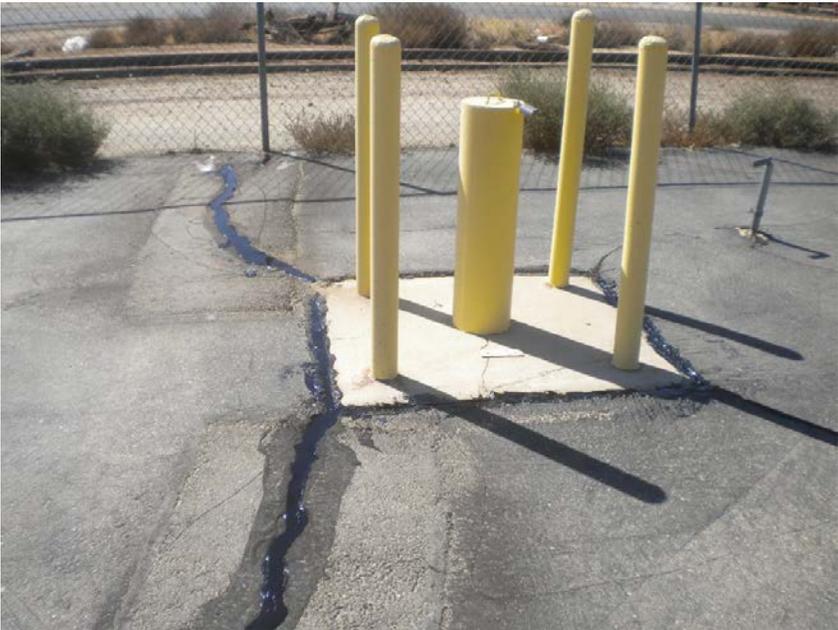
PHOTO NO: NRC-2
		LOCATION: Non-RCRA Cap Map Location Number: NRC-2
		DESCRIPTION: Sealed cracks.

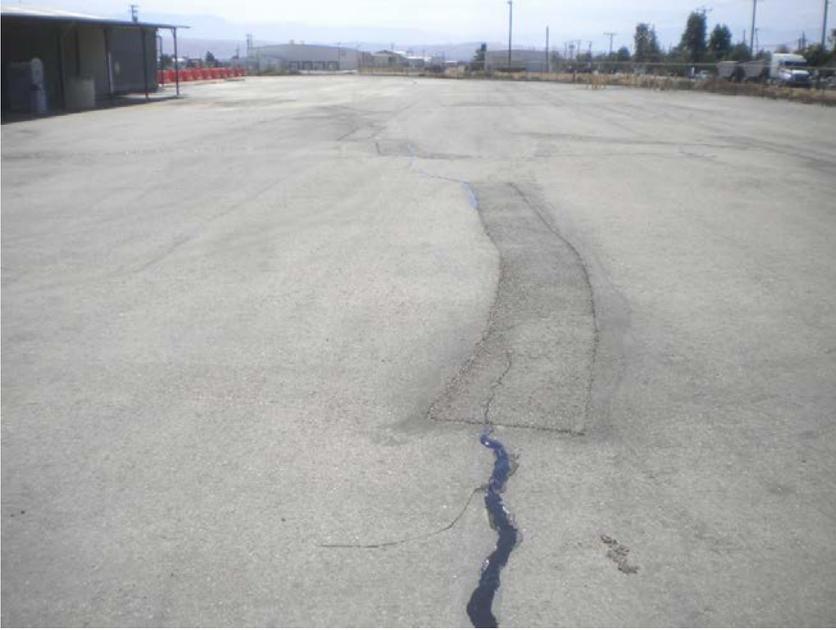
PHOTO NO: NRC-3 LOCATION: Non-RCRA Cap Map Location Number: NRC-3 DESCRIPTION: Sealed crack.

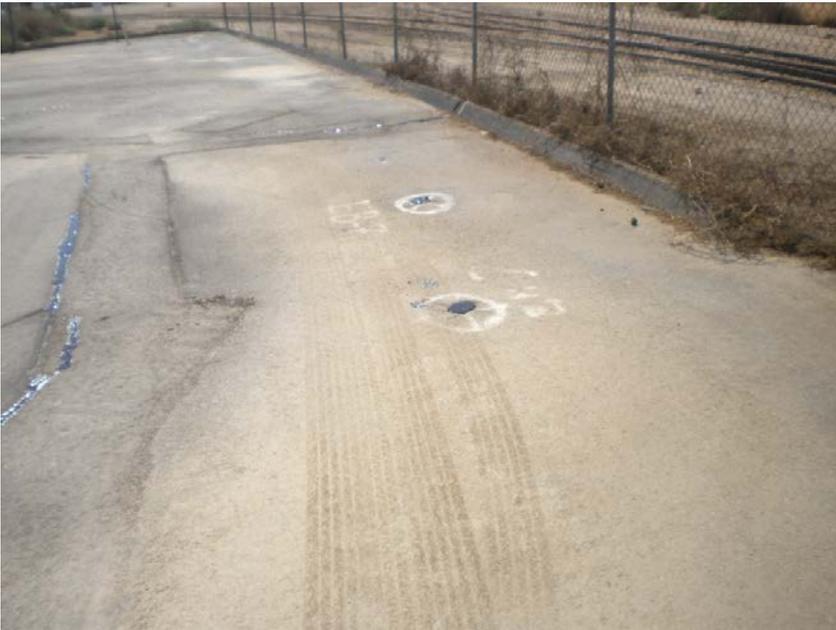
- NRC-4. FAILURE OF SURFACE COMPLETION AT EB-7.
- NRC-5. FAILURE OF SURFACE COMPLETION AT EB-1 AND I-83.
- NRC-6. CRACK ALONG TRENCH CUT SOUTH OF CONCRETE PAD, WEEDS.

PHOTO NO: NRC-4 LOCATION: Non-RCRA Cap Map Location Number: NRC-4 DESCRIPTION: Sealed surface completion.

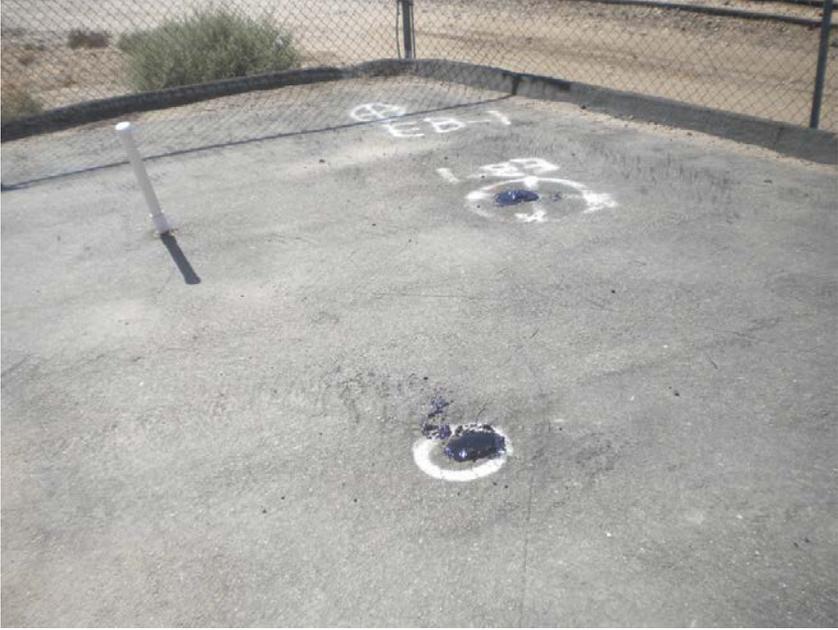
</div> <div style="flex: 2; padding-left: 10px;"> <p>PHOTO NO: NRC-5</p> <p>LOCATION: Non-RCRA Cap Map Location Number: NRC-5</p> <p>DESCRIPTION: Sealed surface completion.</p> </div> </div>		
<div style="display: flex;"> <div style="flex: 1;">

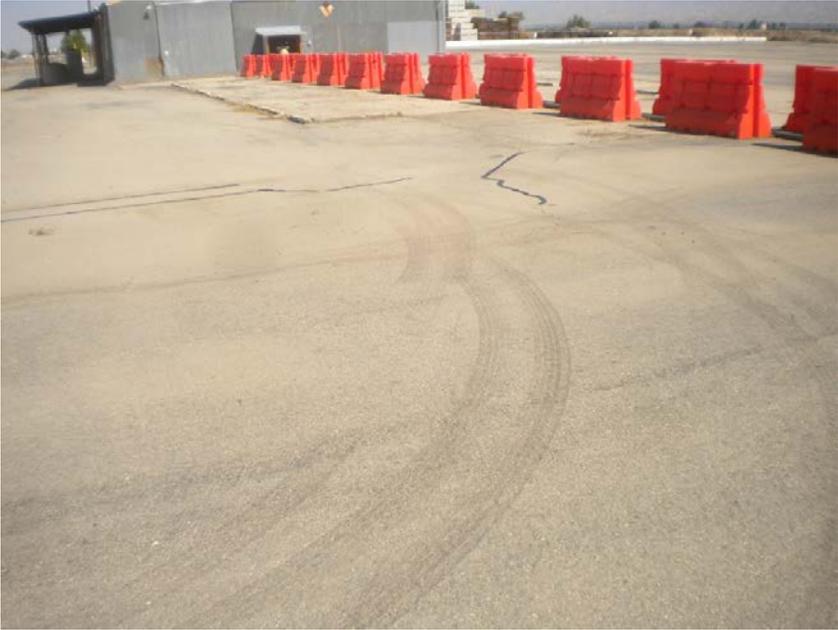
</div> <div style="flex: 2; padding-left: 10px;"> <p>PHOTO NO: NRC-6</p> <p>LOCATION: Non-RCRA Cap Map Location Number: NRC-6</p> <p>DESCRIPTION: Removed weeds and sealed cracks.</p> </div> </div>

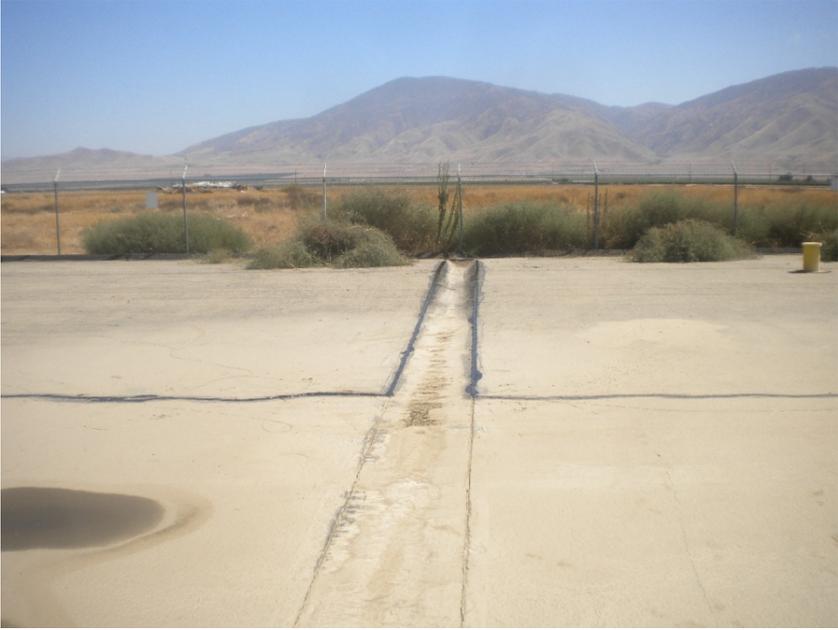
- NRC-7. WEED GROWING AT DRAIN ON EAST SIDE OF NORTH OF PWB-1.
- NRC-8. CRACKS 1/4" TO 1/2" ALONG TRENCH CUT 150' AND EXTENDING WEST 10'.
- NRC-9. CRACKS 1/4" TO 1/2" ALONG TRENCH CUT APPROXIMATELY 60' NORTHEAST.

PHOTO NO: NRC-7 LOCATION: Non-RCRA Cap Map Location Number: NRC-7 DESCRIPTION: Removed weeds and sealed cracks.

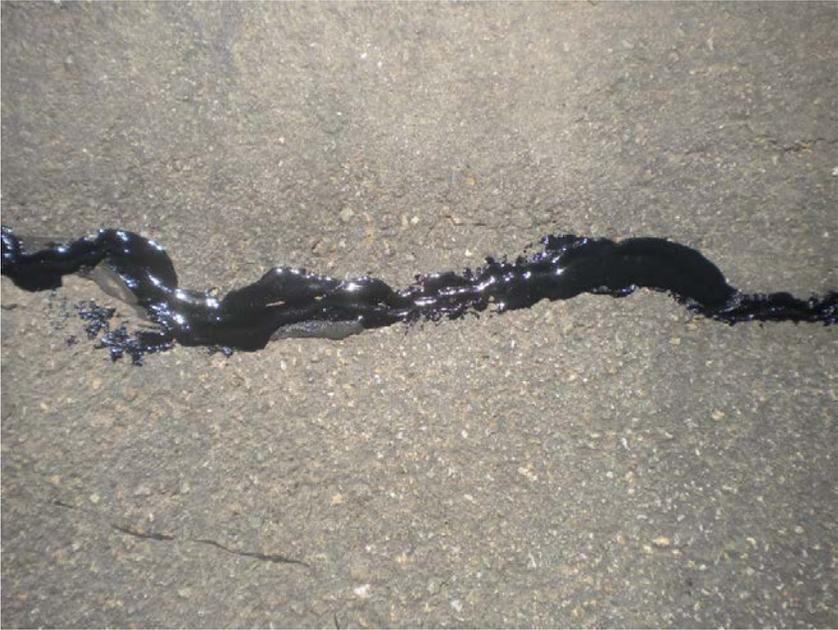
PHOTO NO: NRC-8 LOCATION: Non-RCRA Cap Map Location Number: NRC-8 DESCRIPTION: Removed weeds and sealed cracks.

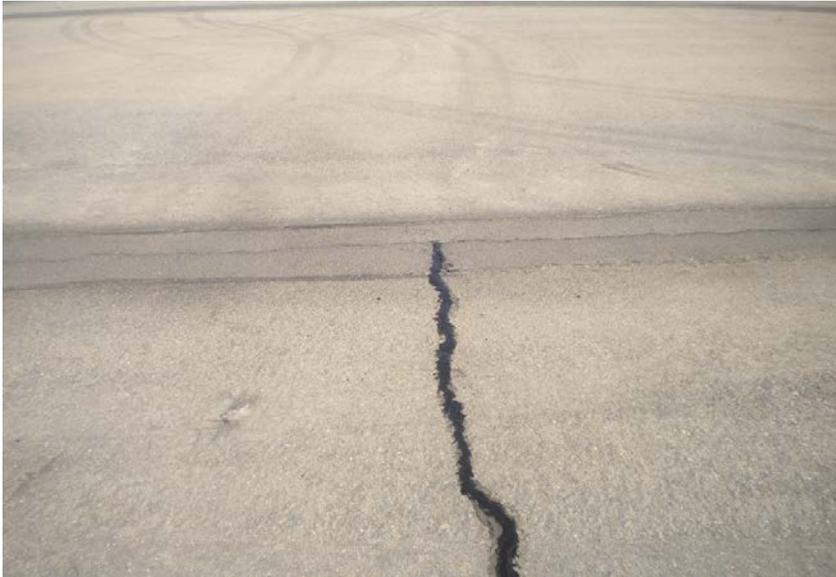
PHOTO NO: NRC-9 LOCATION: Non-RCRA Cap Map Location Number: NRC-9 DESCRIPTION: Sealed cracks.

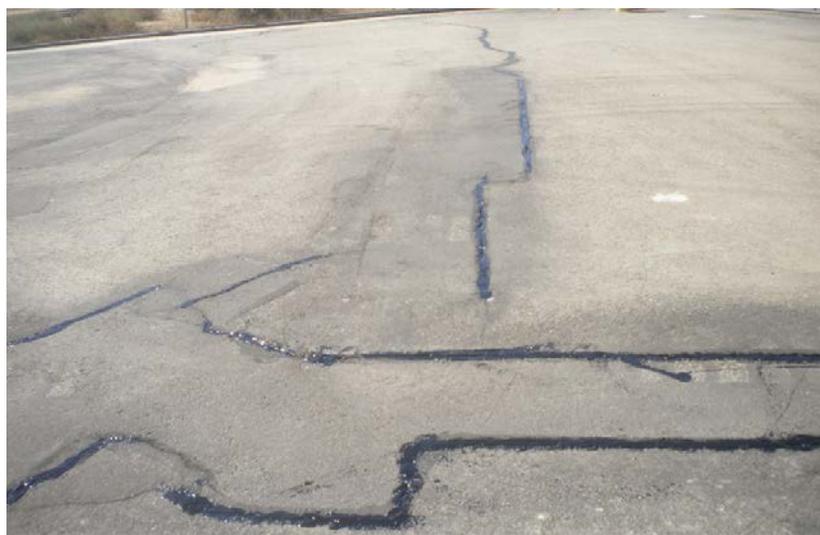
- NRC-10. CRACKS 1/4" TO 1/2" ALONG TRENCH CUT APPROXIMATELY 20' APPROXIMATELY 90' WEST OF EAST FENCE.
- NRC-11. WEEDS GROWING IN CRACKS.
- NRC-12. CRACKS 1/4" TO 1/2" ALONG TRENCH CUT APPROXIMATELY 20'.

PHOTO NO: NRC-10 LOCATION: Non-RCRA Cap Map Location Number: NRC-10 DESCRIPTION: Sealed cracks.

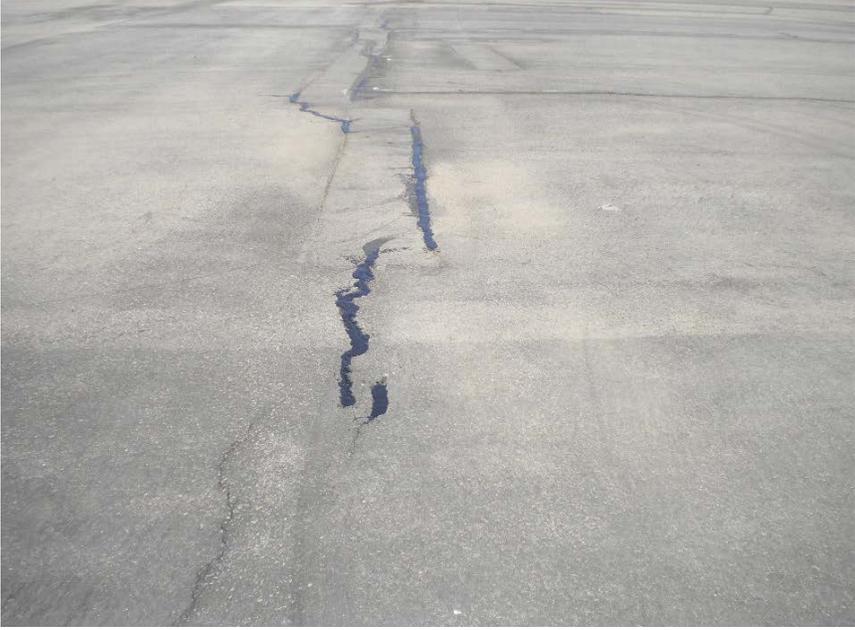
PHOTO NO: NRC-11 LOCATION: Non-RCRA Cap Map Location Number: NRC-11 DESCRIPTION: Removed weeds and sealed cracks.

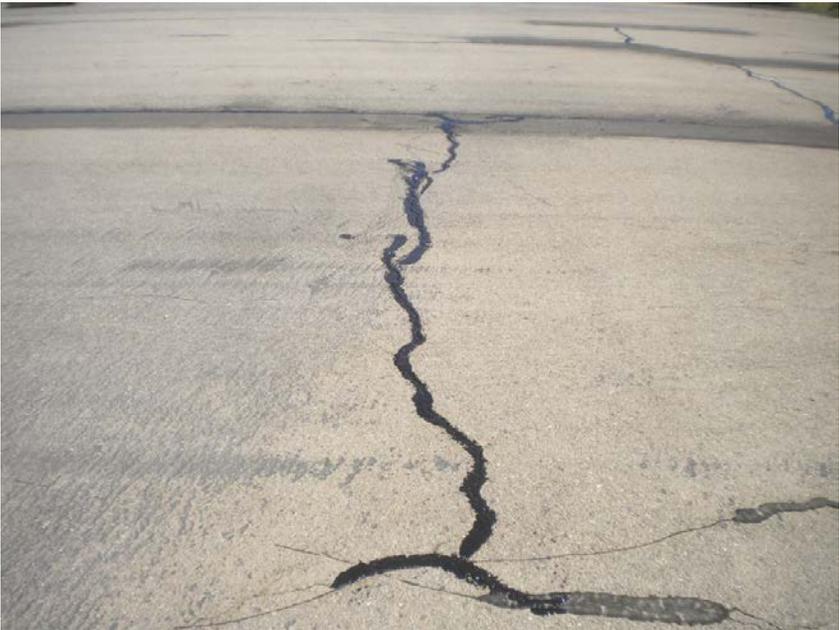
PHOTO NO: NRC-12 LOCATION: Non-RCRA Cap Map Location Number: NRC-12 DESCRIPTION: Sealed cracks.

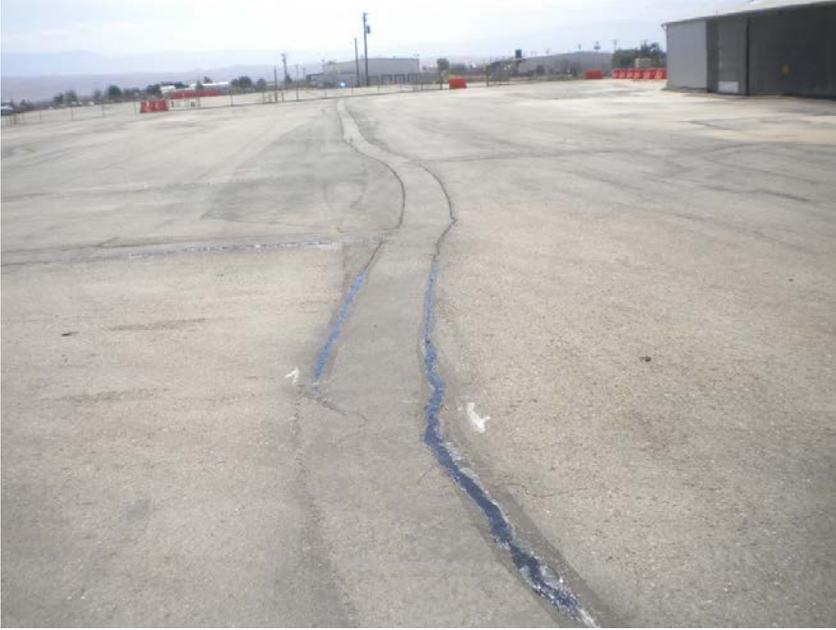
- NRC-13. CRACKS 1/4" TO 1/2" ALONG TRENCH CUT FROM NORTH GATE TO RCRA CAP.
- NRC-14. CRACK 1/4" TO 3/8" APPROXIMATELY 80' LONG.

PHOTO NO: NRC-13
		LOCATION: Non-RCRA Cap Map Location Number: NRC-13
		DESCRIPTION: Sealed cracks.

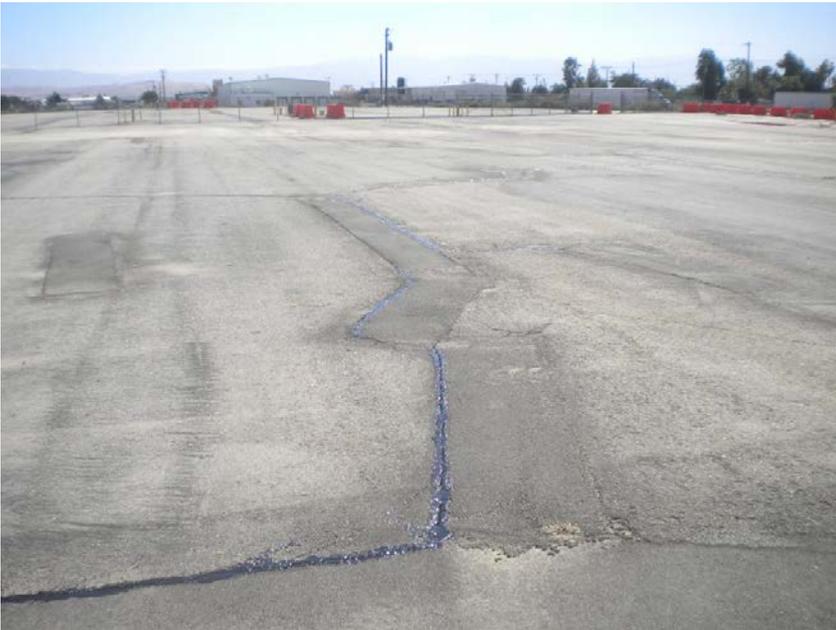
PHOTO NO: NRC-14
		LOCATION: Non-RCRA Cap Map Location Number: NRC-14
		DESCRIPTION: Sealed cracks.

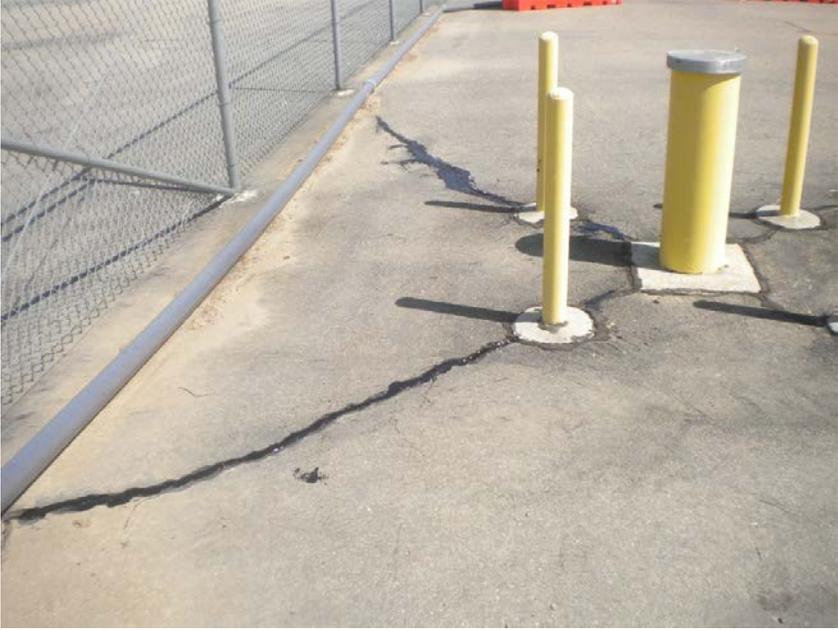
- RC-1. CRACKS APPROXIMATELY 1/4" TO 1/2" AROUND WELL MONUMENT AND BALLARDS EXTENDING APPROXIMATELY 8' NORTHWEST AND NORTHEAST.
- RC-2. CRACKS 1/4" TO 3/8" EXTENDING SOUTH OF WELL TO END OF CAP.

PHOTO NO: RC-1 LOCATION: RCRA Cap Map Location Number: RC-1 DESCRIPTION: Sealed cracks.

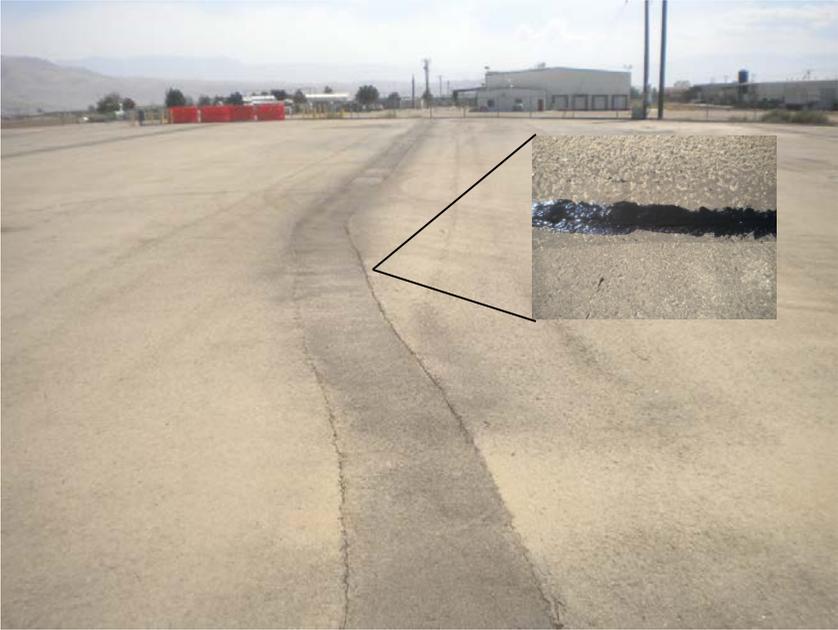
RC-2	Cracks 1/4 to 3/8 inch wide extending south of well to end of cap.	Sealed crack with sealant that meets Caltrans Specifications for Crack Treatment Section 37-5 (Caltrans, 2010).
RC-3	Cracks 1/4 to 3/8 inch wide extending west to approximately mid-point of cap.	Sealed crack with sealant that meets Caltrans Specifications for Crack Treatment Section 37-5 (Caltrans, 2010).
RC-4	Failure of surface completion at CP-3.	Sealed completion sealant that meets Caltrans Specifications for Crack Treatment Section 37-5 (Caltrans, 2010).
RC-5	Cracks 1/4 to 1/2 inch wide extending from northwest tank pad to fence, approximately 80 feet along perimeter trench cuts.	Sealed crack with sealant that meets Caltrans Specifications for Crack Treatment Section 37-5 (Caltrans, 2010).
RC-6	Cracks 1/4 to 1/2 inch wide extending west, approximately 80 feet.	Sealed crack with sealant that meets Caltrans Specifications for Crack Treatment Section 37-5 (Caltrans, 2010).

PHOTO NO: RC-2 LOCATION: RCRA Cap Map Location Number: RC-2 DESCRIPTION: Sealed cracks.
