CAP REPAIR SUMMARY REPORT

**BROWN & BRYANT, ARVIN FACILITY
SUPERFUND SITE, FIRST OPERABLE UNIT
REMEDIAL ACTION**

ARVIN, CALIFORNIA

October 2015

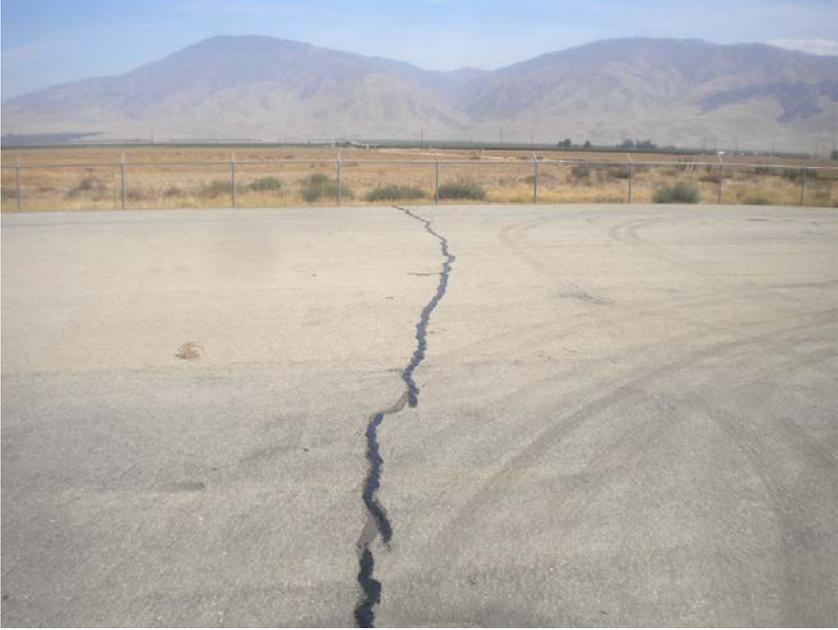
- RC-3. CRACKS 1/4" TO 3/8" EXTENDING WEST APPROXIMATELY MID POINT OF CAP.
- RC-4. FAILURE OF SURFACE COMPLETION AT CP-3
- RC-5. CRACKS 1/4" TO 1/2" EXTENDING FROM NORTHWEST TANK PAD TO FENCE APPROXIMATELY 80' ALONG PERIMETER OF TRENCH CUTS.

PHOTO NO: RC-3 LOCATION: RCRA Cap Map Location Number: RC-3 DESCRIPTION: Sealed cracks.

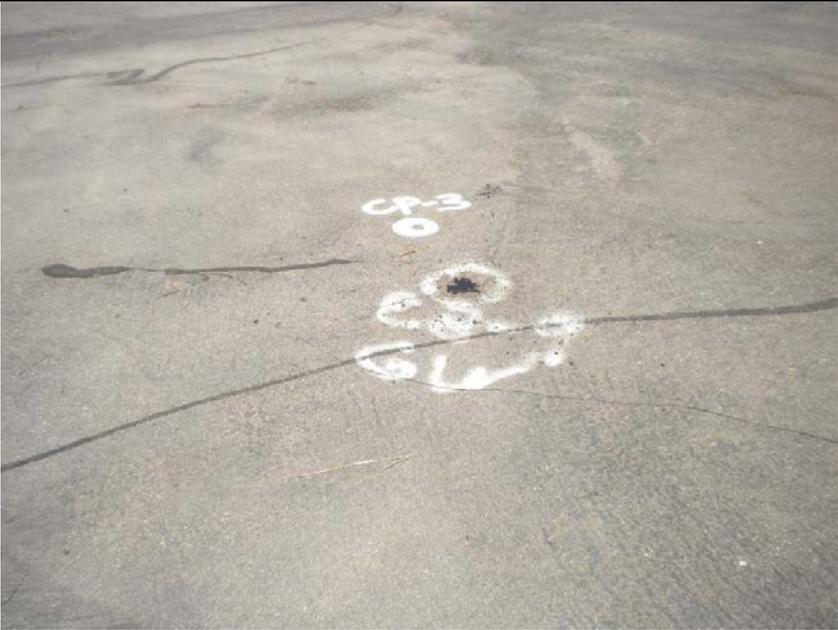
PHOTO NO: RC-4 LOCATION: RCRA Cap Map Location Number: RC-4 DESCRIPTION: Sealed surface completions.

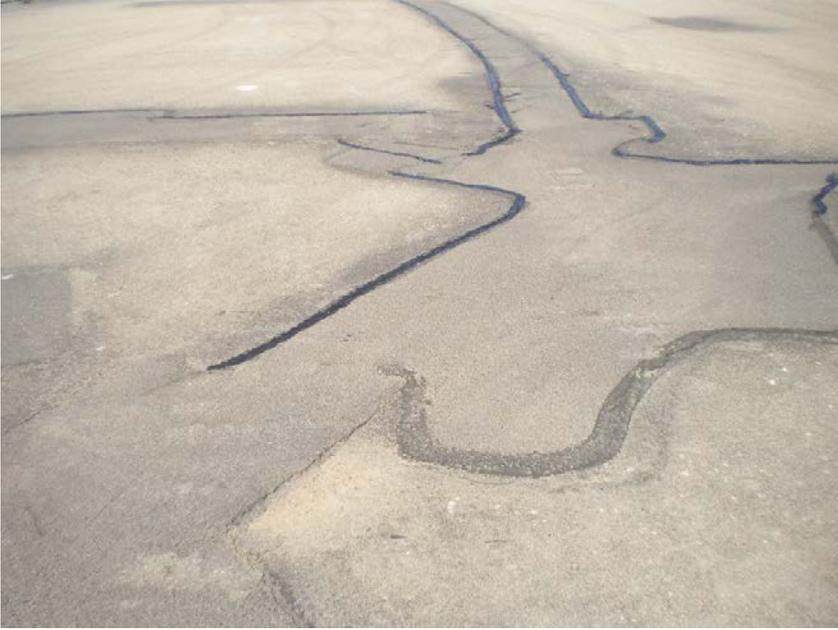
PHOTO NO: RC-5
		LOCATION: RCRA Cap Map Location Number: RC-5
		DESCRIPTION: Sealed cracks.

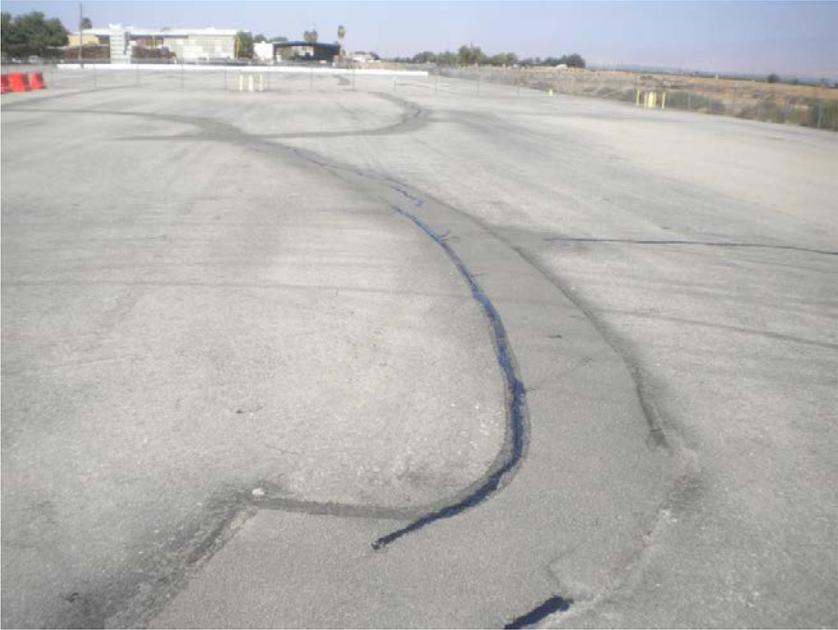
- RC-6. CRACKS 1/4" TO 1/2" EXTENDING WEST APPROXIMATELY 80'.
- RC-7. CRACKS 1/4" TO 3/8" EXTENDING SOUTH TO MW-3.
- RC-8. CRACKS 1/4" TO 3/8" FROM EW-2 TO MW-2 EXTENDING NORTHEAST.

PHOTO NO: RC-6
		LOCATION: RCRA Cap Map Location Number: RC-6
		DESCRIPTION: Sealed cracks.

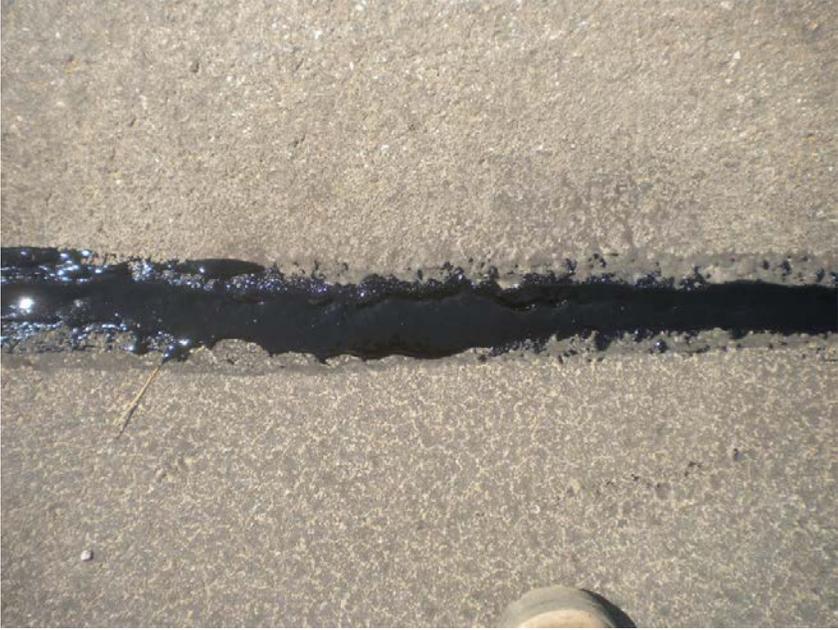
RC-7	Cracks 1/4 to 1/2 inch wide extending south to MW-3.	Sealed crack with sealant that meets Caltrans Specifications for Crack Treatment Section 37-5 (Caltrans, 2010).
RC-8	Cracks 1/4 to 3/8 inch wide from EW-2 extending toward MW-2 and approximately 50 feet beyond.	Sealed crack with sealant that meets Caltrans Specifications for Crack Treatment Section 37-5 (Caltrans, 2010).
RC-9	Cracks 1/4 to 3/8 inch wide extending north along trench cuts.	Sealed crack with sealant that meets Caltrans Specifications for Crack Treatment Section 37-5 (Caltrans, 2010).
RC-10	Cracks 1/4 to 3/8 inch wide extending north along the east side of the cap and down slope along trench cuts.	Sealed crack with sealant that meets Caltrans Specifications for Crack Treatment Section 37-5 (Caltrans, 2010).

PHOTO NO: RC-7
		LOCATION: RCRA Cap Map Location Number: RC-7
		DESCRIPTION: Sealed cracks.

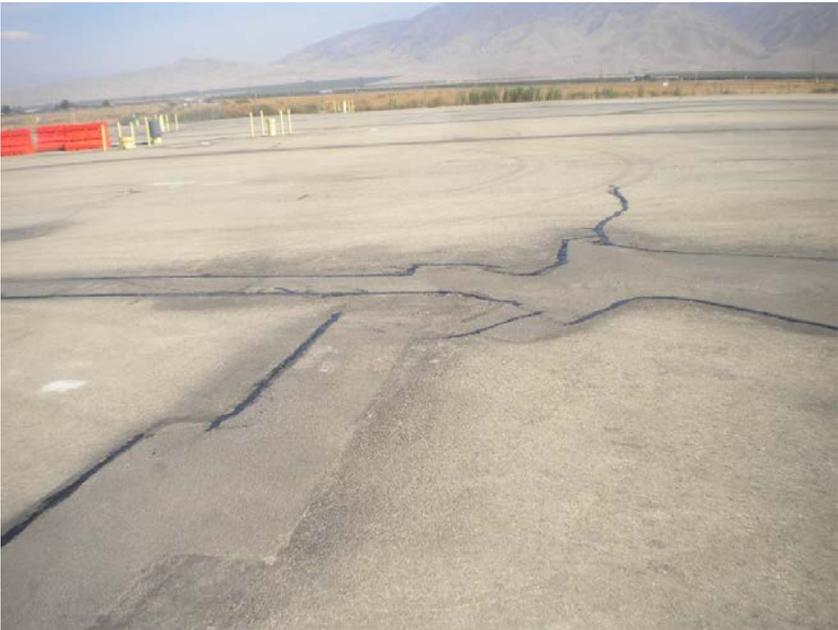
PHOTO NO: RC-8
		LOCATION: RCRA Cap Map Location Number: RC-8
		DESCRIPTION: Sealed cracks.

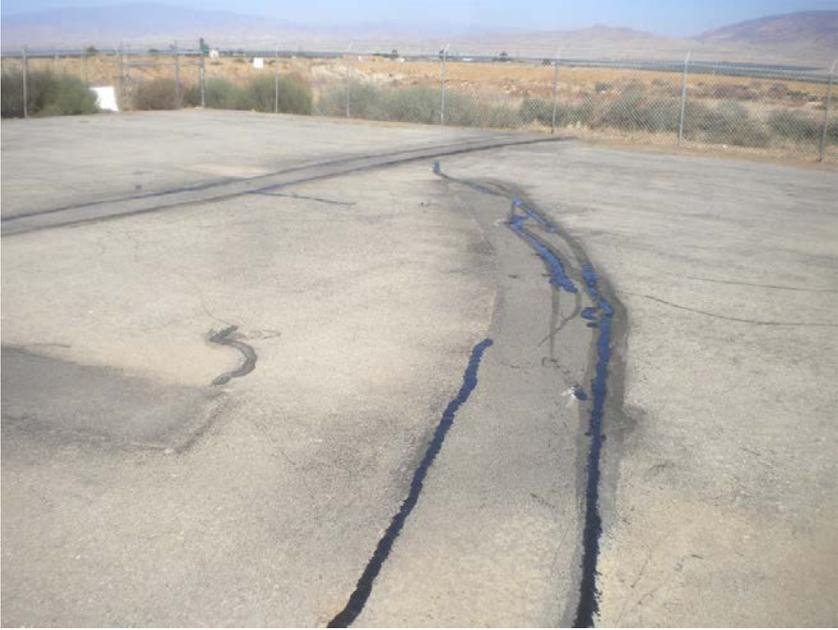
- RC-9. CRACKS 1/4" TO 3/8" EXTENDING NORTH ALONG TRENCH CUTS.
- RC-10. CRACKS 1/4" TO 3/8" EXTENDING NORTH ALONG EAST SIDE OF CAP AND DOWN SLOPE AND ALONG TRENCH CUTS.

PHOTO NO: RC-9 LOCATION: RCRA Cap Map Location Number: RC-9 DESCRIPTION: Sealed cracks.

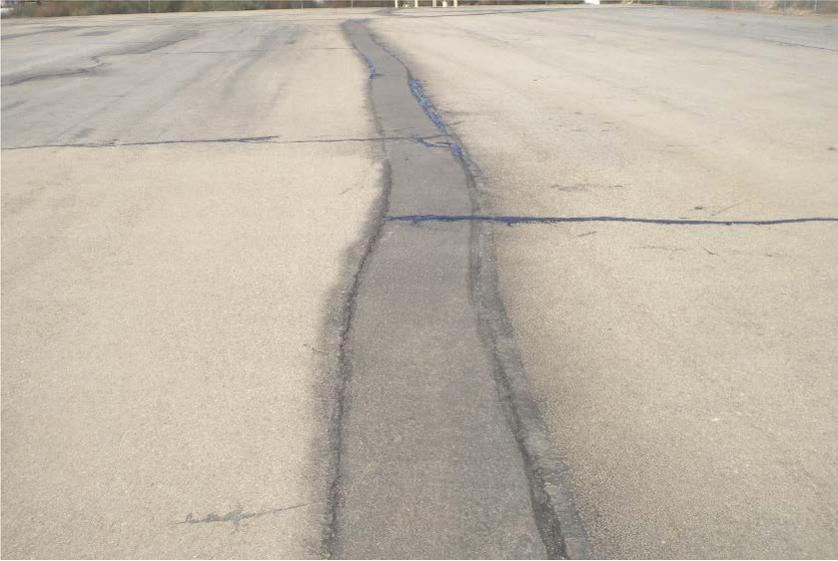
PHOTO NO: RC-10 LOCATION: RCRA Cap Map Location Number: RC-10 DESCRIPTION: Sealed cracks.

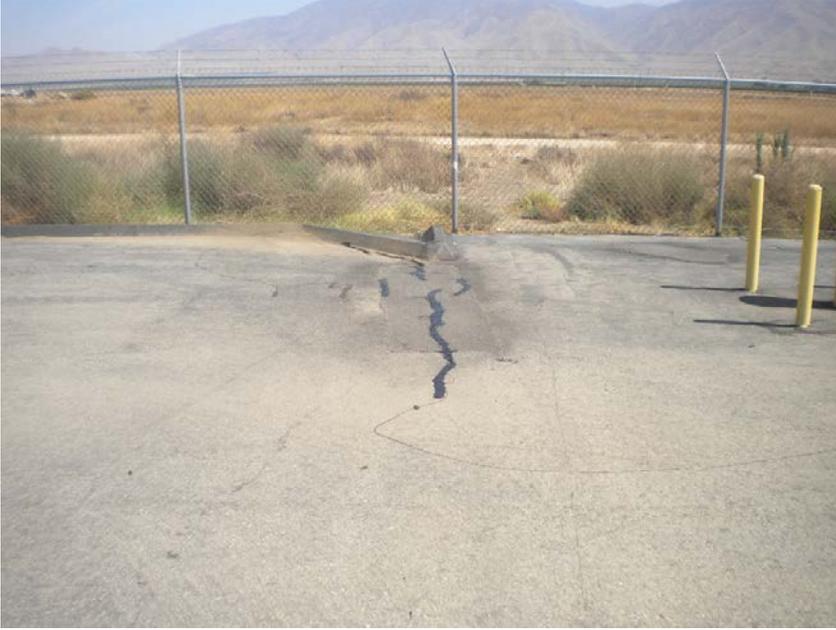
Finding Identifier	Description of Finding	Completed Repairs
RC-11	Cracks 1/2 to 1 inch wide in the northeast corner of the RCRA cap, approximately 25 feet long.	Sealed crack with sealant that meets Caltrans Specifications for Crack Treatment Section 37-5 (Caltrans, 2010).
RC-12	Cracks 3/8 to 1/2 inch wide along well IW-2 and bollards.	Sealed crack with sealant that meets Caltrans Specifications for Crack Treatment Section 37-5 (Caltrans, 2010).

- RC-11. CRACKS 1/2" TO 1" IN NORTH EAST CORNER APPROXIMATELY 25'.
- RC-12. CRACKS 3/8" TO 1/2" AROUND WELL IW-2 AND BOLLARDS.

PHOTO NO: RC-11 LOCATION: RCRA Cap Map Location Number: RC-11 DESCRIPTION: Sealed cracks.

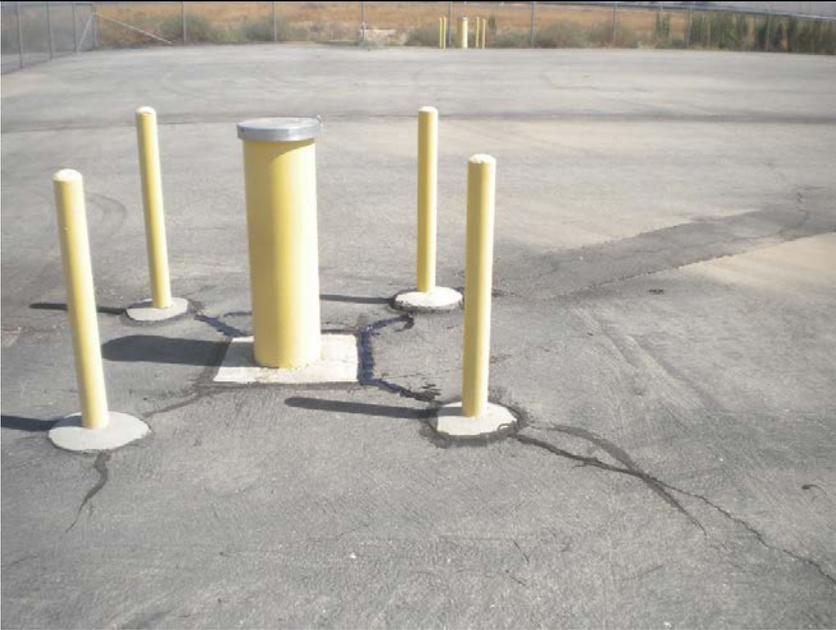
PHOTO NO: RC-12 LOCATION: RCRA Cap Map Location Number: RC-12 DESCRIPTION: Sealed cracks.
