**Attachment I  
Site Inspection Report  
for  
Brown and Bryant Superfund Site  
Arvin, California**

**August 2006**

## **Brown and Bryant Superfund Site Second Five-Year Review**

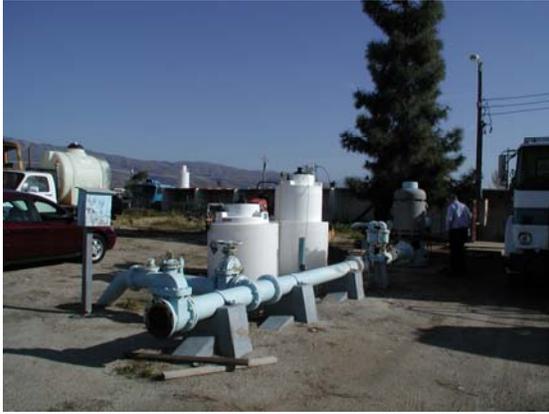
1. City Well Number 1, CW-1

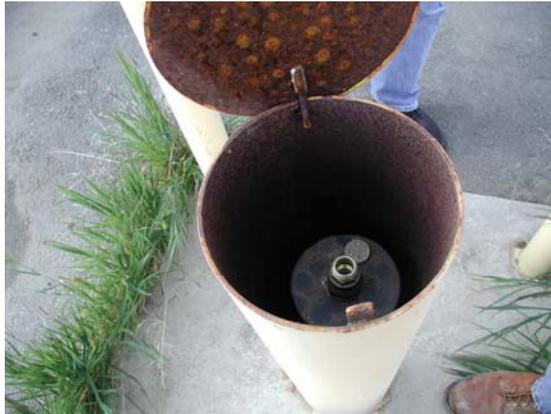
3. Typical Well Equipped with Barcad Sampling System, note weeds at Pad

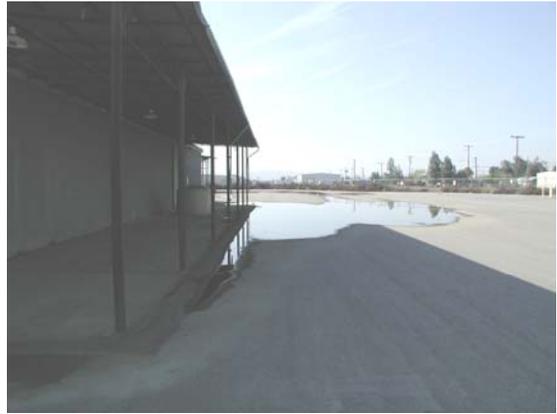
Ponding at the interior of the cover is attributed to settlement while the large ponded area (approximately 100' x 200') on the east-central portion of the cover is due primarily to the primary outlet becoming blocked. The blockage occurs when the adjacent land owner grades the area next to the west security fence to prevent flooding an unimproved road. Optional outlet configurations are being evaluated by the USACE to allow water to drain from the cover even when grading activities similar to past practices are repeated. Additional ponding occurs west of the site warehouse in the west-central portion of the site. The warehouse on site is a "low-point" and water ponds against low asphalt berms constructed on the west side of the warehouse.

4. Area of Pounded Water on the West Side of Existing Building

The USACE construction manager indicated the current grades at the site are very flat and the easiest way to eliminate the interior ponding will require placing a top coat of asphalt and sand of adequate depth over the existing cover (rather than remove and replace the existing asphalt cover) while patching the cracks identified on the USACE crack surveys. The overlay will be of varying depth across the site, but will attempt to direct flow off the cap, eliminating the ponding and resulting infiltration. A new survey of the current conditions will be done this FY to; determine the existing grades over the site, used as a basis for designing the new drainage patterns, and determine the cost for the new overlay and other drainage improvements.

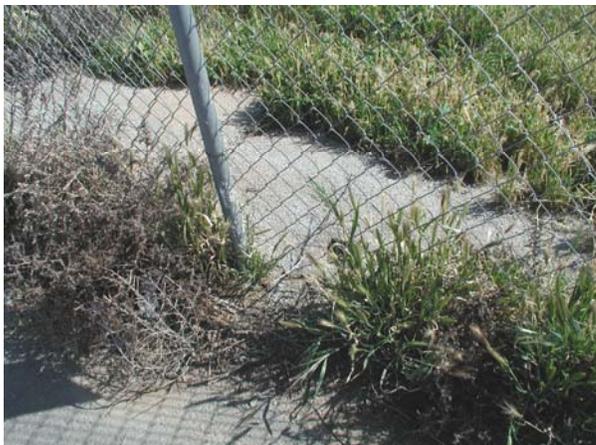
There were approximately 4 locations where rodents had burrowed into the soil adjacent to the cap, but did not penetrate the cover or burrow beneath. A temporary ant infestation was also noted by the USACE Inspector in the RCRA cap next to a power pole anchor but is no longer present. The integrity of cap due to these actions has not been compromised.

5. Evidence of burrowing under fence

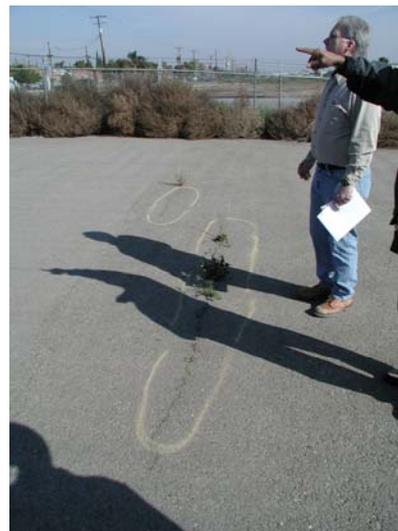
Cracking present in the cap may have occurred due to several factors, settlement in the soil beneath the cap, result of expansion and contraction cycles, or as a result of the magnitude 3.4 earthquake centered in the foothills north east of the site that occurred last year. To ensure the cracking did not occur as a result of the earthquake, Rick Lainhart surveyed the cap and documented the area and length of the cracks by spray painting the extent of the cracks and taking a digital image of each on six month intervals. The cracks have been propagating since the initial survey. The USACE has identified some options to fix the cracks concurrently with the ponding that occurs on the cap.

2.	<b>Cracks</b> ✓ Location shown on site map <input type="checkbox"/> Cracking not evident Lengths <u>varies</u> Widths <u>≤ 1/4"</u> Depths <u>unknown</u> Remarks <u>Several locations on non RCRA- cover and near large tank on RCRA capped area and at change in slope on S &amp; E side of RECRA CAP</u>

6. Example of Cracking in Non RCRA Cap

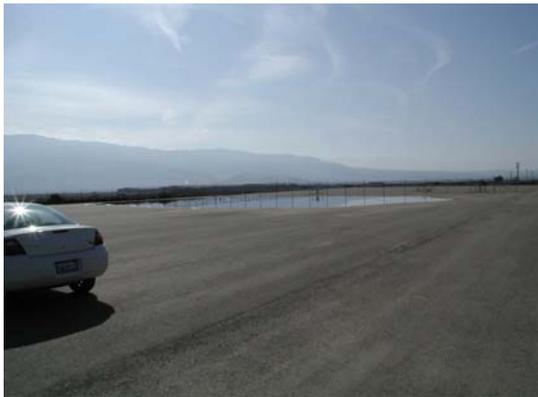
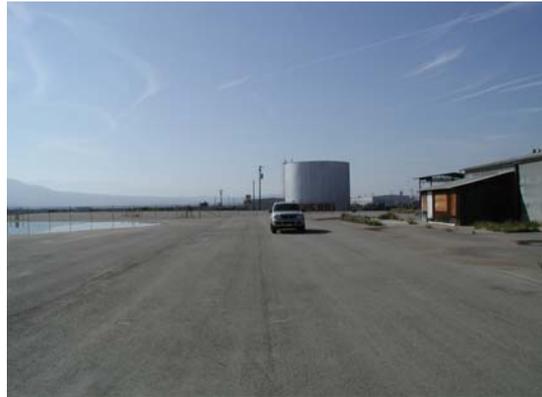
1.	<b>Settlement</b> (Low spots) 50-150    ✓ Location shown on site map <input type="checkbox"/> Settlement not evident Areal extent <u>100 x 200</u> Depth <u>6"</u> Remarks <u>Large area of standing waters- 2 major area west of warehouse. The second larger area on the southern part of non RCRA Cover on the east 1/2 of the site</u>

7. and 8. Ponding present on non RCRA portion of the Cap East of the Existing Buildings  
Looking south

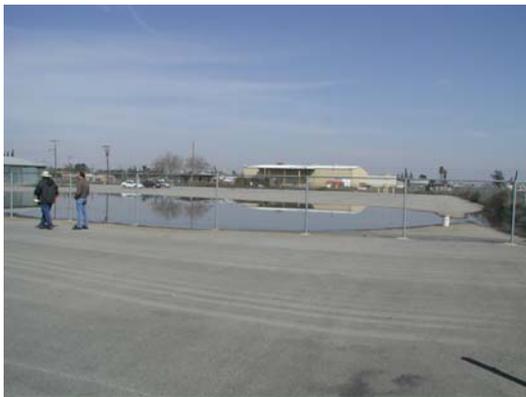
9. Ponding on Non-RCRA cap seen in photo 7  
Looking north

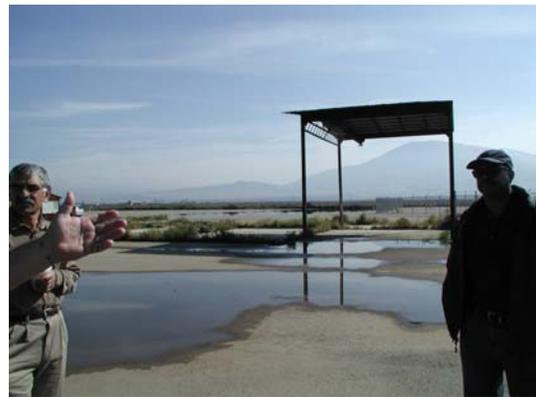
10. Ponding on Non-RCRA cap south of  
Formulation building, west of area  
Shown in photos 7 and 8

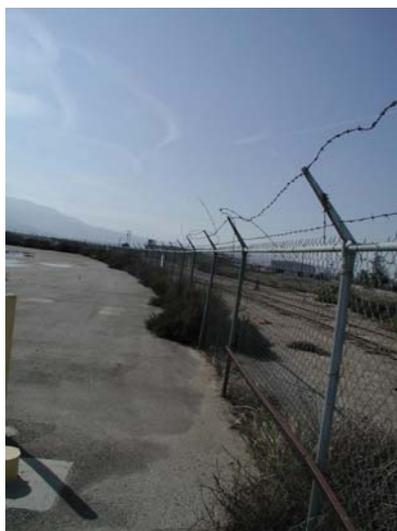
The barbed wire on the fence outriggers (at the Brown and Bryant site inriggers) is broken in several places on the west and north sides of the site, and should be repaired. Overall site security appears adequate with a single access point to the site equipped with a lock. The short period of time before the barbed wire is repaired should not impact security. There have been no reports of vandalism at the site. The fence was originally installed to keep children from playing on the site prior to placement of the asphalt cover.

11. Damaged fencing on West Side  
Of Site

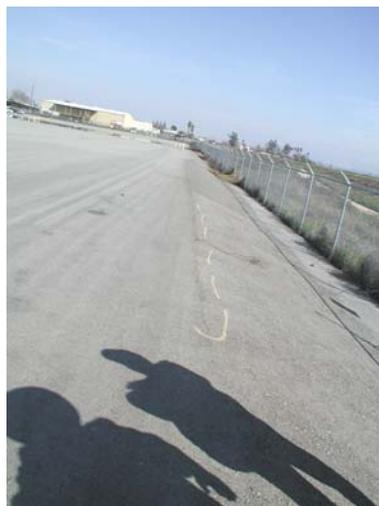
12. Cracking on east side of RCRA Cap

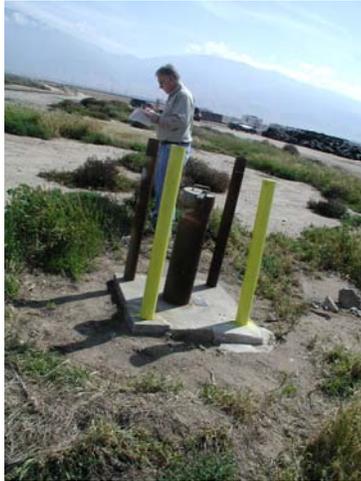
One monitoring well (PWB-2) south of the site was damaged as a result of a grader blade hitting the casing. The well has been repaired and protective bollards placed around the well. In an effort to make the casing and bollards more visible, they were painted bright yellow. The Construction Inspector is in the process of painting all above grade well casings and bollards yellow to improve visibility, and replace the locks on the wells to ensure they are always secured following sampling activities. Monitoring well PWB-7 south of the site was replaced in January, 2006 with a new well PWB-7A, after it was discovered the PWB-7 casing was cracked. Well PWB-7 was abandoned in accordance with state regulations. A significant number of monitoring wells were found to be unlocked and/or unlabelled. Most wellheads were in good shape, though a number of the protective casings are in need of paint. All but two monitoring wells were inspected and observations are provided in the following table.

13. Repair to MW damaged by Grading blade
