# **First Five-Year CERCLA Review of Seven Naval Computer and Telecommunications Area Master Station Pacific National Priorities List Sites**

**JOINT BASE PEARL HARBOR-HICKAM, LUALUALEI  
ANNEX AND WAHIAWA ANNEX, OAHU, HAWAII**

**NCTAMS PAC National Priorities List Site**

February 2015

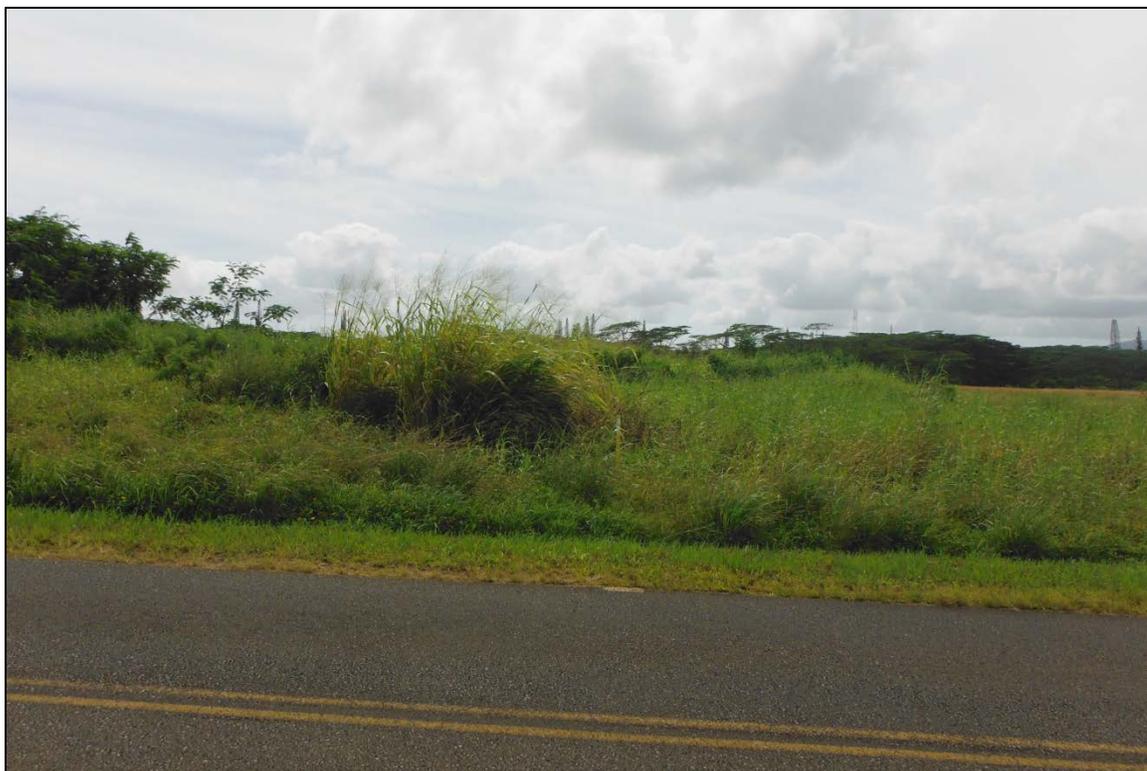
Photograph No. 6: View looking south towards S-17 LUC area from Polaris Drive. A faded yellow post and marking on the road denote the location of the S-17 site.

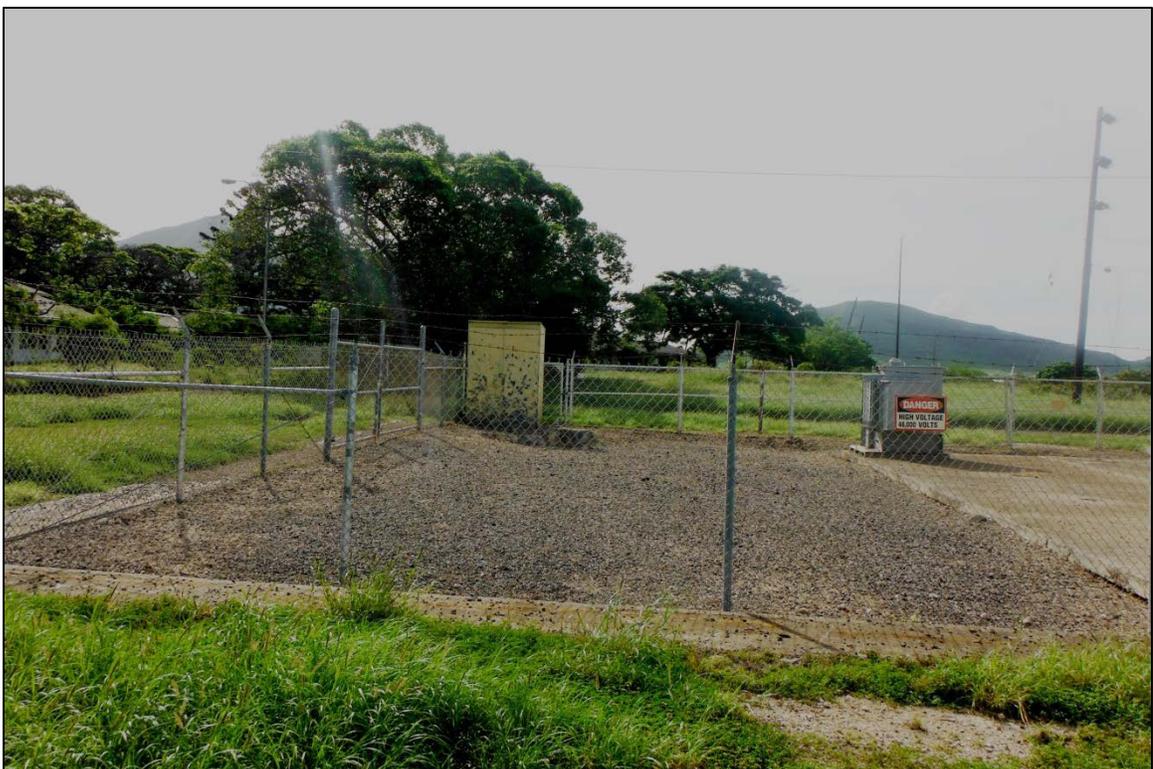
Photograph No. 12: View of exposed coral gravel fill on east part of the LUC area at transformer site S-26. Photo looking south.

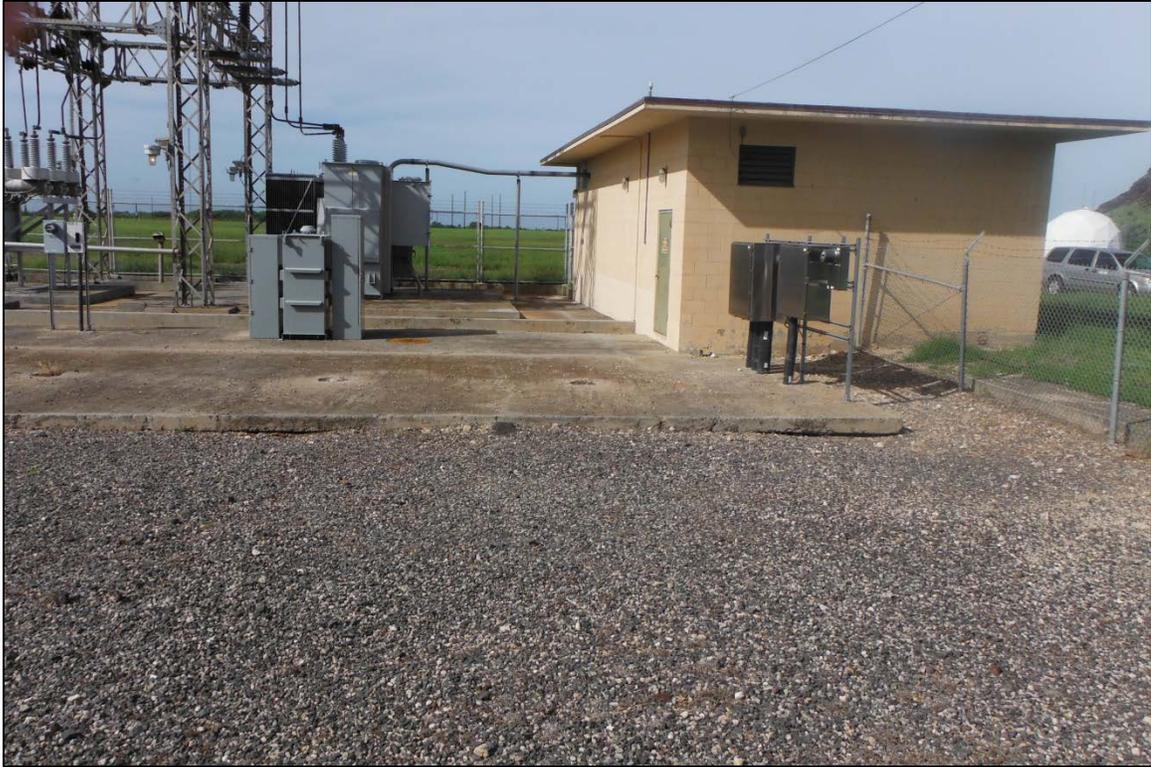
Photograph No. 13: View of concrete covered west part of S-26 LUC area. Note height of coral gravel fill relative to the concrete pad to the west and concrete sidewalk to the north. Photo looking west.

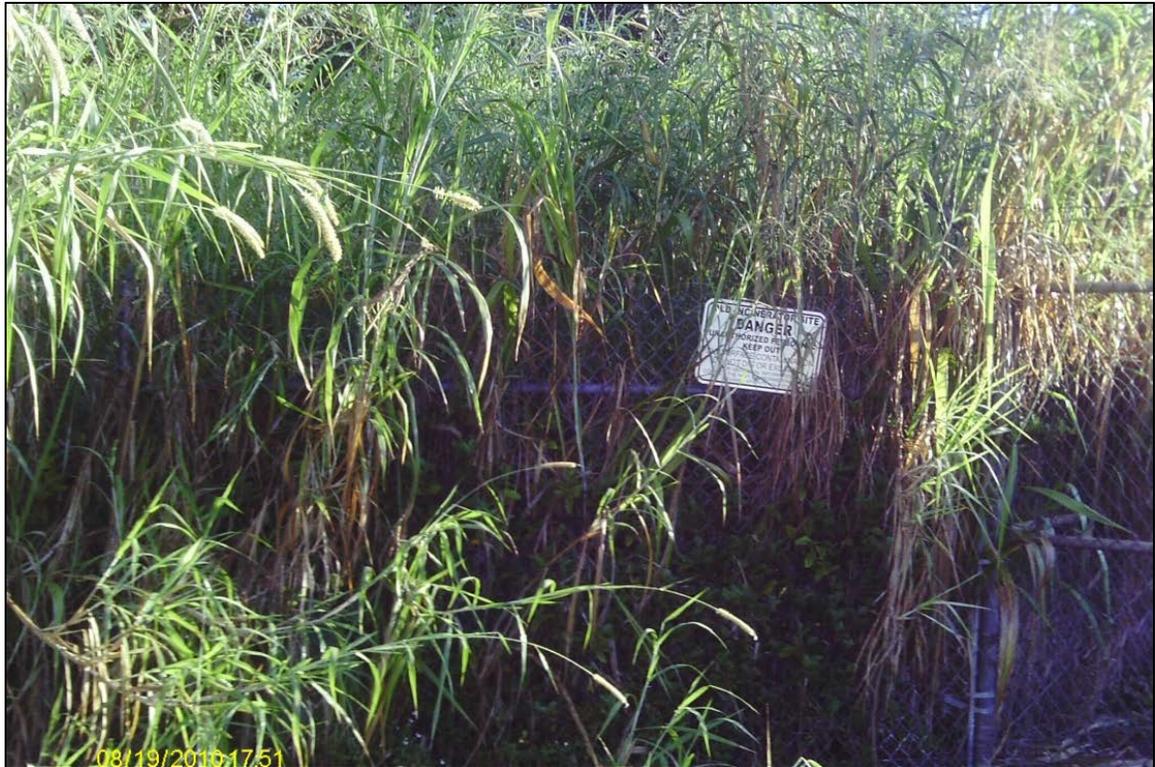
Photograph No. 1: Perimeter fencing with Sign 10 obscured by vegetation, looking northeast. Photographed by ERRG.

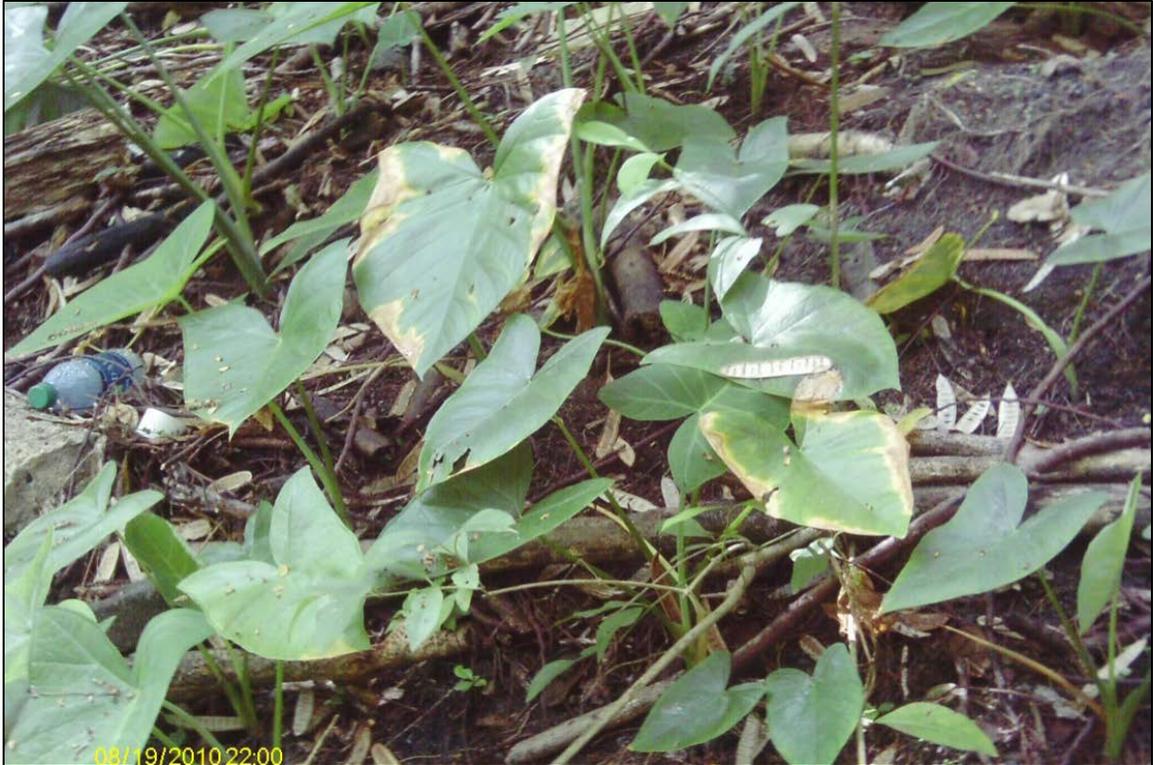
Photograph No. 3: Surface debris and ash exposed at surface. Photo looking southwest.  
Photographed by ERRG.

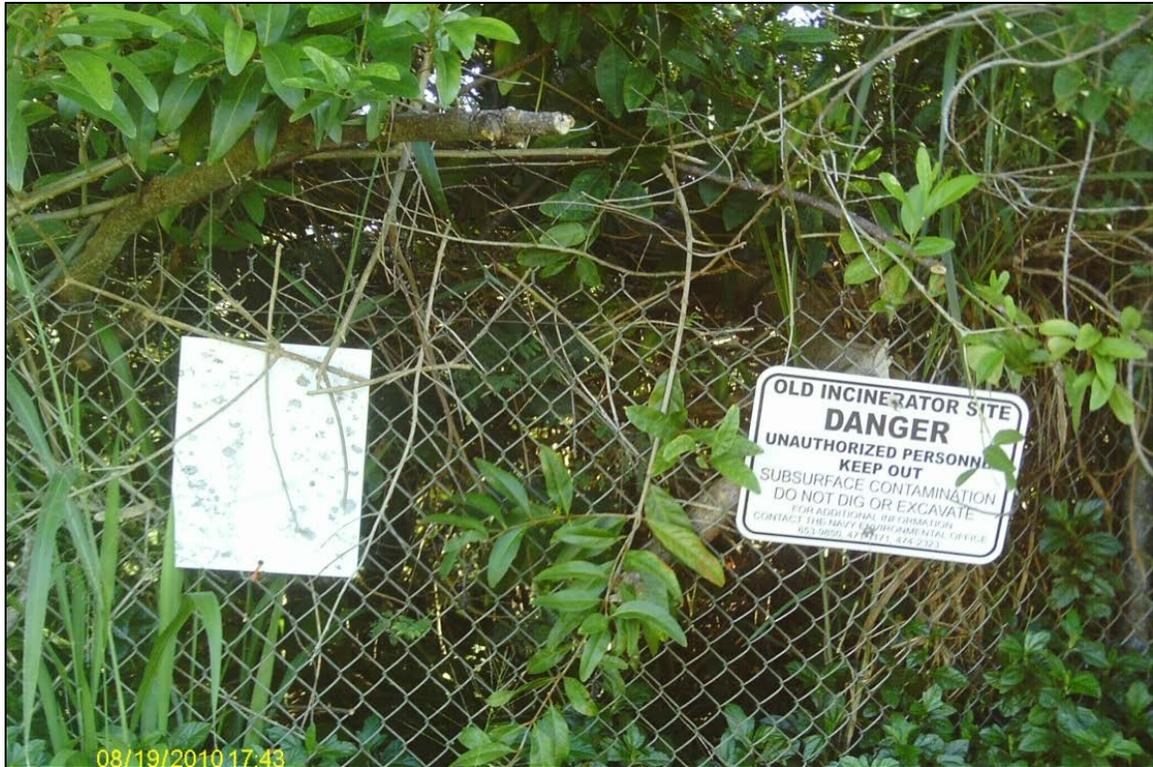
Damaged perimeter fence near Sign S-9.	Replace damaged fence near Sign S-9.	No later than the subsequent LTM event	
If feral pig rooting were to occur within the OIS LUC boundary, subsurface soil may become exposed.	Update the LTM Inspection list to include surface soil disturbances resulting from feral pig activities.	No later than the subsequent LTM event	
<b>Old Wahiawa Landfill</b>			
Trespassers continue to access the southern portion of the OWLF LUC area.	Three additional LUC warning signs will be placed around the area where trespassing was previously observed.	No later than the subsequent LTM event	The remedy at the OWLF site is currently protective of human health and the environment, and exposure pathways that could result in unacceptable risks are being controlled. The soil cover should be maintained to prevent future exposure. No changes in land use are expected in the foreseeable future.

Photograph No. 5: Perimeter fencing near Sign 9, damaged but intact, looking north.  
Photographed by ERRG.

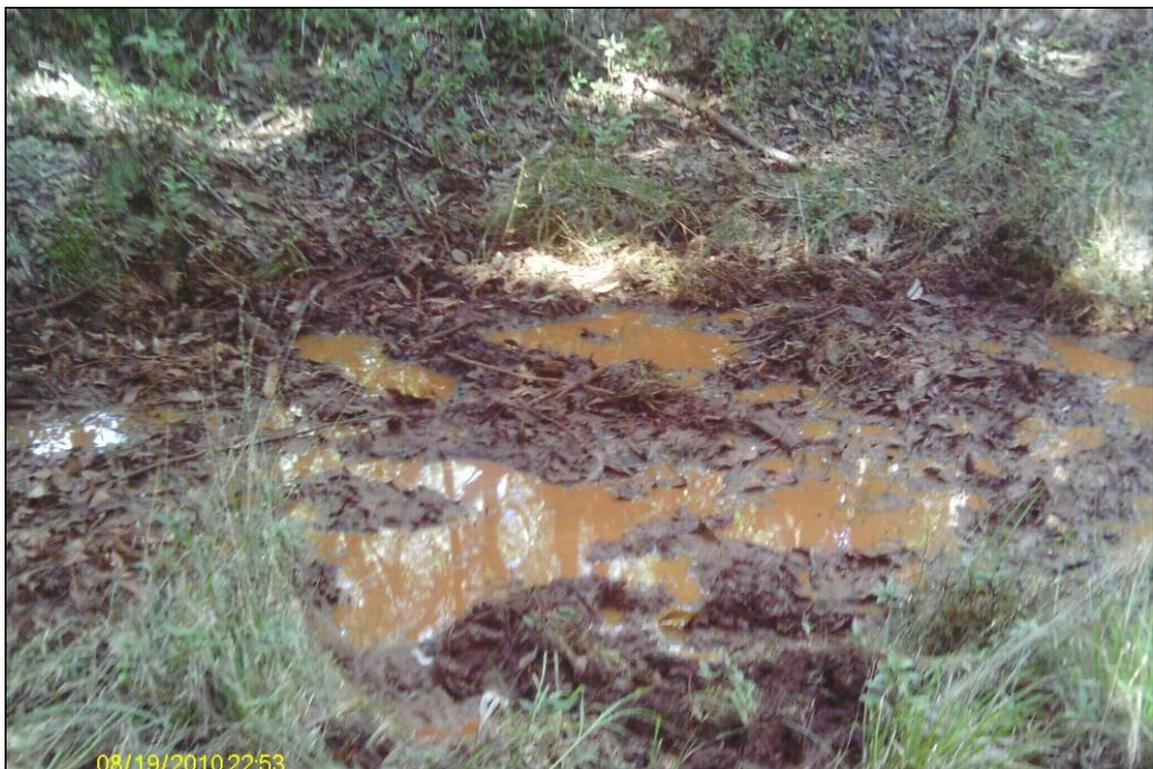
Photograph No. 2: Standing water present near Sign 6. Photo looking south.  
Photographed by ERRG.

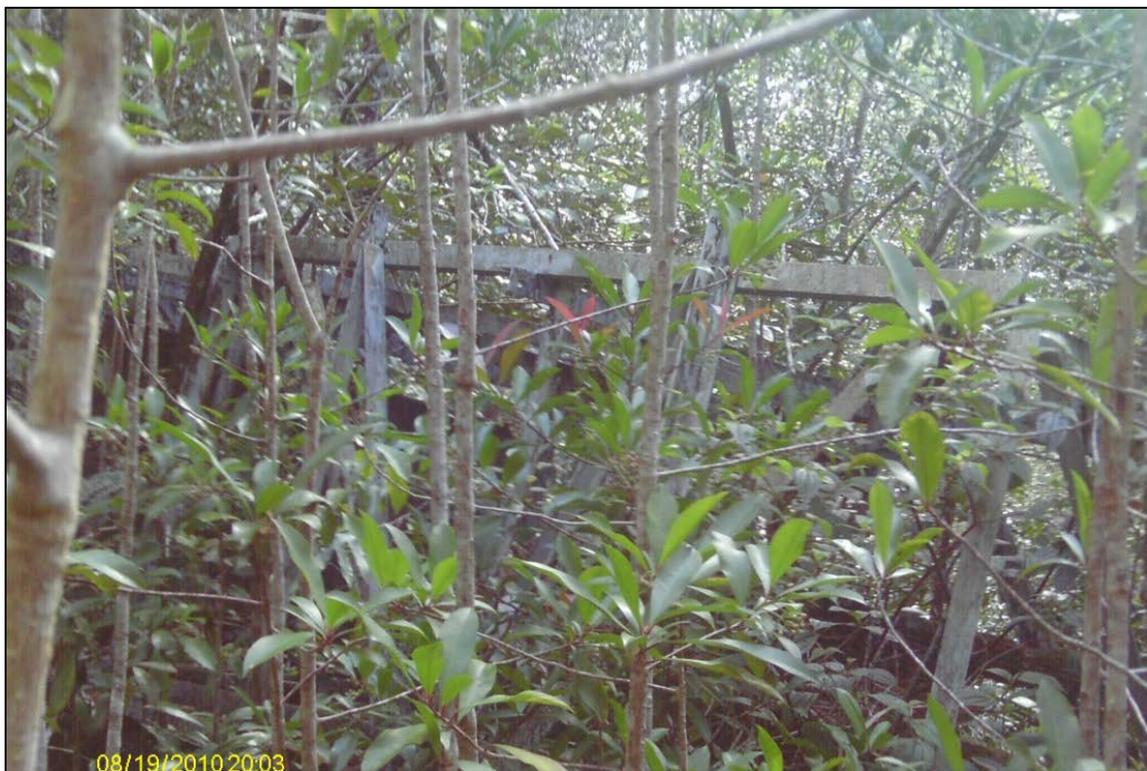
Photograph No. 4: Example of surface debris present throughout the site, looking west.  
Photographed by ERRG.

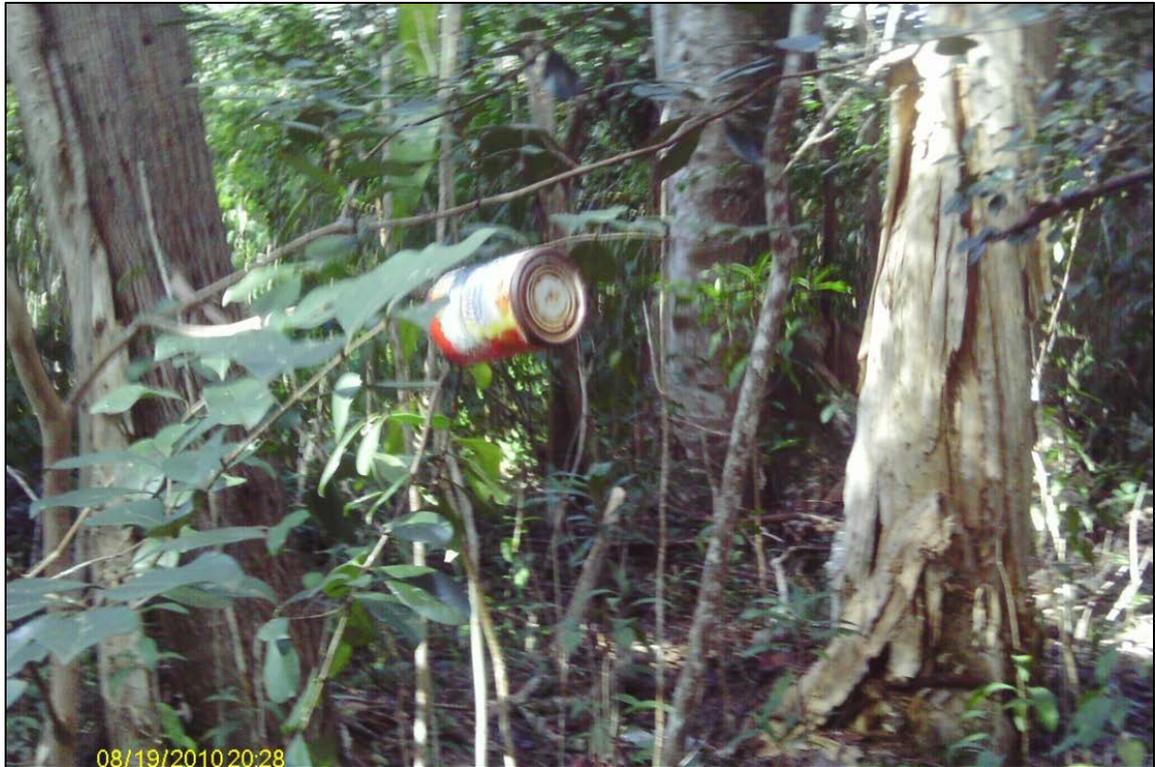
Photograph No. 5: Evidence of trespassing within boundary (can left on branch near Sign 7), looking north. Photographed by ERRG.
