Second Five-Year Review Report

Celtor Chemical Works Superfund Site

**Humboldt County
California**

August 29, 2001

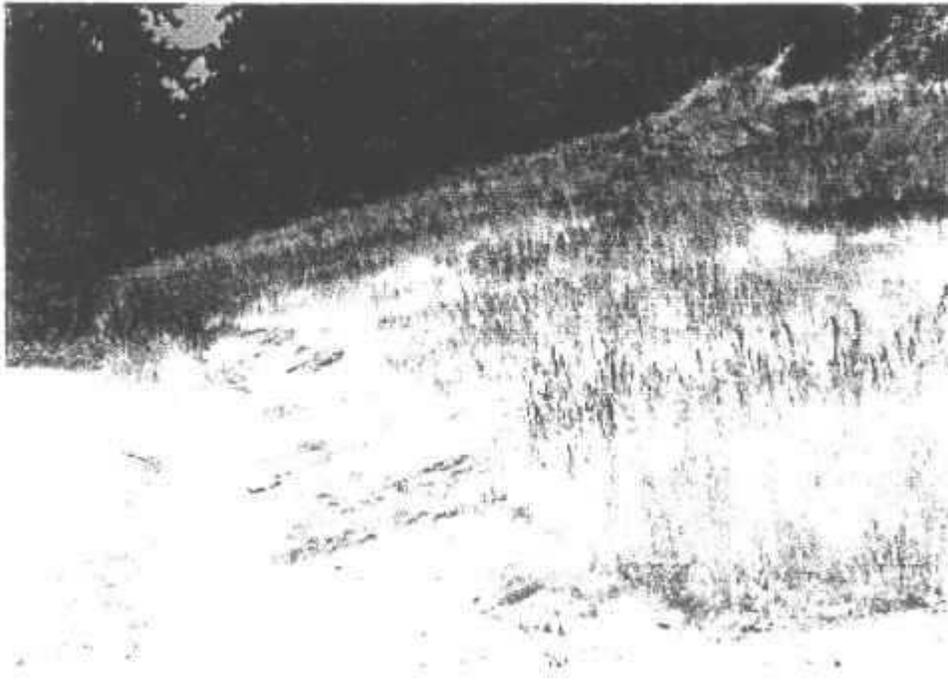
2. The hillside area where salts crystallize: Prior to remediation the Celtor facility was located in this area and was on level ground. Following remediation clean fill was used to create a slope and restore the area to a more natural setting. Salts of unknown origin crystallize in a small patch between the river access road and the base of the hillside during the hot summer months. Sampling of the soil has shown levels above ROD cleanup standards. The salts were not present during the 2001 site visit, but the area where they have been seen was void of any vegetative growth.

Figure 1 Hillside with areas that do not support vegetation (photo taken 1998)

The hillside area where vegetative growth is absent will be sampled by EPA. If elevated levels of ROD contaminants are found, the area will be excavated and backfilled with clean fill. The excavated material will be disposed of appropriately.

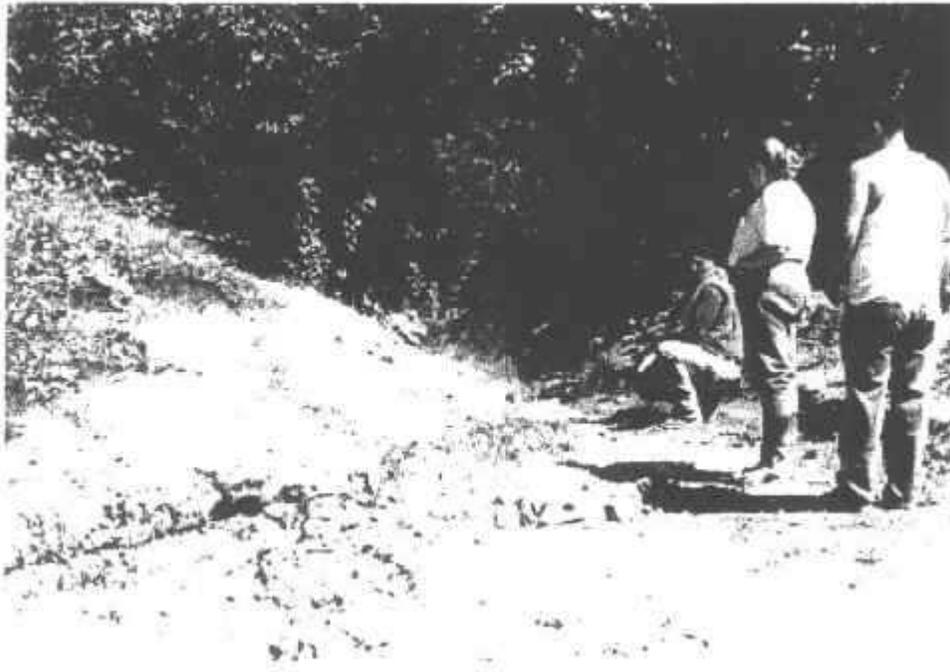
Bob Ulibari spoke of a seep located adjacent to the site that occasionally is an orange tint. The seep discharges into a drainage ditch that ultimately discharges to the Trinity River. Currently EPA has no data on the water from the seep, and no visual confirmation has been made by EPA of the seep having an orange color. The drainage ditch the seep discharges into has been sampled, and no elevated levels of contaminants have been detected. There is no evidence of an unknown source of contamination at the site that would contribute to this seep, or be the cause of the water turning orange. As mentioned before, the area in general is highly mineralized, and the colored seep could be a natural occurrence.

Figure 2 End of drainage ditch (photo taken in 1998)

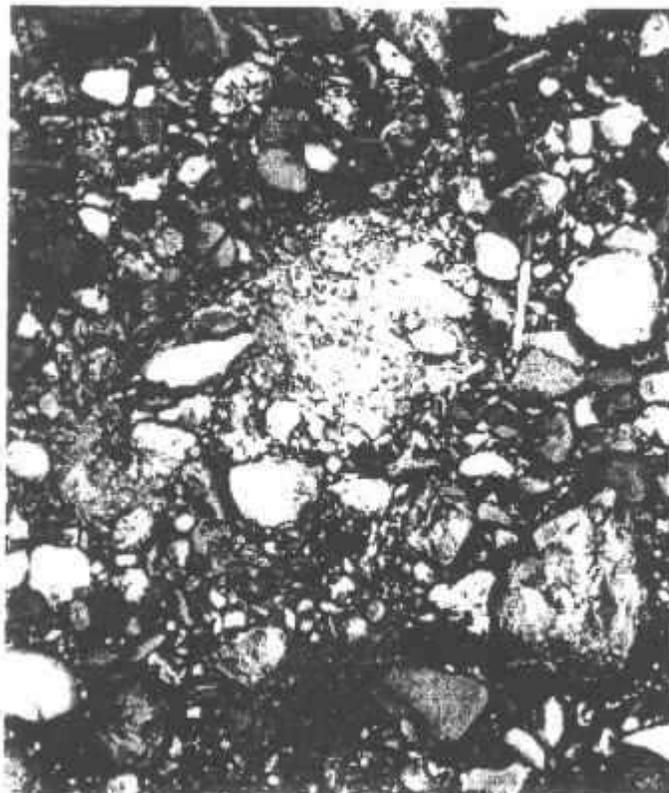
In response to the Hoopa Tribe’s concern, USEPA (1995 and 1996) sampled small yellow-orange patches of sediment (approximately 3-7 inches in diameter) located on a gravel bar in the Trinity River. It is not known what the origin of the stained areas are. It is possible that they could be due to past Celtor Chemical Works operations or they may be natural in origin given that the geology in the area is represented by highly mineralized formations. When I visited the site in the Spring of 1996, there were only a few colored spots that were visible on the gravel bed, and when USEPA personnel visited the site in August 1998 and April 2001, apparently no spots were observed.

Sediment samples collected in the gravel bed during 1996 were taken from both stained areas and non-stained areas to determine if the colored material contained heavy metals at higher concentrations than non-stained areas. In all cases, non-stained sediments contained heavy metal concentrations that were well below soil cleanup standards established in the ROD. However, one-third (2 out of the 6) of the stained sediment samples contained arsenic and lead above the soil cleanup criteria (see Table). Each of these samples exceeded the soil action levels by roughly a factor of two or three.

Figure 4 Orange stain (photo taken 1996)

The Tribe should alert EPA when orange stains appear on the gravel bar. In this way EPA can continue to monitor these occurrences and perhaps identify their origin. Excavation on a case by case basis could be a possibility, but currently remediation is not possible because the stains are not present.
