**US ENVIRONMENTAL PROTECTION AGENCY
NAVAJO NATION
COMPLIANCE EVALUATION INSPECTION
MAY 8, 2012**

Facility: APS Four Corners Power Plant, NN0000019

Report Prepared by: Jamie Marincola

Date Prepared: August 9, 2012

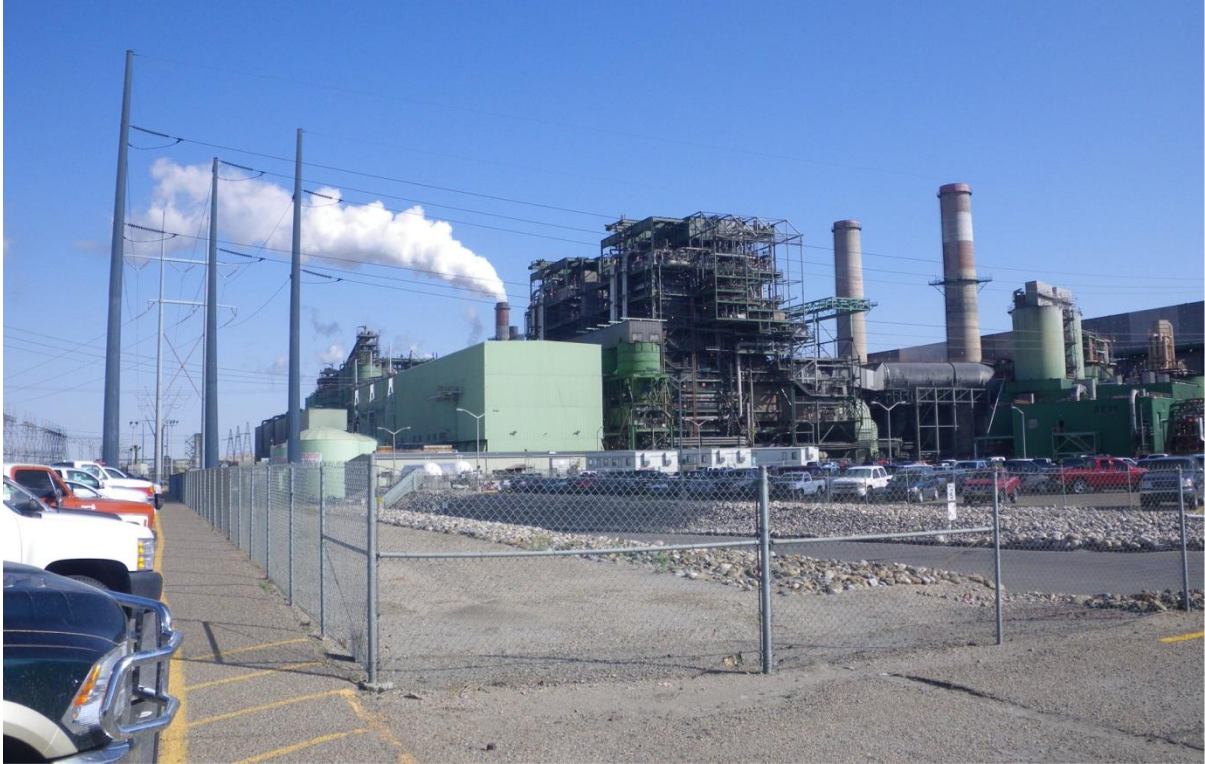
On the day of the inspection, units 1, 3, and 4 were in operation. **Figure 1** shows the plume coming off of generator 3.

Figure 1: APS Four Corners Power Plant. Close up of plume coming off unit 3.

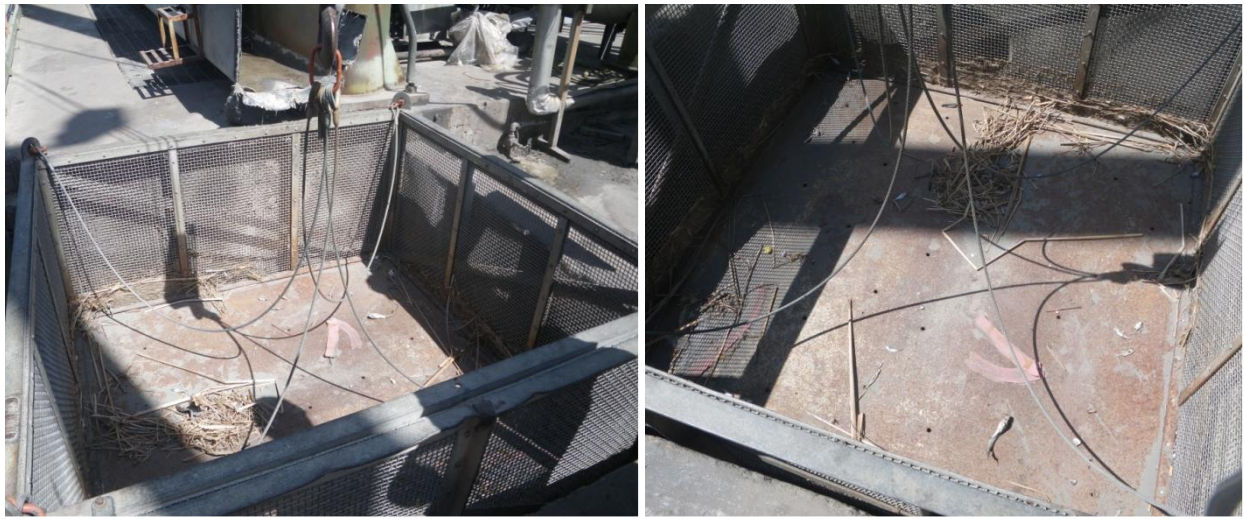
Figure 10: Fish return from traveling screens disposed of once/day. Approximately 12 fish between 1" and 6" observed in basket.

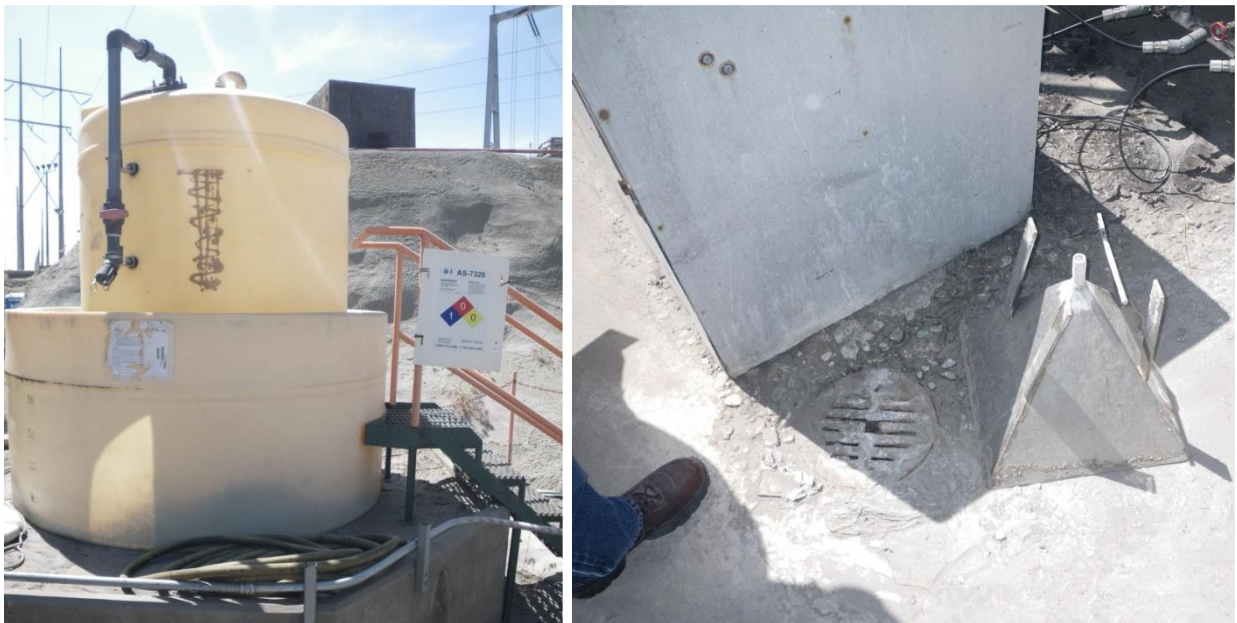
Acrylate copolymer (a corrosion inhibitor) is slowly fed through the influent on a continual basis. Chlorine powder is added once or twice per week on a slug basis (**Figure 11**).

- Monitoring for total residual chlorine in once-through cooling discharge is not specified in the permit as being concurrent with chlorine application. Current chlorine monitoring requirements may not be indicative of chlorine spikes in effluent at 01A.

Figure 11: Corrosion inhibitor, acrylate copolymer (left) and chlorine powder addition (right).

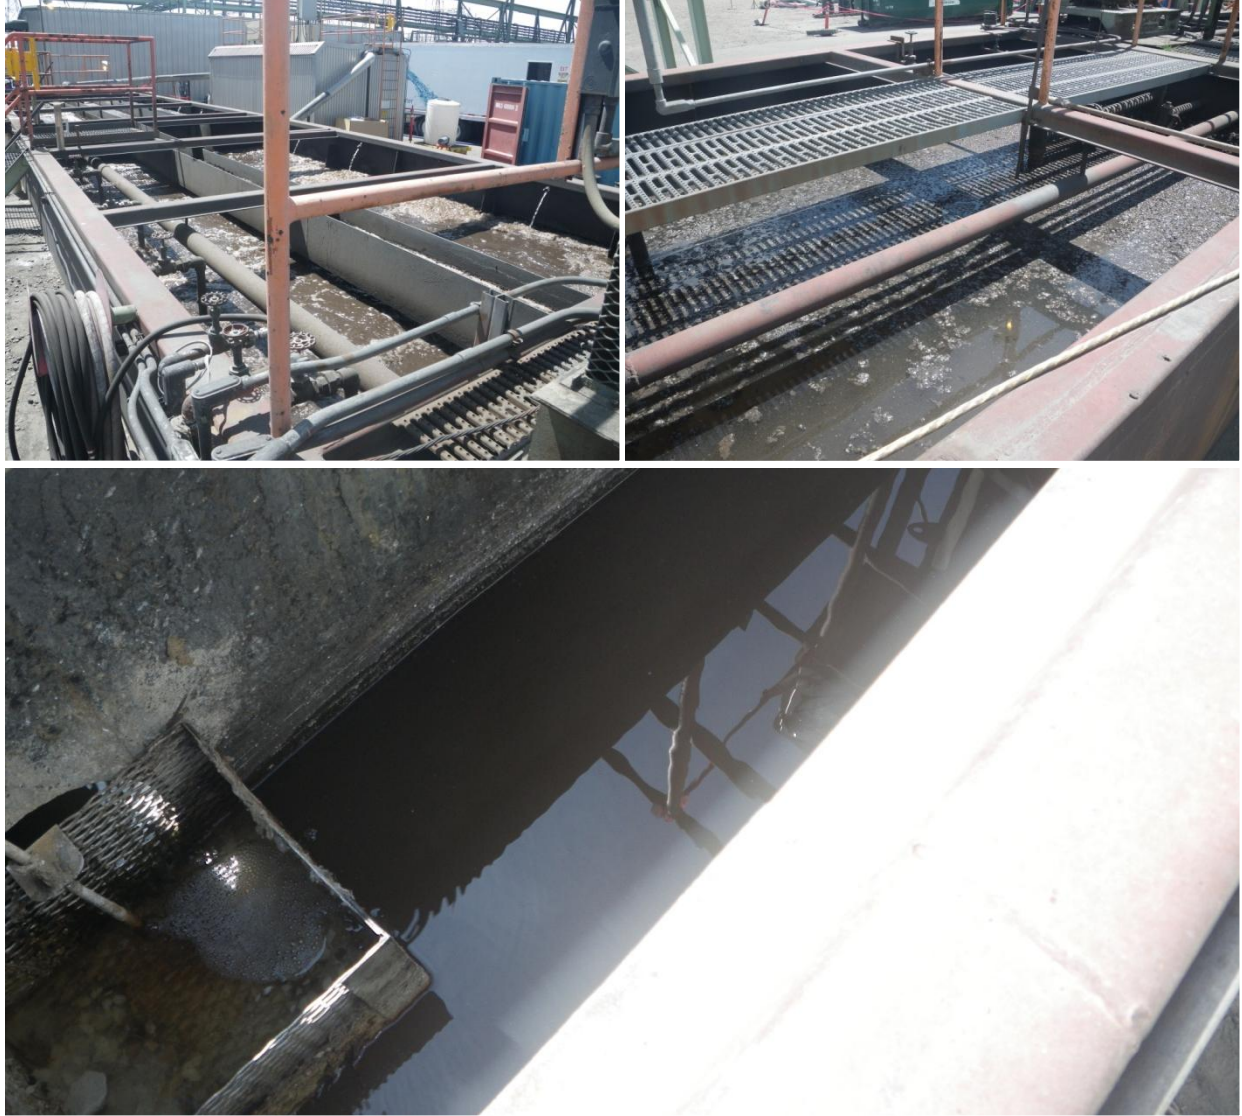
The facility has its own domestic treatment package plant (**Figure 13**). Activated sludge treatment includes aeration and secondary clarifying for 30,000 GPD. The facility is not required to monitor discharge from the secondary package plant, so effluent quality is unknown; however, the effluent appeared to be murky and of poor quality, possibly not meeting secondary standards in 40 CFR 133.102. Effluent from the package plant is sent to the lined fly ash pond and is not discharged or permitted to be discharged to waters of the U.S. It is, however, reused as part of the desulfurization cycle.

Figure 13: Domestic wastewater treatment package plant; final effluent (bottom) murky.

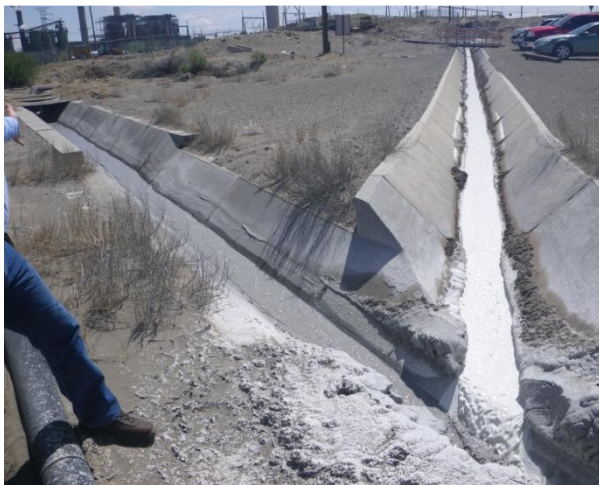
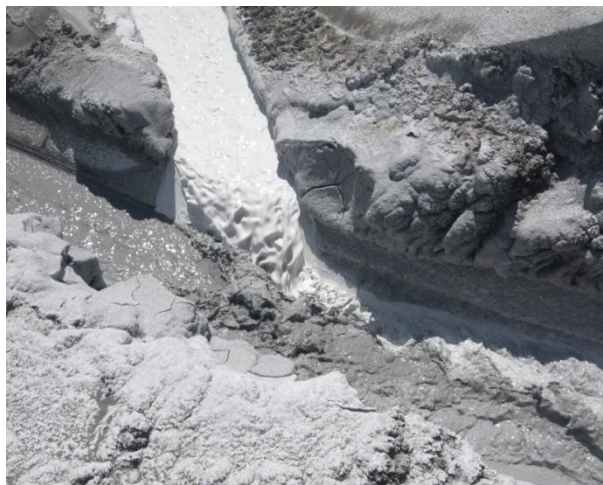
Figure 15: Thickener from blowdown (left stream) and underflow sulfate/sulfite solution (right).
