**US ENVIRONMENTAL PROTECTION AGENCY
NAVAJO NATION
COMPLIANCE EVALUATION INSPECTION
MAY 8, 2012**

Facility: APS Four Corners Power Plant, NN0000019

Report Prepared by: Jamie Marincola

Date Prepared: August 9, 2012

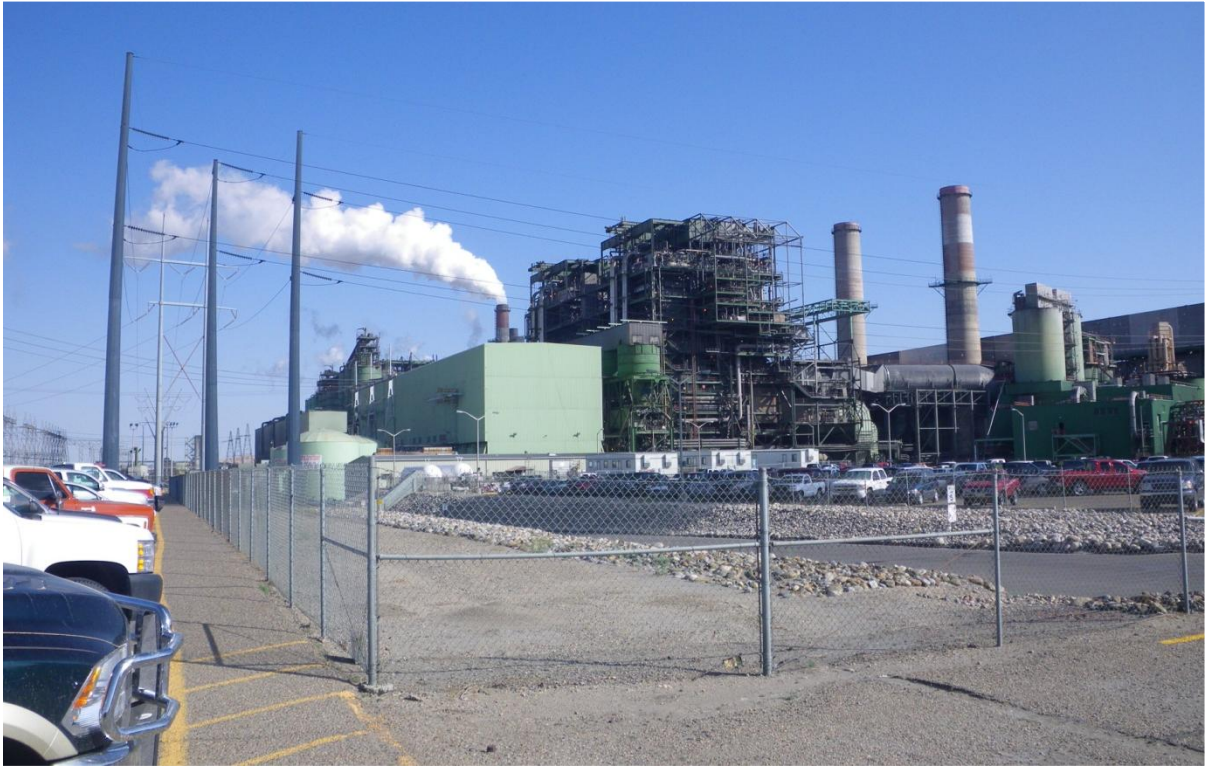
On the day of the inspection, units 1, 3, and 4 were in operation. **Figure 1** shows the plume coming off of generator 3.

Figure 1: APS Four Corners Power Plant. Close up of plume coming off unit 3.

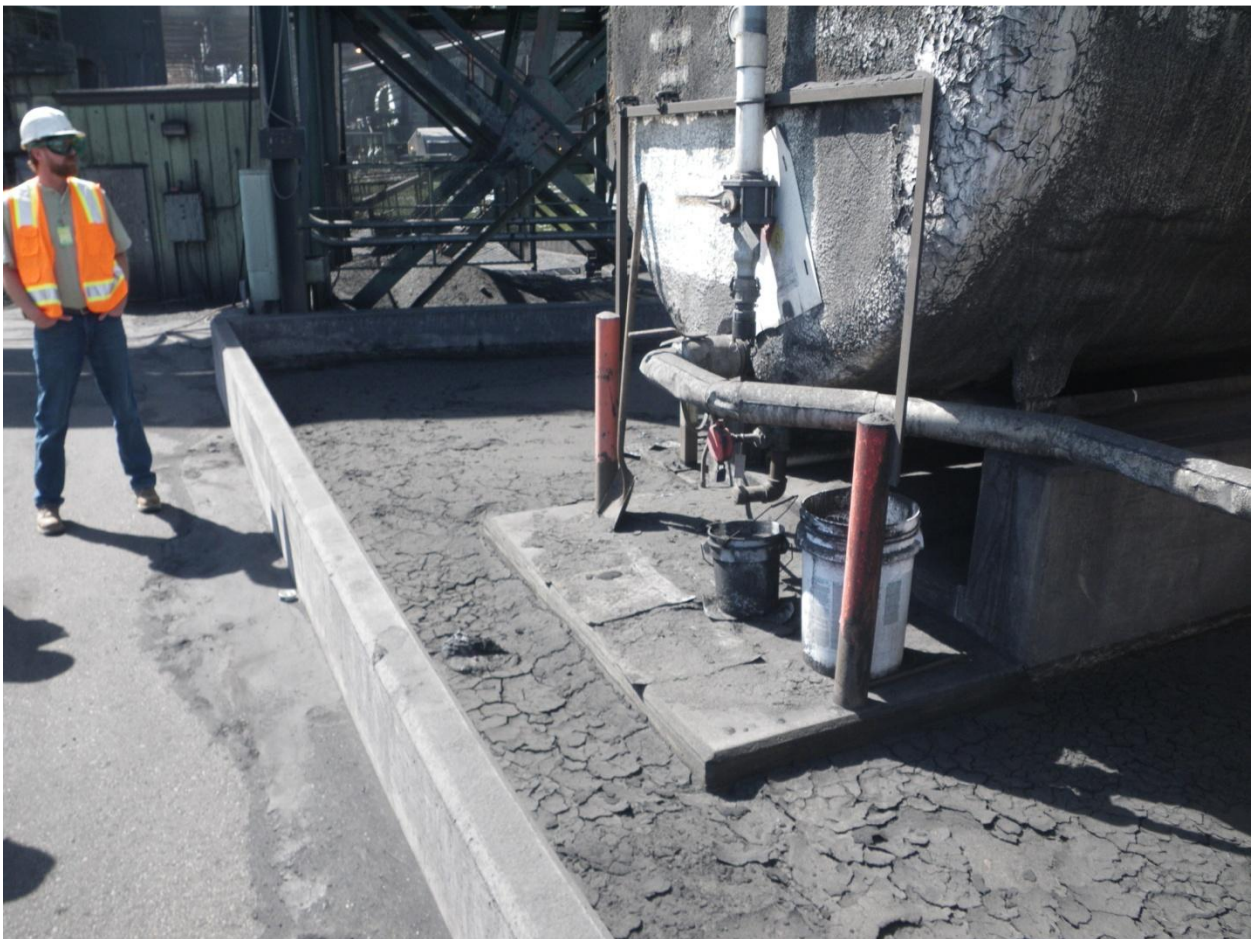
Figure 3: Flocculant for sump with containment. Ash build-up prevalent on the premises.

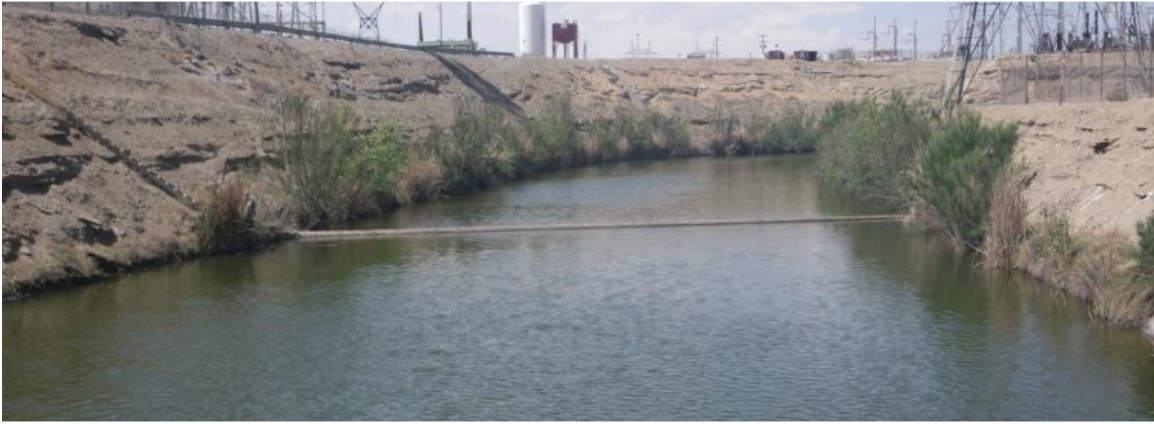
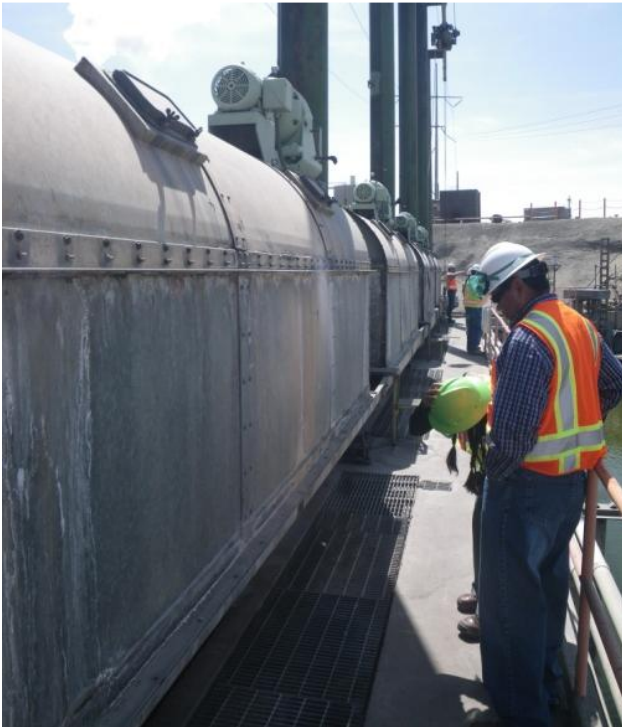
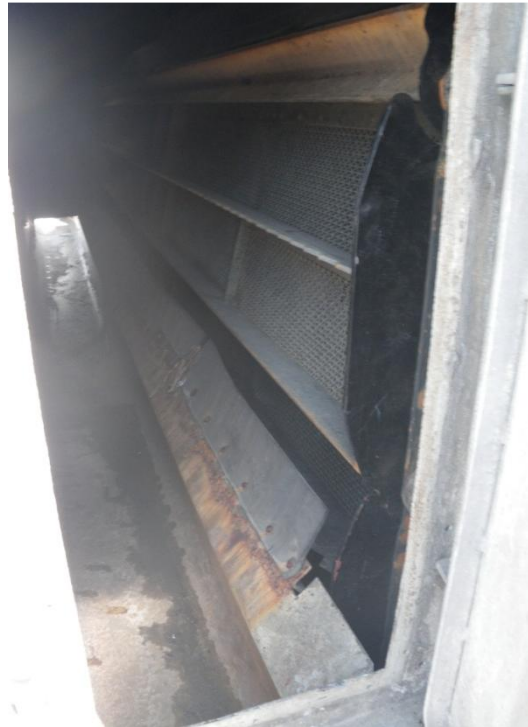
After the berm, a portion of the water is pulled into the intake for units 1-3, the other portion flows down an intake canal specifically for units 4 and 5 (**Figure 9**). The intake structures for units 4 and 5 consist of four sets of traveling screens and pumps: two for each unit. Each pump is rated at 250,000 GPM. Each screen spans a depth of approximately 20 feet and is cleared once per day, at a minimum. A facility representative indicated that through-screen intake velocity for these units is typically "well above" 0.5 ft/s, however he also indicated that they frequently observe fish freely swimming around the intake screens and that the only fish that get impinged are ones that are sick or already dead. Fish that are impinged on the screens are collected in a bucket (**Figure 10**). During the time of inspection, approximately 12 fish between 1 and 6 inches appeared in the collection basket. Operators indicated that the contents of the basket were disposed of daily.

Figure 9: Cooling water intake channel and screens for units 4 and 5.

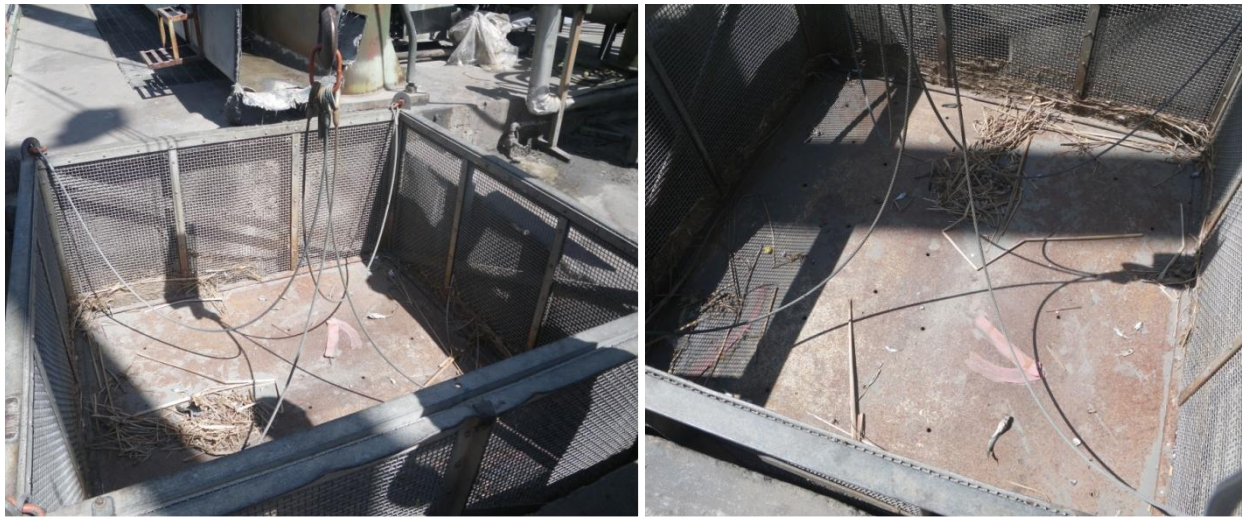
Figure 10: Fish return from traveling screens disposed of once/day. Approximately 12 fish between 1" and 6" observed in basket.

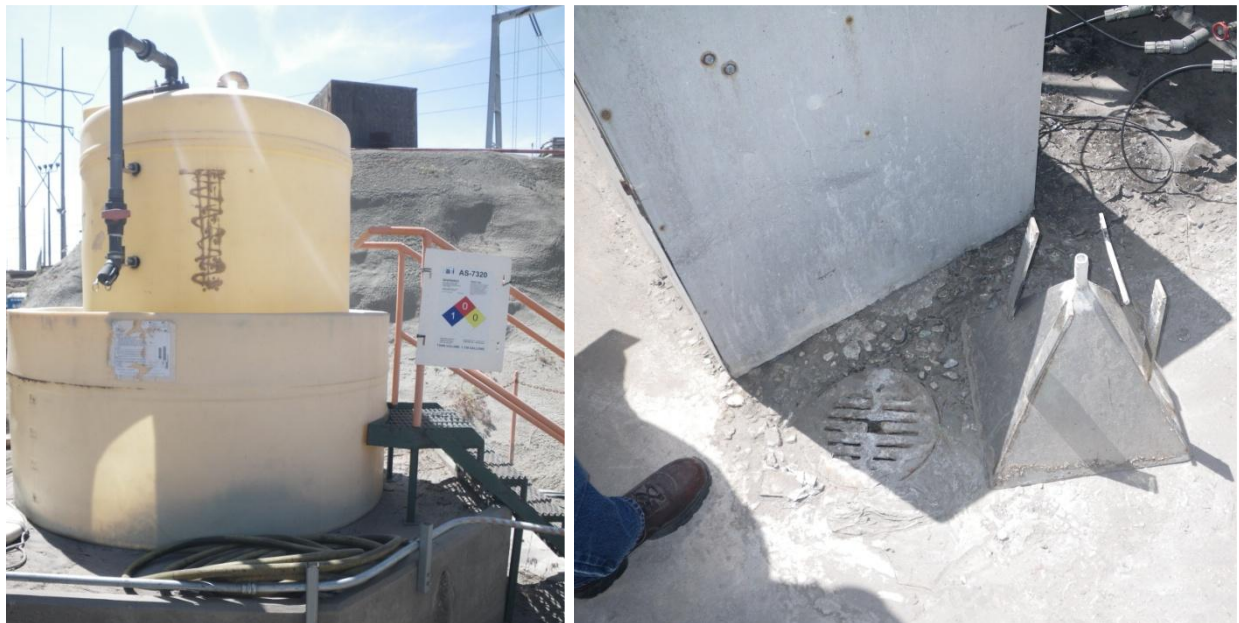
Acrylate copolymer (a corrosion inhibitor) is slowly fed through the influent on a continual basis. Chlorine powder is added once or twice per week on a slug basis (**Figure 11**).

- Monitoring for total residual chlorine in once-through cooling discharge is not specified in the permit as being concurrent with chlorine application. Current chlorine monitoring requirements may not be indicative of chlorine spikes in effluent at 01A.

Figure 11: Corrosion inhibitor, acrylate copolymer (left) and chlorine powder addition (right).

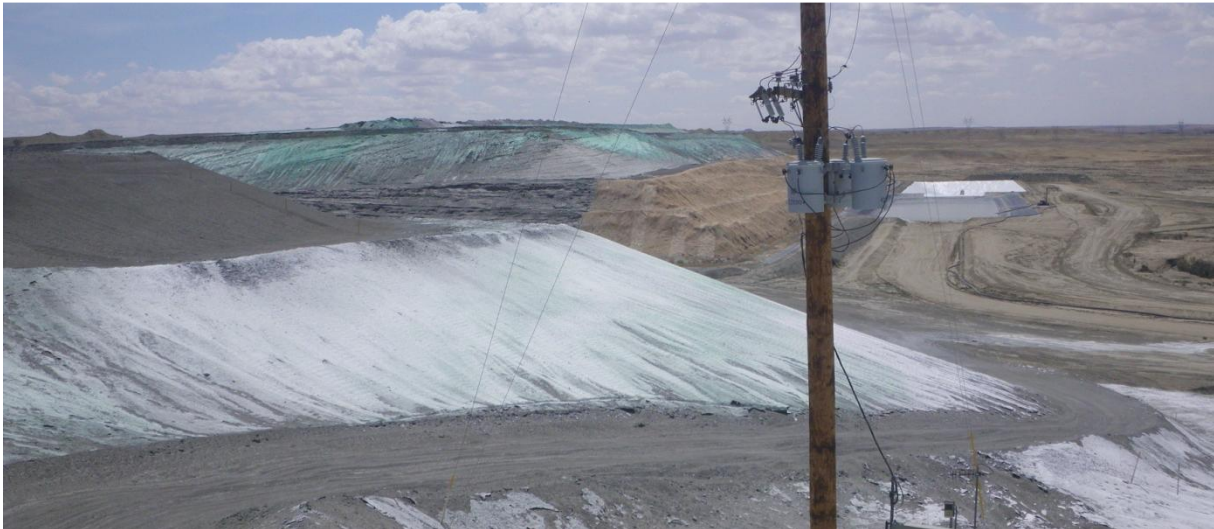
Figure 19 shows an ash pile close to the ponds. The ash pile was covered in chemicals for both dust suppression and pH adjustment. Much of the area surrounding the ash ponds was covered in dust suppressing chemical.

Figure 19: Fly Ash Pile (back) next to single-lined pond (left) with dust-suppression (white) and pH adjustment (green).
