**ARIZONA PUBLIC SERVICE COMPANY'S RESPONSE TO
PETITION FOR REVIEW**

ATTACHMENT 24

**US ENVIRONMENTAL PROTECTION AGENCY
NAVAJO NATION
COMPLIANCE EVALUATION INSPECTION
MAY 8, 2012**

Facility: APS Four Corners Power Plant, NN0000019

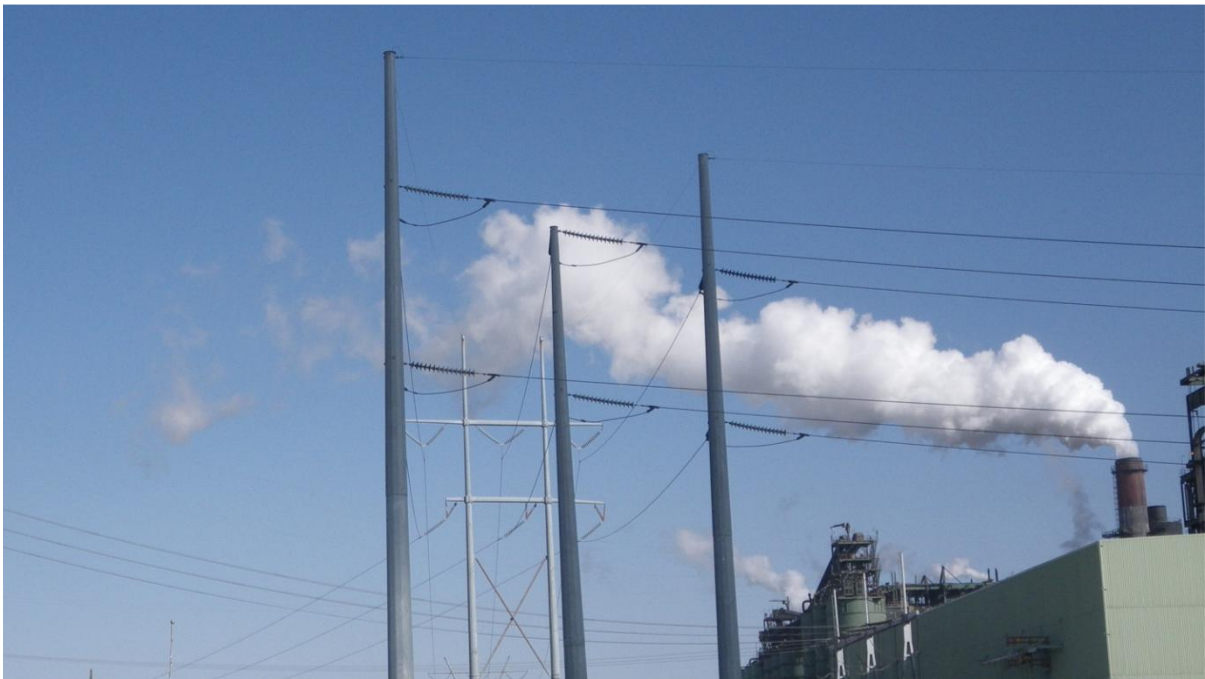
On the day of the inspection, units 1, 3, and 4 were in operation. **Figure 1** shows the plume coming off of generator 3.

Figure 1: APS Four Corners Power Plant. Close up of plume coming off unit 3.

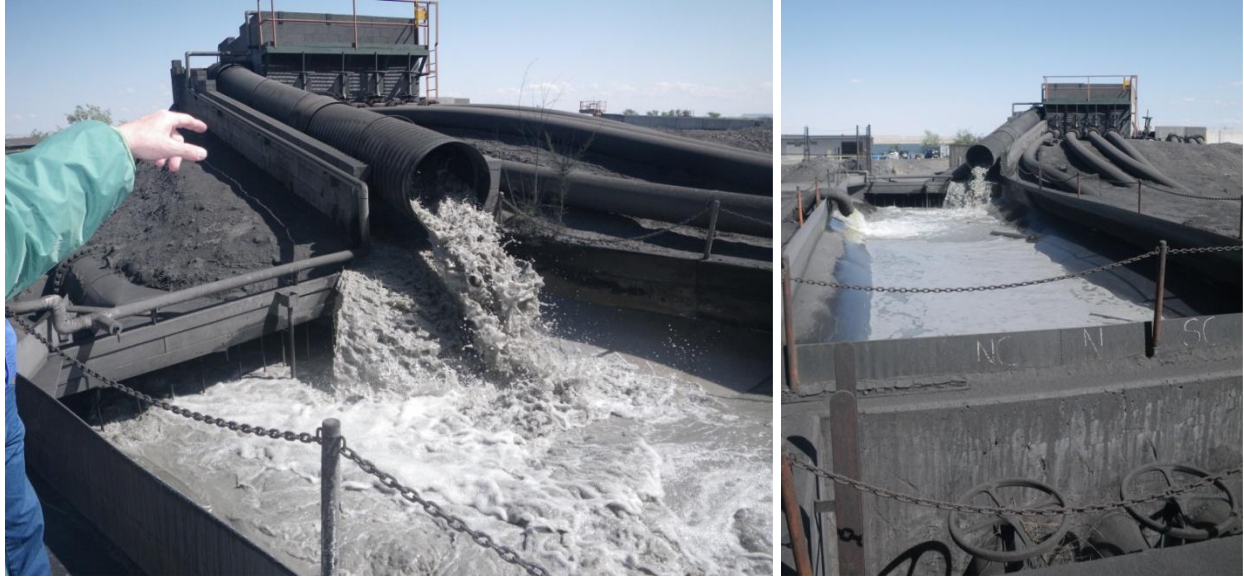
Combined waste streams, including in plant stormwater runoff, are pumped to a combined waste treatment pond (CWTP). **Figure 2** shows the quality of the combined wastewater before treatment. A cationic polymer (flocculant) is added to the wastewater prior to being sent to the CWTP for settling. Layers of coal soot were prevalent in many areas of the facility including the flocculent containment (**Figure 3**).

Figure 2: Sump pumping drainage from facility to Combined Waste Treatment Pond (CWTP).

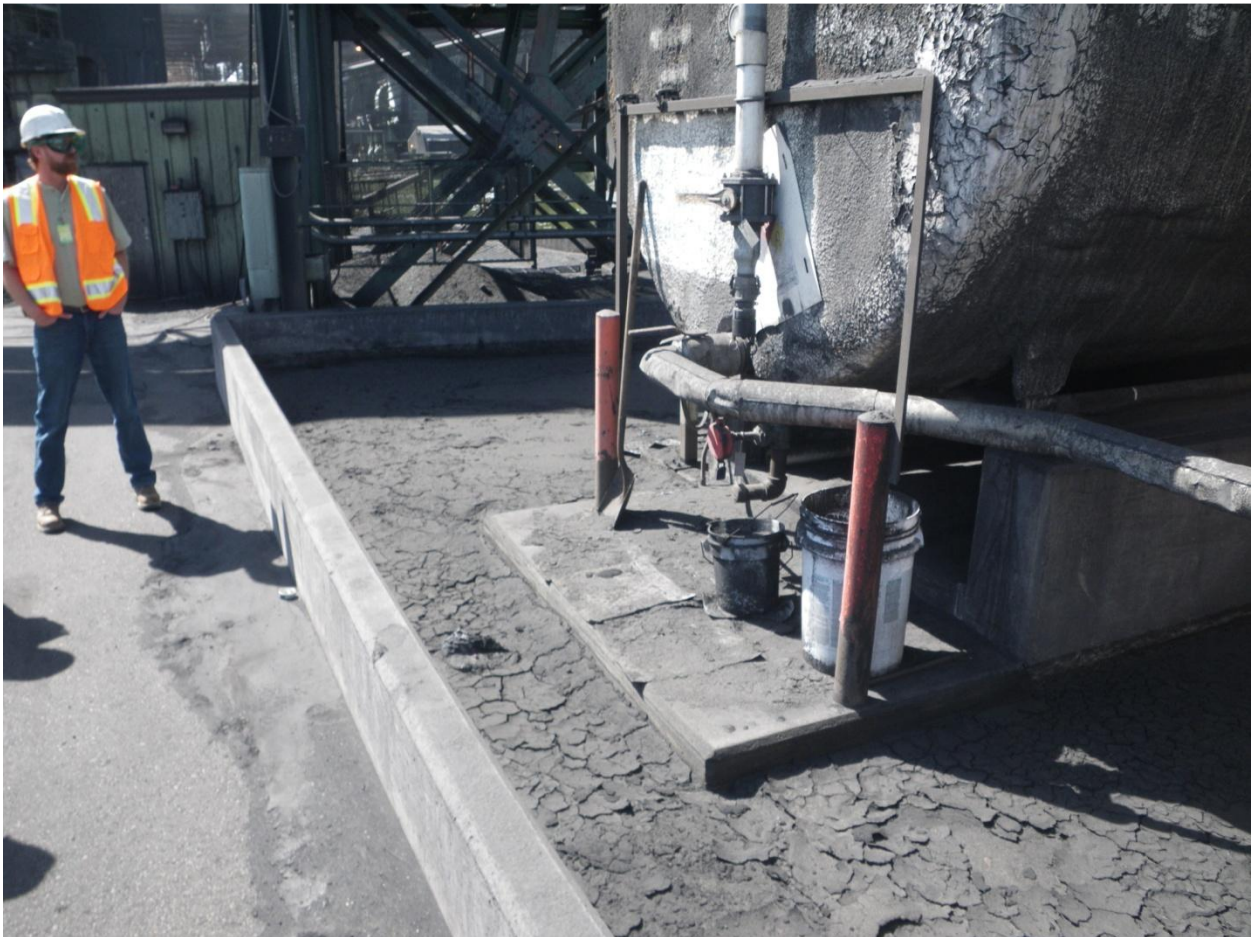
Figure 3: Flocculant for sump with containment. Ash build-up prevalent on the premises.

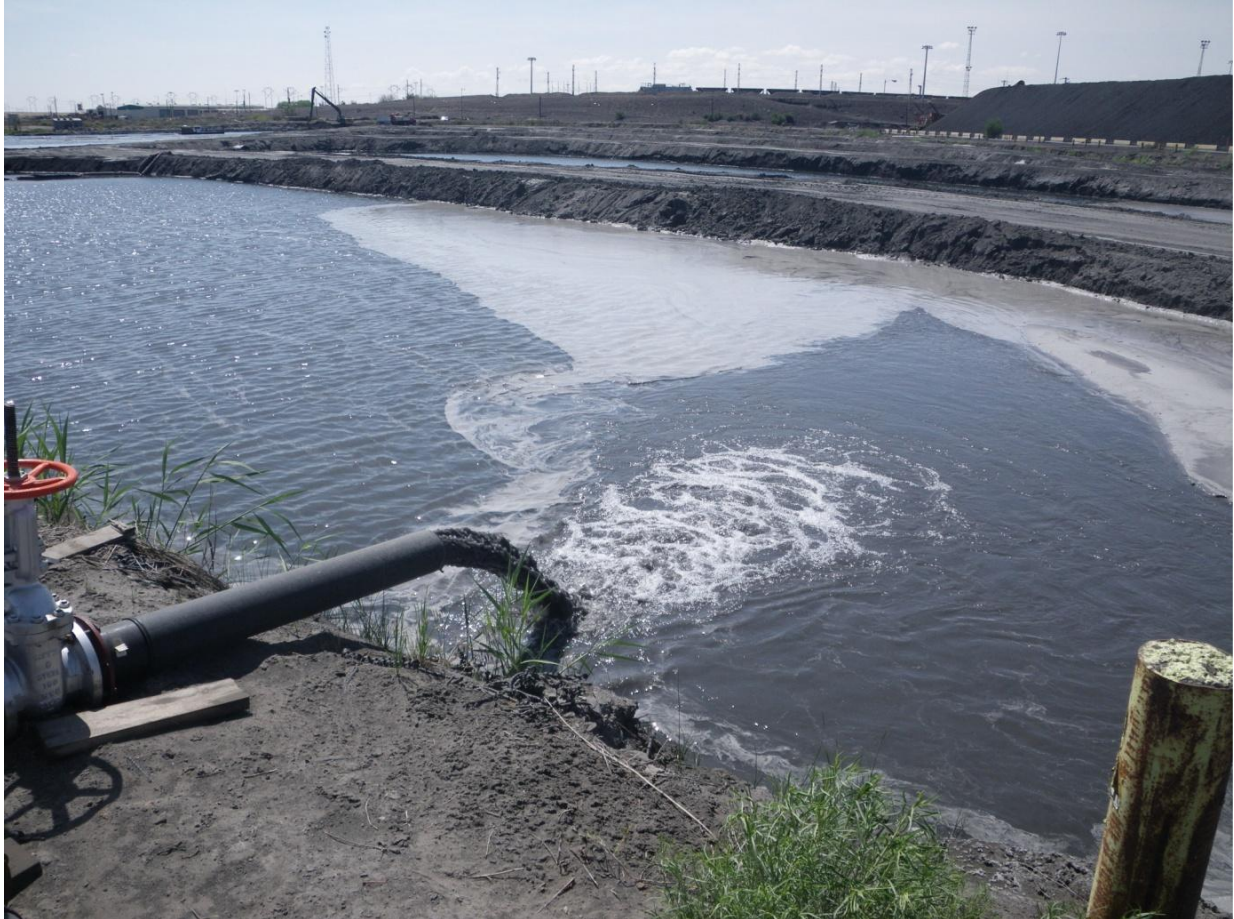
The CWTP (influent pictured in **Figure 4**) is a treatment lagoon that treats 8-13 million gallons per day (MGD) with a detention time of approximately 4-6 hours. The pond includes various baffles, skimmers and segmented flows to prevent short-circuiting and remove oils that accumulate on the surface (**Figure 4, 5, and 6**). A Mudcat (**Figure 6**) is continually used to dredge solids from the bottom of the pond. Recent issues with elevated TSS due to increased solids loading from the coal ash have caused the facility to increase the baffling in the CWTP.

Figure 4: Influent to CWTP

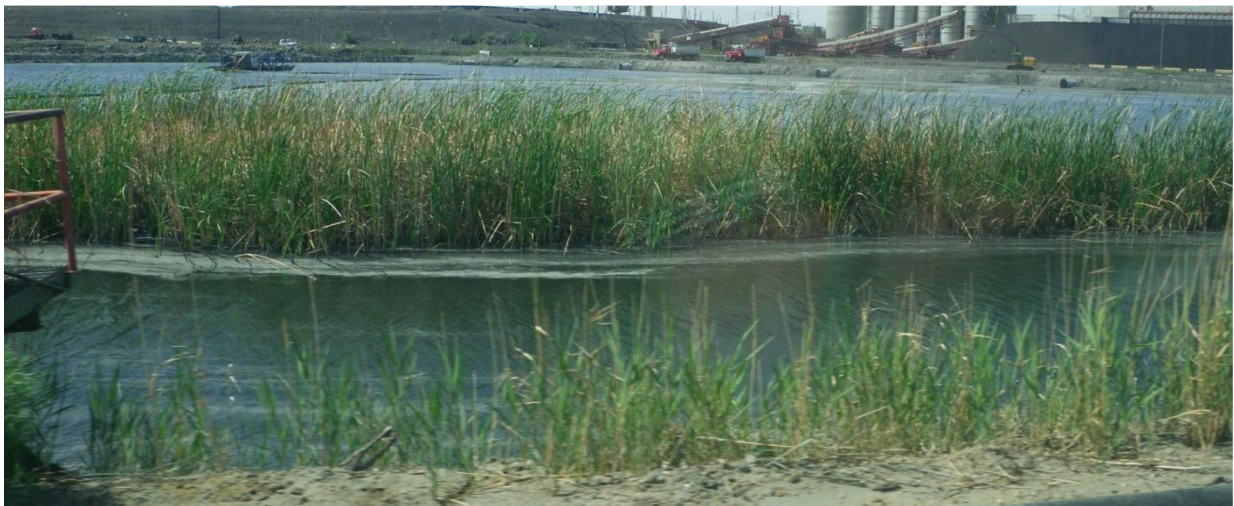
Figure 5: CWTP with oil along bank.

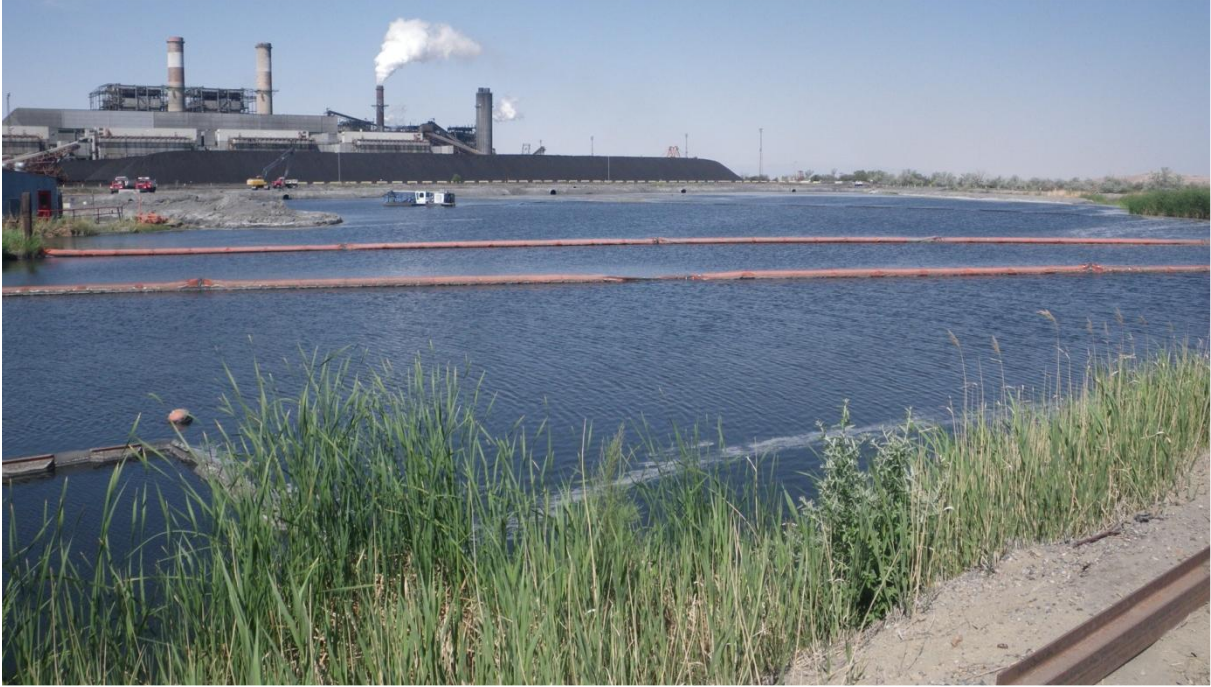
Figure 6: CWTP with berming to control flow and skim grease before outfall (bottom left).

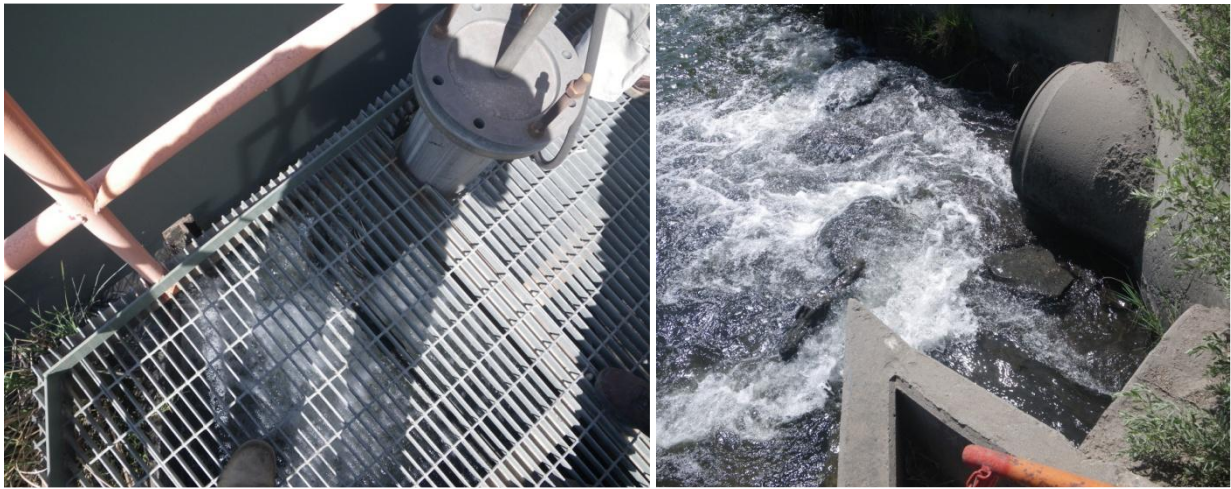
Effluent from the CWTP is metered and logged electronically before entering a culvert leading to the cooling water discharge canal and Outfall 01E (**Figure 7**). A representative sample of Outfall 01E may be taken before or after the culvert.

Figure 7: Flow from CWTP metered (left) goes through culvert before discharging to cooling water effluent canal (right).

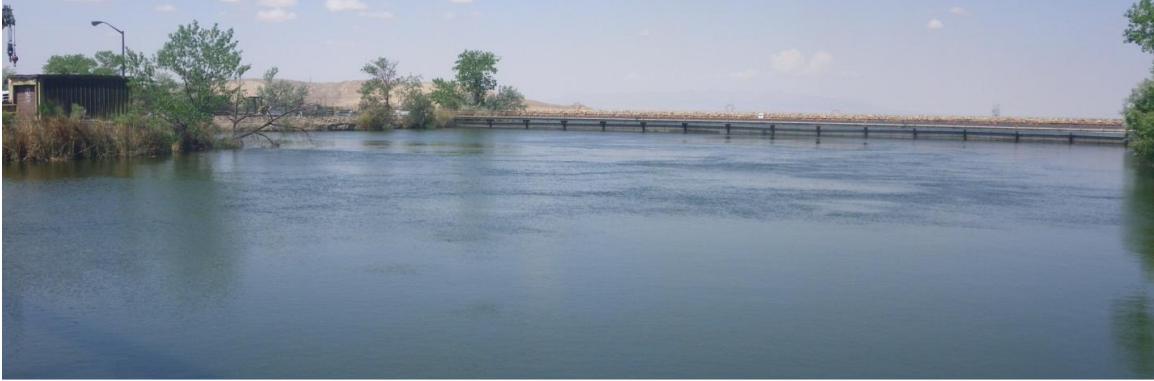
Cooling water for all five units is drawn and discharged back into Morgan Lake. Water is drawn from the lake at a depth of 40 feet. A berm at the inlet (**Figure 8**) is approximately 30 feet deep, meaning the water is pulled from only the bottom 10 feet of the lake. This helps isolate the cooler lake water, but also decreases the amount of fish and fish larvae entering the intake canals.

Figure 8: Berm wall before intake channel to draw only bottom water from Lake Morgan.

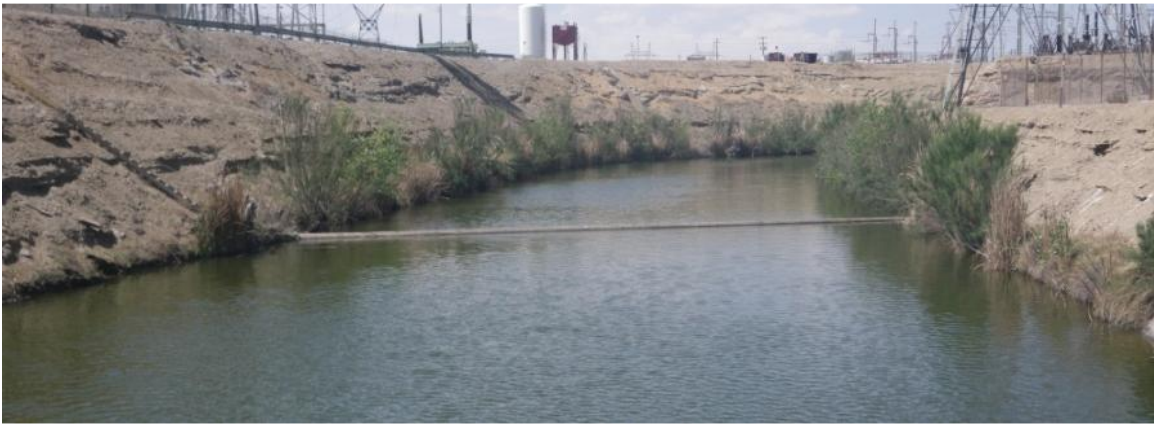
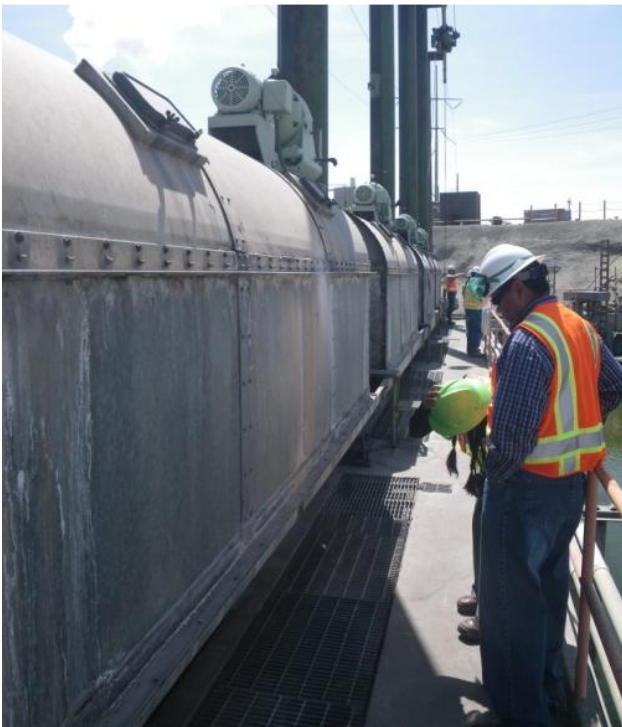
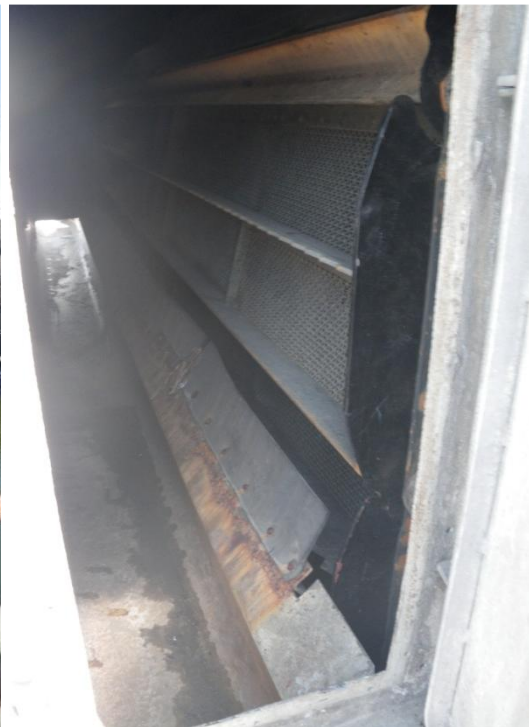
After the berm, a portion of the water is pulled into the intake for units 1-3, the other portion flows down an intake canal specifically for units 4 and 5 (**Figure 9**). The intake structures for units 4 and 5 consist of four sets of traveling screens and pumps: two for each unit. Each pump is rated at 250,000 GPM. Each screen spans a depth of approximately 20 feet and is cleared once per day, at a minimum. A facility representative indicated that through-screen intake velocity for these units is typically "well above" 0.5 ft/s, however he also indicated that they frequently observe fish freely swimming around the intake screens and that the only fish that get impinged are ones that are sick or already dead. Fish that are impinged on the screens are collected in a bucket (**Figure 10**). During the time of inspection, approximately 12 fish between 1 and 6 inches appeared in the collection basket. Operators indicated that the contents of the basket were disposed of daily.

Figure 9: Cooling water intake channel and screens for units 4 and 5.

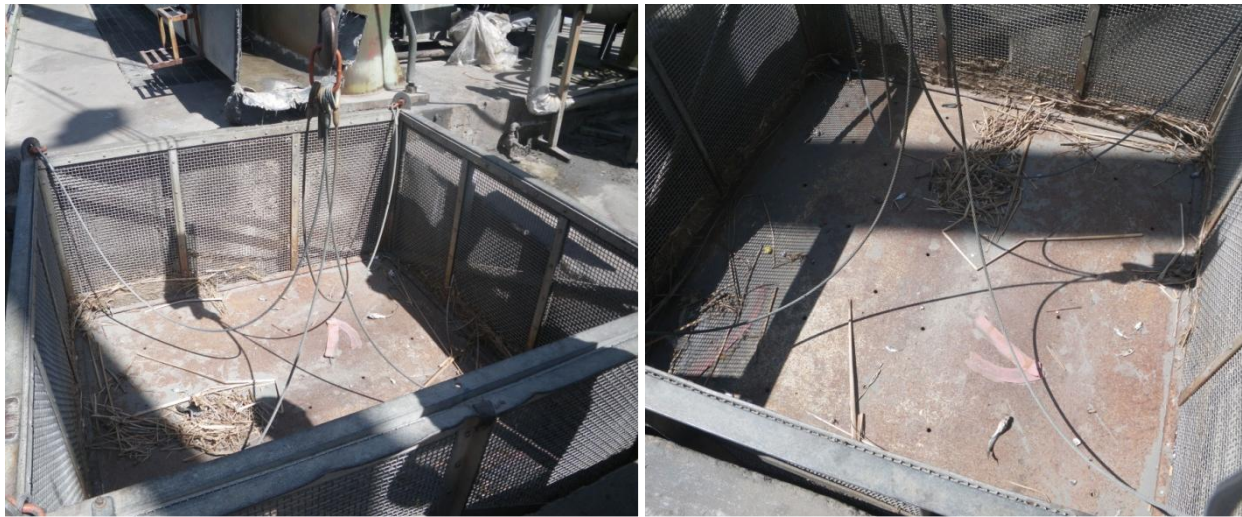
Figure 10: Fish return from traveling screens disposed of once/day. Approximately 12 fish between 1" and 6" observed in basket.

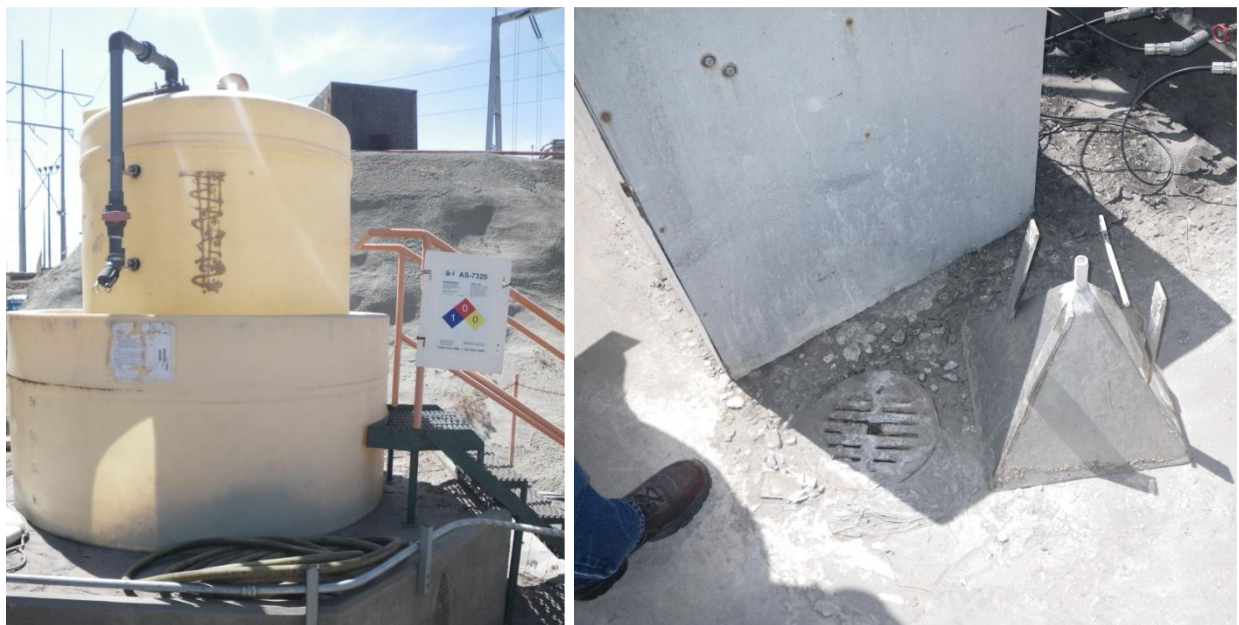
Acrylate copolymer (a corrosion inhibitor) is slowly fed through the influent on a continual basis. Chlorine powder is added once or twice per week on a slug basis (**Figure 11**).

- Monitoring for total residual chlorine in once-through cooling discharge is not specified in the permit as being concurrent with chlorine application. Current chlorine monitoring requirements may not be indicative of chlorine spikes in effluent at 01A.

Figure 11: Corrosion inhibitor, acrylate copolymer (left) and chlorine powder addition (right).

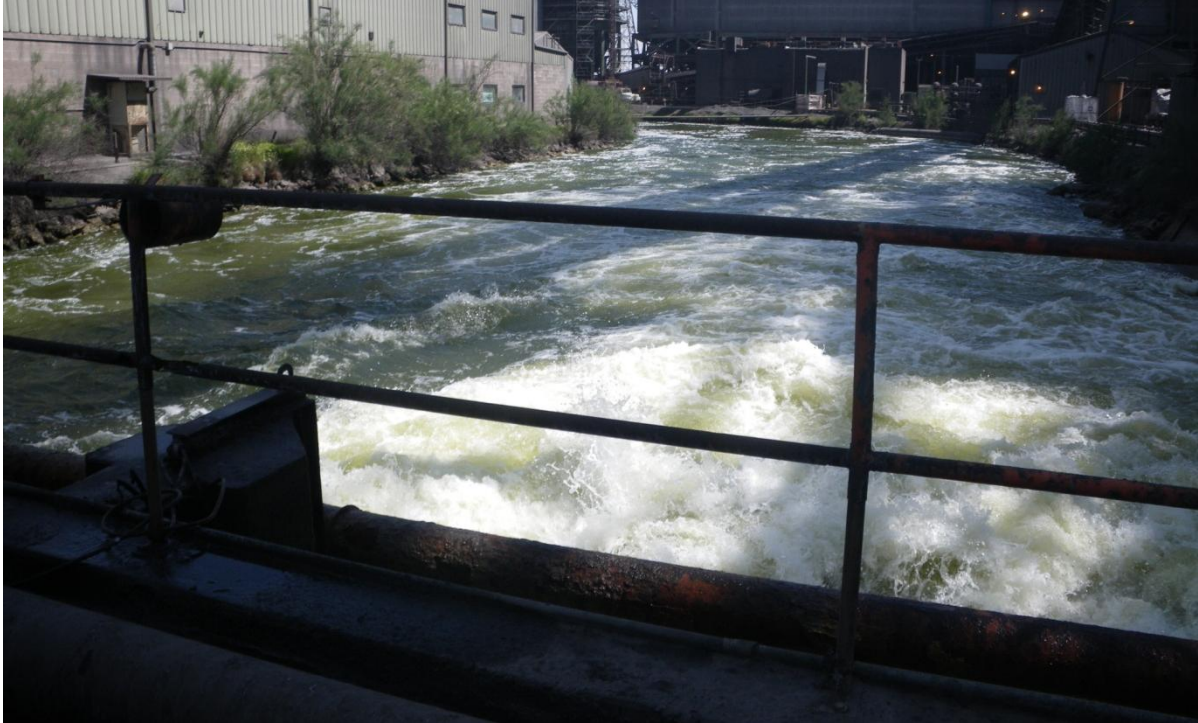
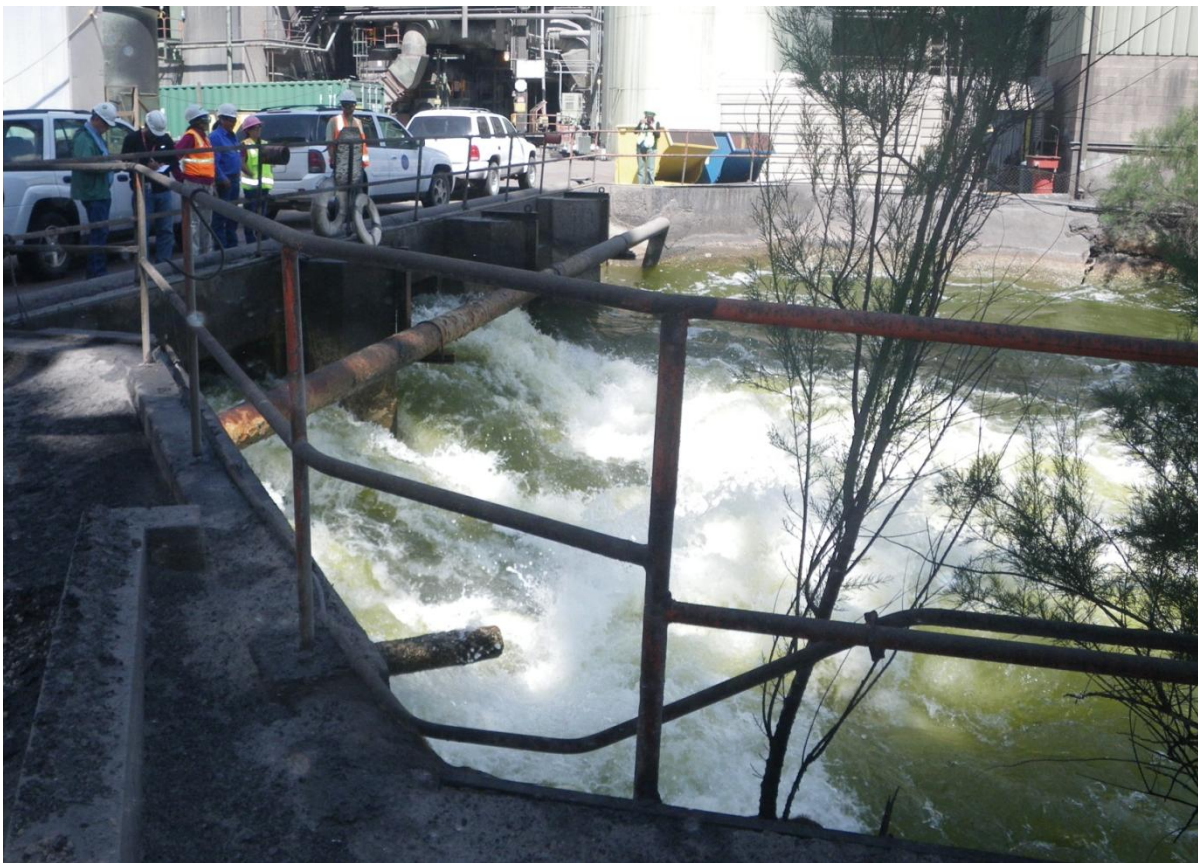
Once-through cooling water from units 4 and 5 is then discharged into an effluent channel (**Figure 12**) to be recirculated through and cooled off in Morgan Lake. Facility representatives indicated that the canal is usually 4-5" higher when both units 4 and 5 are in operation.

Figure 12: Cooling water discharge from unit 4; unit 5 not discharging at time of inspection.

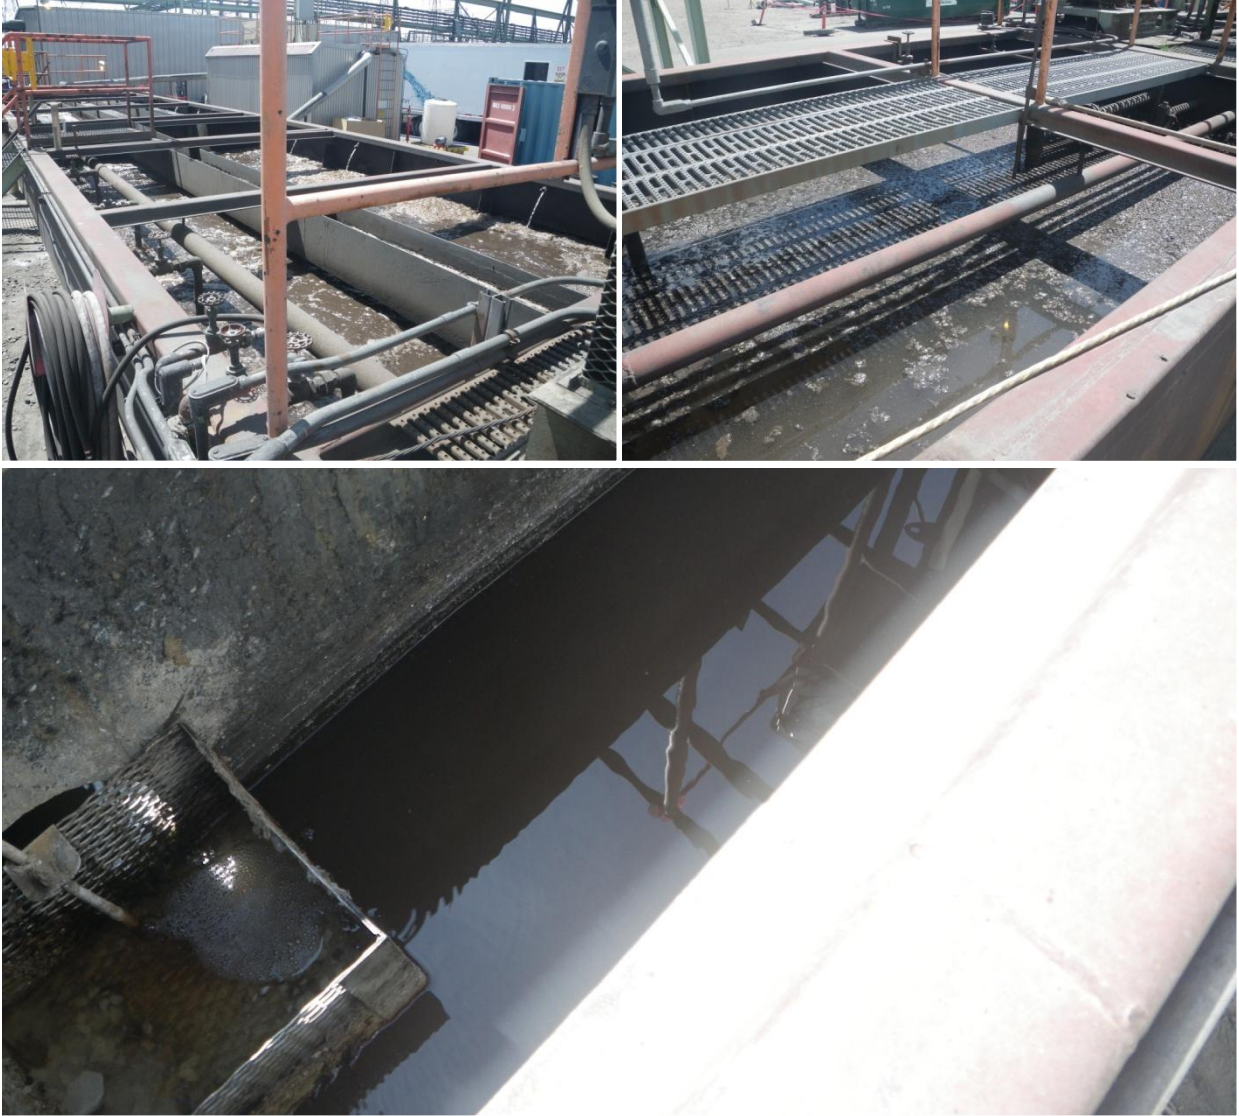
The facility has its own domestic treatment package plant (**Figure 13**). Activated sludge treatment includes aeration and secondary clarifying for 30,000 GPD. The facility is not required to monitor discharge from the secondary package plant, so effluent quality is unknown; however, the effluent appeared to be murky and of poor quality, possibly not meeting secondary standards in 40 CFR 133.102. Effluent from the package plant is sent to the lined fly ash pond and is not discharged or permitted to be discharged to waters of the U.S. It is, however, reused as part of the desulfurization cycle.

Figure 13: Domestic wastewater treatment package plant; final effluent (bottom) murky.

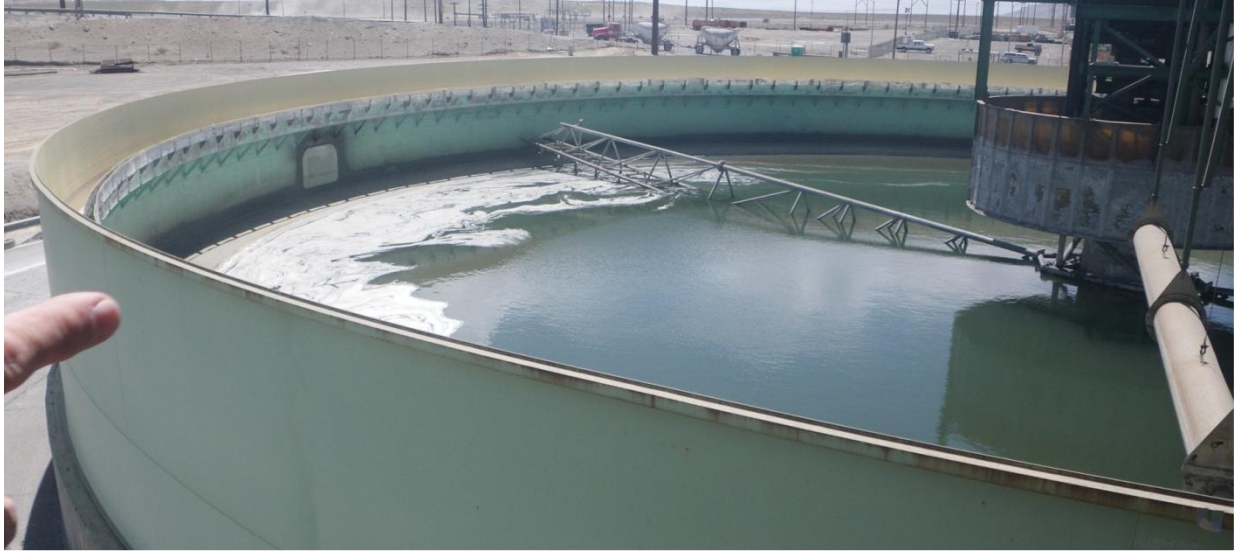
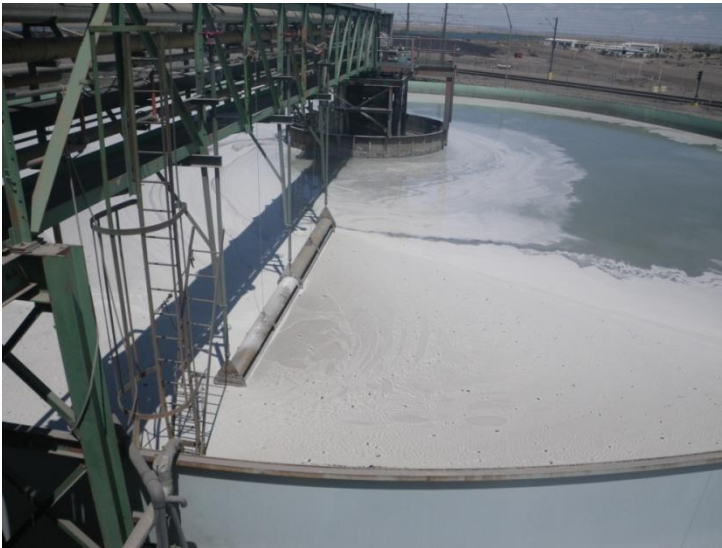
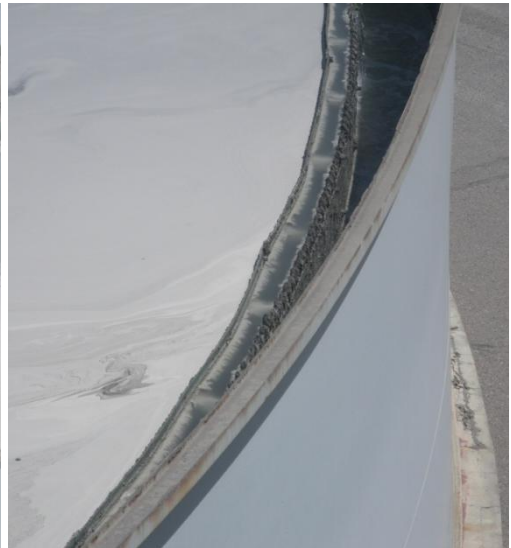
Chemical metal cleaning and flue gas desulfurization wastewater is sent to a series of two fly ash ponds. Blowdown effluent from units 1, 2 and 3 is sent through a clarifier (**Figure 14**) and then combined with underflow from units 4 and 5 (**Figure 15**), metal cleaning wastes (unloaded as a slug by a truck), and sanitary wastewater effluent before being sent to the ash ponds.

Figure 14: Thickeners from blowdown to be sent to fly ash ponds.

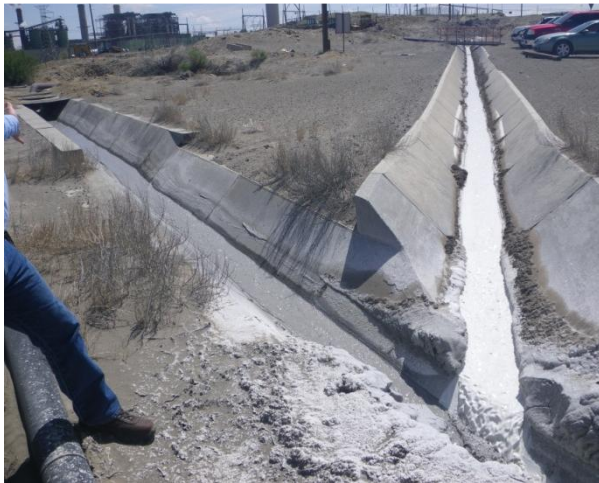
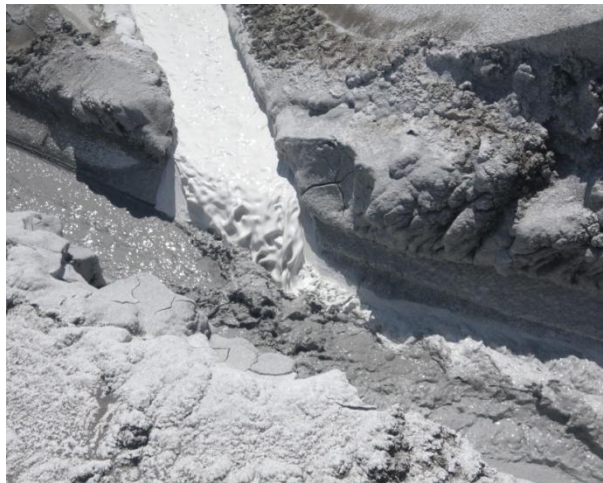
Figure 15: Thickener from blowdown (left stream) and underflow sulfate/sulfite solution (right).

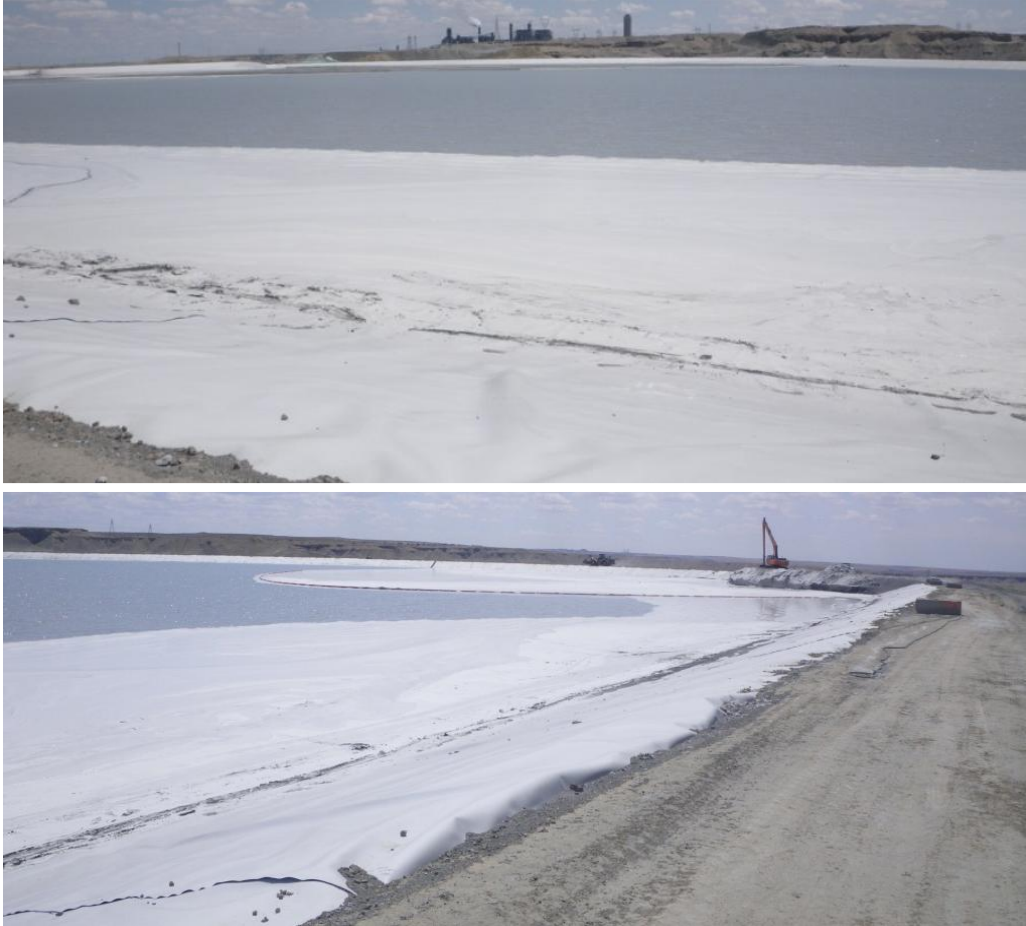
Two ash ponds operate in series. The first is a single-lined pond (**Figure 16**) where floatables are removed and sold for revenue. The effluent from the single-lined pond is sent through a gravel filter downhill to the double-lined pond (**Figure 17**). The double-lined pond serves as a retention basin holding the effluent before it is pumped for desulfurization reuse.

Figure 16: Single-lined fly ash pond. Floatables removed (bottom) and sold.

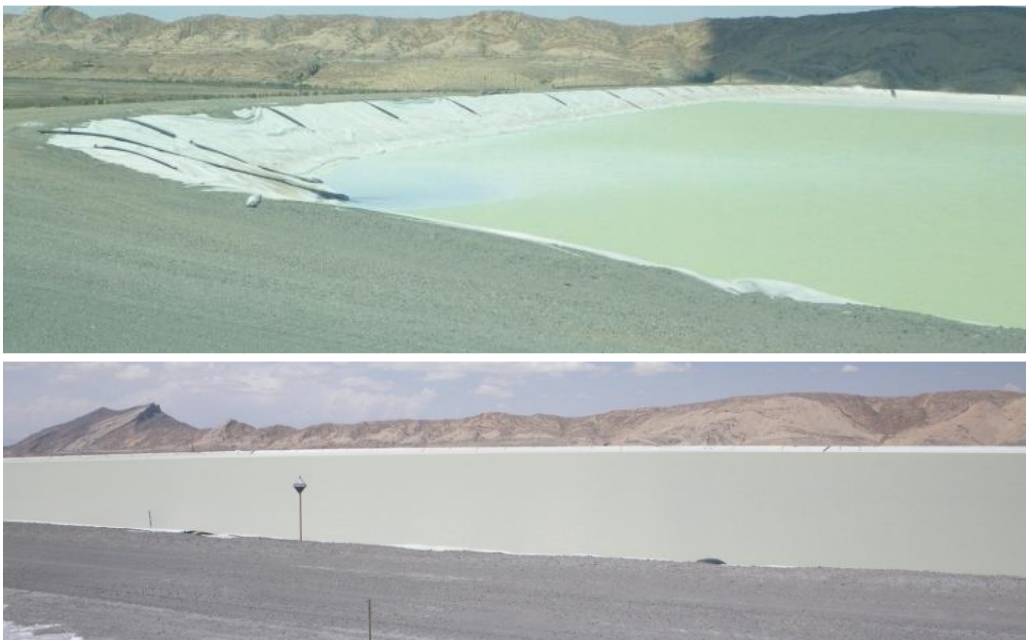
Figure 17: Double-lined fly ash pond; influent from single-lined pond (above).

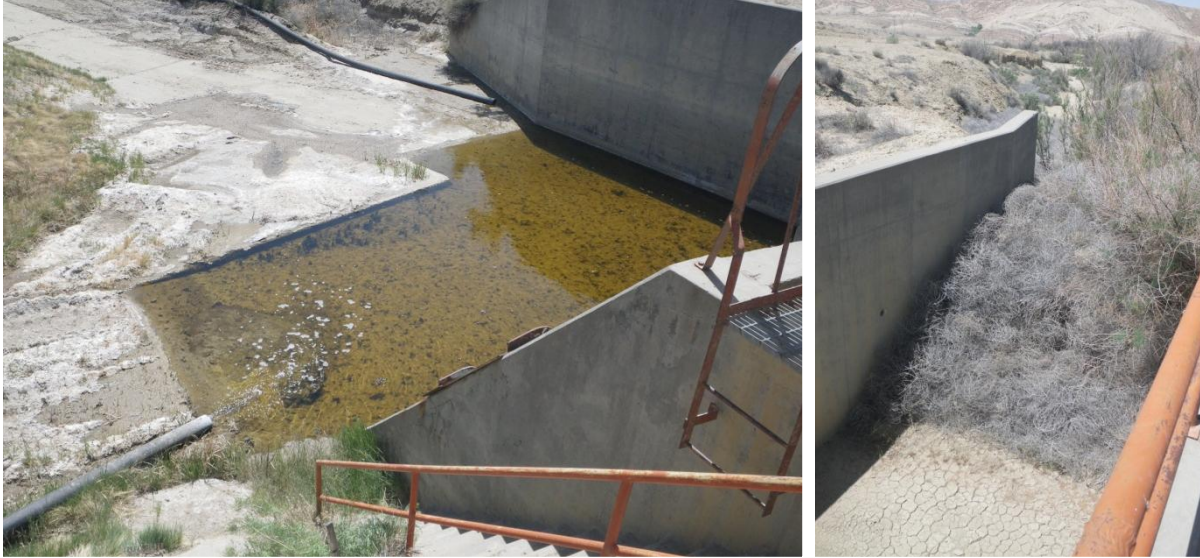
Around the double-lined pond is a French drain system collecting and pumping leachate to a seepage intercept (**Figure 18**) which then pumps the leachate back up to the double-lined pond. During the inspection, flow into the intercept was nontrivial and appeared to be a steady stream through approximately a 4 inch pipe. Prior to being pumped back to the double-lined pond, the intercept served as an outfall; the outfall conveyance has since been walled off.

- Sanitary, fly ash and FGD blowdown wastewater is not regulated in the NPDES Permit. Although there is no discrete outfall from the fly ash ponds, the ponds do have a potential to discharge to Waters of the U.S. through subsurface leaching.

Figure 18: Fly Ash Pond seepage intercept with former leachate outfall (right).

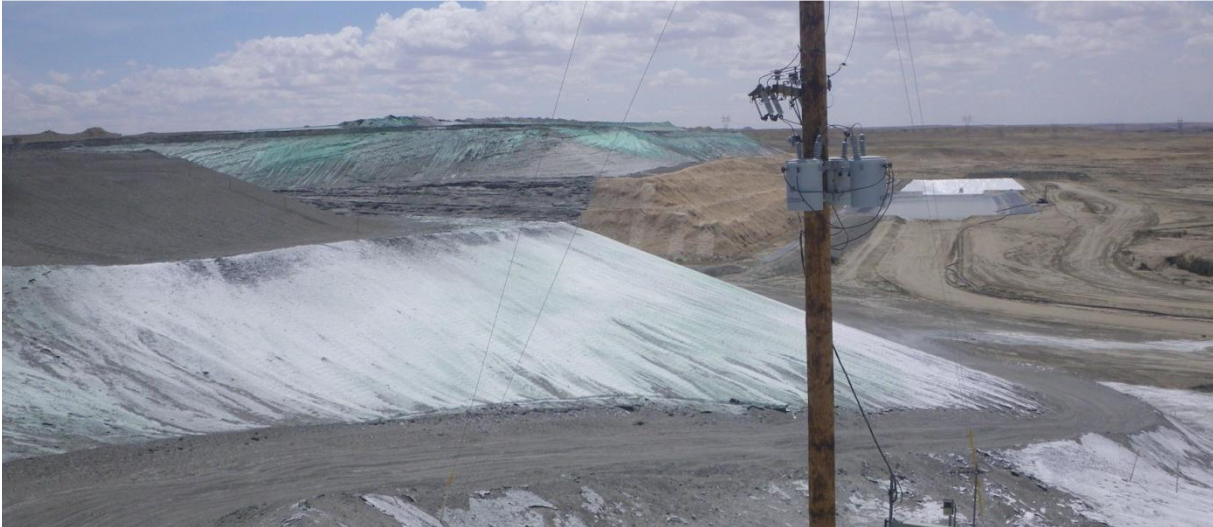
Figure 19 shows an ash pile close to the ponds. The ash pile was covered in chemicals for both dust suppression and pH adjustment. Much of the area surrounding the ash ponds was covered in dust suppressing chemical.

Figure 19: Fly Ash Pile (back) next to single-lined pond (left) with dust-suppression (white) and pH adjustment (green).

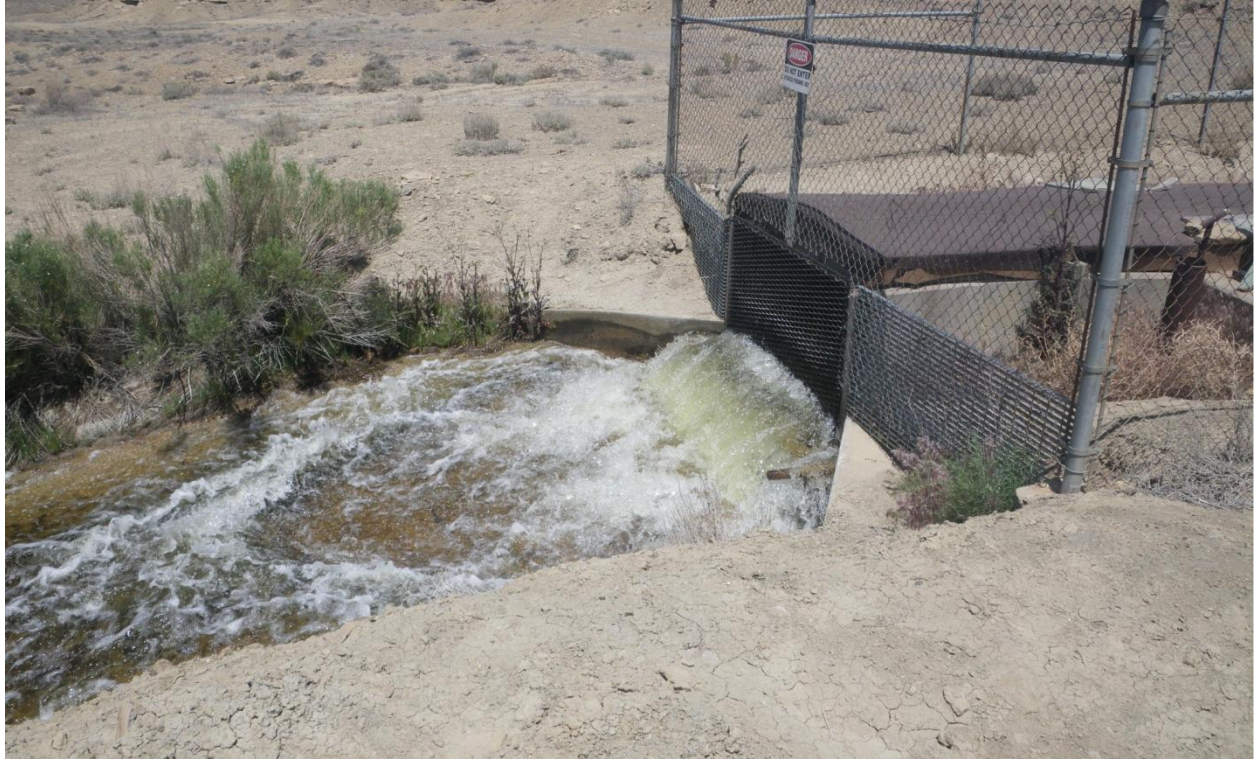
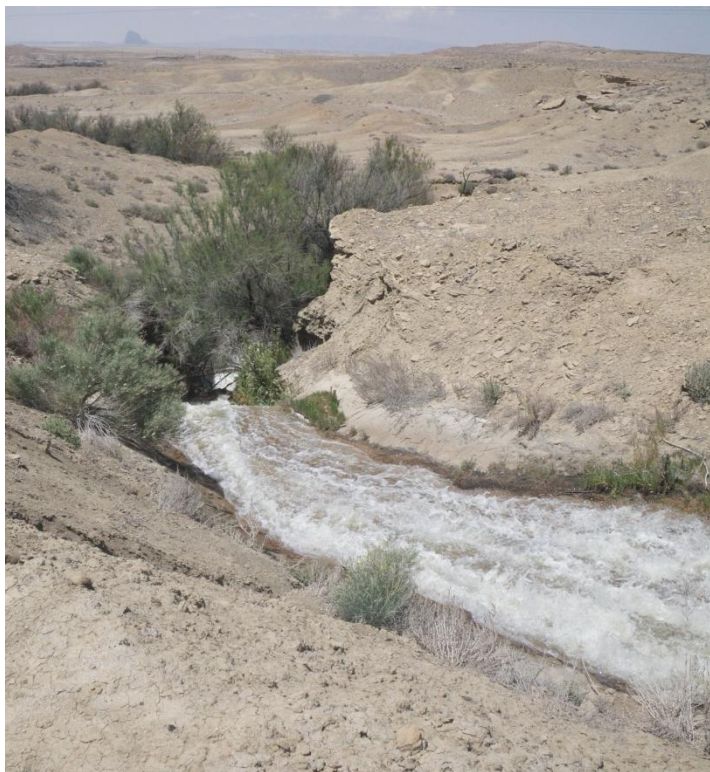
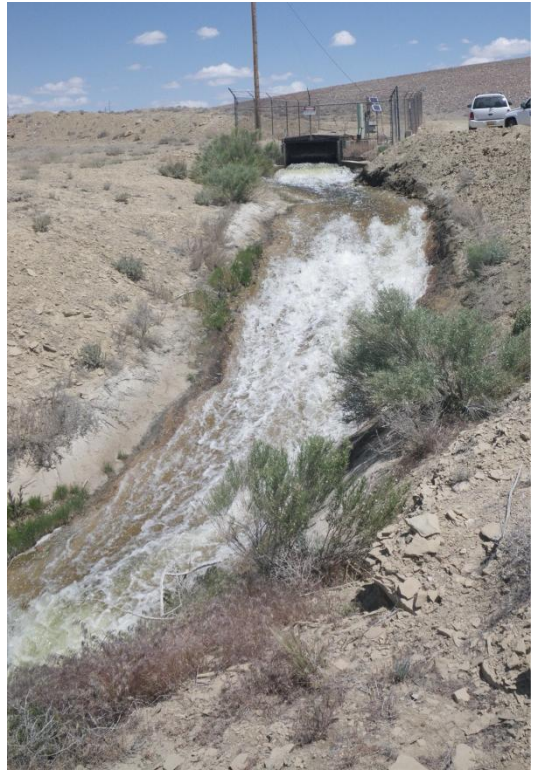
Outfall 001 (**Figure 20**) discharges effluent from Morgan Lake to the effluent-dependant No Name Wash which flows to the San Juan River. The facility mostly discharges in order to reduce the amount of total dissolved solids (TDS) and temperature built up in the lake. The permit does not incorporate a limit for TDS, however a facility representative indicated that TDS levels in the lake are typically 800-1,000 mg/L. Discharge is restricted by temperature. The

- Total Dissolved Solids are built-up in Morgan Lake before being discharged to the receiving water. Elevated TDS may adversely impact downstream beneficial uses, however there is no criterion for TDS in the Navajo Nation Water Quality Standards.

Figure 20: Outfall 001 from Morgan Lake to No Name Wash.

- In order to ensure the accuracy of Section V. Part B of their permit application (Form 2-C), the permittee should conduct a priority pollutant scan at Outfall 001.

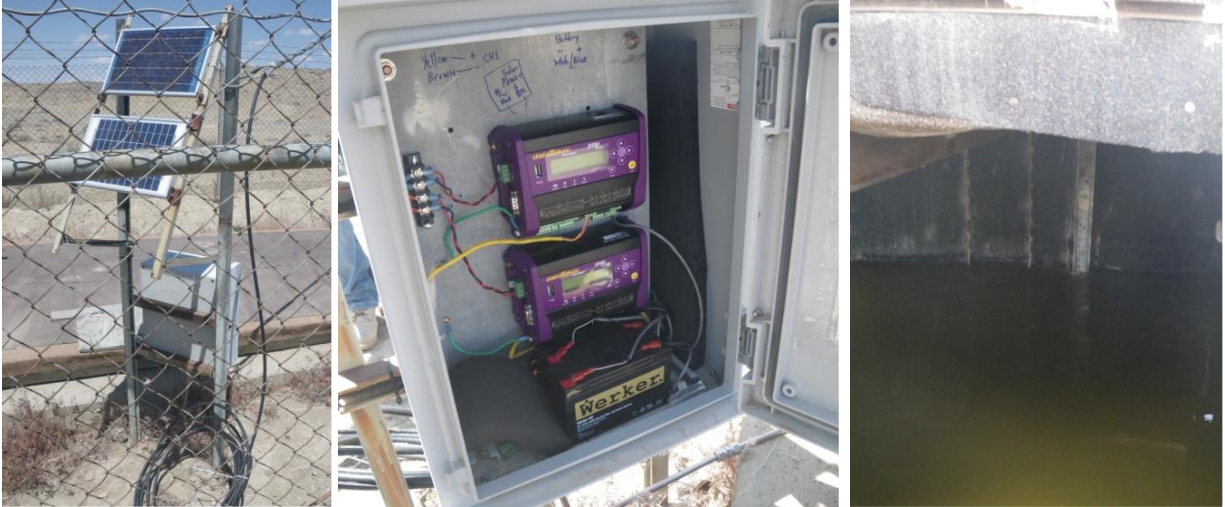
Temperature, flow and grab samples are taken at the outfall structure (**Figure 21**). Temperature is metered by solar-powered logging equipment. Although the facility operates redundant logs and panels, the permittee indicated that they have sporadic issues with their temperature monitoring equipment malfunctioning. The permittee requested that they be allowed to take grab samples for temperature instead of the current continuous monitoring requirement.

Figure 21: Temperature meter and log and flow gage at Outfall 001.

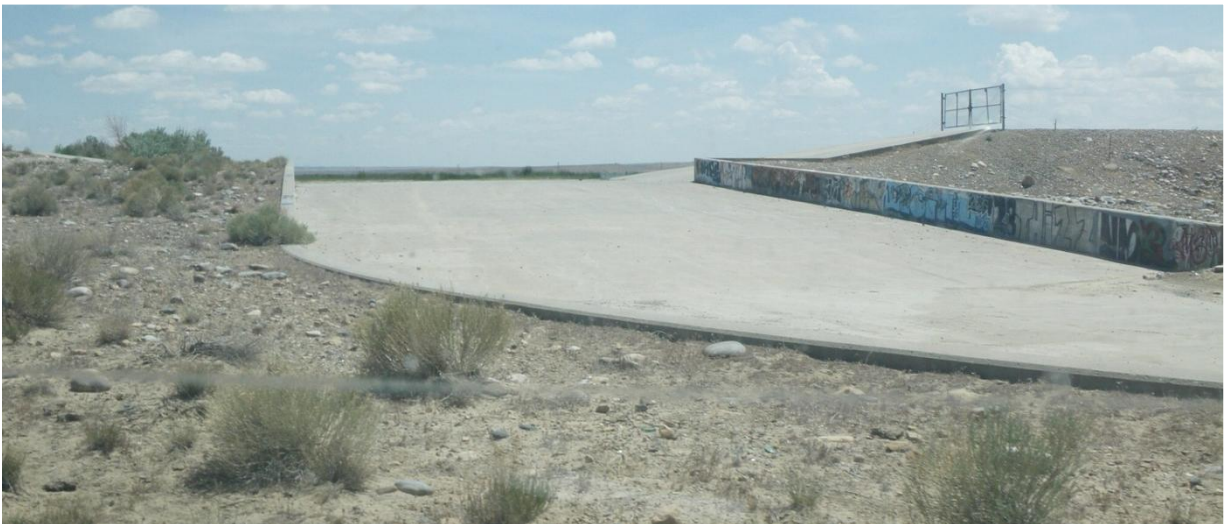
In addition to the outfall, a spillway (**Figure 22**) connects the Lake to the wash. A facility representative indicated that they have never had a discharge from the spillway other than incidental blow over from heavy wind.

- Potential discharges from a designated Morgan Lake spillway are not regulated in the NPDES Permit. Although this is not a regular outfall, provisions for potential discharge monitoring and reporting should be covered under the permit.

Figure 22: Morgan Lake Spillway.
