**ARIZONA PUBLIC SERVICE COMPANY'S RESPONSE TO
PETITION FOR REVIEW**

ATTACHMENT 24

**US ENVIRONMENTAL PROTECTION AGENCY
NAVAJO NATION
COMPLIANCE EVALUATION INSPECTION
MAY 8, 2012**

Facility: APS Four Corners Power Plant, NN0000019

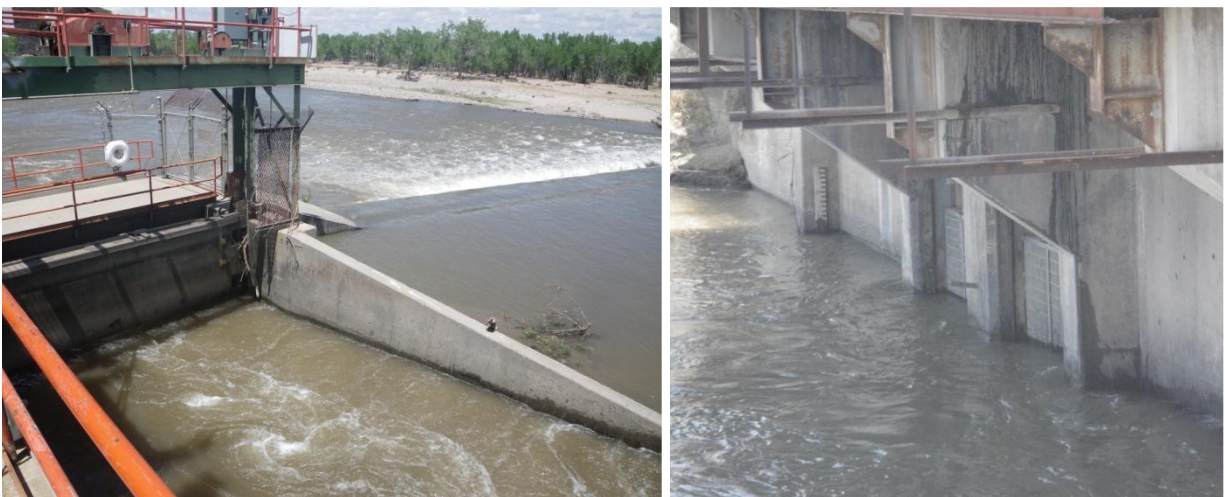
Morgan Lake is restocked with water from the San Juan River through an intake and diversion structure located on the side of the river (**Figure 23**). Facility representatives indicated that they pull no more than 48 MGD from the river to pump up to the lake.

Figure 23: Diversion structure and intake screens along bank of San Juan River.

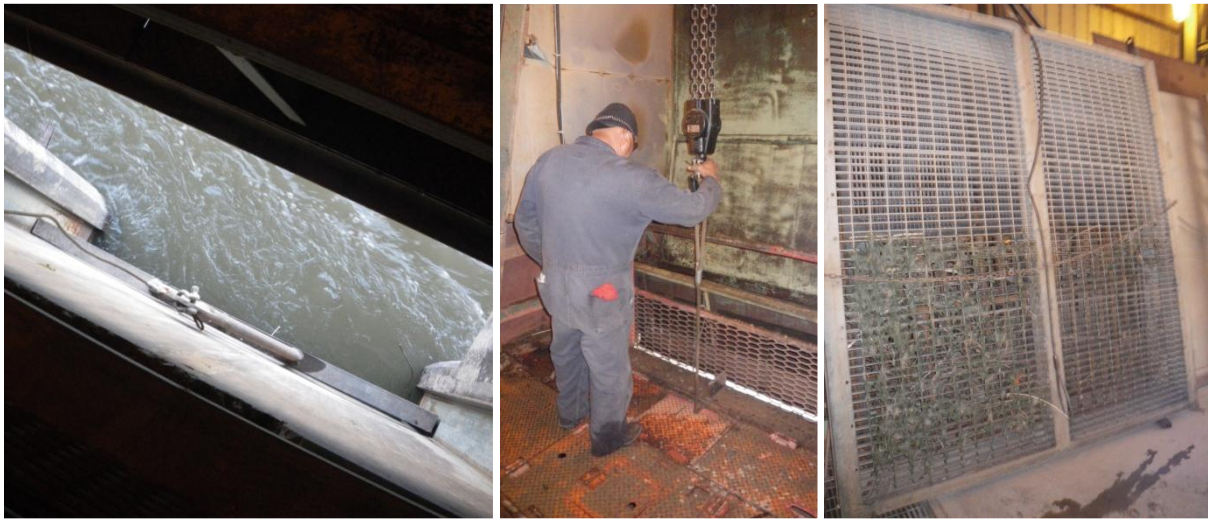
The intake structure consists of two side-by-side screens on the bank of the river. Screens are cycled once per day or more frequently, if necessary (this usually happens in the spring). Slots in the screen measured 3 inches by 1.5 inches. During the inspection, an operator removed a screen to demonstrate the removal process. A recently replaced screen sat next to the active screens and did not appear to be excessively obstructed (**Figure 24**). Facility representatives estimated the through-screen intake velocity from the river to be close to 0.5 ft/s.

Figure 24: Intake screen before, during and after daily removal and replacement.

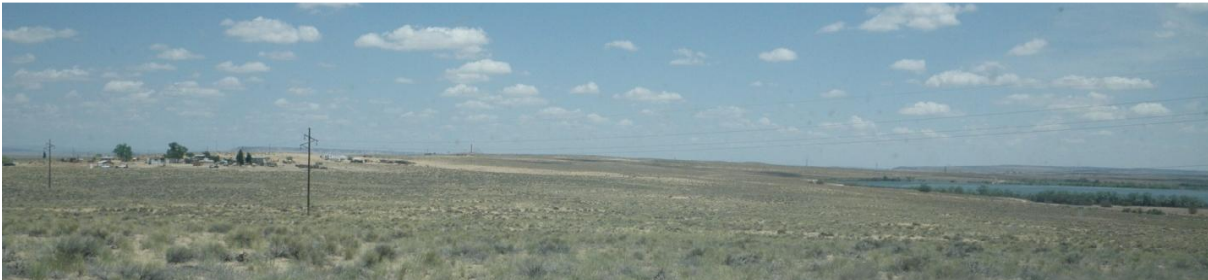
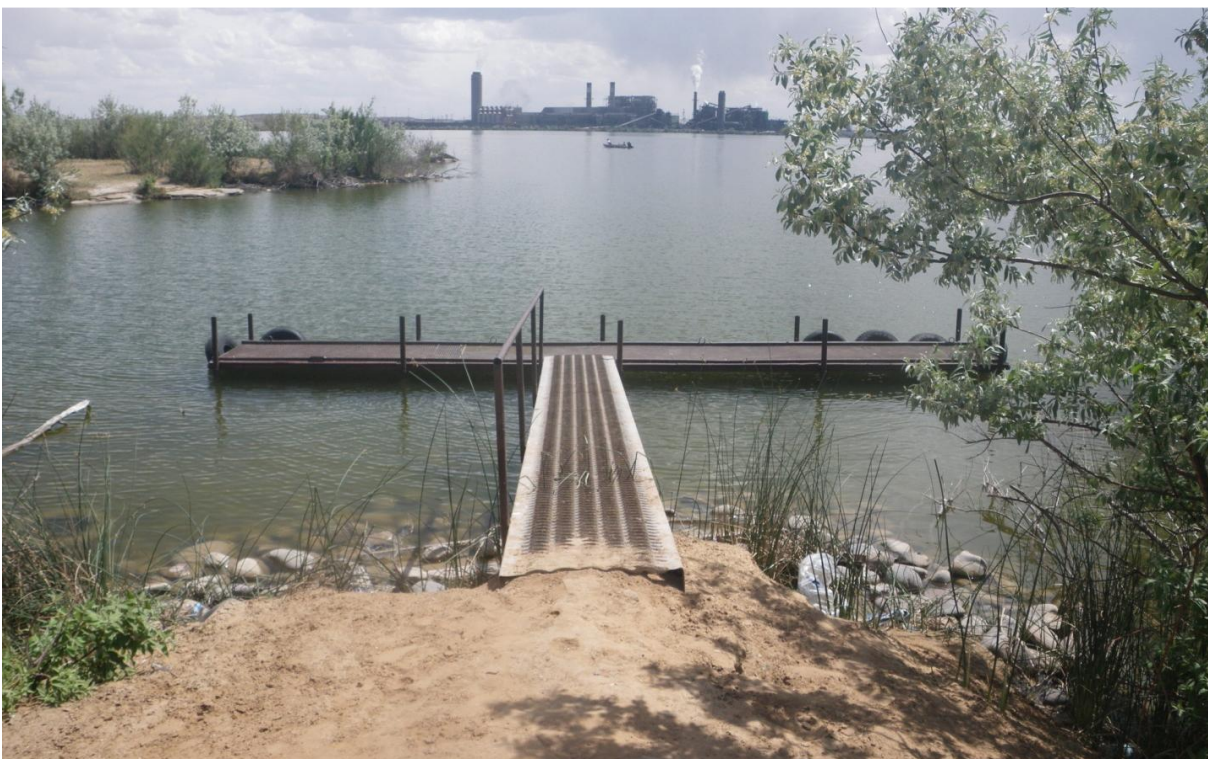
Nearby residents live within 2,000 feet of the lake. Common recreational activities on the lake include fishing, wind surfing and jet skiing. A publically accessible dock and boat ramp are available on the north side of the lake (**Figure 25**).

Figure 25: Morgan Lake. Above: Residences on left within 2,000 feet of lake. Below: Publicly accessible dock and fisherman in lake.
