Attachment 7
Site Inspection Report

Site Inspection Report

Des Moines TCE Site
September 2007

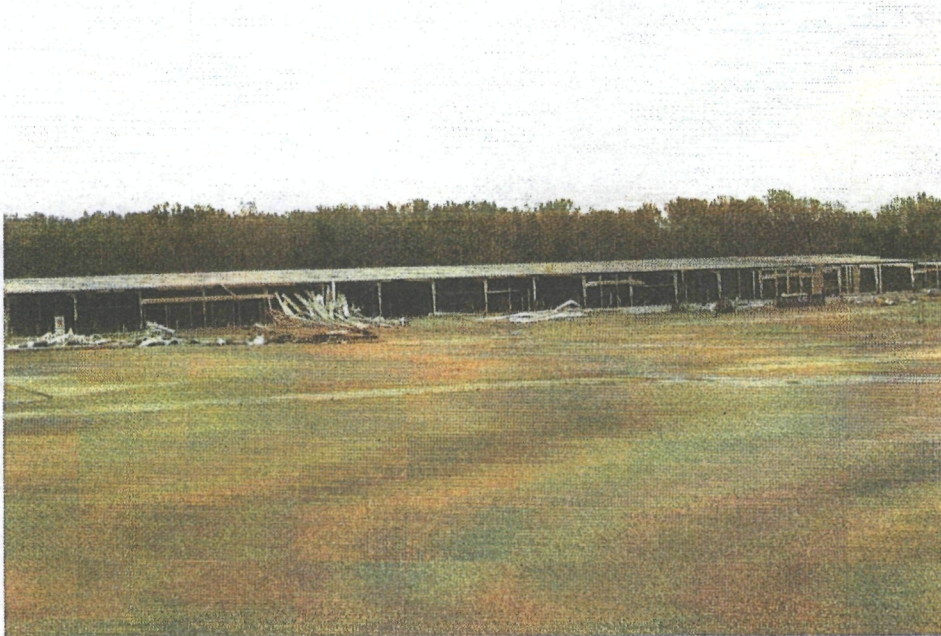
OU2/OU4: The buildings, the asphalt cap, and the South Pond drainage area and ditch east of the site were included in the inspection of OU2 and OU4. The most notable change is the demolition of building 4/5. Dico indicated that the building support structures are being sold and will be erected at another site. Sheet metal will be recycled and other materials will be sent offsite for disposal. The concrete foundation will remain in place. Louis Barrentine indicated that he will provide documentation to EPA regarding the disposition of materials leaving the site. Photographs 1, 2, and 3 depict building 4/5 in the process of demolition.

Dico Building 4/5 demolition; view to the east
9/19/07

1. Send IDNR a copy of the Performance Evaluation Report No. 21.
2. Contact city regarding repair of monitoring well MH1-S.
3. Send a letter to Dico regarding the disposition of demolition debris from building 4/5, extraction system maintenance items, and responding to recommendations in the PER No. 21 report.
4. Contact city economic development office to get an update on the status of the Riverpoint West redevelopment project.
5. Consider an update of the risk assessment for soil exposures to evaluate potential future uses, and to incorporate any new risk assessment guidelines established since the original risk assessment was completed.

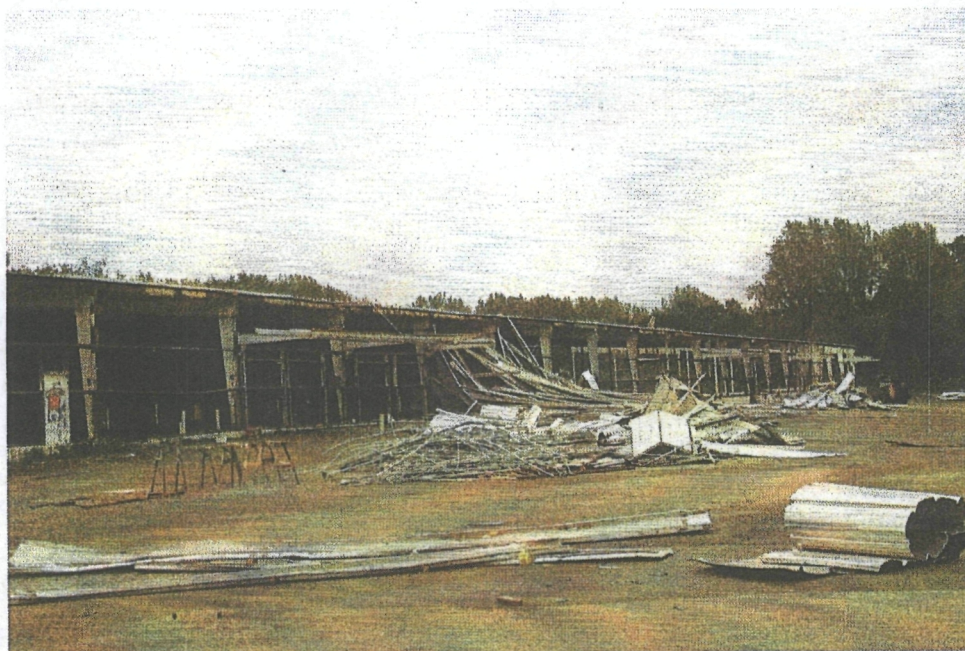
Dico Building 4/5 demolition; view to the south
9/19/07

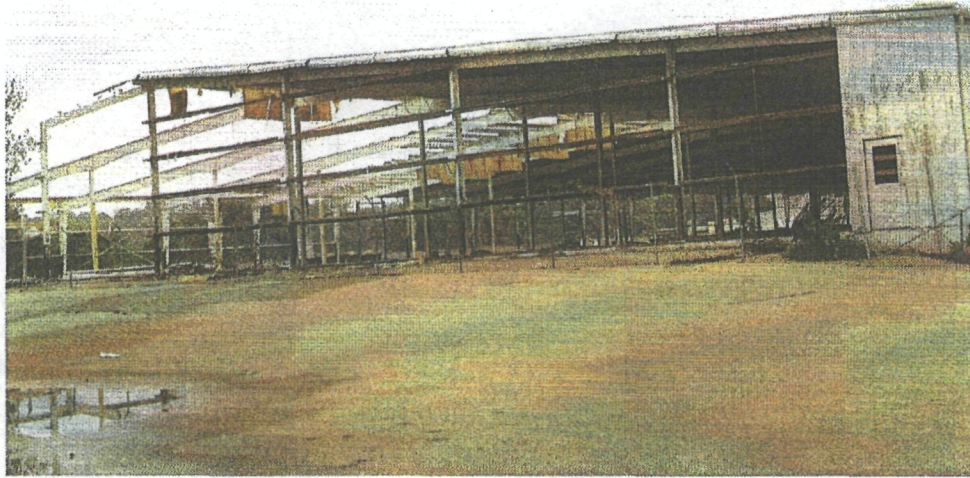
Dico Building 4/5 demolition; view to the northwest
9/19/07

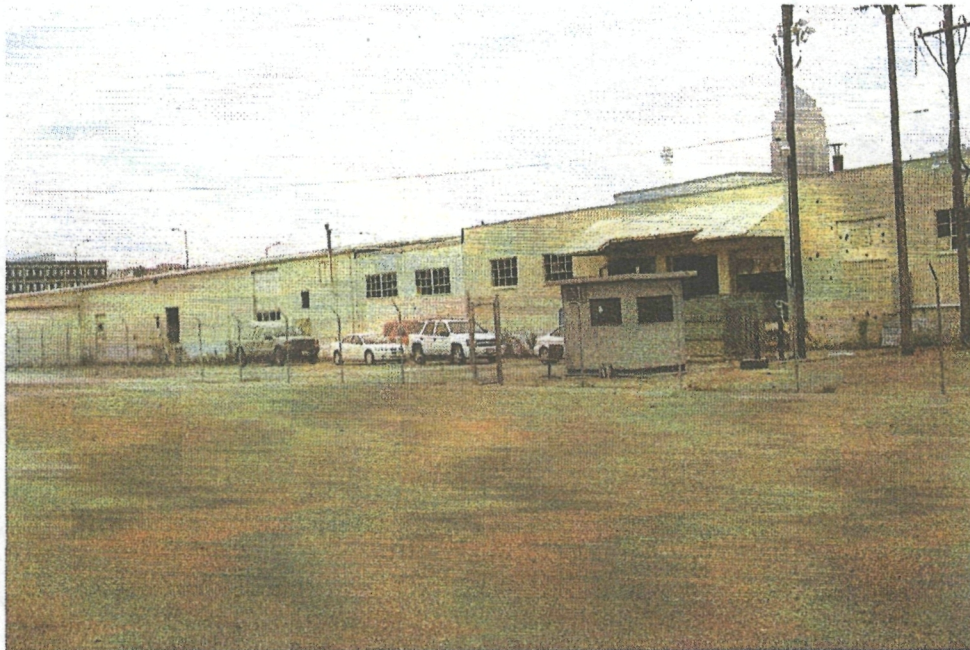
All other buildings remain intact. However, all windows have been broken out and most doors have been knocked in. Approximately 18 months ago, Dico erected a six foot chain link fence with barbed wire across the top to prevent trespassers from accessing the buildings on the property. Photograph 4 shows the fence and the Production building with the guard shack in the foreground. Photograph 5 depicts the general condition of the buildings at the site. Photograph 6 shows buildings 1-3 and the Maintenance building.

Dico Production Building; view to the east
Shows new security fencing and guard shack
9/19/07
