)
In re:	)
HAGERSTOWN AIRCRAFT SERVICES, INC.,	)
Respondent	)
Docket No. RCRA-03-2011-0112	)

### Report of Observations

RCRA ID #: Facility Name: Address: City: County:	Hagers		ces (HAS)	Generator St State: MD	atus: LQG Zip: 21742		
Site Contact: Title:	Kim P Owner	otter /Operator		Phone #: (30)	1) 733-7604		
Inspection Type:	CEI-O	n-Site		Activity #:			
Inspection Start Date: May 3 <sup>rd</sup> , 2013 End Date: May 3 <sup>rd</sup> , 2013							
MDE Lead Inspector: Anthony Enwer Other Inspector: Paul Sudano		Anthony Enweze Paul Sudano					
Documentation							
Photos/Videos taken			Other documentation				
Documents obtained from facility			Request for submission of documents				
Samples taken by	outside	source	Samples tak	ken by the Dep	artment		
Checklist:	⊠Gen	erator	TSI	D Facility

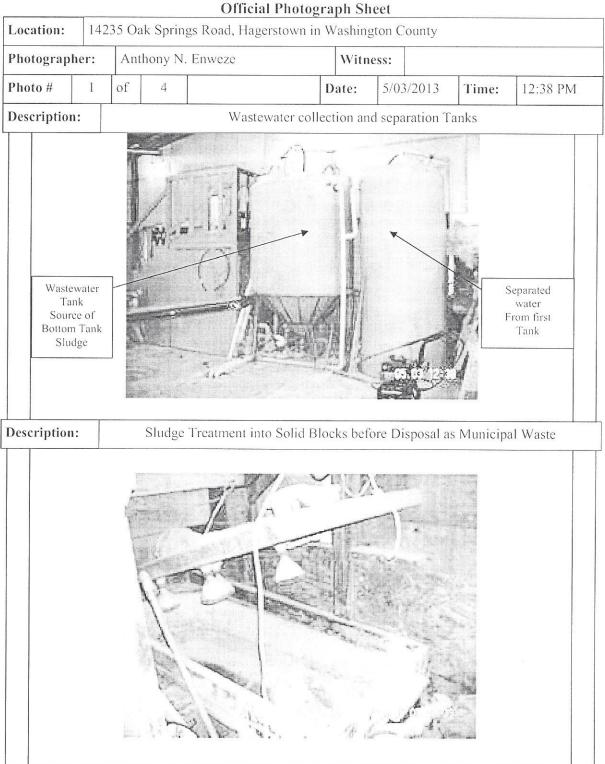
- 1. Two large tanks each of 500-gallon capacity used for storage and separation of wastewater from stripping operations. Mr. Sheffler stated that the first serves as the holding tank where water is separated leaving behind the bottom tank sludge. He stated that pH adjustment of the wastewater takes place in the tank by addition of corrosive liquid as needed. The tank sludge is pumped into a bath tub container where it is dried by heat into solid blocks and disposed in the trash as solid waste. I inquired if waste determination was done and Mr. Sheffler said no. In the same room were containers of Muriatic acid and bags of ferrous sulfate heptahydrate used to form the solid blocks from the tank bottom sludge.

Location:14235 Oak Springs Road, Hagerstown in Washington CountyPhotographer:Anthony N. EnwezeWitness:NonePhoto #2of4Date:5/03/2013Time:12:39Description:Solid Blocks of Sludge after Treatment
