RE: Emergency Administrative Order
Notice of Violation and Addendum
Docket No. SDWA-08-2010-0013
Birney Water System, 083090062
Muddy Cluster Water System,
083090065

Well Pump Failures

Birney Treatment Plant Problems

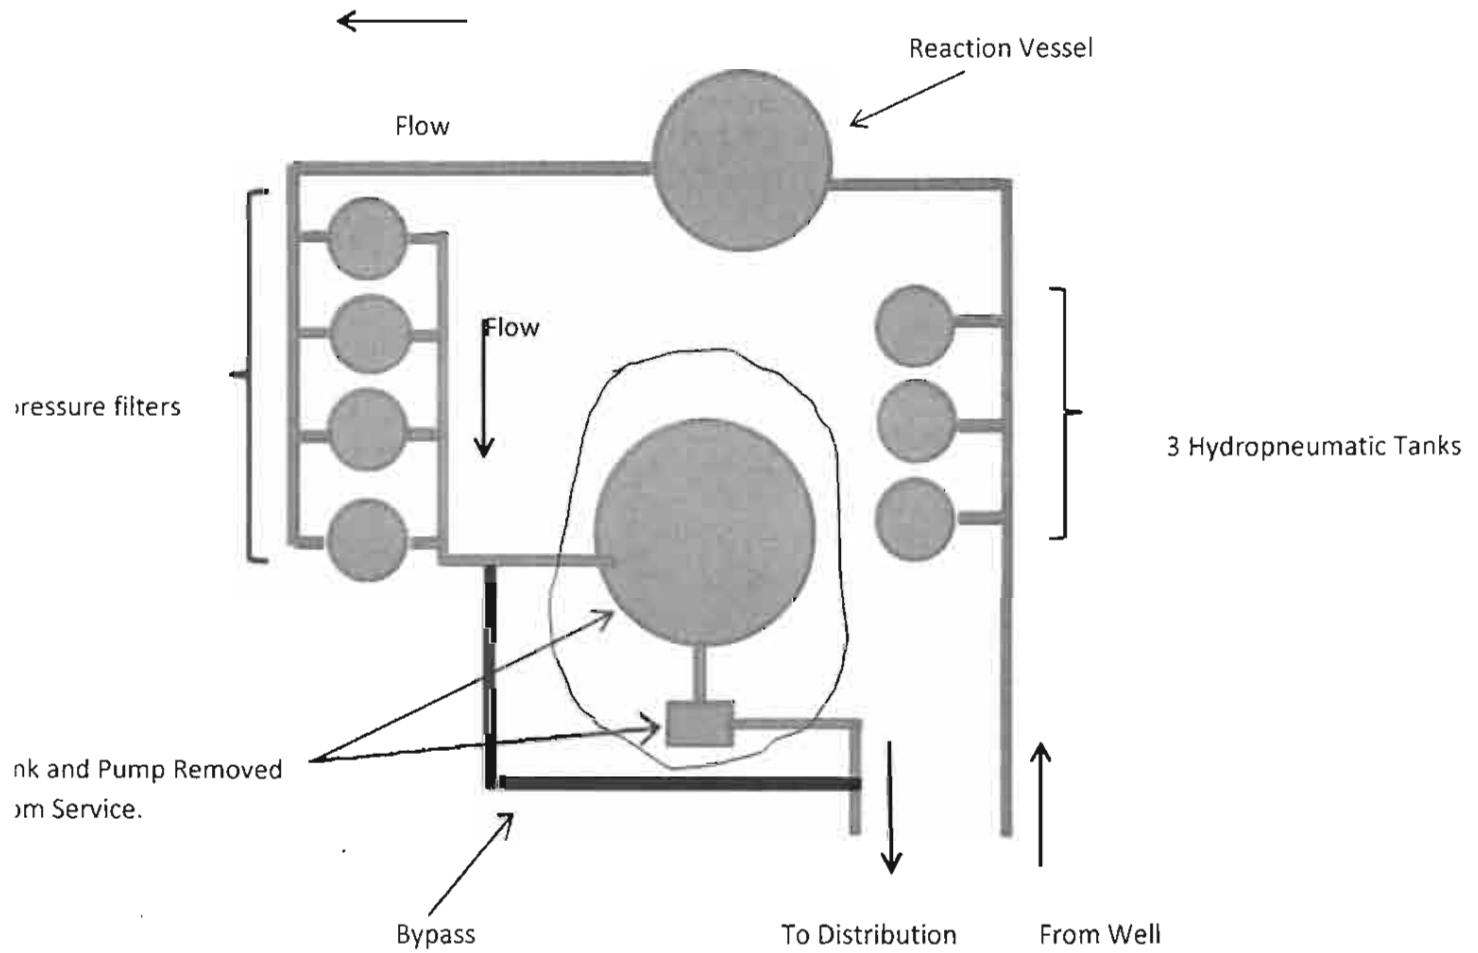
Birney Treatment Plant Schematic

Since initial construction the flow scheme has been altered. The storage tank and the booster pump were removed. A bypass was installed that allowed the well pump to discharge water through the treatment process and into the distribution system. On the above schematic I have circled the items that were removed from service and I have shown the bypass piping in black.

This alteration of the flow scheme has had several undesirable effects:

- 1) A flow restriction results in a rapid pressure build-up once the well turns on. This causes the well to turn off after 30 seconds of run time and to restart approximately 2-1/2 minutes later. This frequent cycling caused the previous well pump to fail after 5 months of service. The cause of this flow restriction is presently unknown and is discussed in further detail later in this report.

- 2) The flow restriction has reduced production through the plant to 6 gallons per minute. This production rate is insufficient to supply the demand from the community.

- 3) The elimination of the booster pump and the Mercoid switch has resulted in no level control for the elevated storage tanks. Recently installed telemetry, which was intended to supply this level control, is inoperable and the operators report that it has not functioned since installation.

- 4) The chemical metering pump for the sodium hypochlorite disinfection system operates continually, even when the well shuts down. This results in over-feeding of chlorine. This overdosing is not acute under the present flow conditions where the well runs for 30 seconds every three minutes, but once the plant is operating correctly severe overfeeding of chlorine will occur.

5) The storage tank and booster pump should be placed back into service at the Birney plant. This will result in a better control scheme for the plant and lower operating pressures.
