In the matter of: )  
)  
)  
Bruneau Cattle Co., ) DOCKET NO. CWA-10-2007-0016  
)  
Owyhee County, Idaho, )  
) COMPLAINANT'S AMENDED  
) PREHEARING EXCHANGE  
Respondent. )  
\_\_\_\_\_)

Observation of Flow and Canal Characteristics  
Southside Irrigation Canal  
June 29, 2007

Observation of Flow and Canal Characteristics  
Southside Irrigation Canal  
August 24, 2007

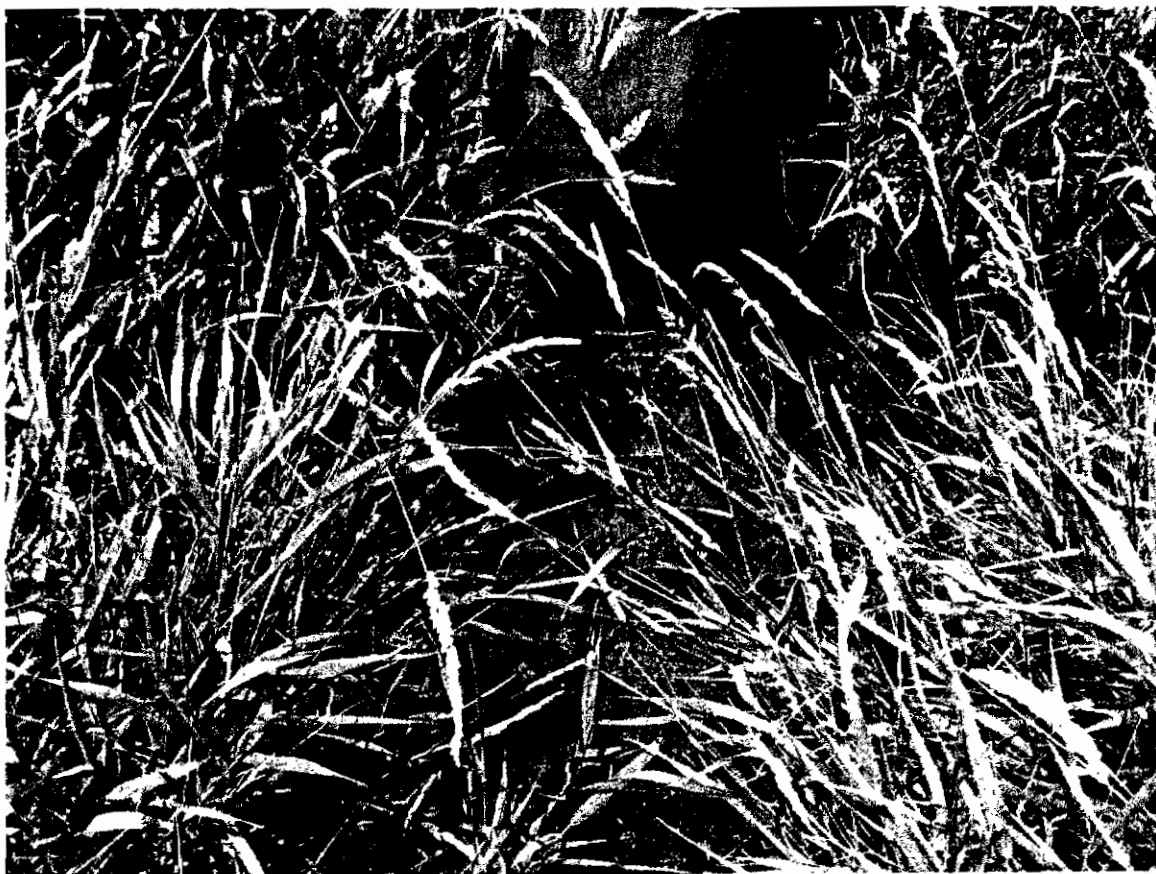
I took photographs 1 and 2 approximately 0.19 miles west of the location of our parked vehicle. I observed water flowing in the Southside Canal from the east to the west, or from the left to the right in both photographs 1 and 2. A cement structure had been placed in the Southside Canal at this point which narrowed the width of the canal and caused an increase in the speed of the flow at this location. I took photograph 3 from same location of photographs 1 and 2, on the north bank of the canal, looking west.

Photograph 1: Looking south, the photograph shows water flowing in the Southside Canal. The water was flowing from the east to the west or from the left to the right in the photograph.

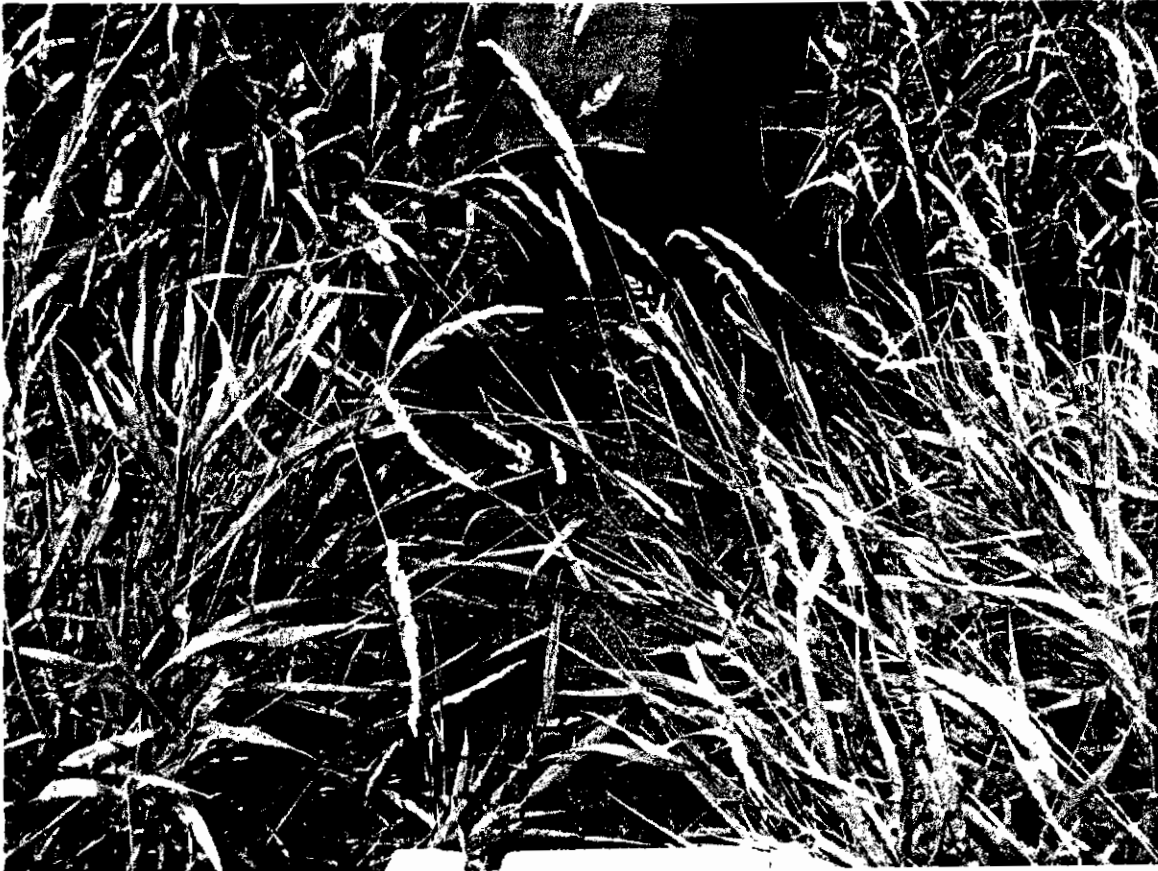
Photograph 2: Same location as photograph 1. Looking south, the photograph shows water flowing in the Southside Canal. The water was flowing from the east to the west or from the left to the right in the photograph.

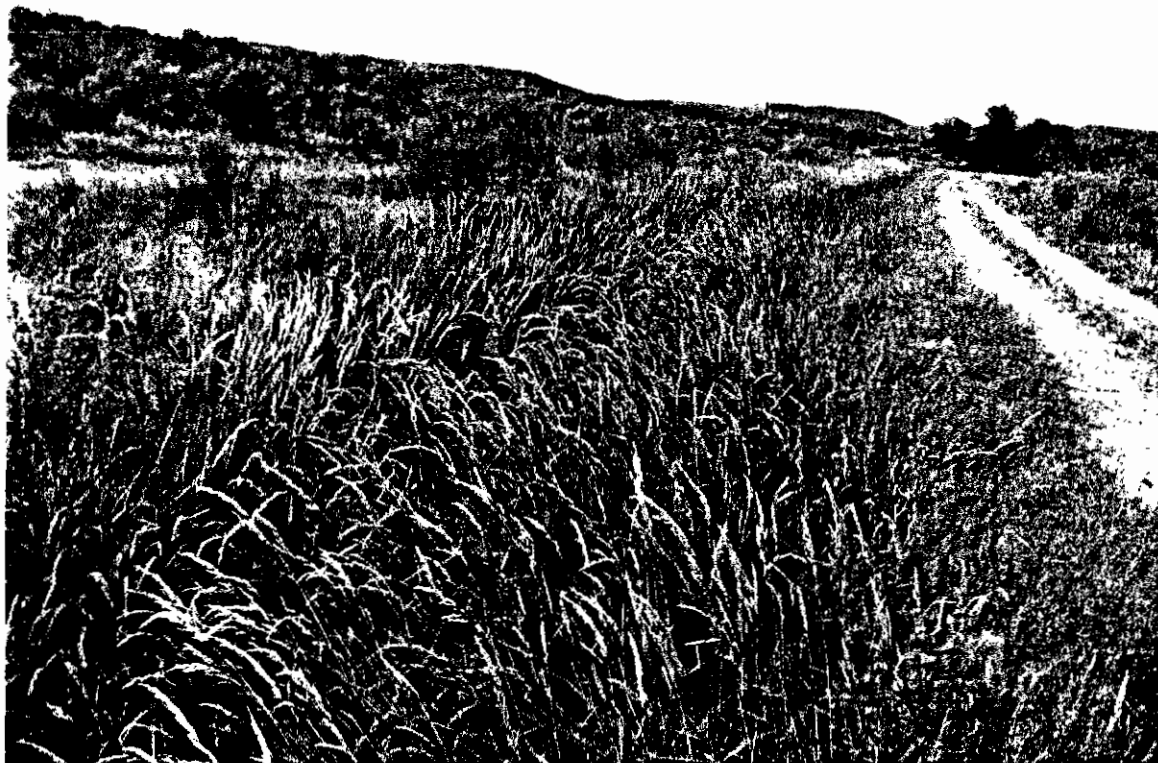
Photograph 3 shows dense green vegetation growing in and along the banks of the Southside Canal.

Photograph 3: Same location as photographs 1 and 2. The photograph was taken looking west along the Southside Canal. The Southside Canal contained dense green grass on the banks.

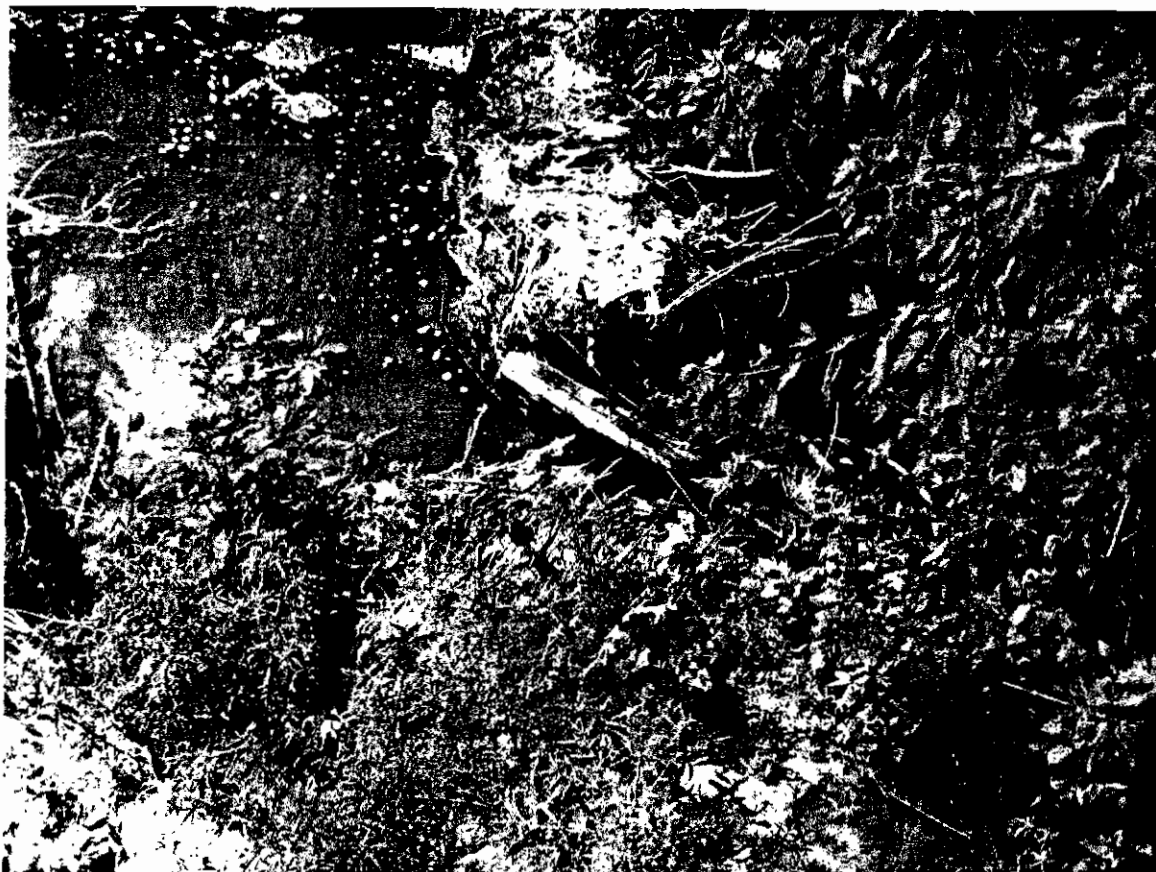
I took photographs 4 and 5 approximately 0.18 miles west of photographs 1-3 and 0.35 miles west of the location of our parked vehicle. At this location, the Southside Canal turned to the north and entered the C.J. Strike Reservoir approximately 0.02 miles to the north. I observed water flowing in the Southside Canal from the east to the west or from the left to the right in photographs 4 and 5. The flow of the Southside Canal was slowed or restricted by a buildup of branches and a log, and small pools had formed both above and below the branches and the log.

Photograph 4: Looking south, the photograph shows flowing water in the Southside Canal. The water was flowing from the east to the west or from the left to the right in the photograph. The buildup of branches and a large log caused the pooling of water both above and below the debris.

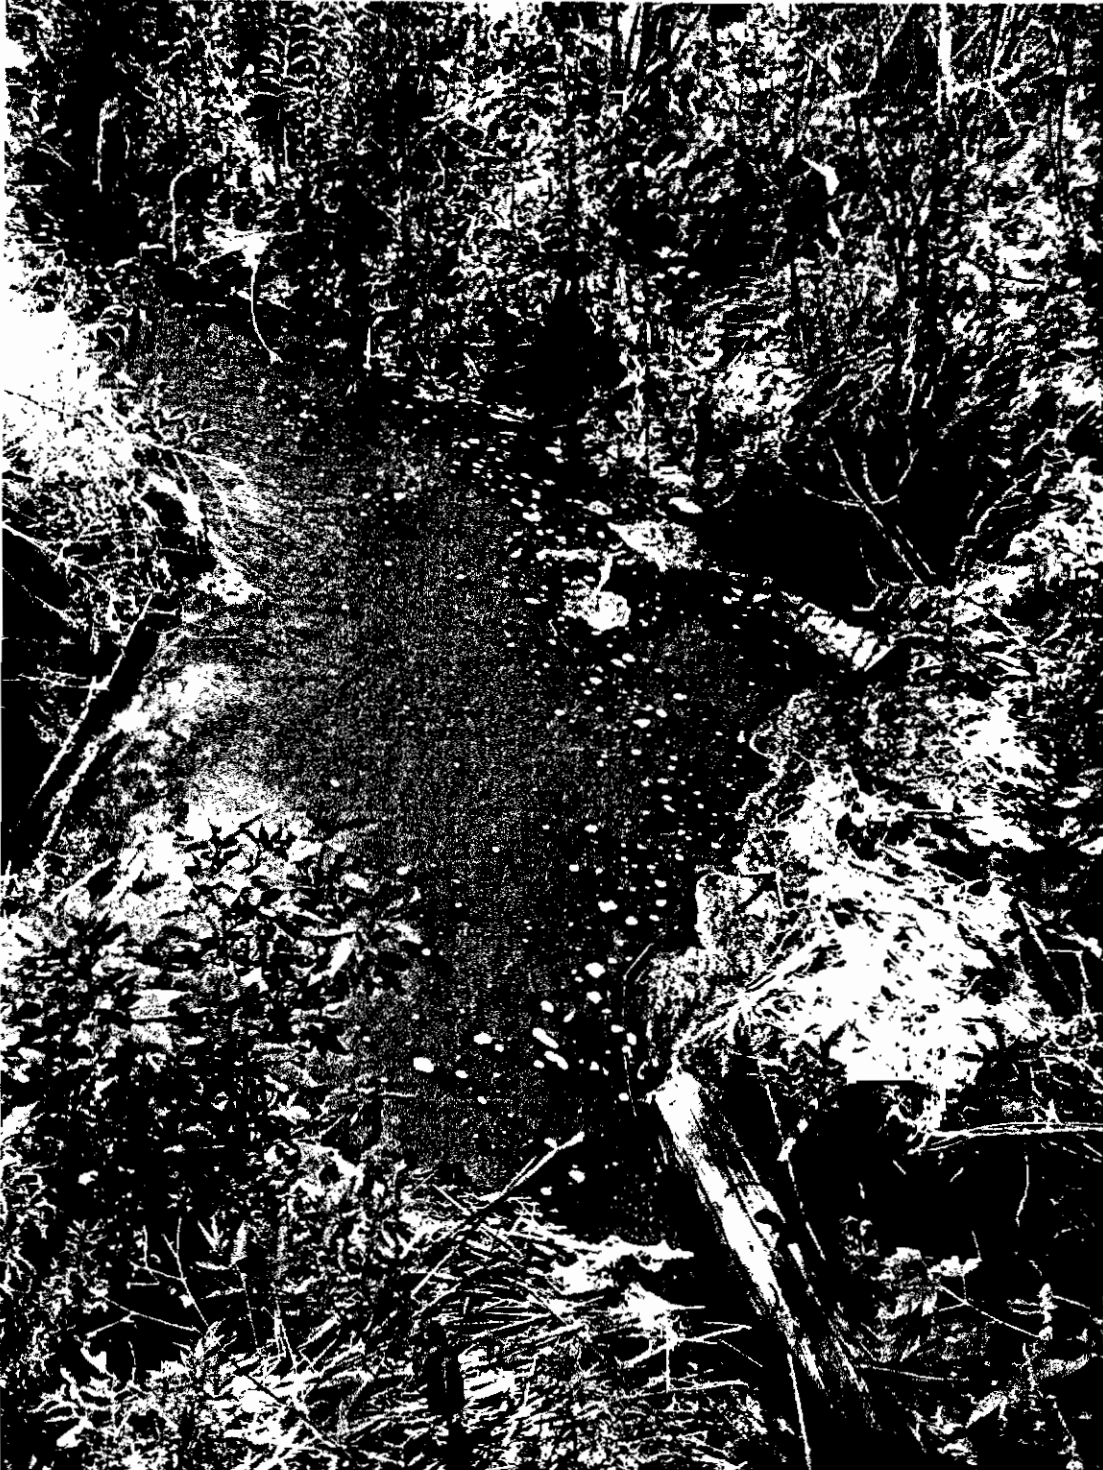
Photograph 5: Same location as photograph 4, looking east. Photograph shows flowing water in the Southside Canal. The water was flowing from the east to the west or from the top left corner to the lower right corner in the photograph. The buildup of branches and a large log caused the pooling of water both above and below the debris.

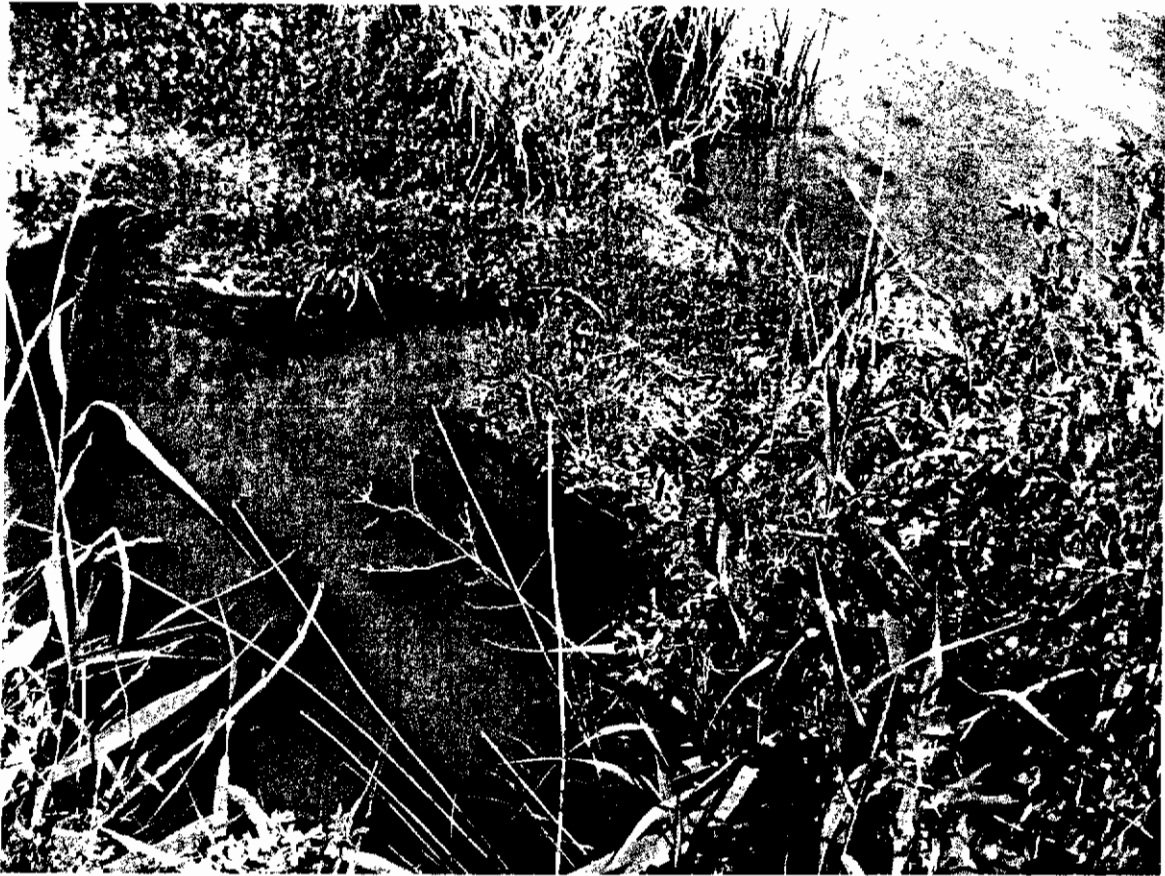
I took photographs 6-8 approximately 0.02 miles north of photographs 4 and 5, 0.20 miles west of photographs 1-3, and 0.55 miles west of the location of our parked vehicle. I observed water flowing in the Southside Canal from the south to the north or from the left to the right in photographs 6-8 and the water in the Southside Canal flowed into the C.J. Strike Reservoir at this location. Prior to entering the C.J. Strike Reservoir, the Southside Canal formed a small pool and I observed two smaller fish swimming in this pool. However, I was unable to identify the type or species of the two fish.

Photograph 6: Photograph shows the Southside Canal flowing into the C.J. Strike Reservoir. The water was flowing from the south to the north or from the left to the right in the photograph. Two small, unidentified fish were observed in the pool shown in the left portion of the photograph.

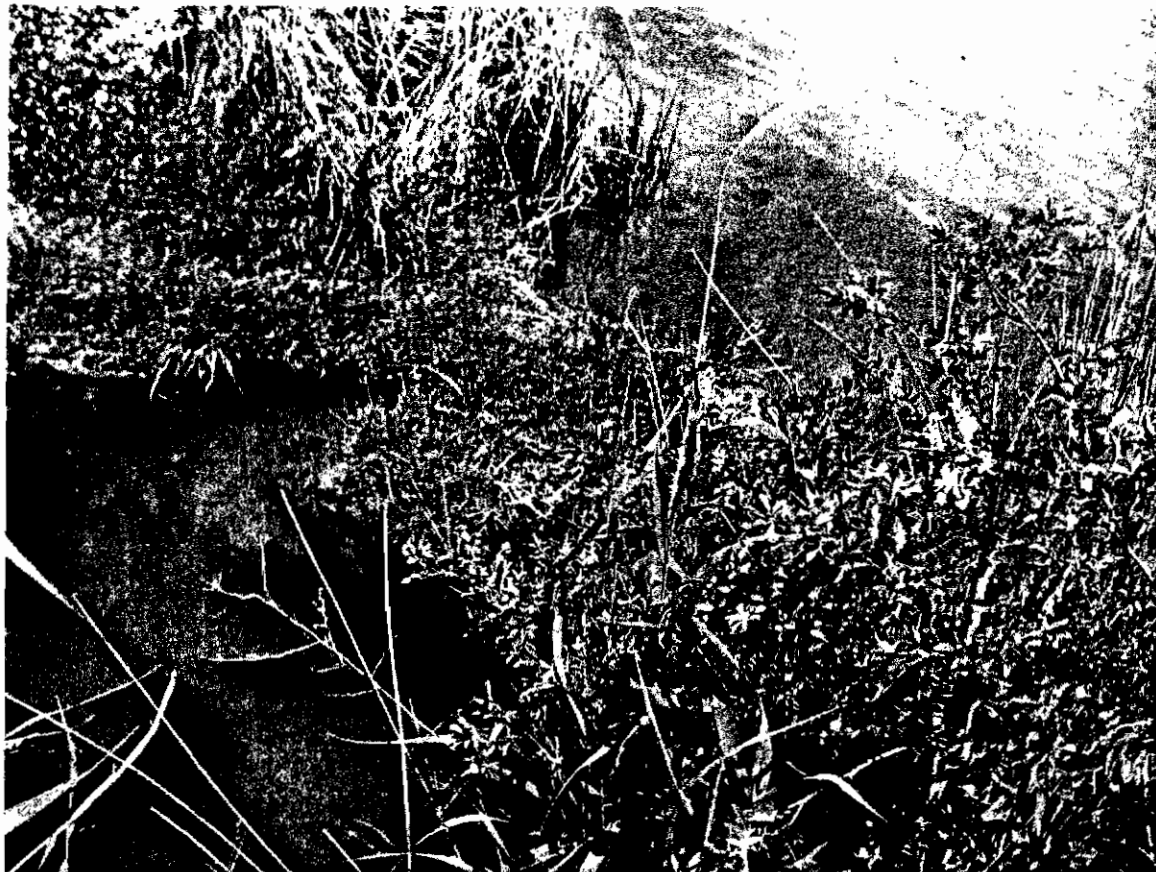
Photograph 7: Same location as Photograph 6. Photograph shows the Southside Canal flowing into the C.J. Strike Reservoir. The water was flowing from the south to the north or from the left to the right in the photograph. Two small, unidentified fish were observed in the pool shown in the left portion of the photograph.

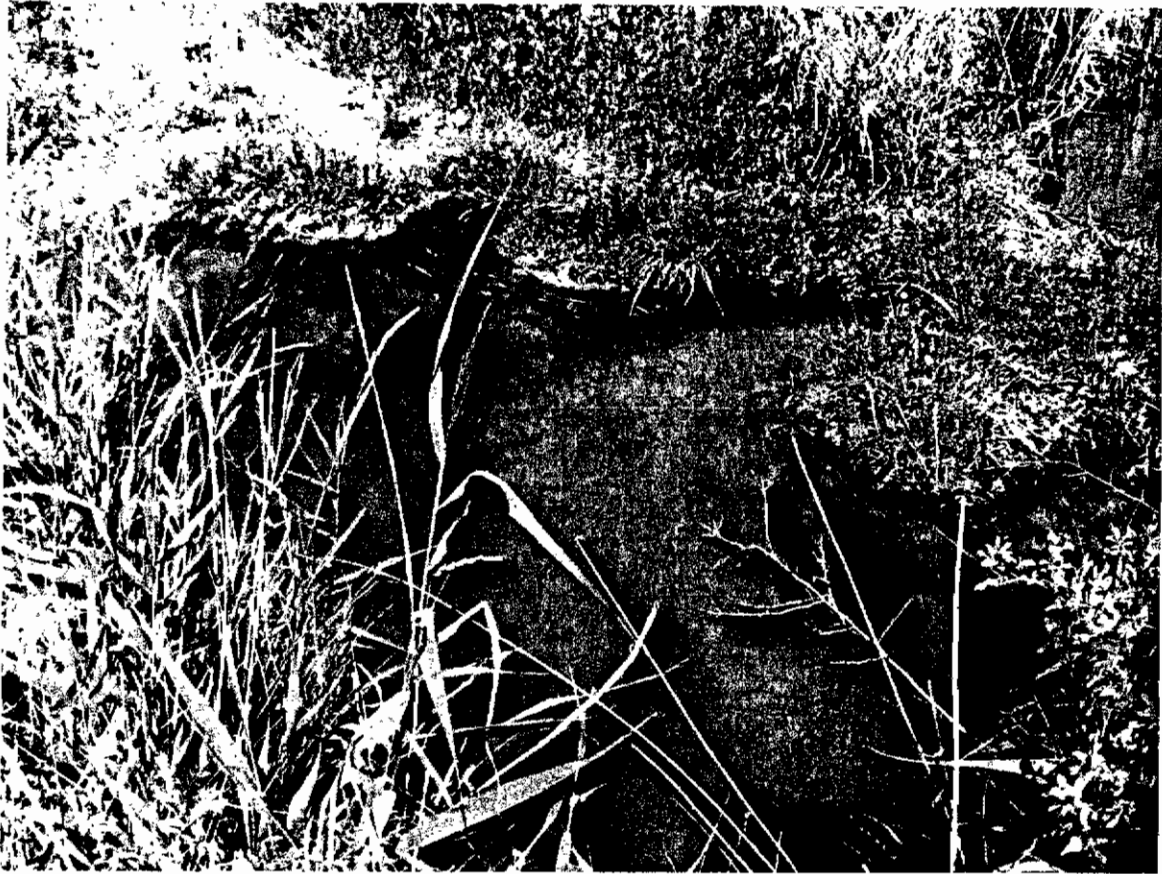
Photograph 8: Same location as Photographs 6 and 7. Photograph shows the Southside Canal flowing into the C.J. Strike Reservoir. The water was flowing from the south to the north or from the left to the right in the photograph. Two small, unidentified fish, were observed in the pool shown in the center portion of the photograph.

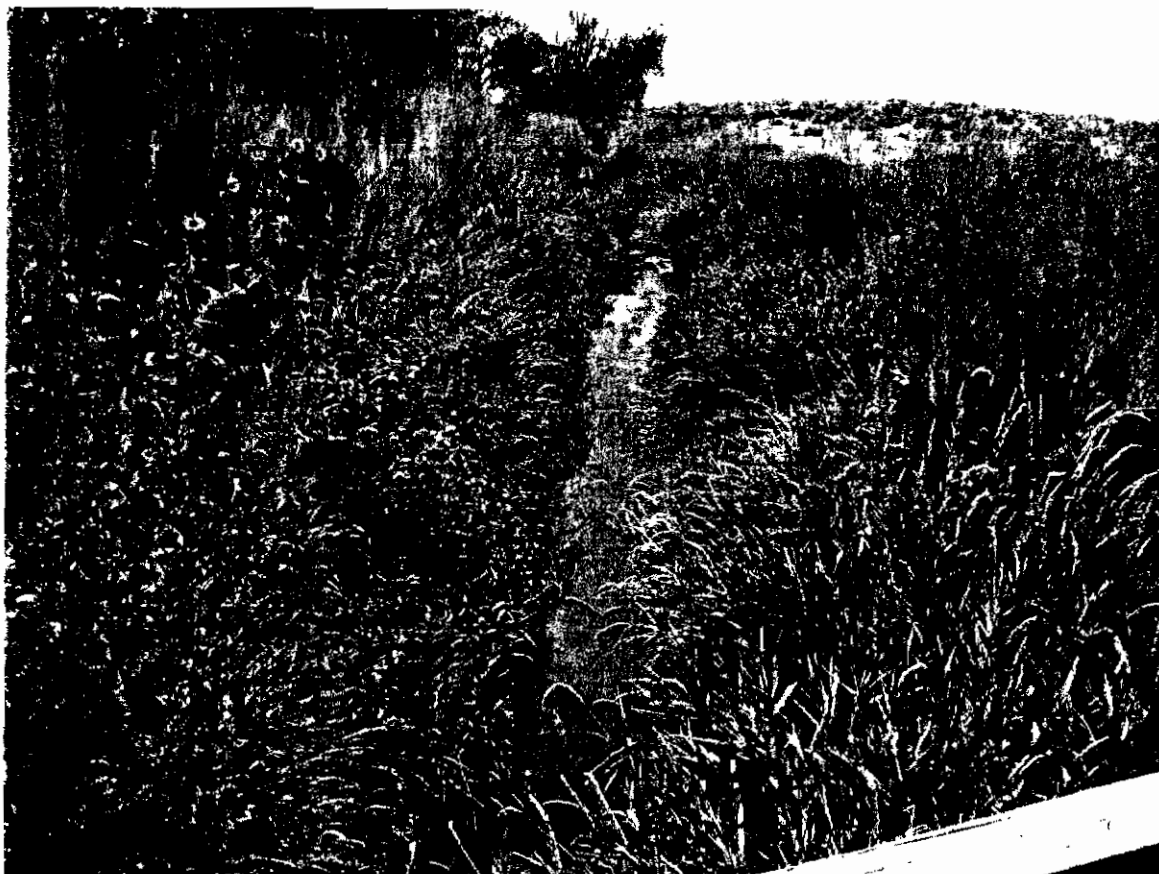
Cottonwood Road with the road to the boat ramp and campgrounds. At this location, I observed flowing water in the canal from the east to west, or from the top to the bottom of photograph 1, from the bottom to the top of photographs 2, and from the lower left corner to the upper right corner of photograph 3.

Photograph 1: Looking east at the location where the canal flowed underneath the road connecting the boat ramp to Cottonwood Road. The flow of water in the canal was from the east to the west or from the top to the bottom of the photograph.

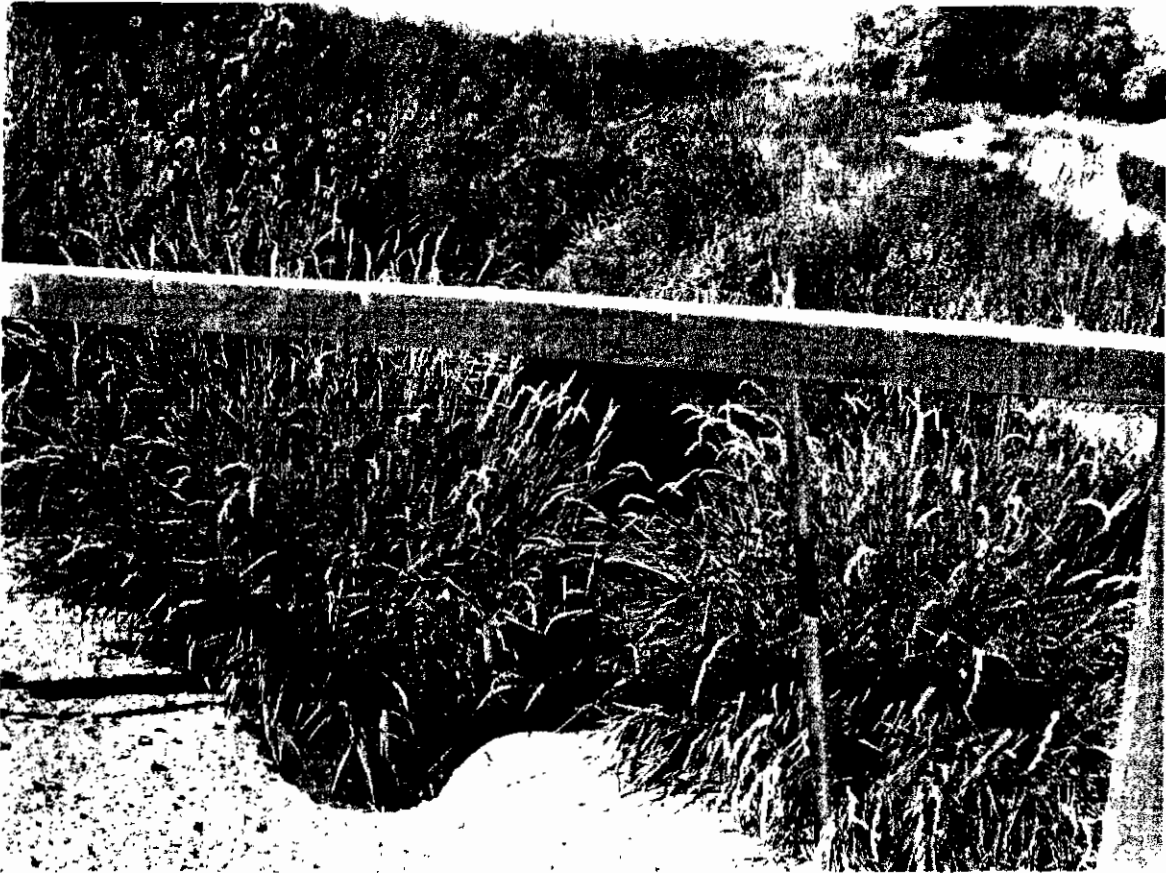
Photograph 2: Looking west at the location where the canal flowed underneath the road connecting the boat ramp to Cottonwood Road. The flow of water in the canal was from the east to the west or from the bottom to the top of the photograph.

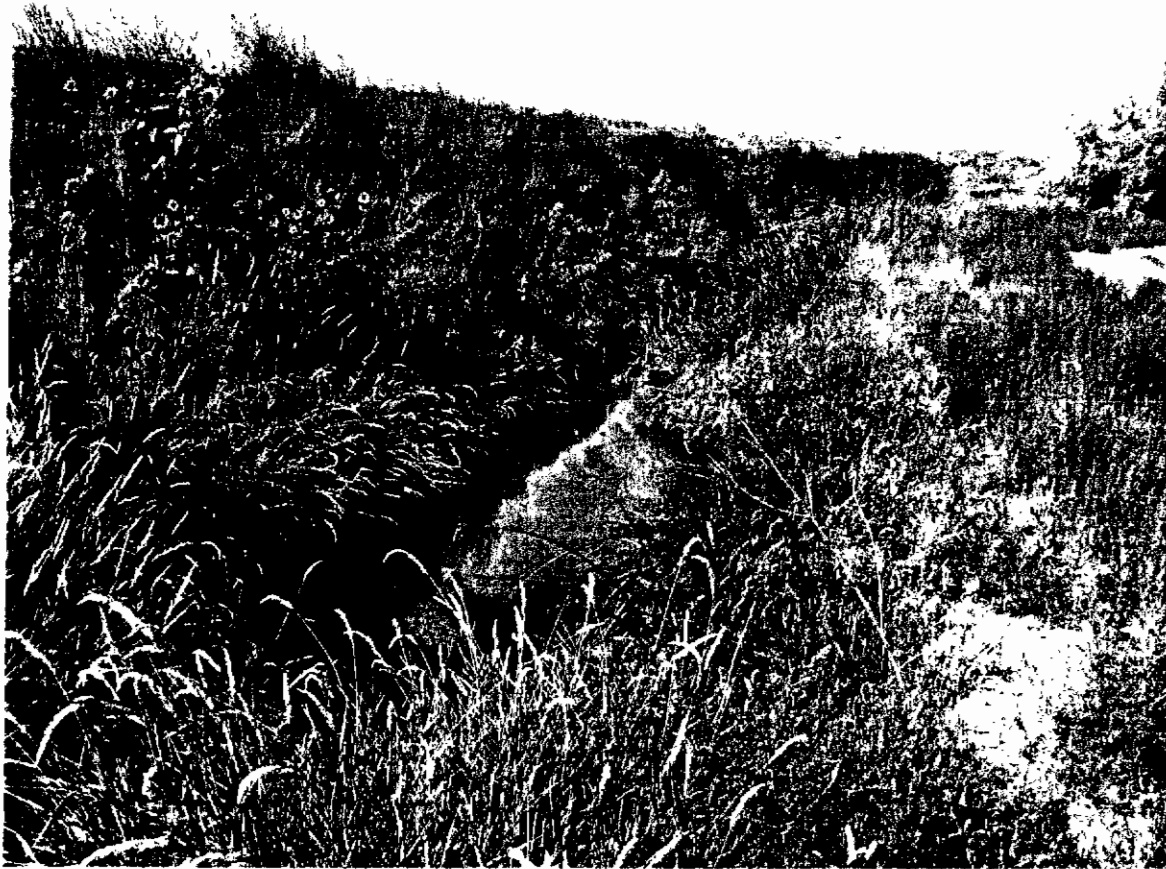
Photograph 3: Looking west at the location where the canal flowed underneath the road connecting the boat ramp to Cottonwood Road. The flow of water in the canal was from the east to the west or from the lower left corner to the upper right corner of the photograph.

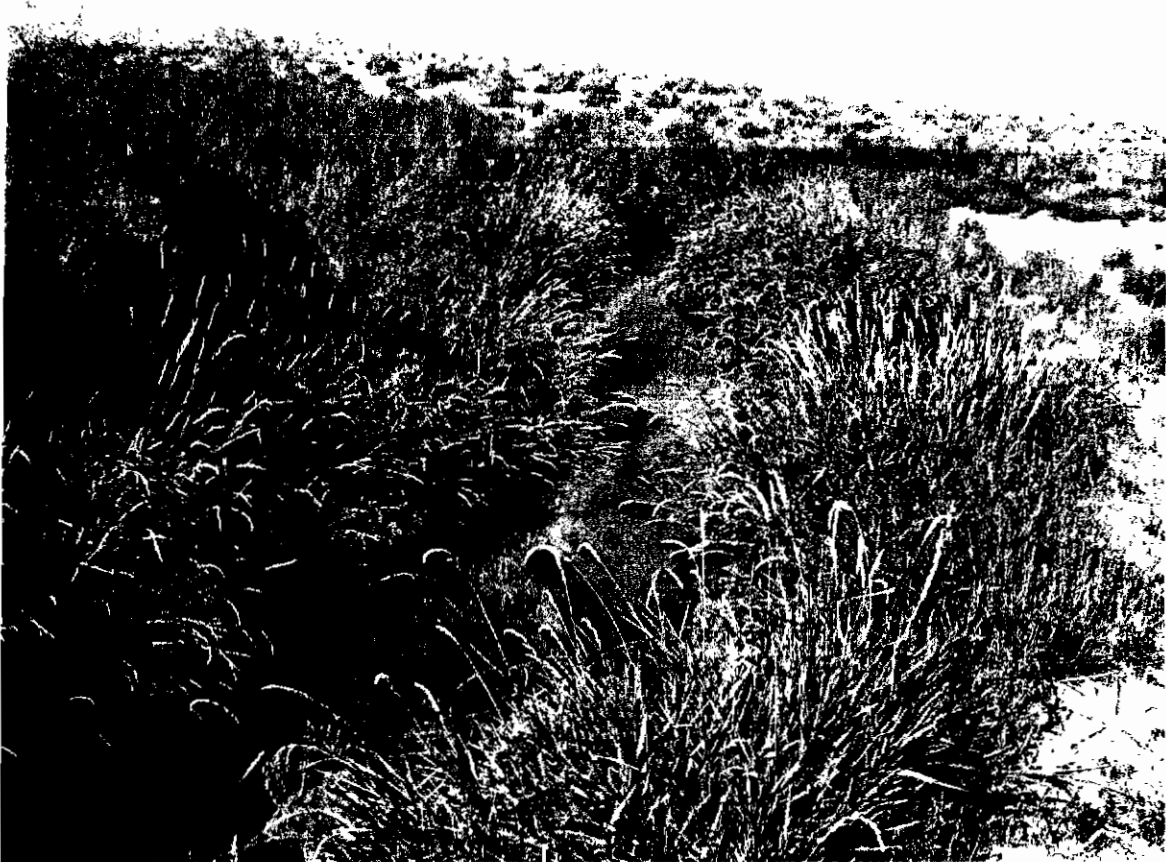
Photographs 4 and 5 were taken approximately 0.03 miles west from where the canal flows underneath the road, and photographs 1-3. I observed flowing water in the canal from the east to the west, or from the lower left corner to the upper right corner in photograph 4 and from the left side to the right side in photograph 5. In addition, I observed debris and/or algae being carried by the flow of the canal as shown in photograph 5.

Photograph 4: Looking west, the flow of water in the canal was from the east to the west or from the lower left corner to the upper right corner of the photograph.

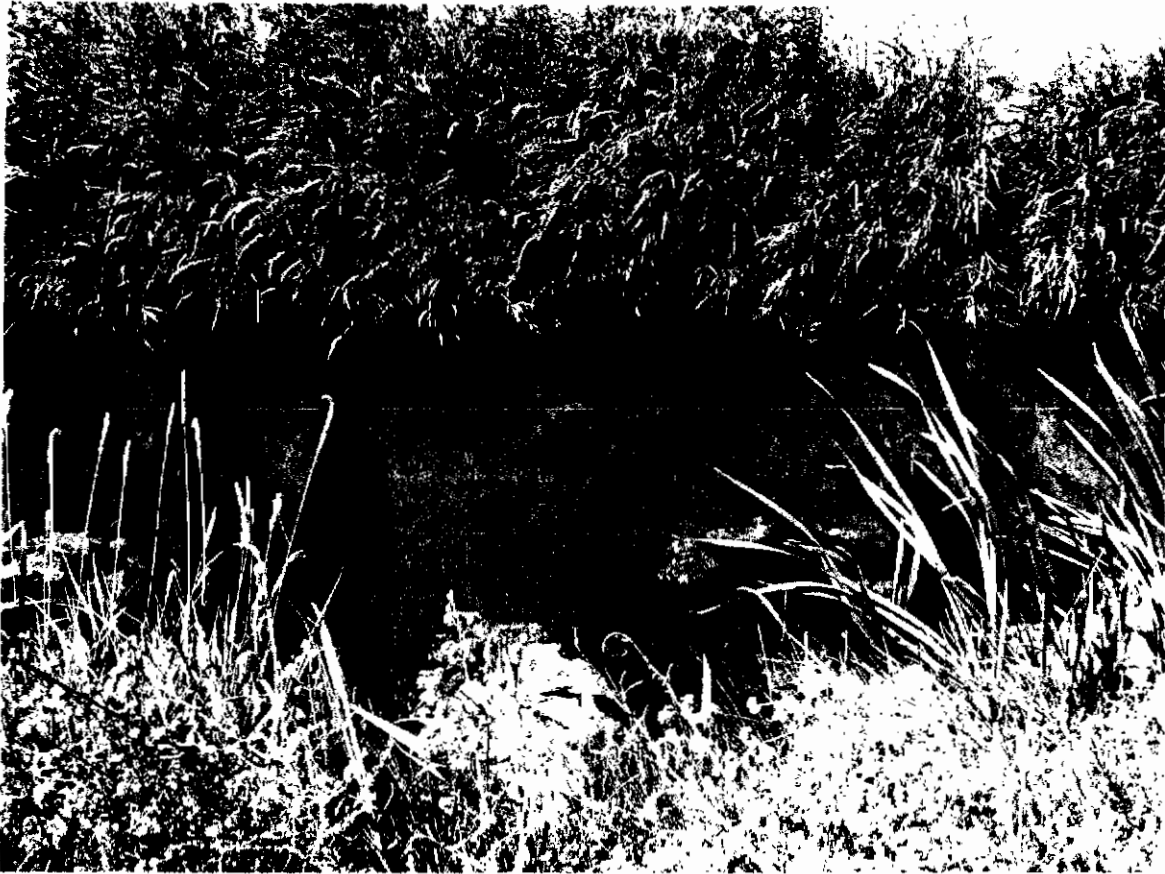
Photograph 5: Looking south, the flow of water of water in the canal was from the east to the west or from the left to the right in the photograph.

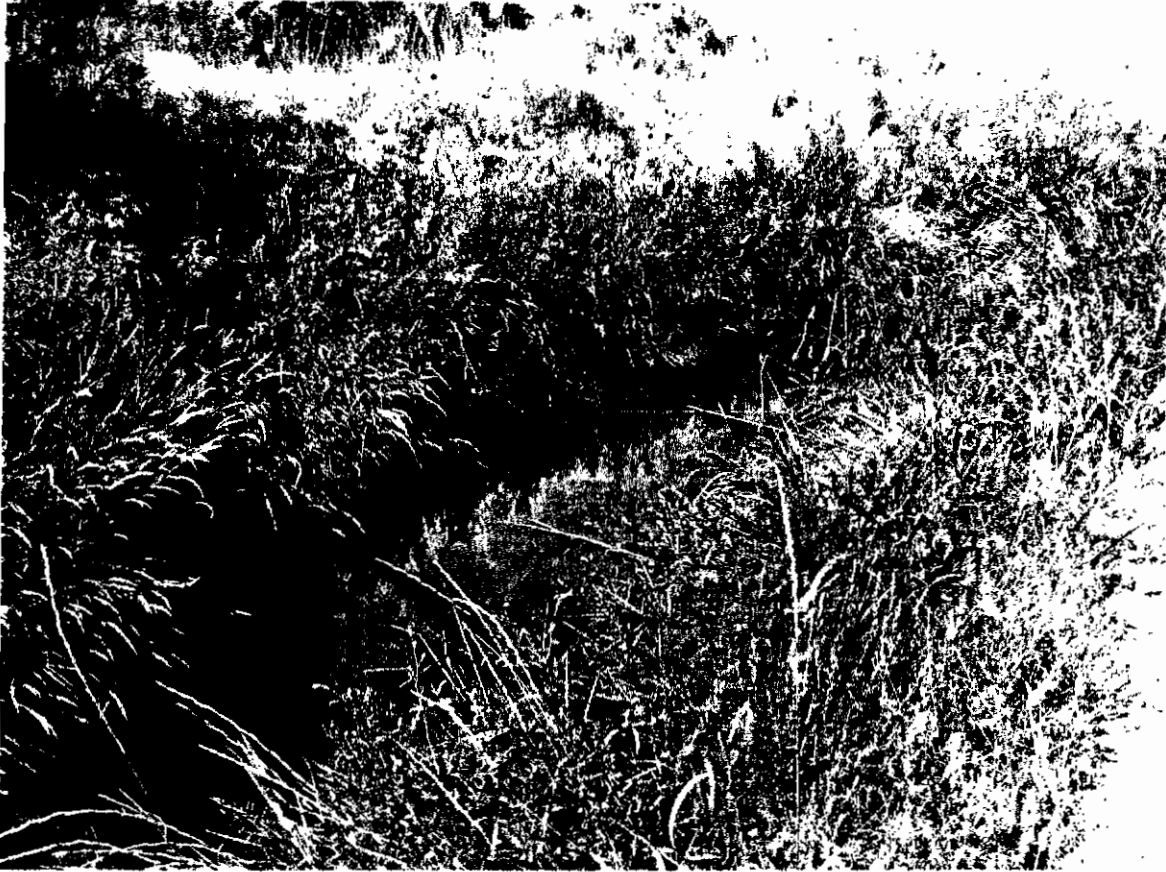
Photograph 6 was taken approximately 0.05 miles from where the canal flows underneath the road and photographs 1-3, or 0.02 miles west from the location of photographs 4 and 5. I observed flowing water in the canal from the east to the west, or from the lower left corner to the upper right corner of photograph 6.

Photograph 6: Looking west, the flow of water in the canal was from the east to the west or from the lower left corner to the upper right corner of the photograph.

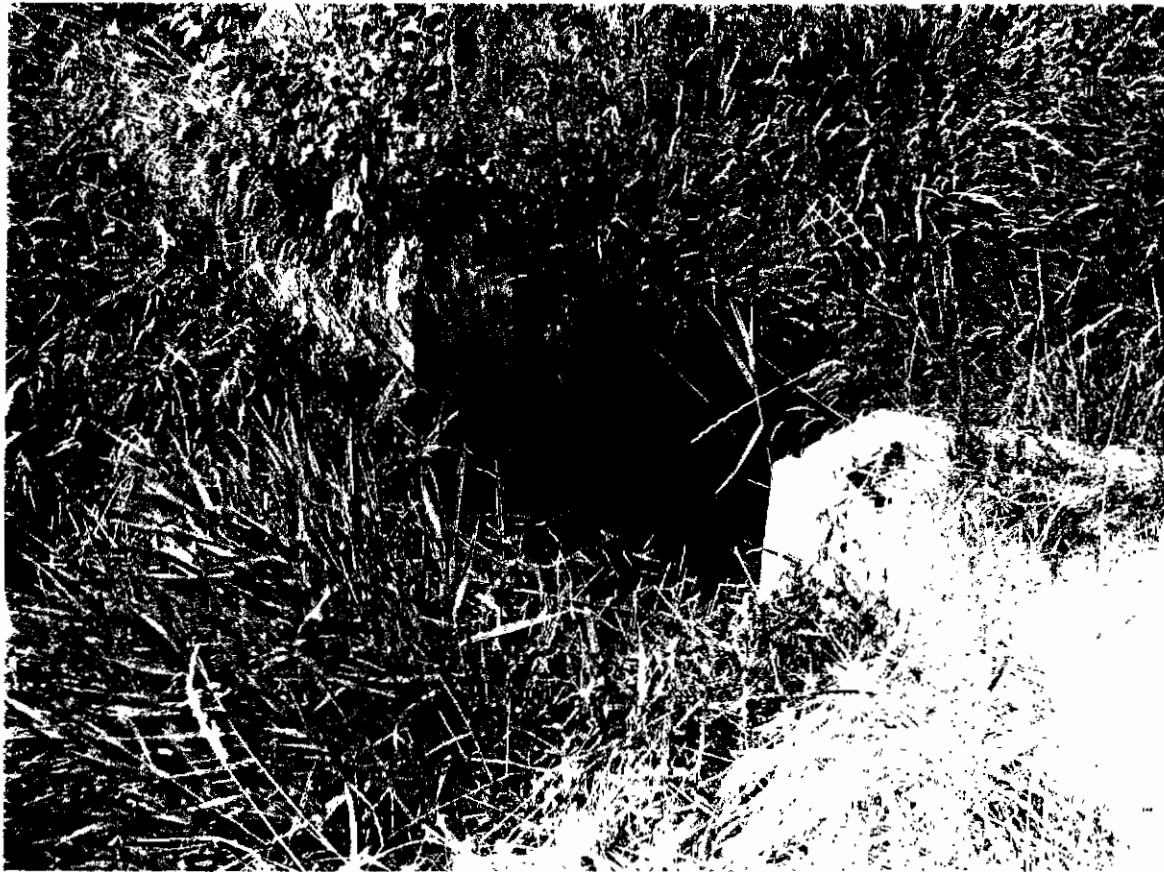
Photographs 7 and 8 were taken approximately 0.18 miles west of where the canal passes underneath the road and photos 1-3, or approximately 0.13 miles west of photograph 6. At this location, I observed a cement structure, which narrowed the width of canal and caused a visible increase in the speed of the water flow at this location. The flow of the water in the canal was from the east to the west or from the left side to the right side in photographs 7 and 8.

Photograph 7: Looking southwest, the flow of the water in the canal was from the east to the west or from the left to the right in the photograph. The concrete structure narrowed the width of the canal at this location.

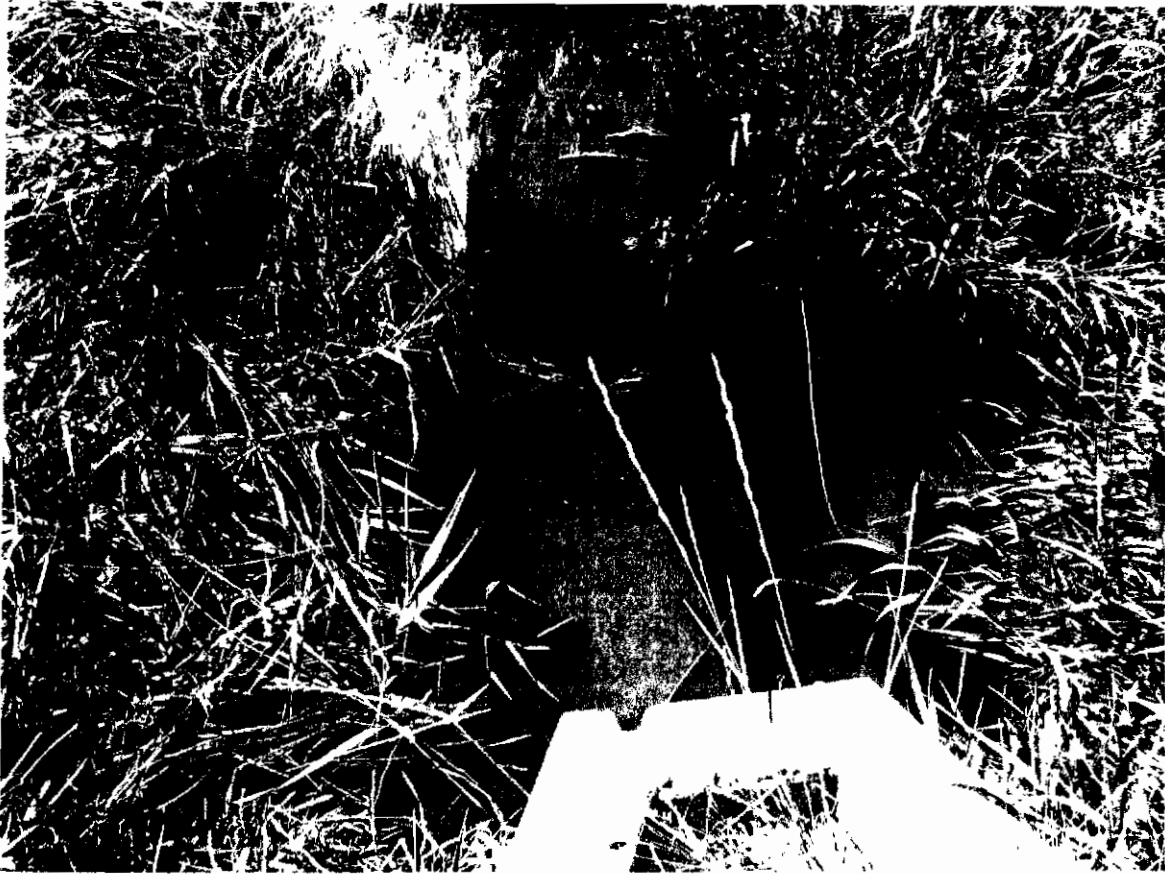
Photograph 8: Looking southwest, the flow of the water in the canal was from the east to the west or from the left to the right in the photograph. The concrete structure narrowed the width of the canal at this location.

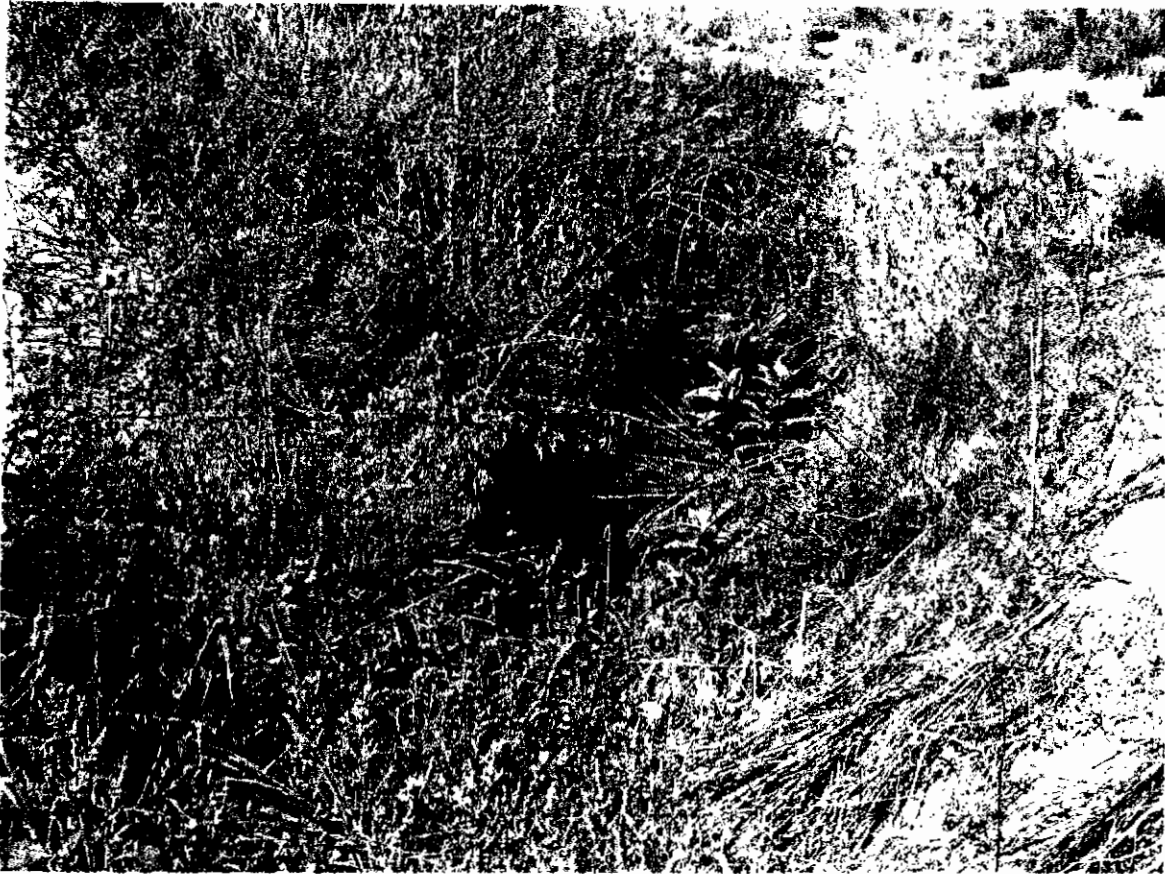
Photographs 9 and 10 were taken approximately 0.13 miles west of photographs 7 and 8 and a total of 0.31 miles west of the location where the canal flows underneath the road. I observed a rocky bottom substrate at this location and the canal appeared to be slightly wider and shallower than the previous locations documented in photographs 1-8. The rocky substrate created a riffle in the flow of the canal, as shown in photograph 10. The water was flowing in the canal from the east to the west, or from lower left corner to the upper right corner in photograph 9 and left to right in photograph 10.

Photograph 9: Looking west, the flow of water in the canal was from the east to the west or from the lower left corner to the upper right corner of the photograph.

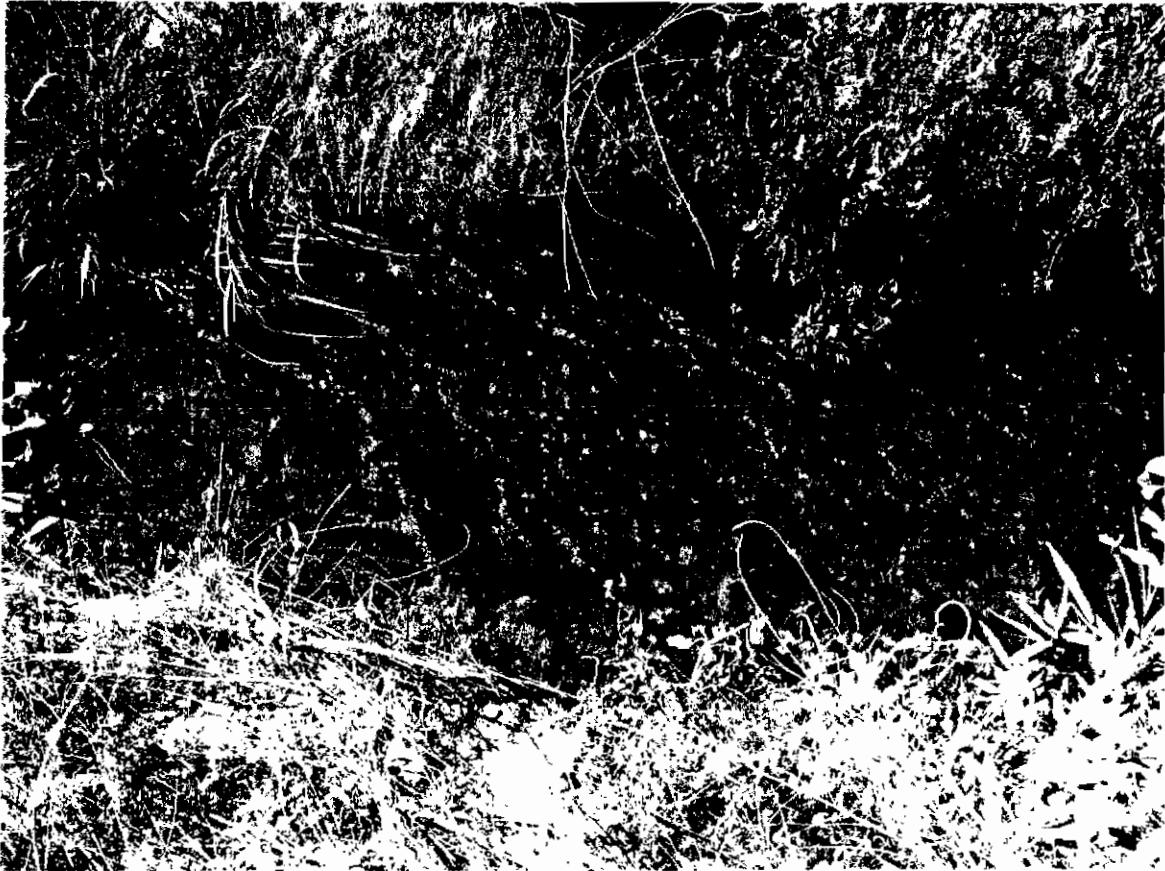
Photograph 10: Looking south, the flow of water in the canal was from the east to the west or from the left to the right in the photograph. Note the rocky bottom substrate causing a riffle in the flow of the canal.

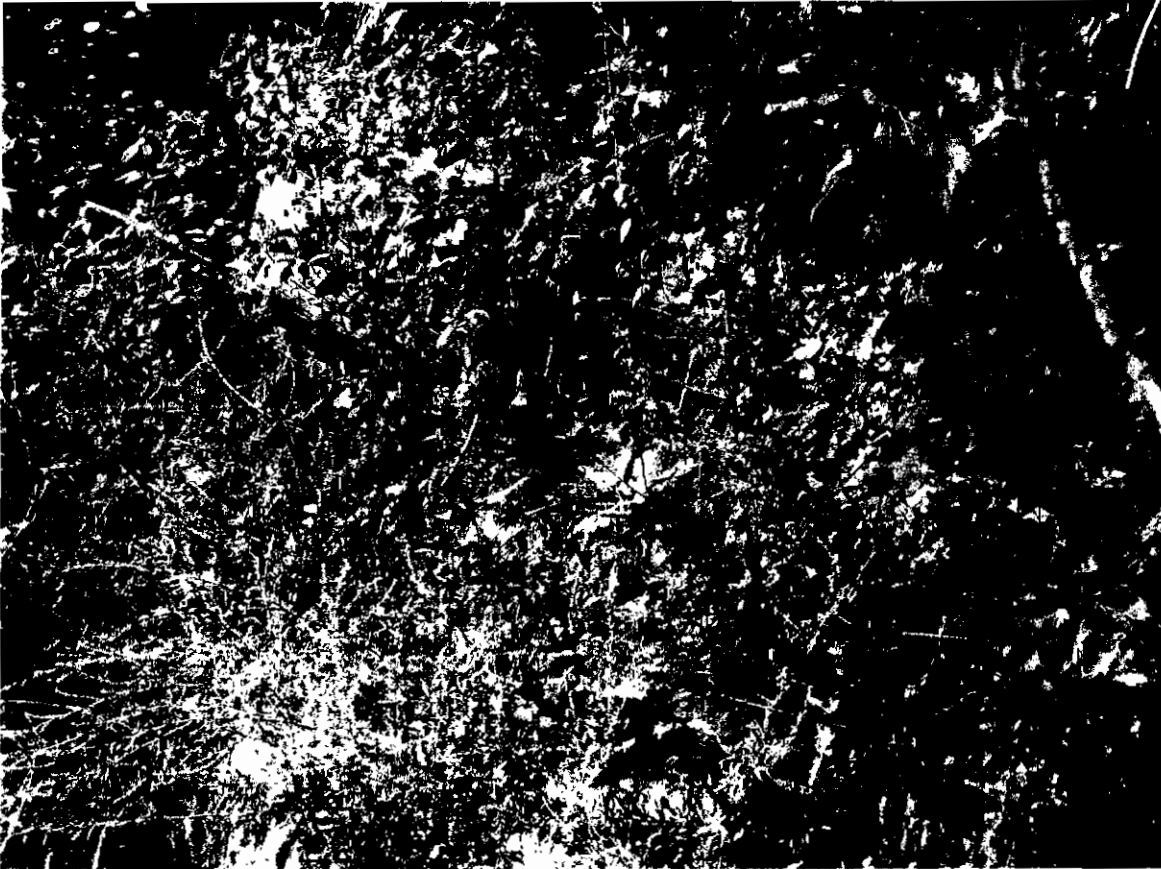
Photographs 11 and 12 were taken approximately 0.05 miles west of photographs 9 and 10. I observed a buildup of debris and sticks at this location, which caused a pooling of water both above and below the debris and sticks. The two pools were connected by a small cascade of water, which caused a foamy substance to form on the surface of the lower pool. The water in the canal flowed from the east to the west or to the left side to the right side in photographs 11 and 12. The canal then turned and flowed north for approximately 0.02 miles where the canal emptied into the C.J. Strike Reservoir. Photograph 13 was taken looking north at the C.J. Strike Reservoir immediately south of where the canal emptied into the reservoir. I was unable to take a picture of the canal flowing into the reservoir due to the density of the vegetation.

Photograph 12: Looking southwest, the flow of the water is from the east to the west or from the top left corner to the lower right corner in the photograph. The buildup of branches and debris caused pools to form above and below the branches and a small cascade between the upper and lower pools.
