In the matter of: )  
)  
)  
Bruneau Cattle Co., ) DOCKET NO. CWA-10-2007-0016  
)  
Owyhee County, Idaho, )  
) COMPLAINANT'S AMENDED  
) PREHEARING EXCHANGE  
Respondent. )  
\_\_\_\_\_)

Observation of Flow and Canal Characteristics  
Southside Irrigation Canal  
June 29, 2007

Observation of Flow and Canal Characteristics  
Southside Irrigation Canal  
August 24, 2007

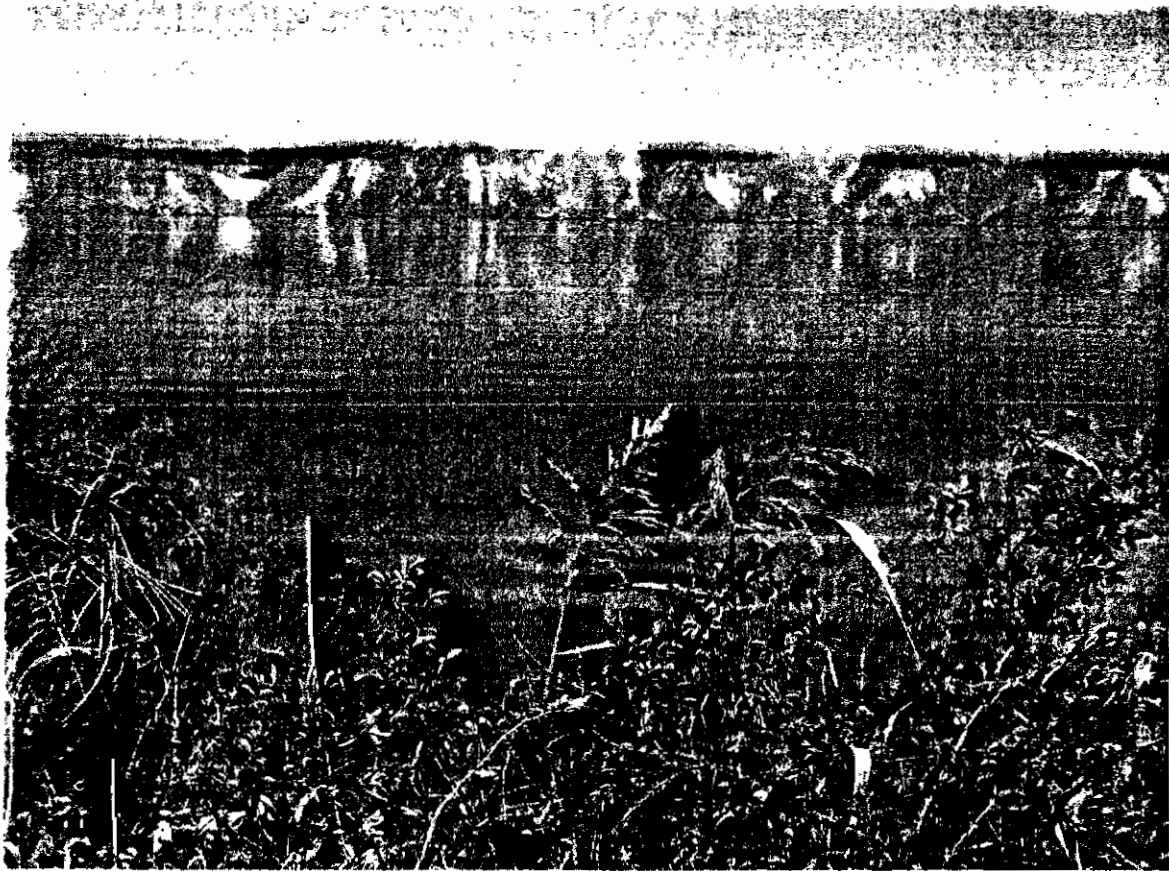
Photograph 13: Looking north, the C.J. Strike Reservoir. The photograph was taken immediately south of where the canal flowed into the C.J. Strike Reservoir.
