**Re: Desarrolladora Yahir, Inc. (DYI) / Tres Palmas Sunset View  
Construction Project – Response to U.S. EPA's NPDES Compliance  
Evaluation Inspection Report**

On behalf of Desarrolladora Yahir, Inc. (DYI), we respectfully submit this response to the United States Environmental Protection Agency's (EPA) NPDES Compliance Evaluation Inspection (CEI) Report dated July 9, 2025, and EPA's Administrative Compliance Order and Request for Information, Docket Number CWA-02-2025-3107, dated July 7, 2025.

Desarrolladora Yahir, Inc. (DYI) / Tres Palmas Sunset View Construction Project

Docket No. CWA-02-2025-3107

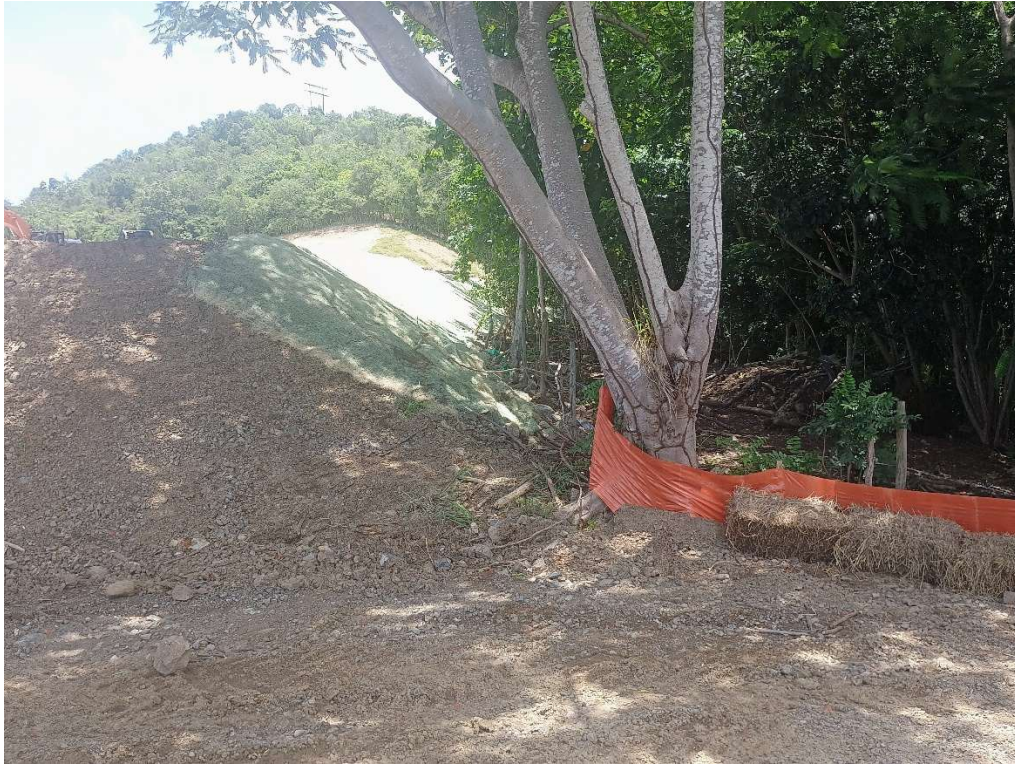
**Picture # 3**

Southeast corner slope working with the implemented erosion control blankets.

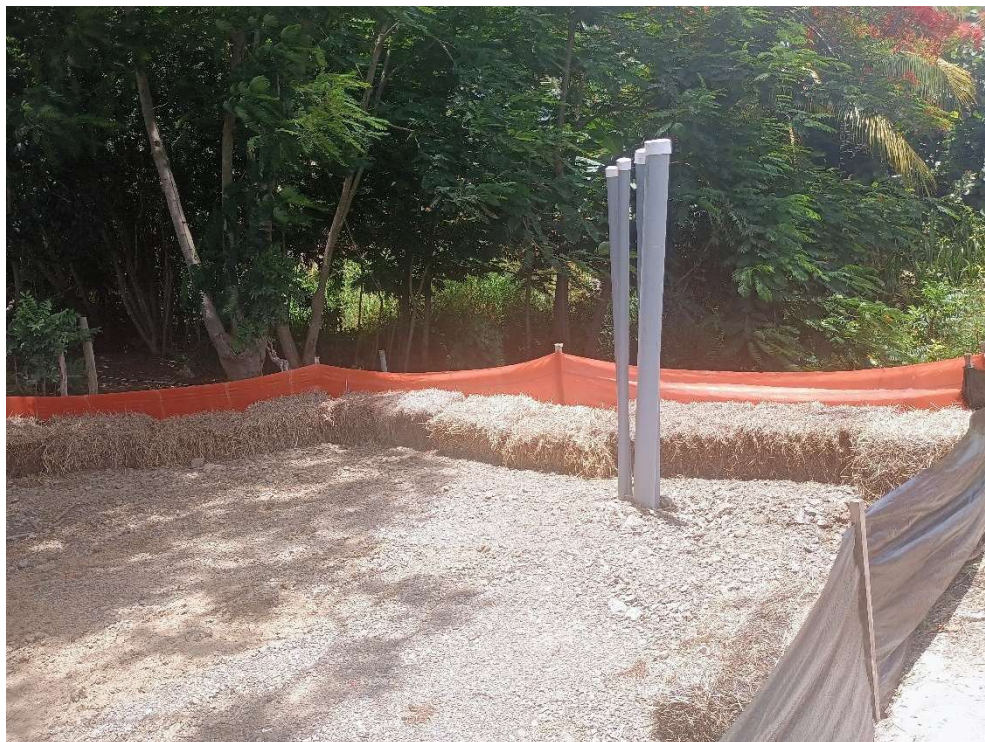
**Picture # 4**

Area located at the south corner of the site identified in the EPA discrete outfall 004 BMPs were implemented in the area (hay bales and silt fence) and it is not a point source as defined in the 2022 CGP permit due to that the stormwater in a sheet (laminar) flow.

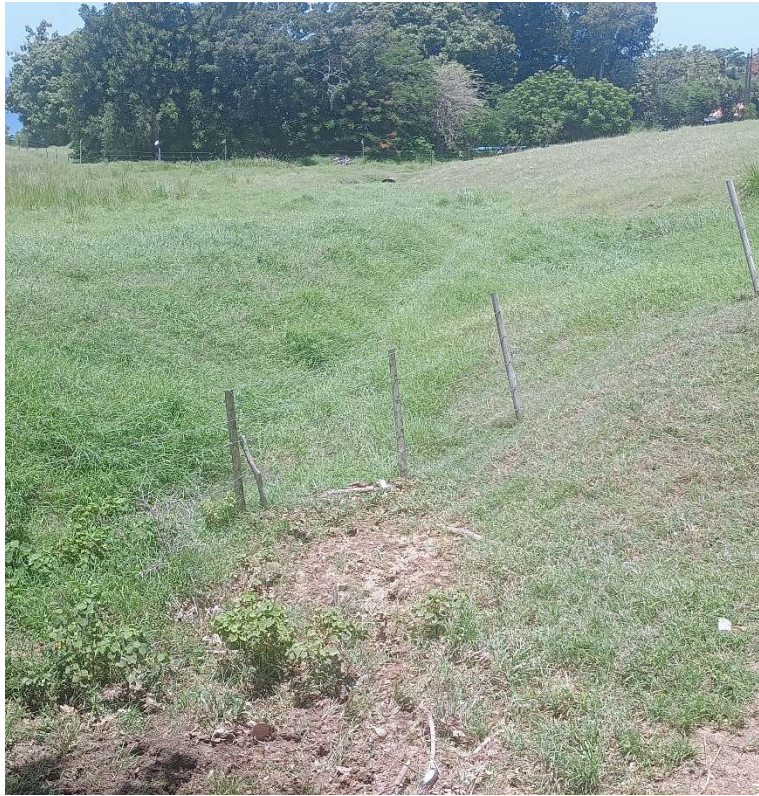
**Picture # 5**

Intermittent creek that conveys stormwater flow from outfall 003 with a grass vegetation established in the bed and bank which slows and filters the stormwater sediments prior to reaching the shoreline.

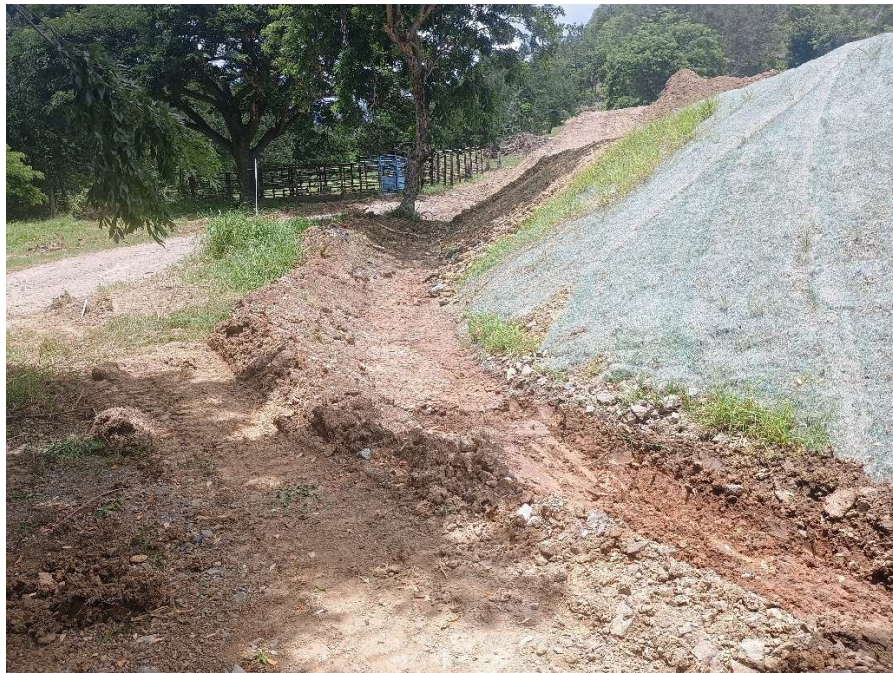
**Picture # 14**

Ditch coming from the west side of the property constructed to divert stormwater flow to outfall 001 from alleged discrete discharge point identified in the EPA inspection report as outfall 002 South side slope of the project with erosion control blanket installed.

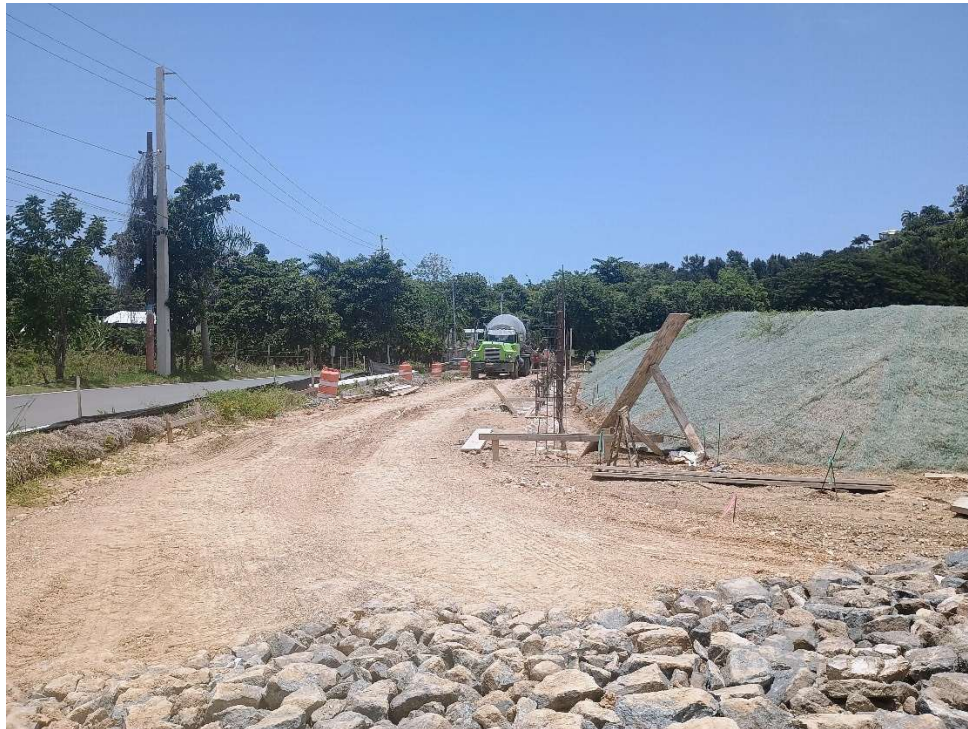
**Picture # 15**

Part of the entrance tracks out stabilization control and slope with erosion control blankets. Also, silt fence and hay bales are installed in the south perimeter next to PR 413 - Road

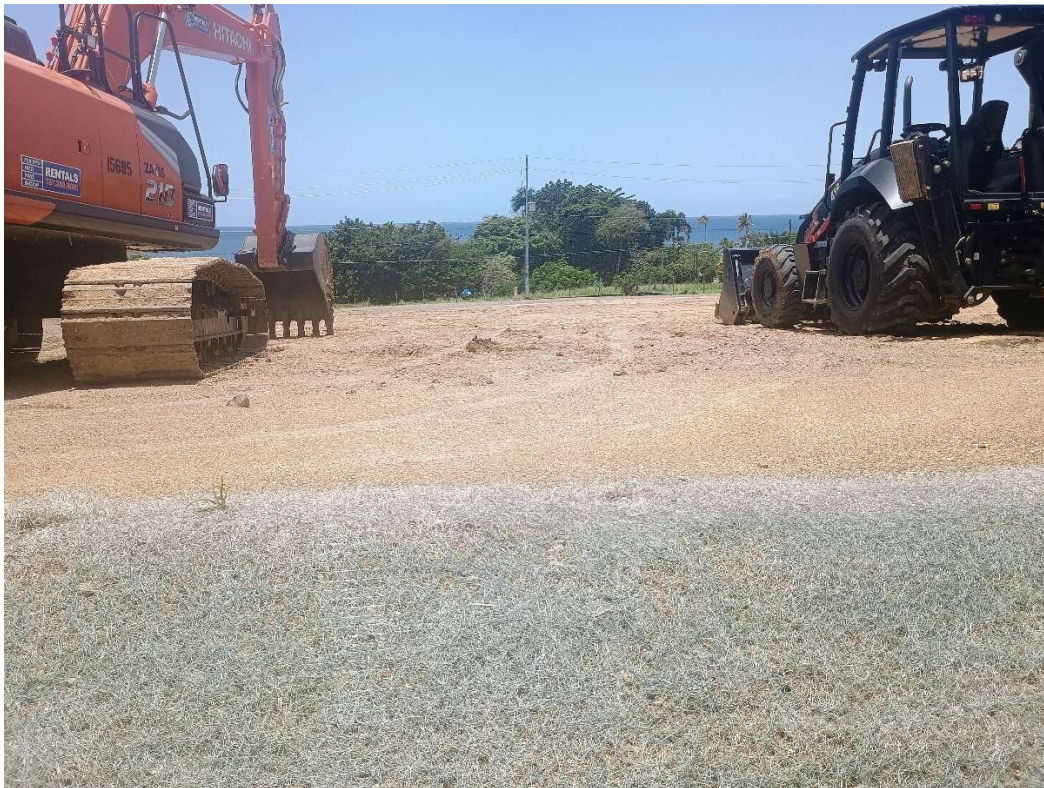
**Picture #16**

Access road number two south side slope with erosion control blanket. Overlooking the site south perimeter with PR 413-Road with a a berm installed at the top of the slope.
