**Re: Desarrolladora Yahir, Inc. (DYI) / Tres Palmas Sunset View  
Construction Project – Response to U.S. EPA’s NPDES Compliance  
Evaluation Inspection Report**

Desarrolladora Yahir, Inc. (DYI) / Tres Palmas Sunset View Construction Project

Docket No. CWA-02-2025-3107

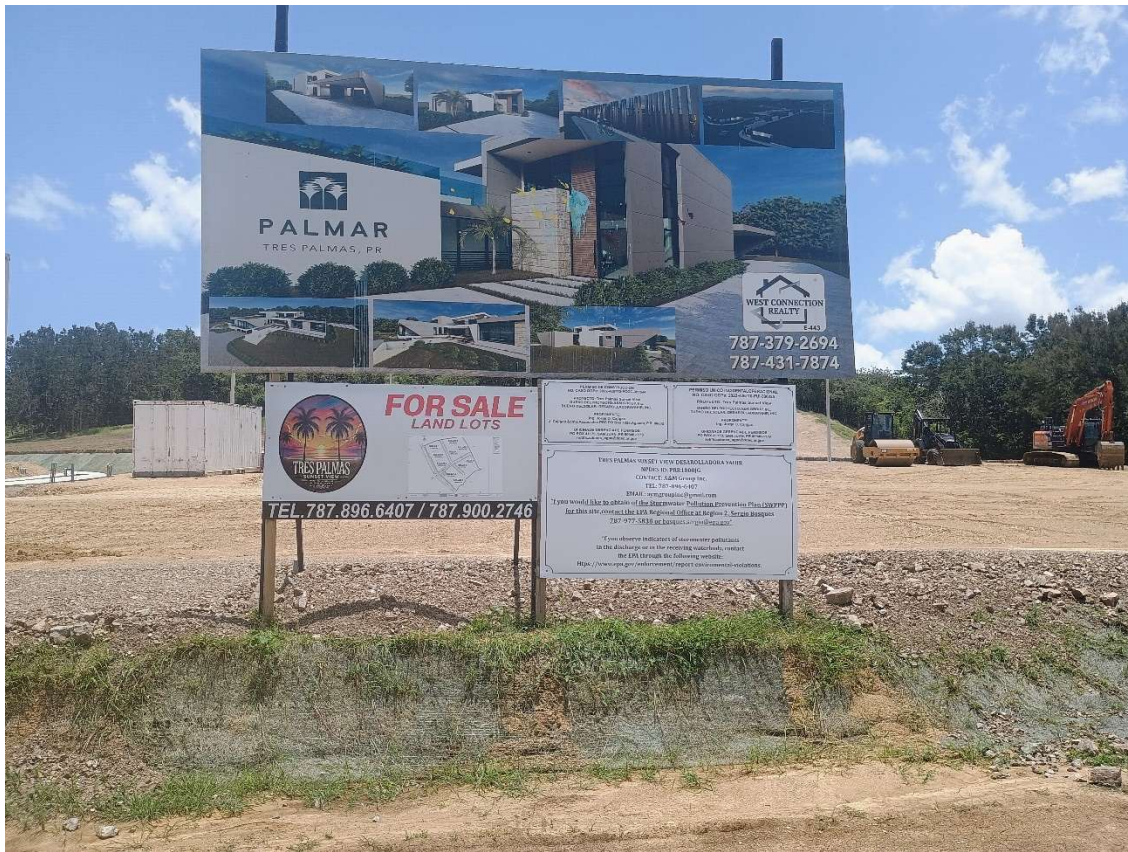
Picture #1

Sign located at the Site entrance main gate depicting NPDES ID Number PRR1000JG.

The sign at the site entrance identifies the project as Tres Palmas Sunset View / Desarrolladora Yahir, Inc., clearly indicating DYI as the project owner. The sign also lists A&M Group, Inc. as the contact, along with its phone number and email address. A&M Group, Inc., owned by DYI's principal, is the designated construction contractor for the project, which is why it is listed as the contact.

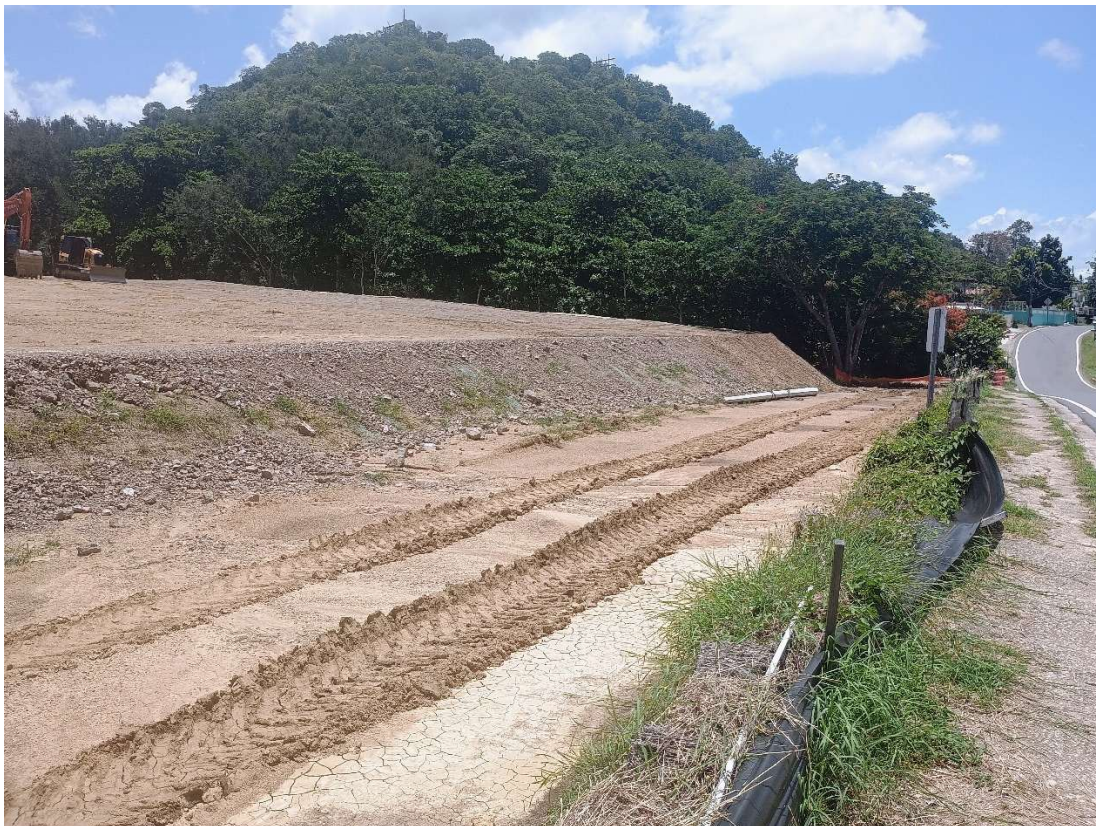
Picture # 2

Retention basin located at the south perimeter adjacent to PR 413-Road Silt fence needs to be fixed but hay bales and a grass buffer established prior to the silt fence.

The silt fence along the southern perimeter adjacent to PR-413 Road has been repaired. Additionally, the slope was temporarily stabilized with erosion control blankets, and a berm was installed at the top of the slope for runoff management.

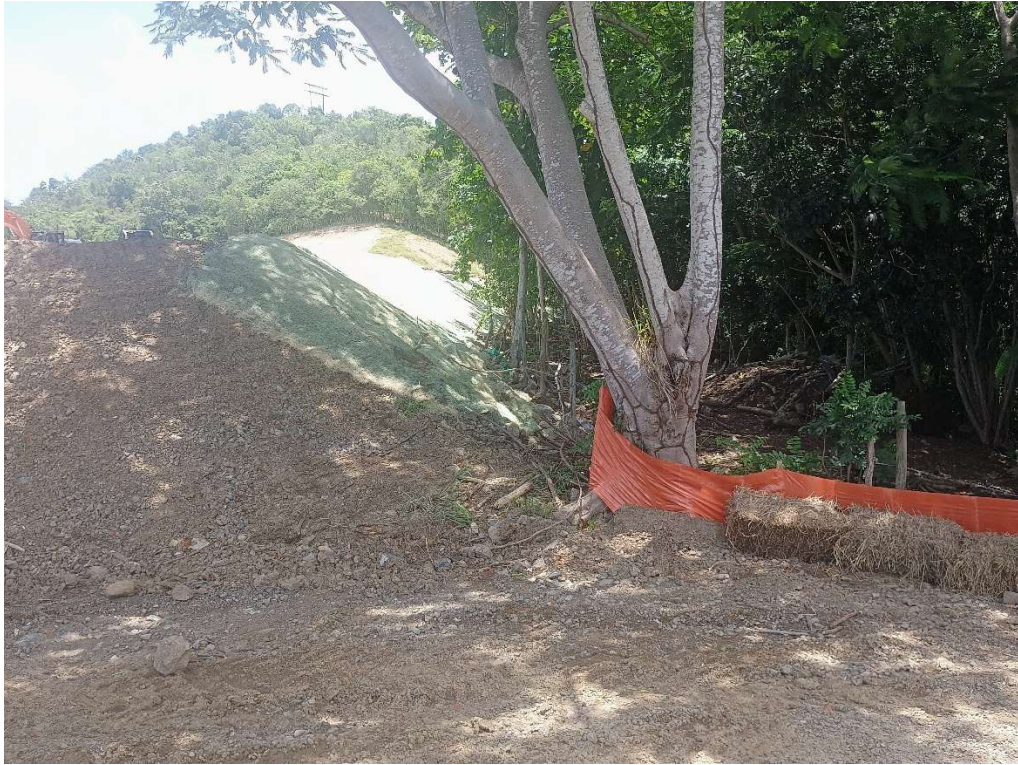
**Picture # 3**

Southeast corner slope working with the implemented erosion control blankets.

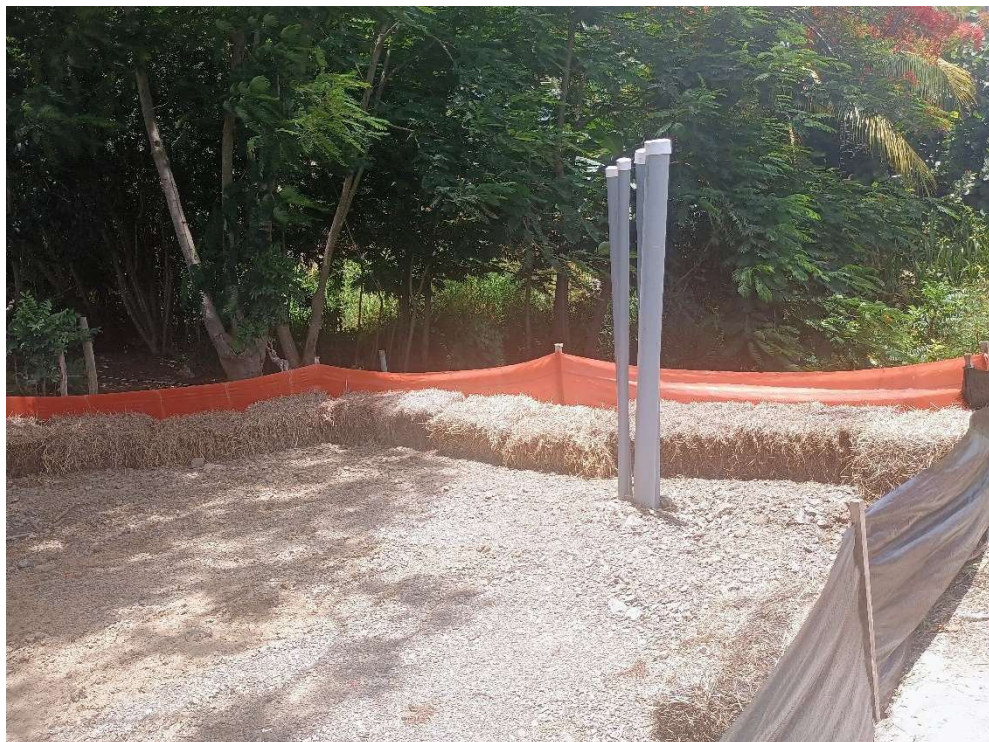
**Picture # 4**

Area located at the south corner of the site identified in the EPA discrete outfall 004 BMPs were implemented in the area (hay bales and silt fence) and it is not a point source as defined in the 2022 CGP permit due to that the stormwater in a sheet (laminar) flow.

Accordingly, Outfalls 002 and 004 were not discrete points but rather temporary features of earth-moving activities. Corrective actions were taken after EPA's inspection to eliminate these potential conveyances.

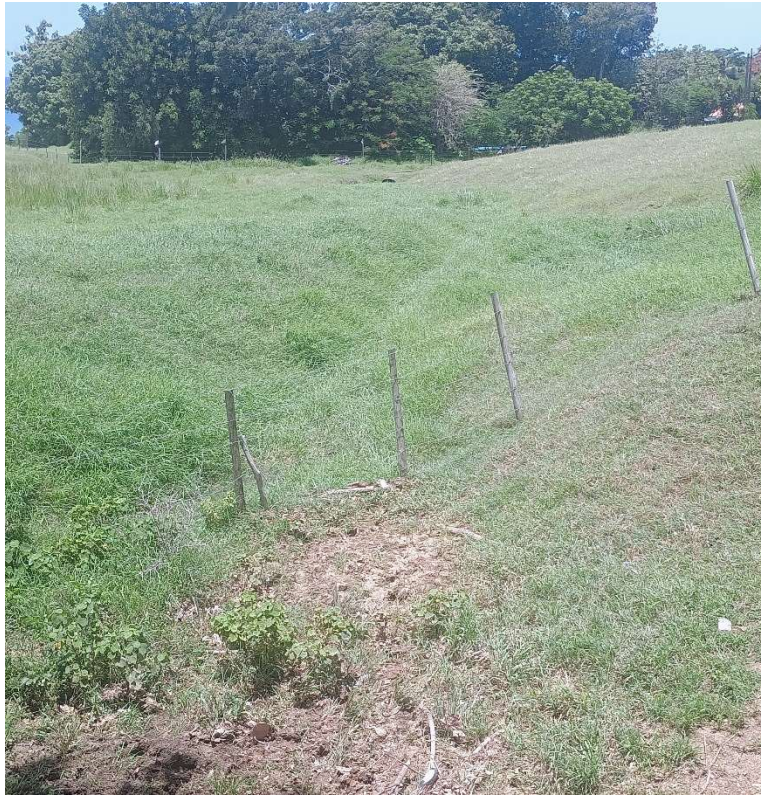
**Picture # 5**

Intermittent creek that conveys stormwater flow from outfall 003 with a grass vegetation established in the bed and bank which slows and filters the stormwater sediments prior to reaching the shoreline.

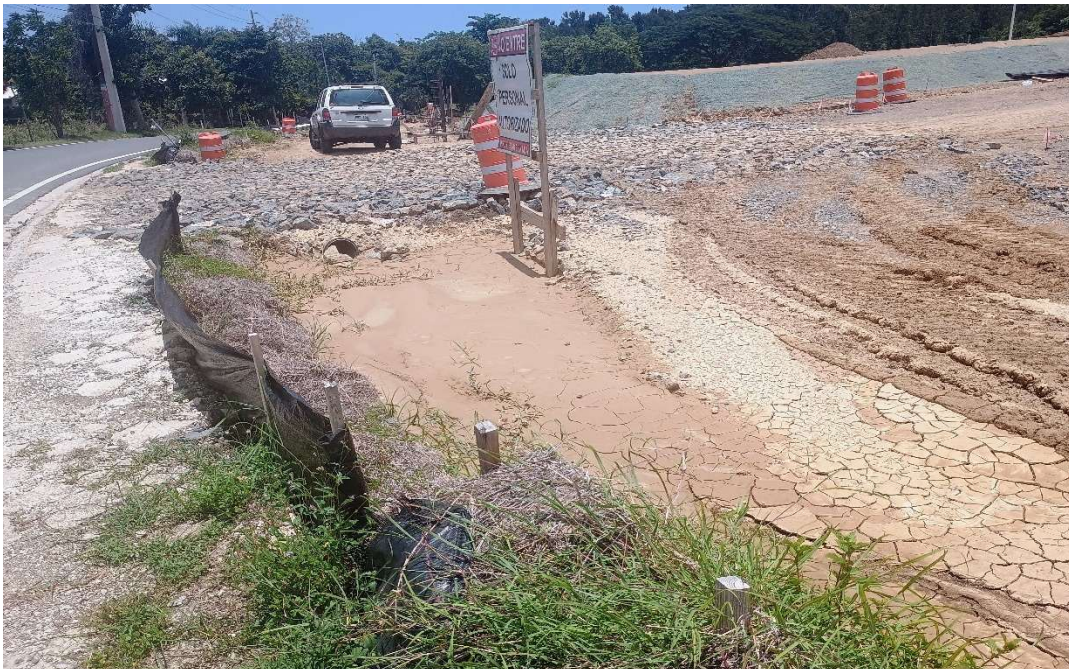
**Picture # 6**

Stormwater temporary retention basin with sediments accumulated working as intended sediments will be removed as needed. Track out control established/installed at the project main entrance.

A sedimentation pond was included in the SWPPP. A small detention/sediment trap area was installed at the southeastern side of the site, parallel to PR-413 Road. Most stormwater infiltrates on-site; remaining flows are collected in this feature, which ultimately discharges through Outfall 001.

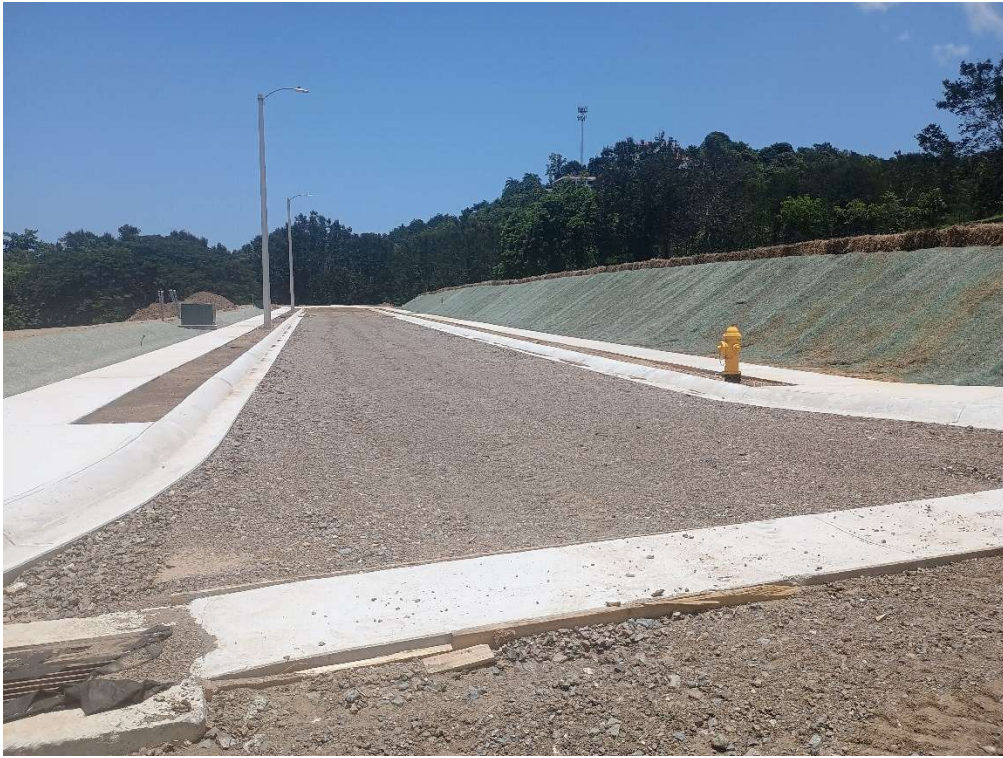
**Picture # 7**

Project road number two which cross the project from west to east with sidewalks and culverts. Also you can see the slopes with erosion control blankets and hay bales installed. A stormwater inlet with a siltfence/ geotextile which provides sediment protection.

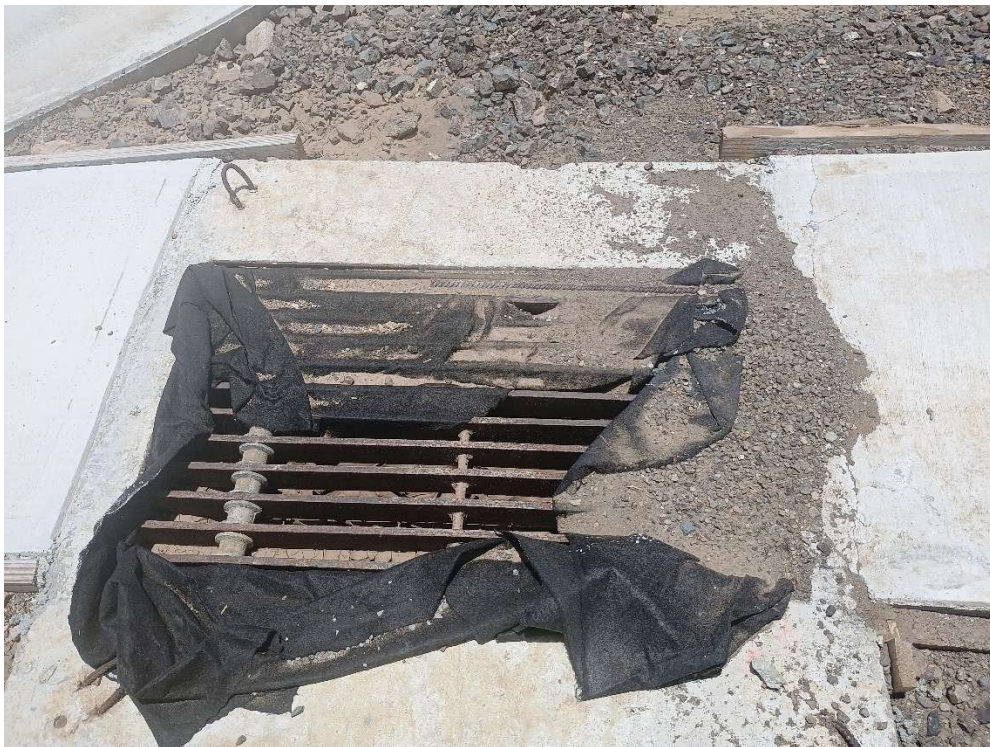
**Picture # 8**

A stormwater inlet with a silt fence/ geotextile which provides sediment protection.

Best Management Practices (BMPs), including silt fences and geotextile fabric under inlet grates, have been installed to prevent excess sediment from entering storm drains. Once the roads are finalized, permanent stabilization will be implemented through paving.

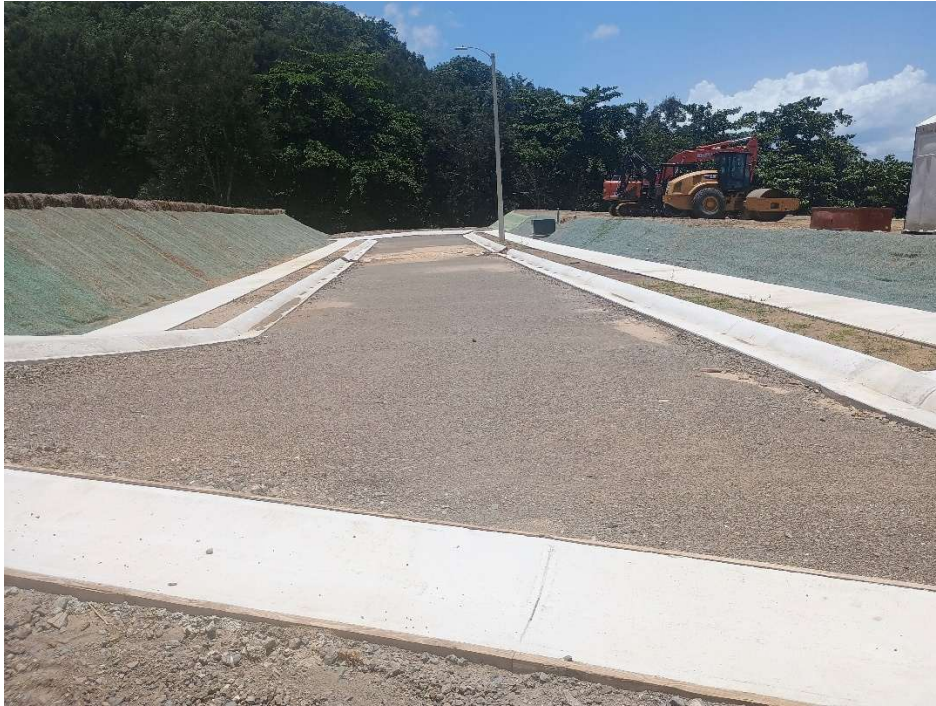
**Picture # 9**

Project road number two east street which crosses the project from west to east with sidewalks and culverts. Also, you can see the slopes with erosion control blankets and hay bales installed.

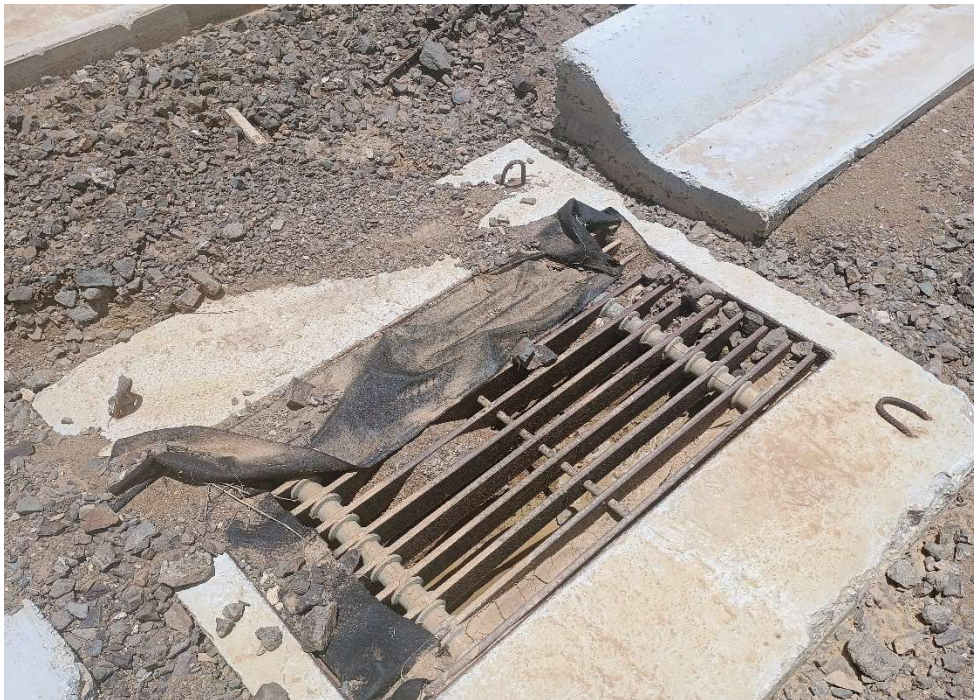
**Picture # 10**

A stormwater inlet with a silt fence/ geotextile which provides sediment protection.

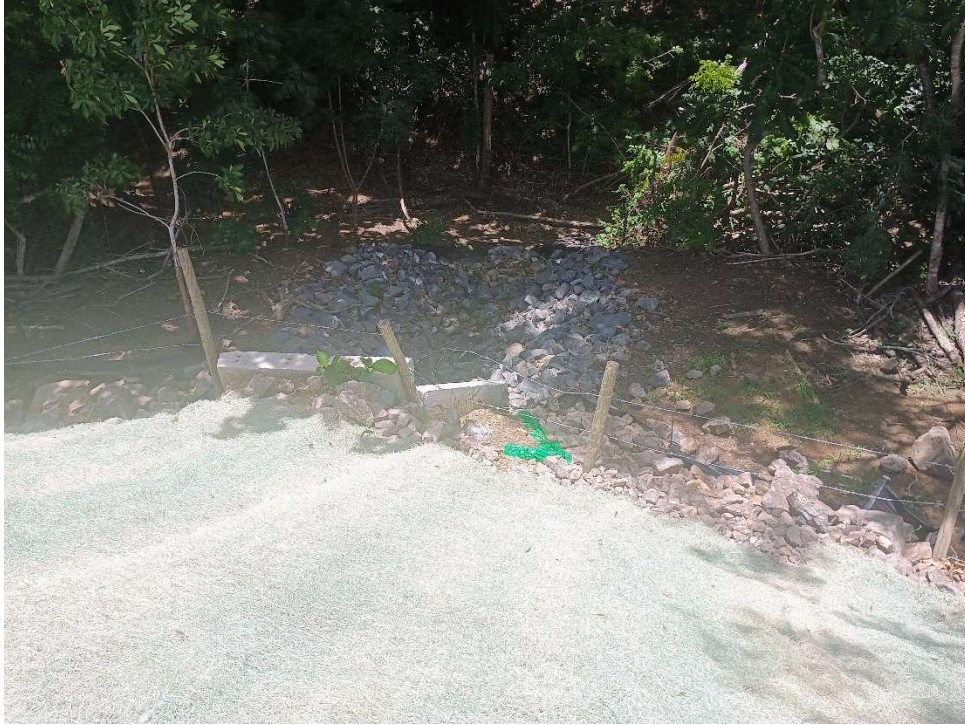
**Picture # 11**

Outfall 002 discharge point located at the east side of the project with headwall and rip rap for flow velocity control and stormwater filtering prior to discharge into the intermittent stream. An erosion control blanket was installed in the slope

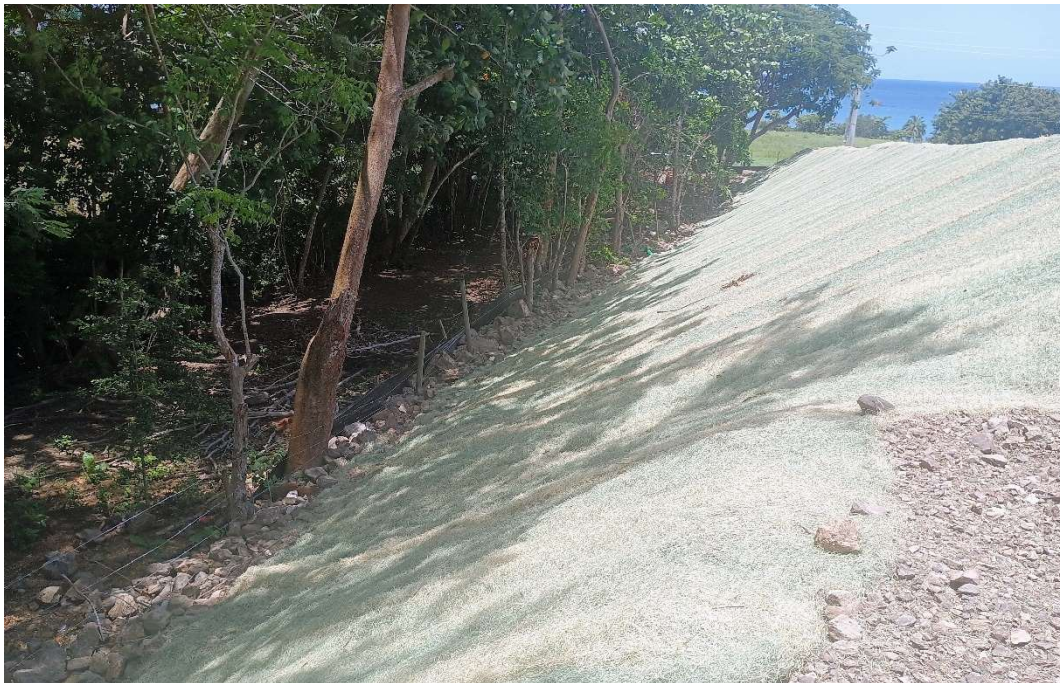
**Picture #12**

East side slope of the project with erosion control blanket installed.

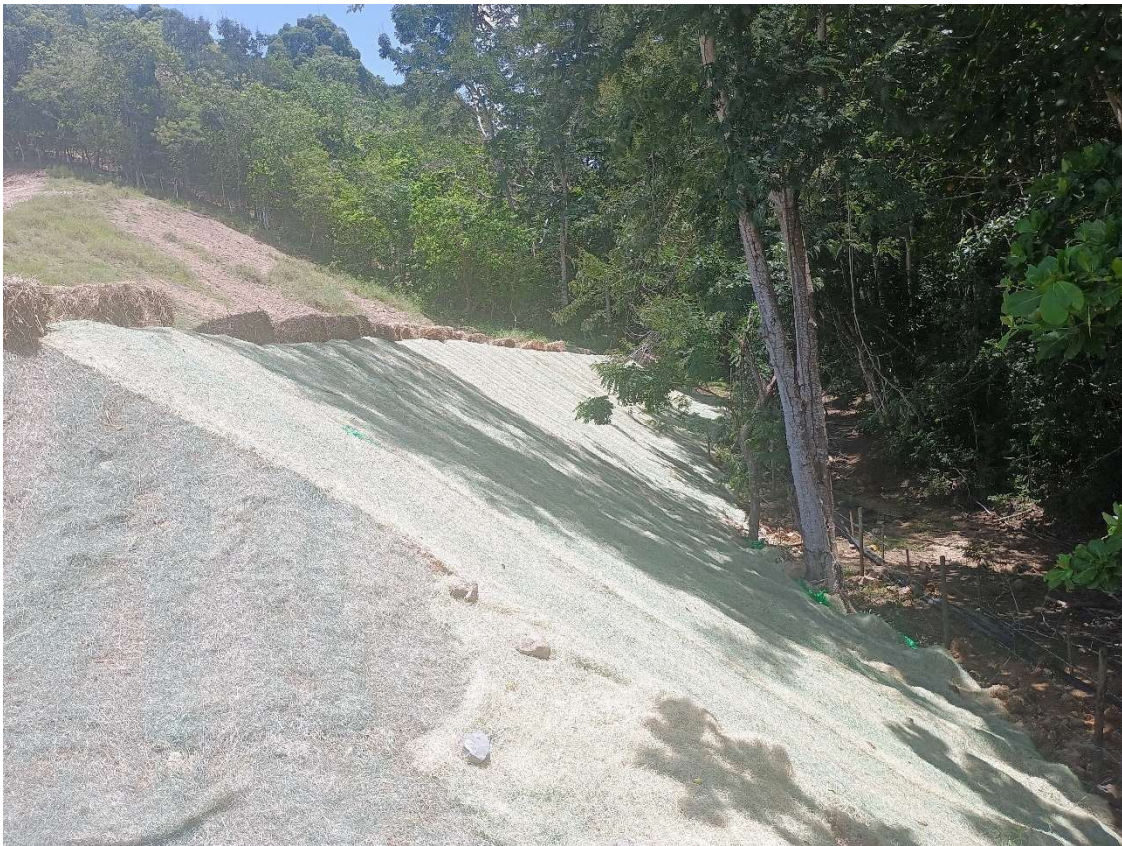
**Picture #13**

Another picture of the southeast part slope with erosion control blanket installed

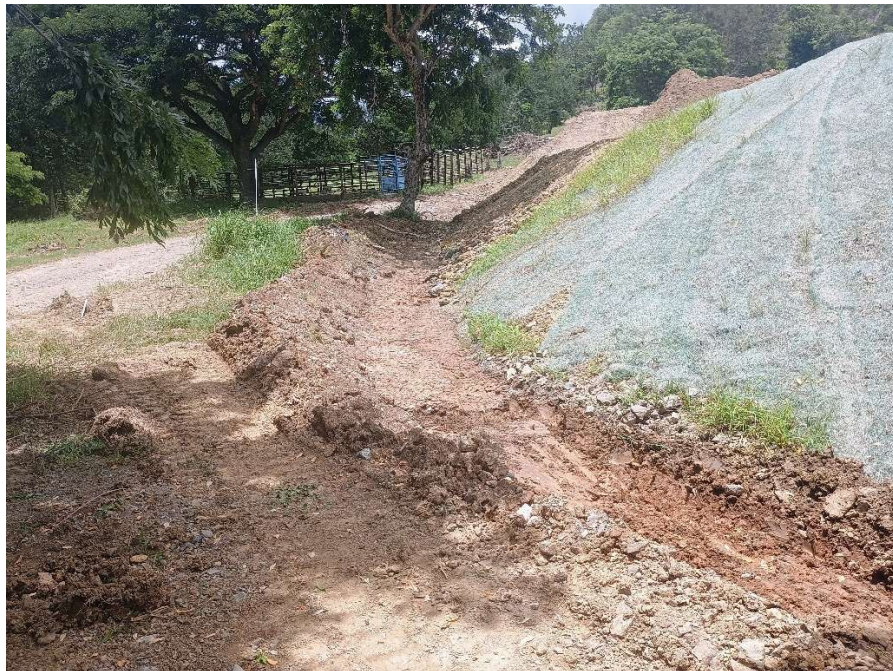
**Picture # 14**

Ditch coming from the west side of the property constructed to divert stormwater flow to outfall 001 from alleged discrete discharge point identified in the EPA inspection report as outfall 002 South side slope of the project with erosion control blanket installed.

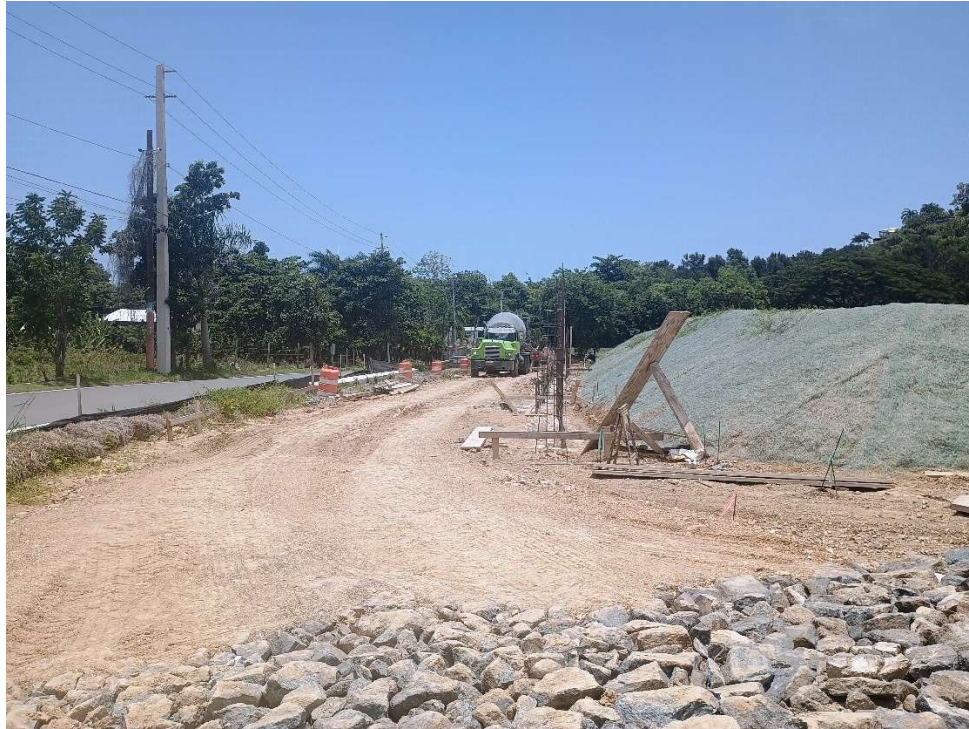
**Picture # 15**

Part of the entrance tracks out stabilization control and slope with erosion control blankets. Also, silt fence and hay bales are installed in the south perimeter next to PR 413 - Road

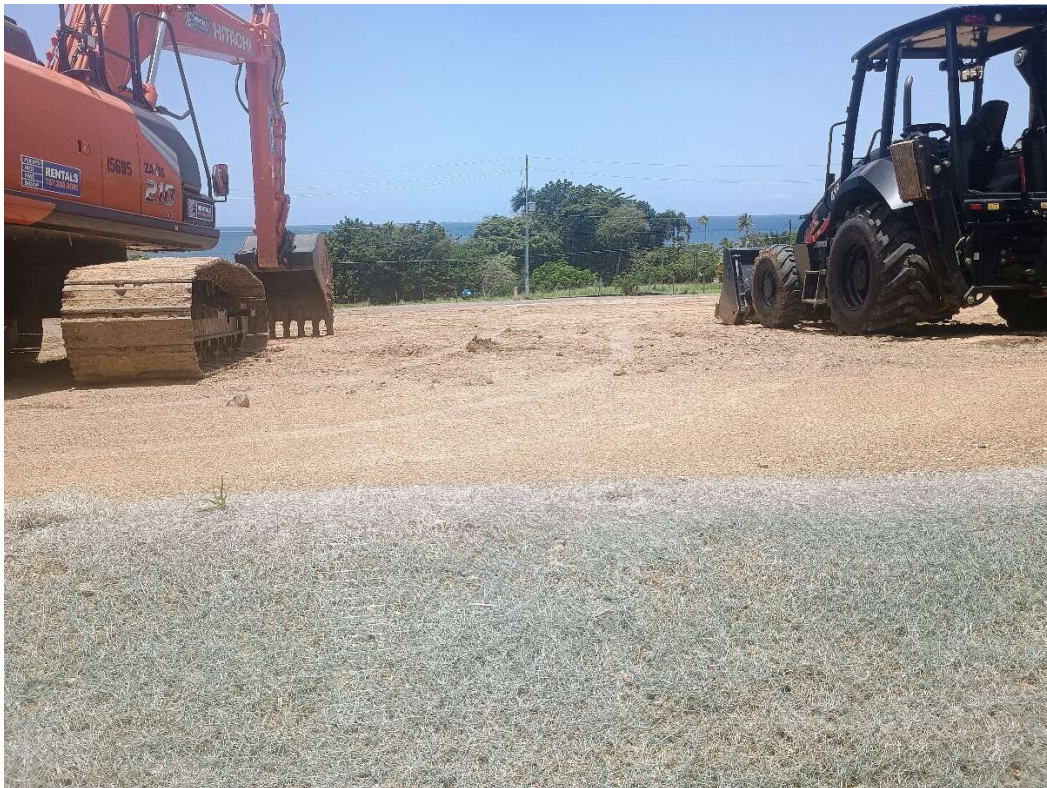
**Picture #16**

Access road number two south side slope with erosion control blanket. Overlooking the site south perimeter with PR 413-Road with a a berm installed at the top of the slope.

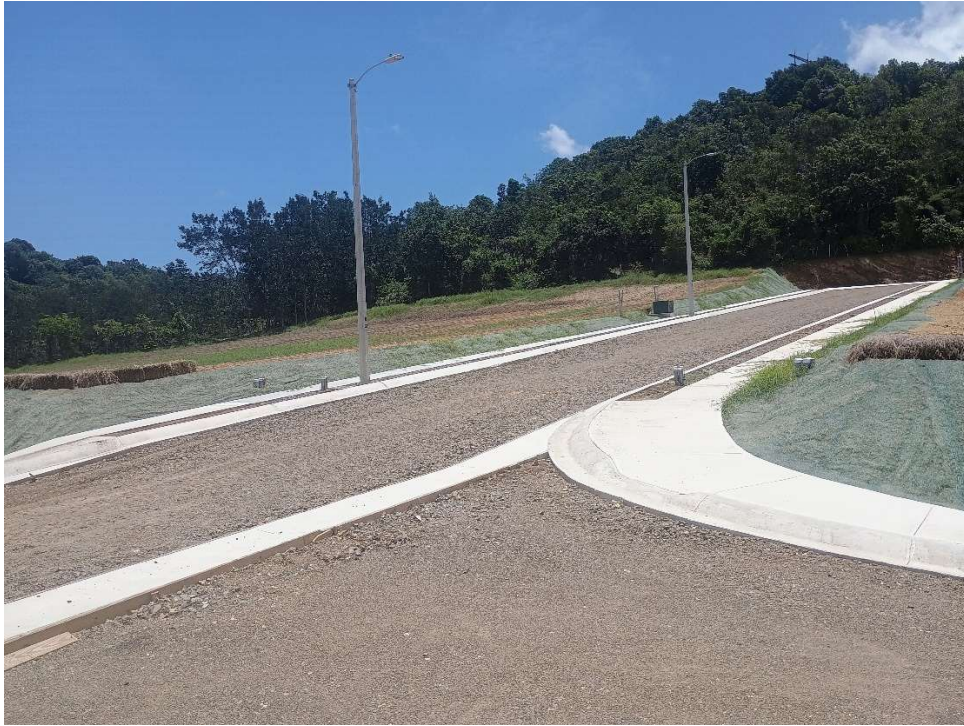
**Picture # 17**

Main access road with temporary stabilization with gravel to prevent further erosion. View of the slopes with erosion control blankets and hay bales installed.

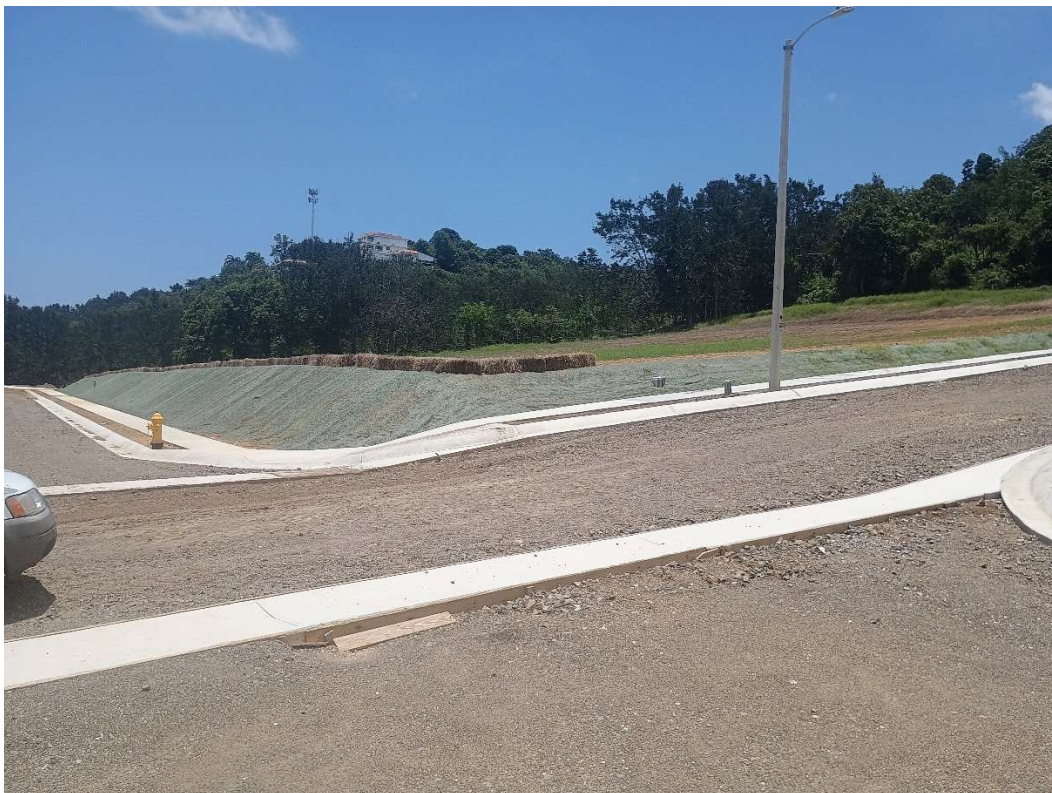
**Picture # 18**

Another view of the west side of access road number 2 with erosion blankets on slopes and hay bales. Also, with temporary stabilization with gravel to prevent further erosion

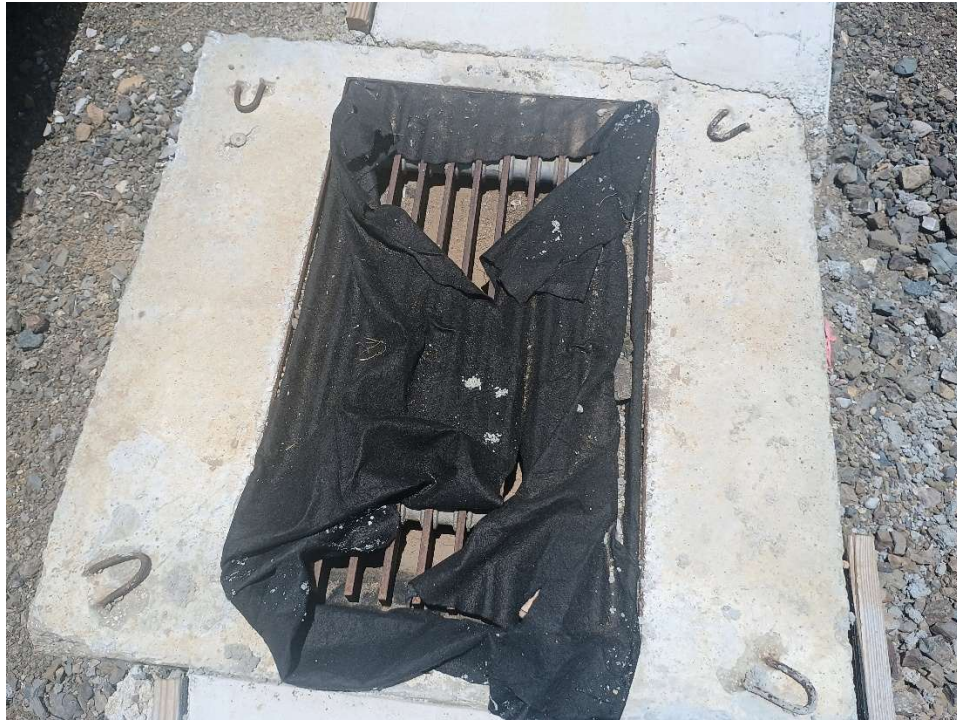
**Picture # 19**

Another stormwater inlet located in access road # 2 with silt fence/geotextile installed for sediment control and protection.

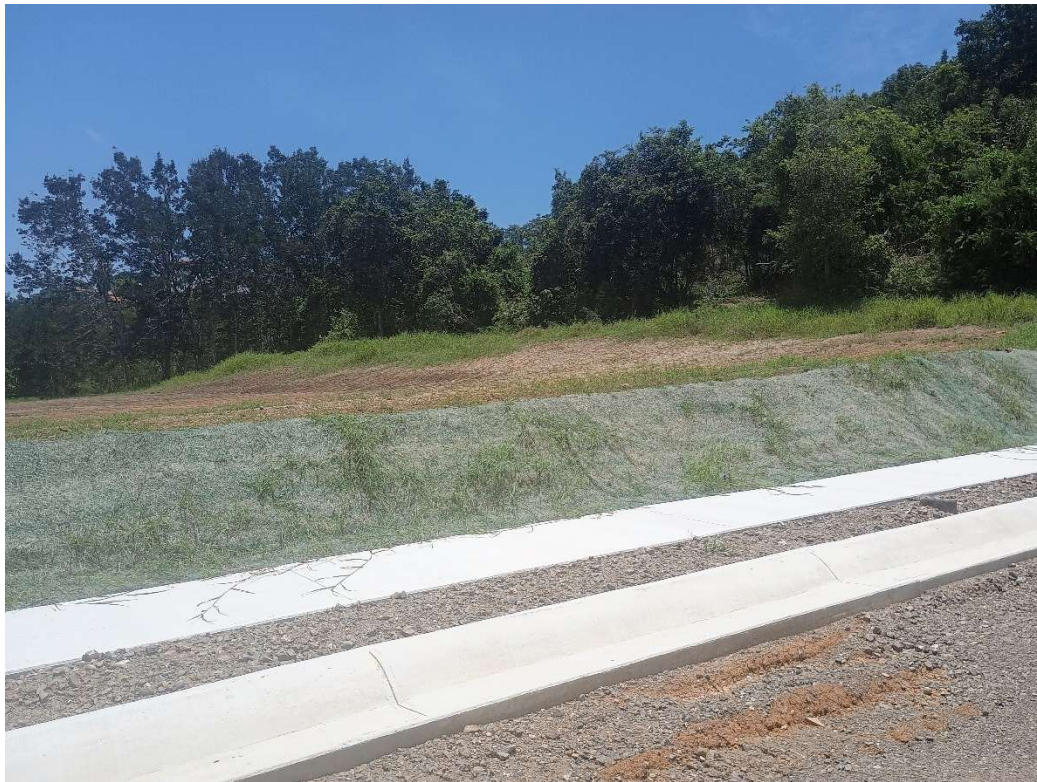
**Picture # 20**

West side upper parcel of the site with vegetation buffer established for runoff control. Also, main access road slope of this area with erosion control blanket

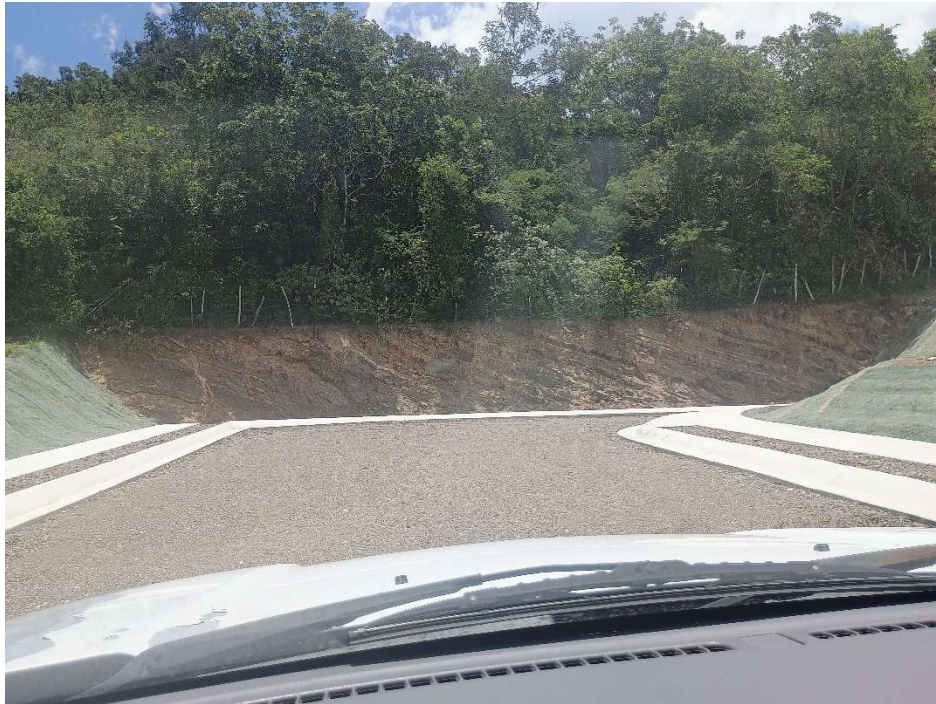
**Picture # 21**

North slope of the project facing main access road. The slope is stabilized because the soils are solid sedimentary rock and run on is managed through the stormwater sewer system of the project. Also, the road has temporary stabilization with gravel for erosion control.

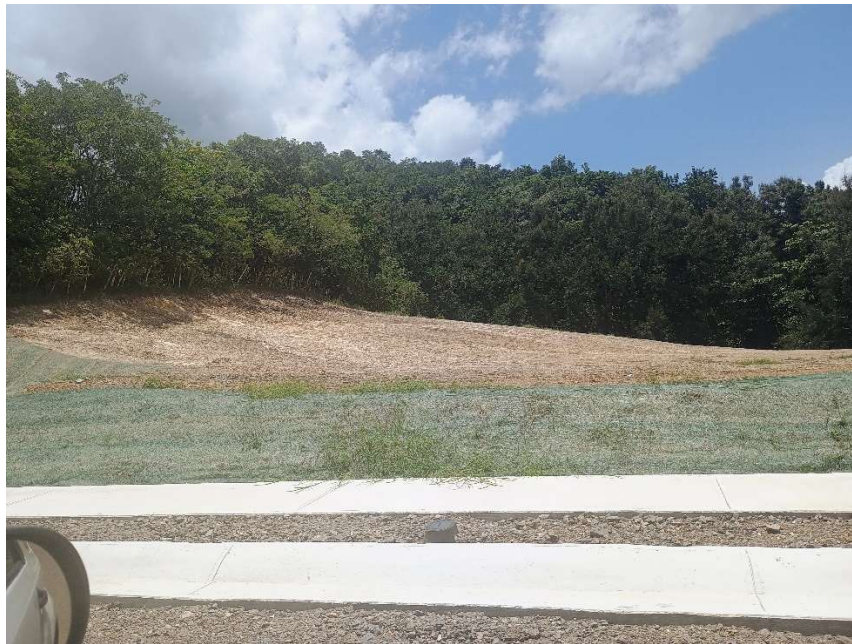
**Picture # 22**

Overview of the upper east side parcel of the project and slope with erosion control blankets and a berm on top of the slope.

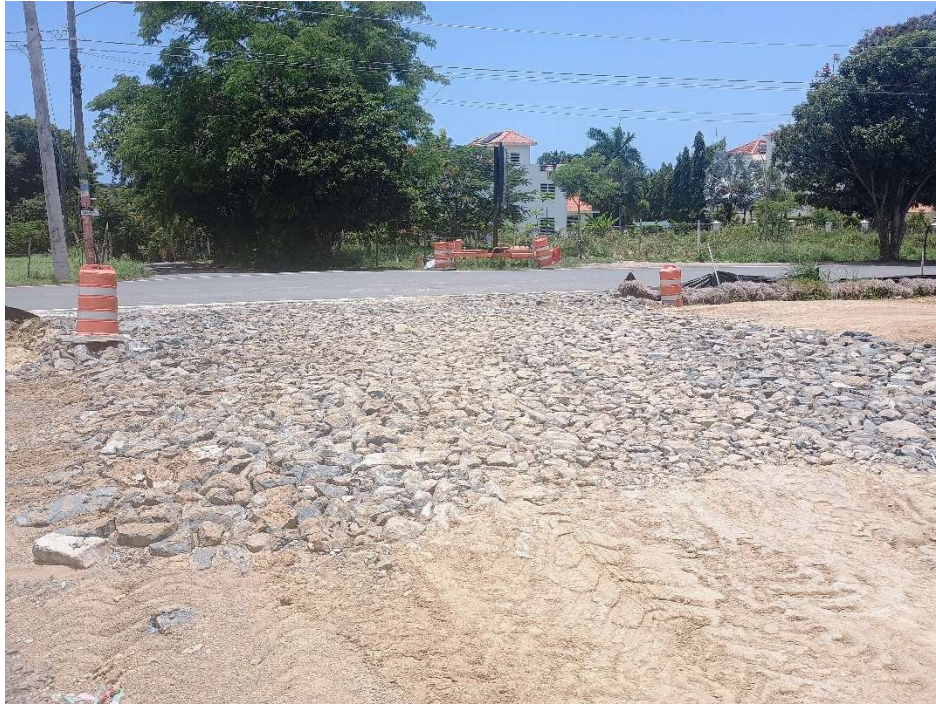
**Picture # 23**

Track out control established/installed at the project main entrance. No sediment track out on the PR 413- Road.

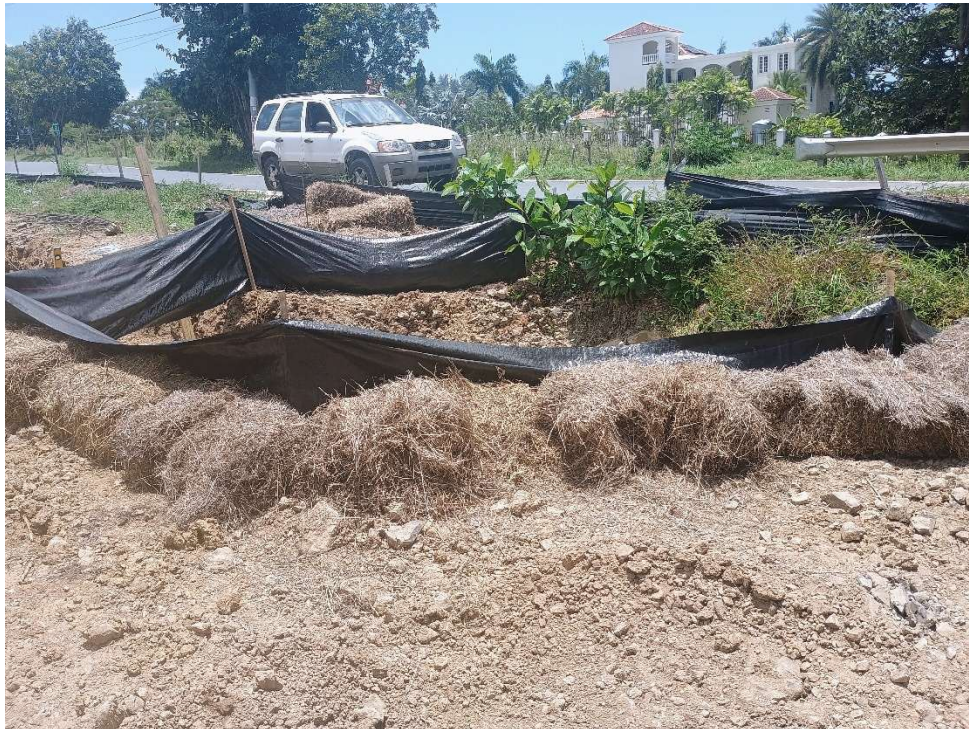
**Picture # 24**

Outfall 001 with hay bales and silt fence to control outside sediments from earth movement activities from going in.

Corrective measures were implemented following the inspection. Sediments were removed, the silt fence was replaced, and the area was graded to final ground levels. These actions improve stormwater runoff management and facilitate ongoing stabilization measures.
