Re: Administrative Order Closure, EPA Docket No. CWA-08-2009-0013

Clean Water Act Section 404 Inspection Report

Photo Log – Dunn County – CWA-08-2009-0013 – 07/27/18

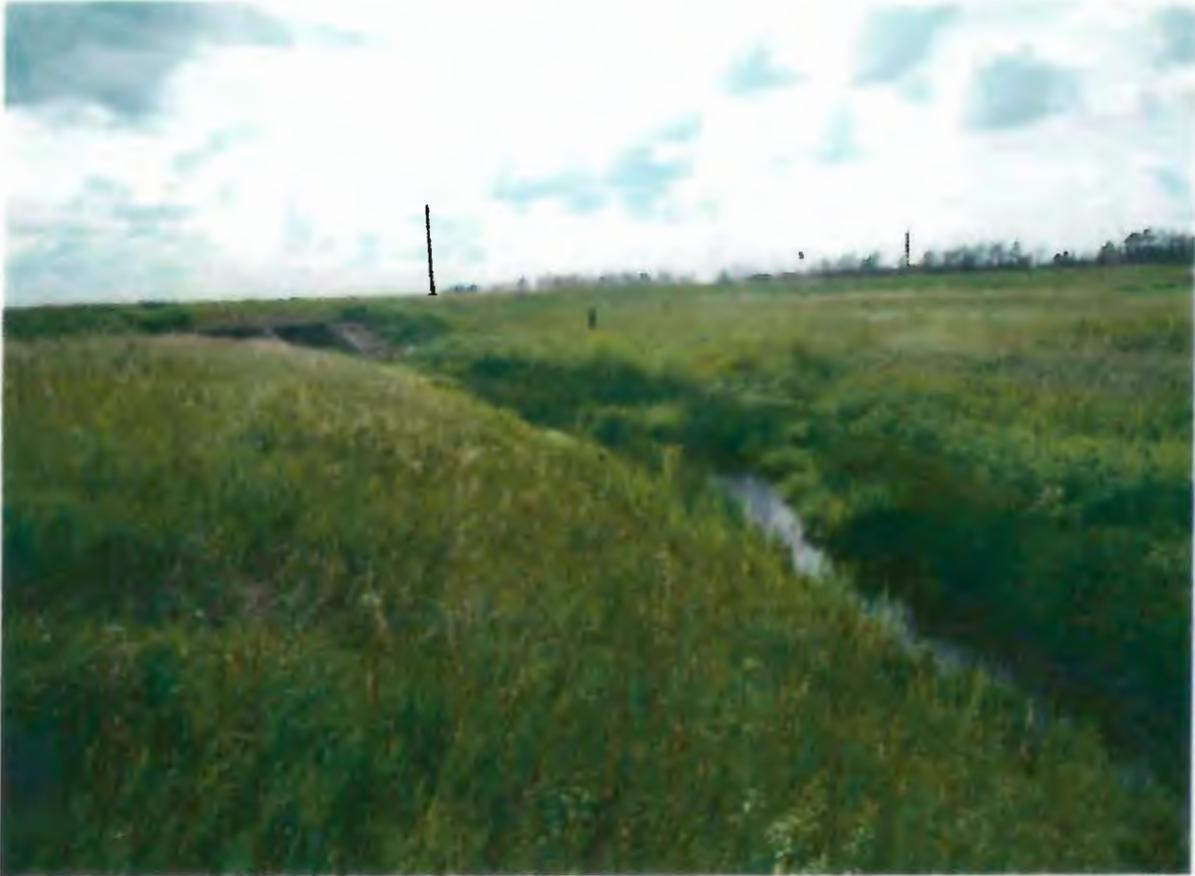
Photo 4: Downstream of station 1+00, looking east-southeast (downstream). Note lush vegetation along stream; little sign of erosion.

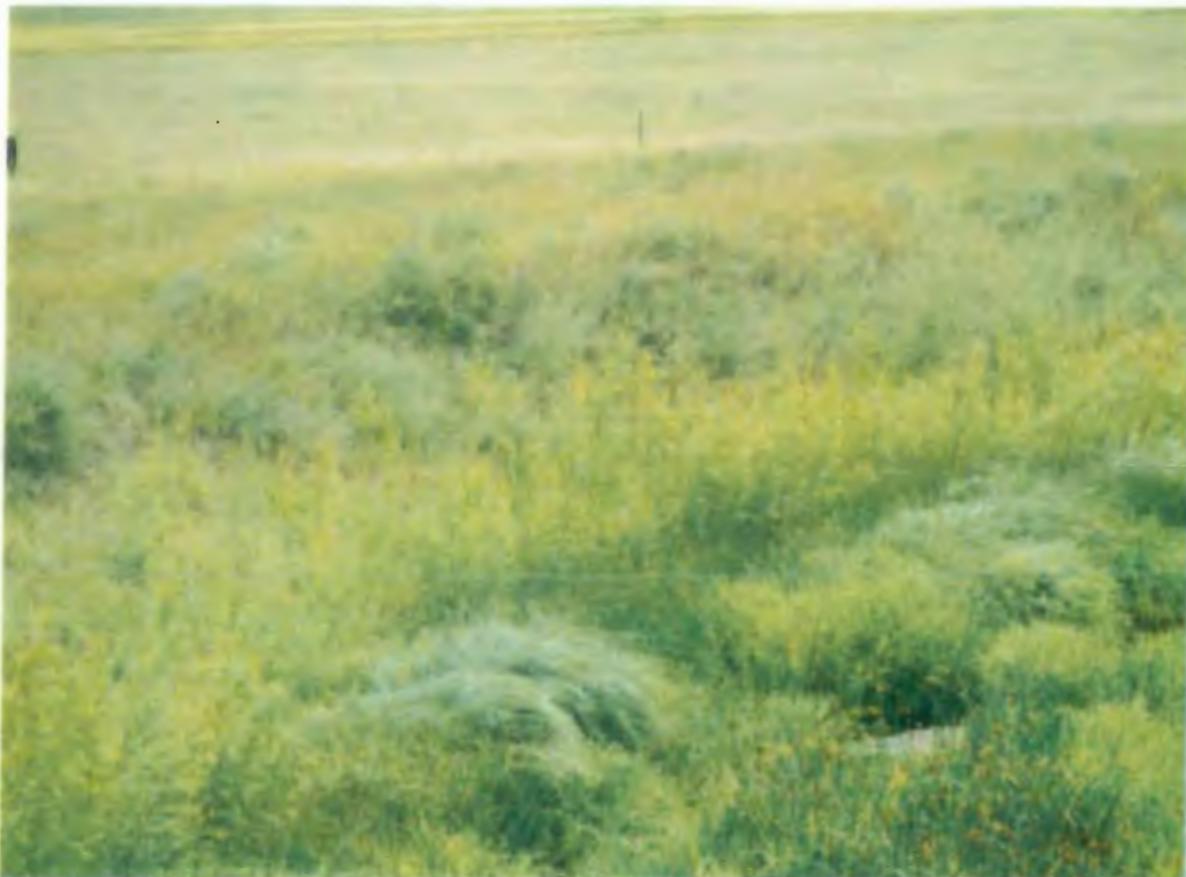
Photo 10: From top of road (113th Ave. SW), looking east (downstream). Note riparian vegetation along bank. Telephoto setting used.

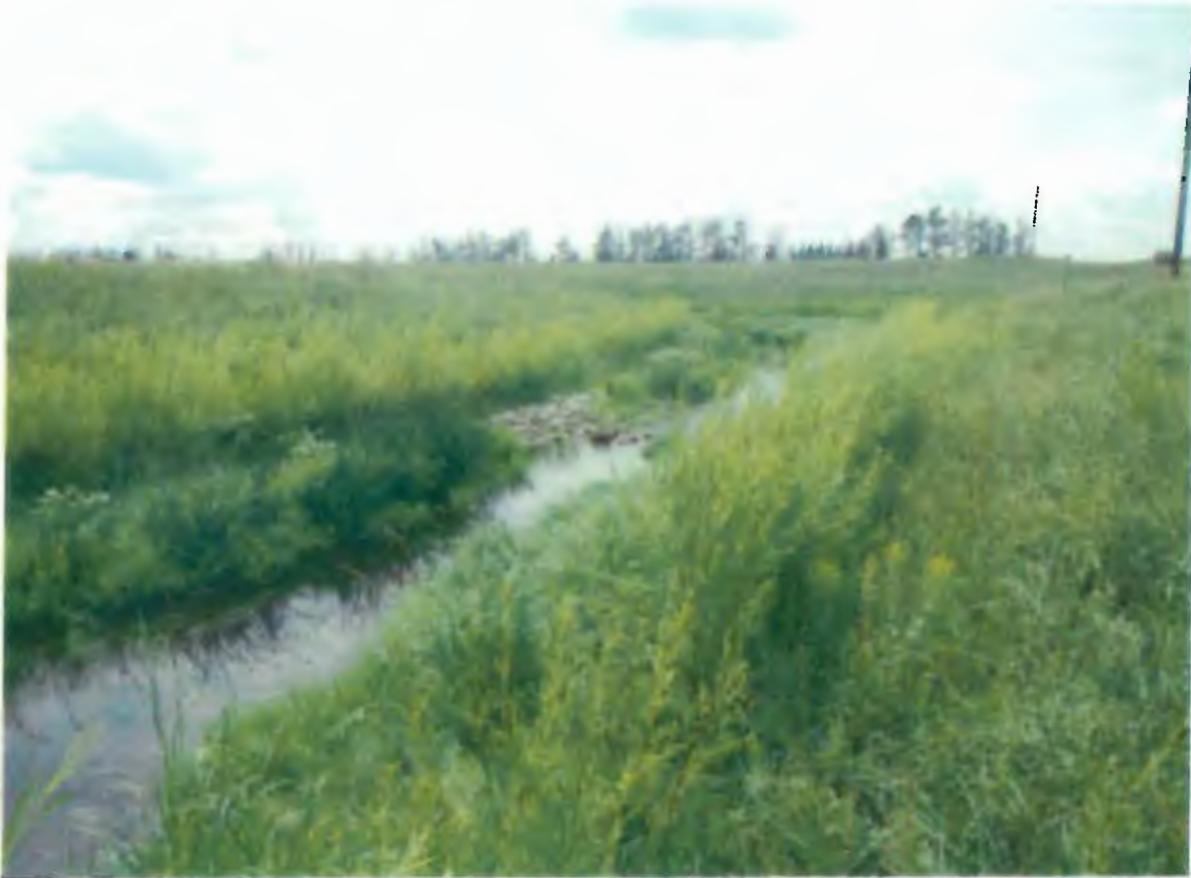
Photo 14: Between stations 7+00 and 9+00, looking south-southeast (downstream). Note rock riffle.

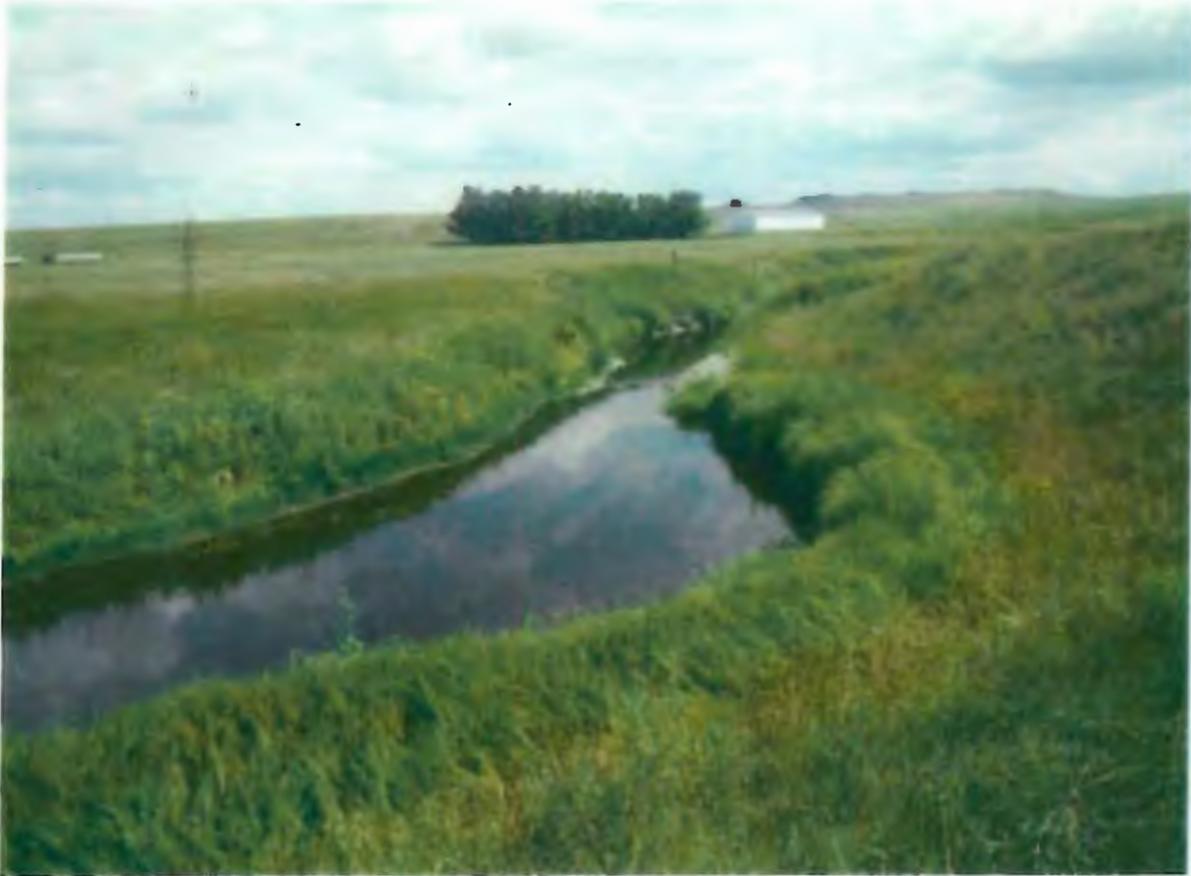
Photo 17: Between stations 9+00 and 11+00, looking east-northeast (downstream). Note riffle.
