SITE VISIT RECORD

Subject: Violation: 2020-00951 Wetlands and Channels Excavated

Date: May 18, 2021

2020-00951

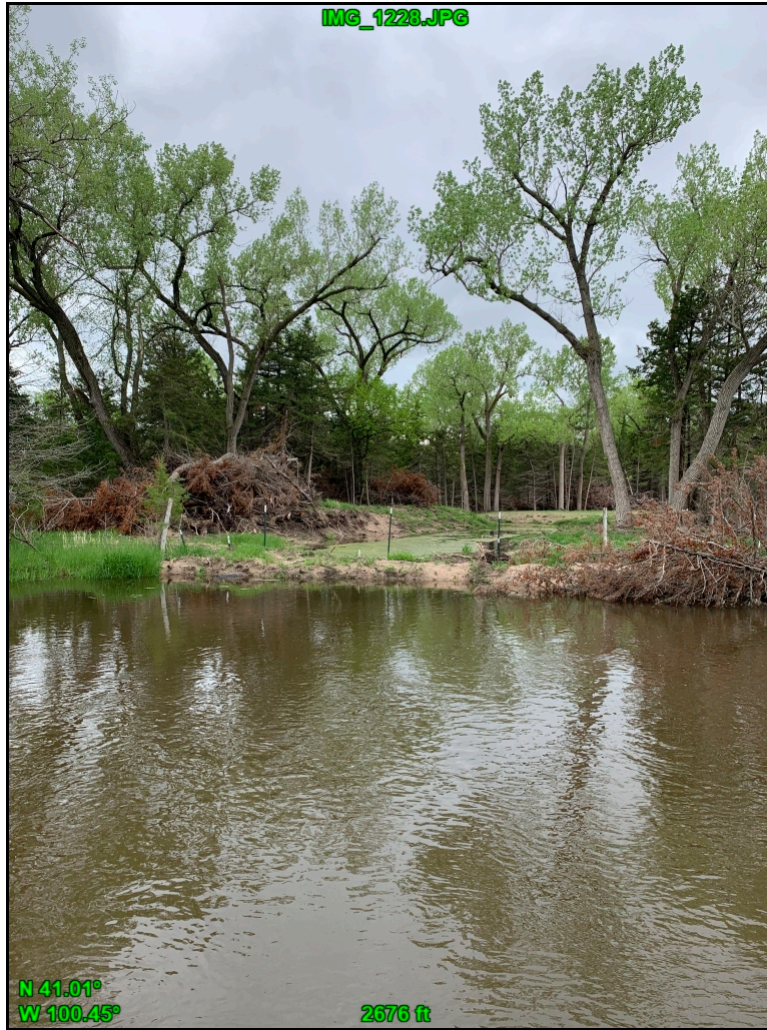
IMG_1229.JPG

Photo taken from the north side of the channel facing south. The photo shows the area excavated behind the fence line and the berm installed between the channel and the newly excavated channel. There is a plastic culvert (about 24-inch) installed connecting the excavated area to the channel.

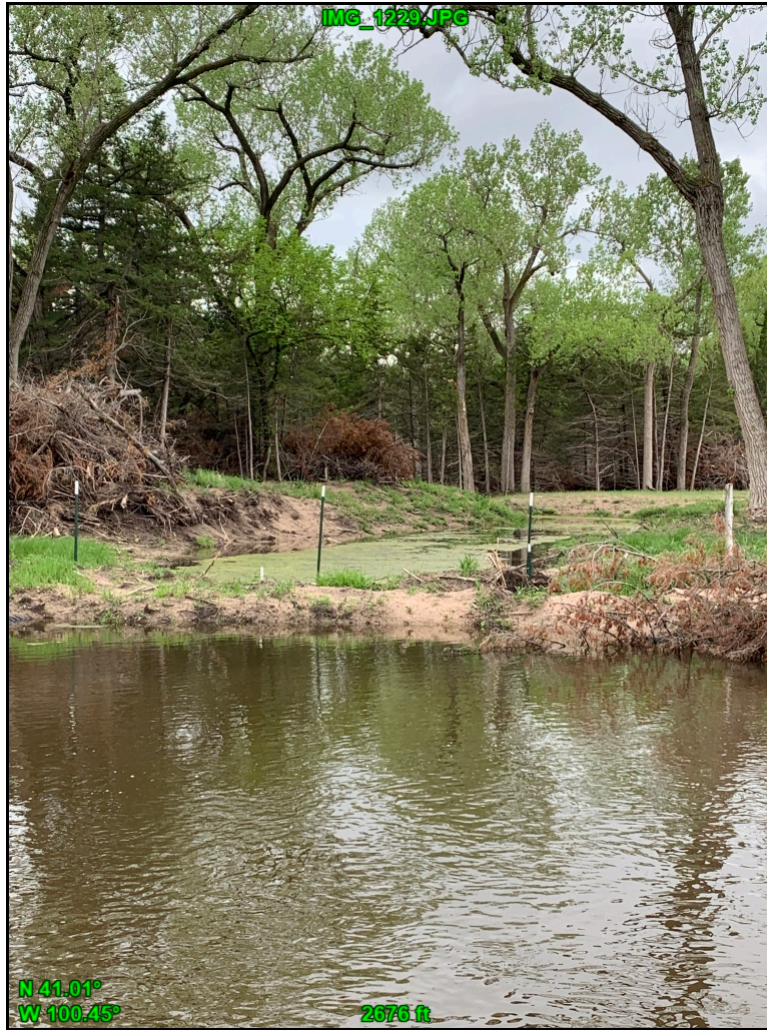
IMG_1230.JPG

Photo taken from the north side of the channel facing south. The photo shows the area excavated behind the fence line and the berm installed between the channel and the newly excavated channel. There is a plastic culvert (about 24-inch) installed connecting the excavated area to the channel.

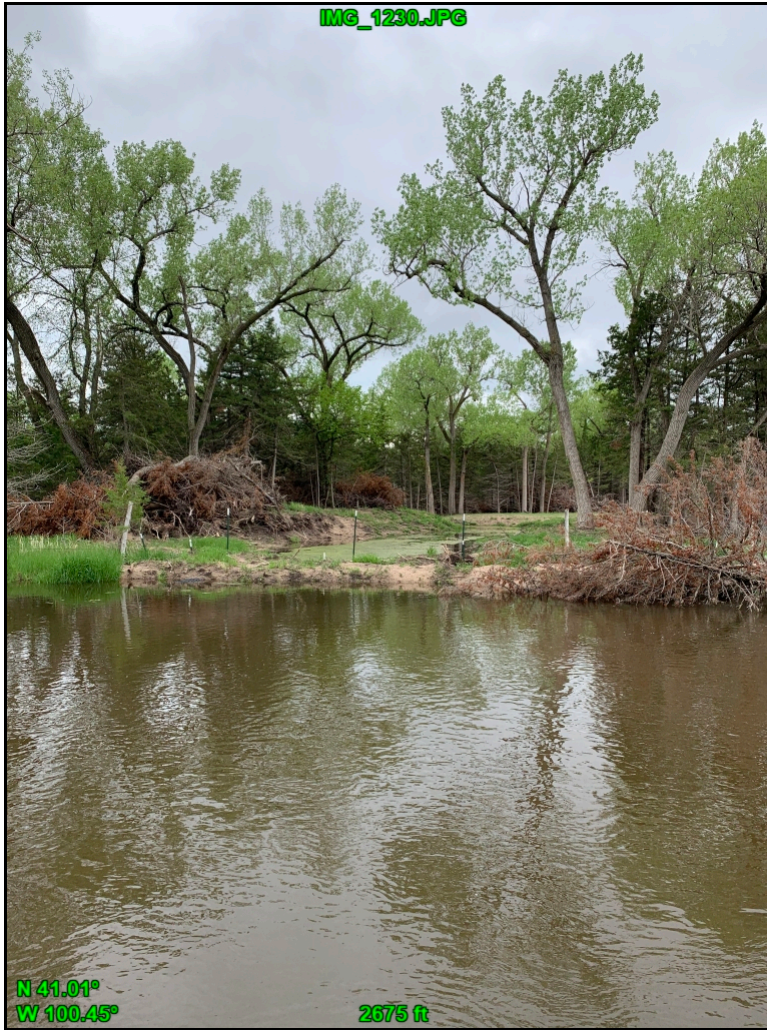
IMG_1231.JPG

Photo taken from the north side of the channel facing south. The photo shows the area excavated behind the fence line and the berm installed between the channel and the newly excavated channel. There is a plastic culvert (about 24-inch) installed connecting the excavated area to the channel.

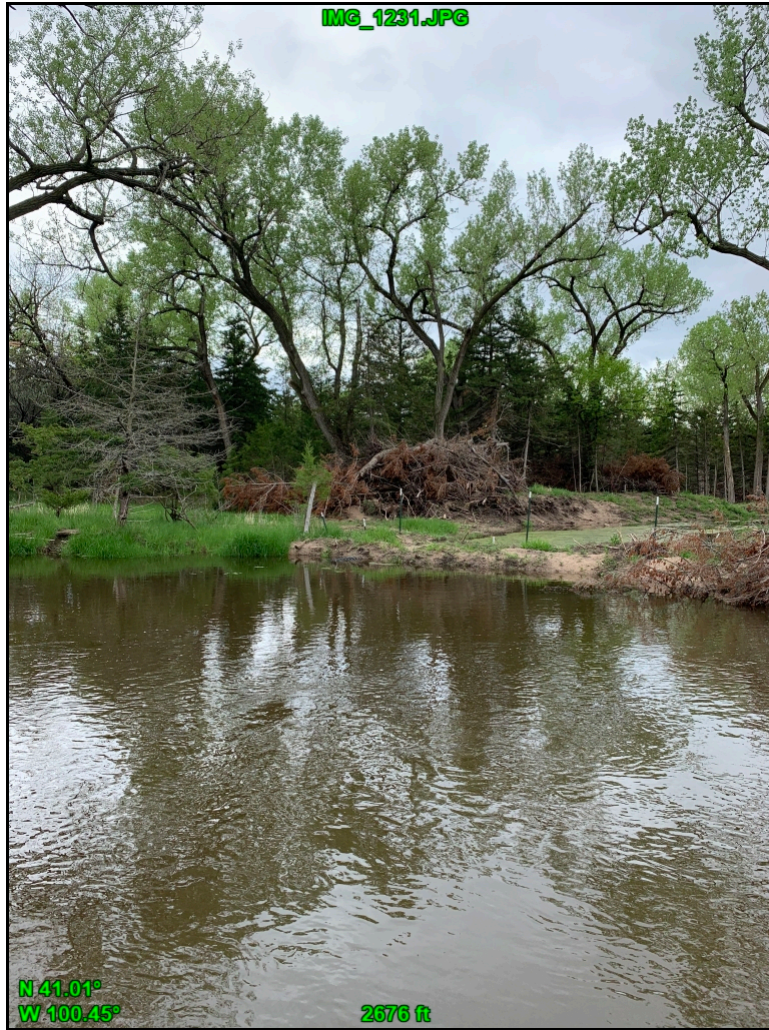
IMG_1234.JPG

Photo taken from the north side of the channel facing south. The photo shows the area excavated behind the fence line and the berm installed between the channel and the newly excavated channel. There is a plastic culvert (about 24-inch) installed connecting the excavated area to the channel.

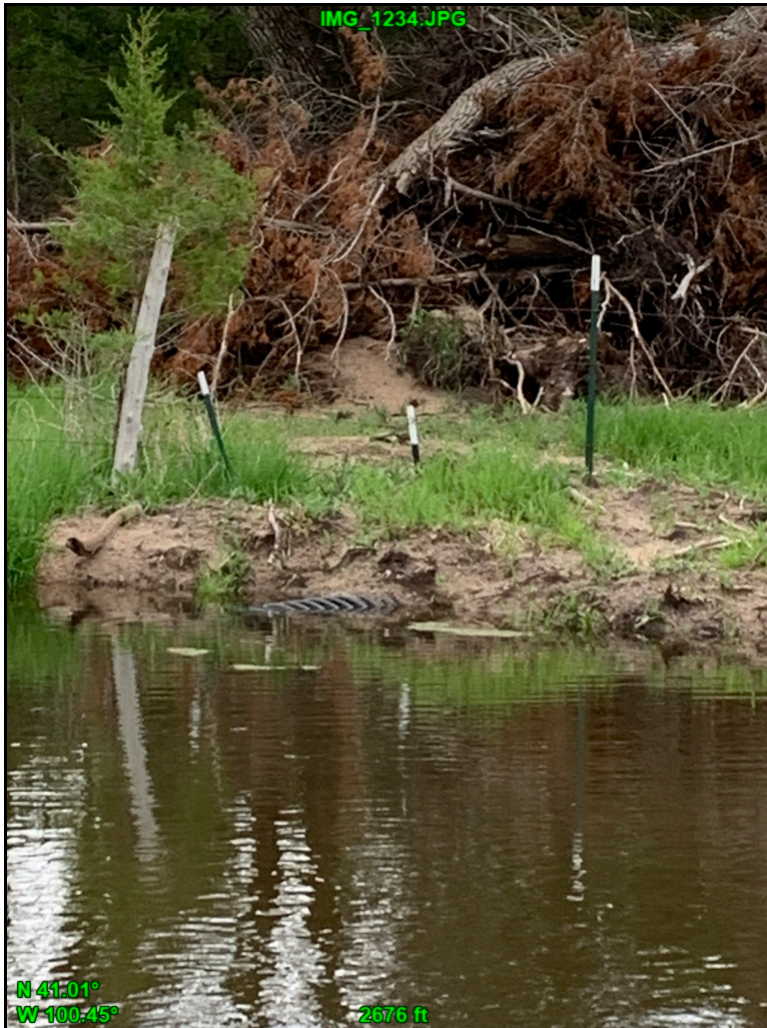
Photo showing the culvert installed below the berm.

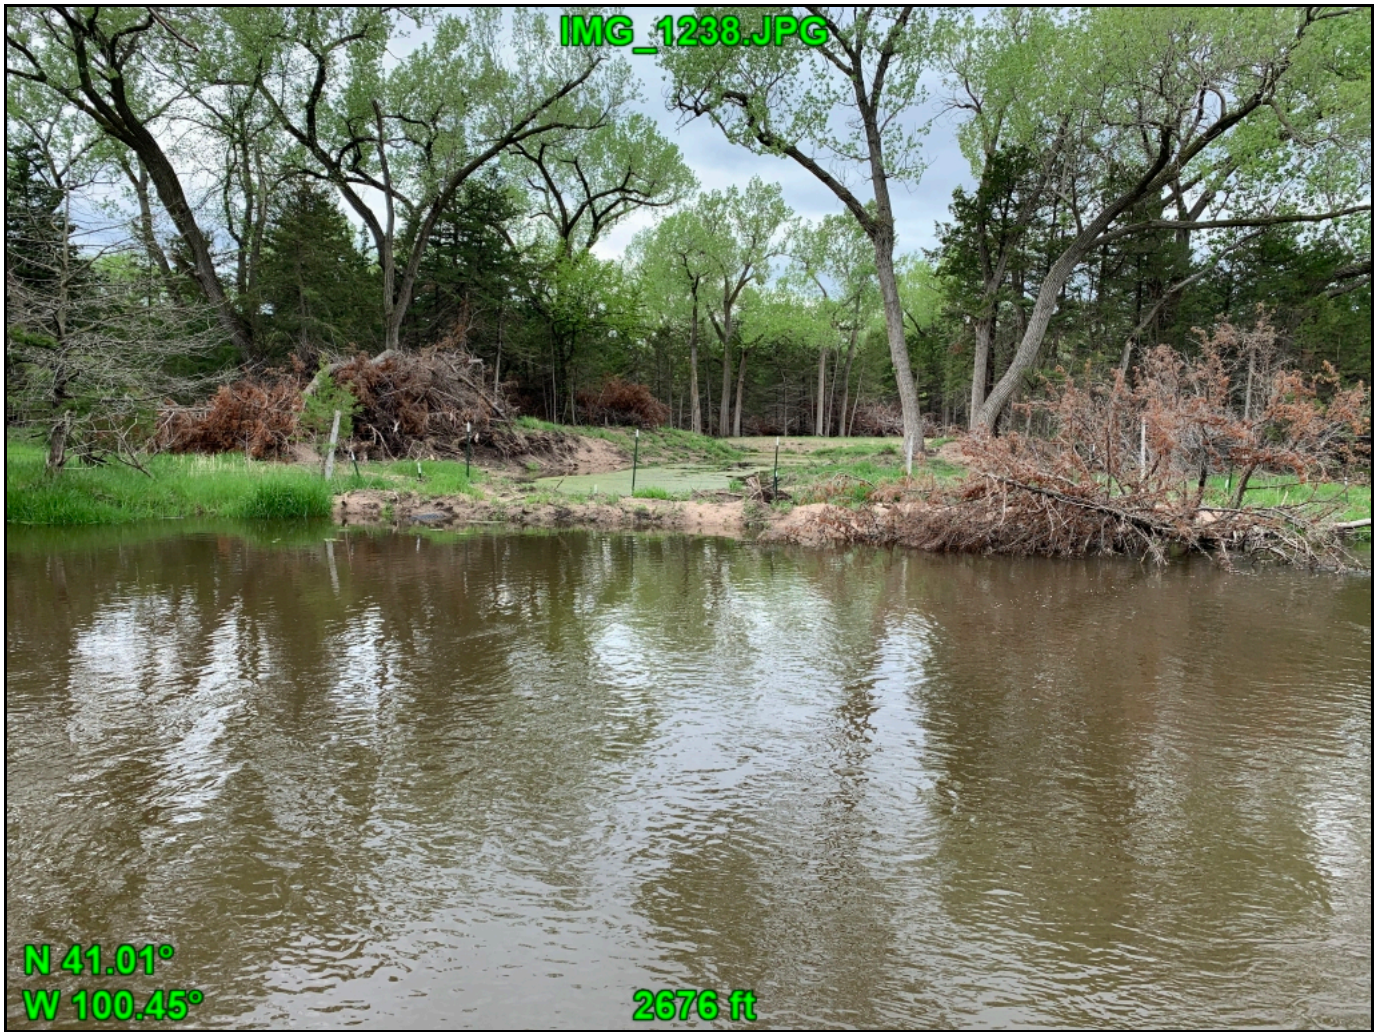
IMG_1240.JPG

Photo taken from the north side of the channel facing south. The photo shows the area excavated behind the fence line and the berm installed between the channel and the newly excavated channel. There is a plastic culvert (about 24-inch) installed connecting the excavated area to the channel.

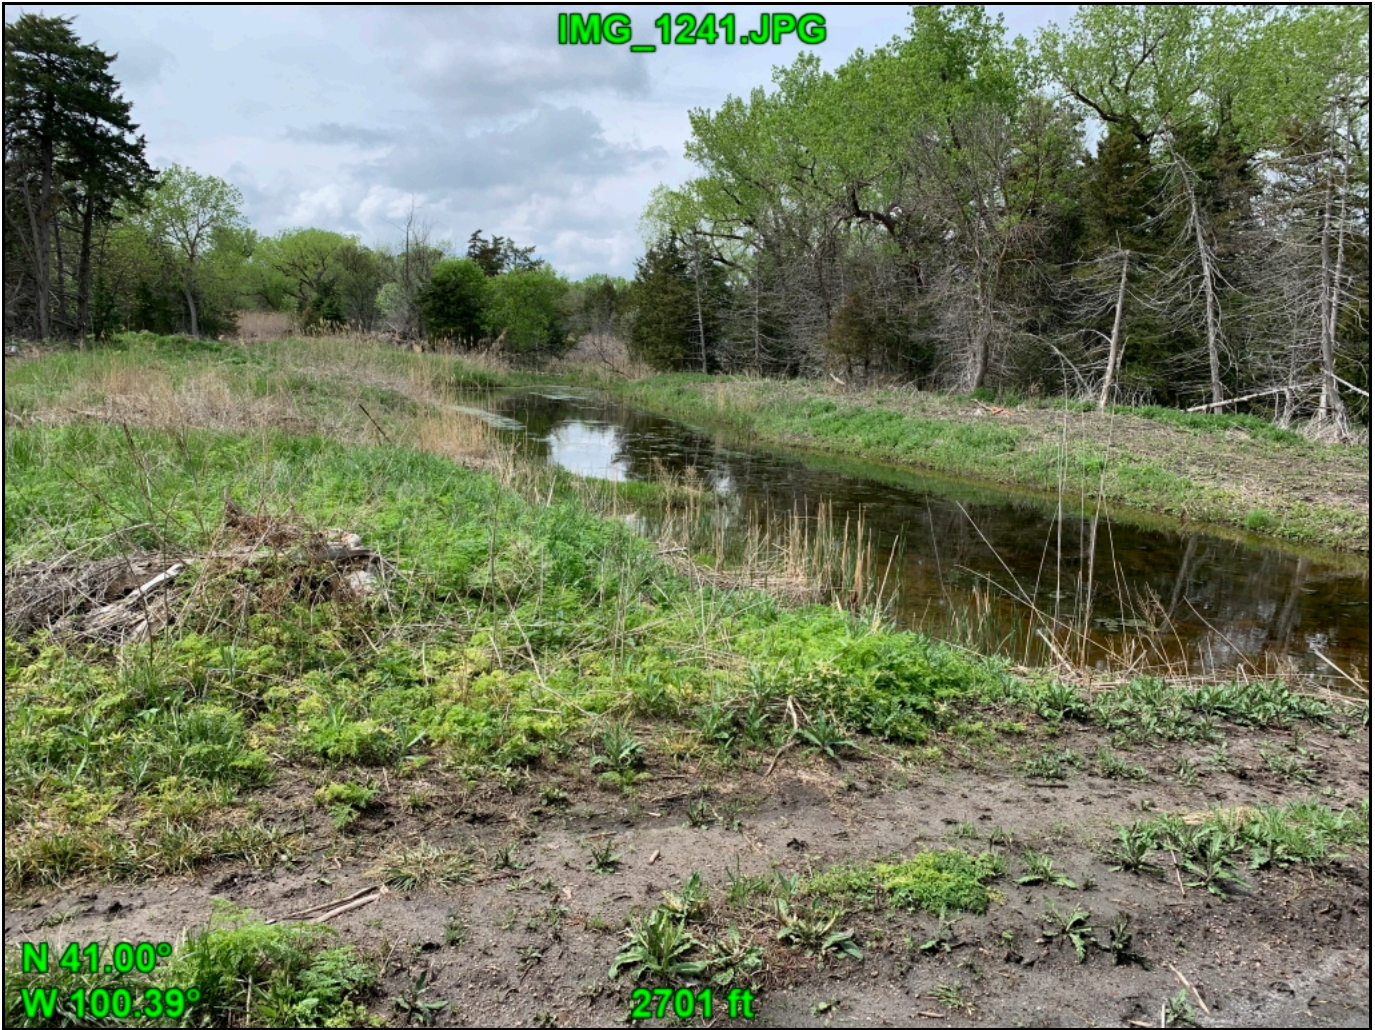
Photo taken facing west showing excavated channel south of the crossing.

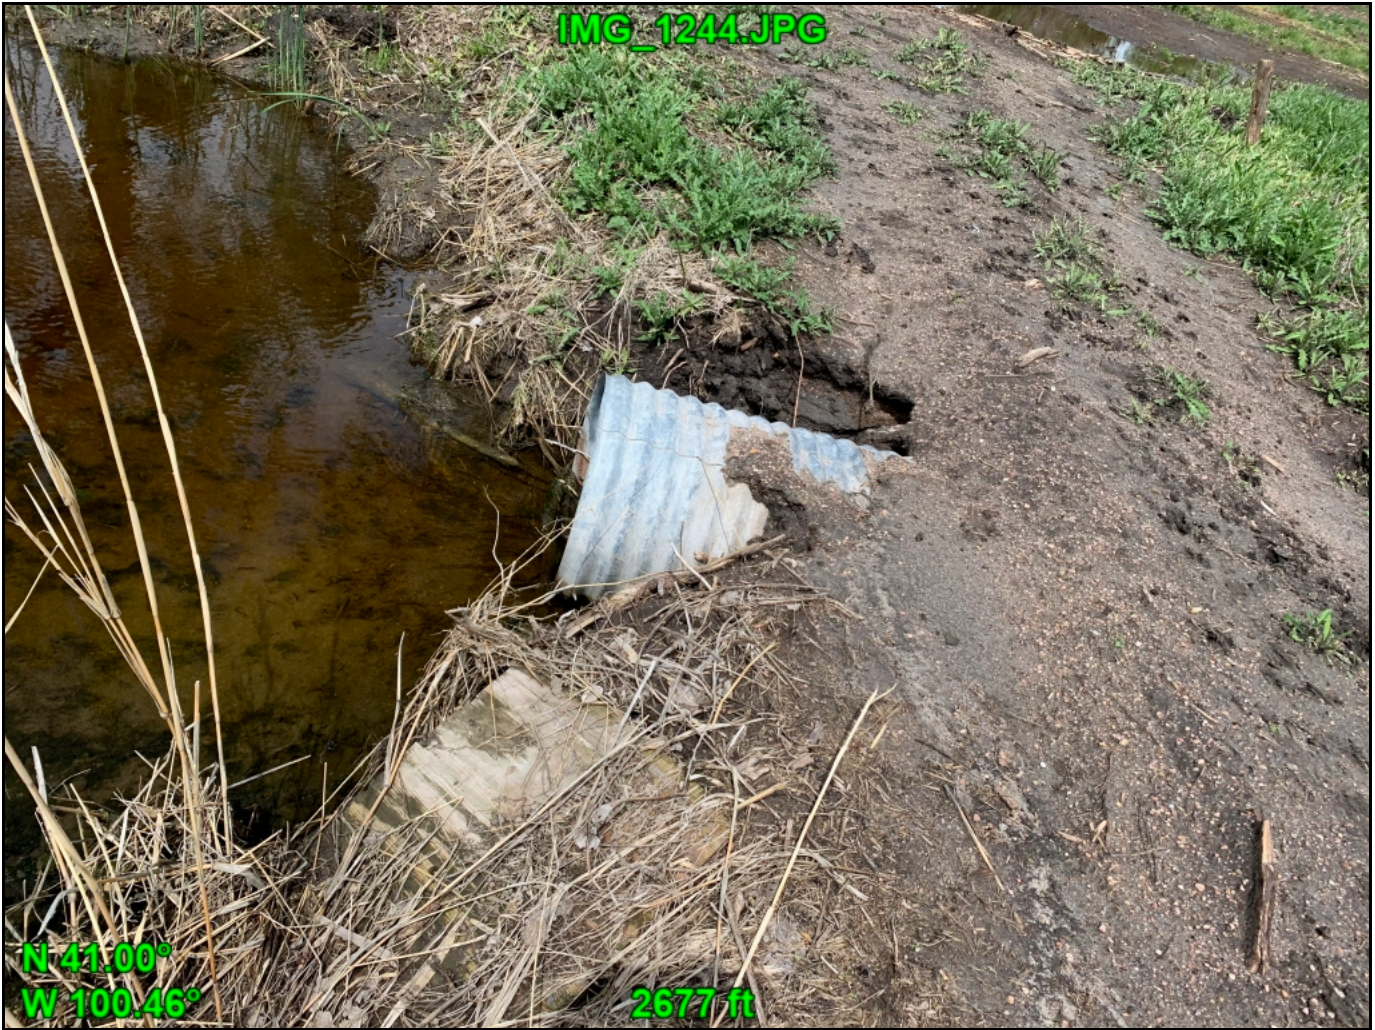
IMG_1248.JPG

Photo of CMP in the crossing.

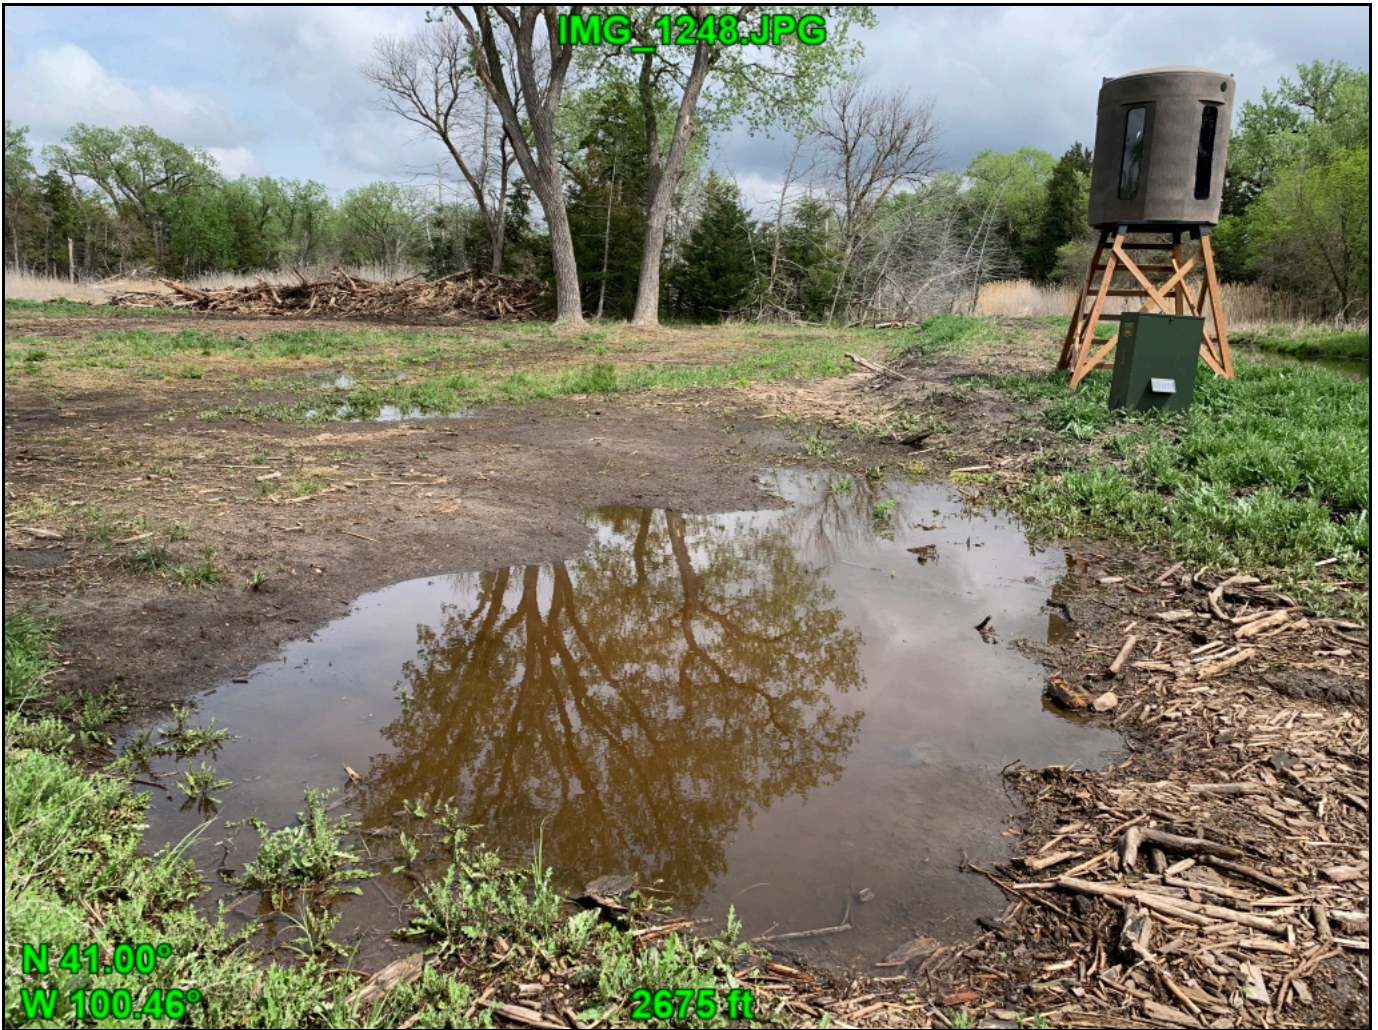
IMG_1249.JPG

Photo of the berm along excavated channel.

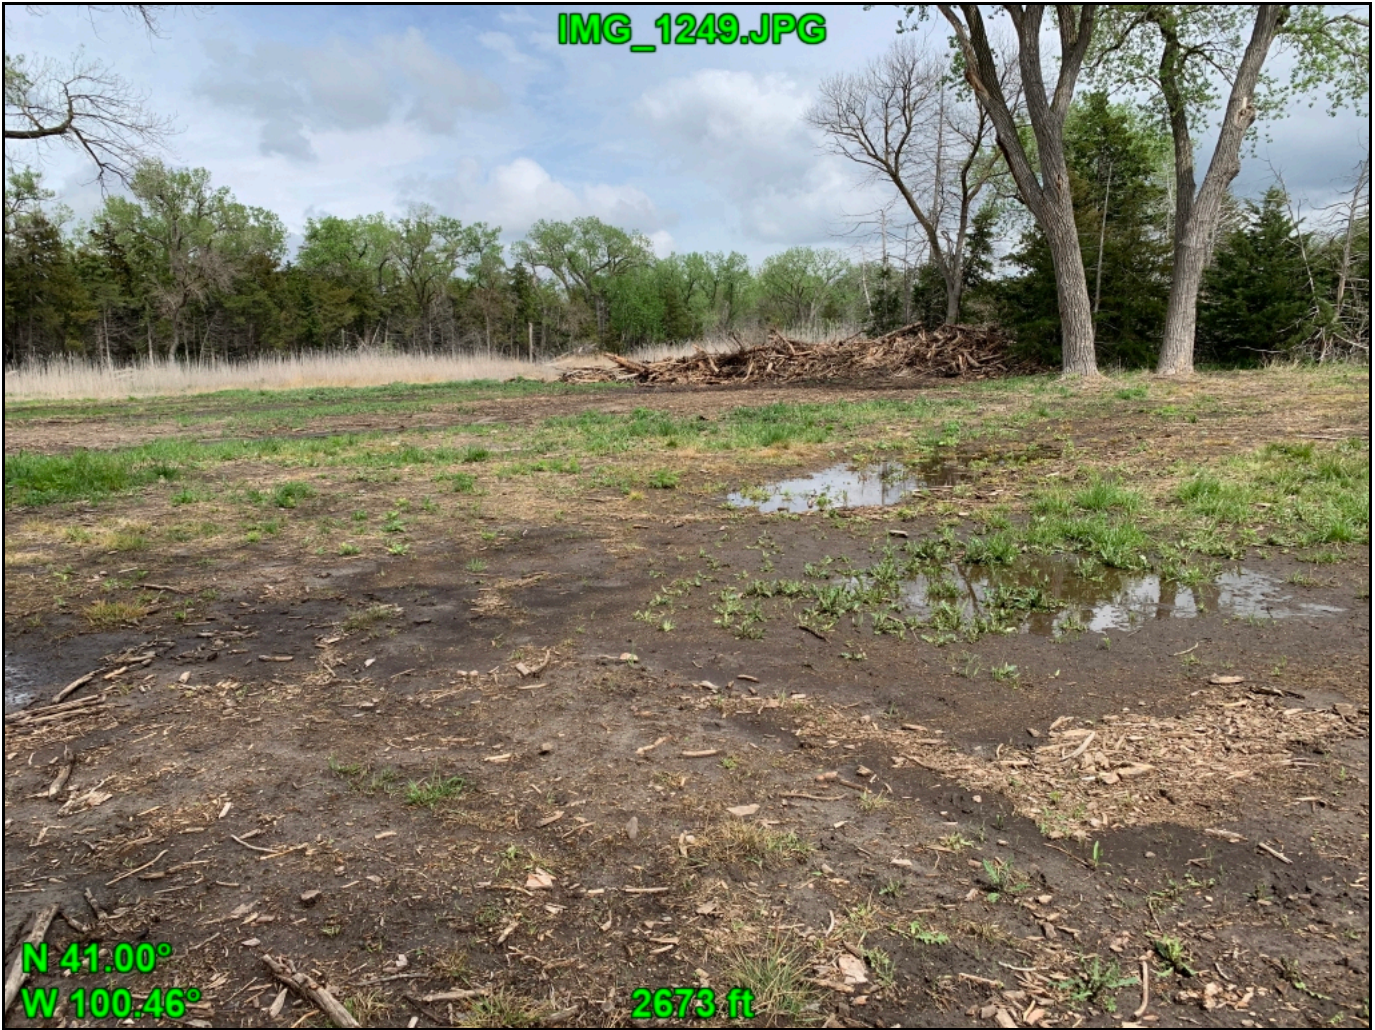
Showing veg removal as above.

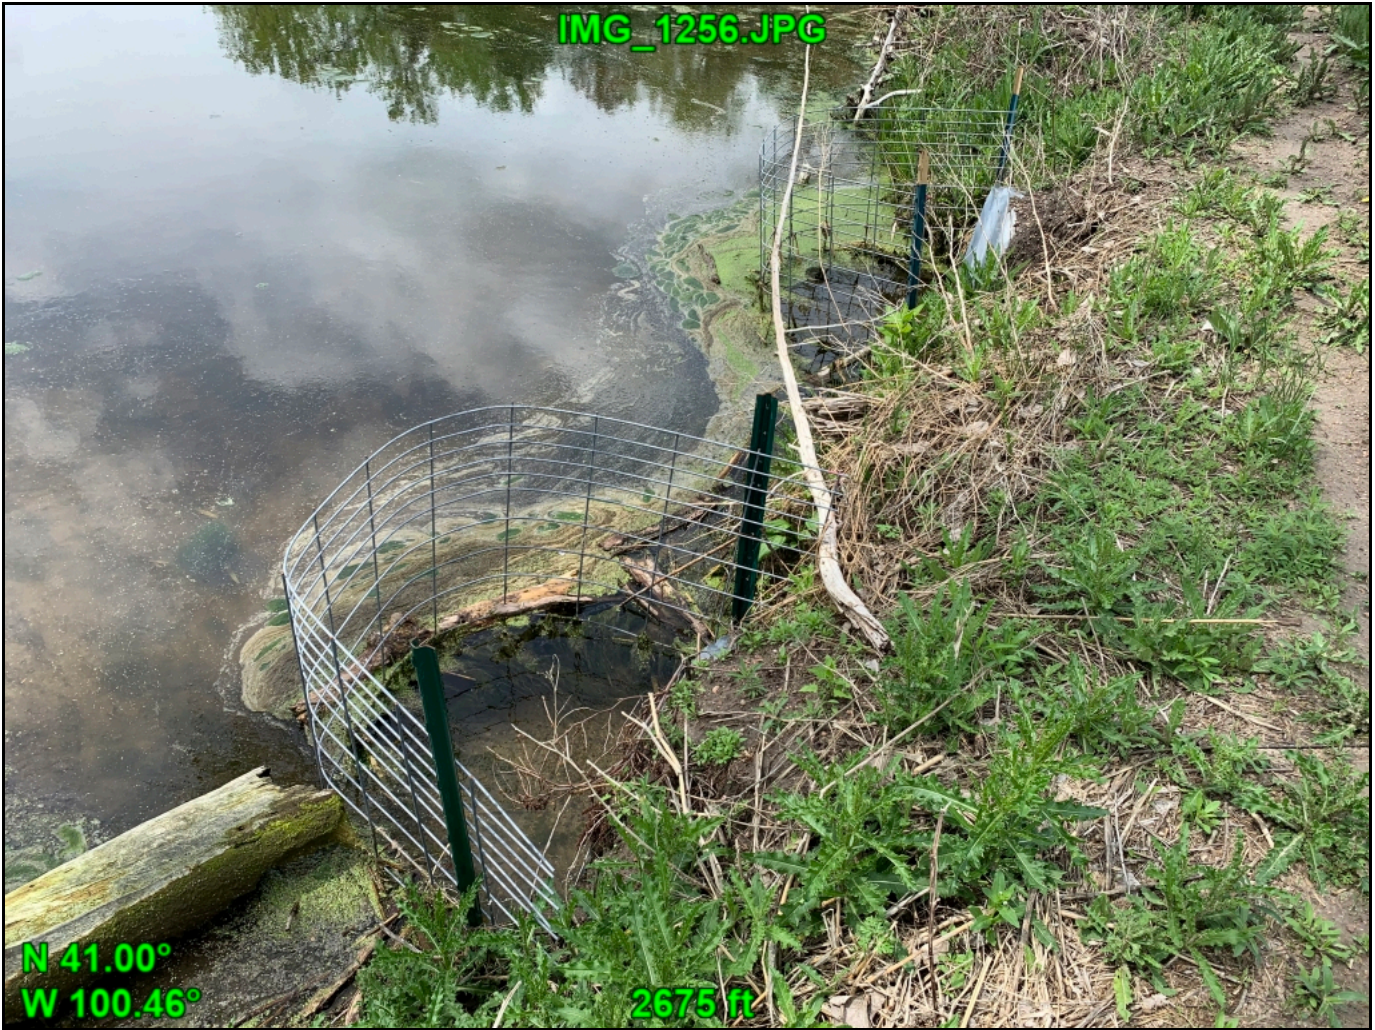
IMG_1257.JPG

Photo of both CMP structures in the crossing.

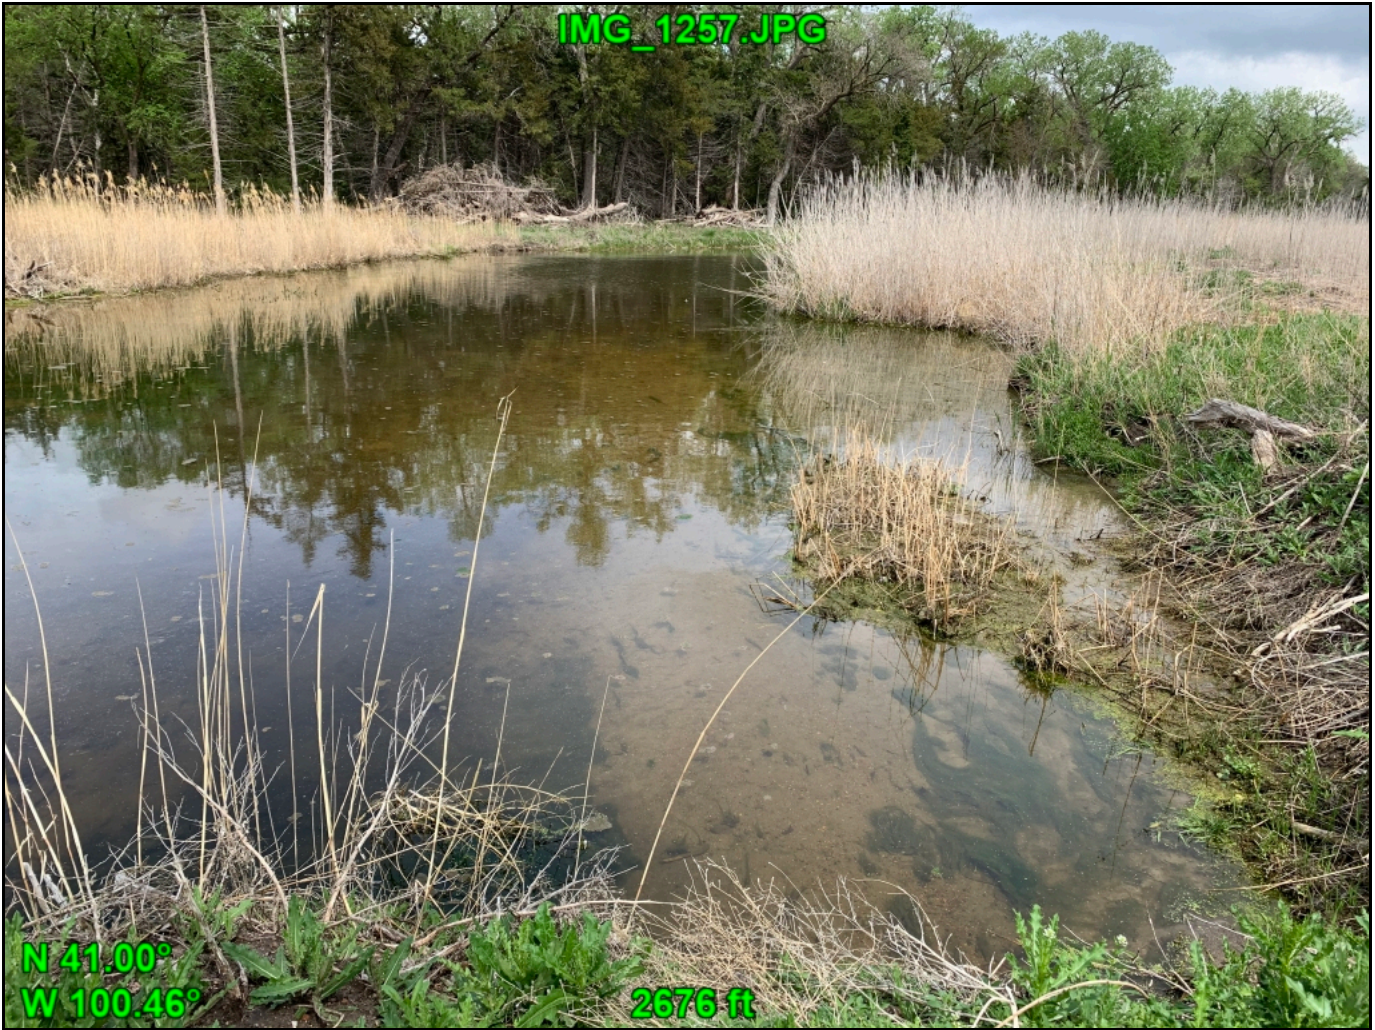
IMG_1258.JPG

Excavated channel from the crossing.

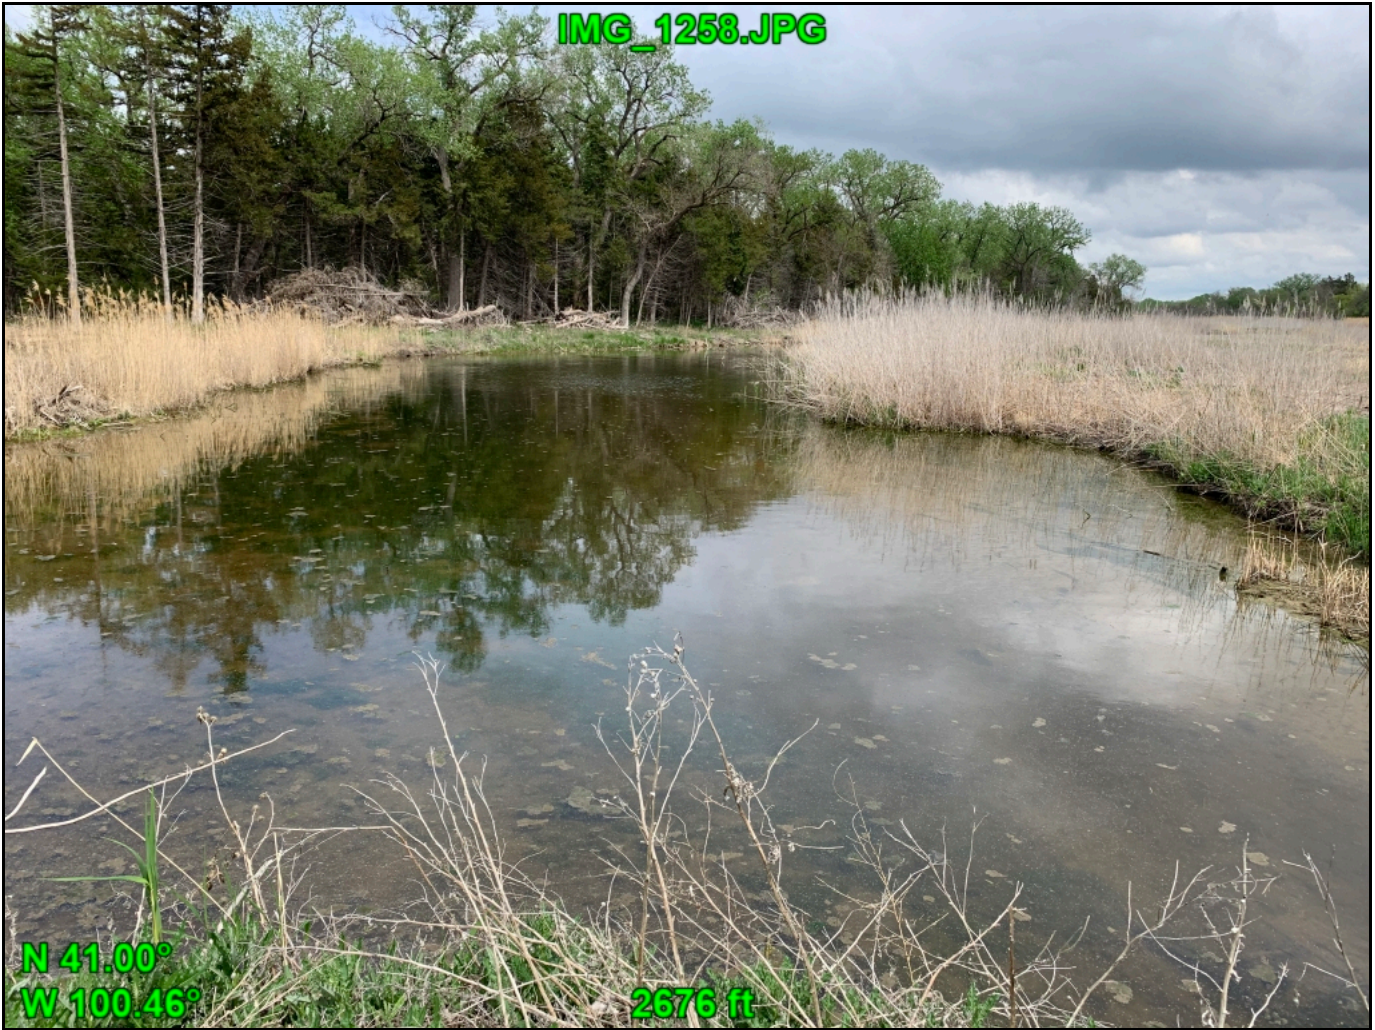
Excavated channel from the crossing.

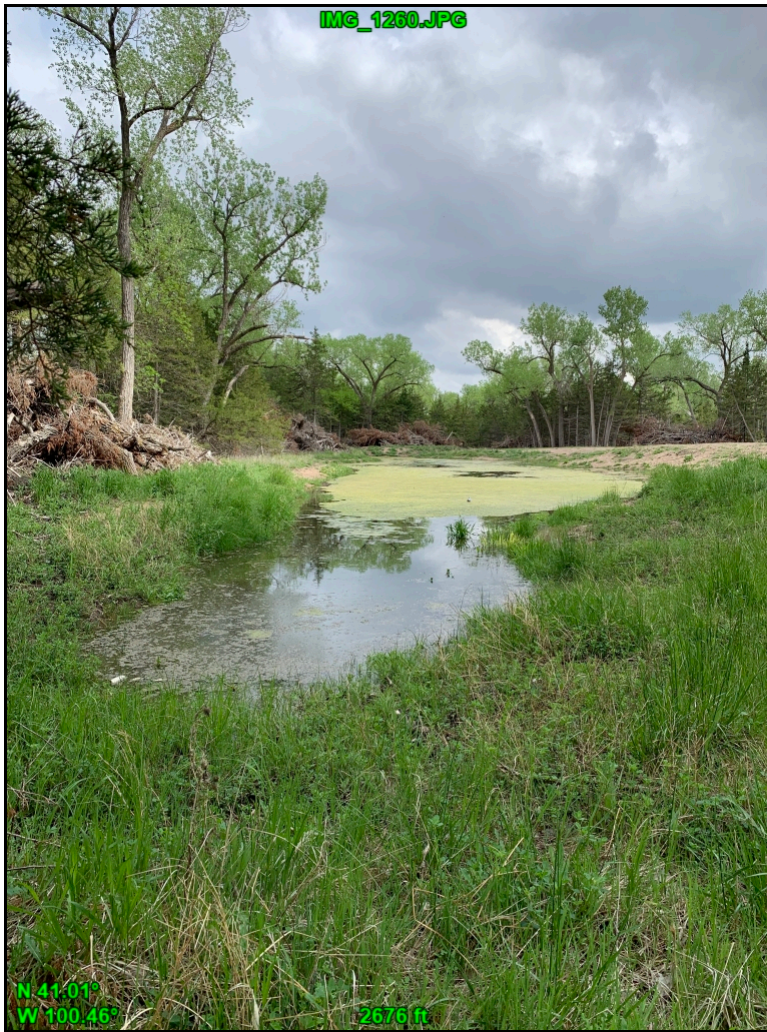
IMG_1261.JPG

Photo facing east, this is the western limit of the excavated channel connecting to the constructed berm abutting the Platte River.

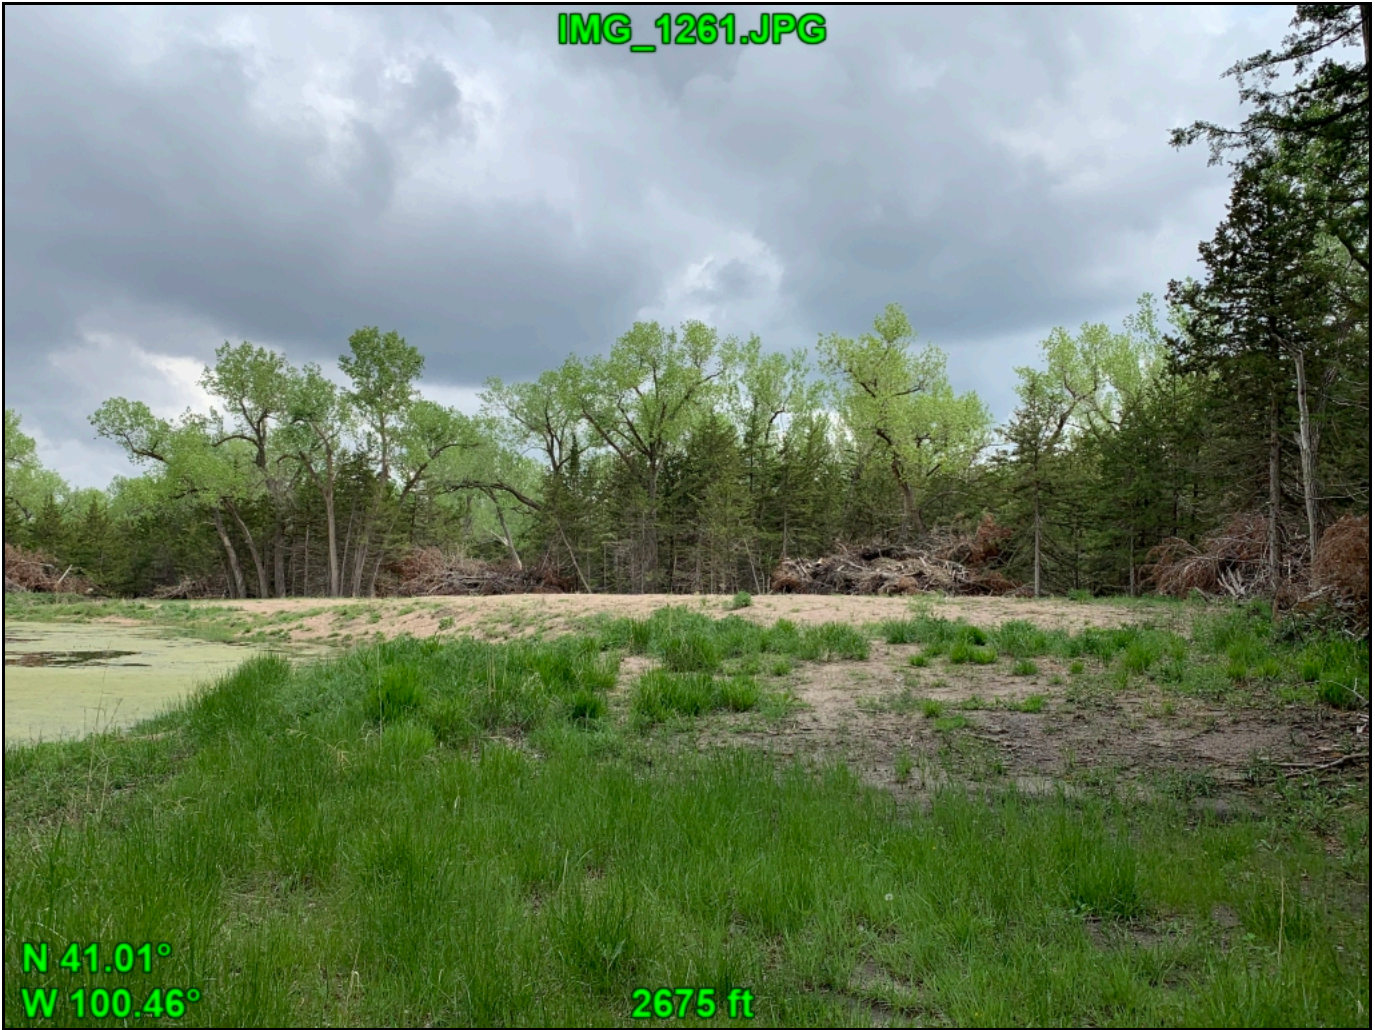
Photo shows the fill from the excavated channel to the north.

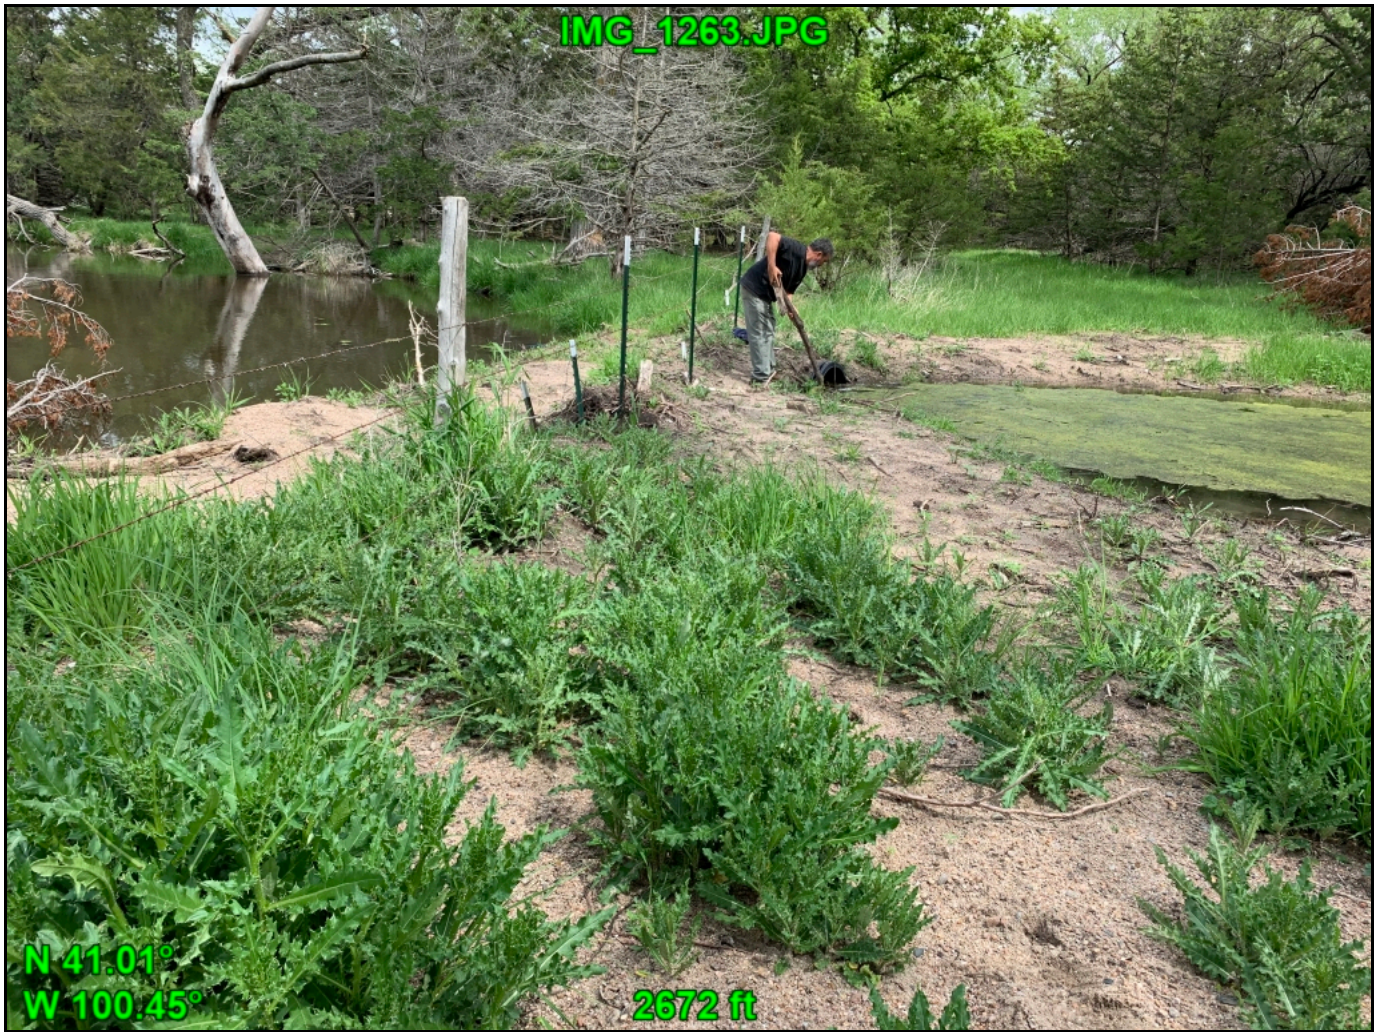
IMG_1264.JPG

Showing the berm, excavated channel to the south and Platte River to the north.

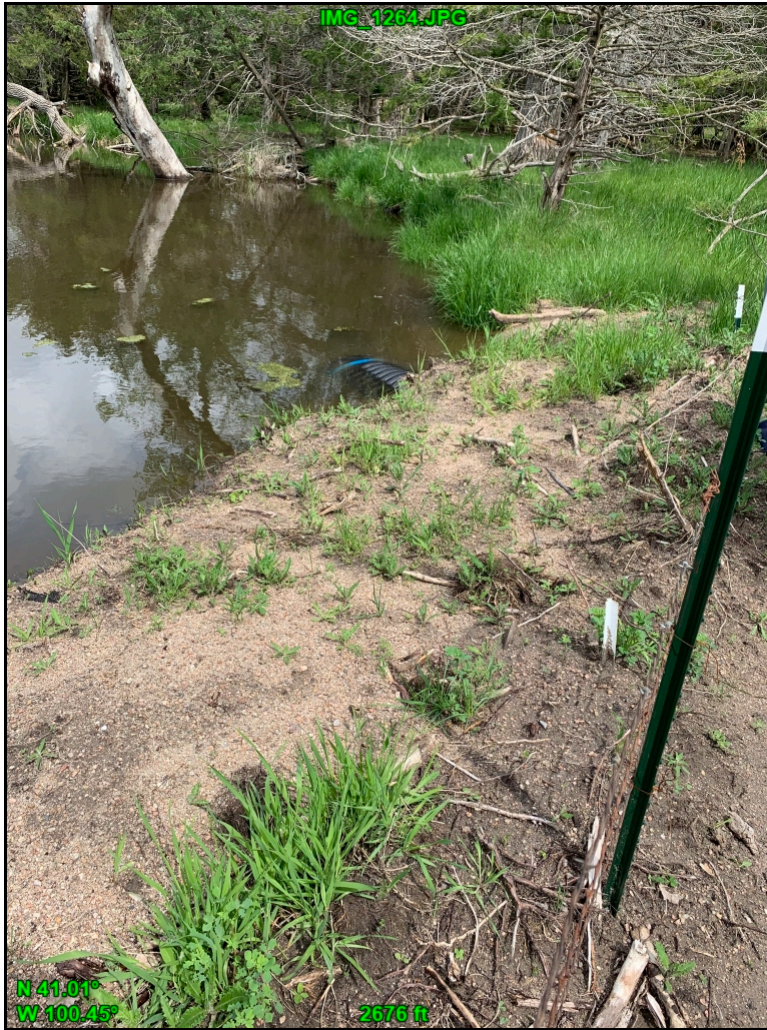
IMG_1265.JPG

Photo shows culvert connecting the Platte River to the new excavated channel to the south.

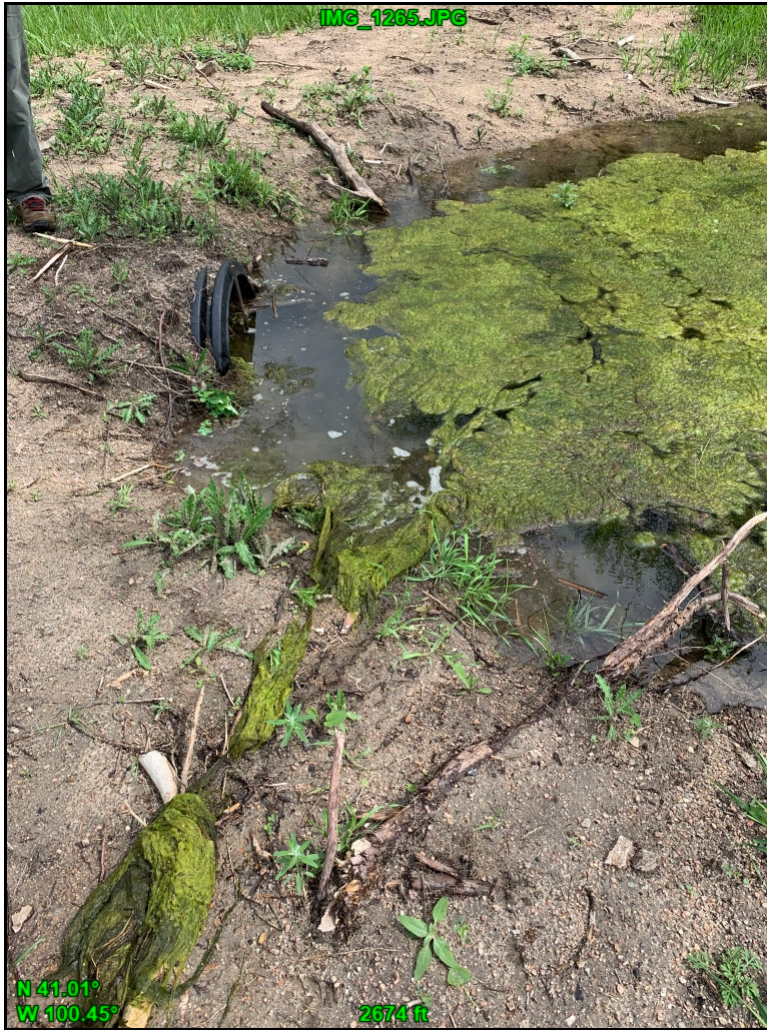
Berm culvert

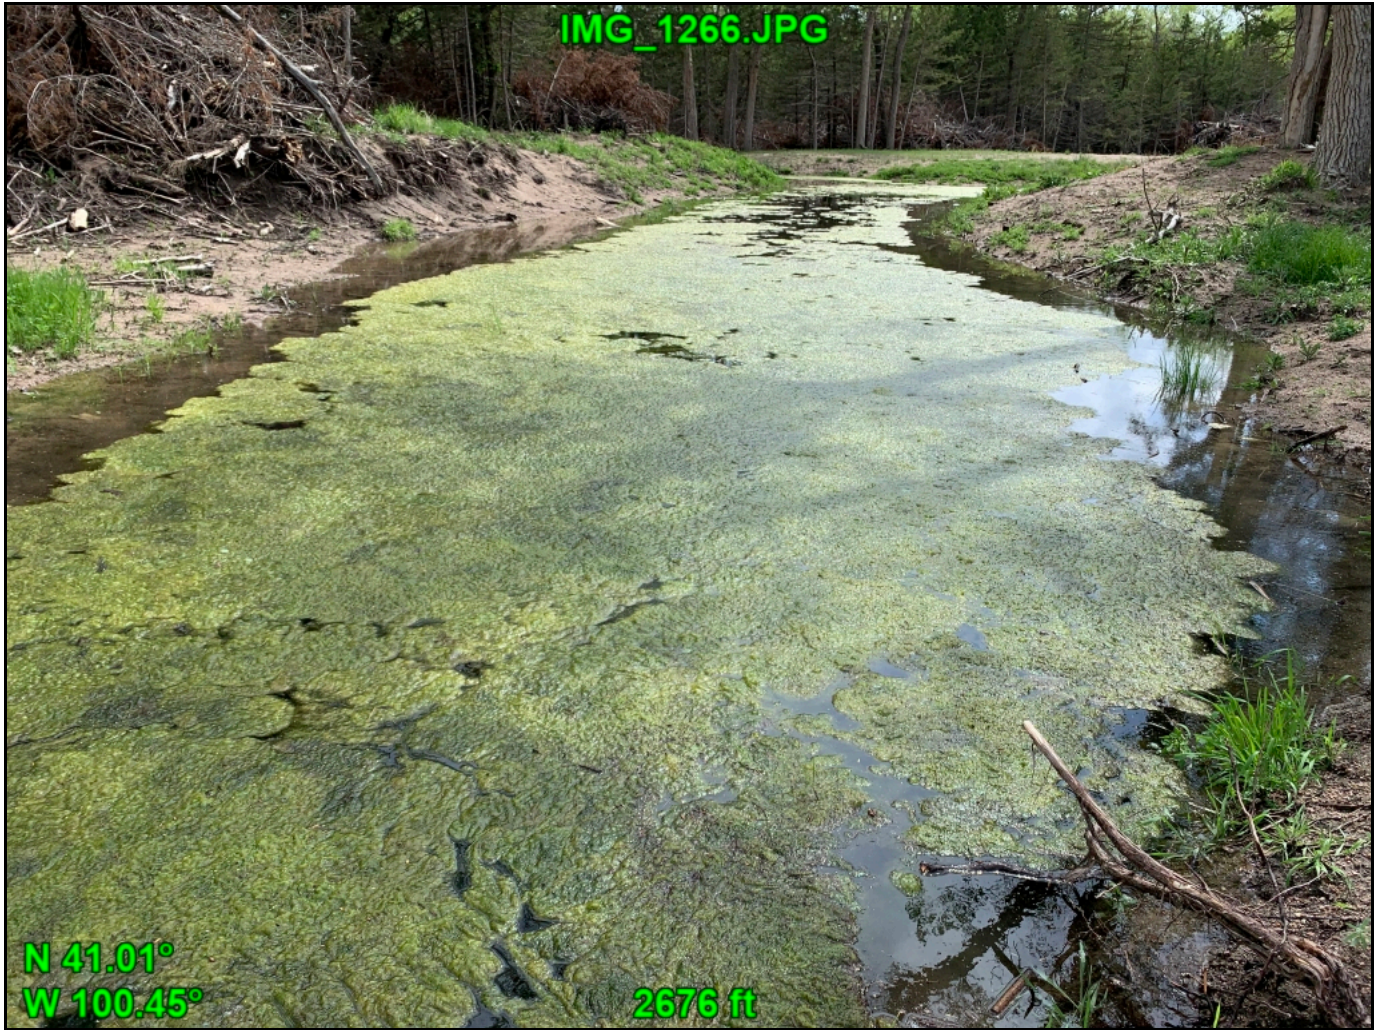
Photo facing south from the berm along the south bank of the Platte River. This area was excavated south and extends west (photo 1260).
