SITE VISIT RECORD

Subject: Violation: 2020-00951 Wetlands and Channels Excavated

Date: May 18, 2021

2020-00951

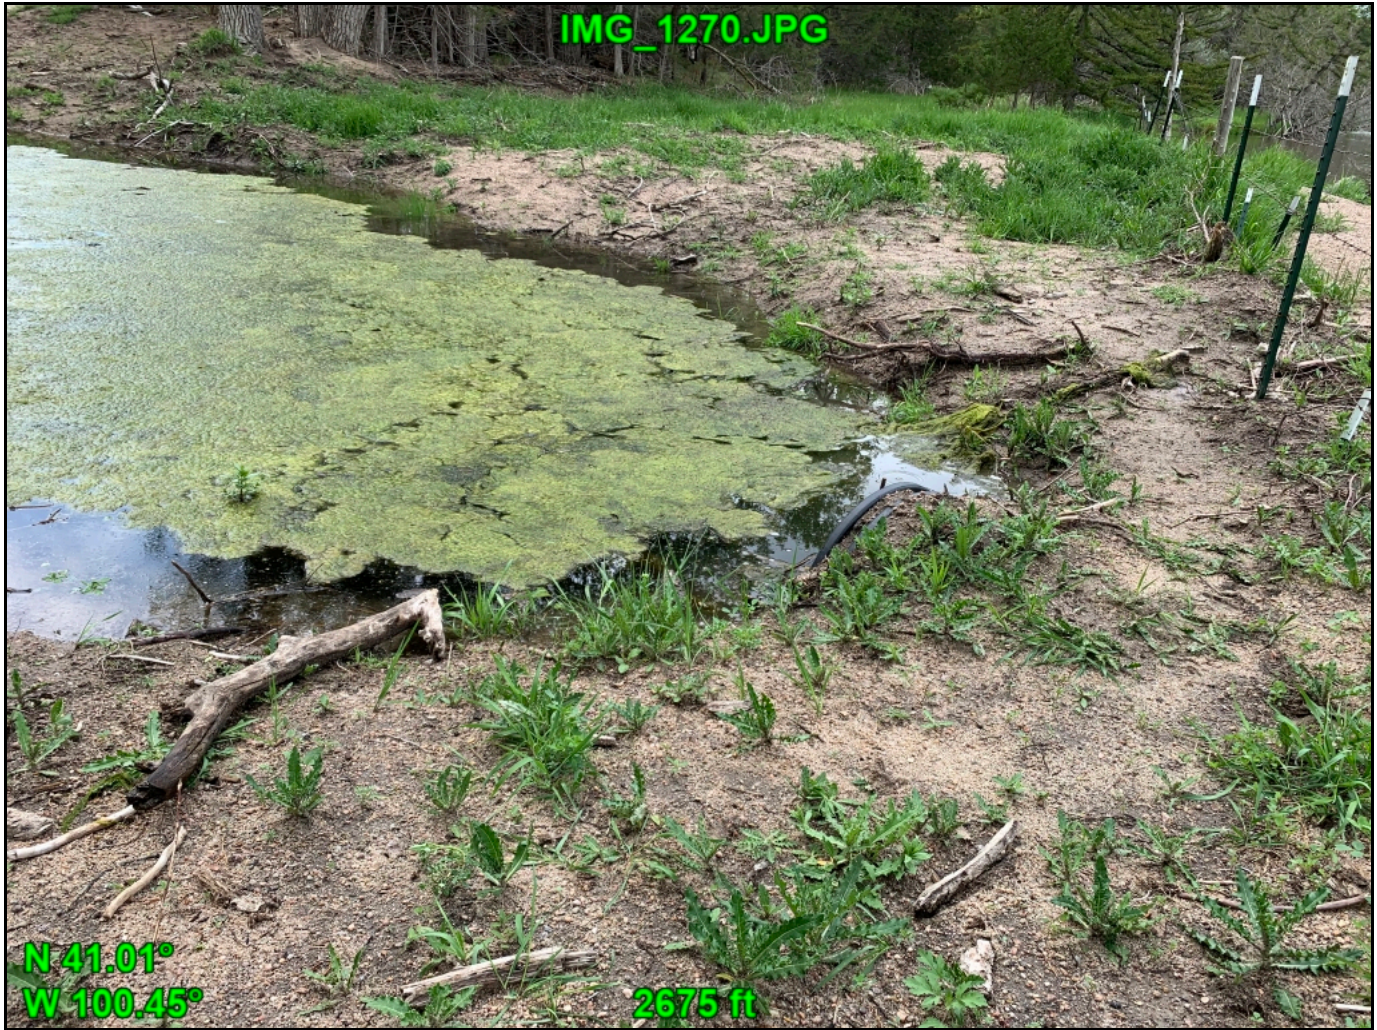
Berm south of the Platte River

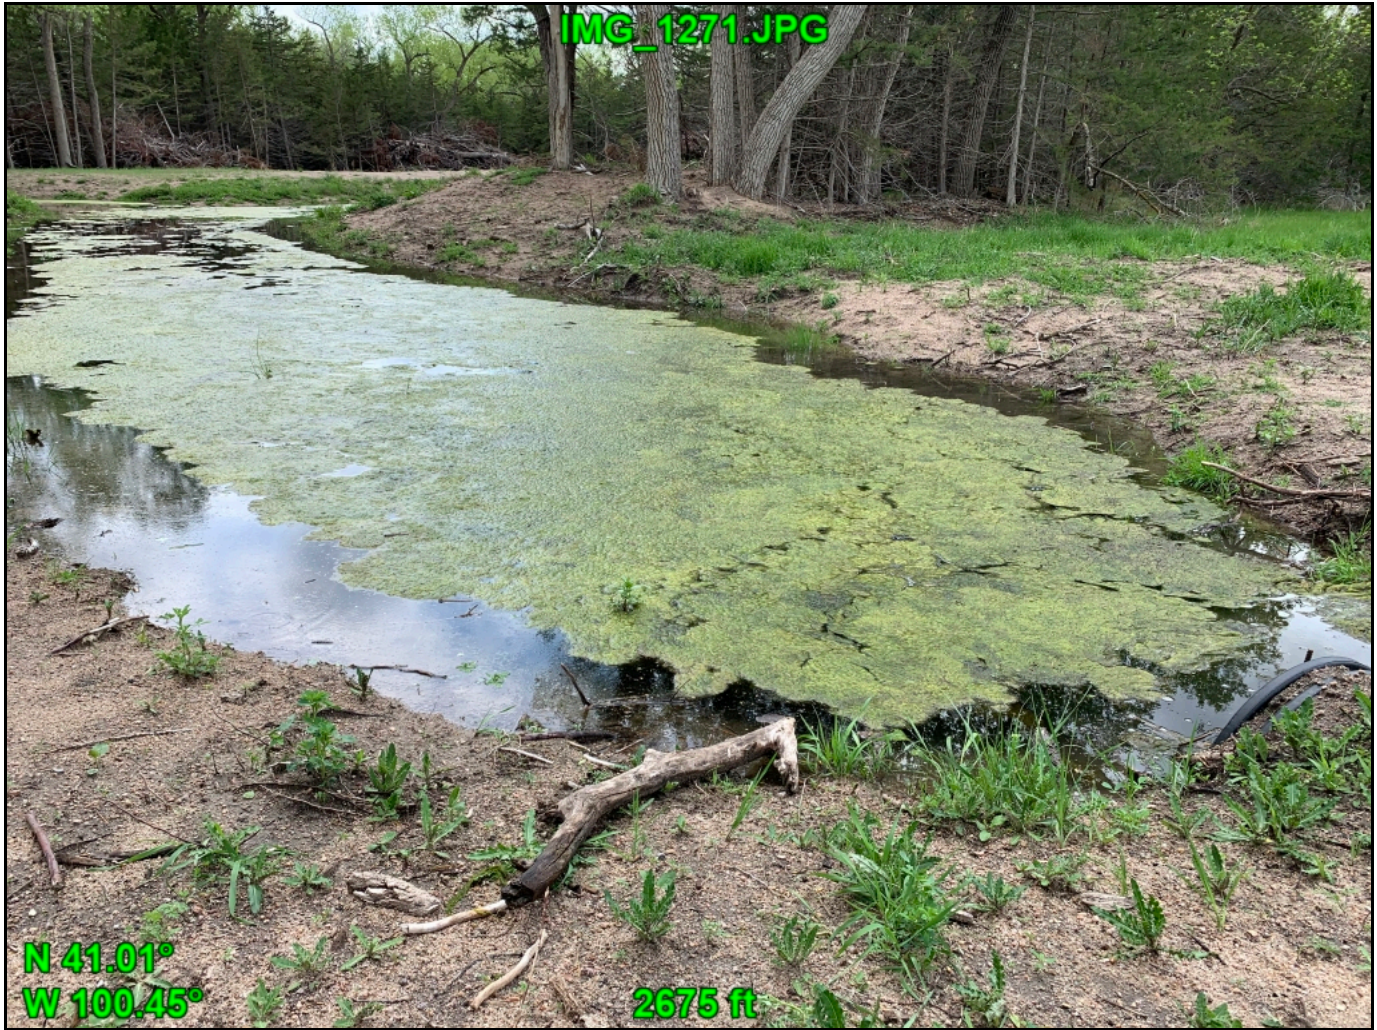
IMG_1272.JPG

From the berm facing west showing area of excavation.

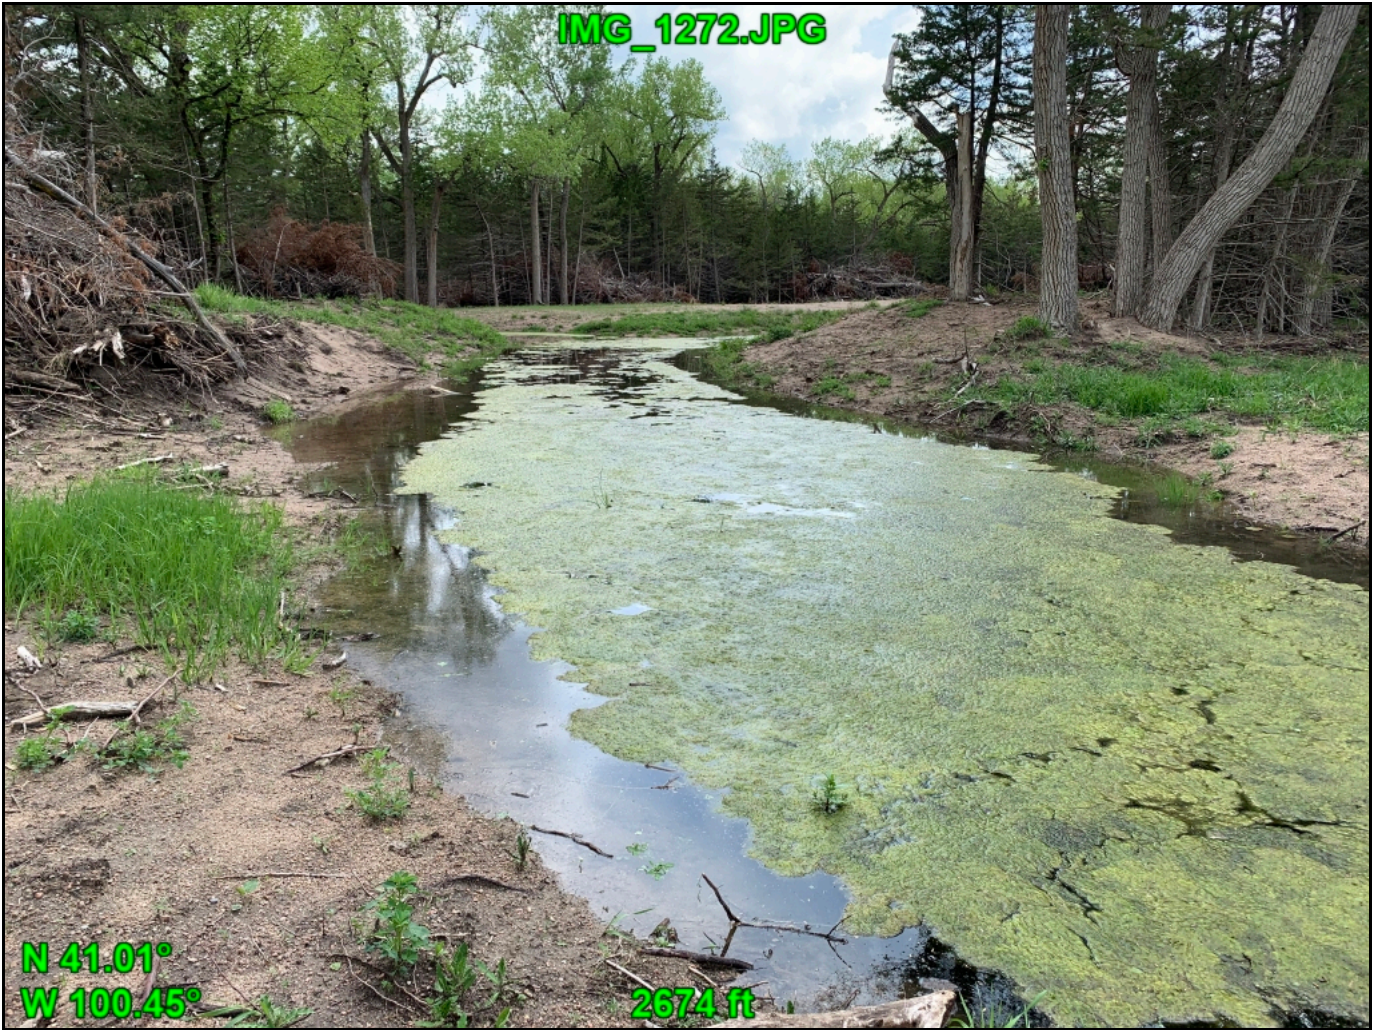
IMG_1274.JPG

From berm facing south showing area of excavation.

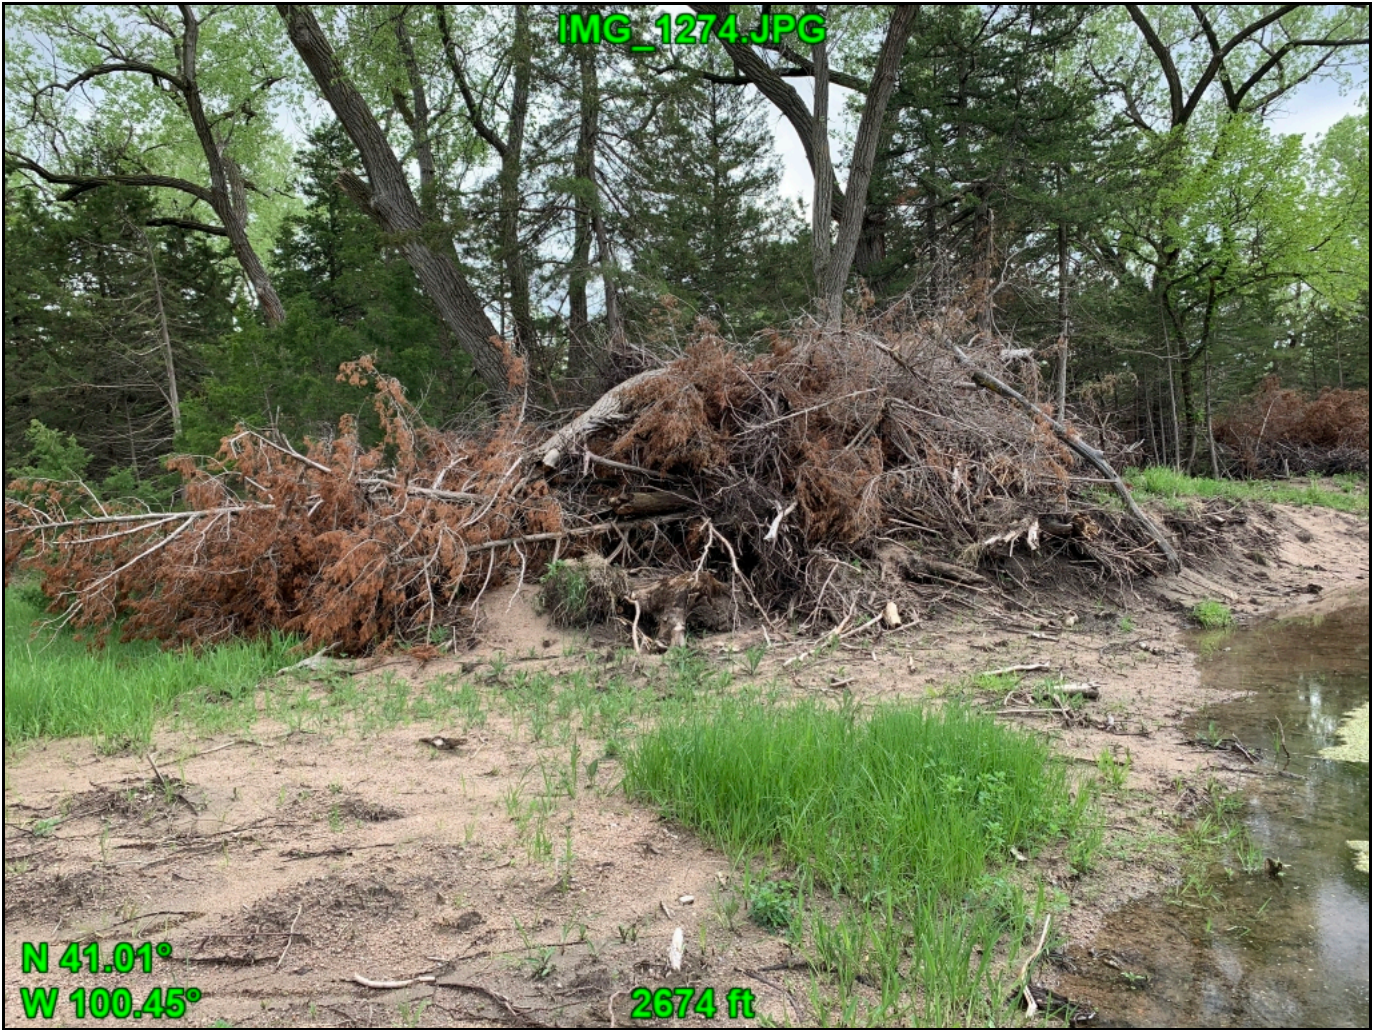
IMG_1275.JPG

Debris pile east of dug channel.

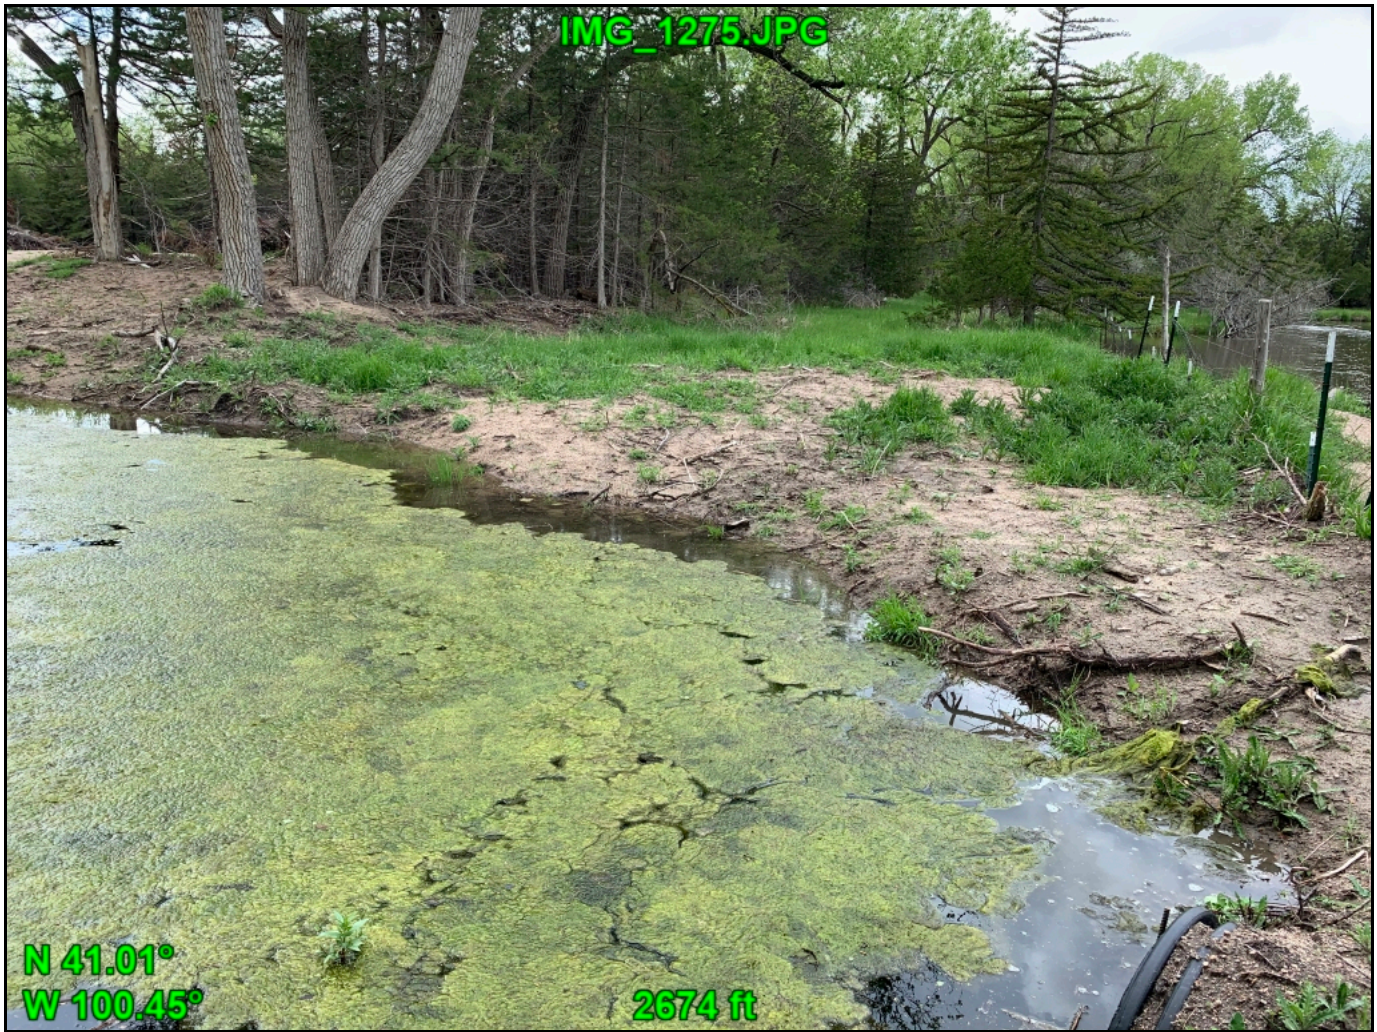
Elevation change- normal ground level is shown near tree line.

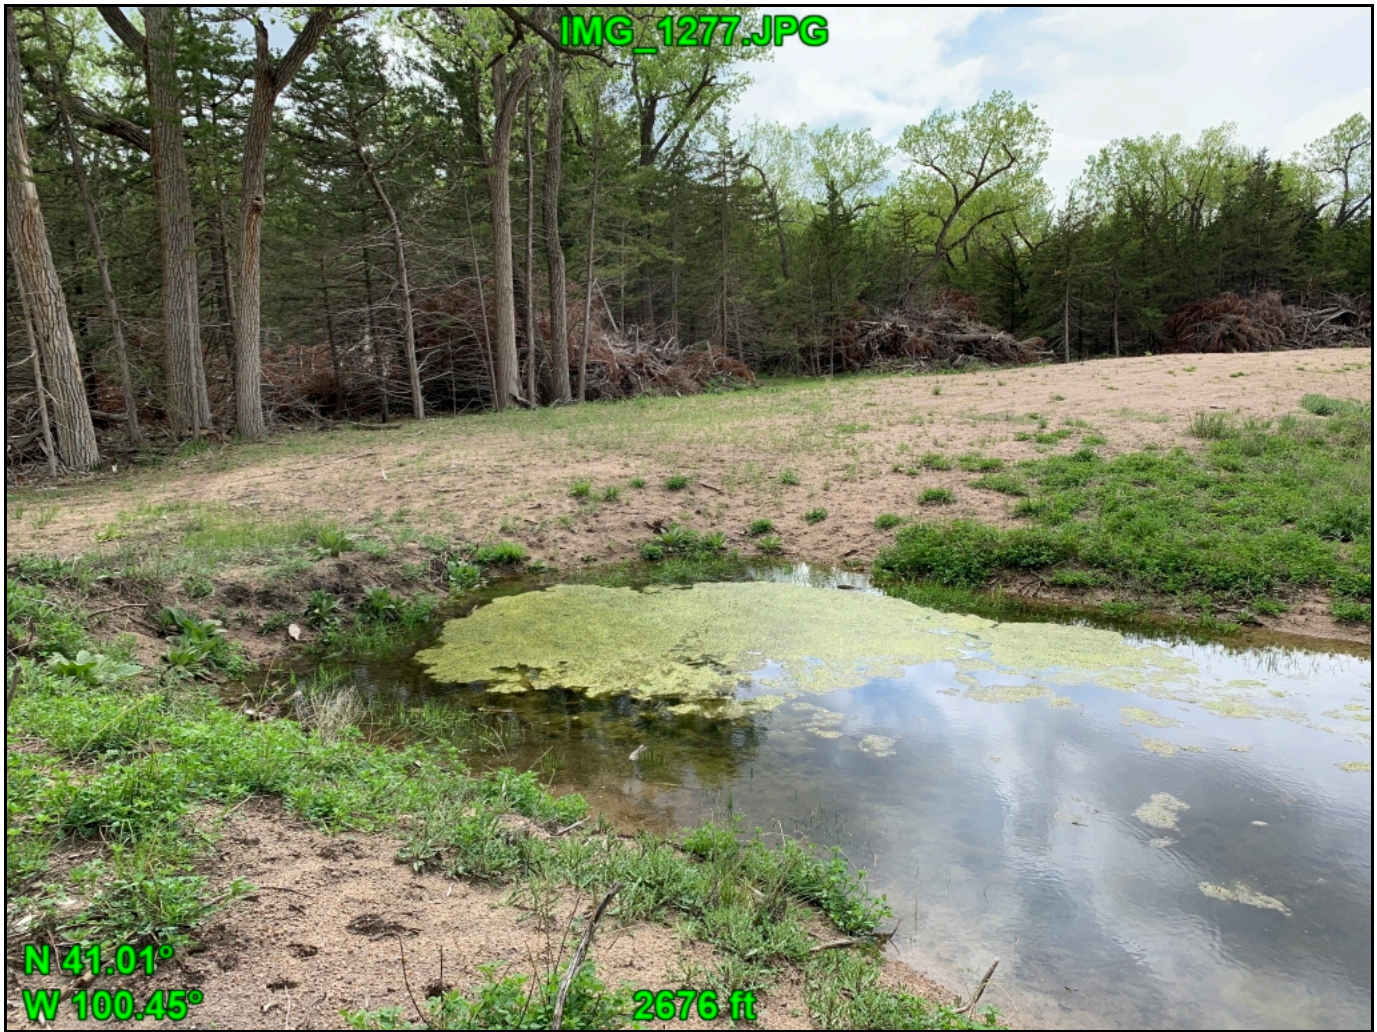
IMG_1279.JPG

Fill location from excavation of channels.

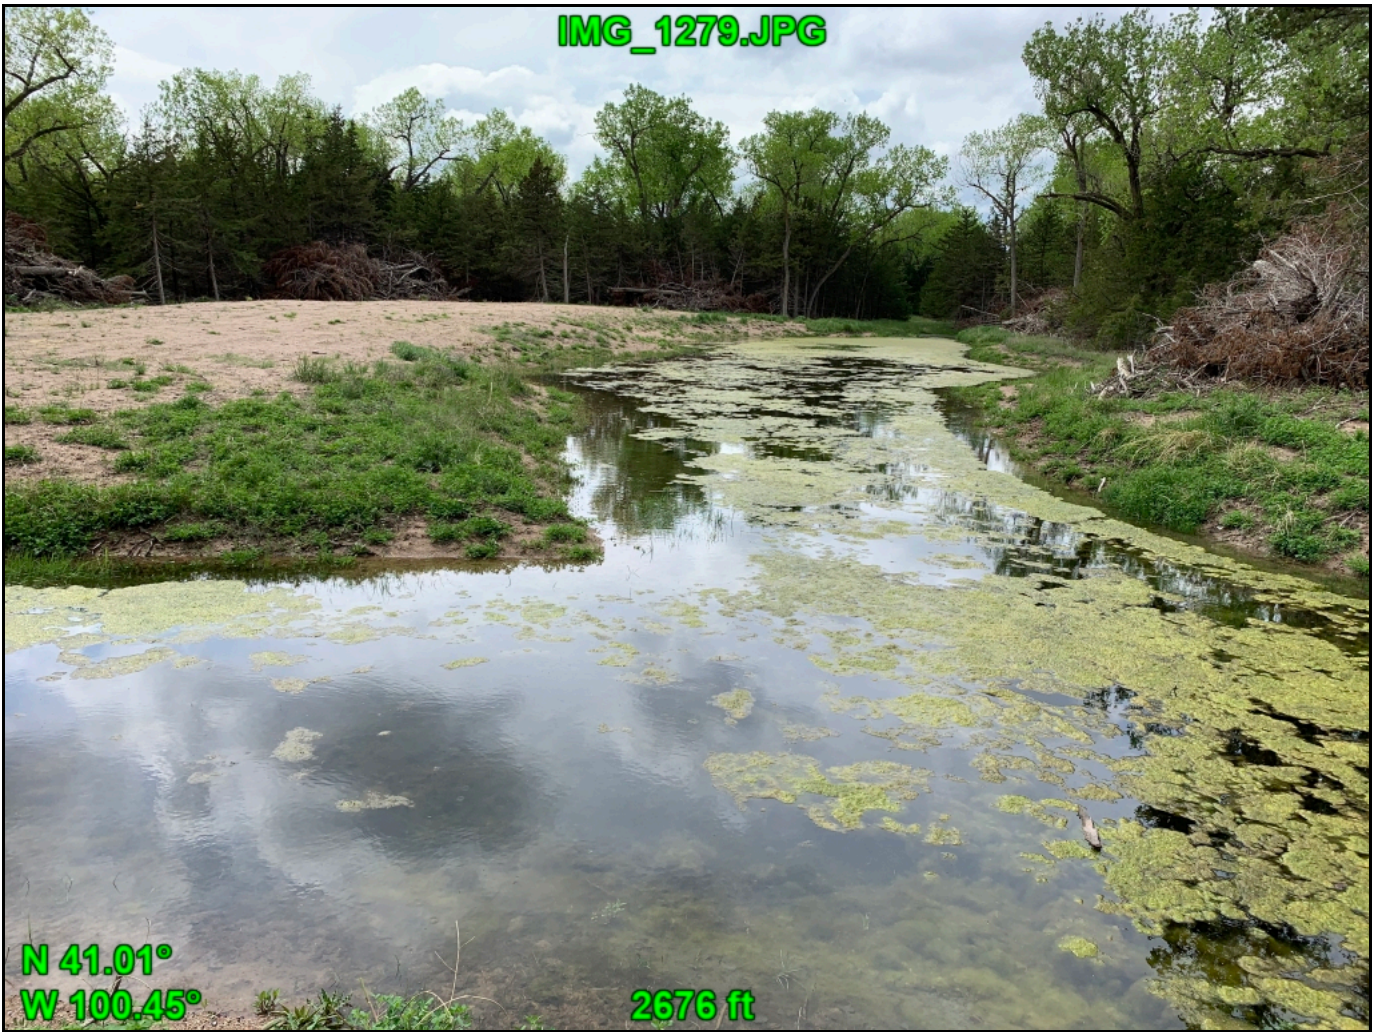
IMG_1280.JPG

Photo 1278 shows where the north to south excavation (site 4) which flows into the existing channel meets with the east to west excavation (site 3) and the side casted material to the north.

Fill location and excavated channel confluence. This flows north into the Platte River.

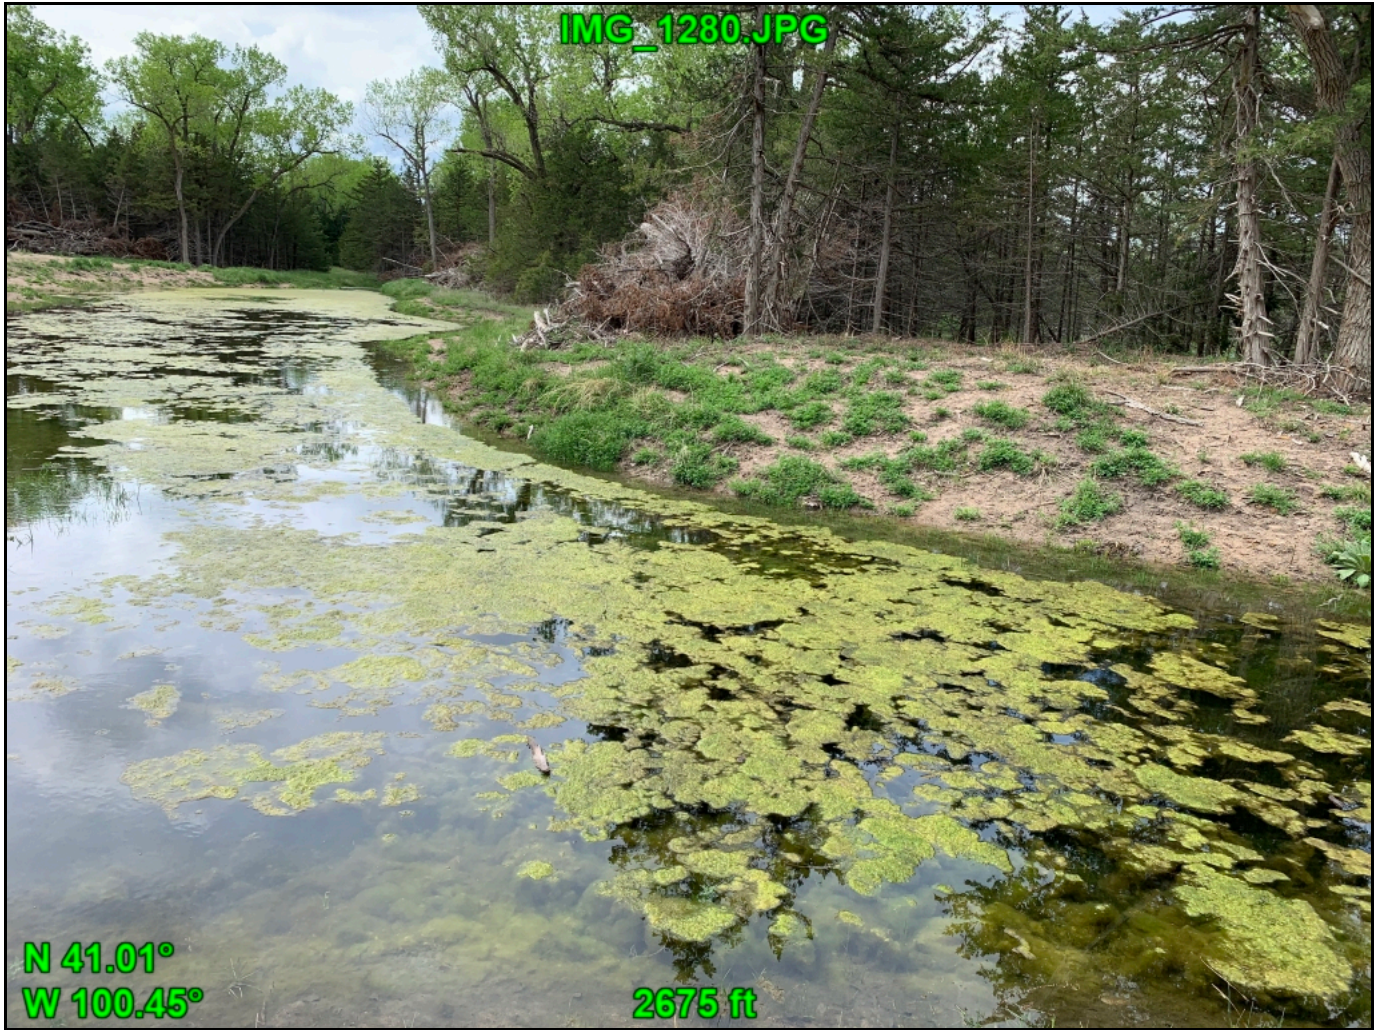
IMG_1281.JPG

Excavated channel

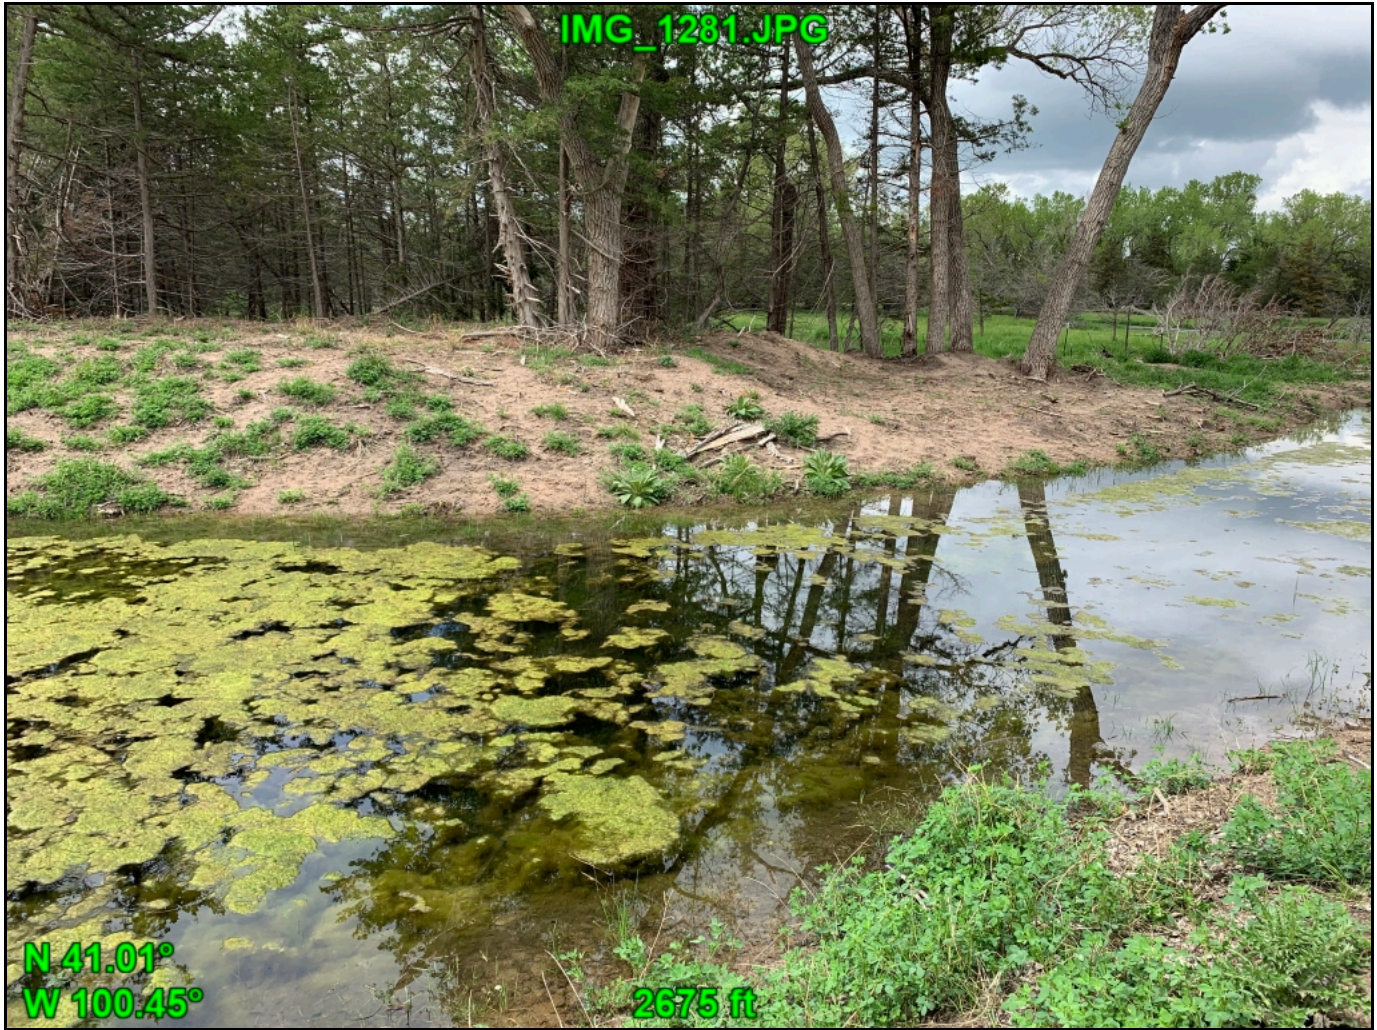
Excavated channel

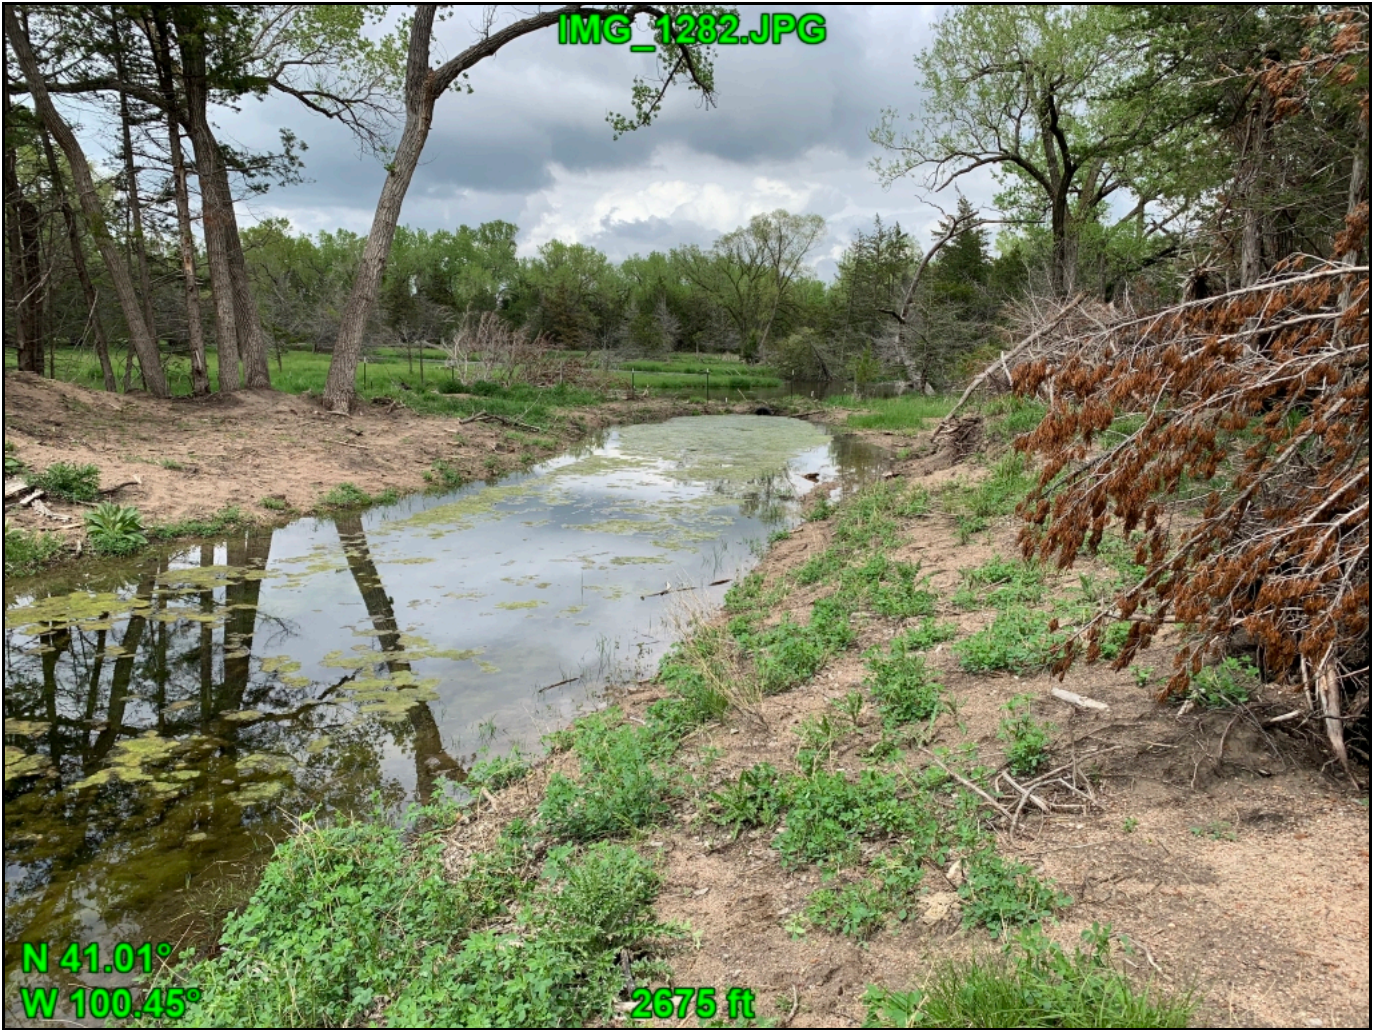
Excavated channel from confluence toward Platte River.

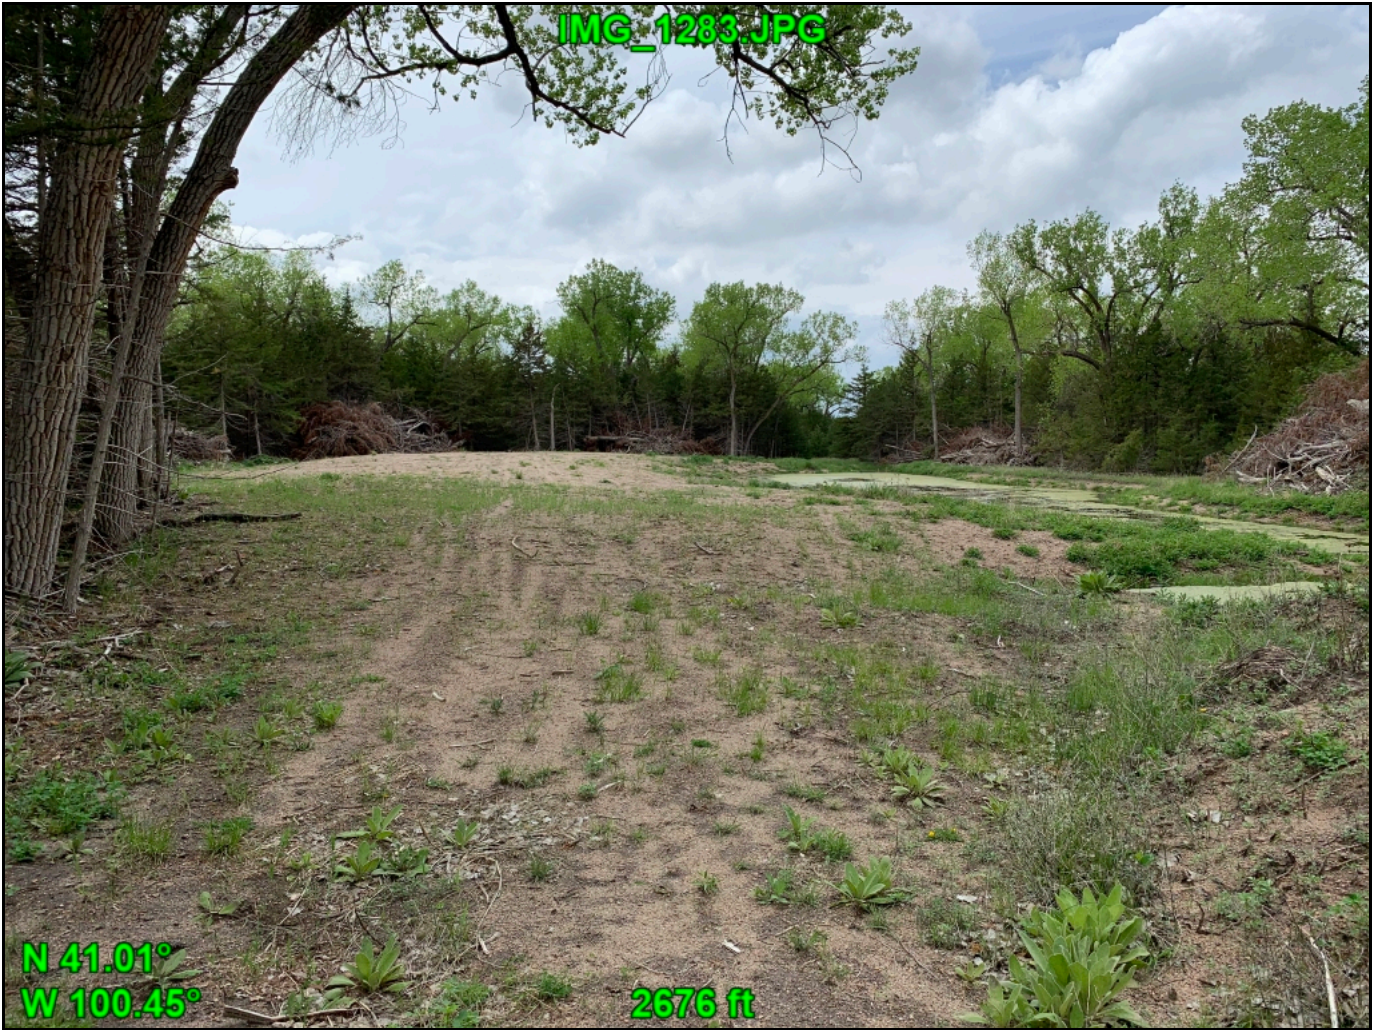
Fill location from excavated channels.

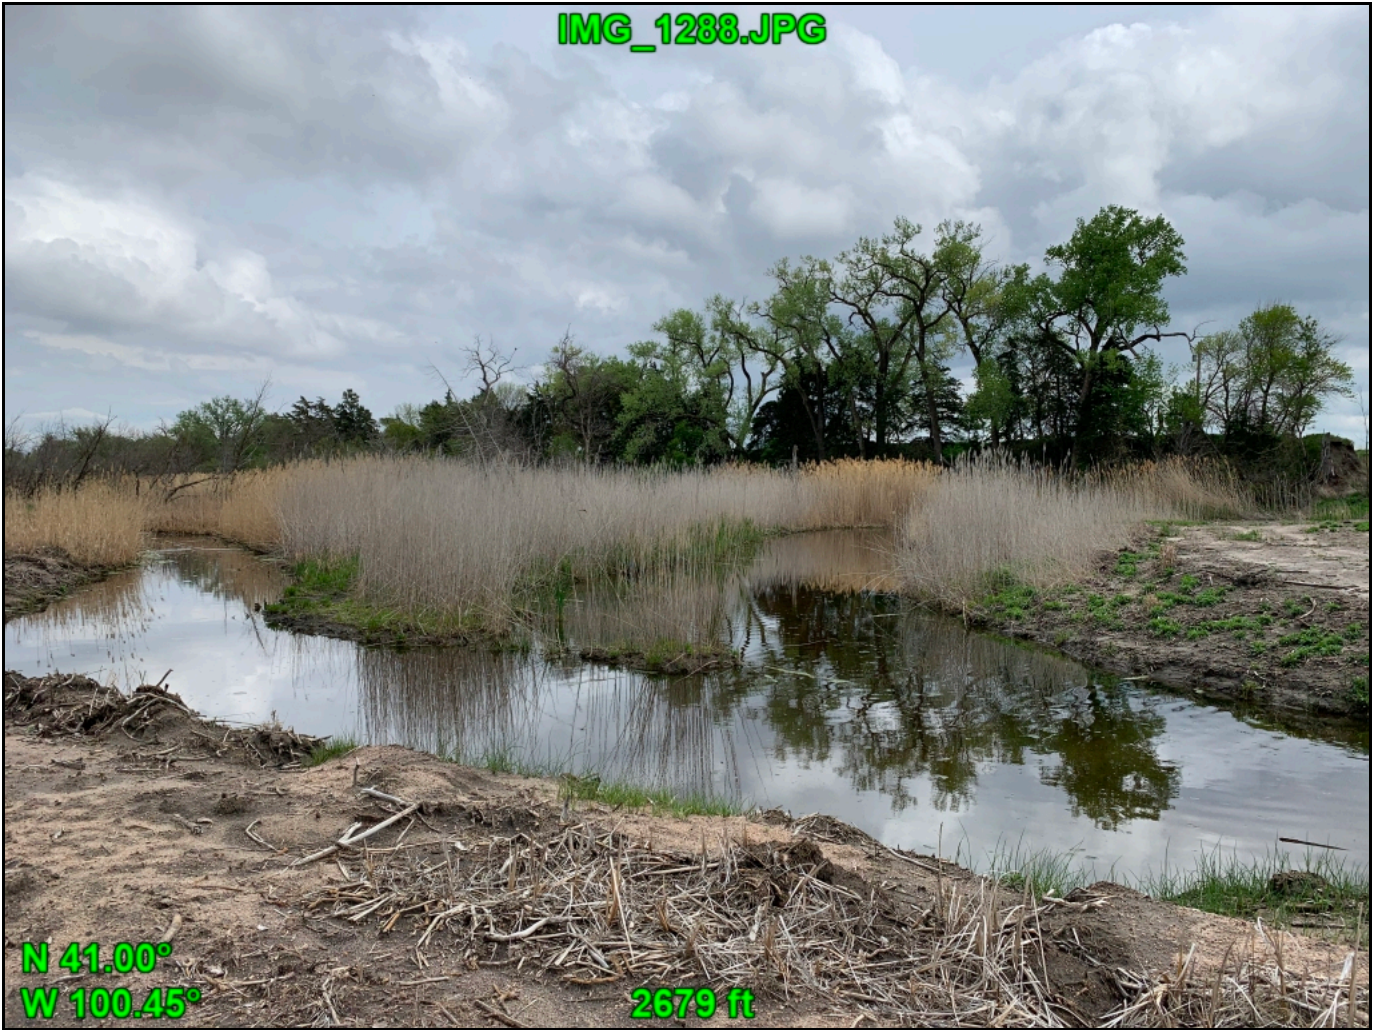
Excavated channels east of crossing 4.

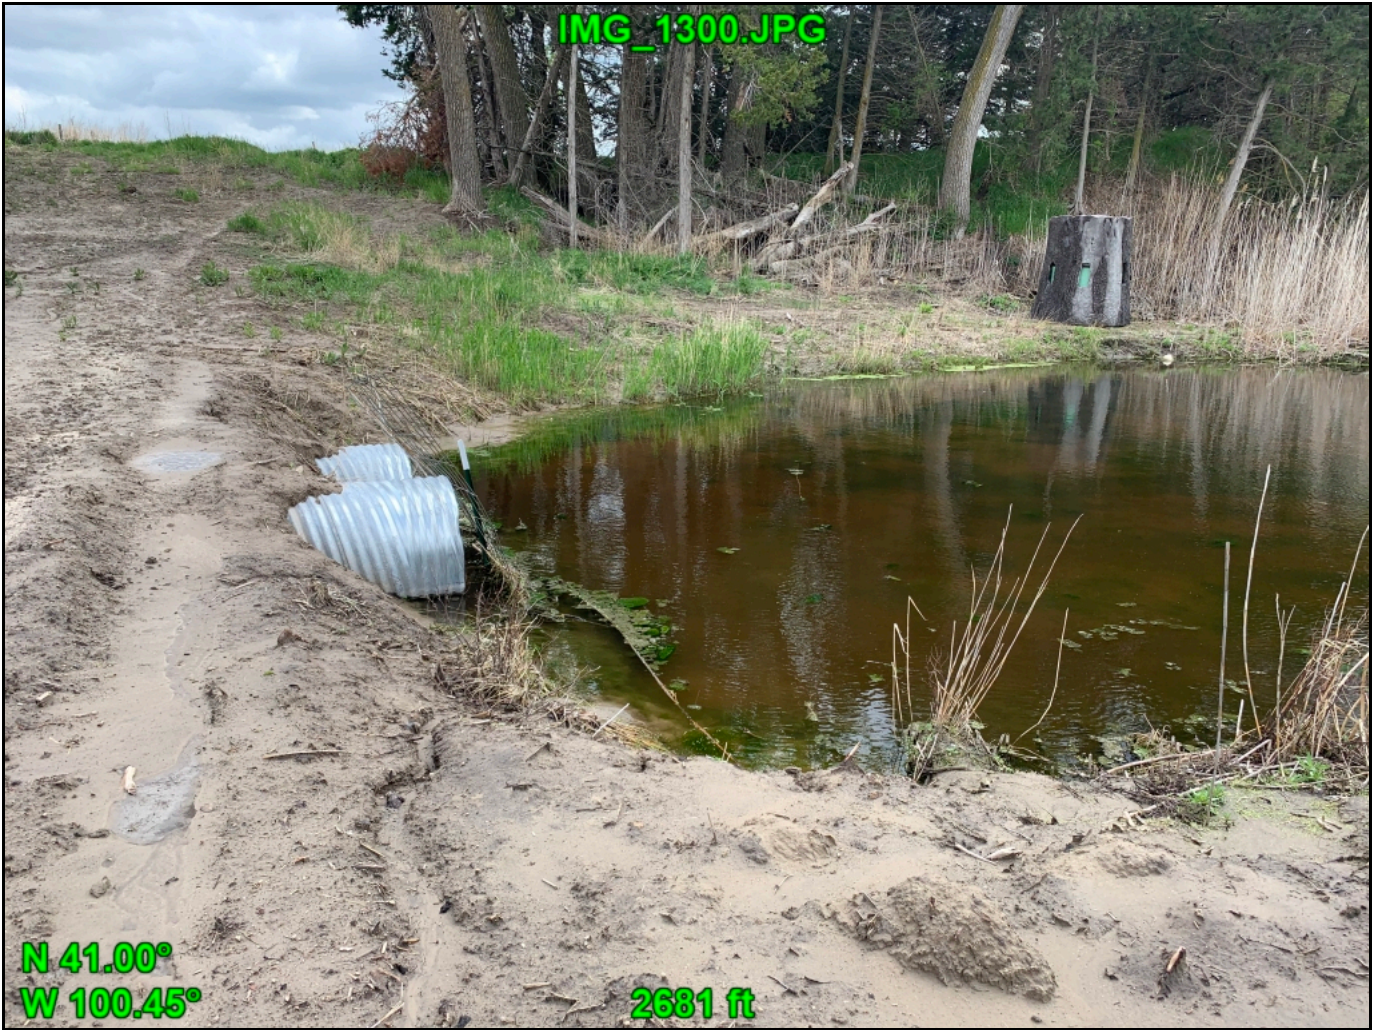
IMG_1301.JPG

Crossing 3.

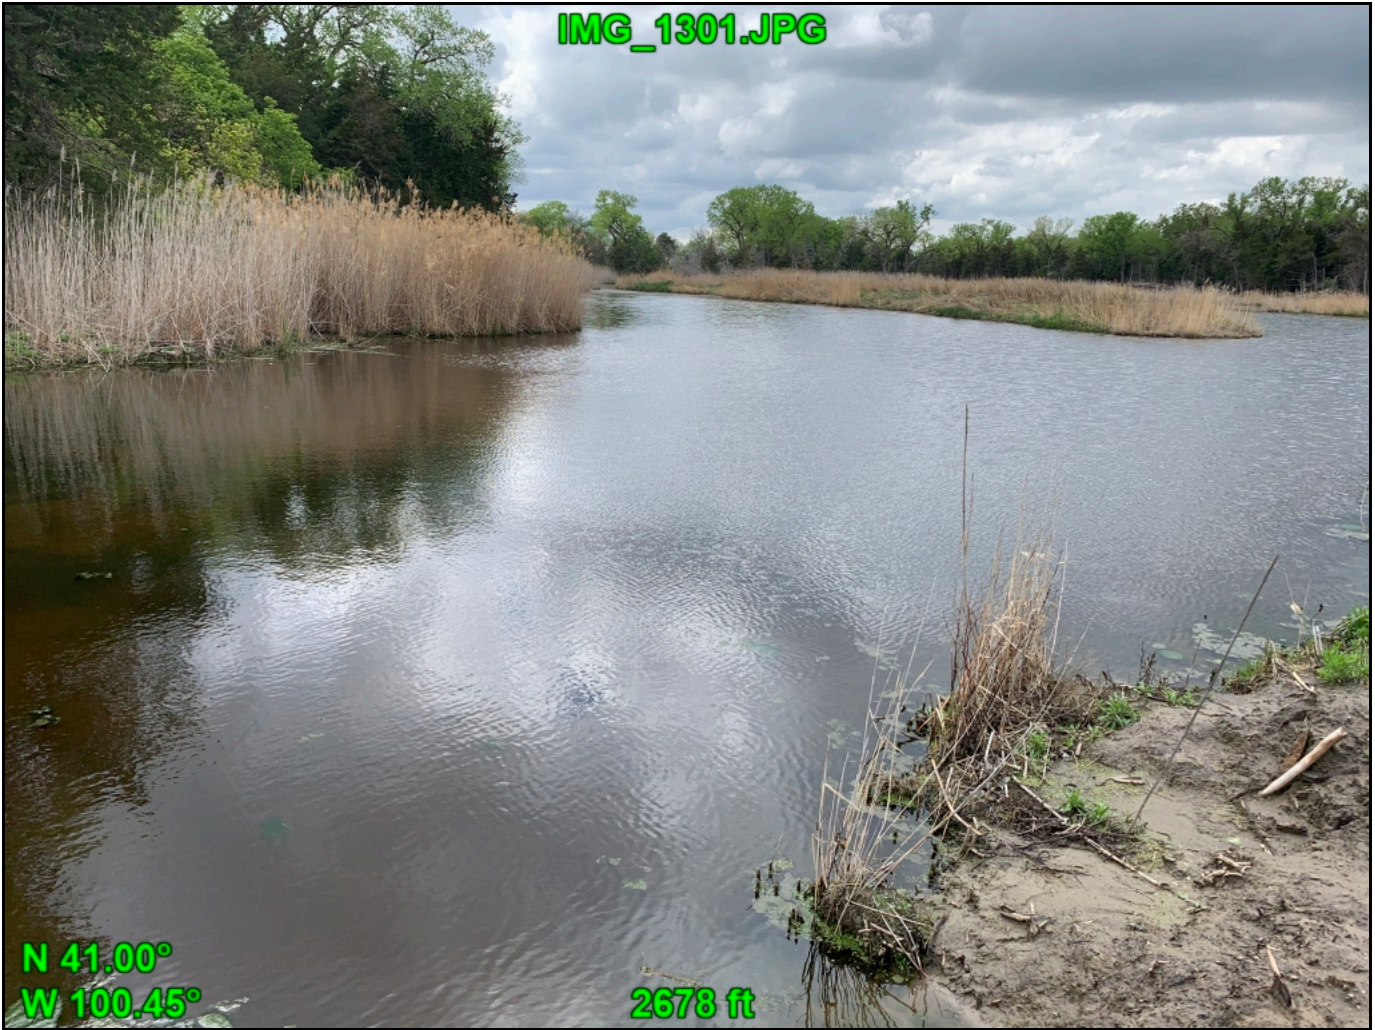
IMG_1303.JPG

Shows excavated channels from crossing 3.

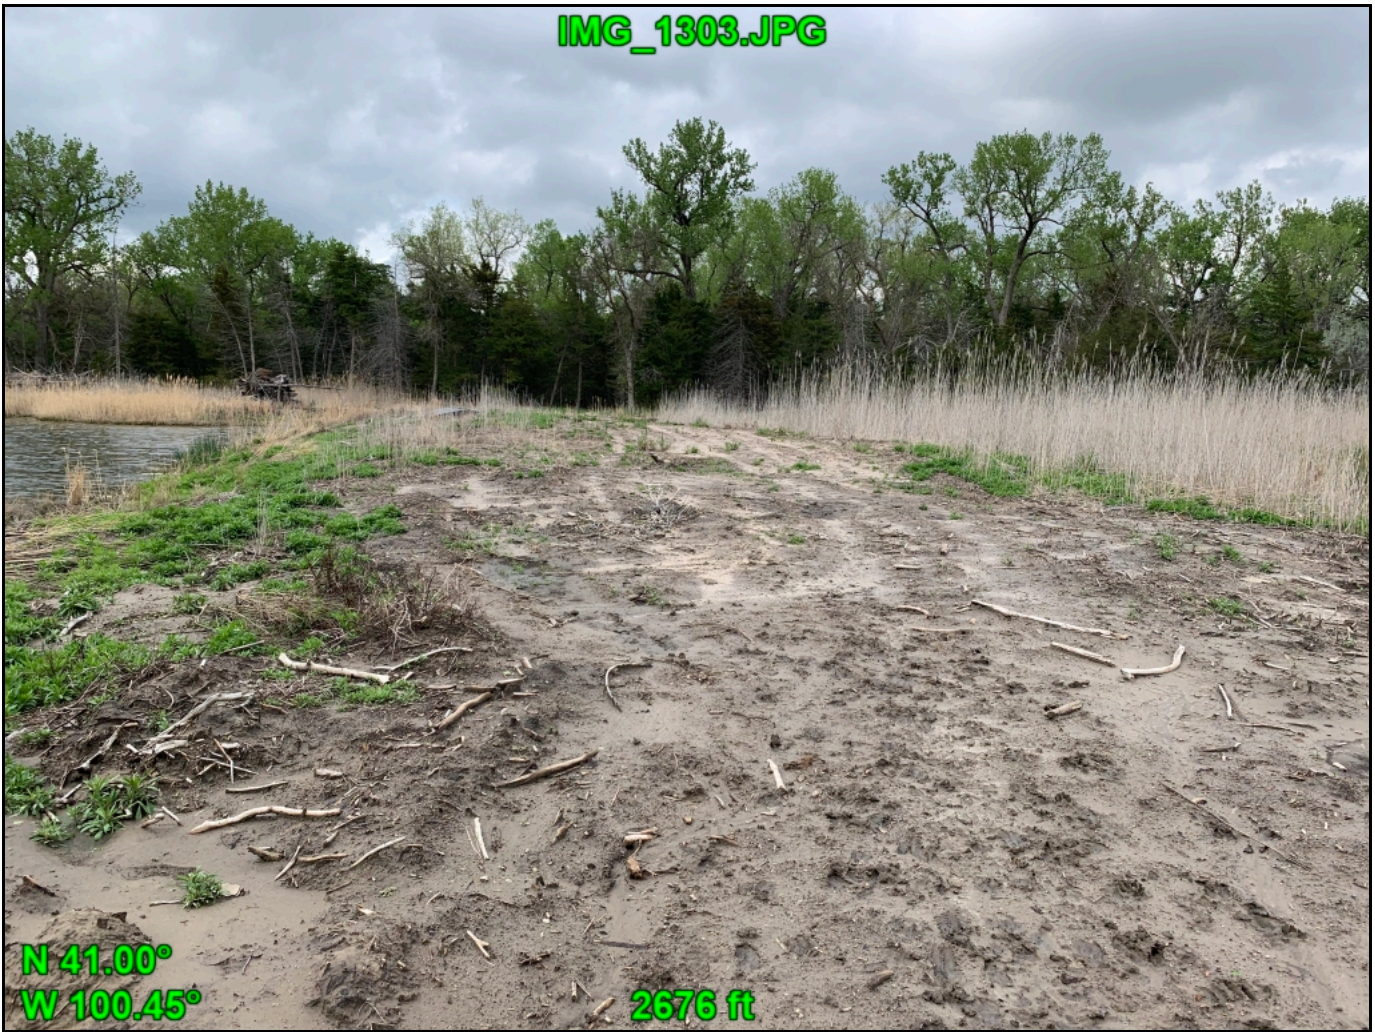
IMG_1305.JPG

Roadway constructed and crossings installed.

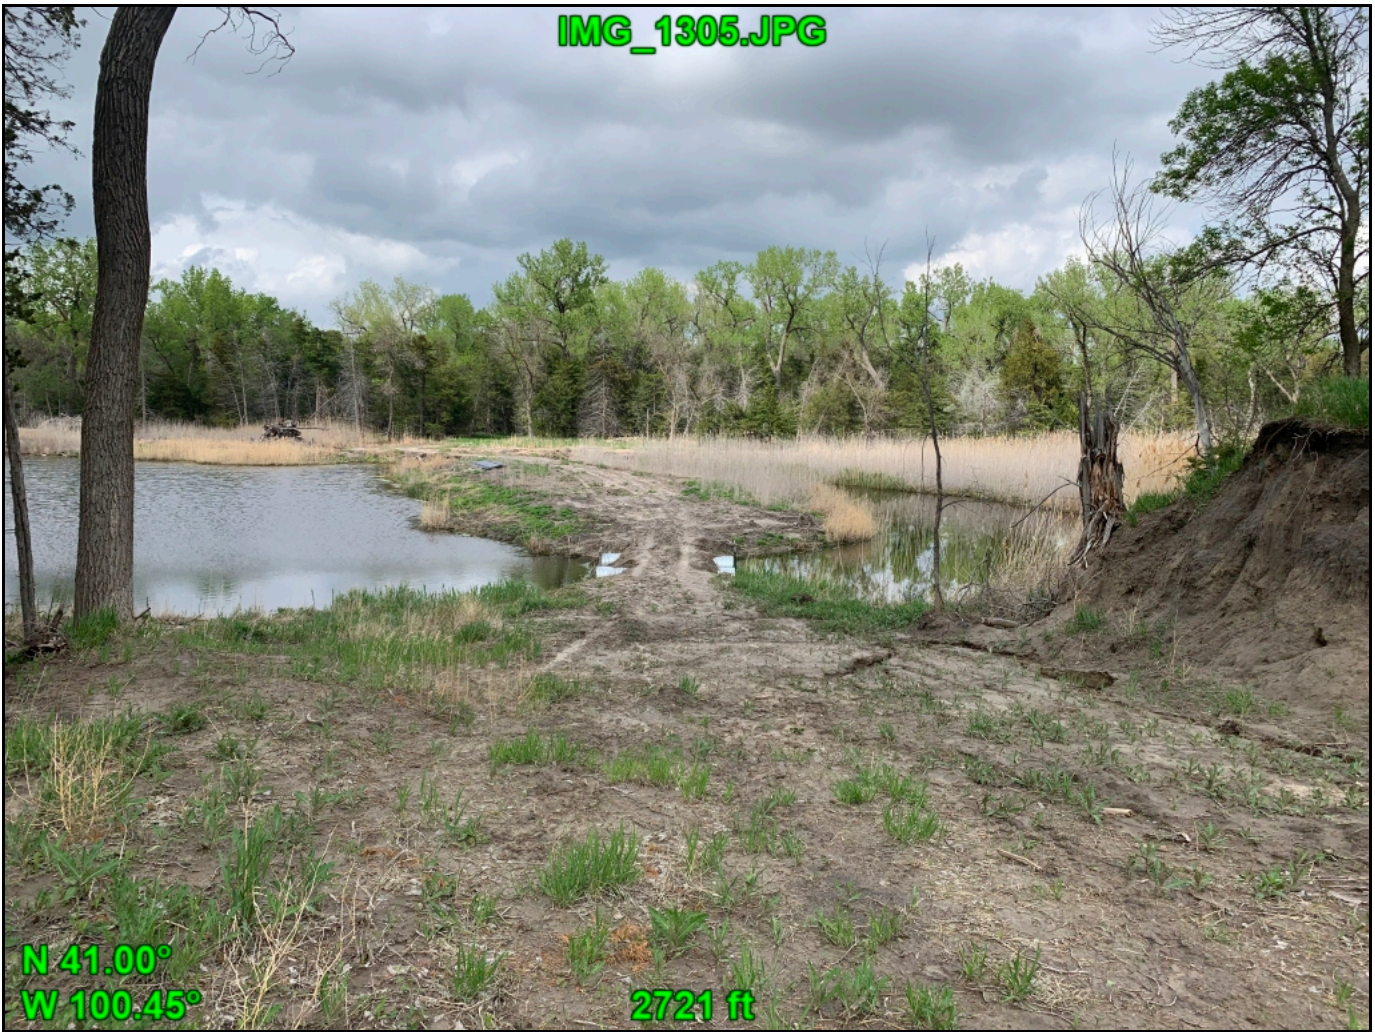
Constructed road and crossings looking north.
