SITE VISIT RECORD

Subject: Violation: 2020-00951 Wetlands and Channels Excavated

Date: May 18, 2021

2020-00951

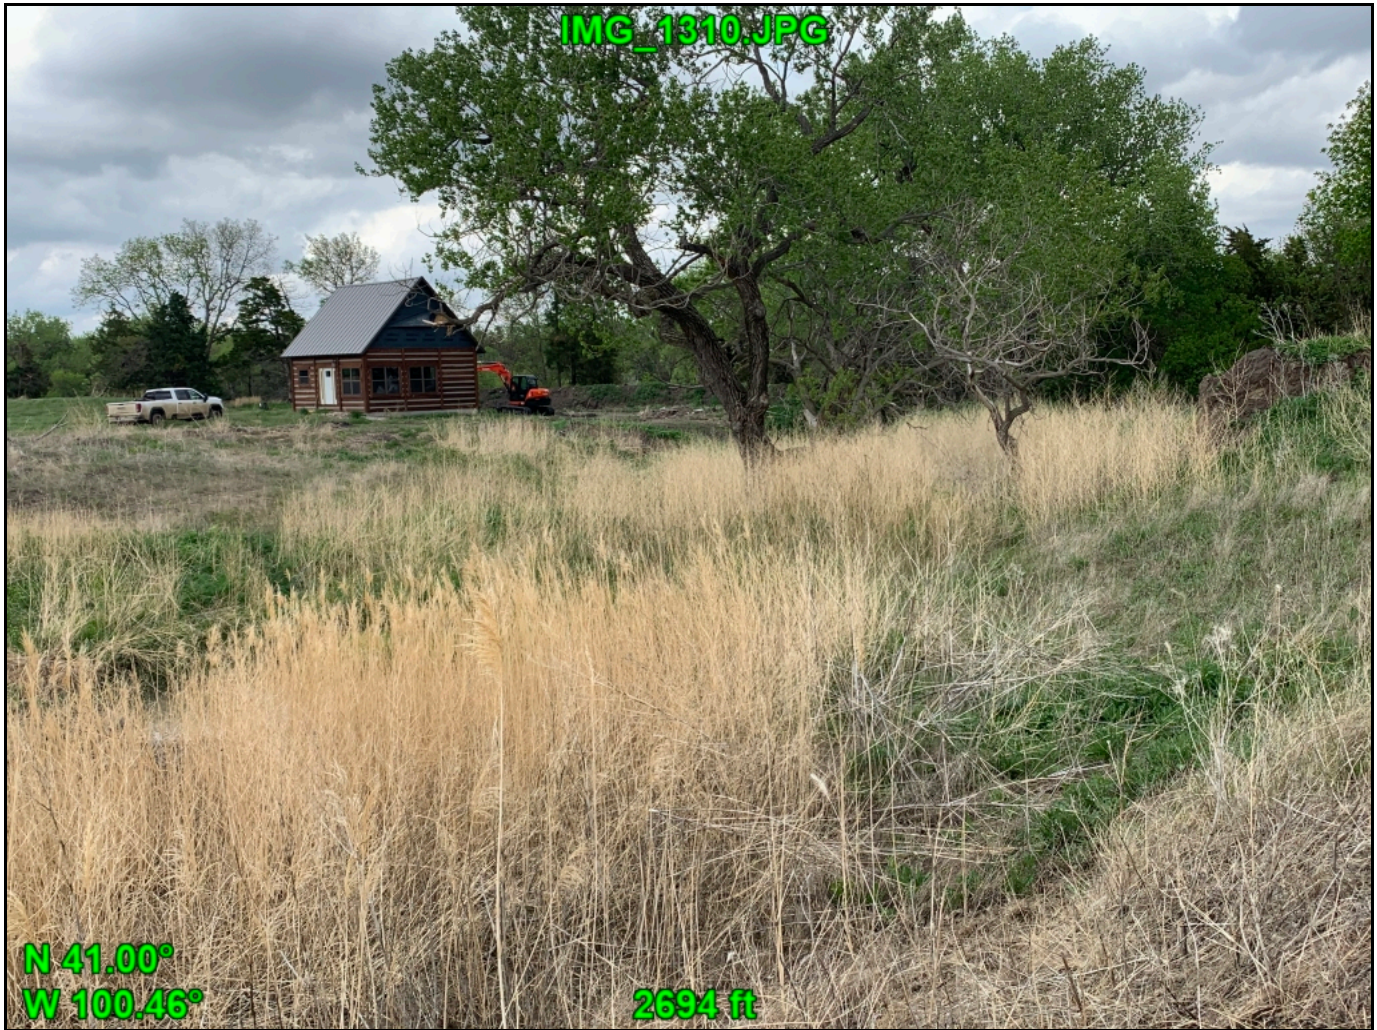
Kubota excavator on site 41.002622 -100.458396.
