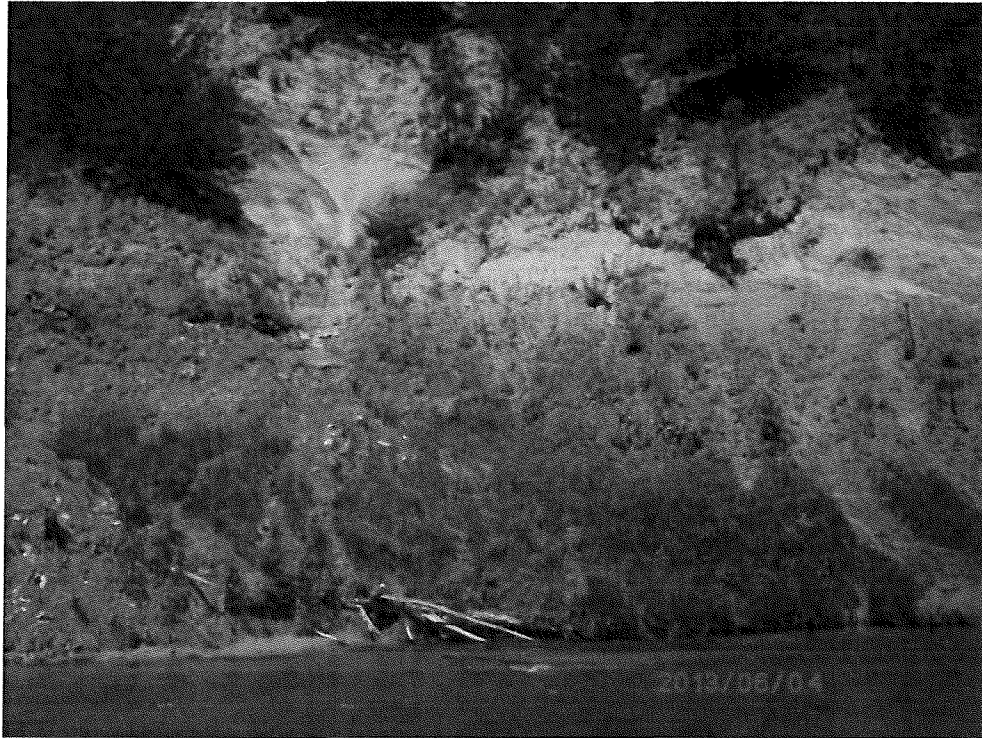
Photo 39 – Site 4 midstream measurement location looking to left bank.

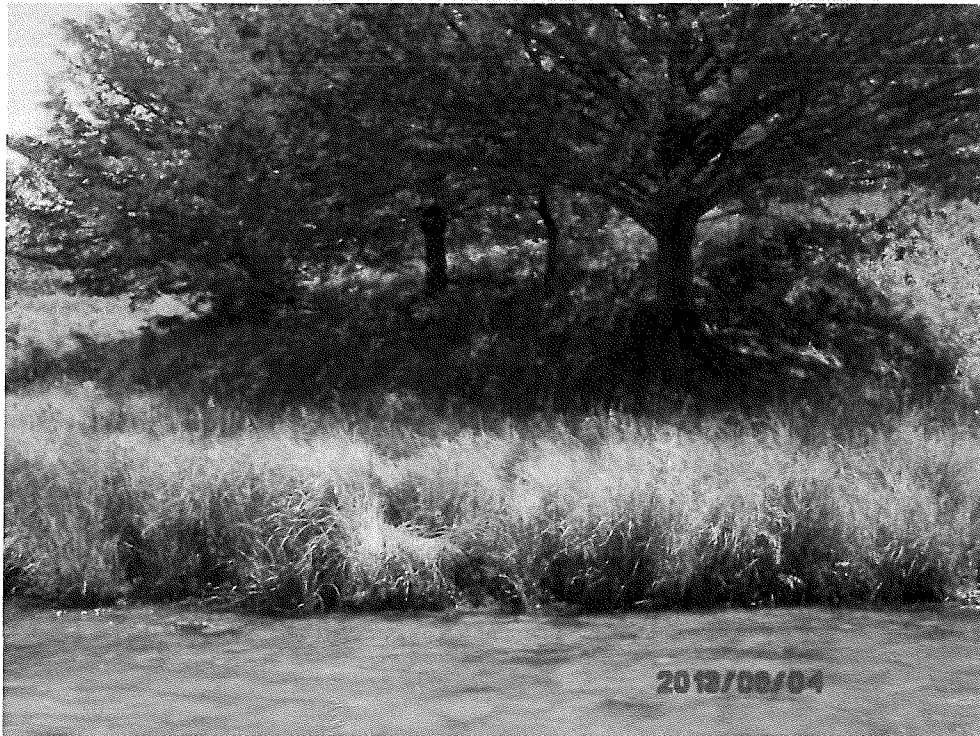
Photo 40 – Site 4 midstream measurement location looking to right bank

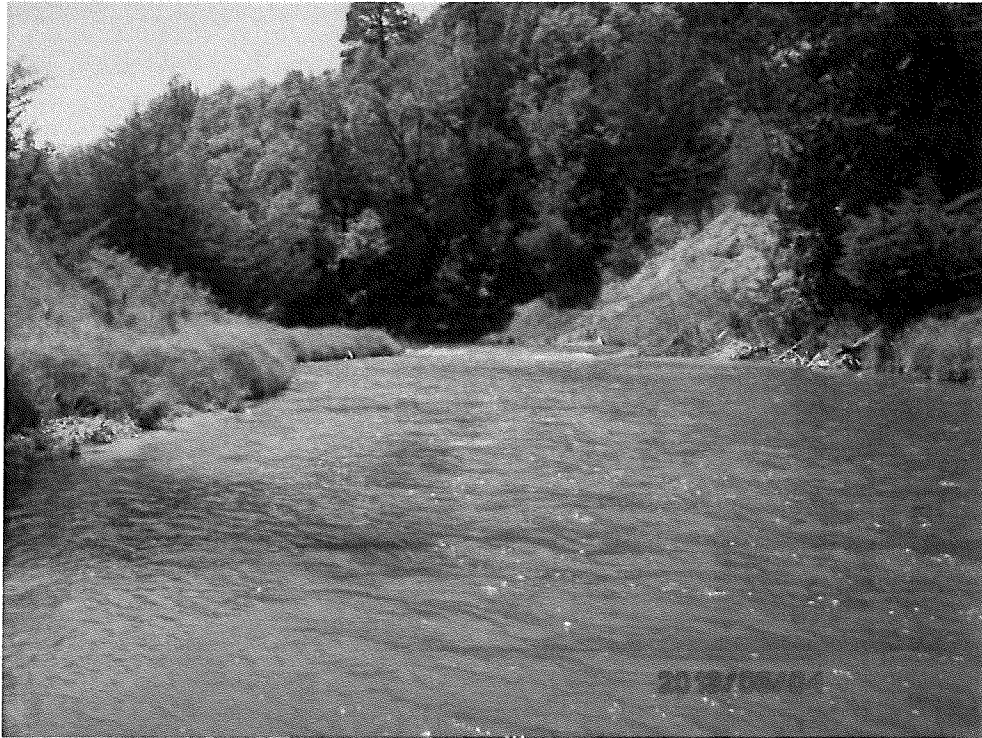
Photo 41 – Site 4 downstream measurement location looking upstream.

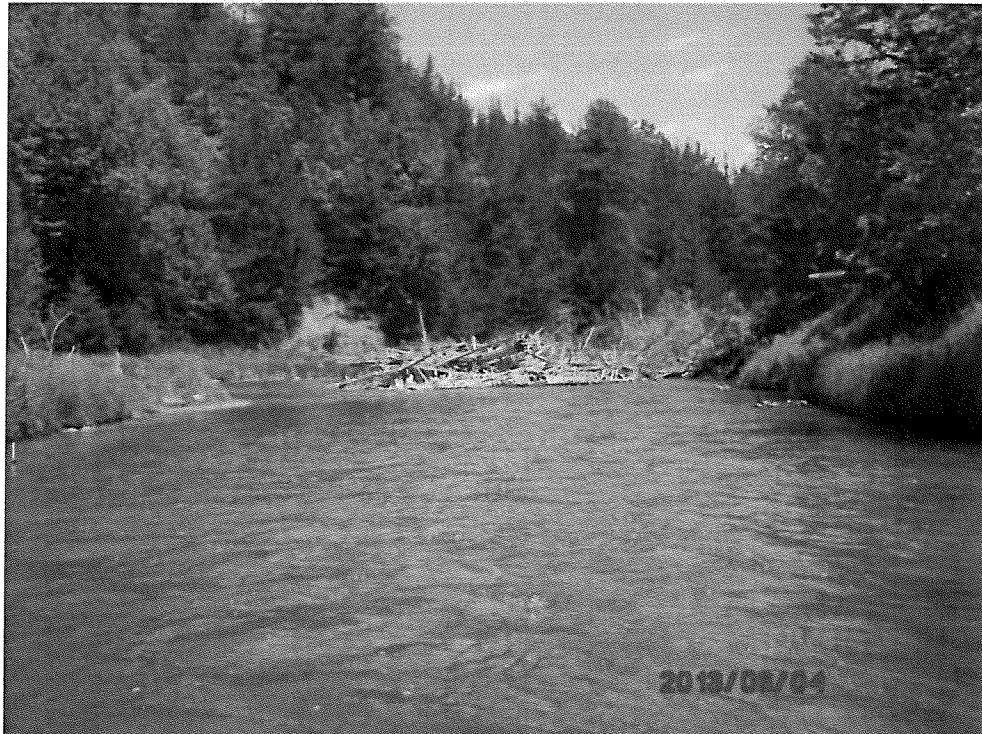
Photo 42 – Site 4 downstream measurement location looking downstream.

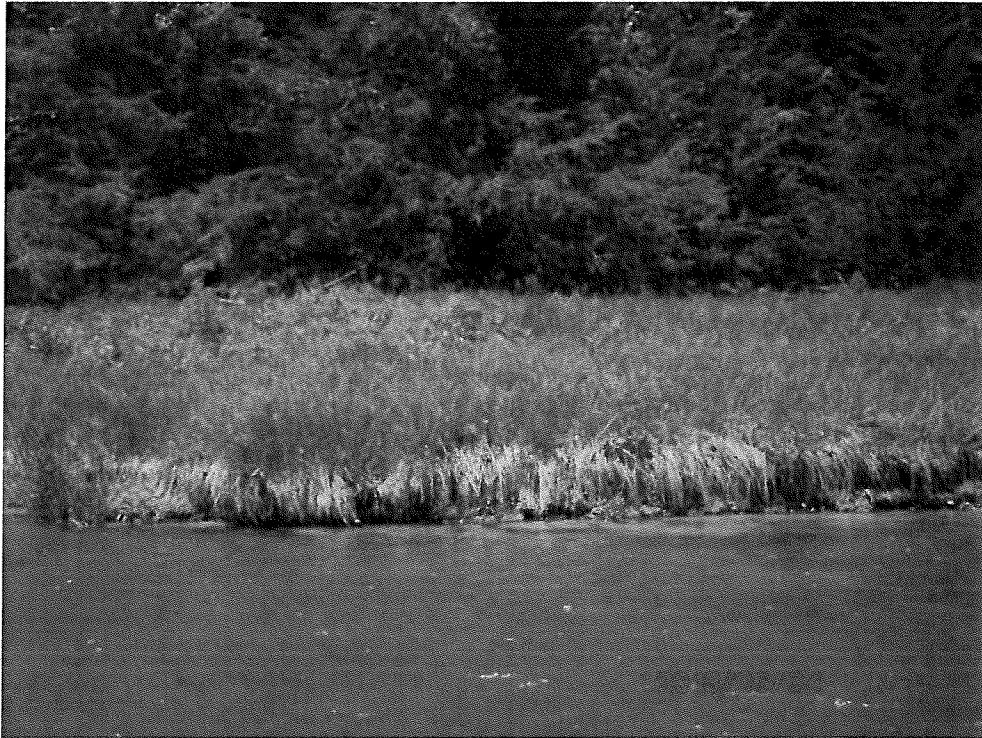
Photo 43 – Site 4 downstream measurement location looking to left bank.

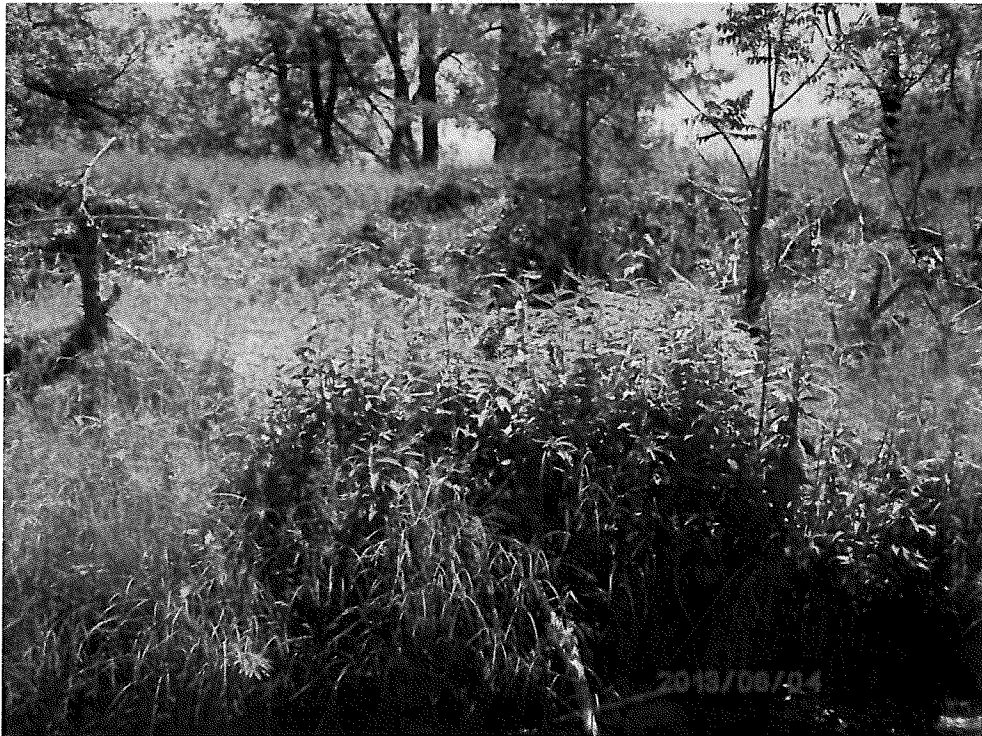
Photo 44 – Site 4 downstream of dam measurement location looking to right bank.

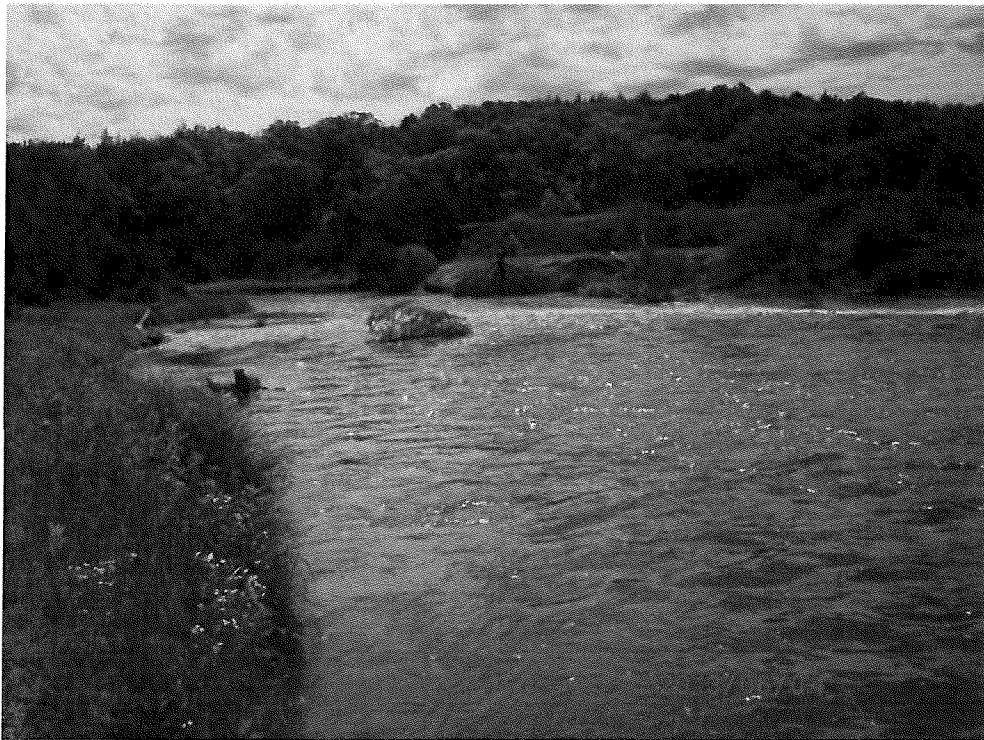
Photo 45 – Site 5 upstream measurement location looking upstream.

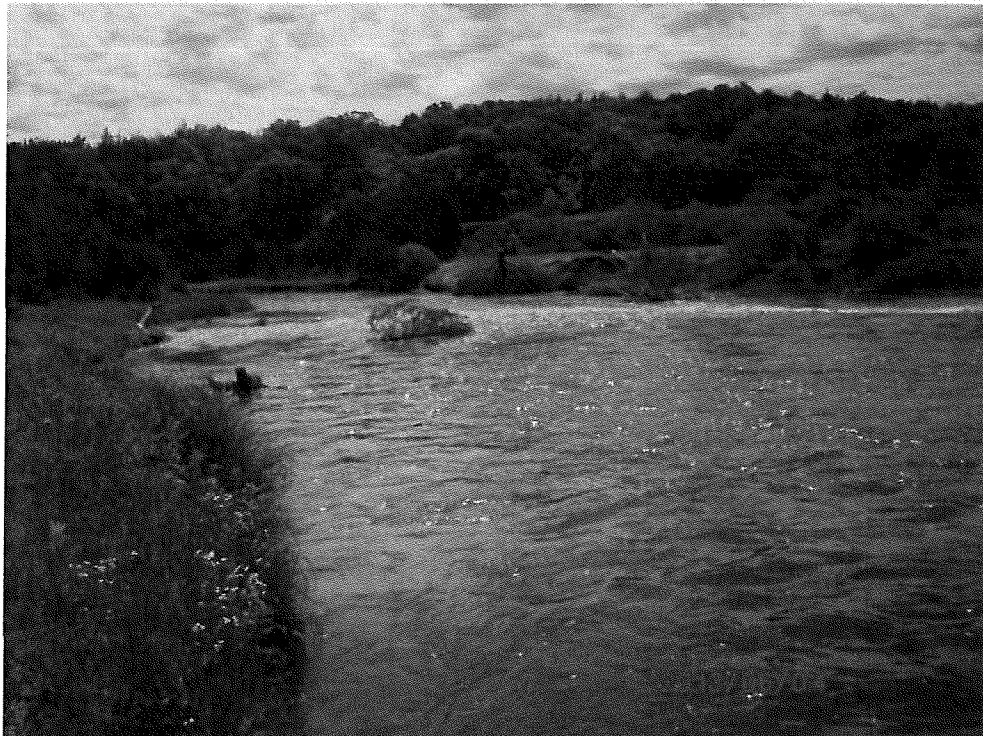
Photo 46 – Site 5 upstream measurement location looking downstream.

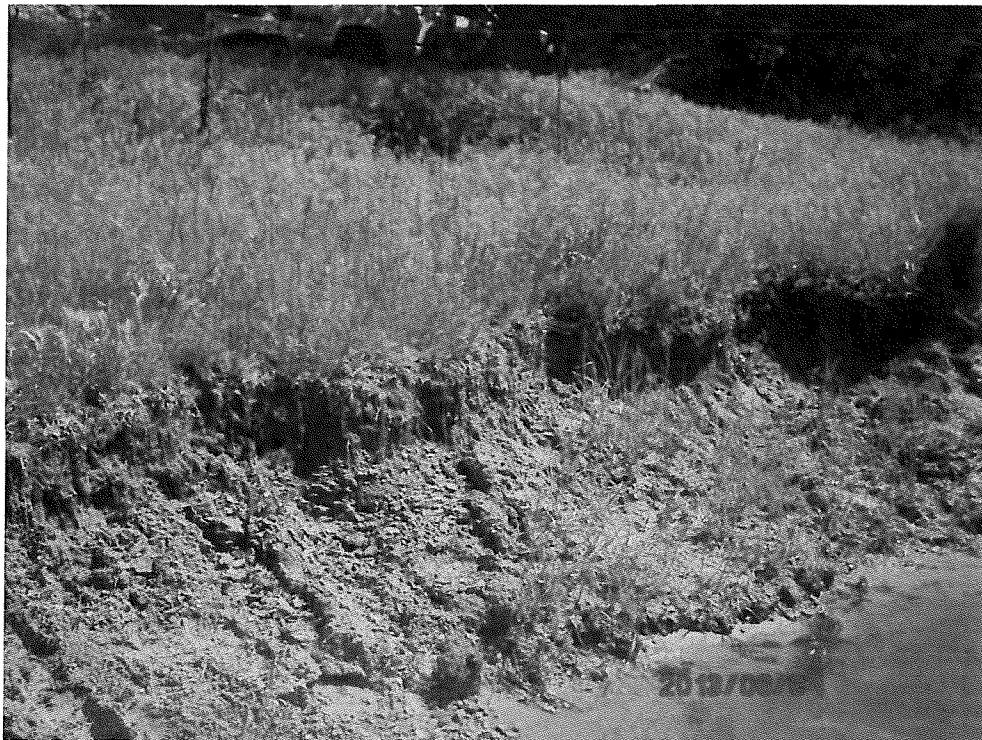
Photo 47 – Site 5 upstream measurement location looking to left bank.

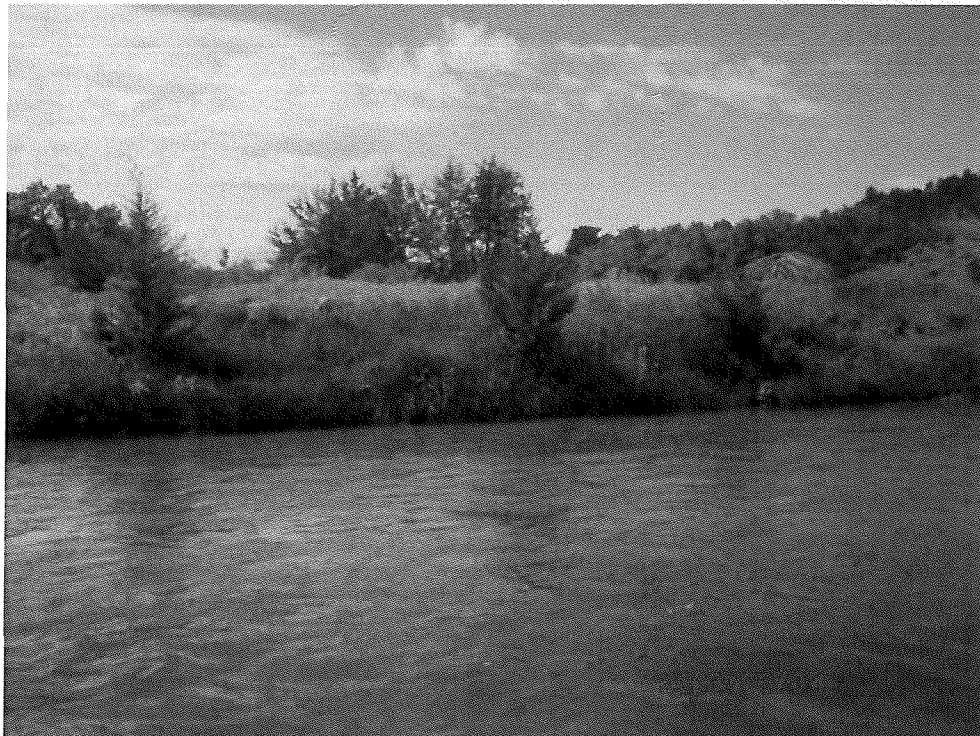
Photo 48 – Site 5 upstream measurement location looking to right bank.

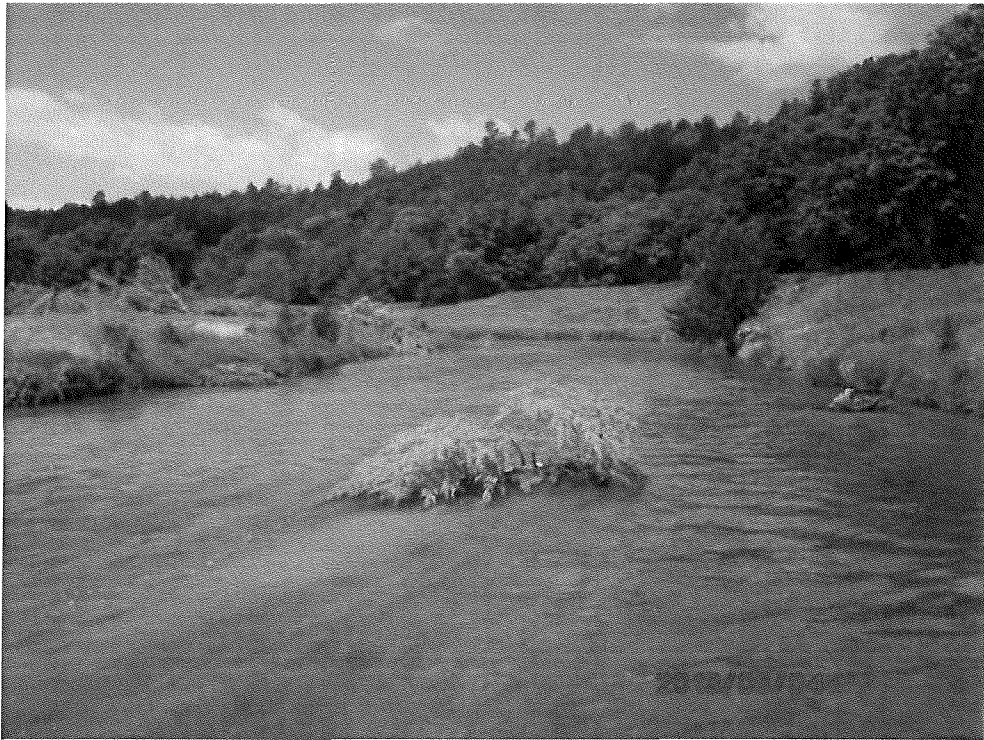
Photo 49 – Site 5 shale/mudstone riffle location looking upstream.

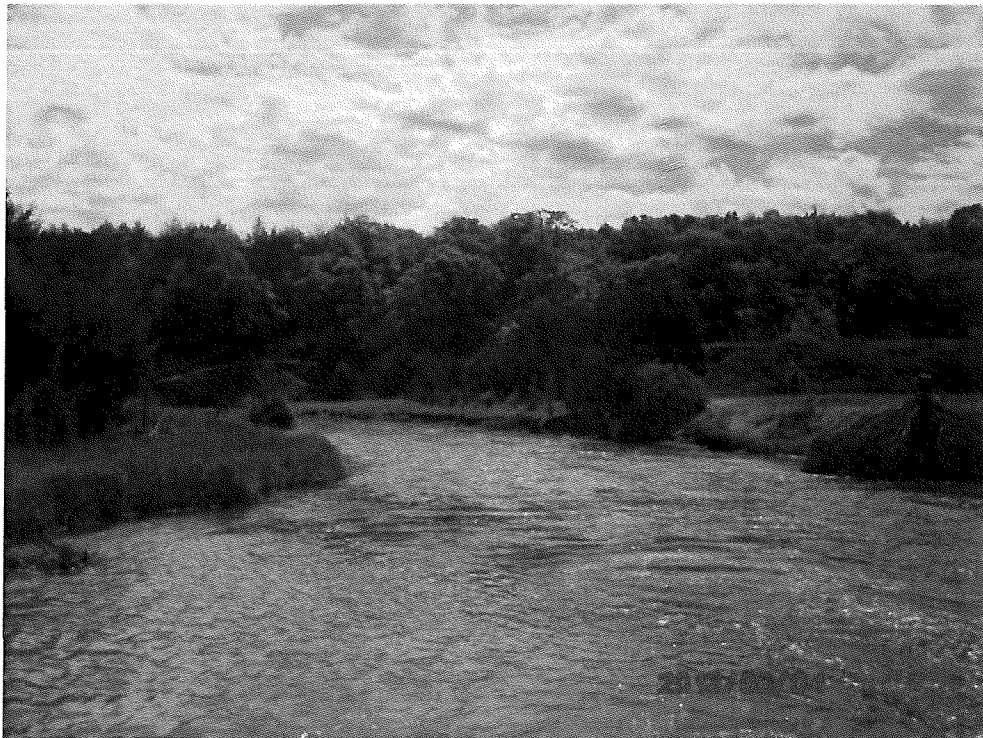
Photo 50 – Site 5 shale/mudstone riffle location looking downstream.

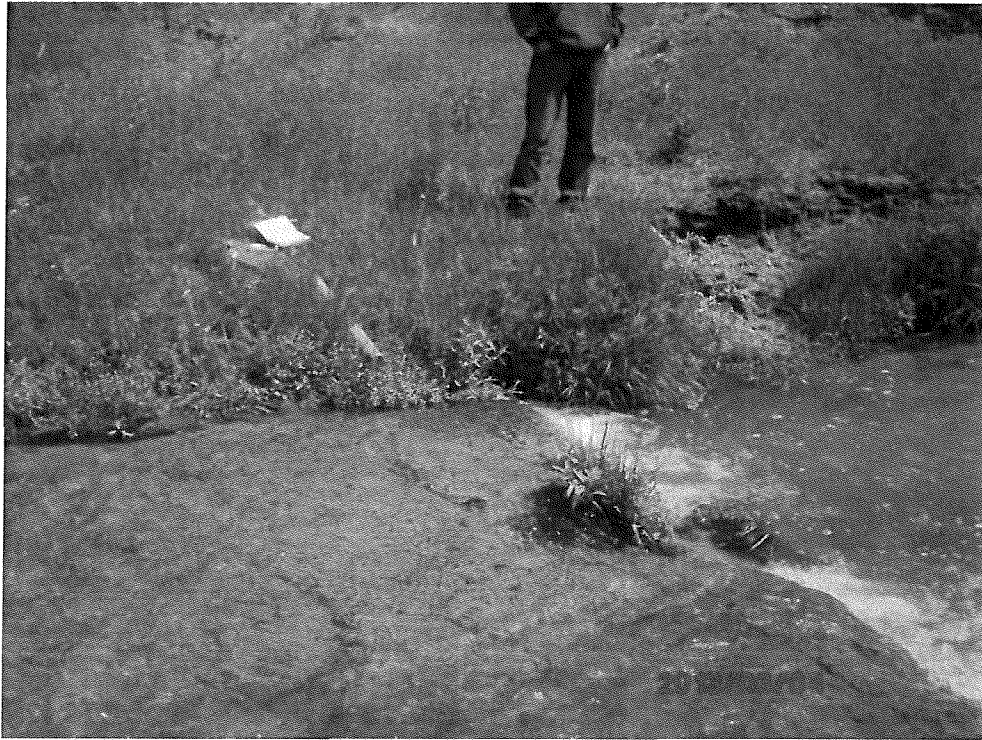
Photo 51 – Site 5 shale/mudstone riffle location looking to left bank.

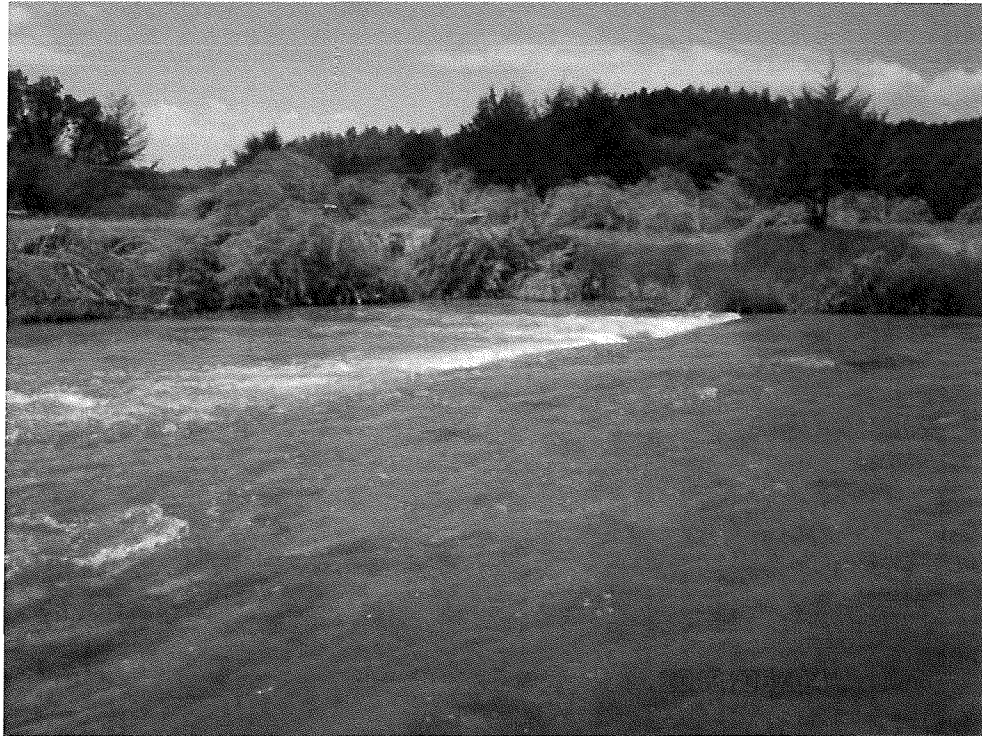
Photo 52 – Site 5 shale/mudstone riffle location looking to right bank.

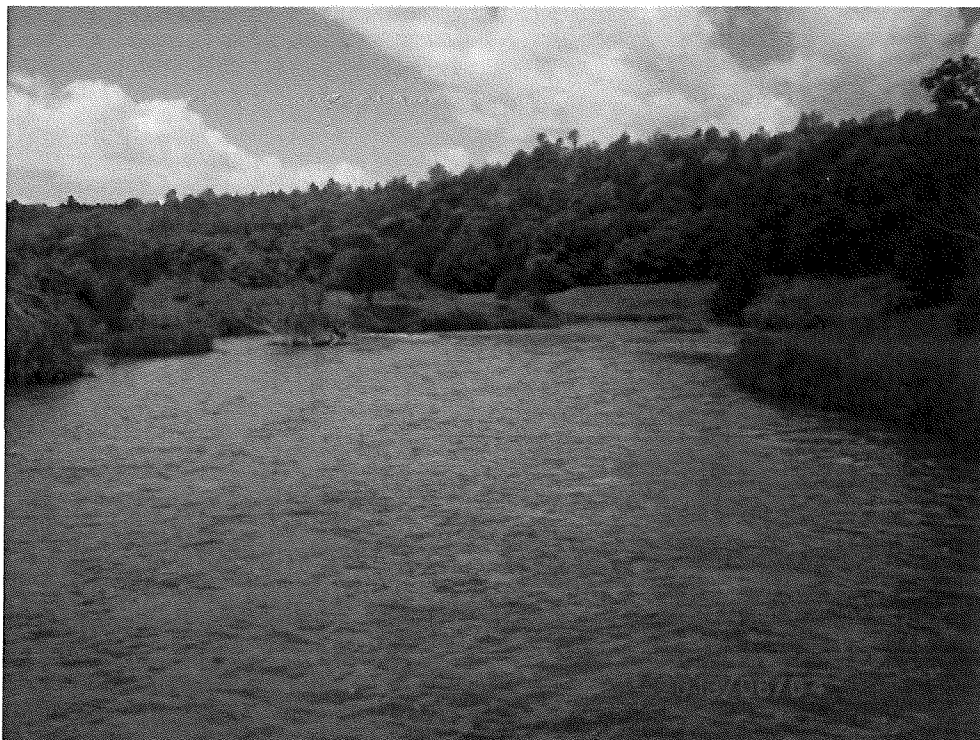
Photo 53 – Site 5 downstream measurement location looking upstream.

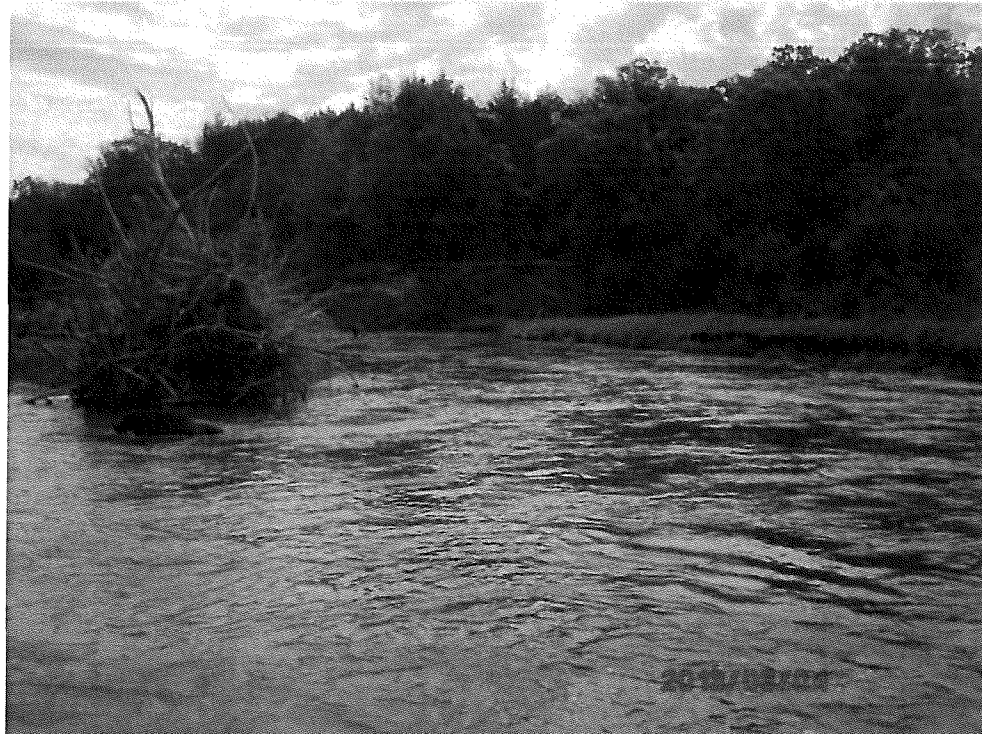
Photo 54 – Site 5 downstream measurement location looking downstream.

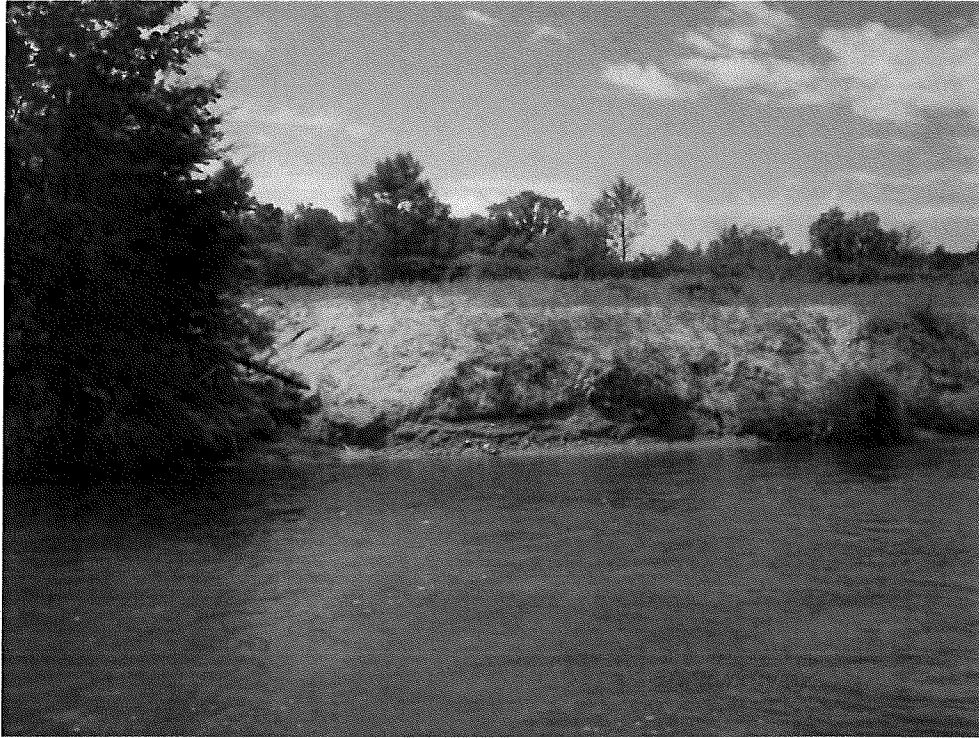
Photo 55 – Site 5 downstream measurement location looking to left bank slightly upstream.

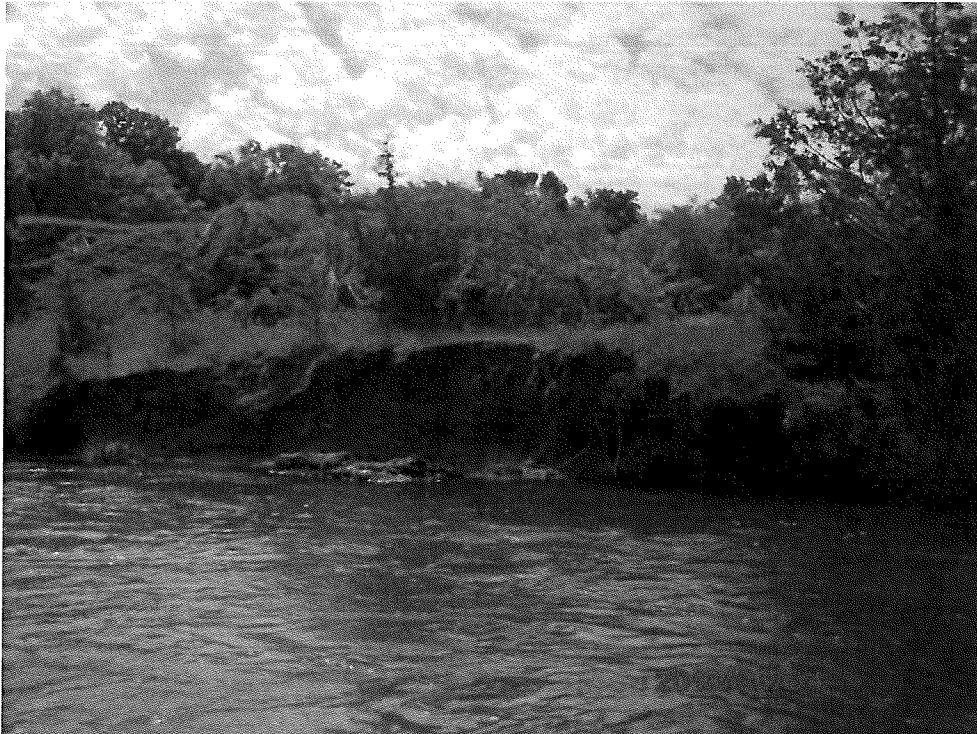
Photo 56 – Site 5 downstream measurement location looking to left bank slightly downstream.

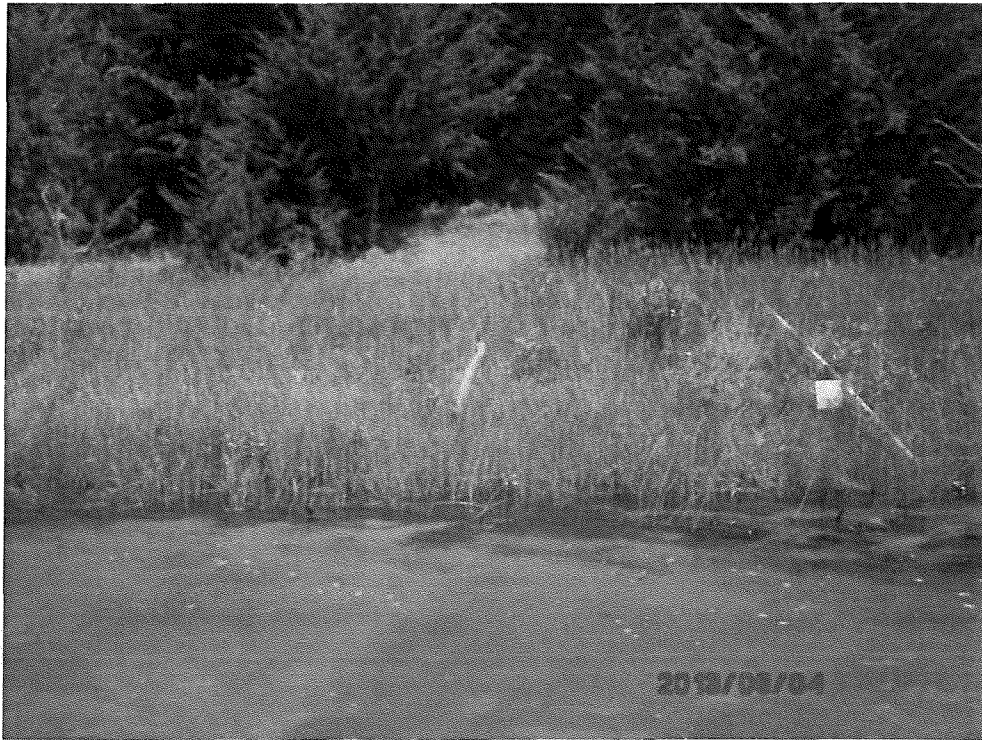
Photo 57 – Site 5 downstream of dam measurement location looking to right bank.

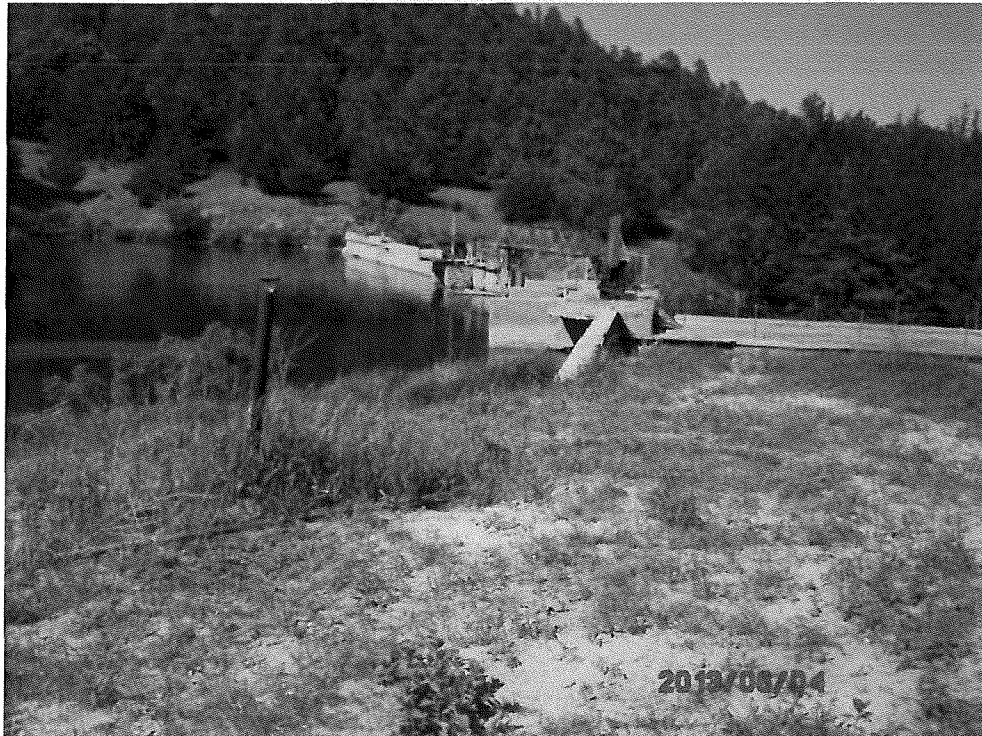
Photo 58 – McGowan Dam seen from upstream right abutment.

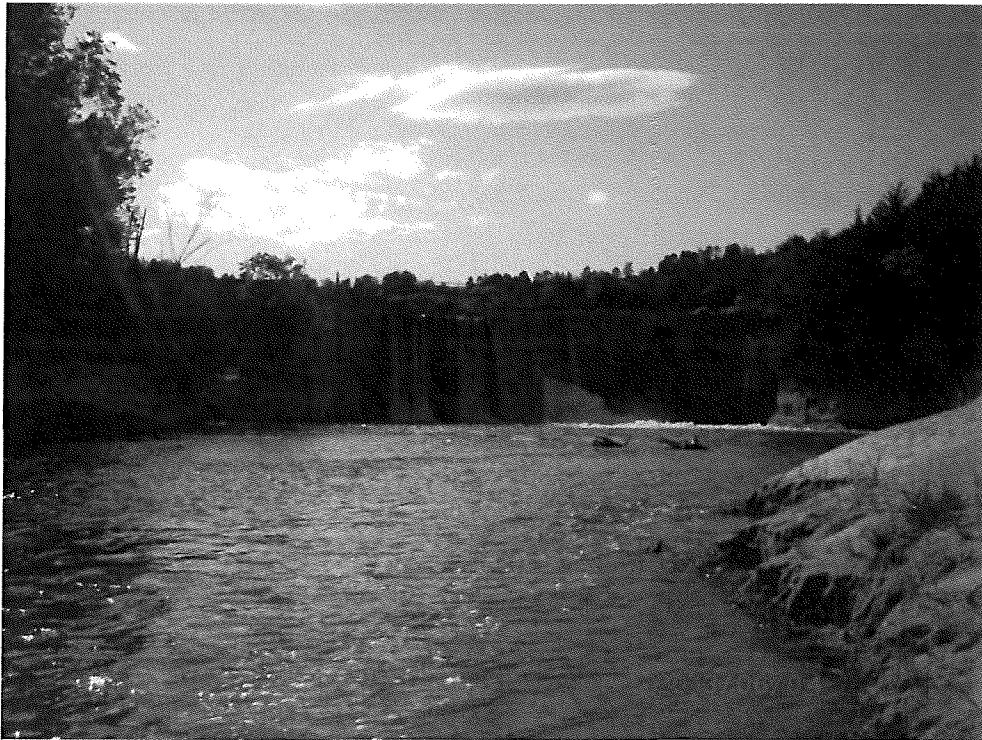
Photo 59 – McGowan Dam as seen from downstream.

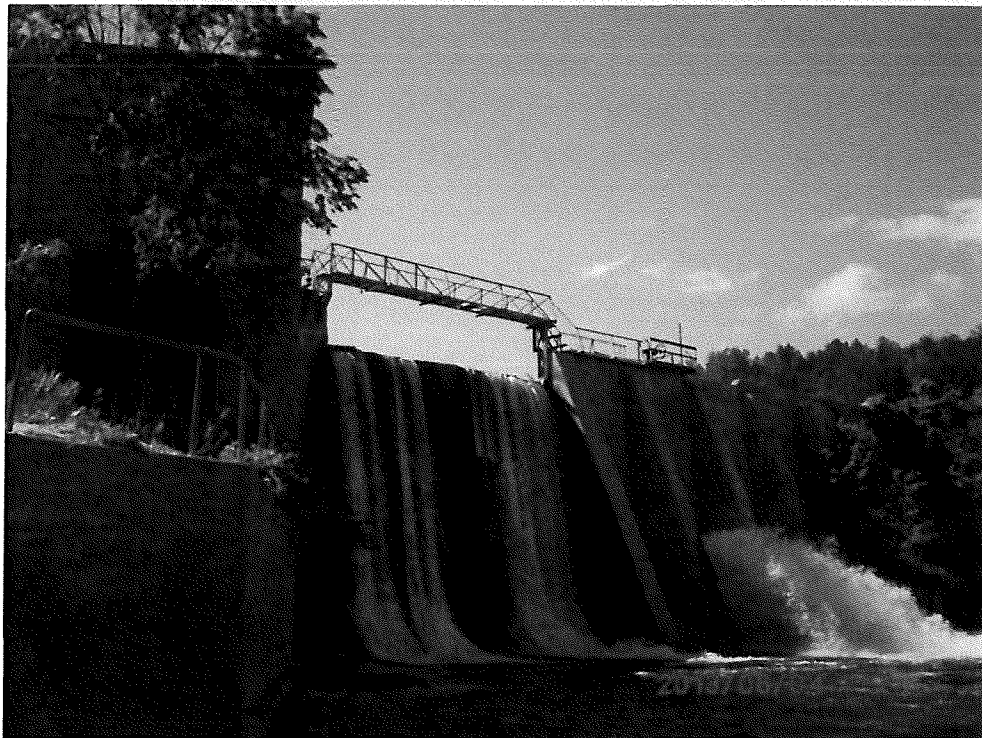
Photo 60 – McGowan Dam spillway and base discharge.

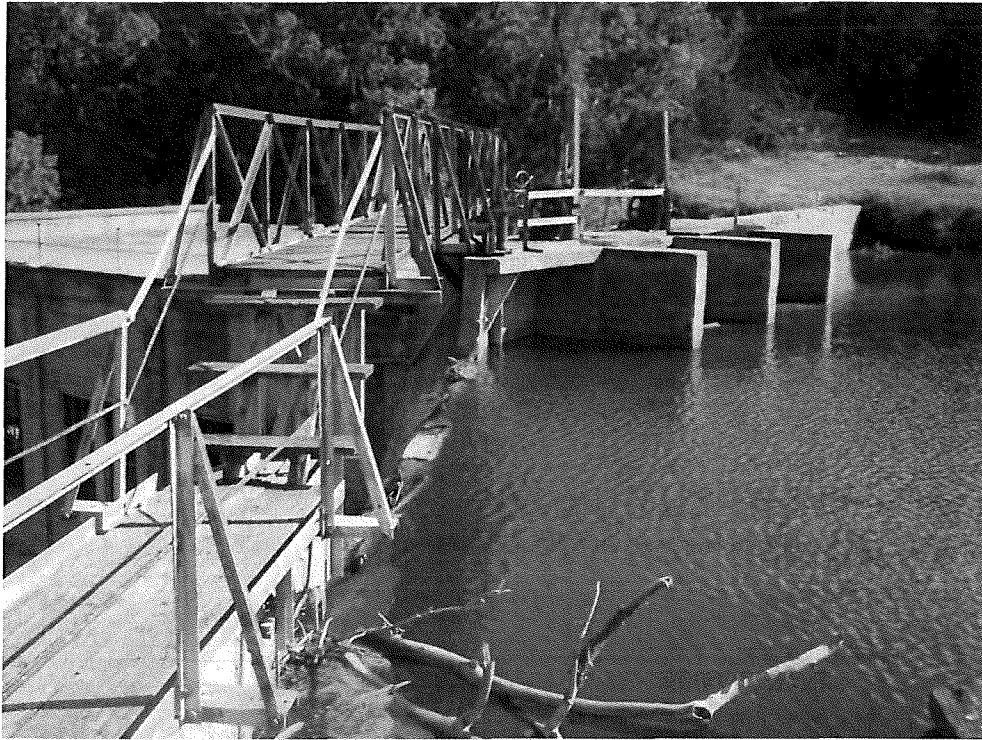
Photo 61 – Spillway catwalk with penstock Inlets in the background, looking to the right abutment.

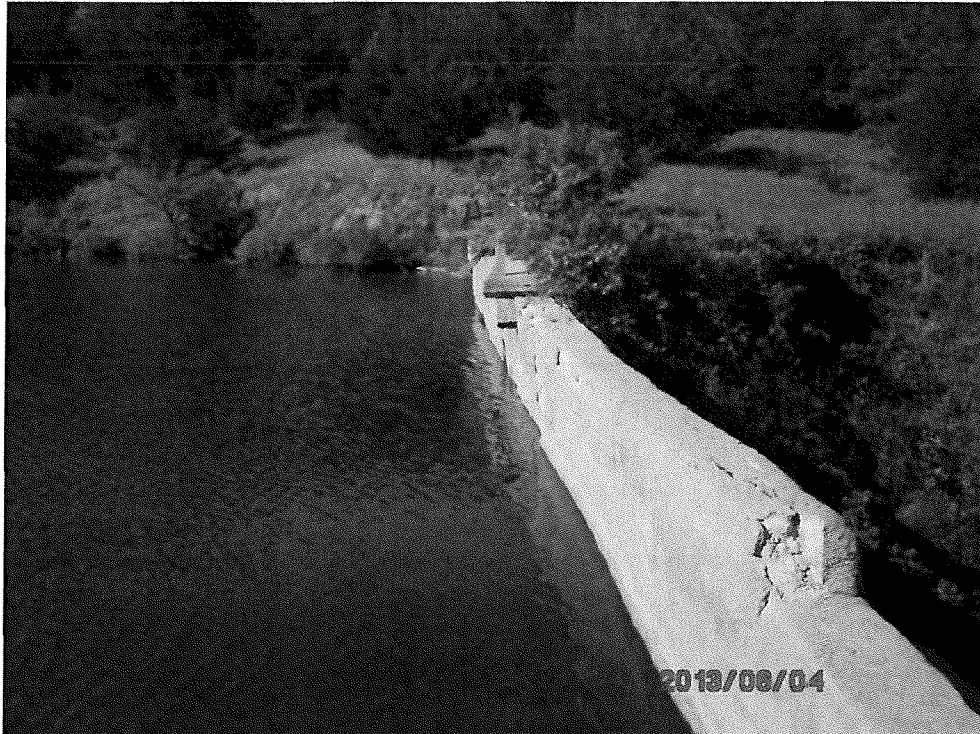
Photo 62 – Looking to left abutment from base outlet gatewell.

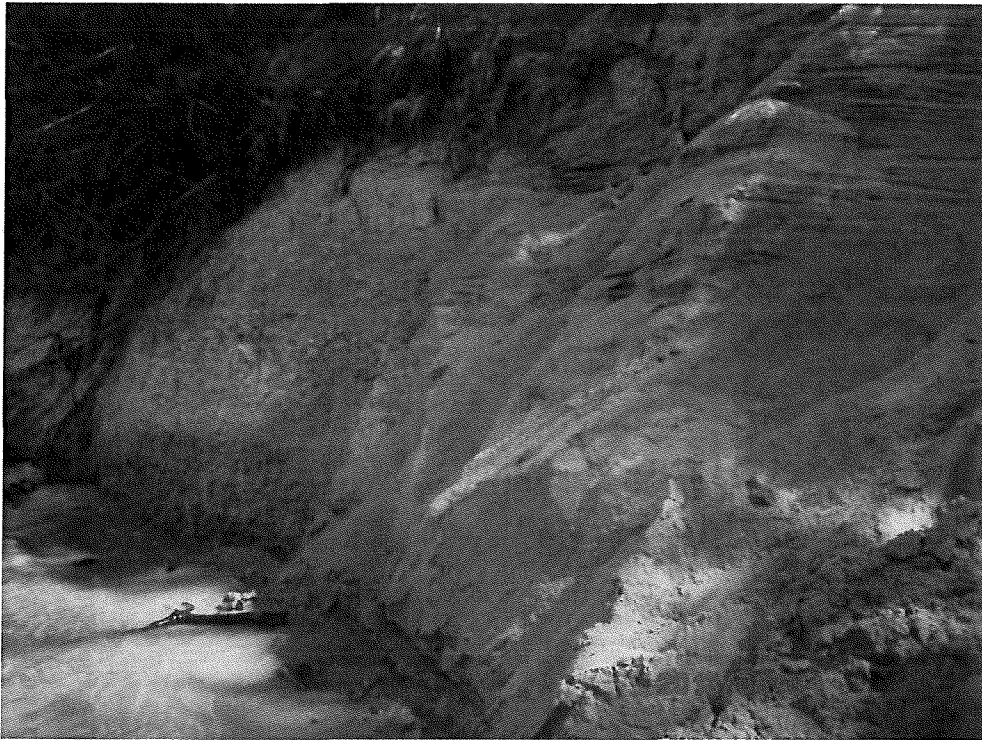
Photo 63 – Right bank material immediately downstream of the dam, shale/mudstone on the left, sand on the right.

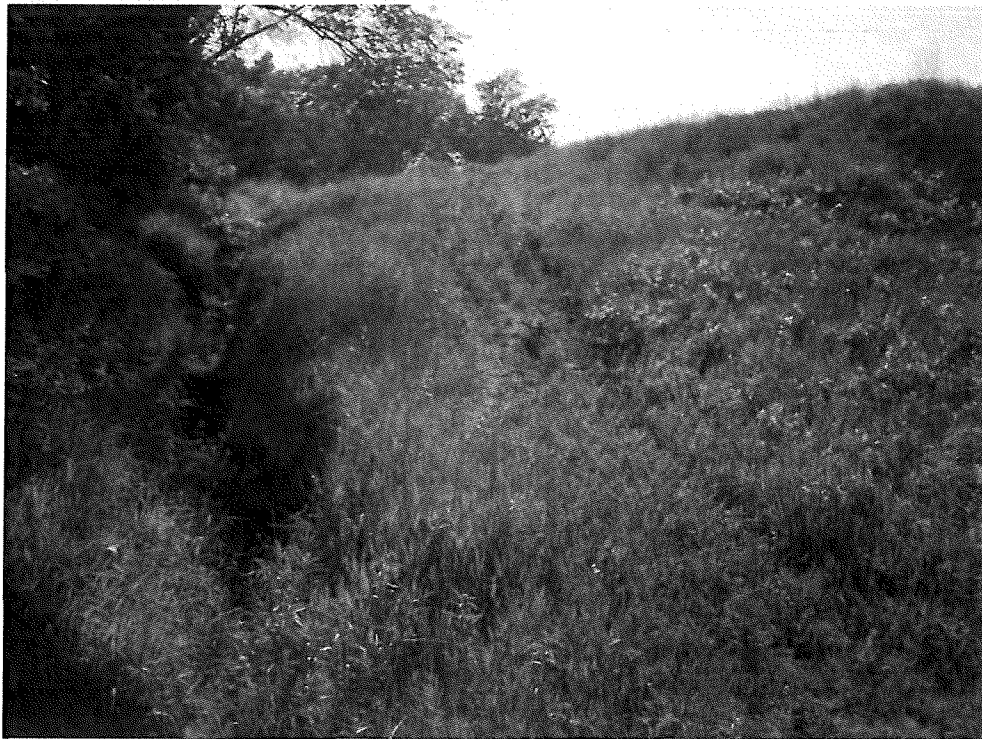
Photo 64 – Right abutment on downstream side.

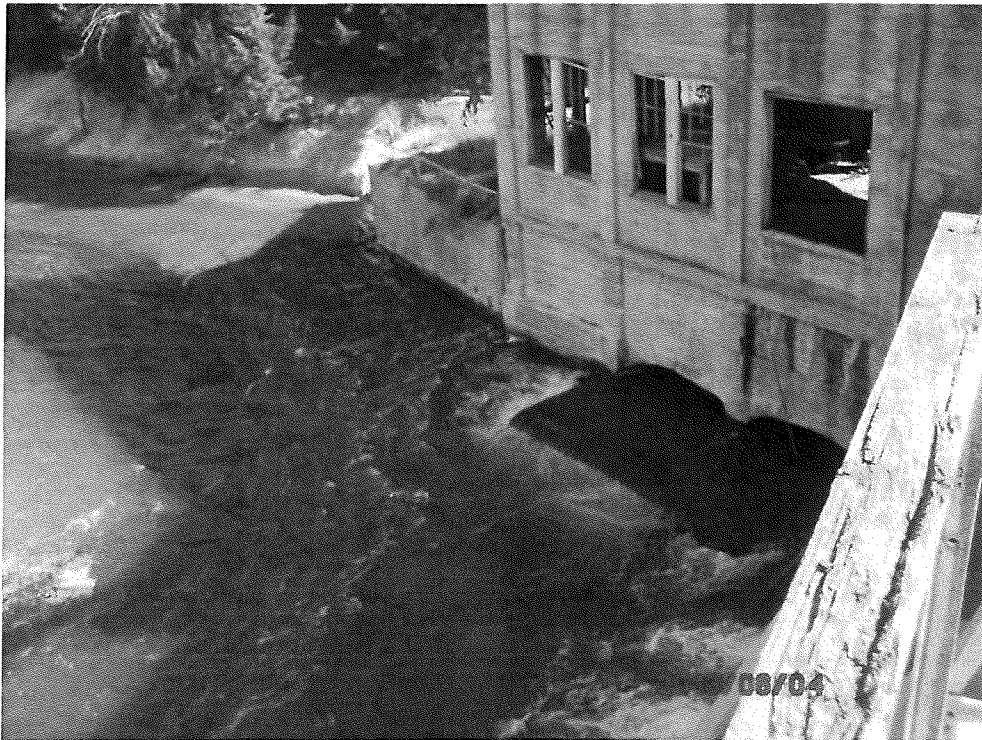
Photo 65 – McGowan Dam tailrace.

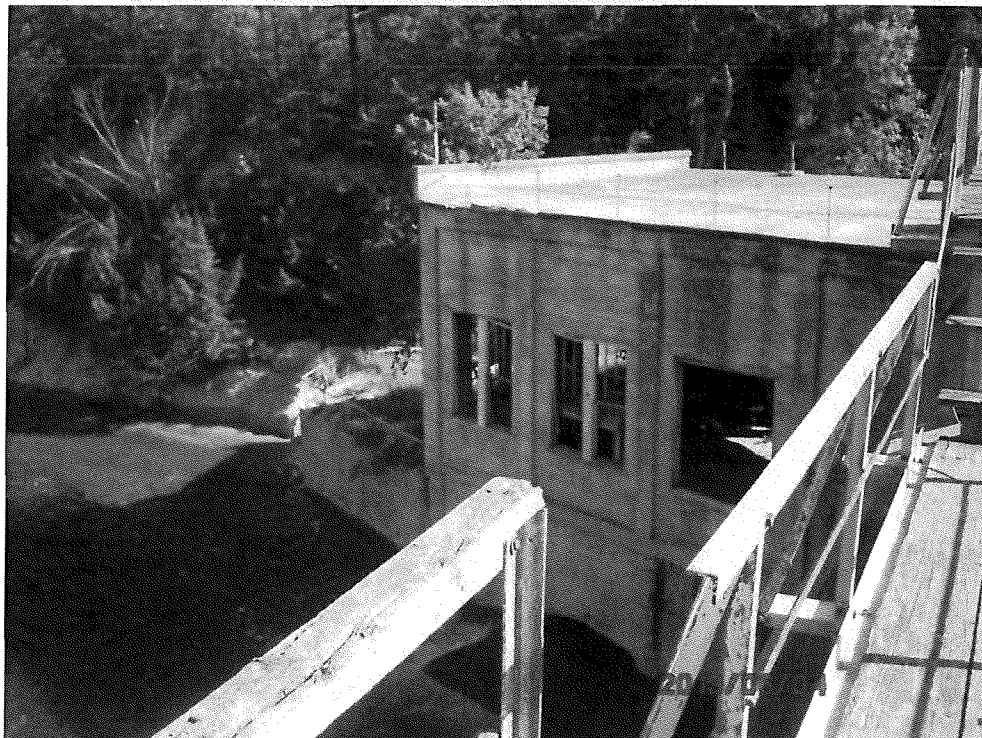
Photo 66 – McGowan Dam powerhouse north wall.

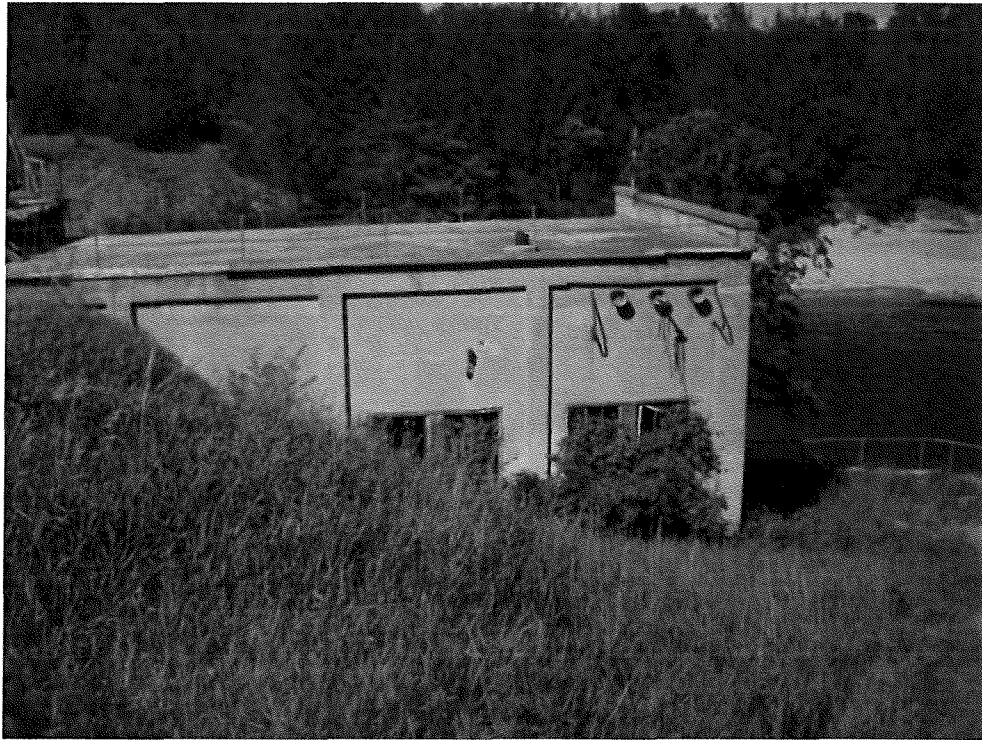
Photo 67 – Powerhouse south wall.

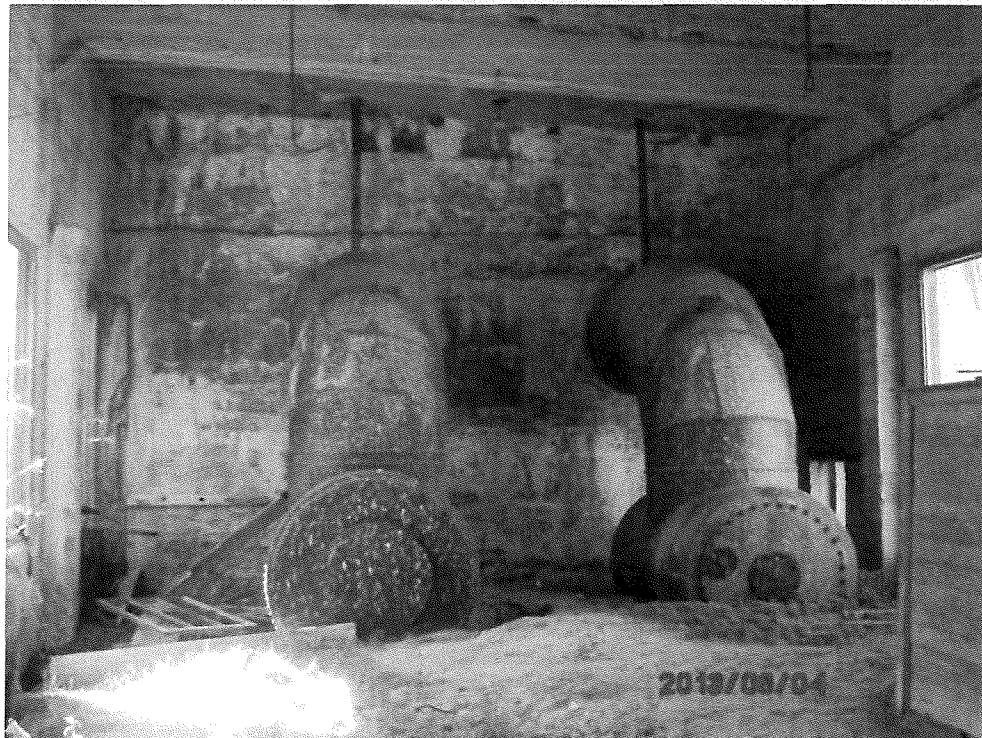
Photo 68 – Penstocks inside powerhouse.

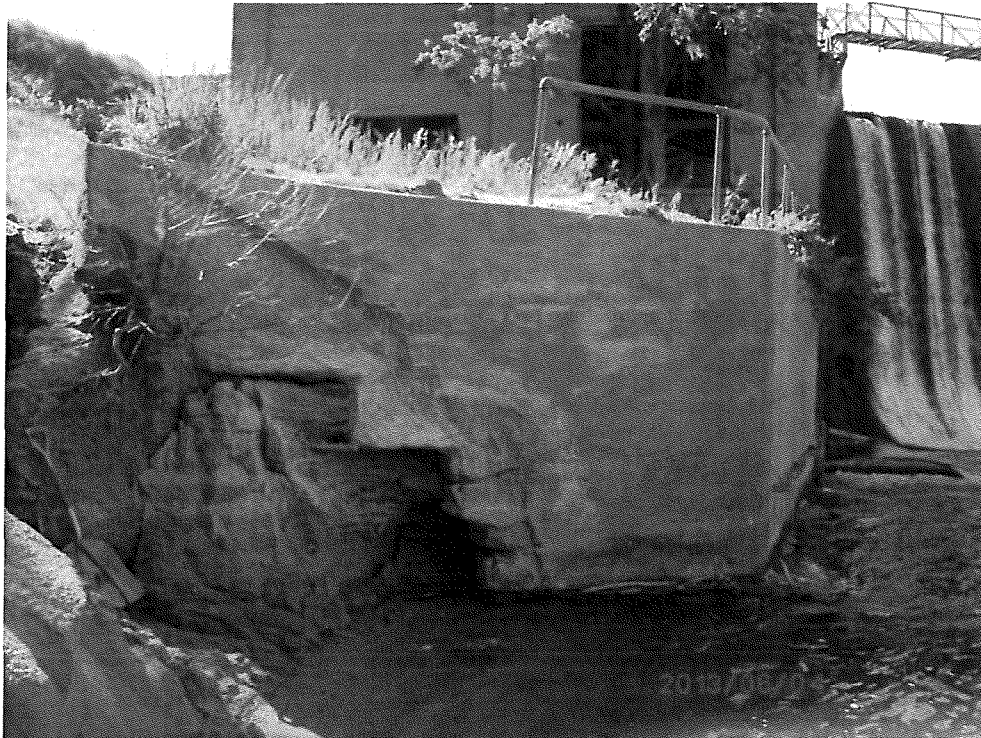
Photo 69 – Powerhouse trailing wall.
