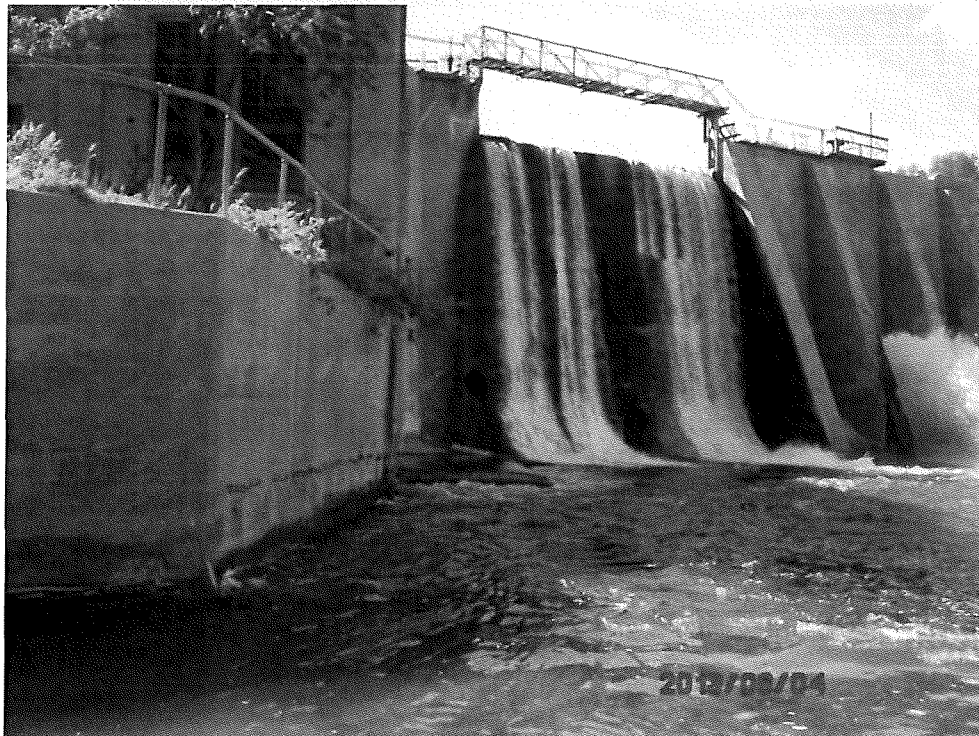
Photo 70 – Powerhouse training wall and tailrace.

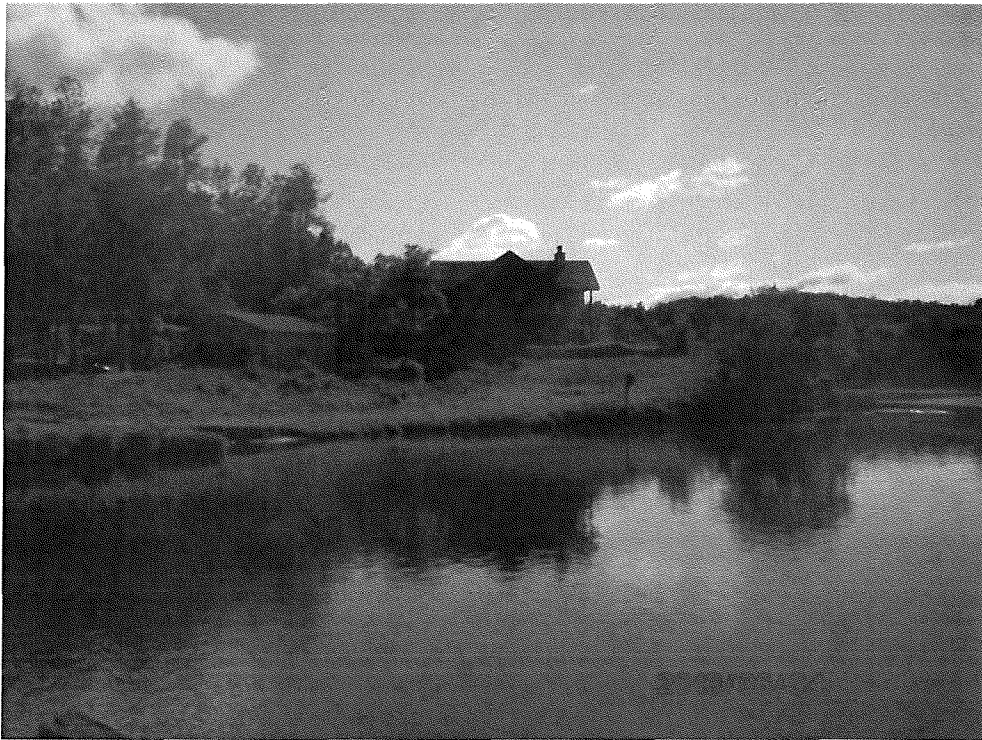
Photo 71 – Right banks of McGowan Reservoir as seen from dam.

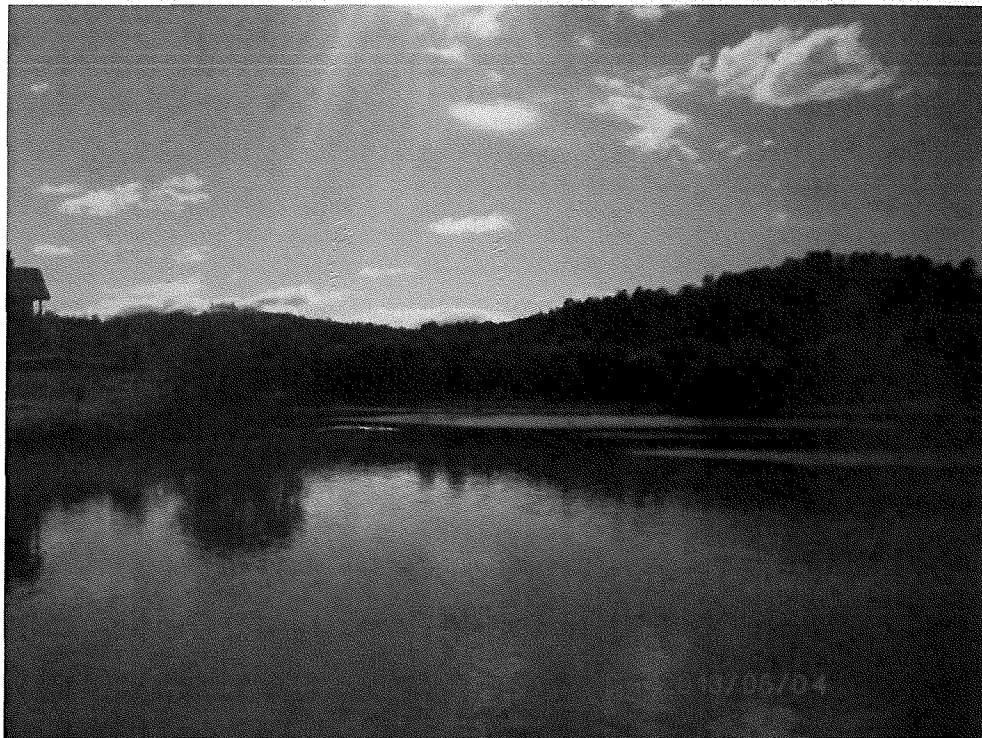
Photo 72 – McGowan Reservoir right bank as seen from dam.

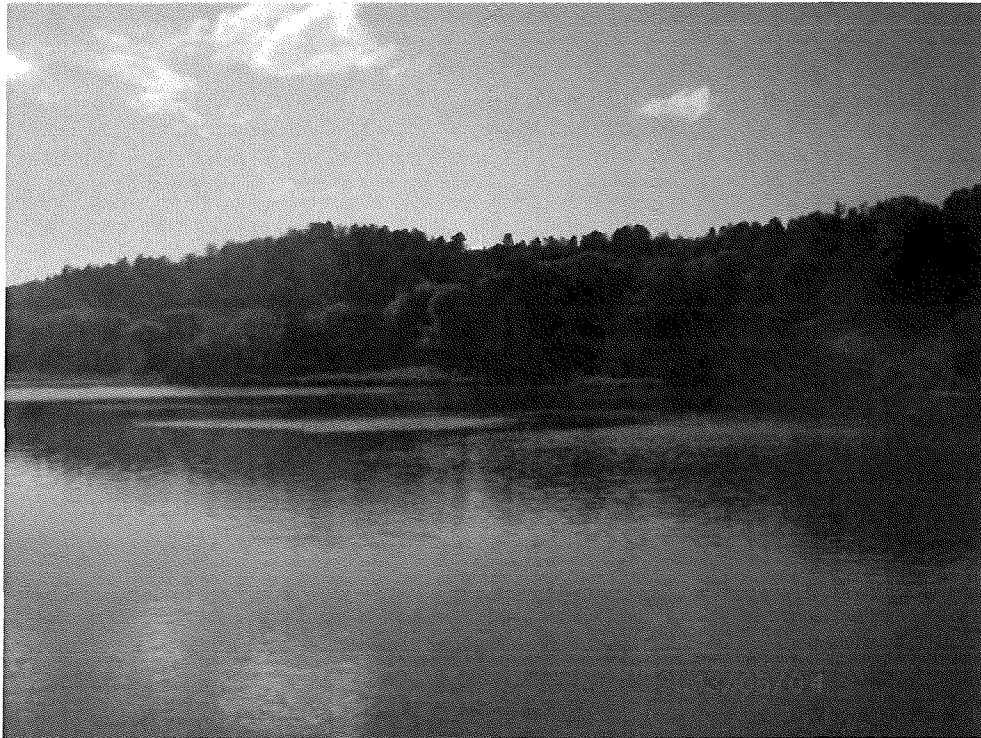
Photo 73 – McGowan Reservoir central area as seen from dam.

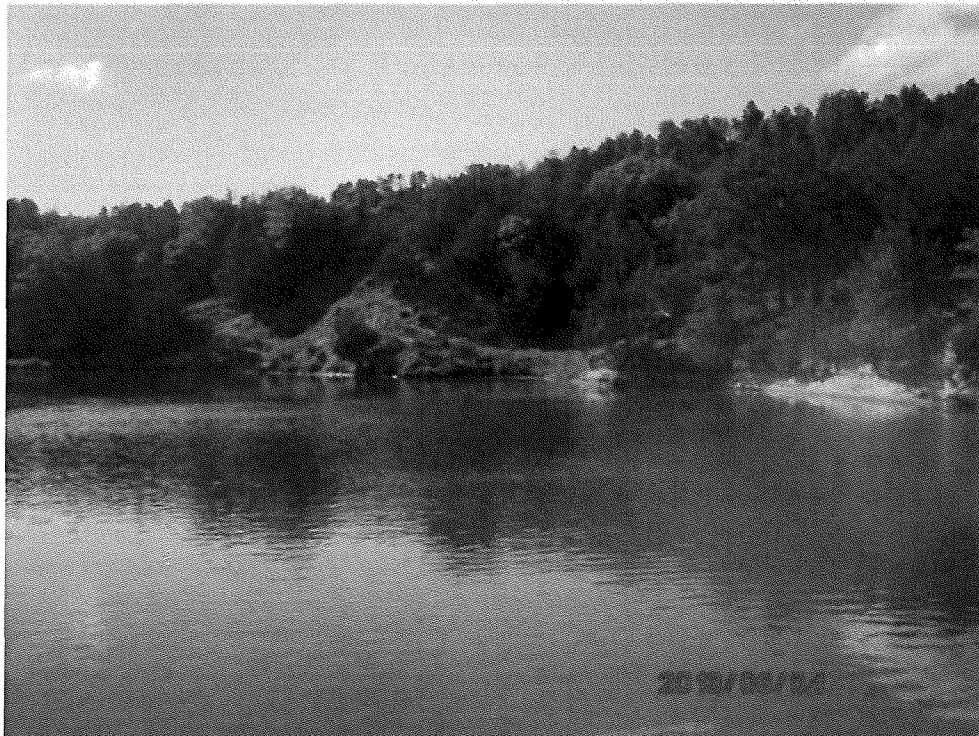
Photo 74 – McGowan Reservoir left bank as seen from dam.

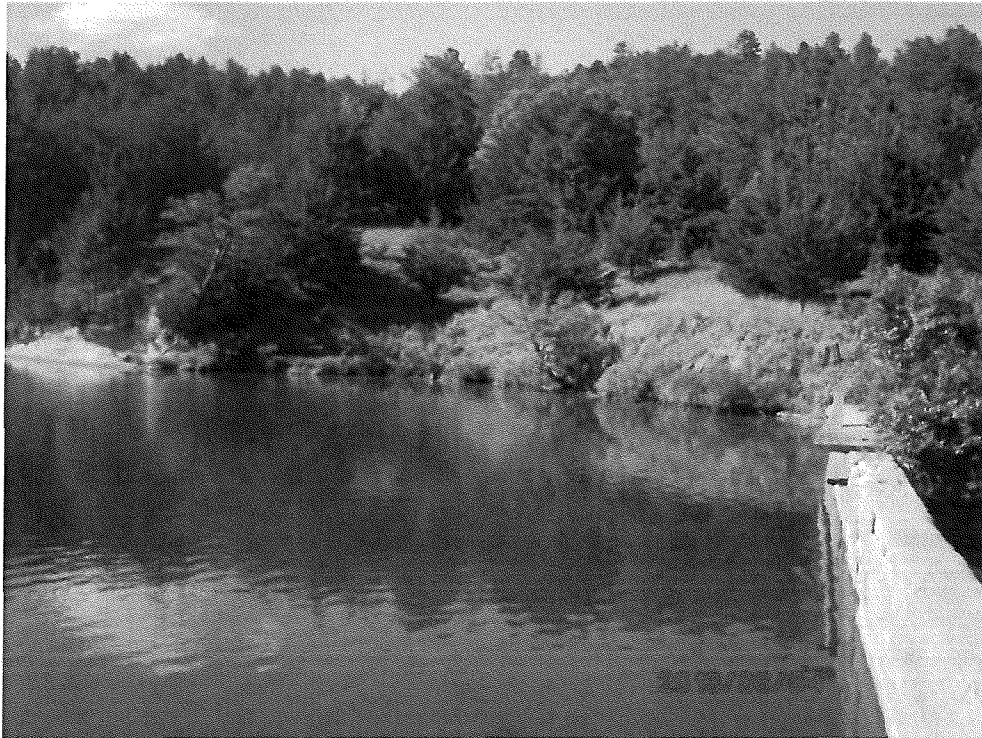
Photo 75 – McGowan Dam upstream left abutment.

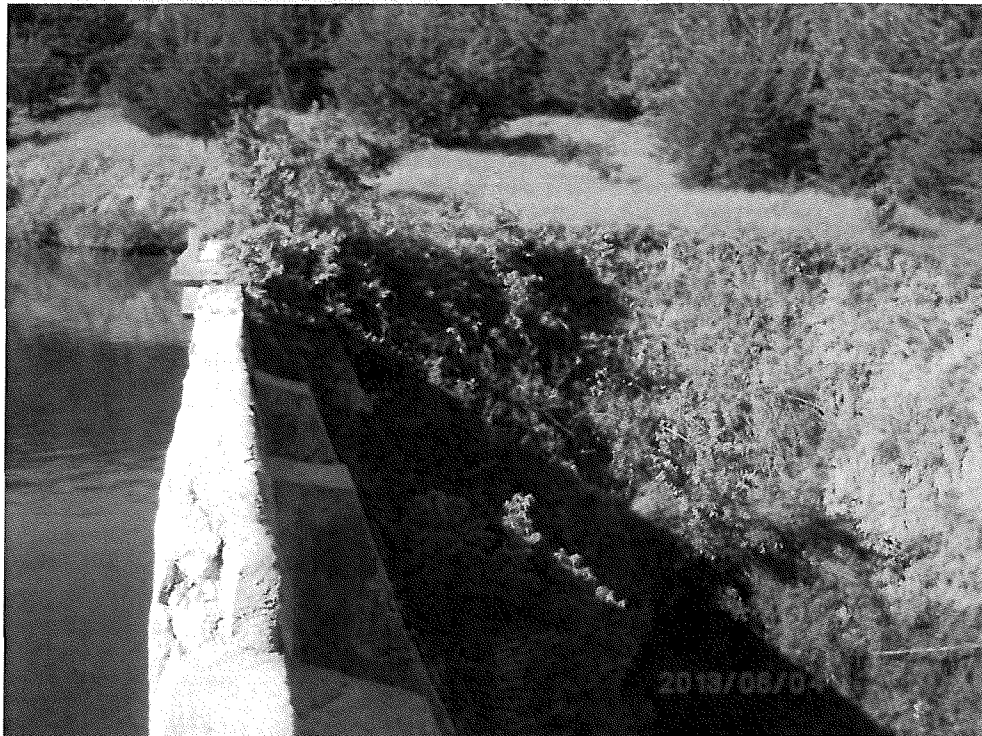
Photo 76 – Downstream of McGowan Dam.

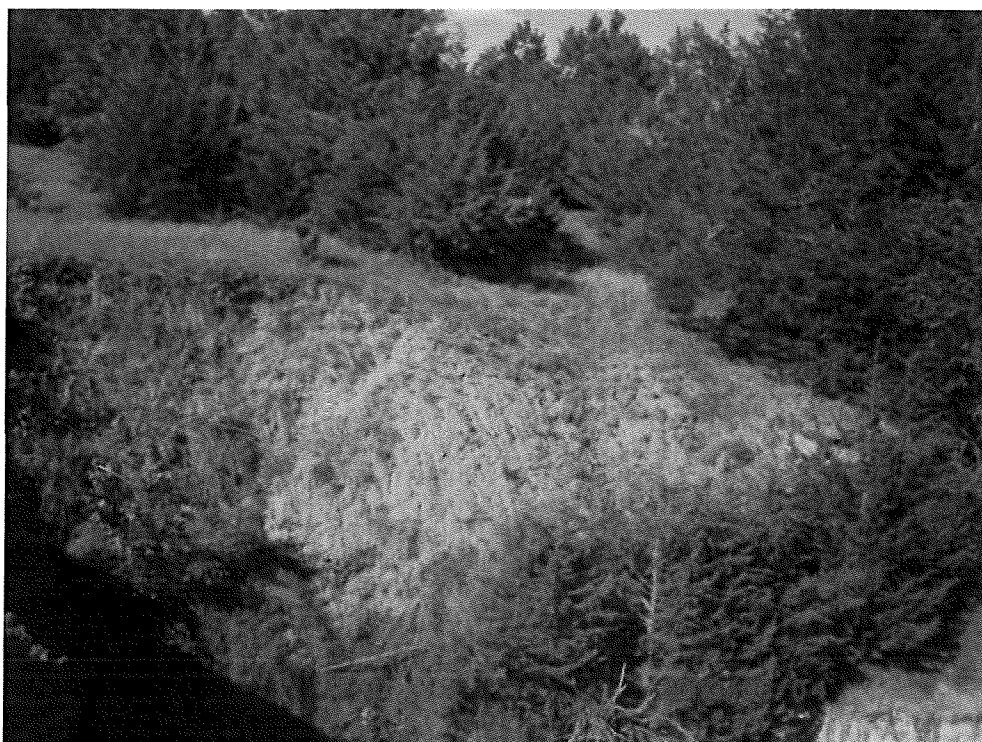
Photo 77 – Left abutment as looking downstream from McGowan Dam.

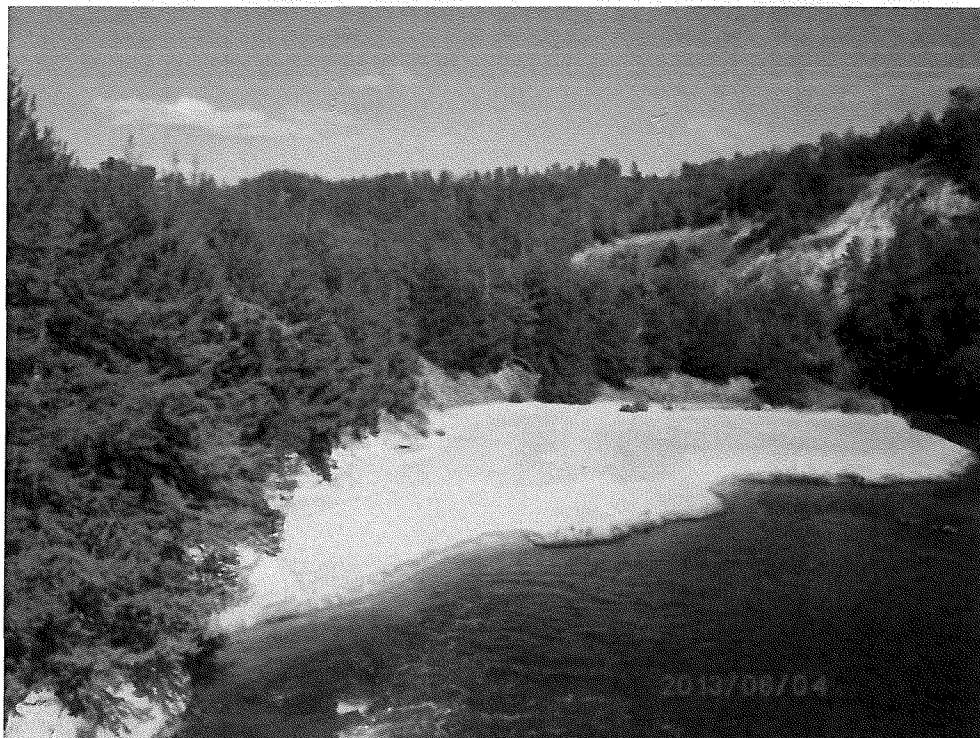
Photo 78 – Left bank sand terraces downstream of McGowan Dam.

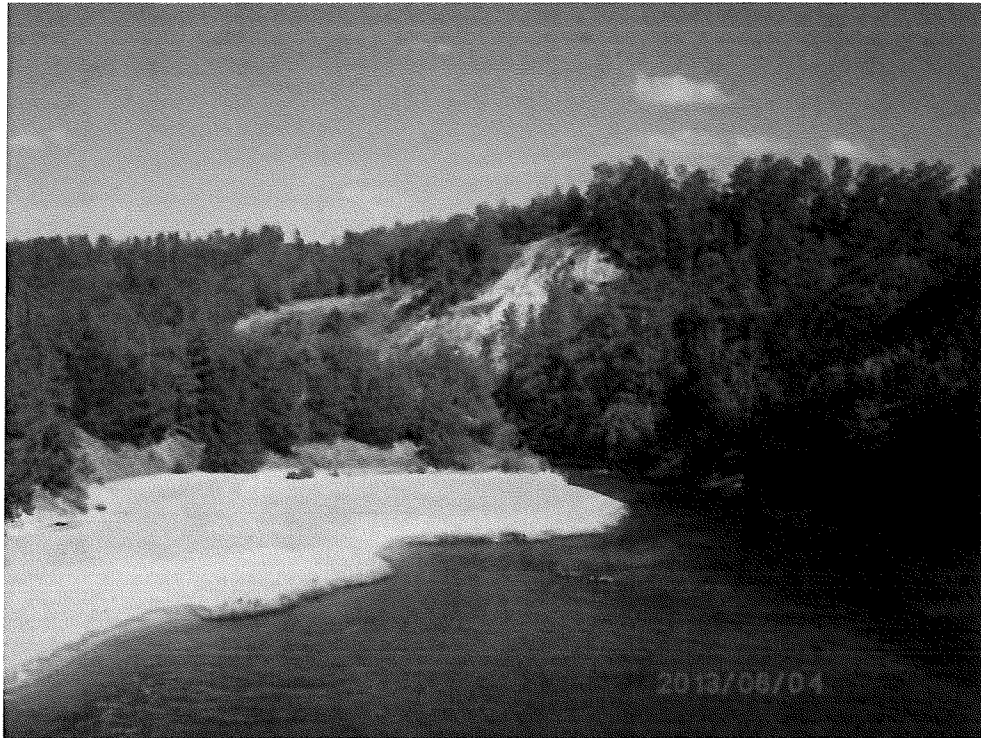
Photo 79 – Downstream of McGowan Dam.

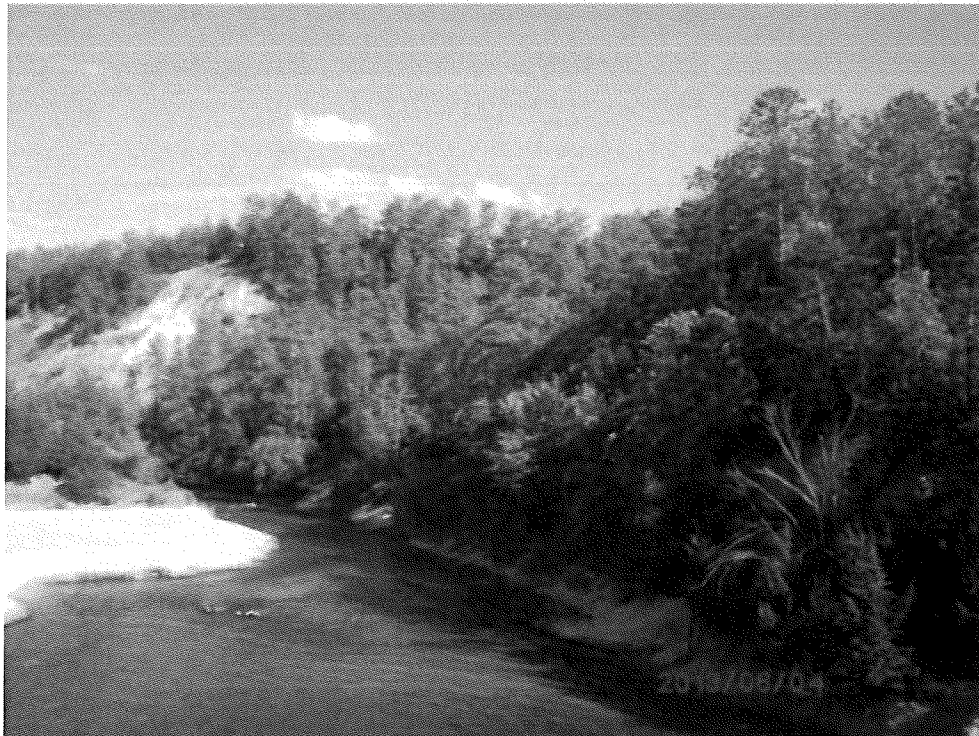
Photo 80 – Right bank downstream of McGowan Dam.

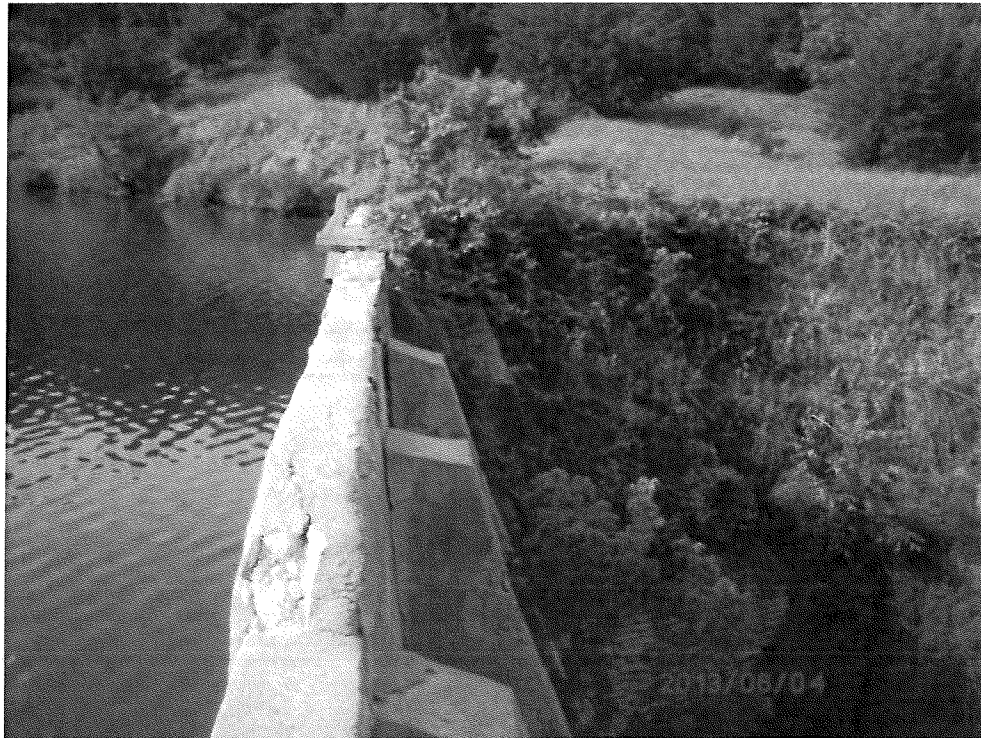
Photo 81- Separation between buttress wall and downstream dam face.

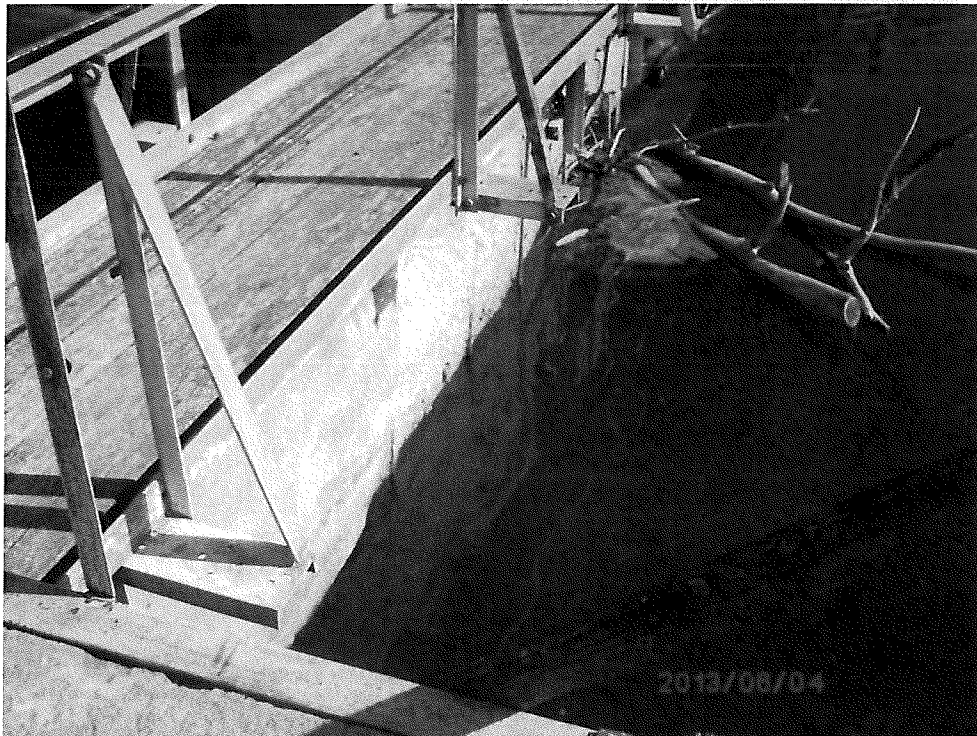
Photo 82 – Exposed concrete reinforcement on reservoir side of McGowan Dam.

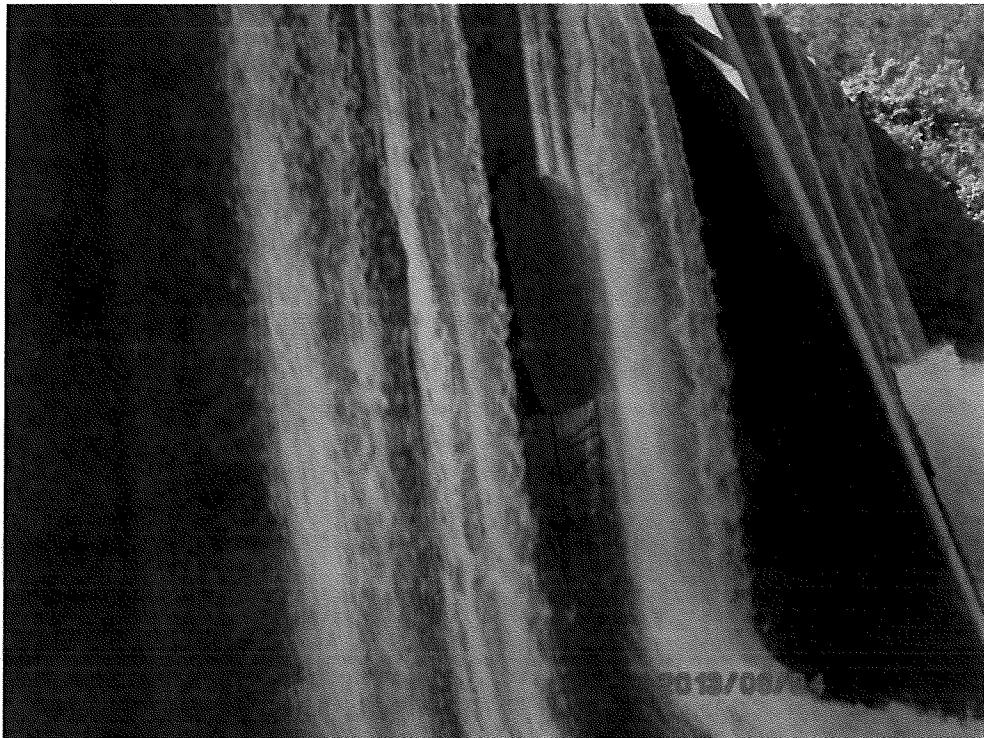
Photo 83 – Spalling concrete on spillway.
