**TSCA SECTION 402(c) – RECORDKEEPING / WORK PRACTICE STANDARDS  
INSPECTION REPORT**

**Renovation Firm:** Greenbuild Design & Construction LLC  
**EPA Certification No.:** NAT-F190683-1  
Expired on August 24, 2023

**Renovation Site:** 2208 Turnagain Parkway  
Anchorage, Alaska 99517

**Inspection Date:** July 25, 2018

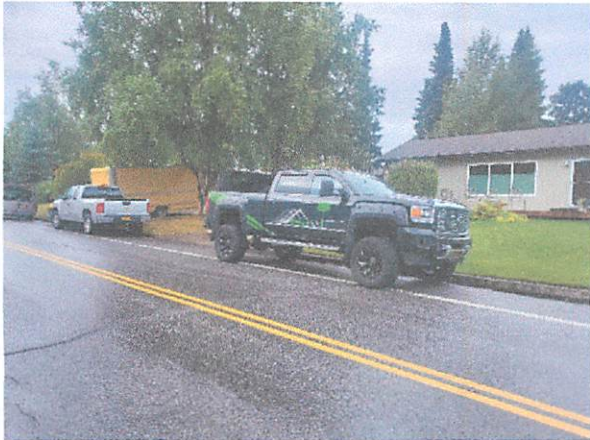
July 25, 2018, Photo 20180725\_115121.jpg

Photo 20180725\_115121.jpg taken July 25, 2018 at 11:51 a.m. is a picture of the work truck owned by Greenbuild Design, parked on the street near the active renovation site located at 2208 Turnagain, Anchorage, Alaska. Photo 20180725\_115135.jpg taken July 25, 2018 at 11:51 a.m. is a picture of the work trailer owned by Greenbuild Design parked in the driveway of the target property.

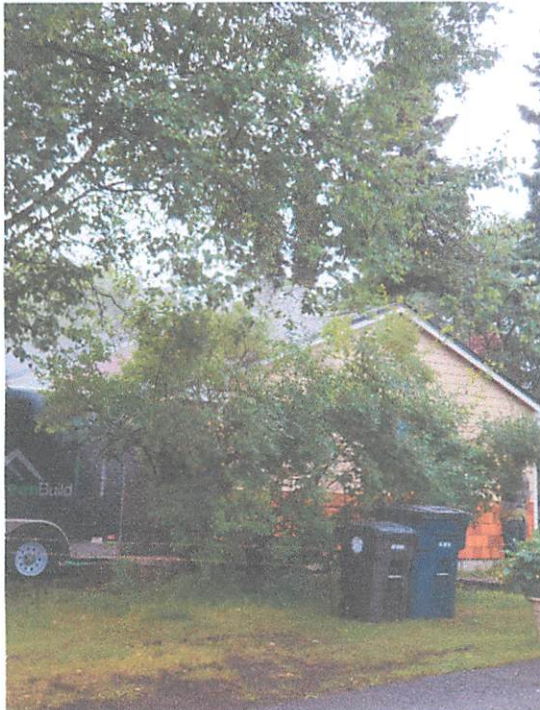
July 25, 2018, Photo 20180725\_115646.jpg

Photo 20180725\_115646.jpg taken July 25, 2018 at 11:56 a.m. during the onsite inspection for property located at 2208 Turnagain, Anchorage, Alaska shows the water mist that can be seen spraying above the roof from the backyard towards the front of the house during the active pressure washing that could be heard from the street. The photograph also shows a worker on the right side of the target property during the active pressure washing. Photo 20180725\_115648.jpg taken July 25, 2018 at 11:56 a.m. shows water mist going above the roof from the active pressure washing being completed from the backyard of the target property during the inspection. The photograph also shows a worker on the right side of the target property during the active pressure washing.

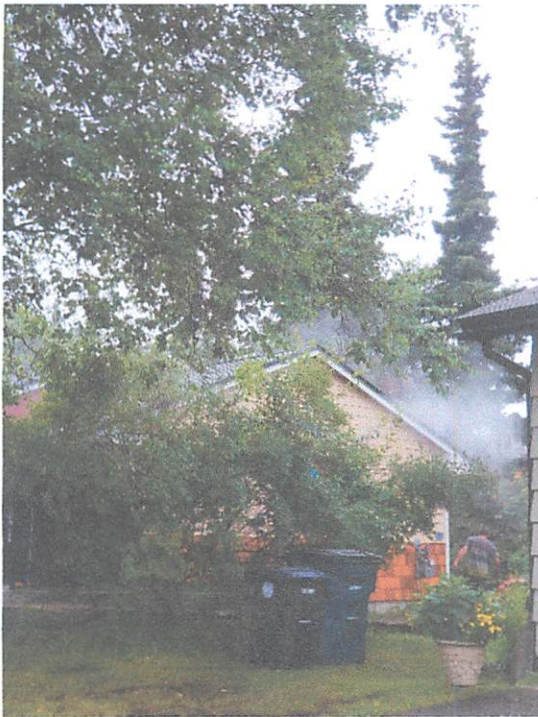
July 25, 2018, Photo 20180725\_115707.jpg

Photo 20180725\_115707.jpg taken July 25, 2018 at 11:57 a.m. shows water mist from the backyard of the target property going above the roof towards the front of the property during the active pressure washing at property located at 2208 Turnagain, Anchorage, Alaska during the onsite inspection. The photograph shows a worker walking in the backyard. Photo 20180725\_115932.jpg taken July 25, 2018 at 11:59 a.m. shows water mist from the active pressure washing in the backyard of the target property during the onsite inspection. The photograph also shows a worker behind the house while the target property during the pressure washing. The photograph is evidence showing there is no containment being utilized during the pressure washing, and no signs posted during the active renovation work.

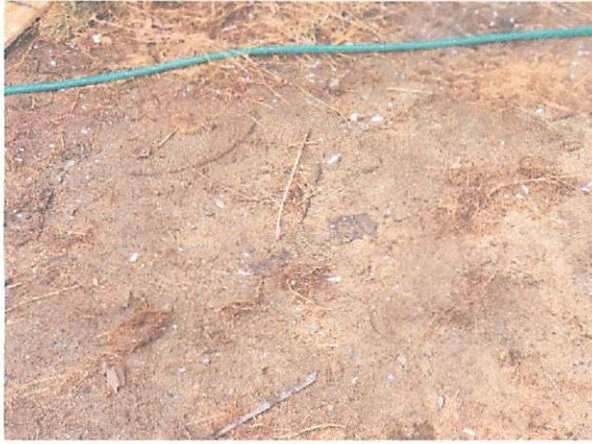
July 25, 2018, Photo 20180725\_120029.jpg

Photo 20180725\_120029.jpg taken July 25, 2018 at 12:00 p.m. shows visible paint chips on bare ground in front of the property to the right of the front porch close to the foundation located at 2208 Turnagain, Anchorage, Alaska. The photograph indicates that no containment was utilized during active renovation work. Photo 20180725\_120057.jpg taken July 25, 2018 at 12:00 p.m. shows visible paint chips on bare ground close to the foundation to the left side of the front porch of the same property. The photograph indicates that no containment was utilized during active renovation work.

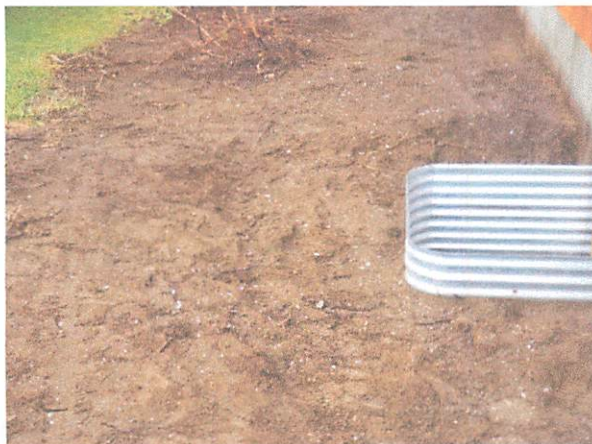
July 25, 2018, Photo 20180725\_120105.jpg

Photo 20180725\_120105.jpg taken July 25, 2018 at 12:01 p.m. shows visible paint chips on bare ground to the left of the house next to the foundation of target property located at 2208 Turnagain, Anchorage, Alaska. The photograph indicates that no containment was utilized

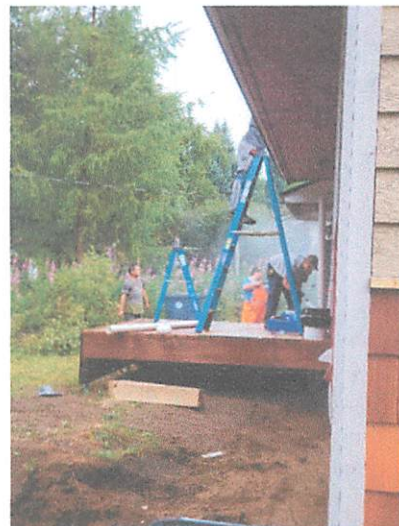
July 25, 2018, Photo 20180725\_120128.jpg

during active renovation work. Photo 20180725\_120128.jpg taken July 25, 2018 at 12:01 p.m. shows active pressure washing in backyard of target property during the onsite inspection. The photograph shows three workers performing active renovation work during the inspection. The photograph shows that no containment is being utilized during the active renovation work.

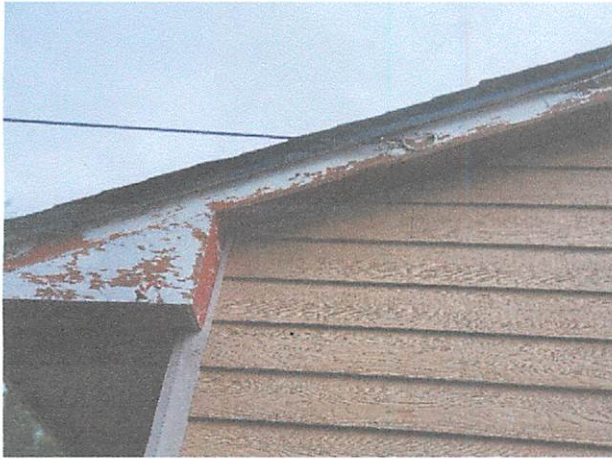
July 25, 2018, Photo 20180725\_120145.jpg

Photo 20180725\_120145.jpg taken July 25, 2018 at 12:01 p.m. shows trimming that looks to have been prepped for painting by scraping the paint off. The trimming is located on the left side towards the backyard of the target property located at 2208 Turnagain, Anchorage, Alaska. Photo 20180725\_120152.jpg taken July 25, 2018 at 12:01 p.m. shows the full trimming that looks to have been prepped for painting by scraping the paint off. The trimming is located on the left side of the target property

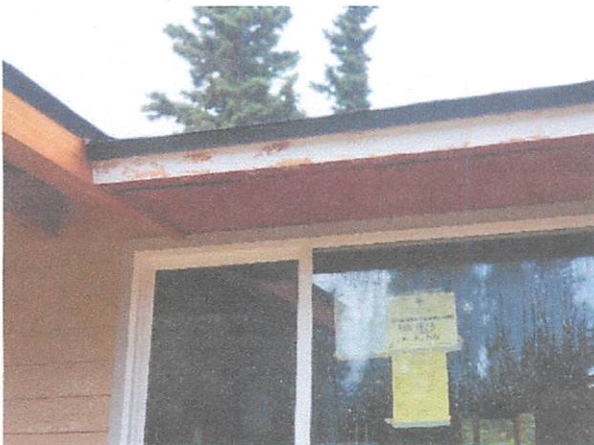
July 25, 2018, Photo 20180725\_120227.jpg

Photo 20180725\_120227.jpg taken July 25, 2018 at 12:02 p.m. shows trimming that looks to have been prepped for painting by scraping the paint off. The trimming is located on the back of the house above the window of target property located at 2208 Turnagain, Anchorage, Alaska. Photo 20180725\_120227.jpg taken July 25, 2018 taken 12:02 p.m. shows paint chips on bare ground to the right side of the target property close to the driveway. The photograph shows that no containment was utilized during the active renovation work.
