# Clean Water Act Section 404: Site Visit/Case Development

Site Name: Villegas

Site Name	Villegas	Start Date	May 18, 2022
		End Date	May 18, 2022
Inspection Purpose	Initial site visit		
<b>Opening Conference</b>			
<input checked="" type="checkbox"/> Presentation of Inspector Credentials			
Name and Title (Use N/A if owner/operator not available to join the inspection)			
N/A			
<input checked="" type="checkbox"/> Opening Conference			
Name of person authorizing access if applicable			
Tom Villegas through his attorney Stephen Mossman			
Notes from Opening Conference			
No opening conference took place since Mr. Villegas was unable to be at the site during the inspection.			
<input checked="" type="checkbox"/> Access Issues if Any			
Describe			
Was initially told that Mr. Villegas would be meeting us at the site at 9:00 am on May 18, 2022. When Mr. Simmons and I arrived at the site nobody was present. After waiting for approximately half an hour I called Natasha Goss (assigned EPA Attorney) and asked that she check with Mr. Villega's attorney (Stephen Mossman) to see if Mr. Villegas would be joining us. Mr. Mossman indicated that Mr. Villegas would not be able to join us for the

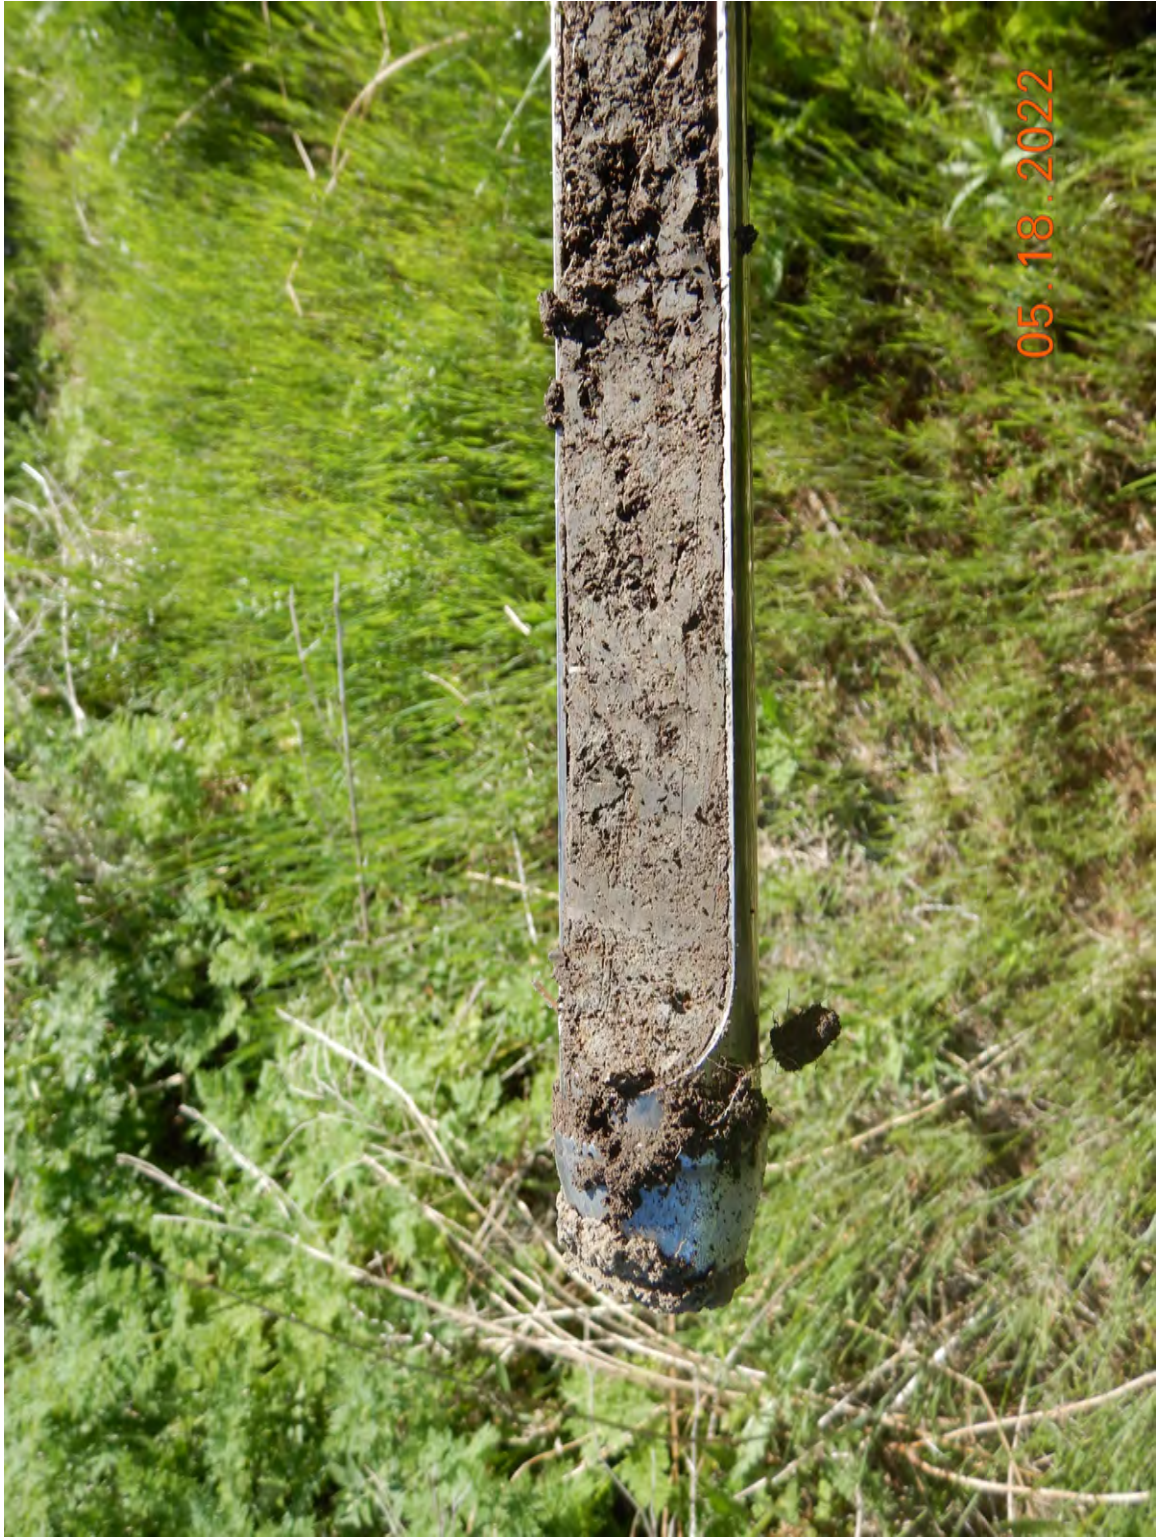
Photo 1

<b>Taken by:</b>	<b>Date</b>	<b>Approximate Time (mil)</b>	<b>File Name</b>	<b>Photo/Video Number</b>	<b>Description</b>
D. Garcia	05/18/22	0943	DSCN012.JPG	1	Soil core sample, hydric soil present.

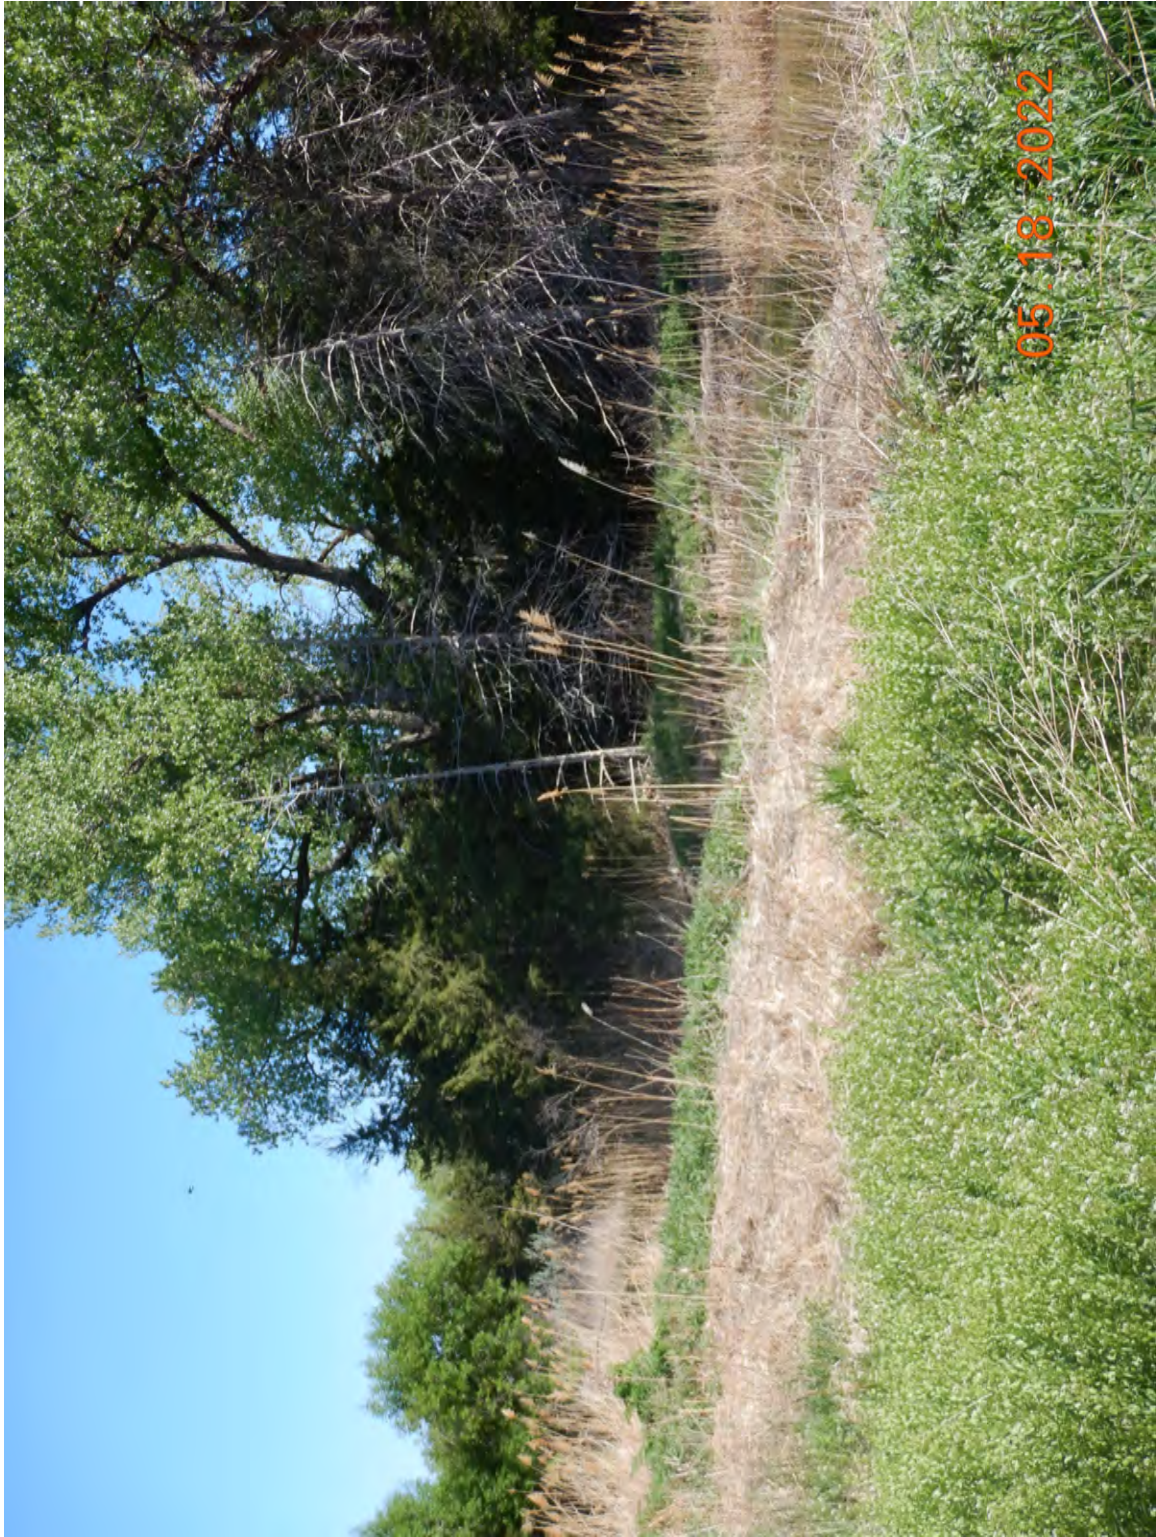
Photo 3

D. Garcia	05/18/22	0951	DSCN013.JPG	2	Frog within channel (bottom center third of photograph).
D. Garcia	05/18/22	0954	DSCN014.JPG	3	Facing berm created from sidecasted material that was excavated from channel.

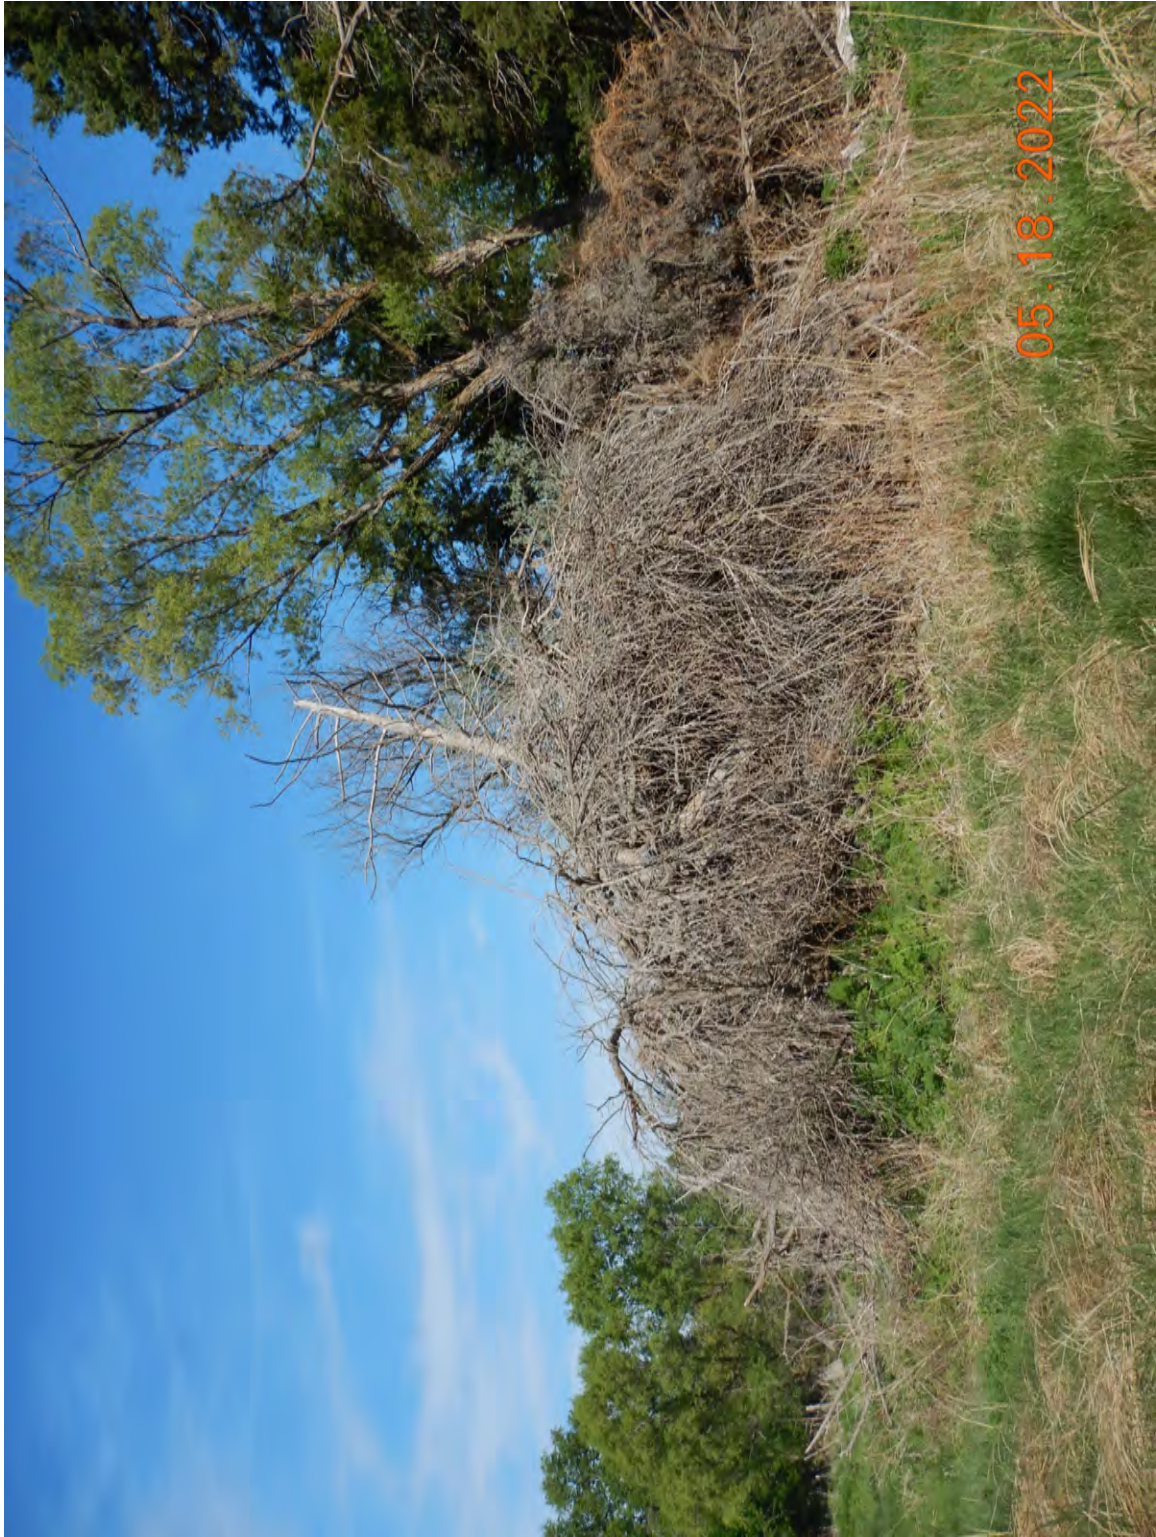
Photo 4

D. Garcia	05/18/22	0954	DSCN015.JPG	4	Large pile of cleared trees.
D. Garcia	05/18/22	0955	DSCN0016.JPG	5	Facing northeast at stream crossing (A3).
D. Garcia	05/18/22	0957	DSCN0017.JPG	6	Looking at channel within berm in Photo 3. This area was approximately 6 feet wide and discharged into excavated tributary just north of it.

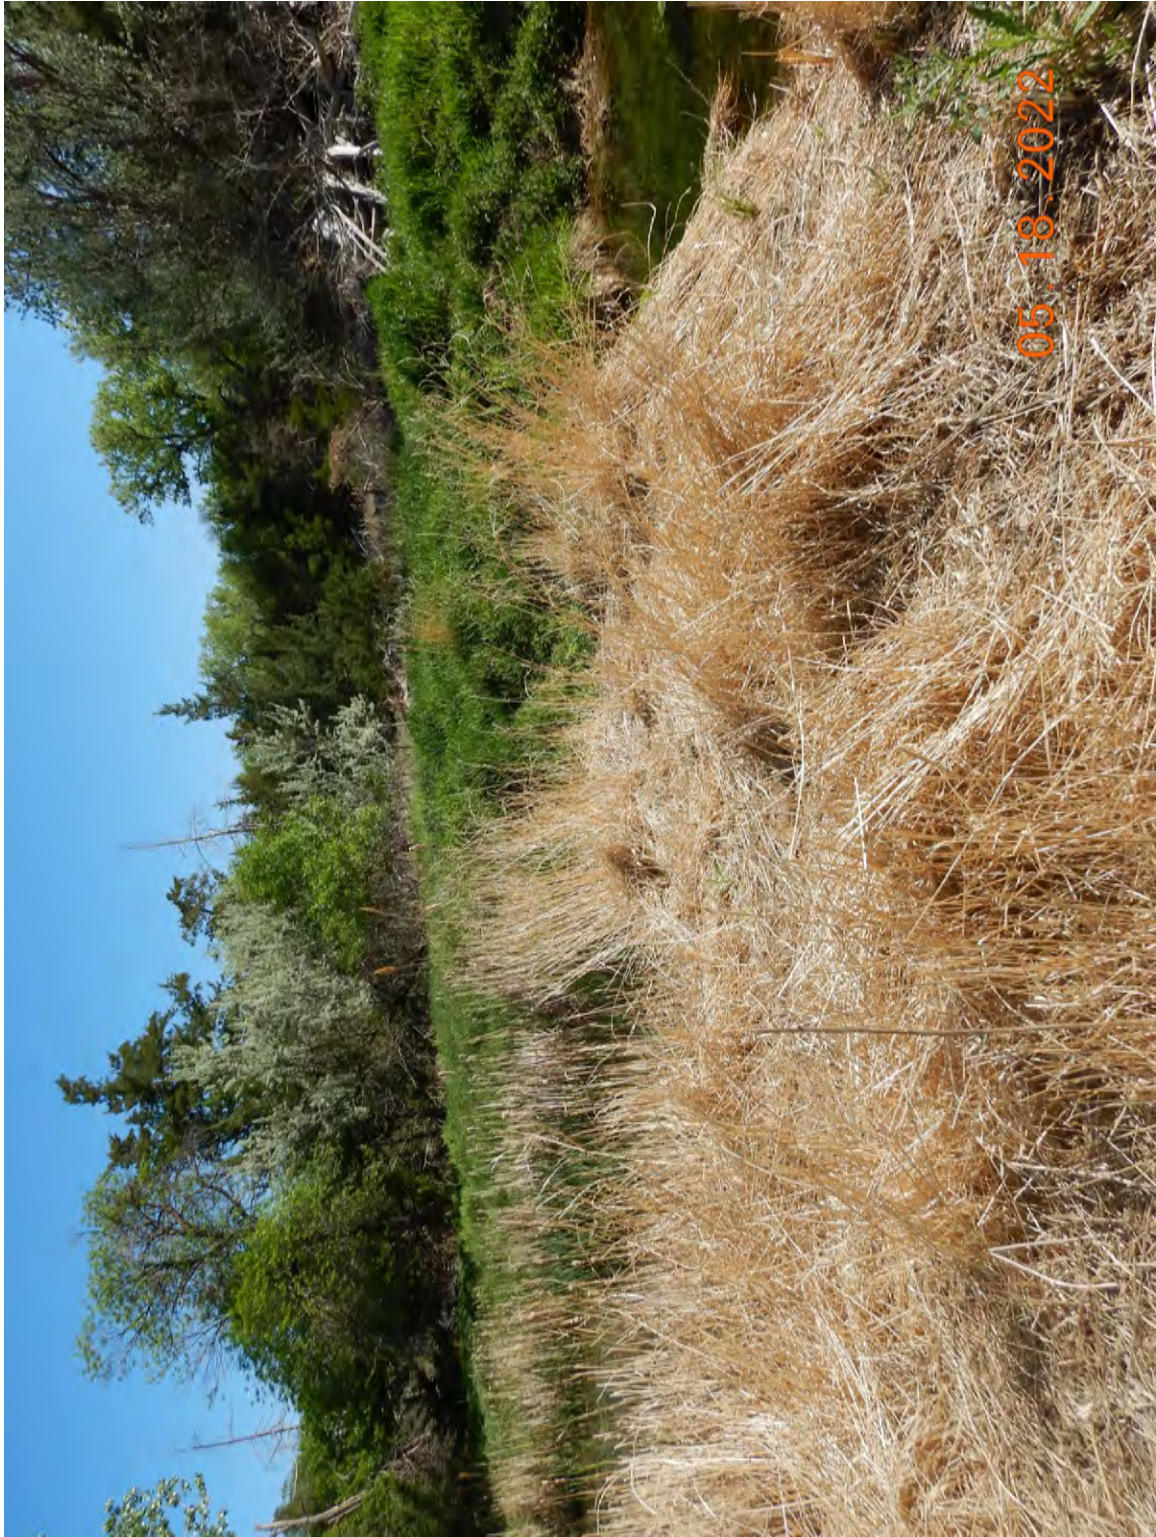
Photo 7

D. Garcia	05/18/22	1000	DSCN0018.JPG	7	Looking at another stream crossing (A4) located to the west of crossing 1
D. Garcia	05/18/22	1002	DSCN0019.JPG	8	Looking at stream channel just west of crossing in Photo 7. There were some minnows present within this channel but photograph did not capture them.

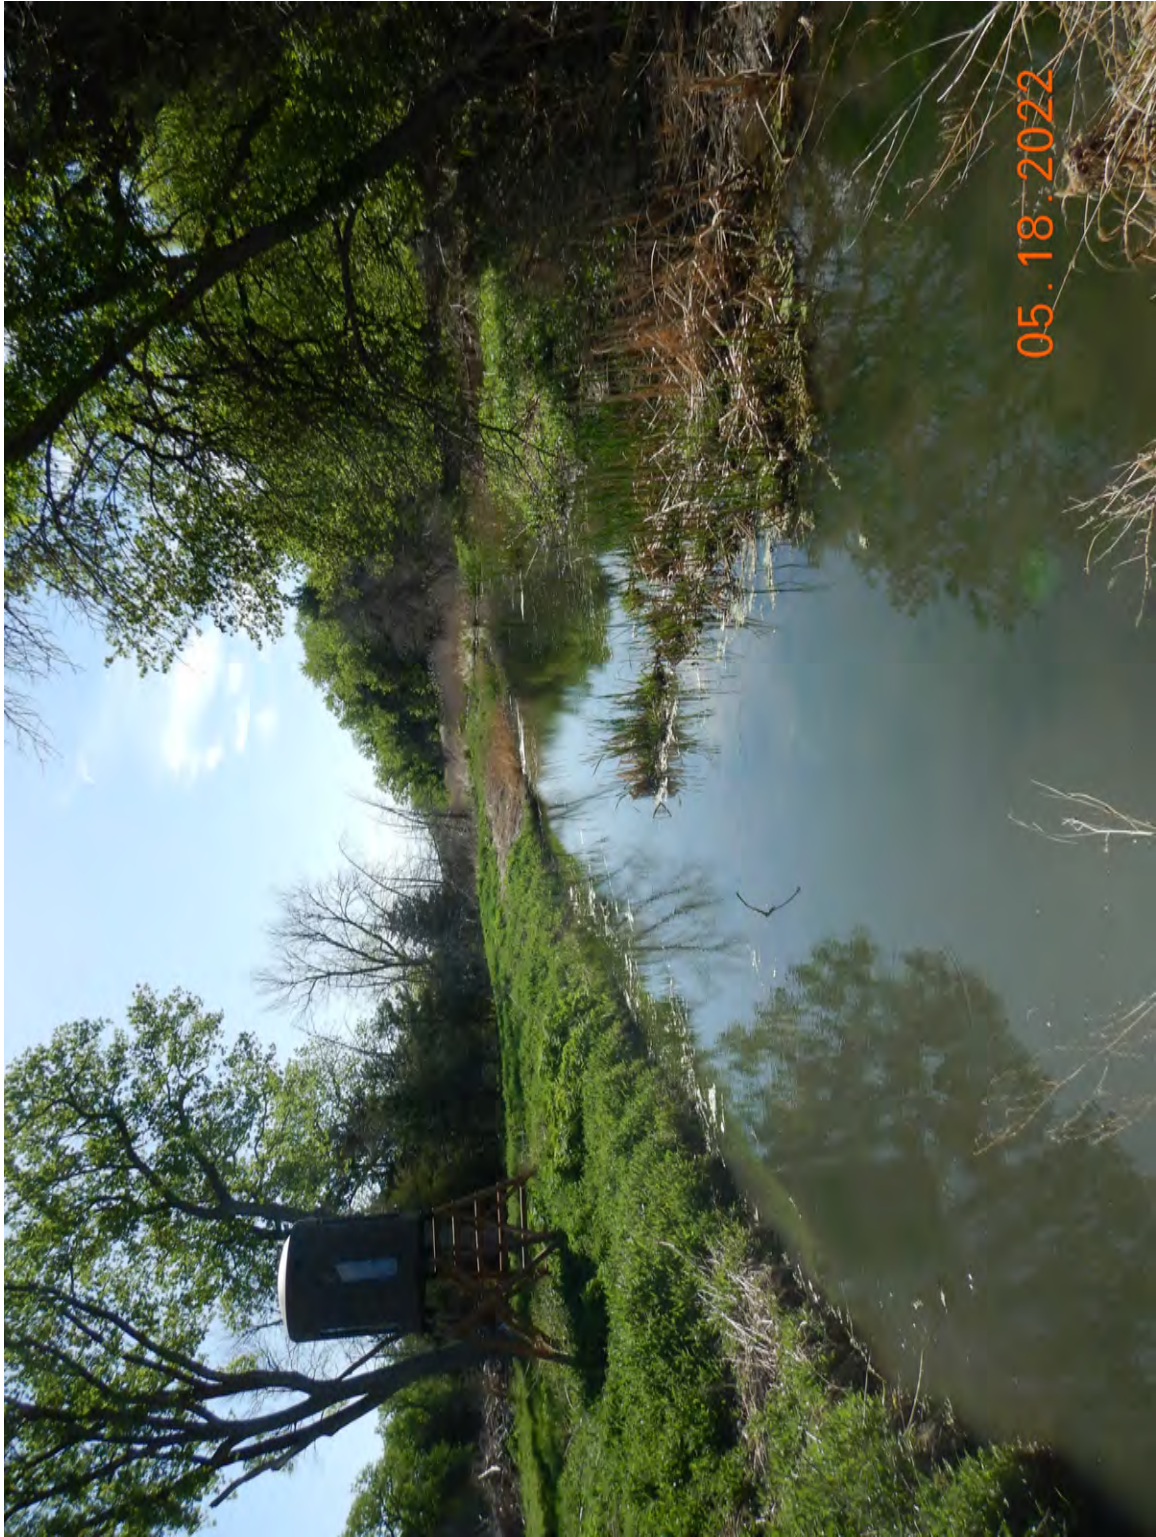
Photo 9

D. Garcia	05/18/22	1003	DSCN0020.JPG	9	Looking at excavated stream channel near stream crossing A3.

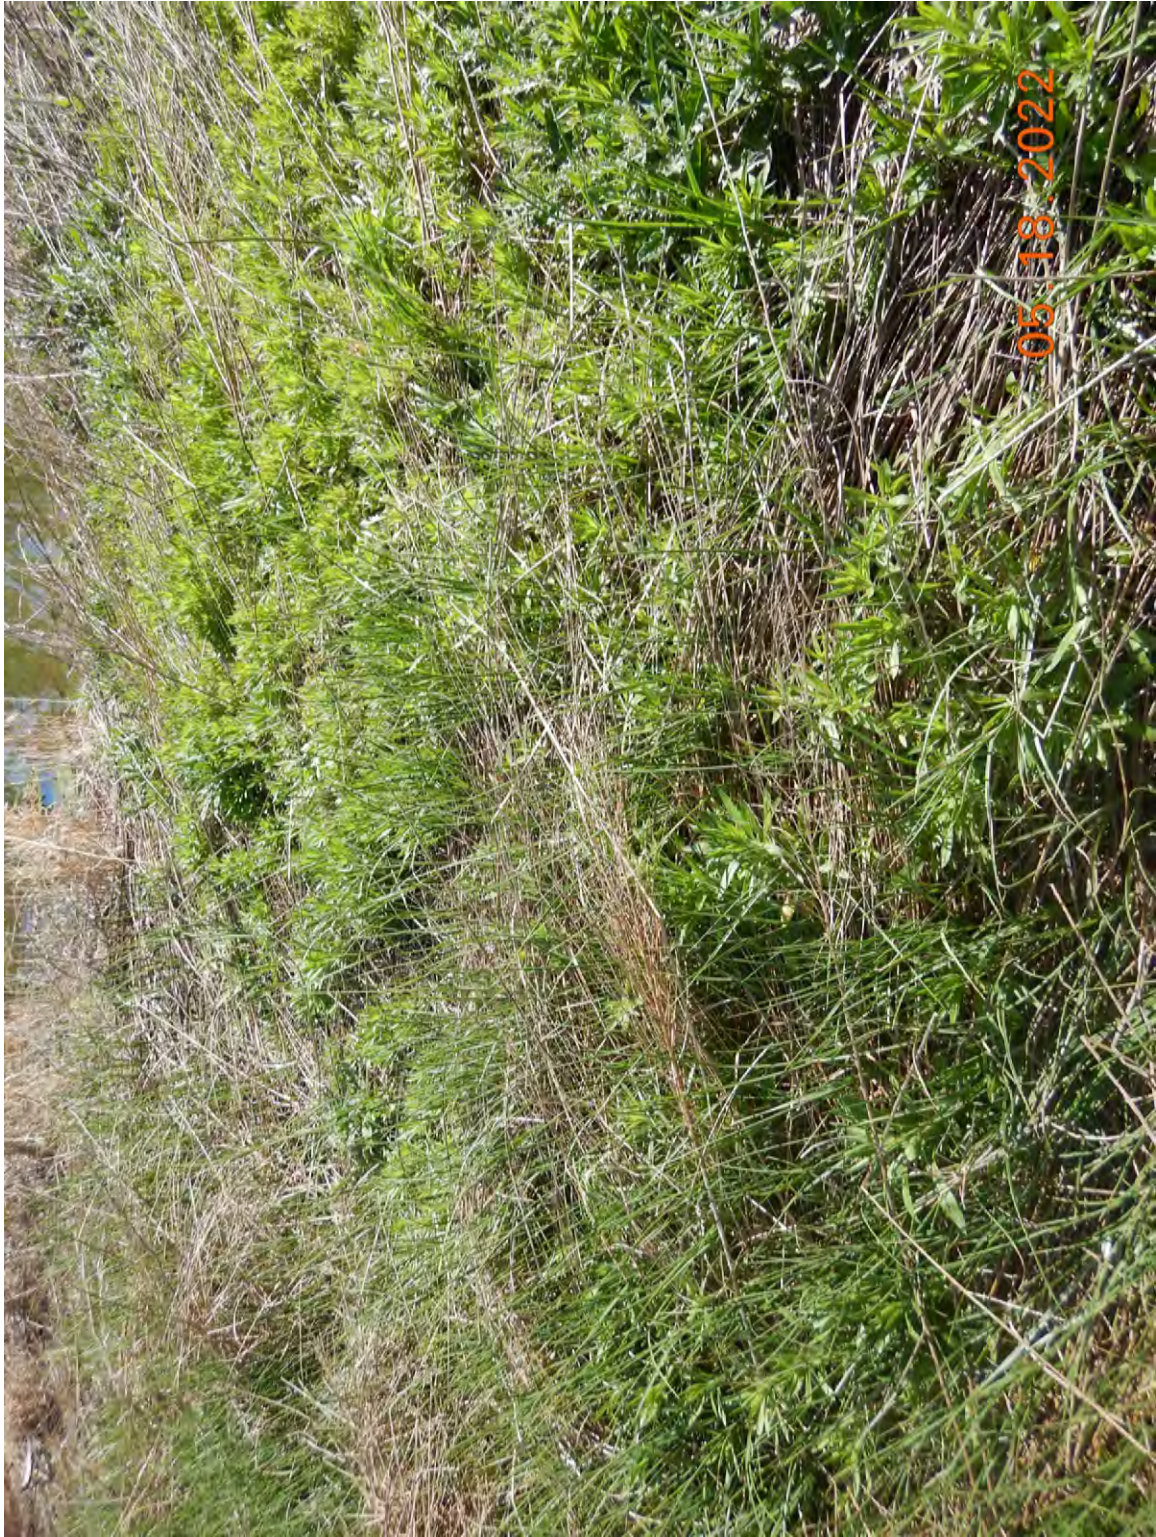
Photo 11

D. Garcia	05/18/22	1013	DSCN0021.JPG	10	Near the edge of the berm, looking at one of the cleared areas.
D. Garcia	05/18/22	1014	DSCN0022.JPG	11	Looking straight down at edge of berm crated from sidcasted excavated material.

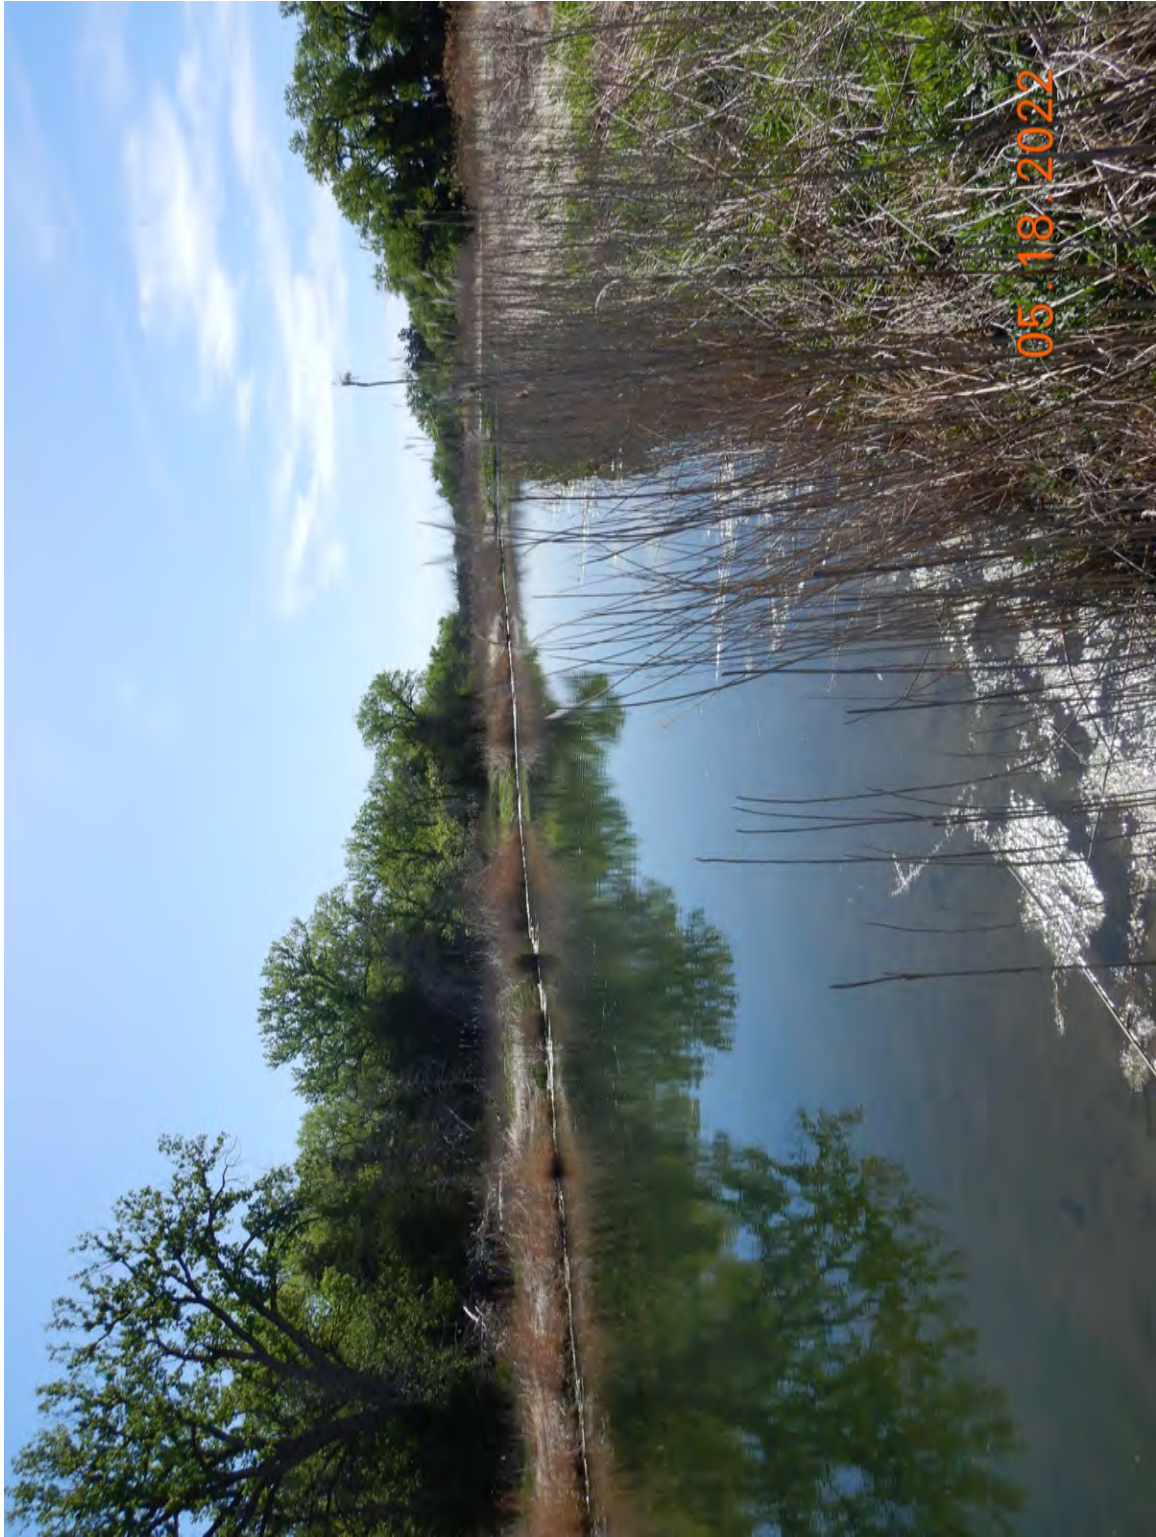
D. Garcia	05/18/22	1014	DSCN0023.JPG	12	Looking at stream channel that was excavated and expanded to create more of a pond.
D. Garcia	05/18/22	1015	DSCN0024.JPG	13	Taken from same location as Photo 12 but facing the other direction.

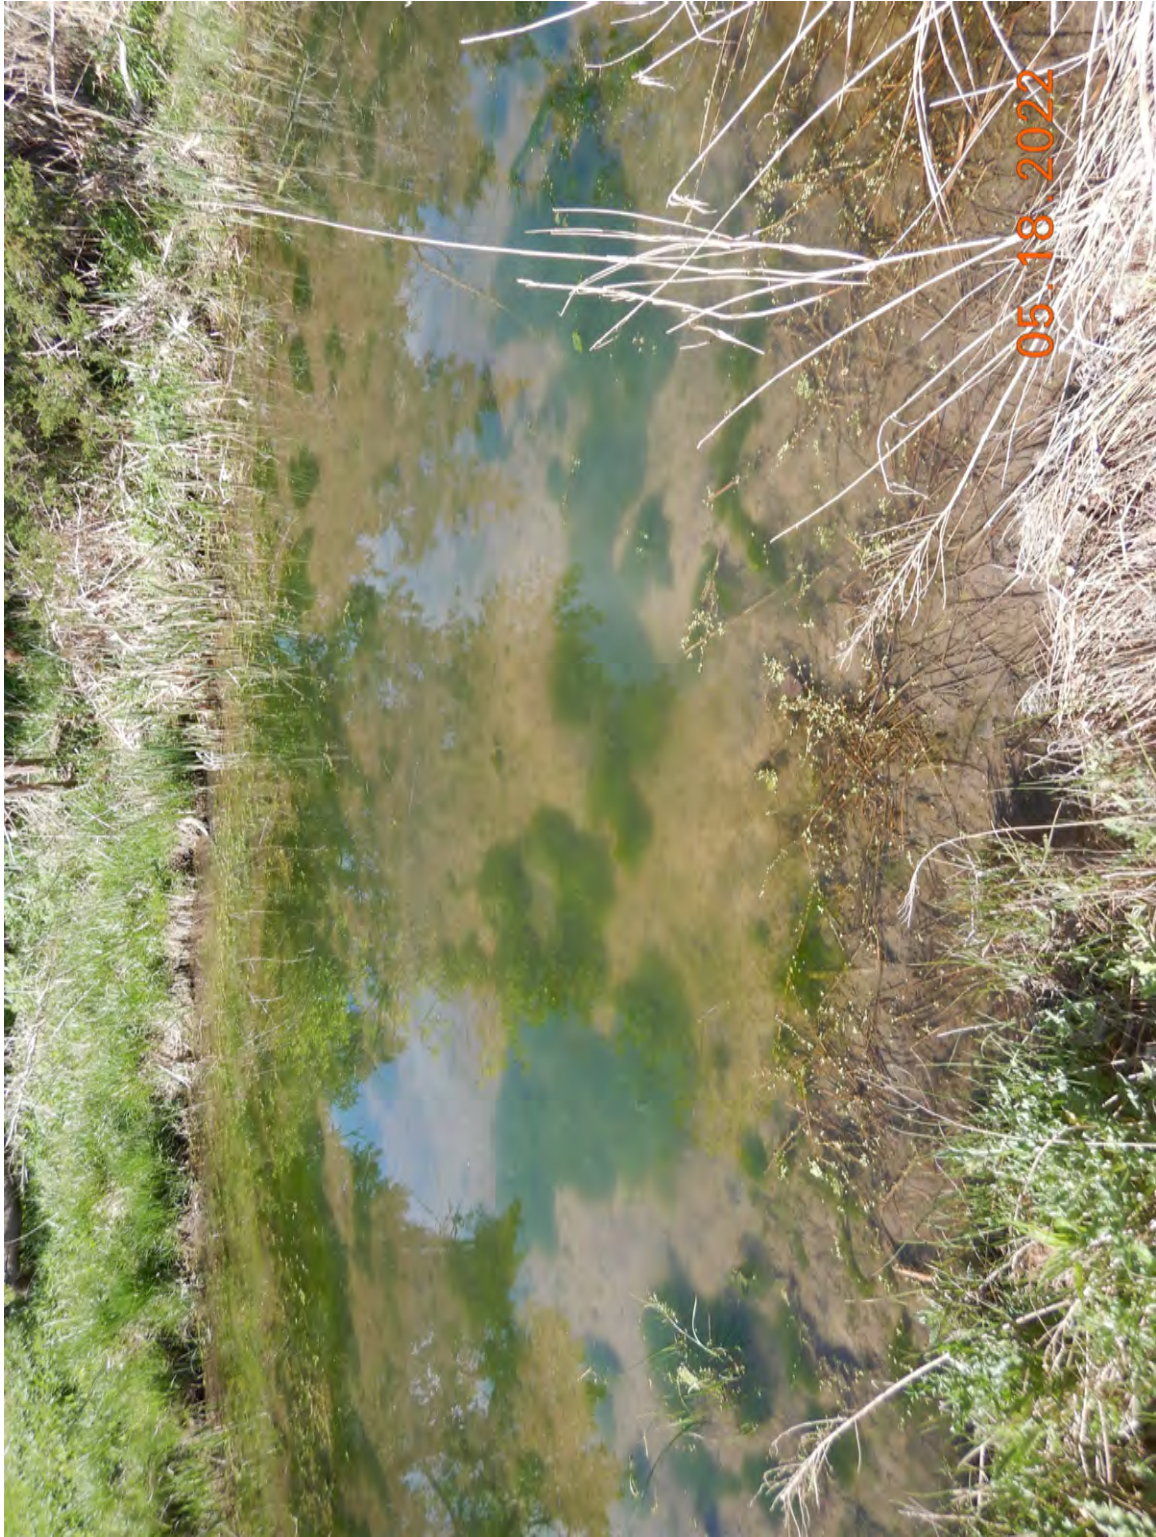
Photo 17

D. Garcia	05/18/22	1017	DSCN0027.JPG	16	Looking at stream crossing 3.
D. Garcia	05/18/22	1022	DSCN0028.JPG	17	Looking down at silt and algae within excavated stream channel.

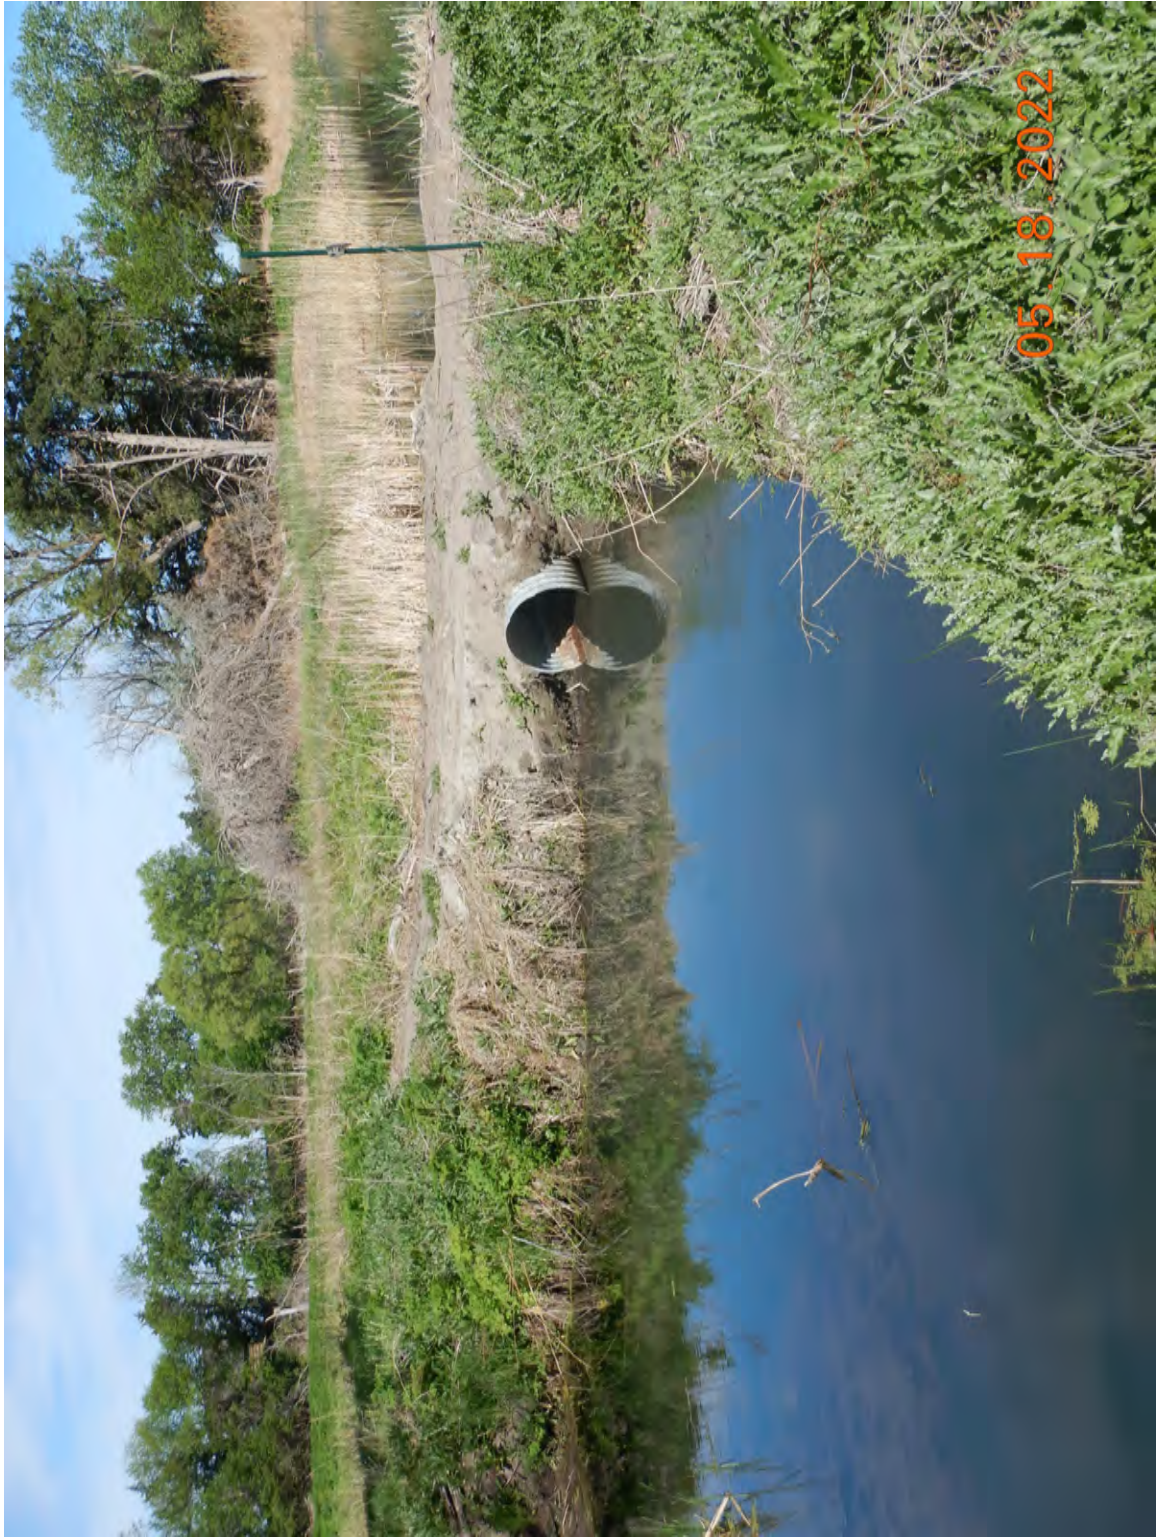
Photo 19

D. Garcia	05/18/22	1022	DSCN0029.JPG	18	Same as photo 18, just slightly different angle.
D. Garcia	05/18/22	1024	DSCN0030.JPG	19	Looking at culvert in stream crossing (A3).

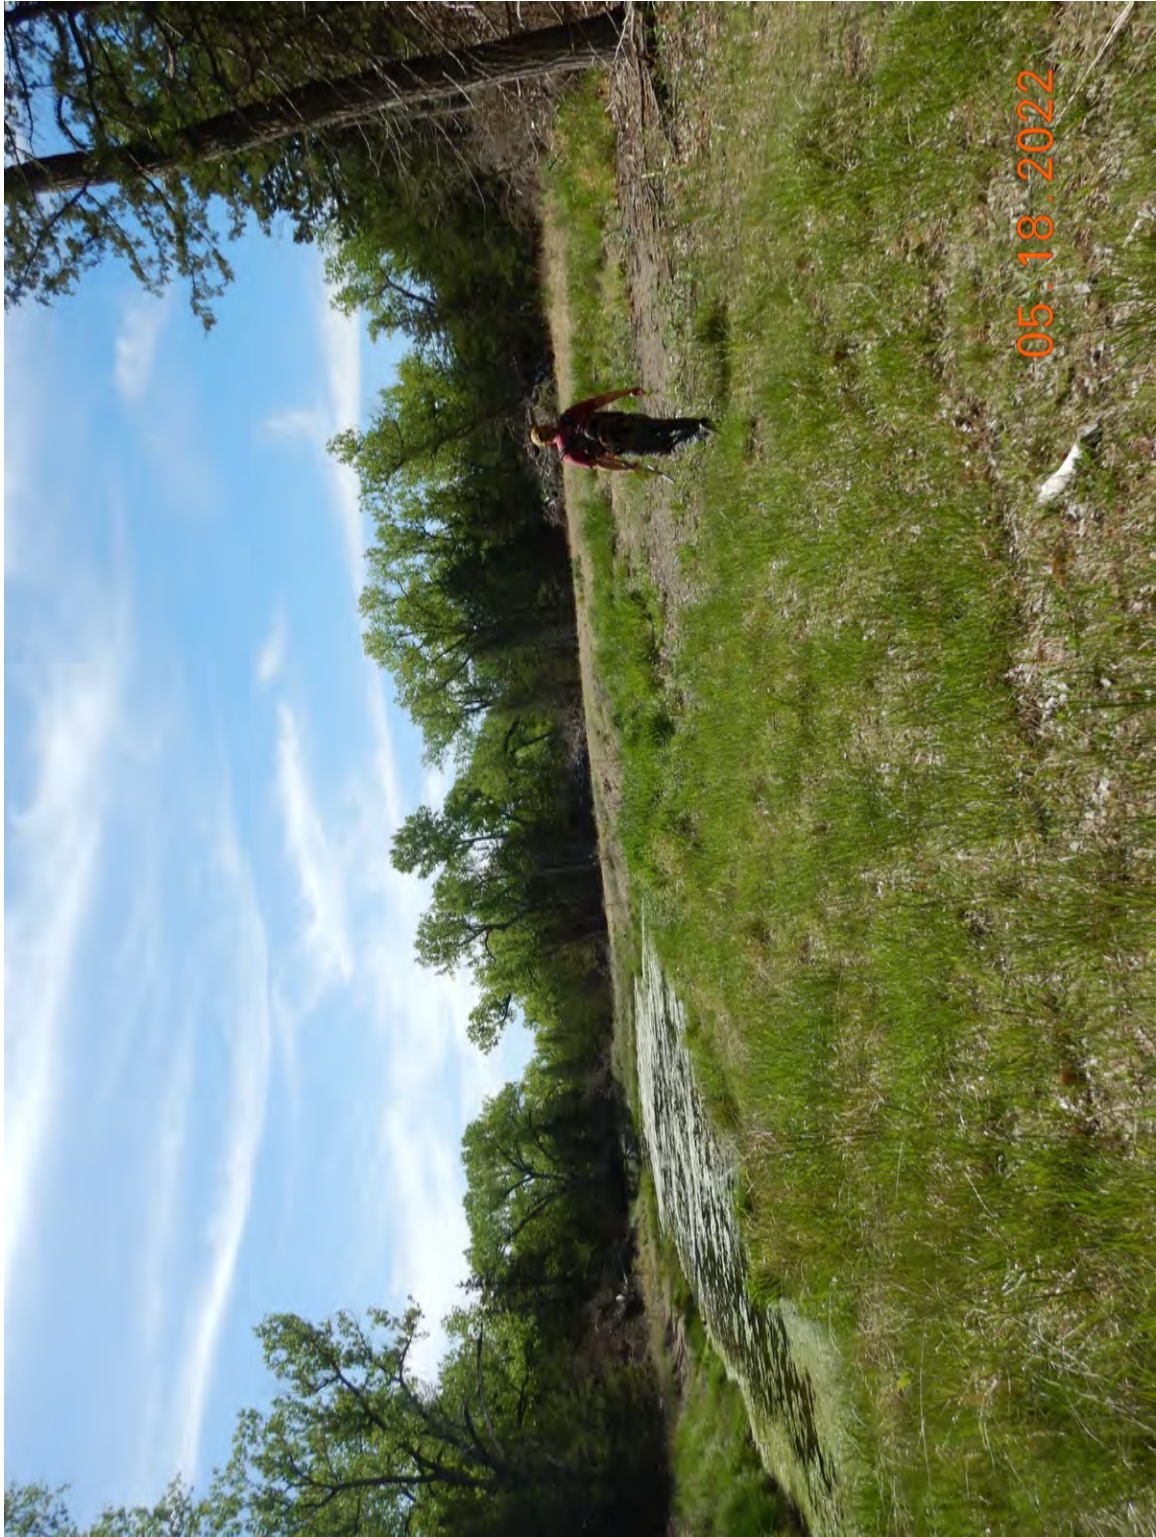
Photo 40

D. Garcia	05/18/22	1109	DSCN0050.JPG	39	Soil core sample, hydric soil present.
D. Garcia	05/18/22	1113	DSCN0051.JPG	40	Looking at berm that was created from side casting of sediment that was excavated to create channel, and the excavated channel.

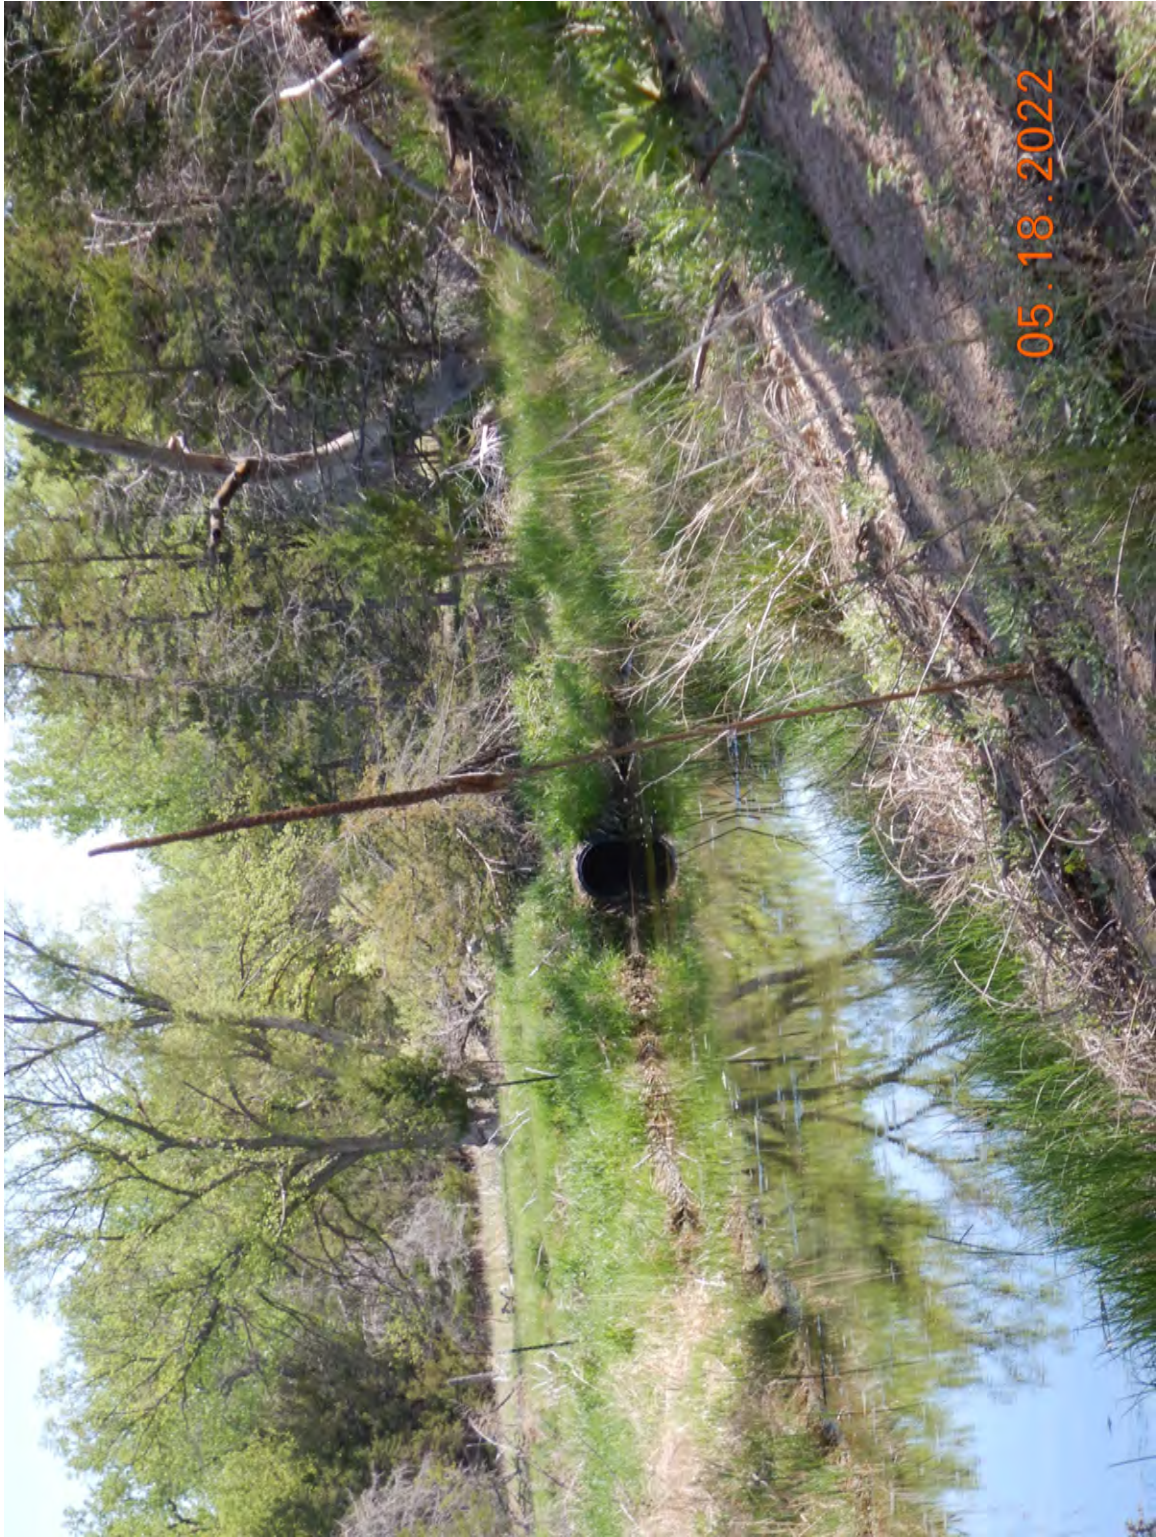
Photo 43

D. Garcia	05/18/22	1118	DSCN0054.JPG	43	Looking at culvert that connects excavated channels to the Platte River.

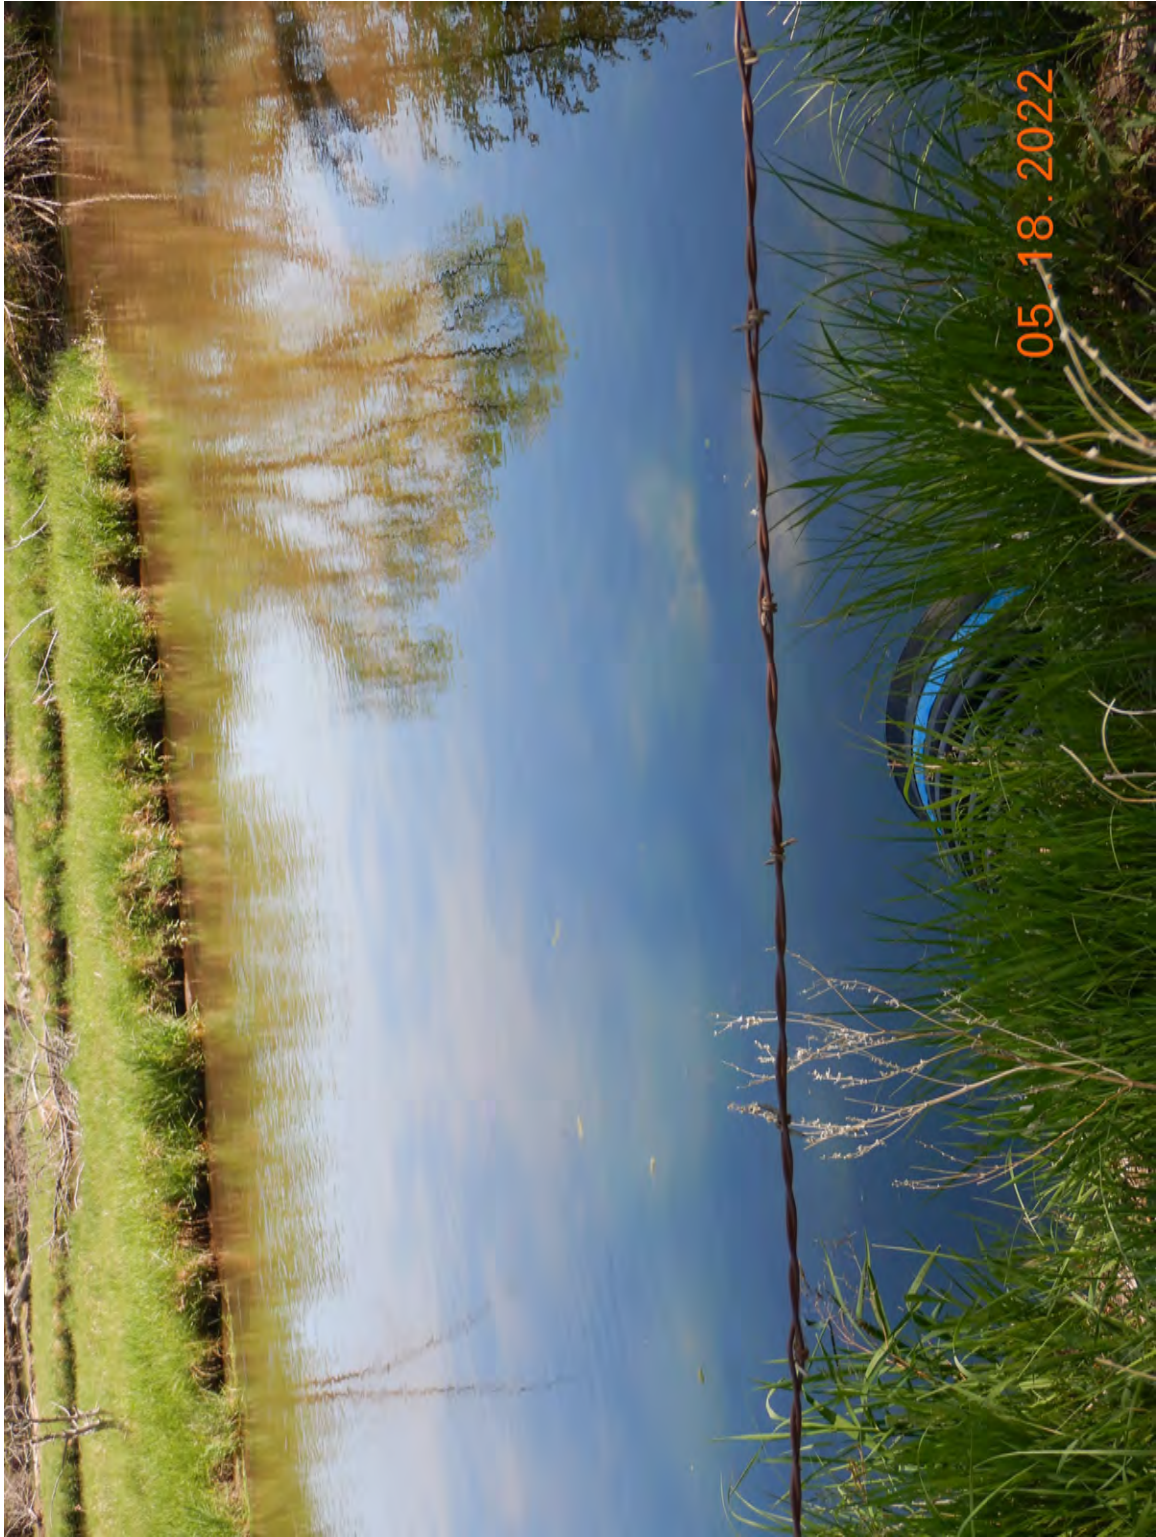
Photo 44

D. Garcia	05/18/22	1120	DSCN0055.JPG	44	Culvert from Photo 43 that connects excavated channel to Platte River.
D. Garcia	05/18/22	1121	DSCN0056.JPG	45	Same culvert as the one in Photos 43 and 44, this end is on the excavated channel.
