# Clean Water Act Section 404: Site Visit/Case Development

Site Name: Villegas

Site Name	Villegas	Start Date	May 18, 2022
		End Date	May 18, 2022
Inspection Purpose	Initial site visit		
<b>Opening Conference</b>			
<input checked="" type="checkbox"/> Presentation of Inspector Credentials			
Name and Title (Use N/A if owner/operator not available to join the inspection)			
N/A			
<input checked="" type="checkbox"/> Opening Conference			
Name of person authorizing access if applicable			
Tom Villegas through his attorney Stephen Mossman			
Notes from Opening Conference			
No opening conference took place since Mr. Villegas was unable to be at the site during the inspection.			
<input checked="" type="checkbox"/> Access Issues if Any			
Describe			
Was initially told that Mr. Villegas would be meeting us at the site at 9:00 am on May 18, 2022. When Mr. Simmons and I arrived at the site nobody was present. After waiting for approximately half an hour I called Natasha Goss (assigned EPA Attorney) and asked that she check with Mr. Villega's attorney (Stephen Mossman) to see if Mr. Villegas would be joining us. Mr. Mossman indicated that Mr. Villegas would not be able to join us for the

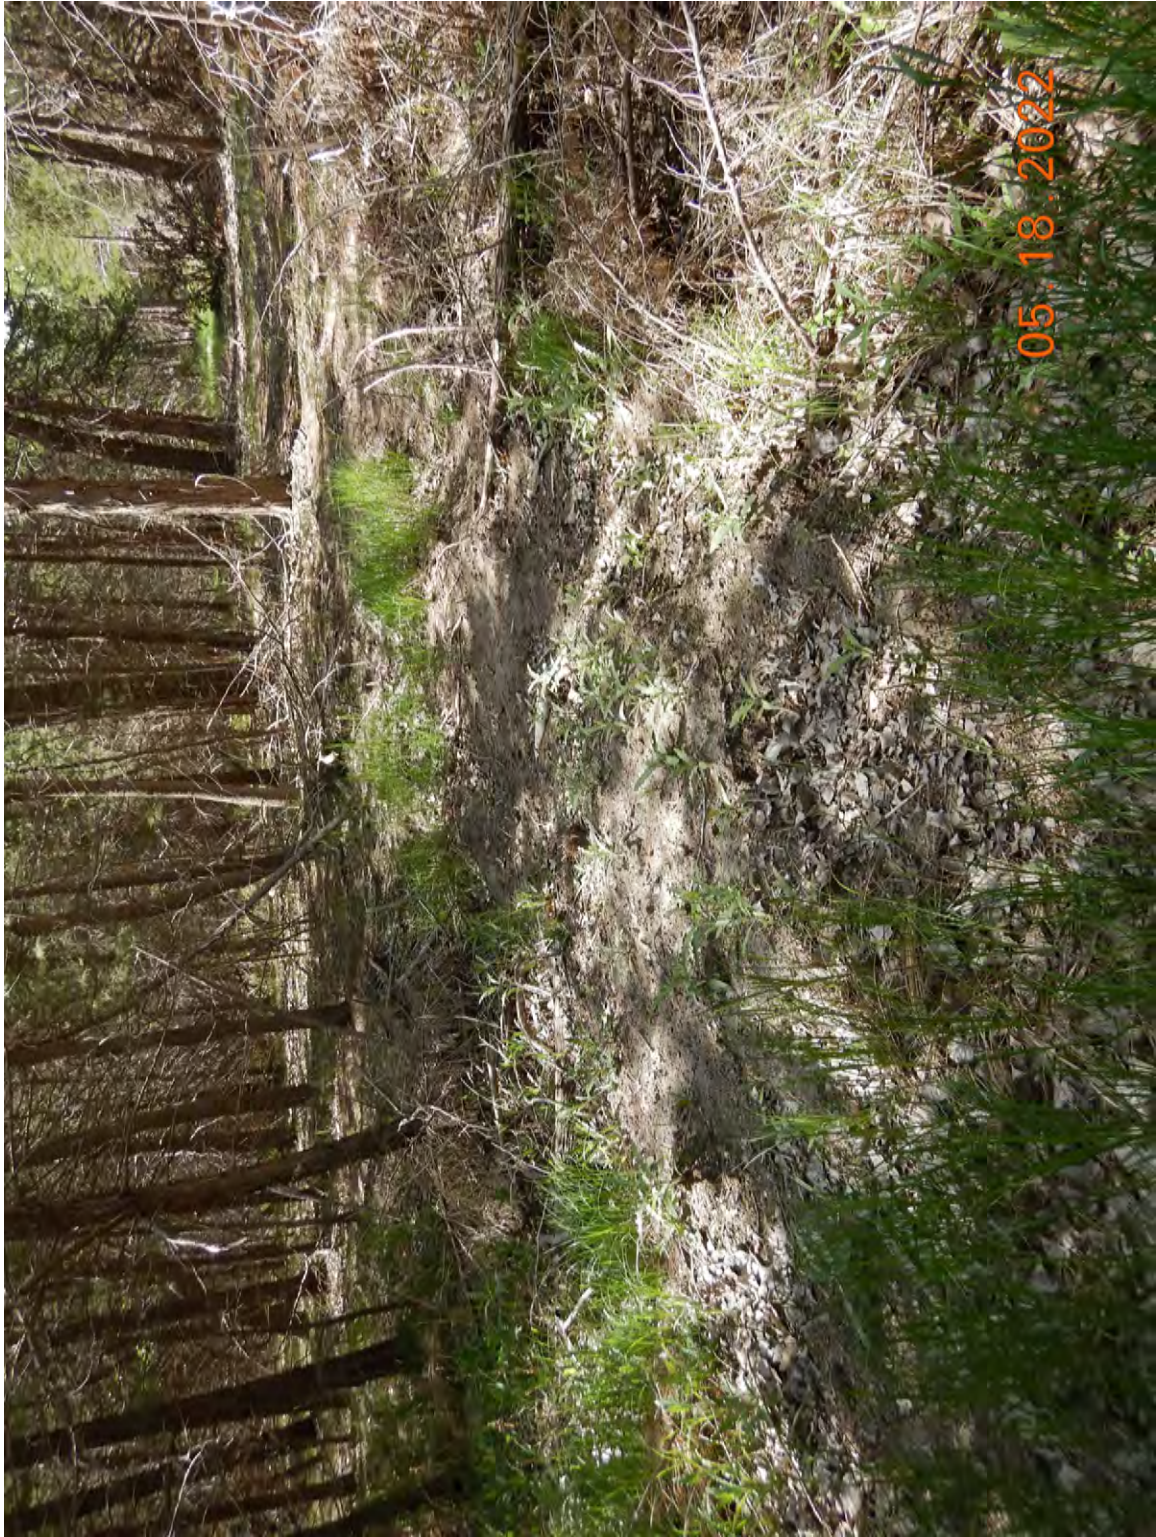
Photo 50

D. Garcia	05/18/22	1140	DSCN0061.JPG	50	Stream crossing (A10)
D. Garcia	05/18/22	1142	DSCN0062.JPG	51	Pile of cleared trees.
D. Garcia	05/18/22	1143	DSCN0063.JPG	52	Borrow area, potentially used as fill material for stream crossing A11.

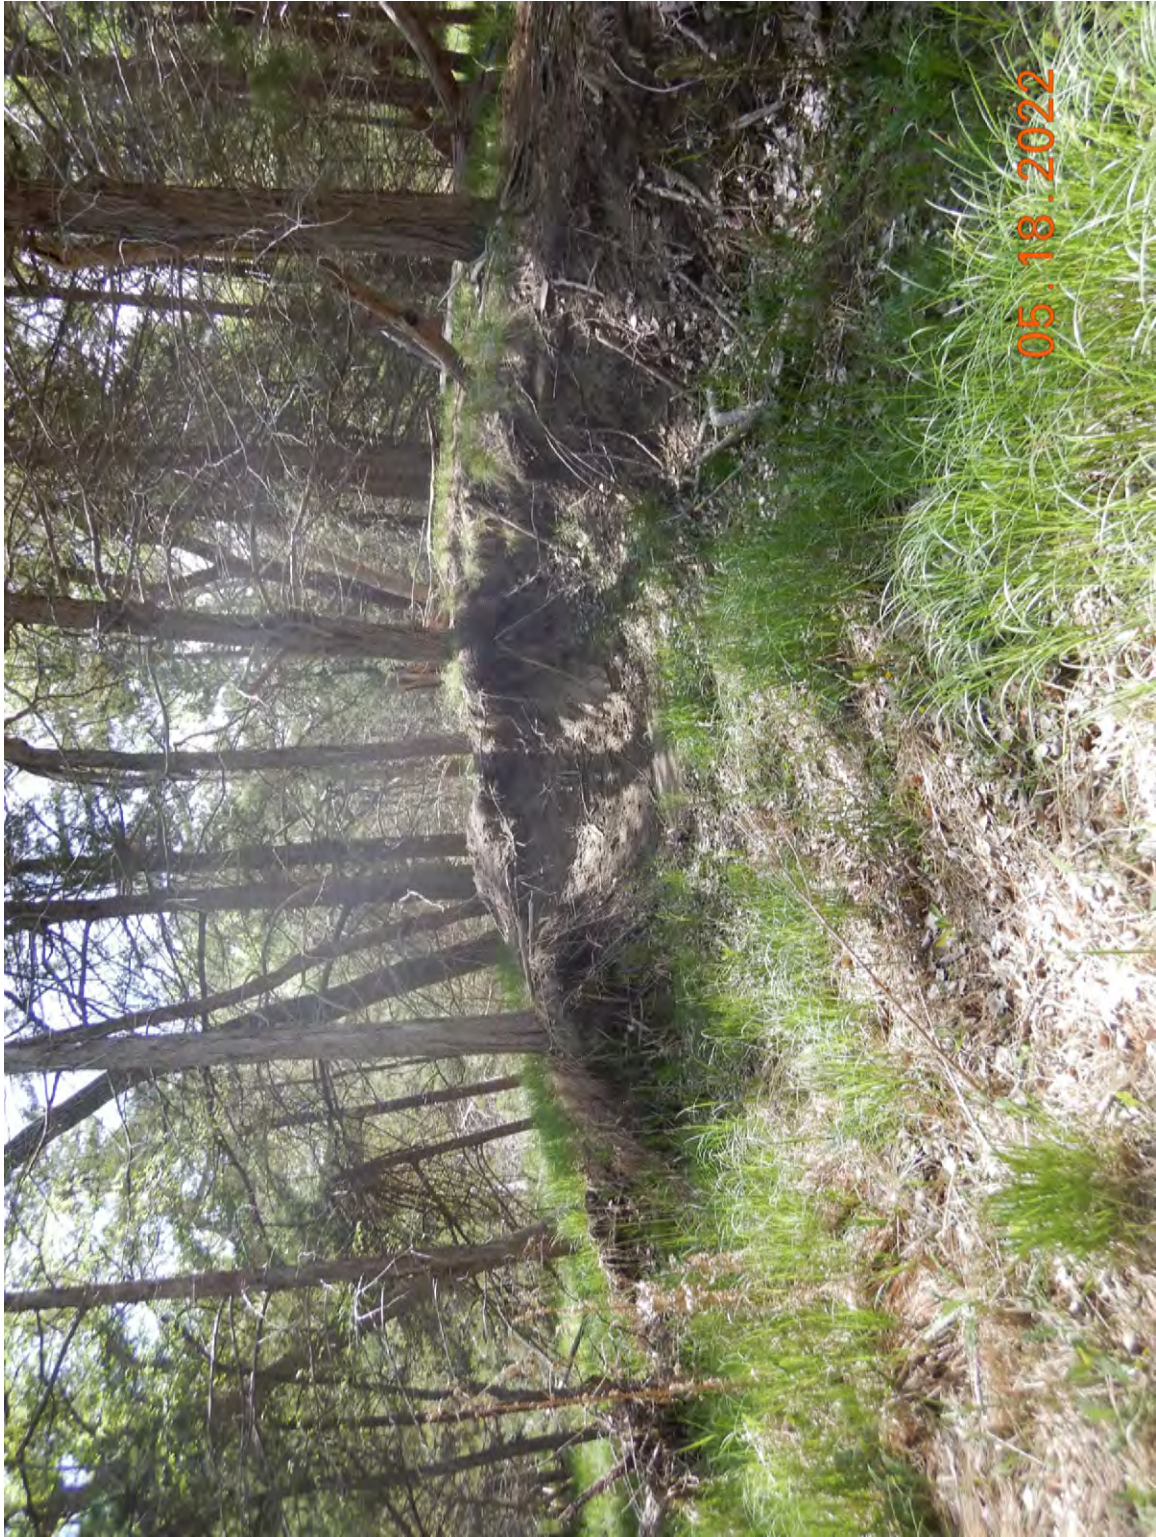
Photo 52

Site Name	Villegas	Start Date	May 18, 2022
		End Date	May 18, 2022
<p>number 20 in GPS Locations Map in Attachment 1) which had been excavated and was located between the A10 and A11 stream crossings. It appeared as though it had served as a borrow area for the material that was utilized for one of those crossings.</p> <p>We continued walking south and stopped once we reached the northern stream channel on the south side of the site. I saw and heard Red-winged blackbirds (<i>Agelaius phoeniceus</i>) in this area, and saw Asian carp (<i>Cyprinus carpio</i>) within the channel . I also saw a considerable amount of silt deposits in the excavated and expanded stream channel (Photo 56 in Attachment 2). A large area has been cleared of vegetation and graded (A13). I walked around both stream crossings (crossings 3 and 4) and the berm that was created just north of the excavated channel (all combined counted as A12). A waterfowl hunting blind was placed in between those two stream crossings (Photo 57 in Attachment 2). A considerable amount of erosion had occurred between the two culverts in crossing 3 (Photos 58 and 64 in Attachment 2). I also noticed that additional fill material had been placed on the north side of the excavated channels in this area but it was not as extensive (see Photo 63 in Attachment 2). As we walked across the two stream crossings we noticed a large area just south of the crossings that might have served as a borrow area for the fill material utilized in the crossings (Photo 59 in Attachment 2)</p>

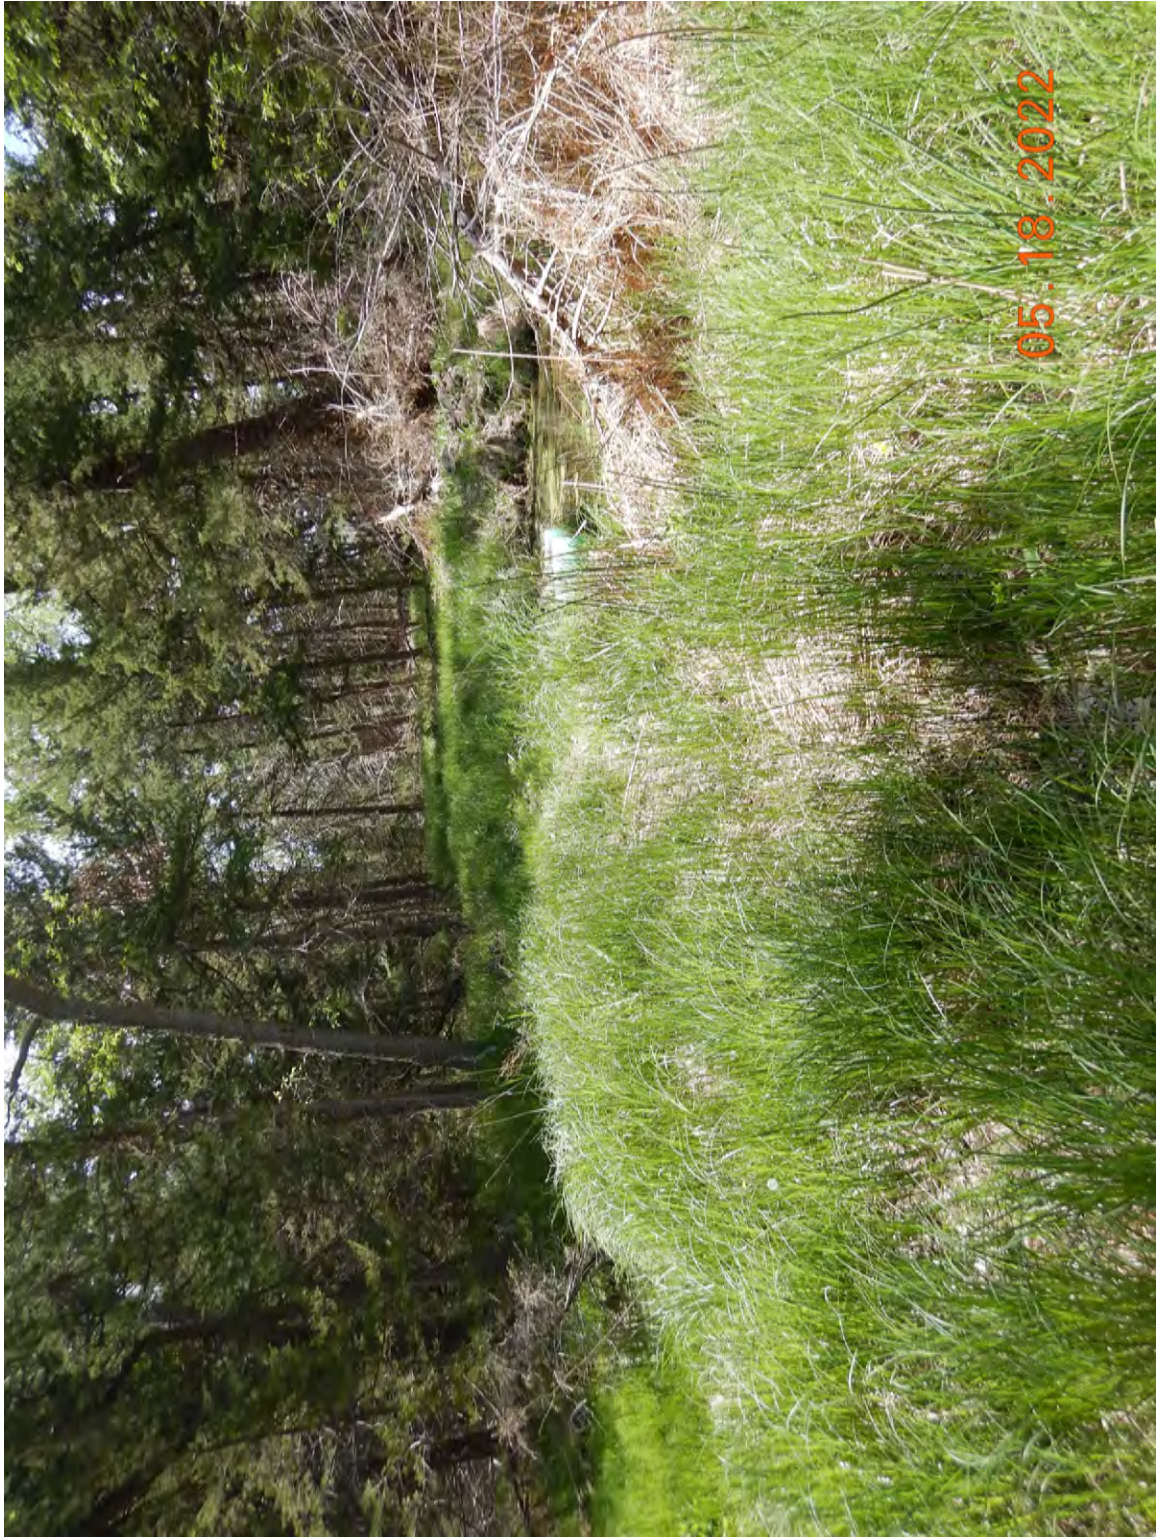
Photo 53

D. Garcia	05/18/22	1144	DSCN0064.JPG	53	Stream crossing A11
D. Garcia	05/18/22	1146	DSCN0065.JPG	54	Stream channel over which stream crossing A11 was built.

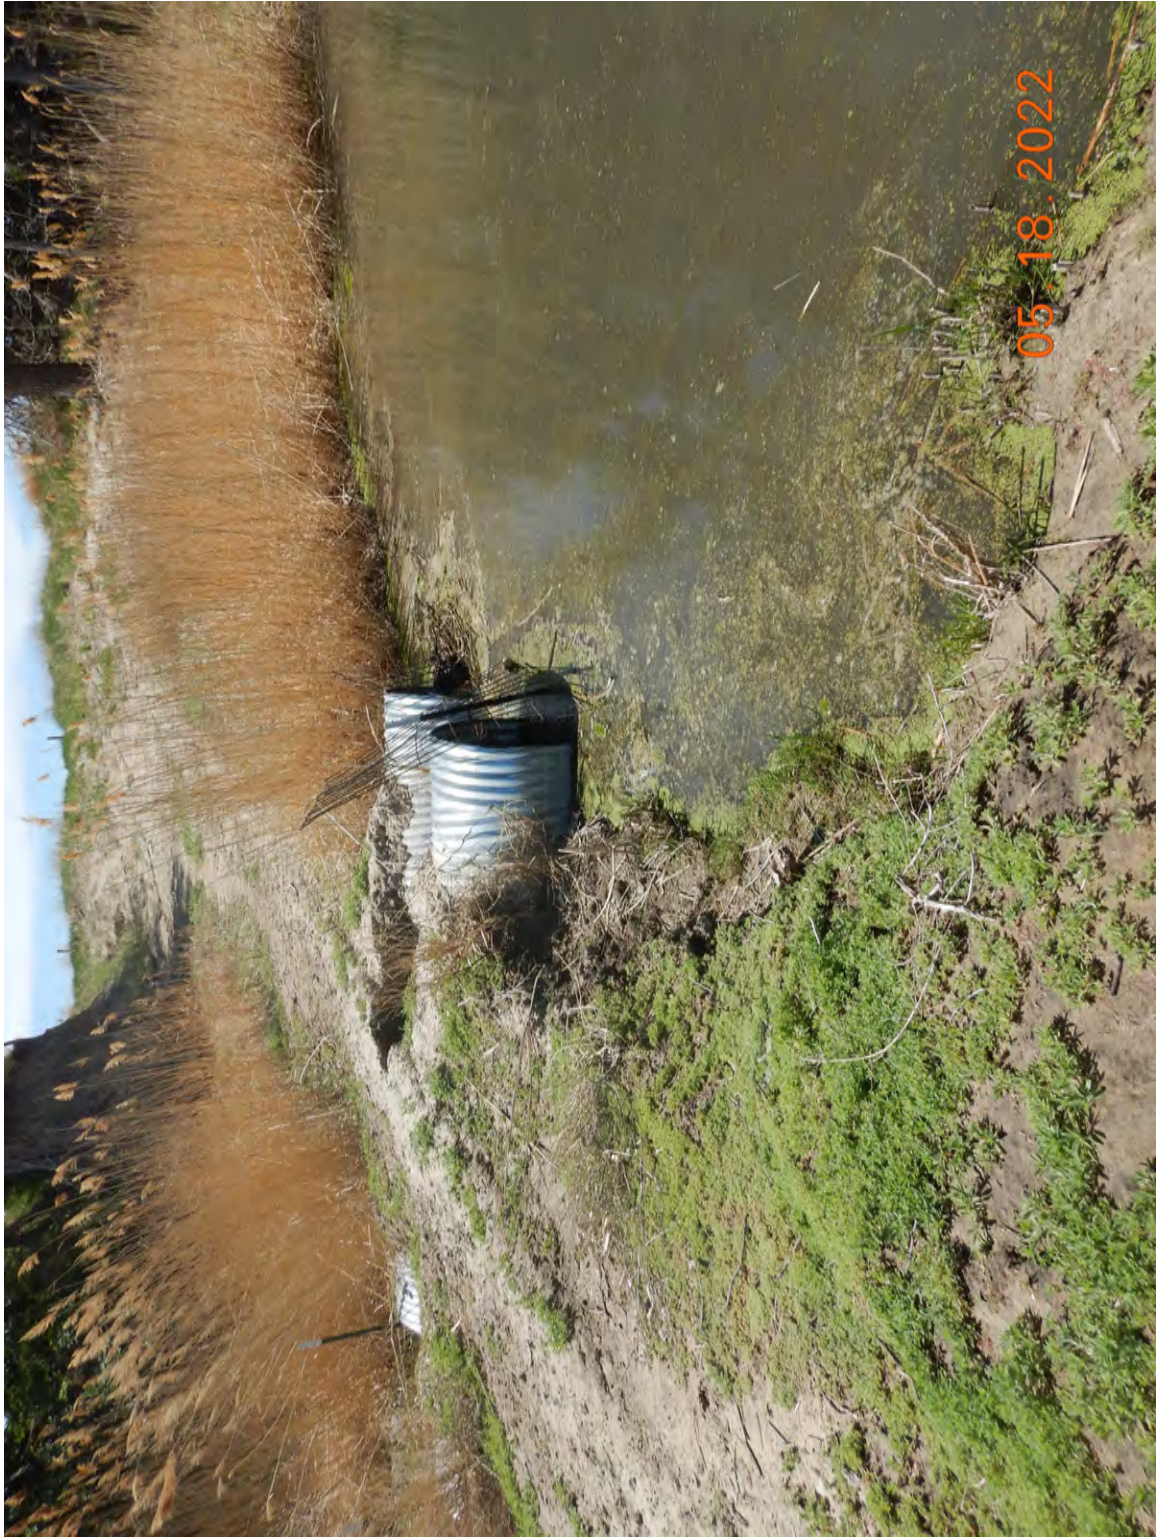
Photo 58

D. Garcia	05/18/22	1157	DSCN0068.JPG	57	Close view of waterfowl blind from Photo 15.
D. Garcia	05/18/22	1158	DSCN0069.JPG	58	Culverts in stream crossing 3, note the amount of erosion that has taken place.

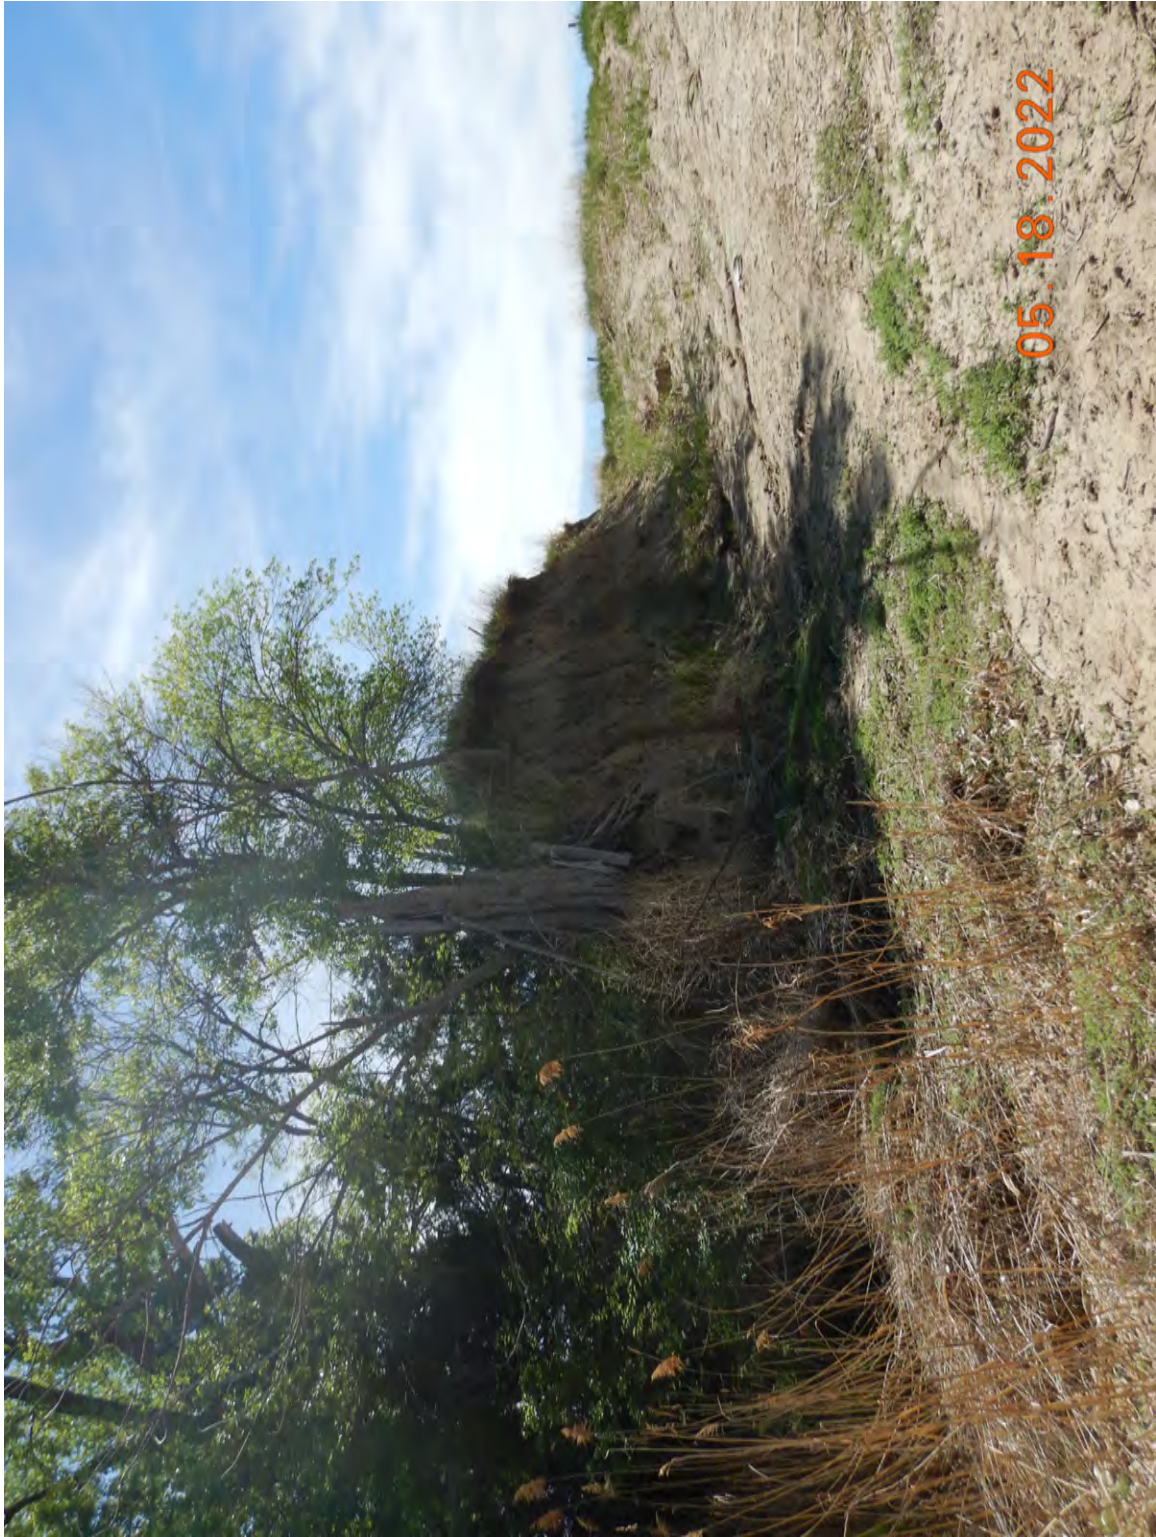
Photo 59

D. Garcia	05/18/22	1159	DSCN0070.JPG	59	Cut in uplands, might have used material to build stream crossings and berms.
D. Garcia	05/18/22	1200	DSCN0071.JPG	60	Looking at excavated stream channel.

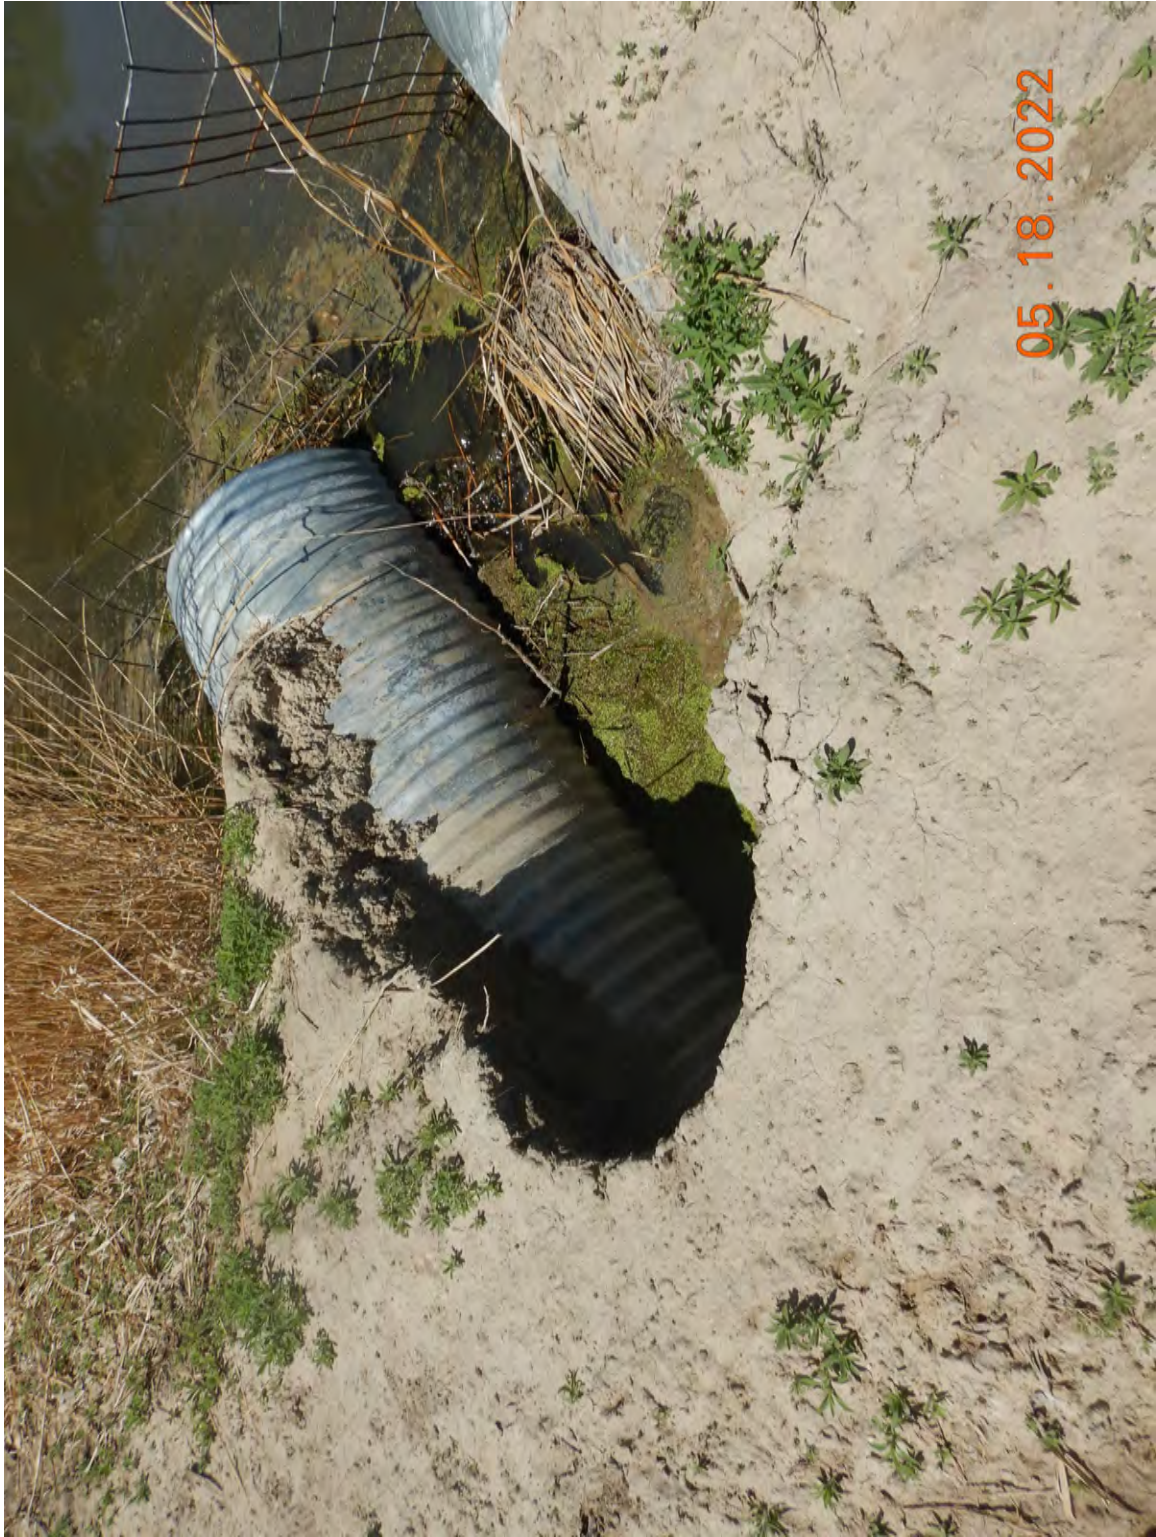
Photo 64

D. Garcia	05/18/22	1201	DSCN0072.JPG	61	Looking at excavated stream channel.
D. Garcia	05/18/22	1202	DSCN0073.JPG	62	Looking at excavated stream channel.
D. Garcia	05/18/22	1204	DSCN0074.JPG	63	Looking at excavated stream channel. Standing on top of fill material but not as extensive as in other locations (in terms of depth).
D. Garcia	05/18/22	1210	DSCN0075.JPG	64	Close view of erosion taking place between the two culverts in stream crossing 3. Same area as Photo 58.
