BEFORE THE  
UNITED STATES ENVIRONMENTAL PROTECTION AGENCY

JACKSON & SON DISTRIBUTORS, INC.,  
dba JACKSON AND SON OIL,

DOCKET NO. CWA-10-2025-0023

**DECLARATION OF RICHARD FRANKLIN**

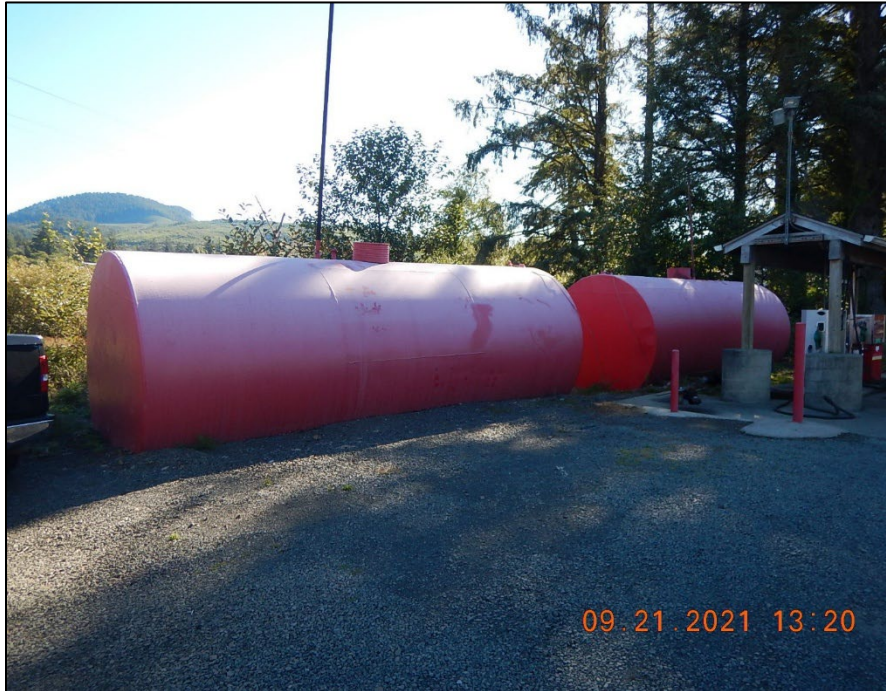
*Figure 1 - Photo of Two 10,000-Gallon Aboveground Storage Tanks*

6. During the Inspection, I observed several aboveground storage tanks at the Facility. As shown in photographs 6-9 of my Inspection Report (CX 01 at 33-36), the Facility had two 10,000-gallon single-walled aboveground storage tanks for diesel fuel that did not have adequate secondary containment sufficient to hold the capacity of one of the 10,000-gallon aboveground storage tanks plus sufficient freeboard to allow for precipitation, as required by 40 C.F.R. § 112.8(c)(2). These aboveground storage tanks were located on vegetated soil that was nearly at grade with the adjacent parking lot, and had no other visible structure that would provide adequate secondary containment. During the Inspection, Casey Jackson stated that there was not a liner under the tanks. Photo 6 from my Inspection Report (CX 01 at 33) is reproduced as Figure 1 below.

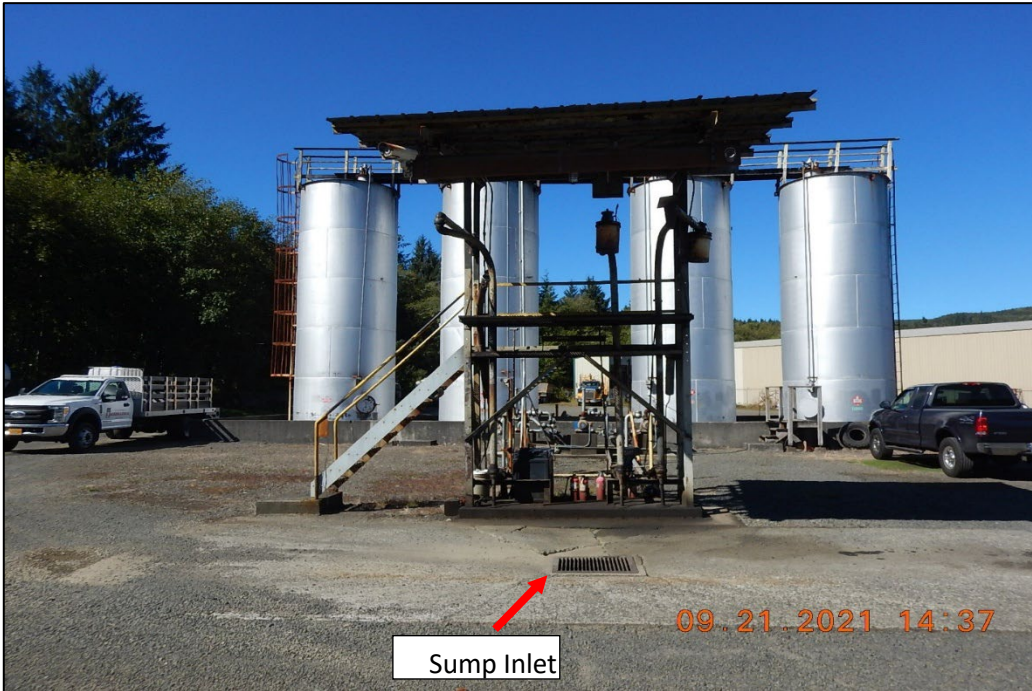
*Figure 2 - Four Aboveground Storage Tanks Within Secondary Containment*

7. At the time of the Inspection, the largest aboveground storage tanks at the Facility were four 20,000-gallon aboveground storage tanks. These aboveground storage tanks are listed in Table 2 of the Facility's December 2024 SPCC Plan (identified as tanks 1-4 in the bulk tank area) (CX 23 at 8). These aboveground storage tanks are shown within concrete secondary containment in photographs 15 and 16 of my Inspection Report (CX 01 at 42-43). Photograph 15 from my Inspection Report is reproduced as Figure 2 below. An aerial view of these four aboveground storage tanks can be seen in my Inspection Report (CX 01 at 60).

8. On April 5, 2023, Powers Engineering and Inspection, Inc. conducted integrity testing of these four aboveground storage tanks, the results of which can be found at CX 04 through CX 07. Each report states the capacity and location of the respective aboveground storage tank and has a picture of the aboveground storage tank, which are the same aboveground storage tanks that I viewed during the Inspection, and are shown in Photograph 15 from my Inspection Report, which is reproduced as Figure 2 above.

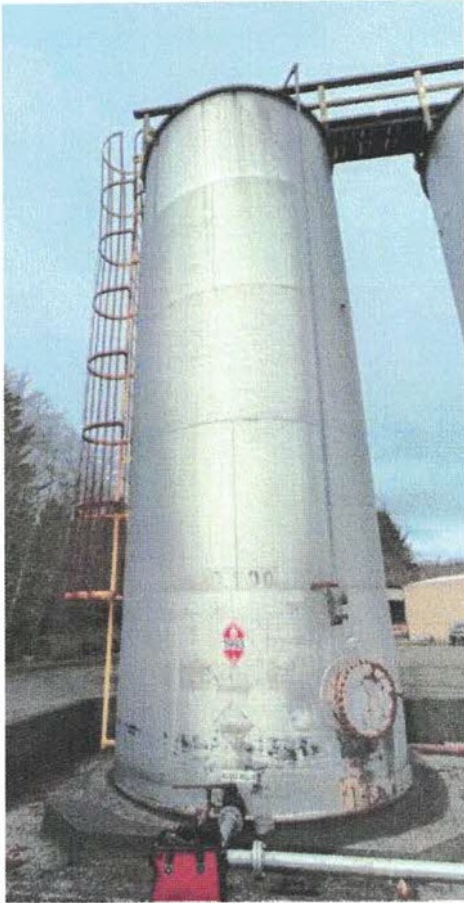
*Figure 3 - Aboveground Storage Tank from CX 04*

9. For example, CX 04 is the integrity testing report for one of these four aboveground storage tanks. CX 04, page 2, states that the capacity of the aboveground storage tank is 20,000 gallons, that the aboveground storage tank stores gasoline, and that it is located on the west side of the Facility. A picture of the aboveground storage tank can be found at CX 04, page 5, which is reproduced as Figure 3 below.

10. Comparing this photograph with photograph 15 from my Inspection Report, reproduced as Figure 2 above, the aboveground storage tank is the same as the leftmost aboveground storage tank in Figure 2 above. The aboveground storage tanks are in the same position relative to the other tanks, have the same color, have the same number and appearance of tank shell courses<sup>1</sup> and manway at bottom right, have the same enclosed ladder in the same position on the left-hand side, the same configuration and end point of the walkway/catwalk on top, tan building in the background, and tree line to the left (south).

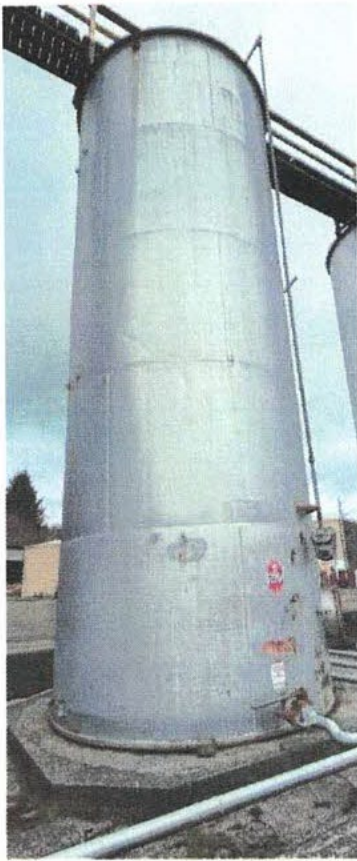
*Figure 4 - Aboveground Storage Tank from CX 05*

11. Moving to the adjacent tank to the right, CX 05, page 2, states that the capacity of the aboveground storage tank is 20,000 gallons, that the aboveground storage tank stores gasoline, and that it is located on the west side of the Facility. A picture of this aboveground storage tank can be found at CX 05, page 5, which is reproduced as Figure 4 below.

12. The aboveground storage tank in Figure 4 and the aboveground storage tank that is in the foreground in Figure 5 above are the middle two aboveground storage tanks that I observed in my Inspection. As compared to Figure 2 from my Inspection above, they are in the same position relative to the other tanks, have the same color, have the same number and appearance of tank shell courses, the same walkway/catwalk on top, and tan building in the background. Figure 4 shows the aboveground storage tank that is center left as it shows the tree line to the left (south). Figure 5 shows the aboveground storage tank that is center right as the photograph was taken looking north.

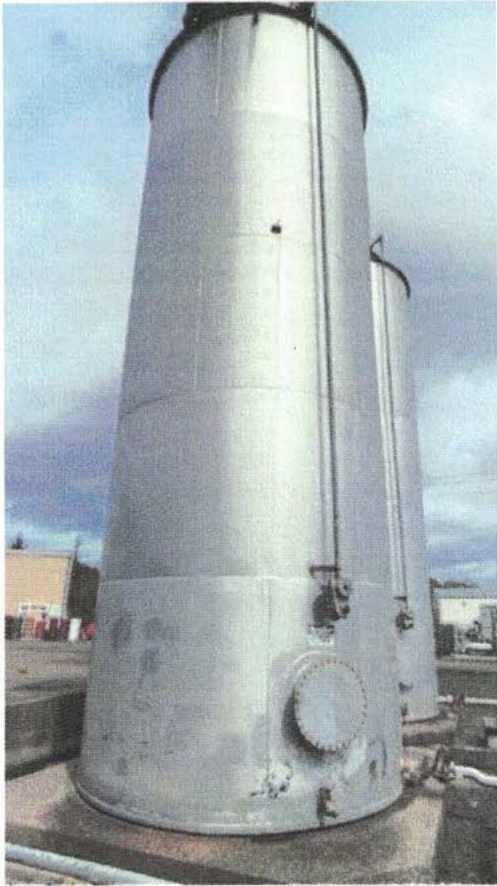
*Figure 5 - Aboveground Storage Tank from CX 06*

Moving again to the right, to the next adjacent aboveground storage tank, CX 06, page 2, states that the capacity of the aboveground storage tank is 20,000 gallons, that the aboveground storage tank stores diesel, and that it is located on the west side of the Facility. A picture of this aboveground storage tank can be found in the foreground of the picture at CX 06, page 5, which is reproduced as Figure 5 below.

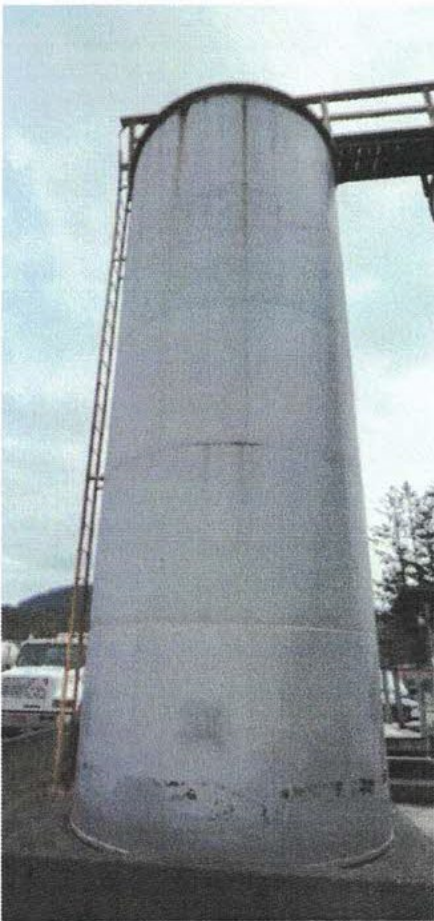
*Figure 6 - Aboveground Storage Tank from CX 07*

13. The last aboveground storage tank within that concrete secondary containment area is evaluated in CX 07. CX 07, page 2, states that the capacity of the aboveground storage tank is 20,000 gallons, that the aboveground storage tank stores diesel, and that it is located on the west side of the Facility. A picture of this aboveground storage tank can be found at CX 07, page 5, which is reproduced as Figure 6 below.

This aboveground storage tank matches the rightmost (northern) aboveground storage tank shown in Figure 2 above from my Inspection. While the photograph is taken from the opposite direction, the aboveground storage tanks are the same. As compared to Figure 2 from my

Inspection above, they are in the same position relative to the other tanks, have the same color, have the same number and appearance of tank shell courses, the same walkway/catwalk on top, and yellow ladder on the side.
