**REPORT OF INITIAL FINGERPRINTING
FINDINGS RELATED TO
PUERTO RICO OLEFIN SITE
PEÑUELAS, PUERTO RICO**

Prepared by:
Ady Padan, Ph.D

February, 2015

Analytical Environmental
Services International, Inc.
611 Monserrate Street
2nd Floor, Santurce, P.R. 00907
(787) 722-0220 / Fax (787) 724-5788

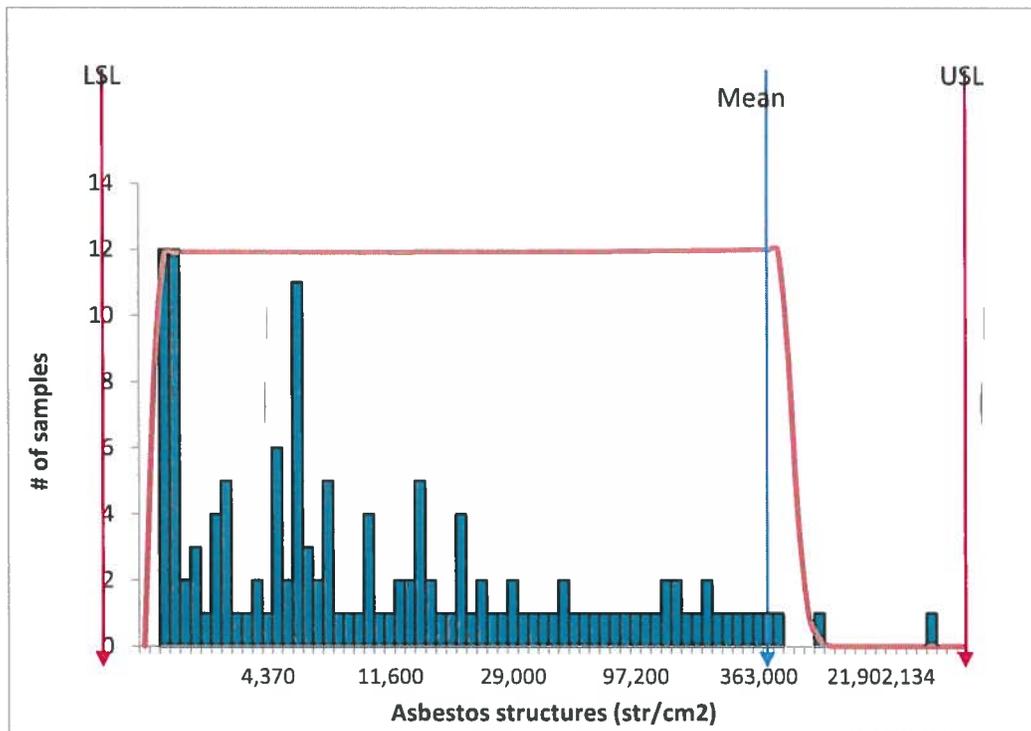
All data of dust wipes samples containing Chrysotile collected outside Olefins facility was initially examined. The data (str/cm²) is presented on the graph below (Figure 1) in accordance to sampling events (I thru III) performed by Weston. It can be clearly observed that there are two (2) outliers way above all the others and both are from samples located in the area south-east of the Olefins plant (Weston samples PO006-WP1-01 and PO005-WP01-01), close to state road PR-127.

Figure 1. Frequency Histogram for outside Olefins dust wipes data (Data from Weston reports I thru III)

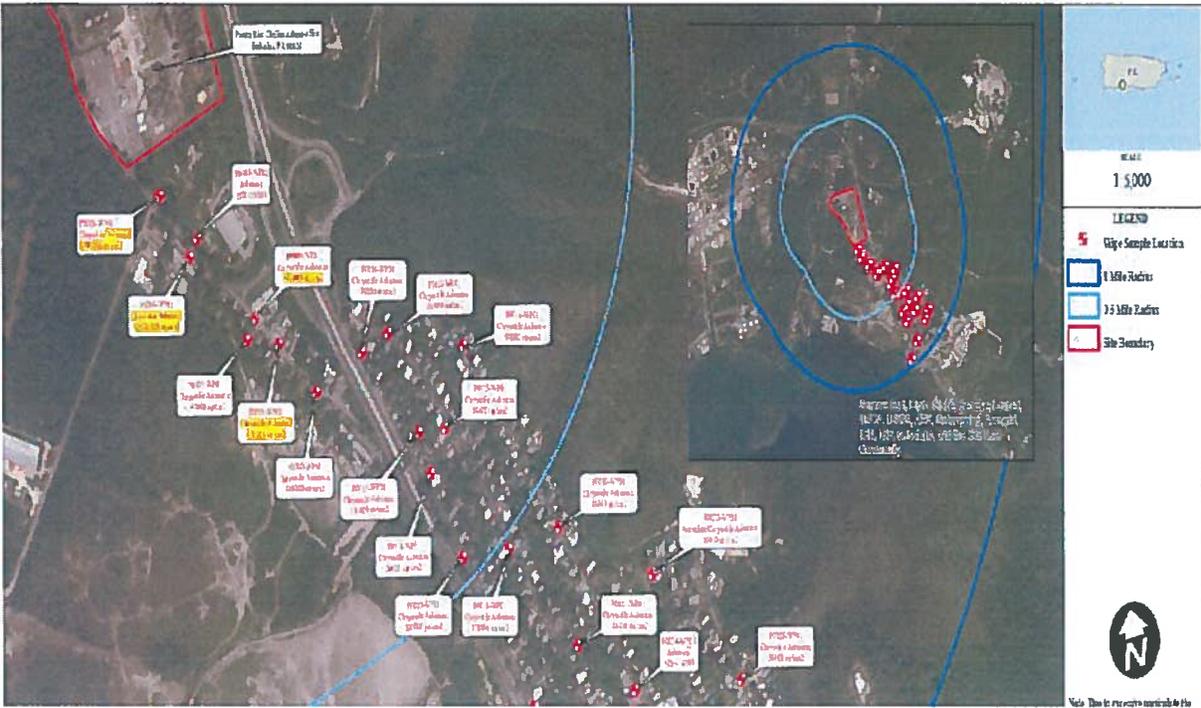
The two outliers and the two highest values above 400,000 str/cm² present in the Encarnacion Community are from samples located in the same area (see Figure 2 air photo below from Weston report, Phase IIIB sampling) and are close to state road PR-127.

Figure 2. Dust sampling points (Highlighted) found by Weston to contain Chrysotile concentrations higher than 400,000 str/cm² (data from Weston report IIIB).

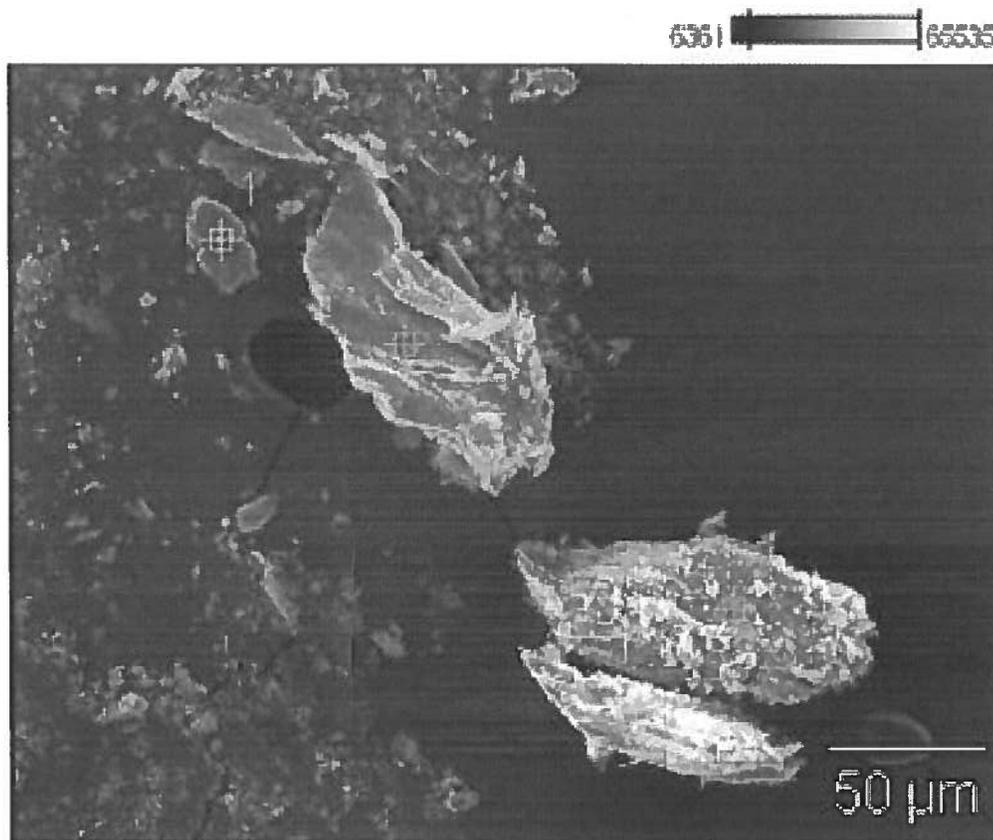
SEM images of Lizardite (left, #1) and bundles of Chrysotile fibers (right, #2 and #3) are shown in Figure 14. A non-fibrous Lizardite is also shown at a higher magnification in Figure 15b. The bundle of Chrysotile fibers (#3) is shown at a higher magnification in Figure 16b.

Figure 14. SEM photo of fibrous and non-fibrous serpentine Lizardite #1 and Chrysotile (#2 and #3) detected during analysis of sample, R-Q1-AP4

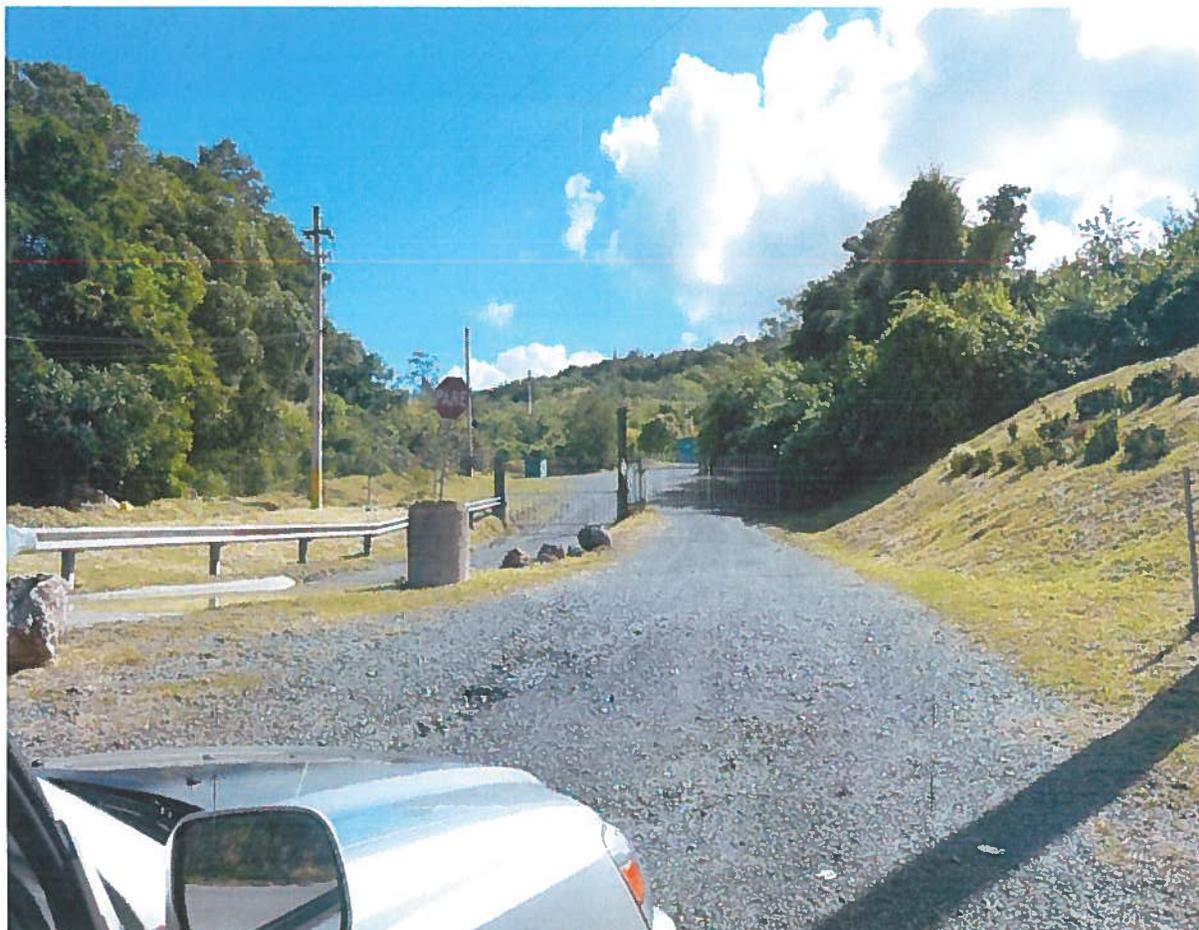
A photo of quarry #20 located in San Germán is shown below (Figure 19). Quarry #20 is located in the municipality of San Germán route PR-329 KM 3.2. The quarry is named Cantero y Gravelero. Its sign does not show its permit number. The access to the quarry was restricted but the access road is currently paved with Serpentinite gravel.

Figure 19. Quarry #20, Cantero y Gravelero. Entrance Road paved with Serpentinite

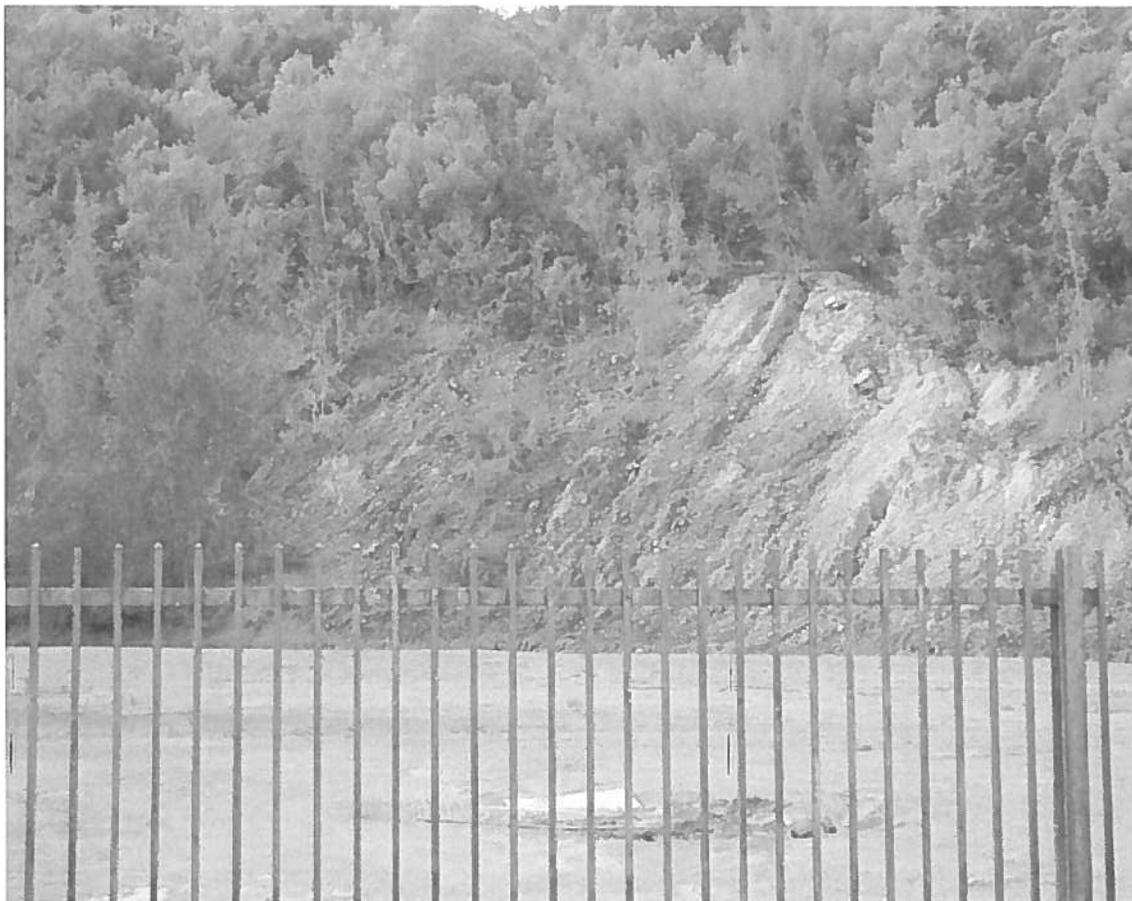
Another quarry located in the municipality of Mayagüez near PR-105 KM 105, behind “Centro Juvenil de Mayagüez Aguadilla” (Figure 20), used for cut and fill for the construction of the project and/or the parking lot. A sign showing the name of permit number of the project or the quarry could not be found.

Figure 20. A quarry behind Centro Juvenil de Mayagüez, Aguadilla

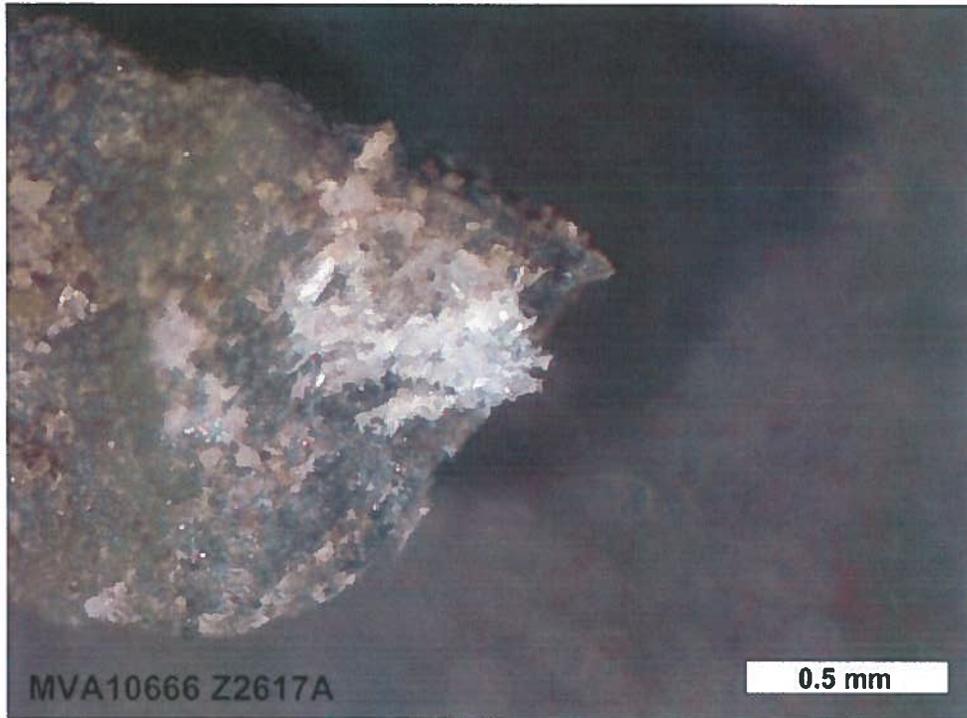
Figure 23a. Stereo-micrograph of non-fibrous serpentine mineral (lizardite) with fibrous serpentine intergrowth (chrysotile) observed in aggregate sample S-TEC-ARE-P0006-ER1.

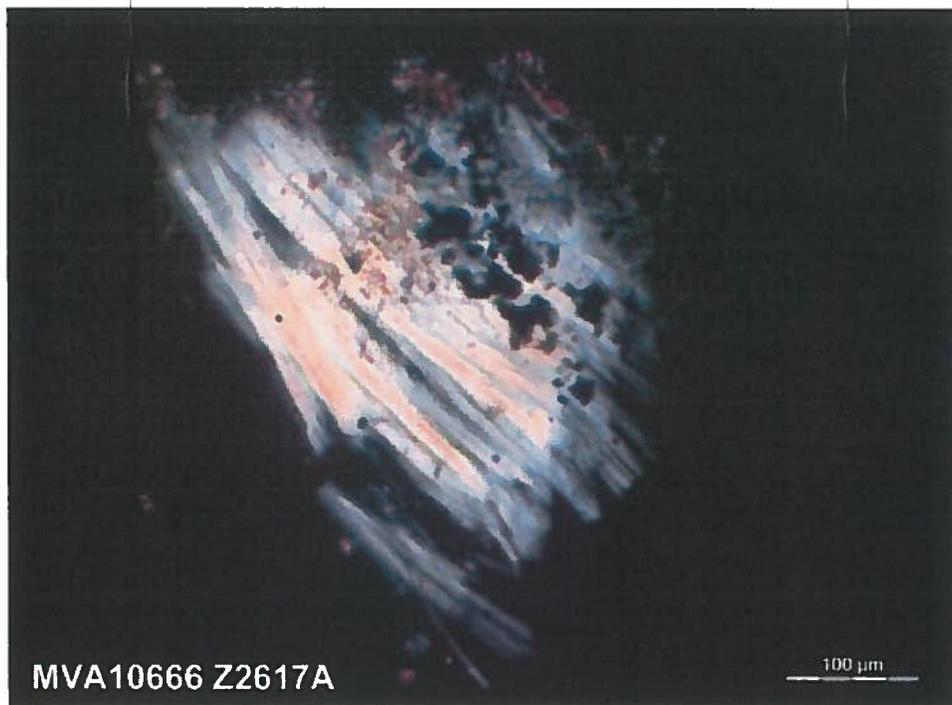
Figure 23b. PLM image of chrysotile asbestos observed in aggregate sample S-TEC-ARE-P0006-ER1.

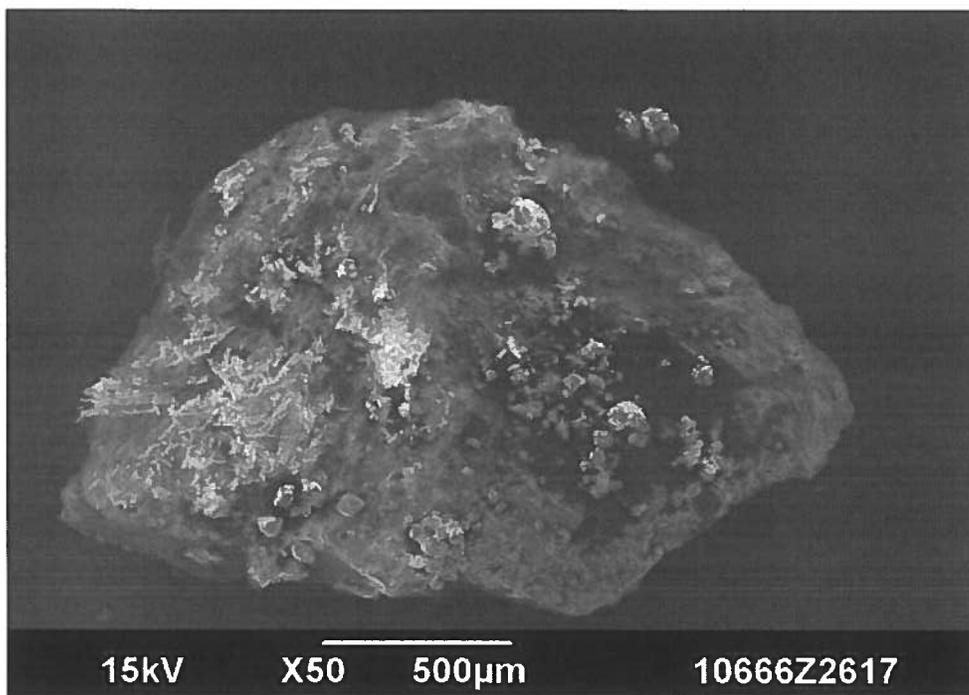
Figure 23c. SEM image of serpentine mineral (Figure 27a). Note fibrous mineral growth on left side of aggregate particle. Numbers (below) denote areas where EDS spectra were obtained.

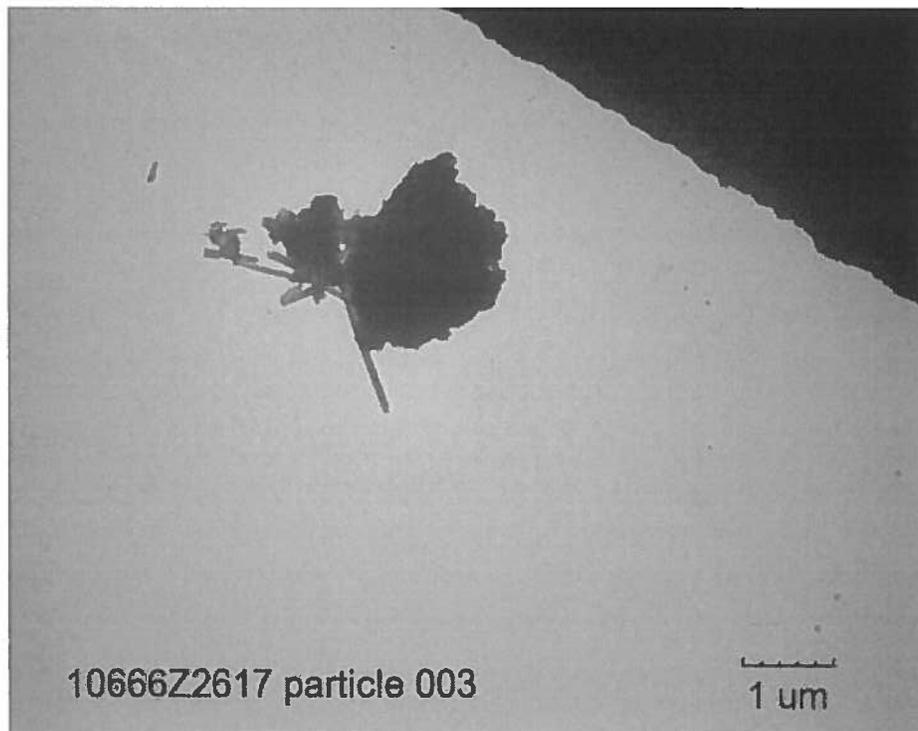
Figure 23h. TEM image (top) and EDS spectrum (bottom) of Lizardite particle observed during analysis of aggregate sample S-TEC-ARE-P0006-ER1.

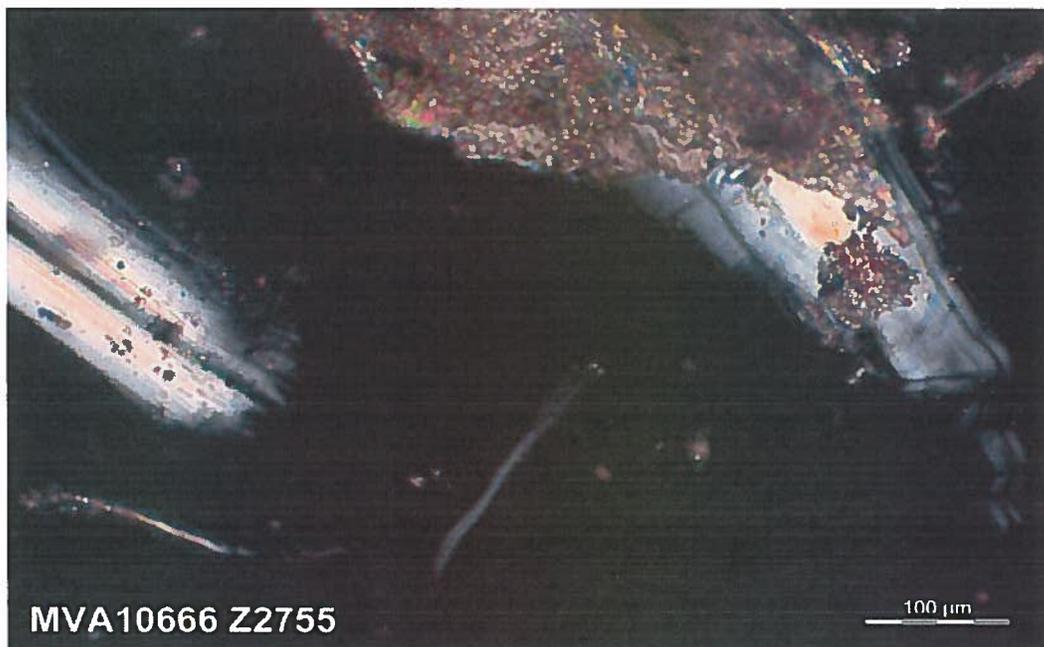
Figure 24a. PLM image of Chrysotile asbestos (center) observed in aggregate sample S-TEC-BUS-ER2.

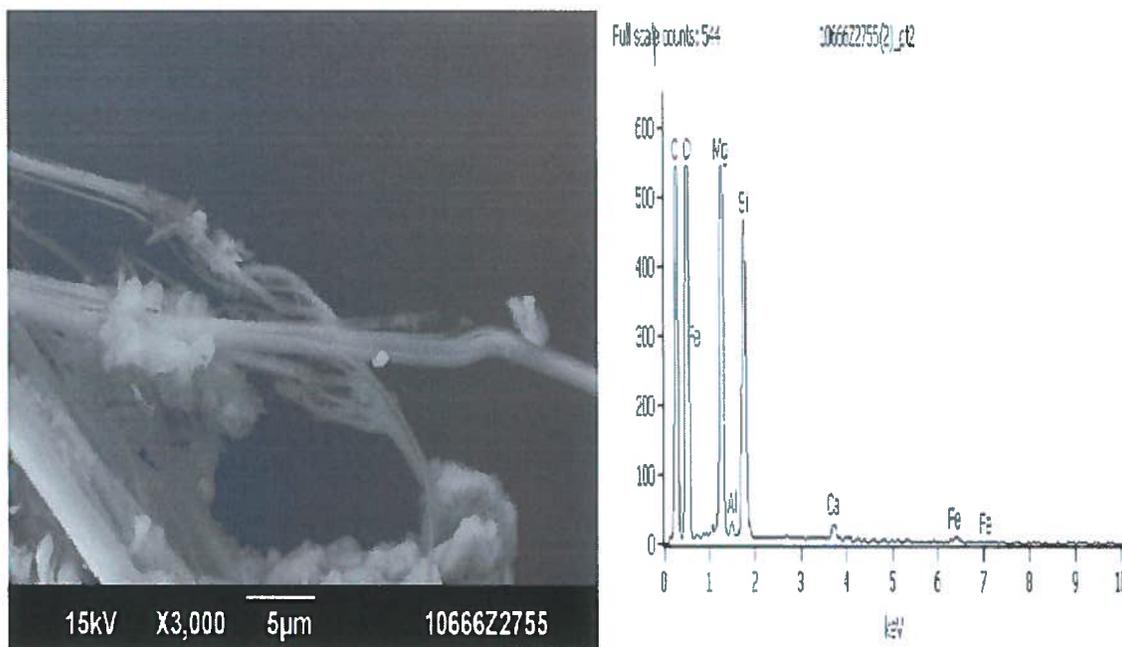
Figure 24b. SEM image of debris particles from aggregate sample S-TEC-BUS-ER2. Numbers (left) and typical EDS spectra (right). Note presence of Fe and Al traces..

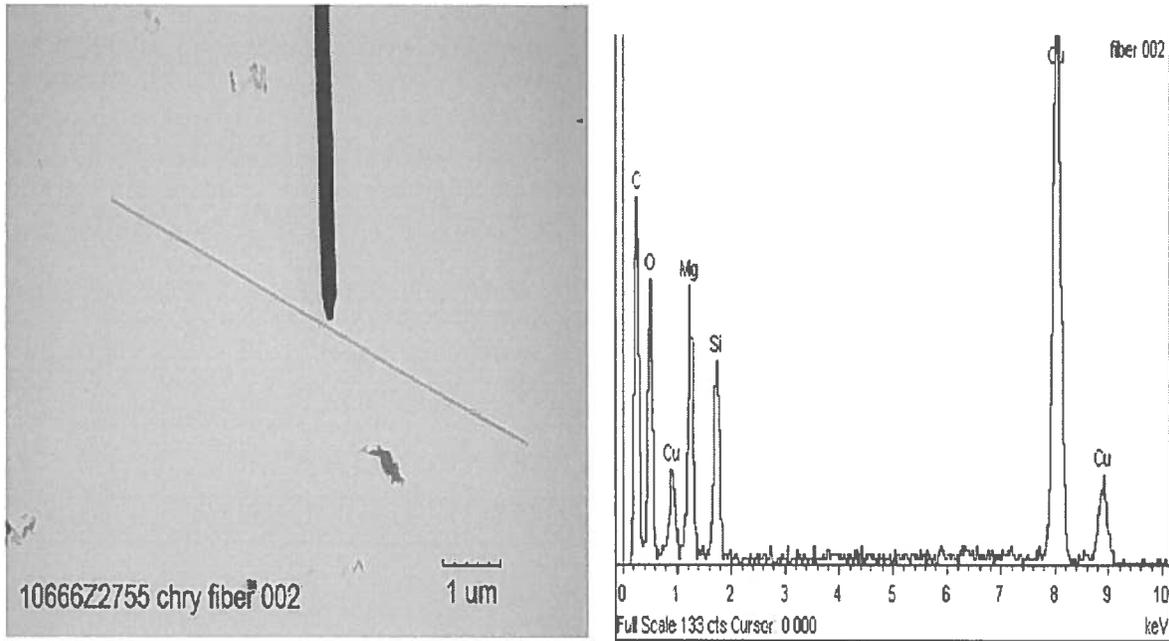
Figure 25. TEM image (left) and EDS spectrum (right) of a Chrysotile asbestos fiber observed during analysis of aggregate sample S-TEC-BUS-ER2. No Fe or Al observed.

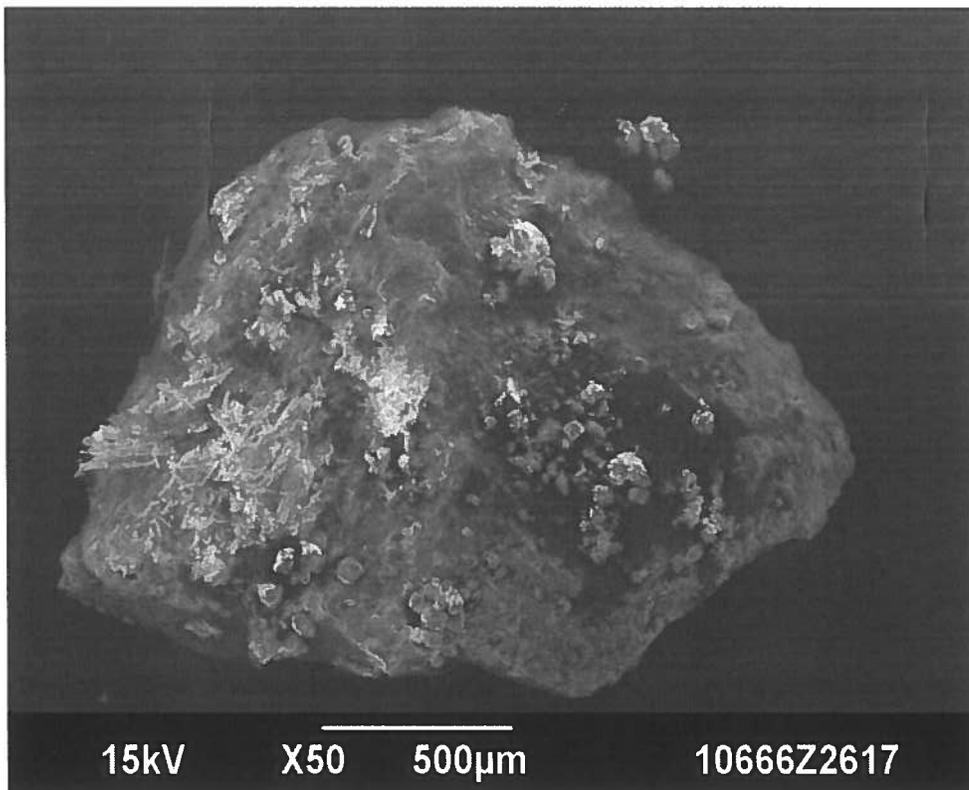
- Presence of non-fibrous (Lizardite) together with fibrous (Chrysotile) serpentines minerals and Magnetite in some of the dust samples collected around Olefins facility. Same mineral association was observed in the source rock (Serpentinites) mined from quarries located in the south-west side of Puerto Rico (Figures 14 thru 16).
- Presence of Lizardite, Magnetite and Chrysotile in the aggregate samples collected from gravel used as backfill. The source of the gravel is probably from the present/past quarries located in the southwest part of Puerto Rico. Both Lizardite and Chrysotile were observed to be present and closely intergrown in the samples collected from the aggregates (see Figure 30).

Figure 30. SEM image of Chrysotile (left fibrous) intergrowth with Lizardite (the large aggregate). The aggregate was collected from the gravel sample S-TEC-ARE-P0006-ER1

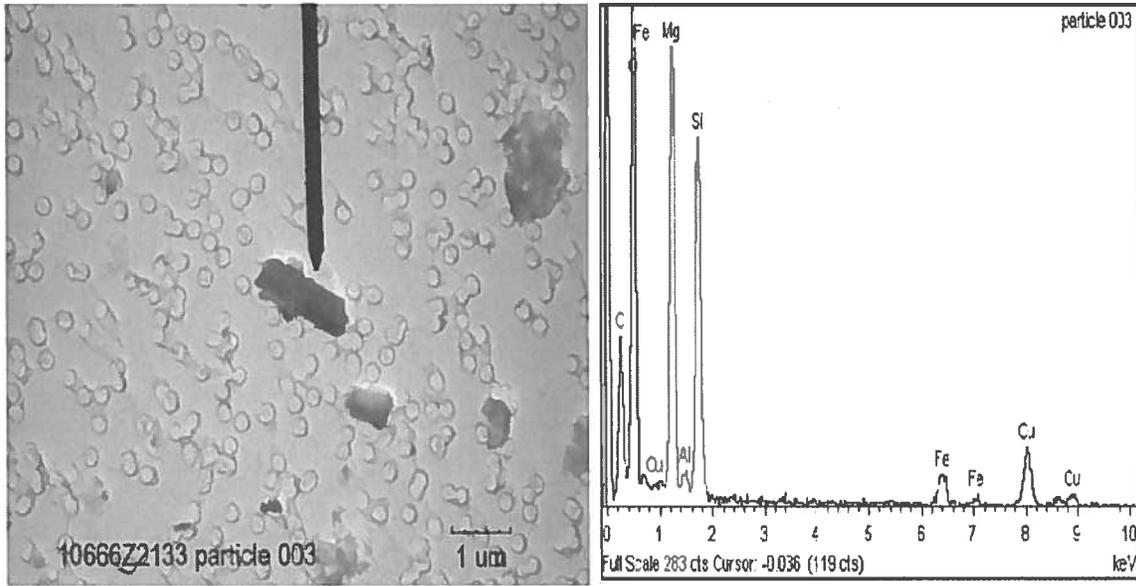
Figure 2. TEM image (left) and EDS spectrum (right) of a Chrysotile asbestos bundle detected in sample D-NOW-P0036-ER10 collected from the bus stop bench located at intersection of state roads PR-385 and PR-384, Penuelas.
