DUST FINGERPRINTS FINDINGS AT OLEFIN SITE PENUELAS PUERTO RICO

Ady Padan, Ph.D, P.G.

Scope of Work

Fingerprint the various types of asbestos containing dust found within and outside the Olefin facility.

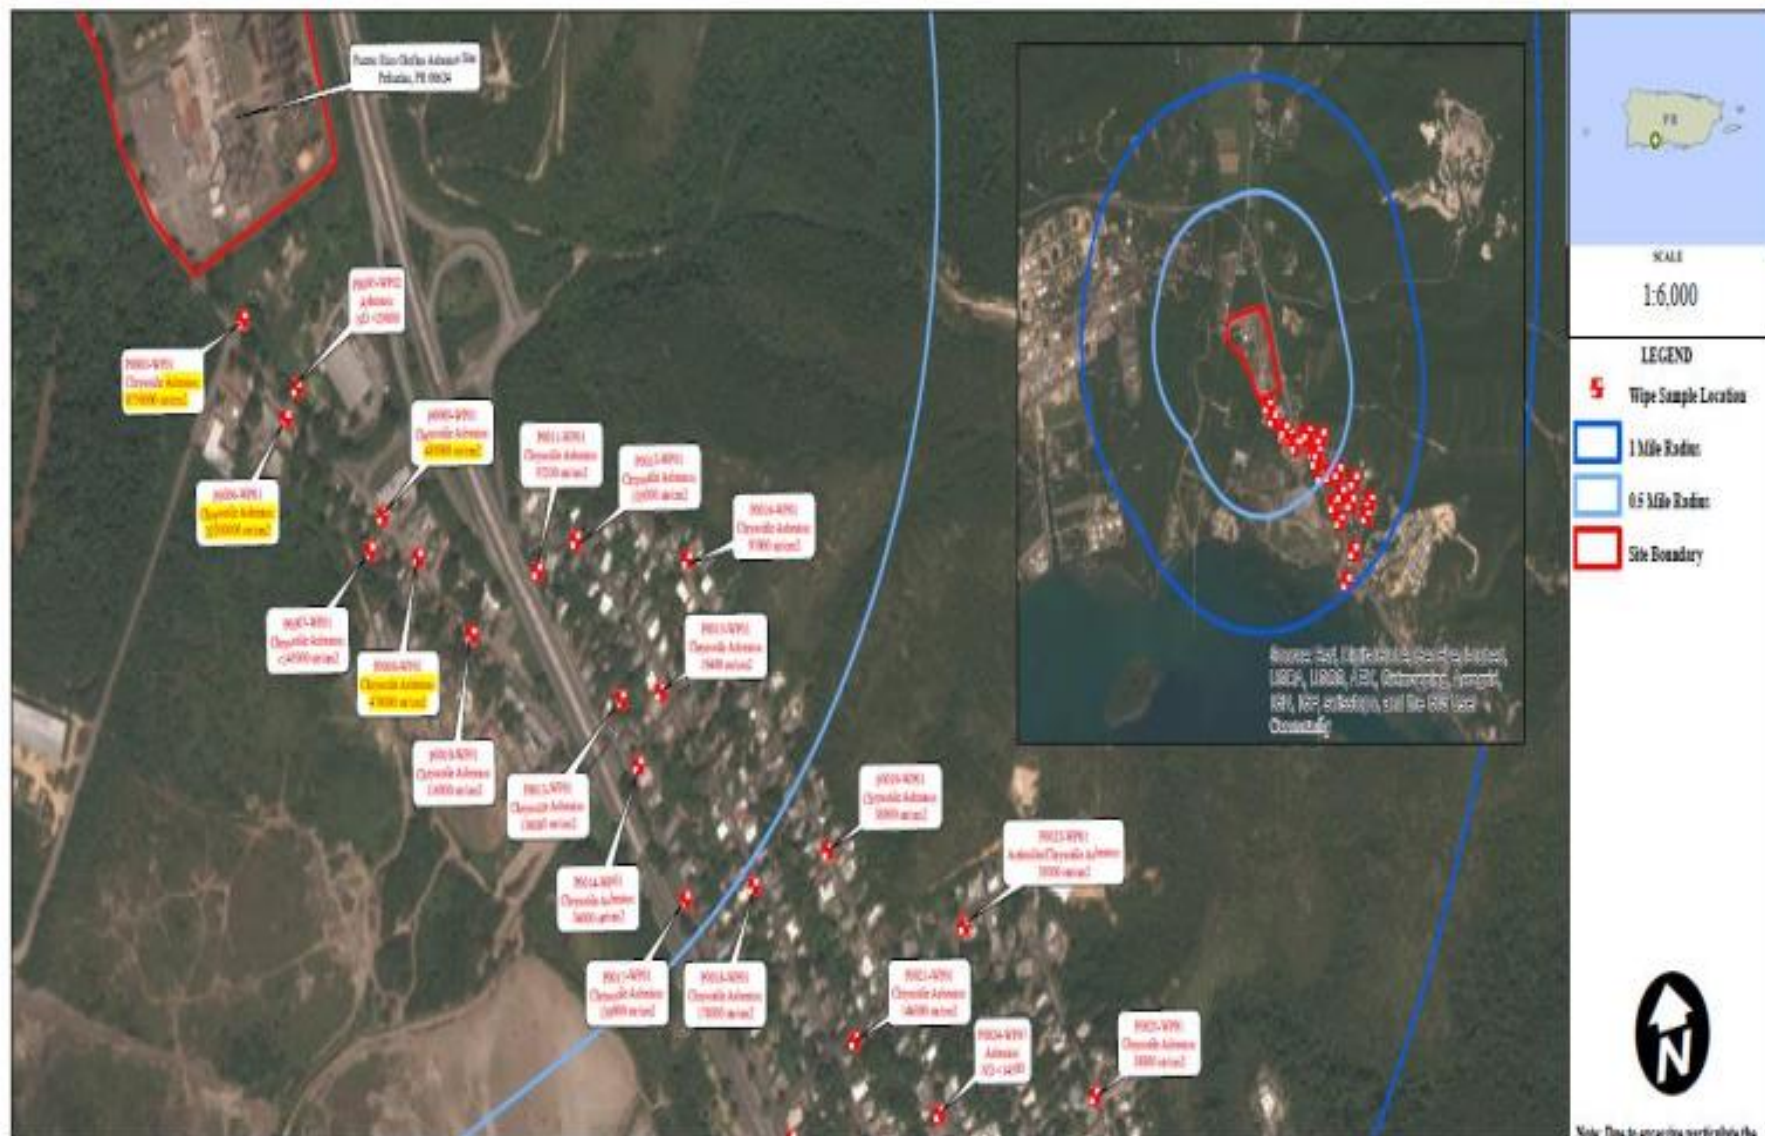
Figure 6. Dust sampling points (Highlighted) found by Weston to contain Chrysotile concentrations higher than 400,000 str/cm² (data from Weston report IIRP)

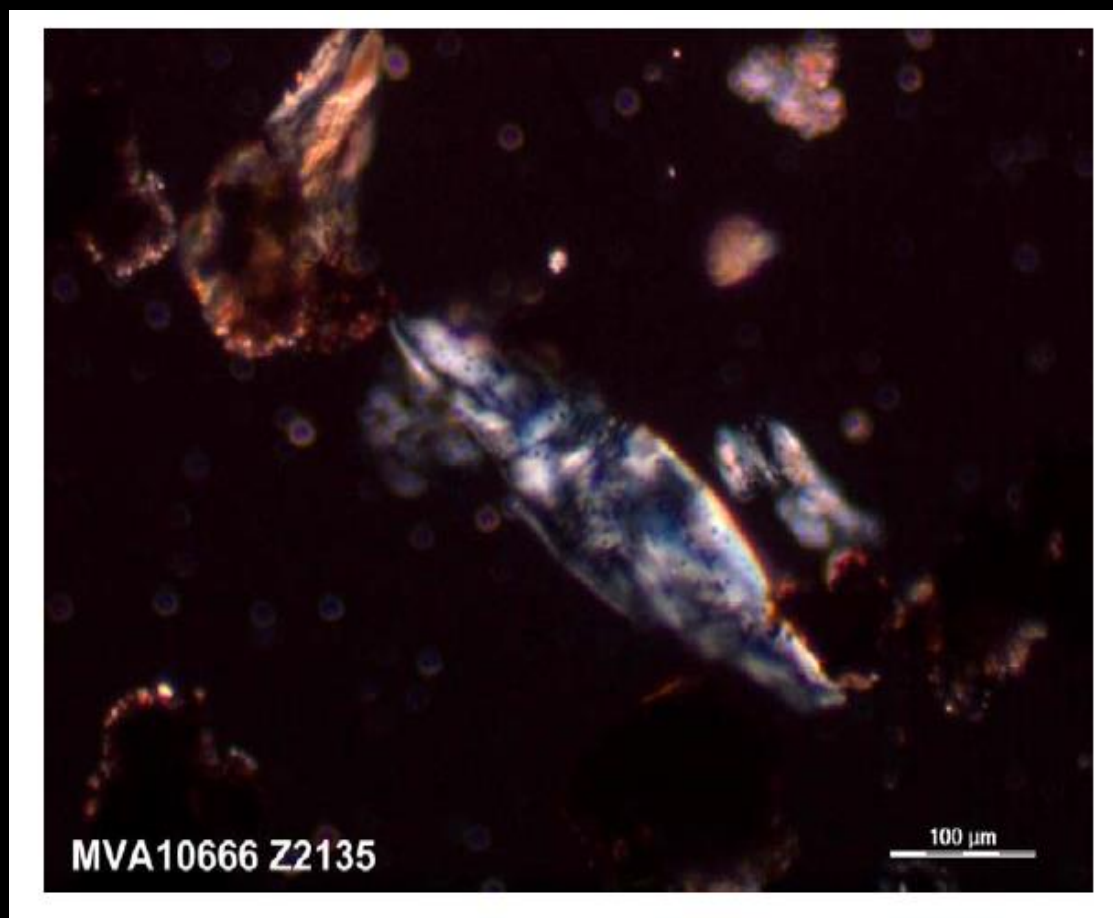
Sampling Point: D-TEC-P0018-C2-ER12

**PLM image of a Lizardite particle detected during analysis of sample
D-TEC-P0018-CR-ER12
Dust, corner street 2, west of street 2, Tallaboa Encarnation Community**

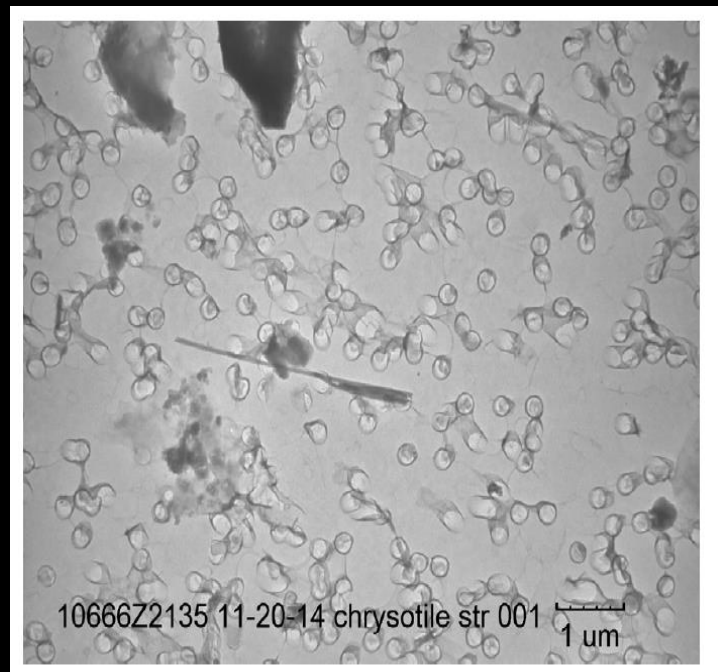
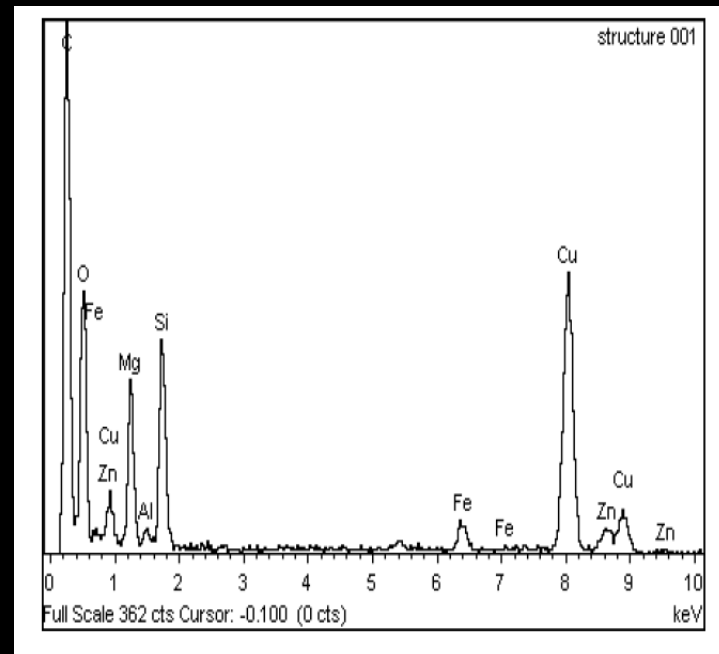
TEM image (left) and EDS spectrum (right) of a Chrysotile asbestos bundle detected in sample D-TEC-P0018-C2-ER12, Dust floor, corner street 2, west of street 2, Tallaboa Encarnation Community

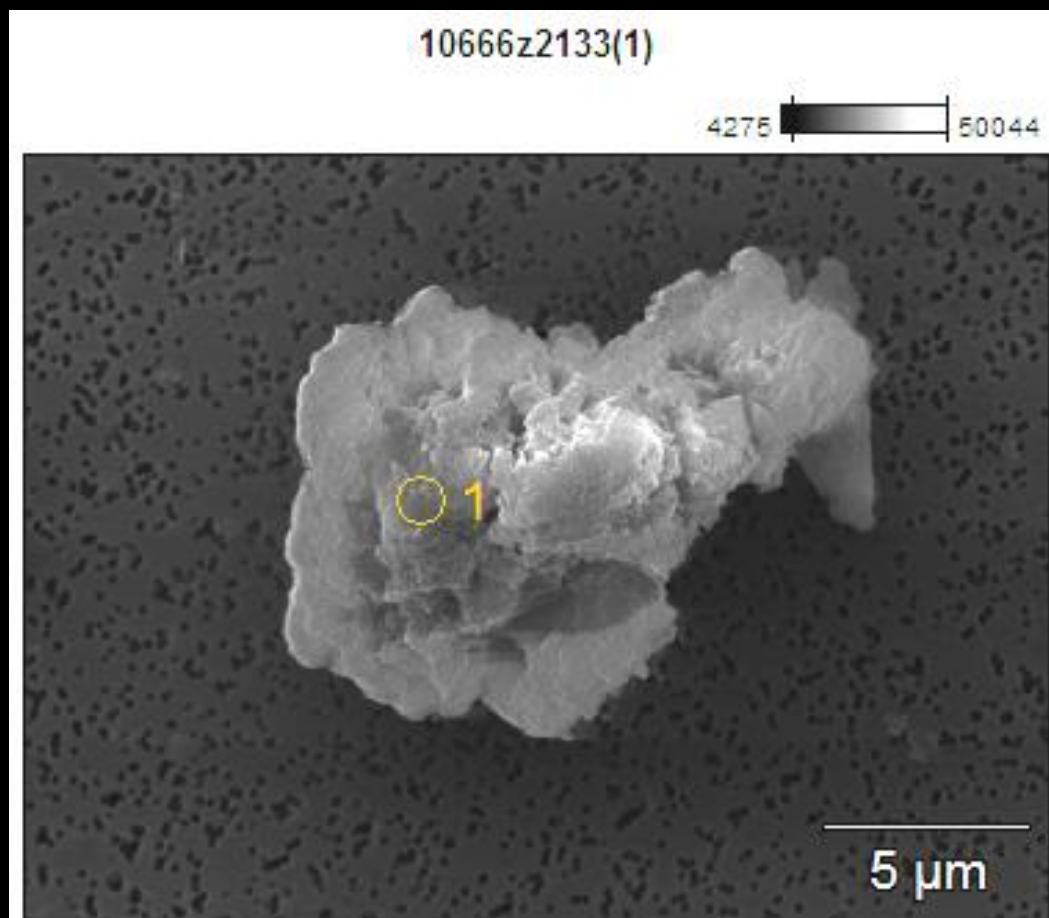
SEM image of a Lizardite particle detected during analysis of sample D-NOW-P0036-BS-ER10 collected from the bus station at the intersection of State roads 384 and 385.

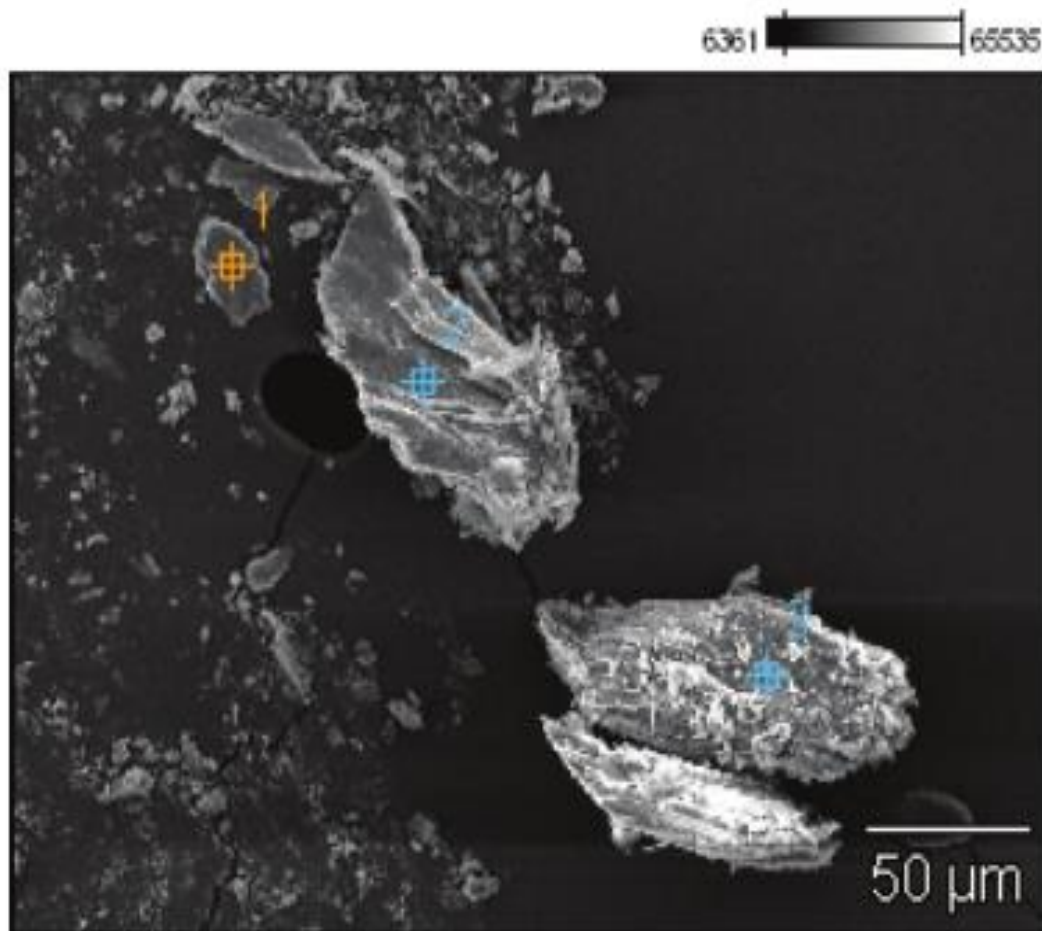
SEM photo of fibrous and non-fibrous serpentine Lizardite (#1) and Chrysotile (#2 and #3) detected during analysis of sample, R-Q1-AP4

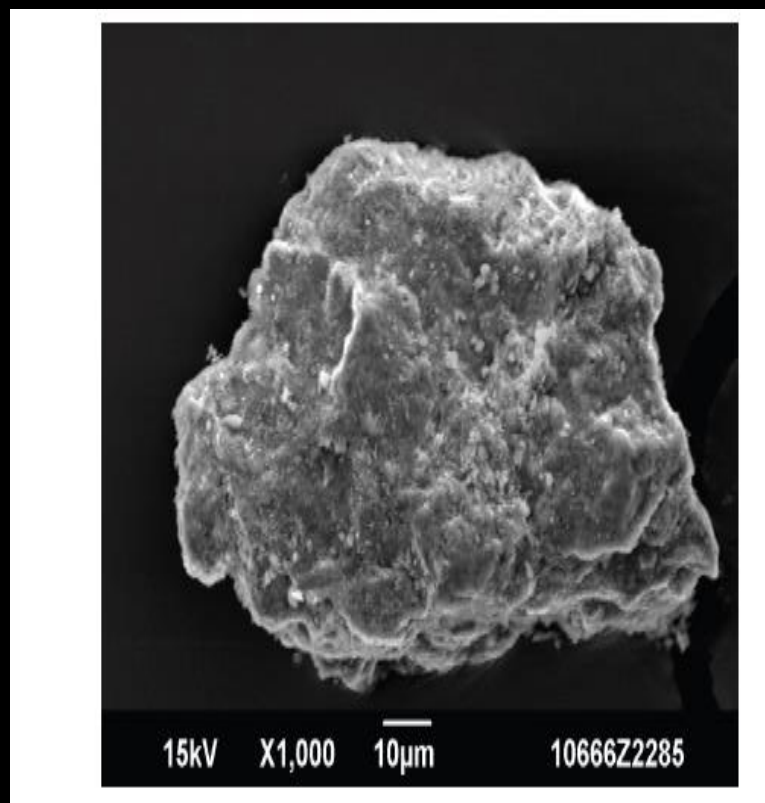
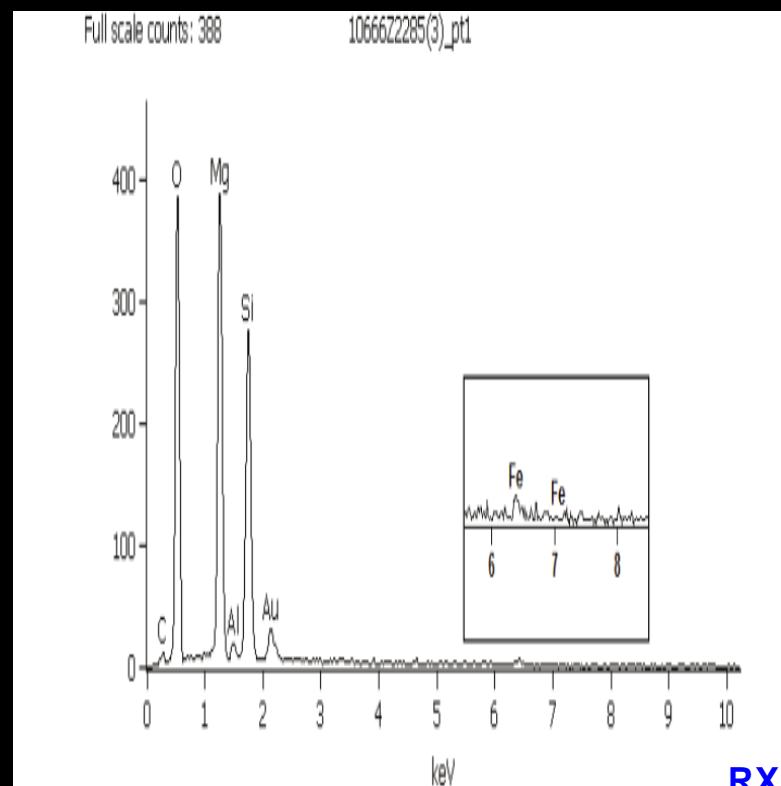
SEM photo (left) and EDS spectra (right) of non-fibrous serpentine (lizardite) detected during analysis of Quarry 1 sample R-Q1-AP4)

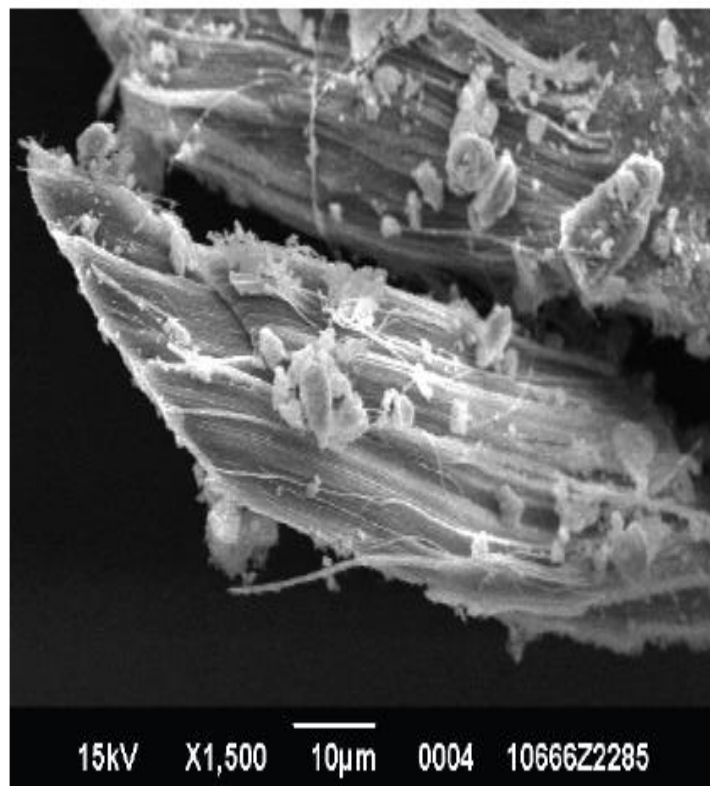
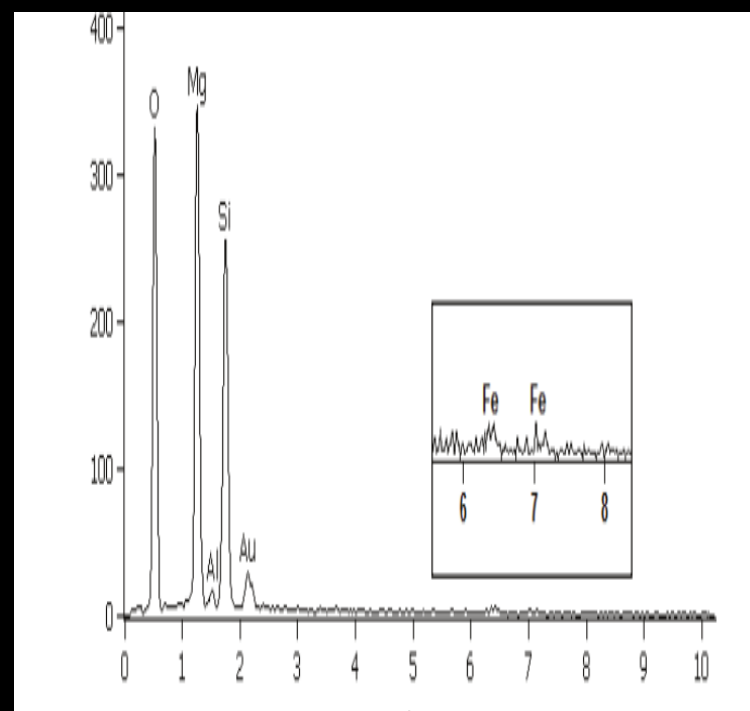
SEM photo (left) and EDS spectra (right) of a fibrous serpentine (Chrysotile) detected during analysis of Quarry 1 sample R-Q1-AP4). Chrysotile appears to be a pseudomorph.

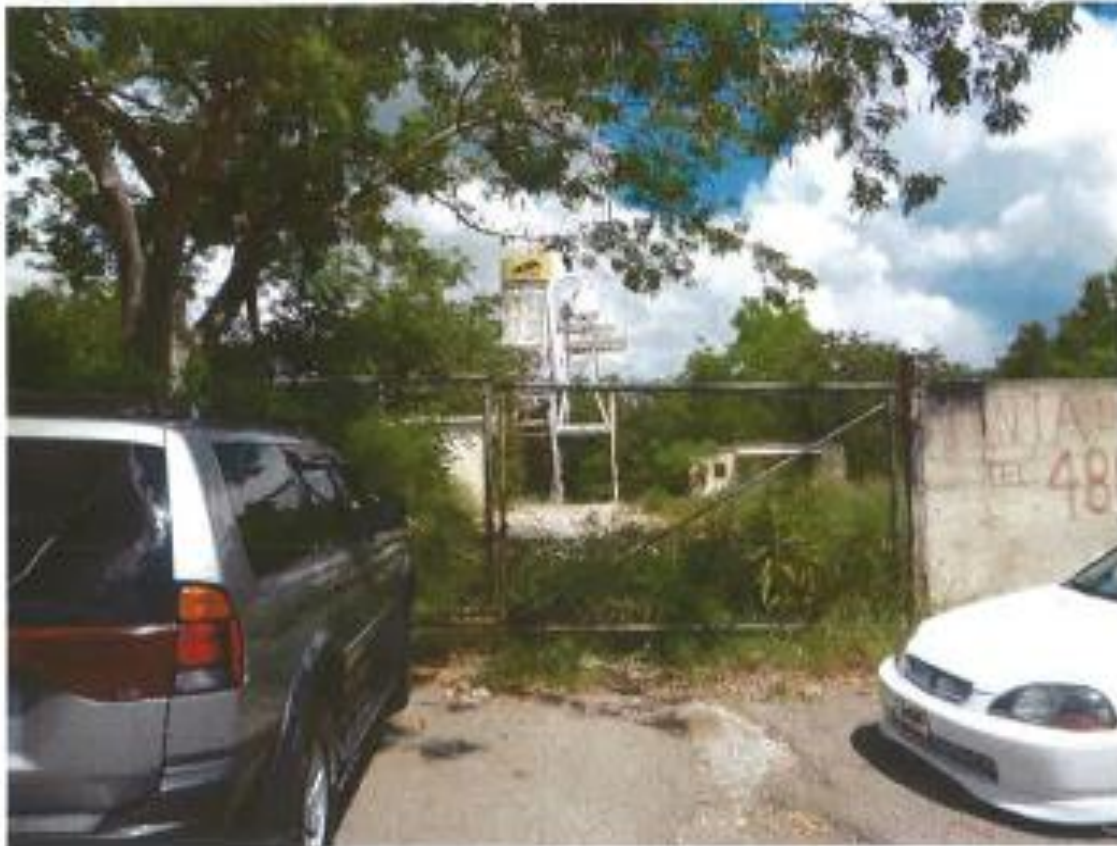
A concrete plant (Hormigonera Mayaguezana) is present in the vicinity of the quarry suggesting that the extracted material was crushed and used for commercial purposes (see photo below).

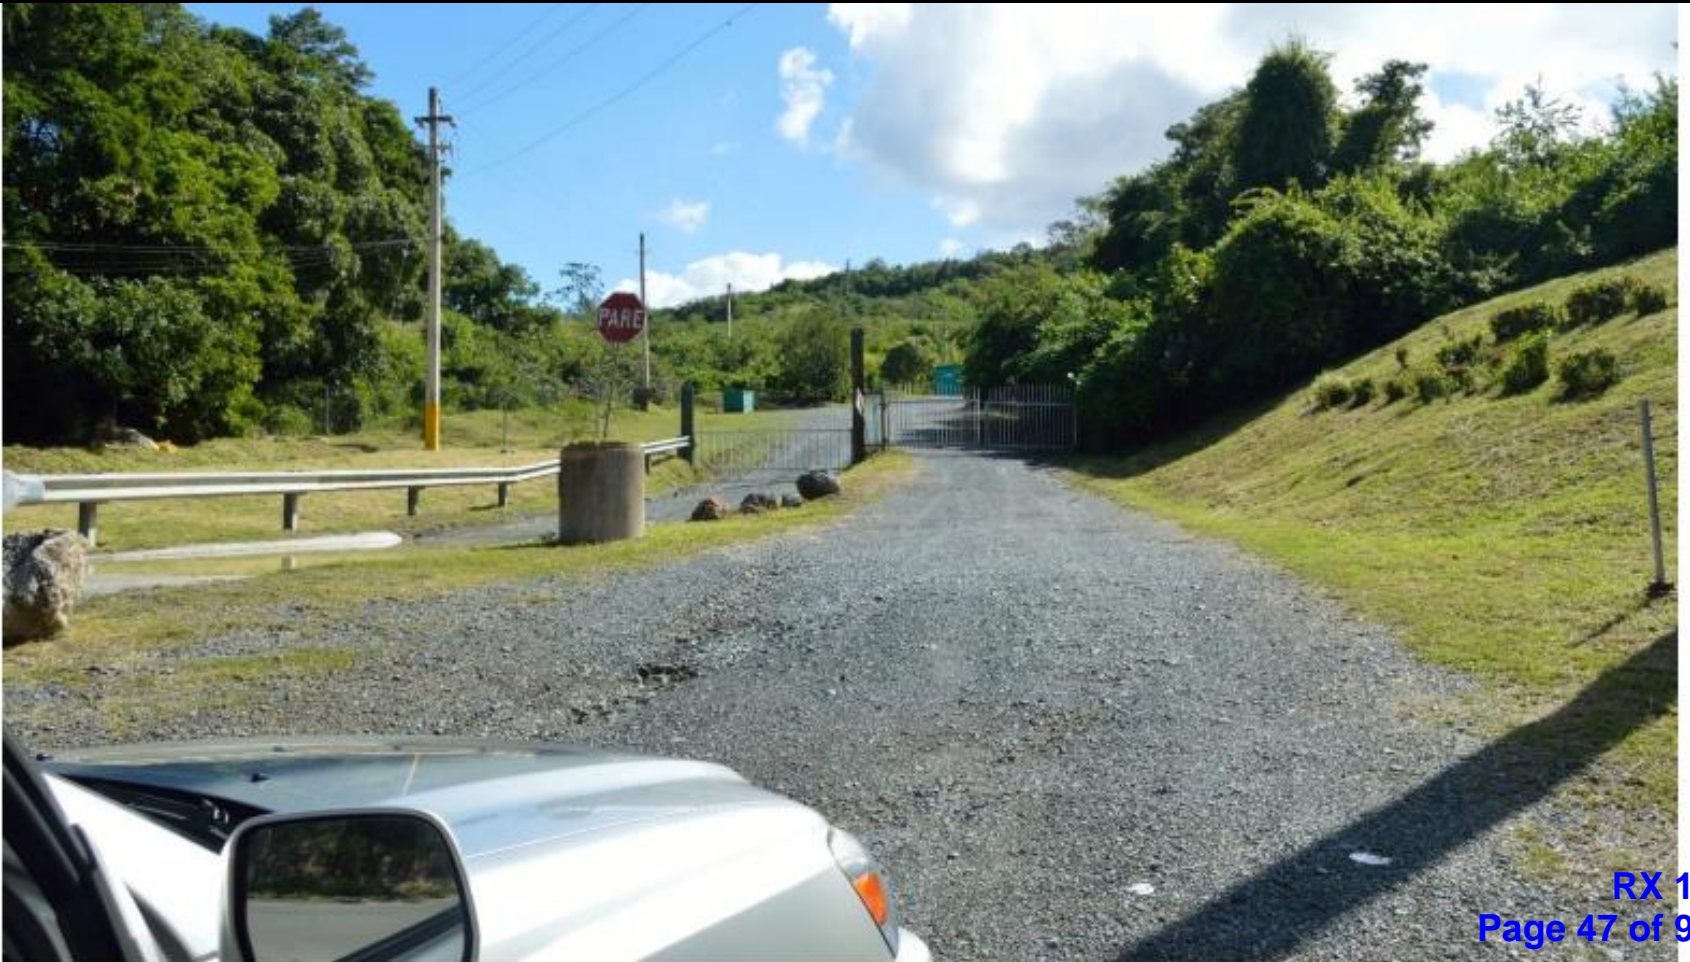
A quarry (Cantero y Gravelo) located in the Municipality of San Germán route PR-329 KM 3.2. There is no permit number on the sign. The access road is currently paved with Serpentine aggregate.

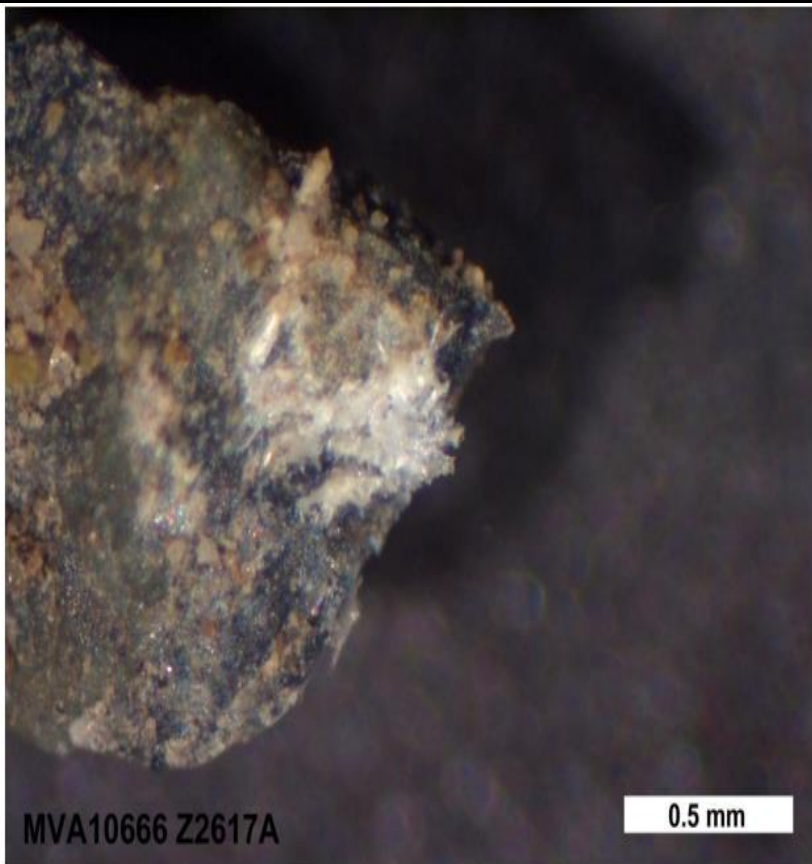
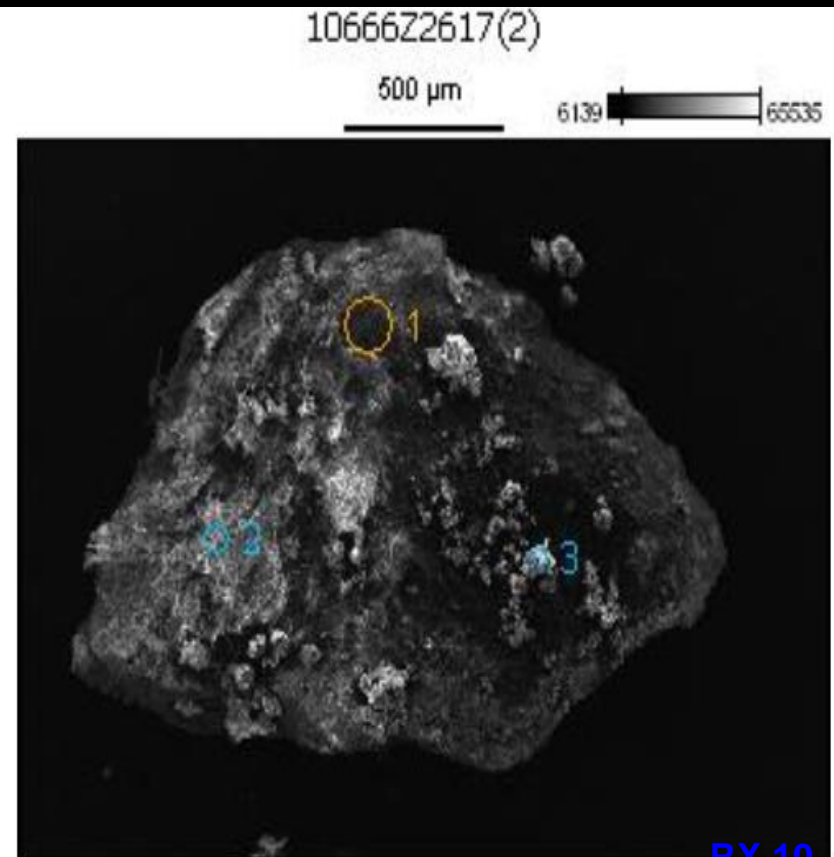
Stereo-micrograph (left) and SEM (right) of non-fibrous serpentine mineral (lizardite) with fibrous serpentine intergrowth (chrysotile) observed in aggregate sample S-TEC-ARE-P0006-ER1.

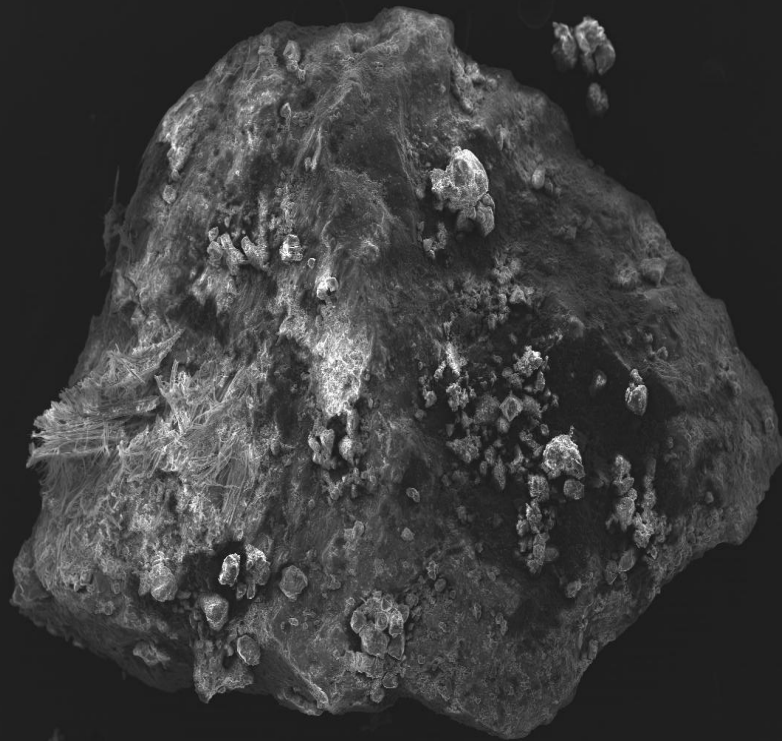
SEM image of Chrysotile intergrowth with Lizardite (the large aggregate). The aggregate was collected from gravel sample S-TEC-ARE-P0006-ER1

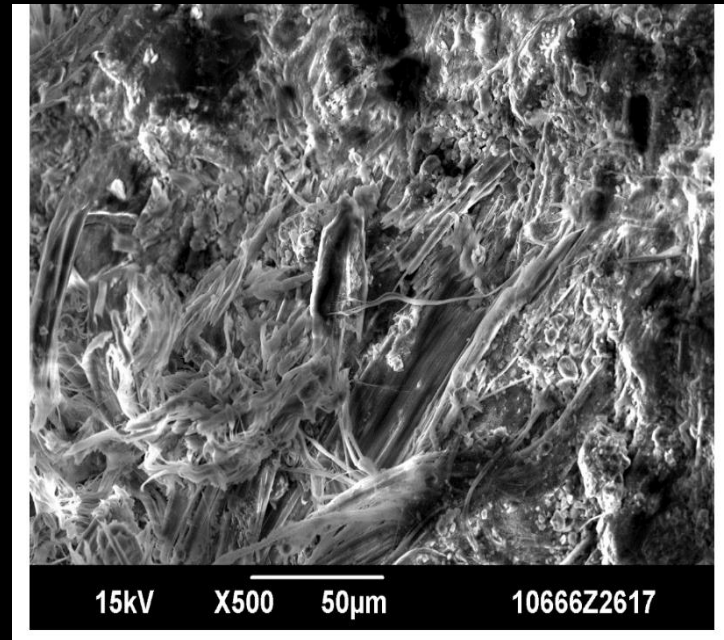
Chrysotile from the left side of the aggregate

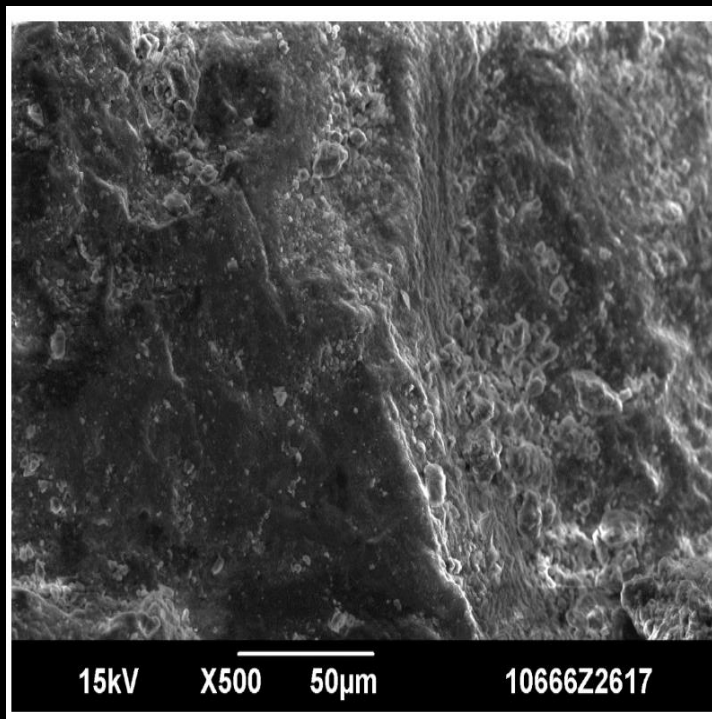
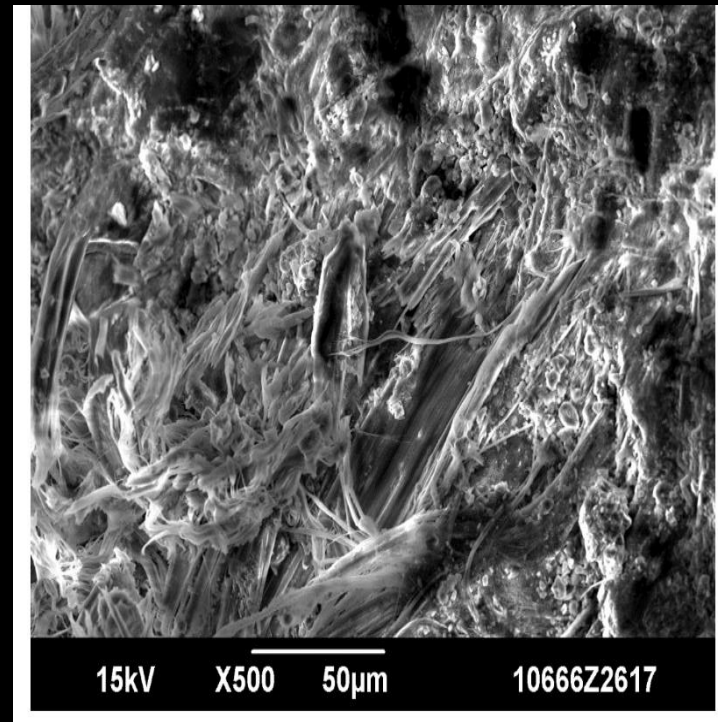
SEM images of fibrous serpentine (Chrysotile) mineral surface (right, area 2) and Lizardite (left, area 1). Areas 1 and 2 were shown in the previous slide.

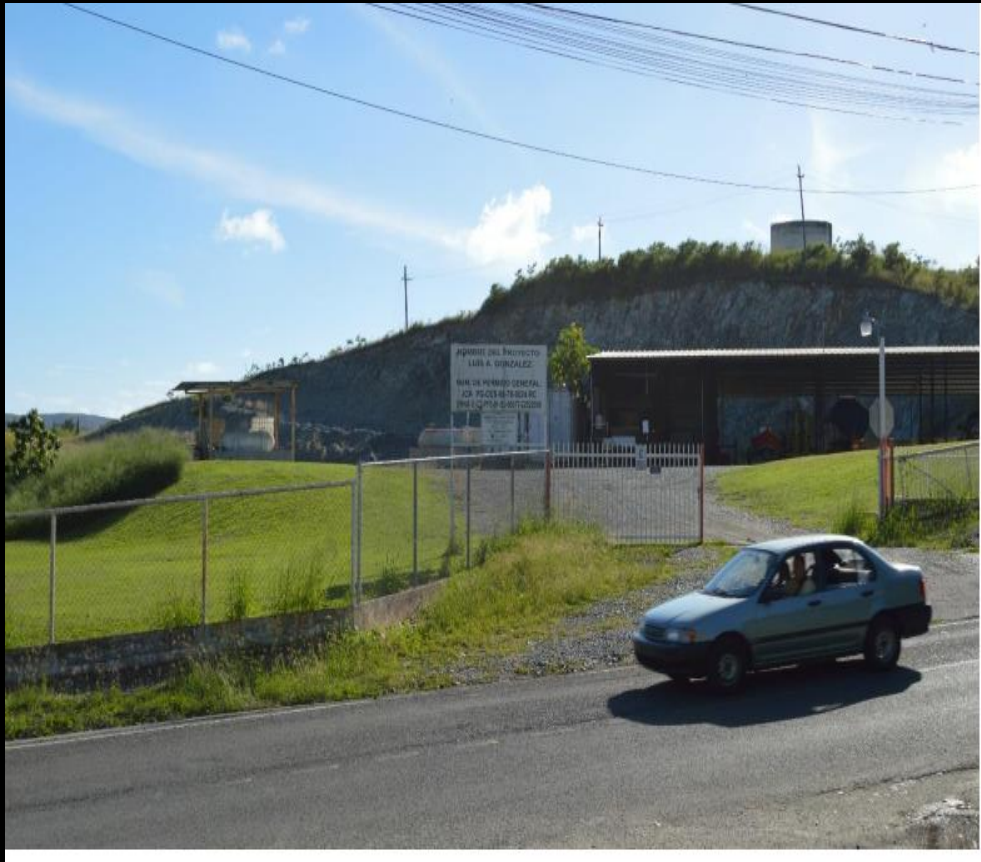
An active quarry (Luis A. Gonzalez, quarry #17) located along route PR-121 Sector Cuatro Calles in Yauco. JCA and DRNA permits are posted at its entrance

- Dust sample was collected on the road at the entrance.
- **290,000,000** str/cm²
- Lizardite also Observed

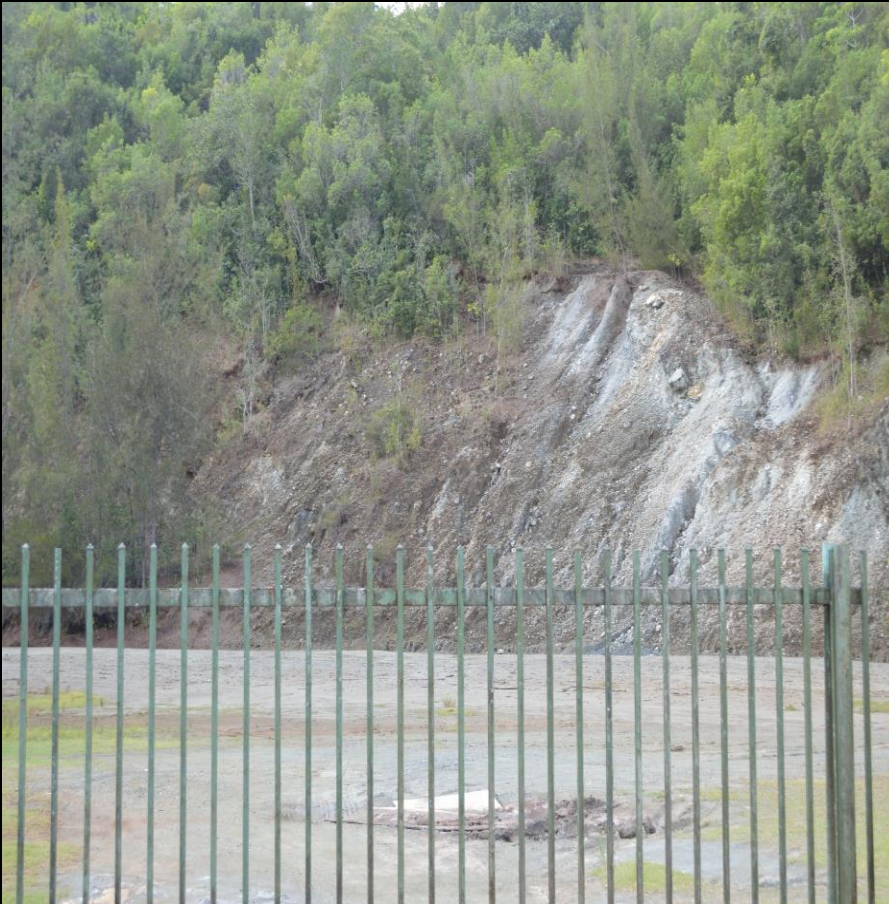
Entrance to the Parking of “Centro Juvenil de Mayagüez Aguadilla”, Mayaguez

- Dust sample was collected on the road at the entrance to the parking.
- **75,000,000** str/cm²
- Lizardite also Observed

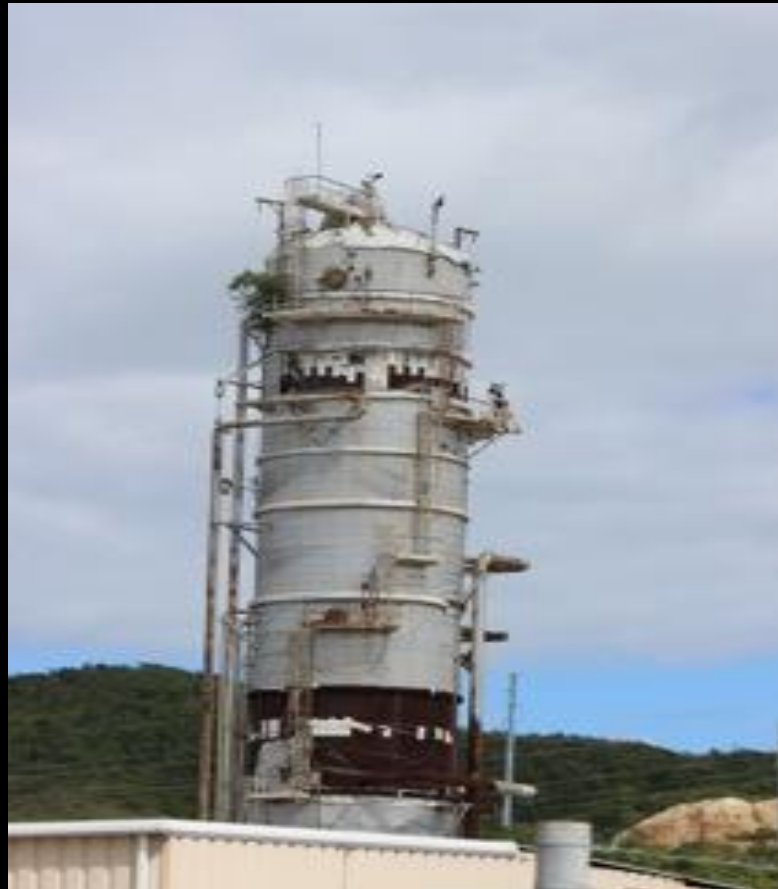
- **Tall structures Stacks/Tanks**
 - Chrysotile concentration are up to 40%, Amosite is 5%
- **Low structures (ground level) Boilers**
 - Chrysotile concentrations up to 5%, Amosite 40%

Bulk sample result of TSI on distillation tower

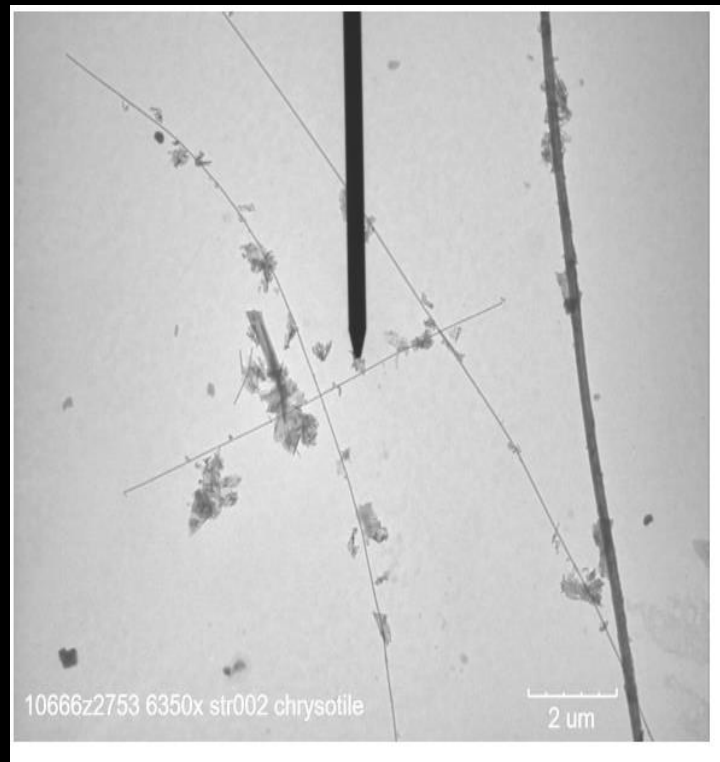
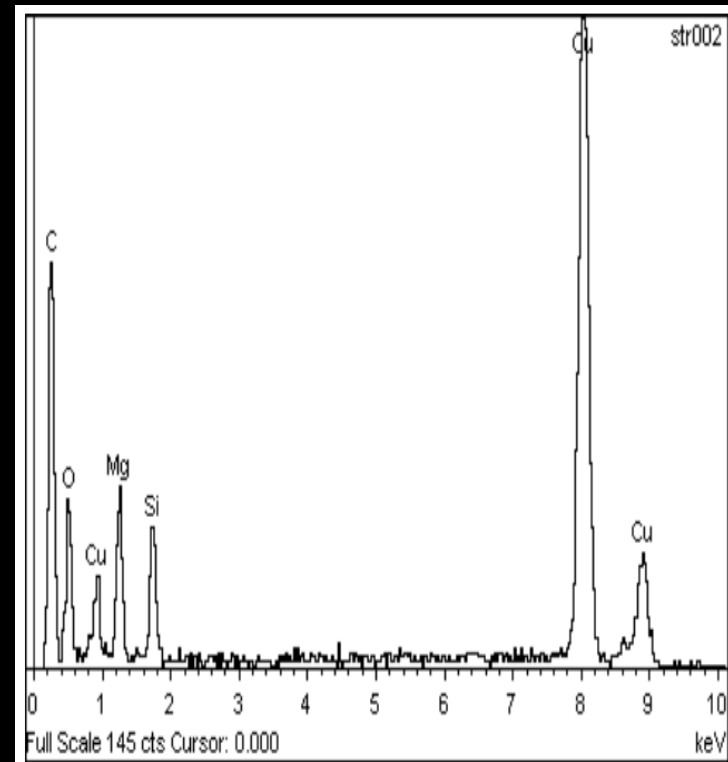
TEM image (left) and EDS spectrum (right) of a representative Chrysotile fiber detected during analysis of insulation sample BULK-OL-CHM4-ER2 (MVA Z2753). No Aluminum or Iron peaks are visible.

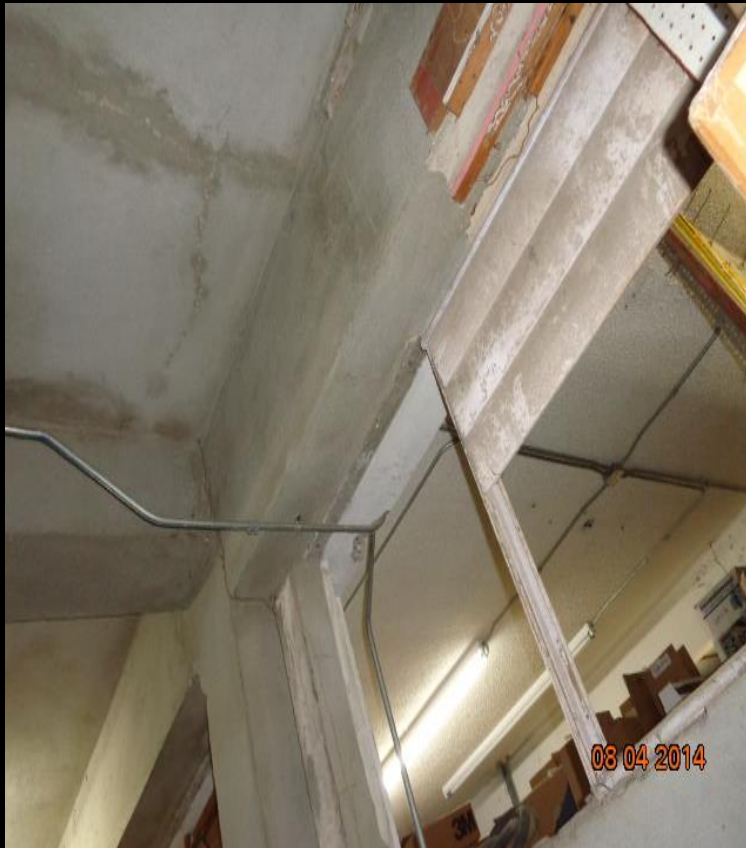
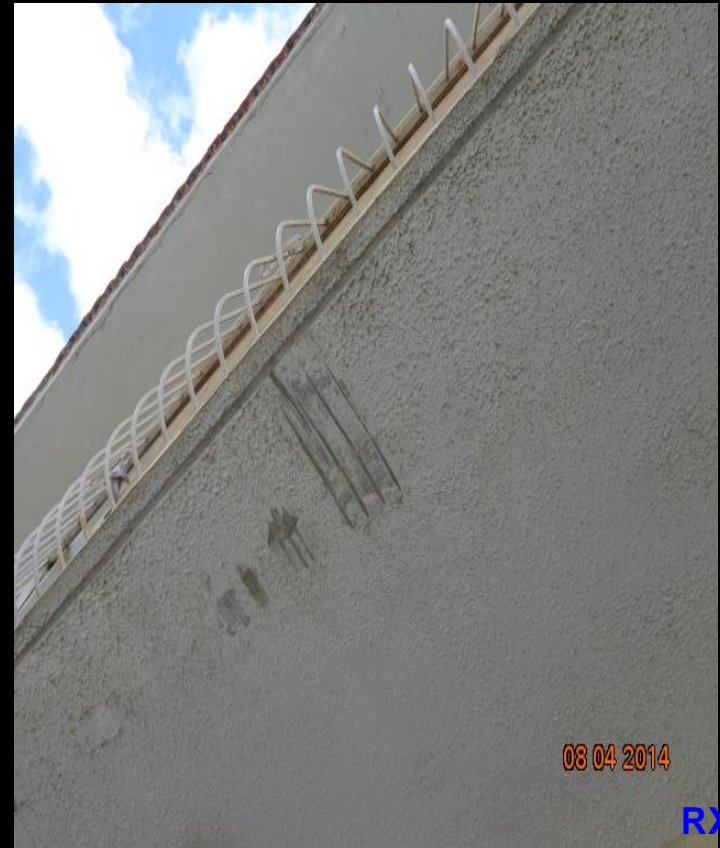
PACM Spray on Ceiling (stucco) on the first floor (exterior right/interior -left) ceiling-Property P0008 built in 1967. Second floor was under construction (Weston report Phase IV)

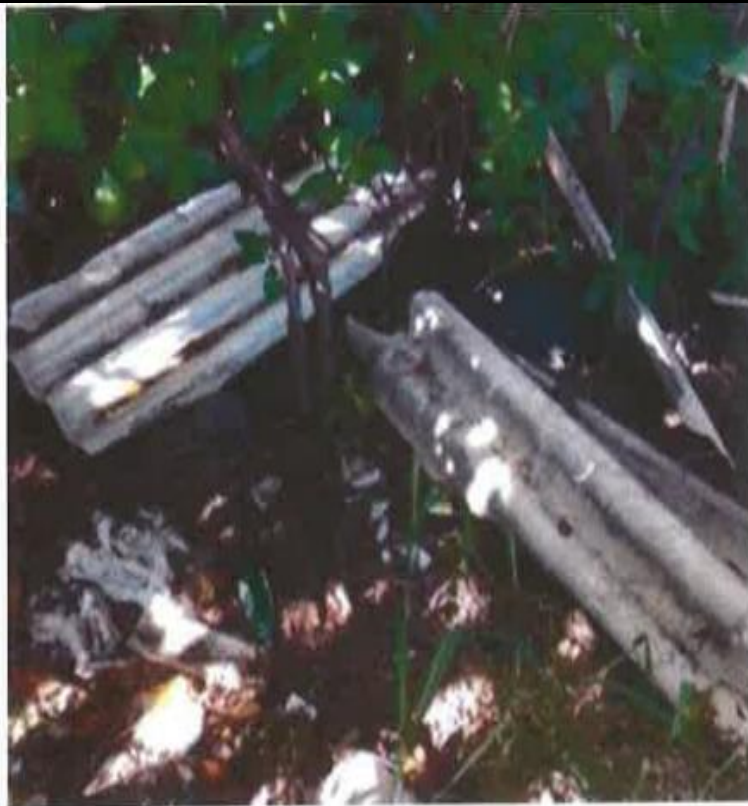
Waste Pile #3

General View of asbestos transite panels mixed with trash.

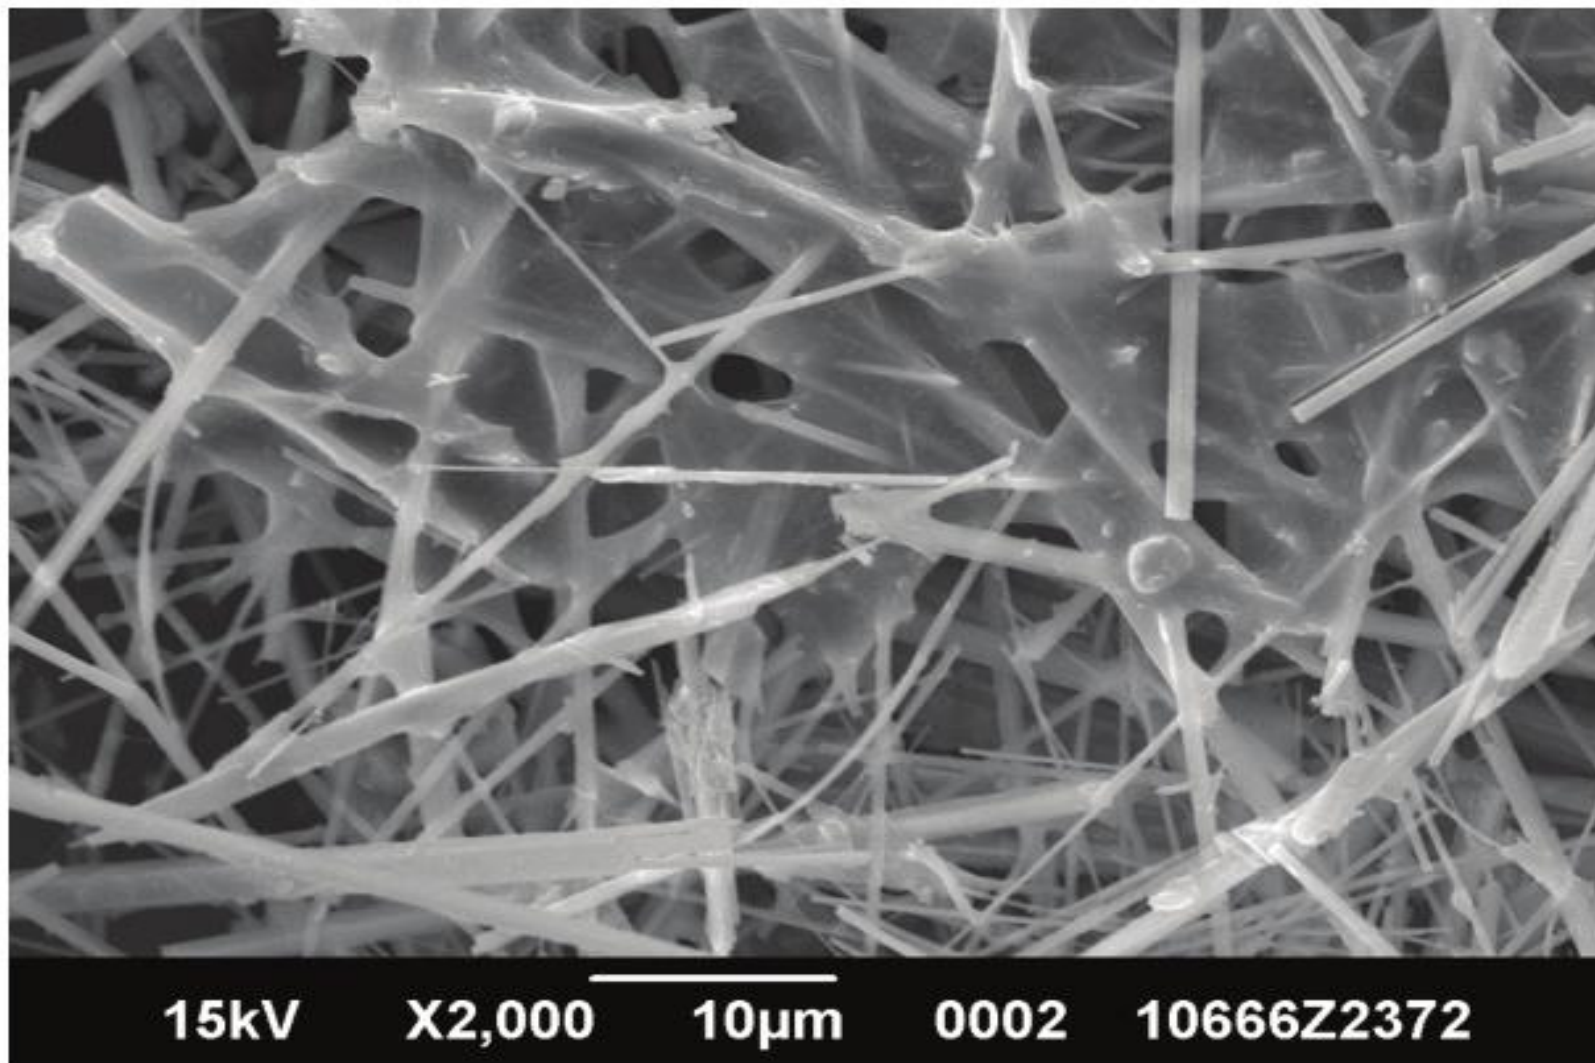
Insulation sample B-OL-PS408-ER5 (MVA Z2372). Numbers denote areas where EDS spectra were collected. Large bundles of amosite were identified in point 1. Diatoms were identified in point 2. Smaller amosite fibers with silicon-rich binder material are present in point 3.
