MILLER BREWING COMPANY

RE: *Written Report Reportable Diesel Fuel Spill 2/11/2008 - Miller Brewing Company Fort Worth, Texas 76134*

Reportable Diesel Fuel Spill
February 11, 2008

Incident Report

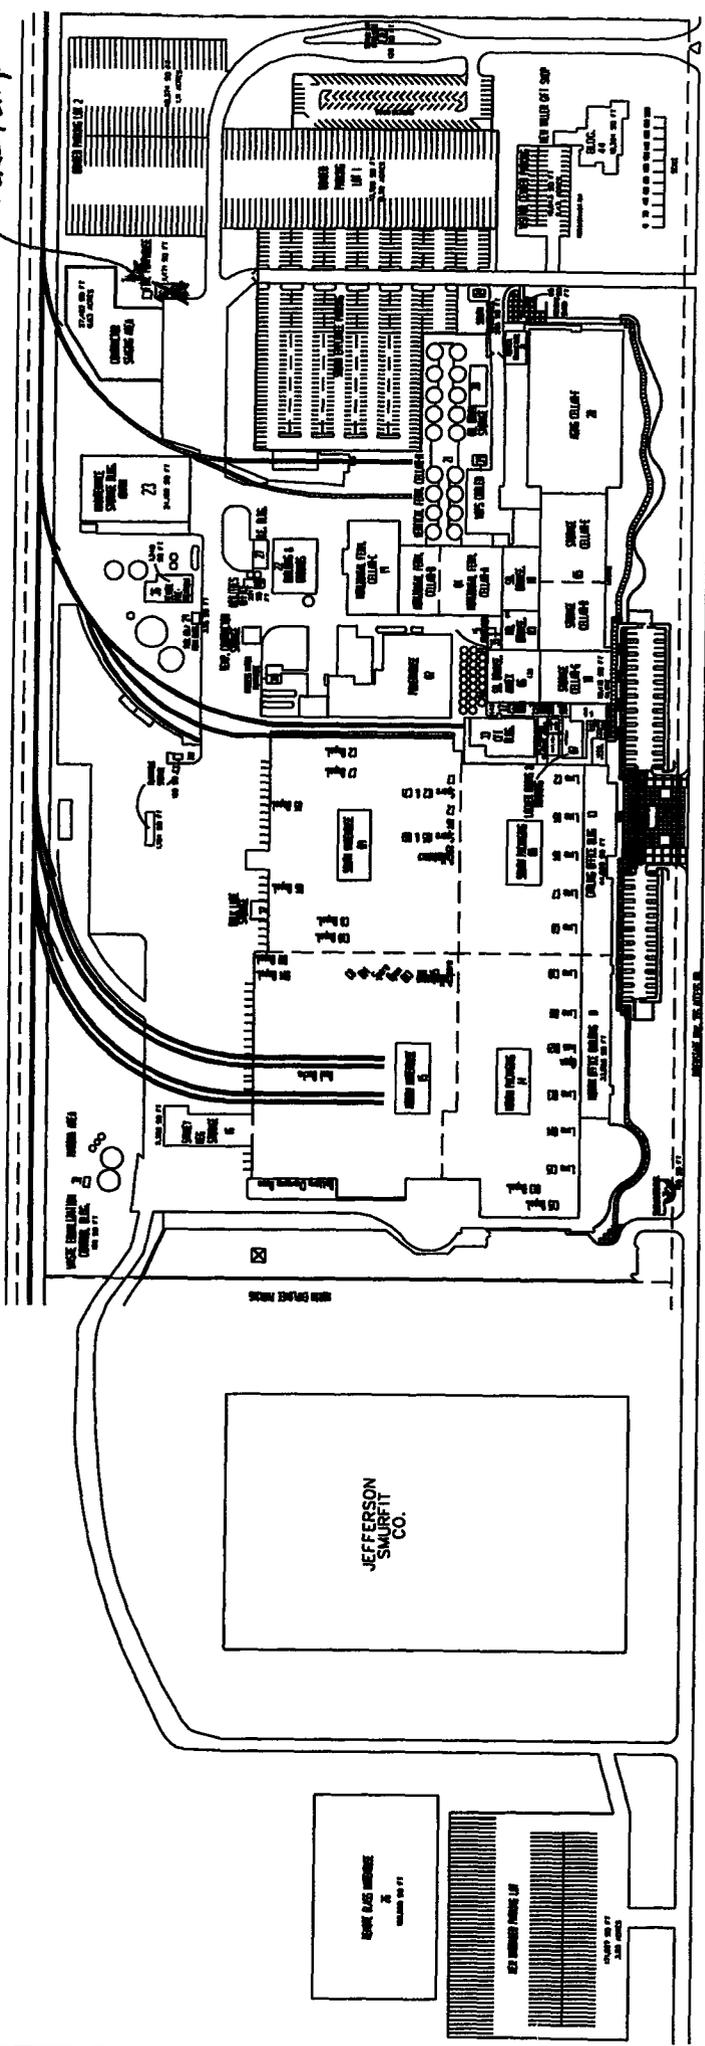
2-11-08
 Spill Site
 Fire Pump house

At about 10:05 AM during unloading of diesel fuel # 2 to the fire pump house inside tanks, approximately thirty (30) gallons were spilled on the roof and into the tank containment systems via the tank vents. Duration of the event was about five minutes. Fuel ran down the roof drains to the ground below. About 10 gallons (of the thirty gallons) spilled to ground. Immediate action by the driver and fire pump house operator included moving the fuel inlet catch pans under the two drain spouts and using a bucket to recover fuel from the catch pans back into the truck tank. Once additional assistance (Buildings and Grounds personnel, M. Torres, R. Crabbe and M. Gomez) arrived at 10:12 AM, pig mat was spread on the roof to absorb the diesel and clay absorbent was piled on the ground around the building drain spouts. The Miller Emergency Response Team was not called out since the spill had been controlled and contained. The spill covered approximately 400 sq. ft. of roof area and about 138 sq. ft. of ground for both drain spouts.

Eagle Environmental Services was contacted at 10:47 AM and arrived at the brewery at 12:08 PM to conduct the spill clean up. They sprayed Microblaze on the affected roof area, collected the spent pig mat, removed top surface of roof and gravel, and drained the remaining fuel on the roof to the catch pans below. The inside of the drain spouts were sprayed with Microblaze and all materials were placed into plastic bags. The catch pans were also treated with Microblaze after the diesel fuel was collected from the pans. About 50 gals of diesel fuel was recovered from both of the overfilled tanks. Eagle also removed about 138 cubic feet of soil. The roof was given a second treatment of MicroBlaze and absorbent socks were placed at the roof drain openings. The dug out areas on the ground were also treated with MicroBlaze. All affected materials were collected into a plastic lined and covered dumpster. Eagle Environmental Services will provide the remediation of the soil and disposal of all materials.
