Second Five-Year Review Report

Triumph Mine Tailings Piles Site

Blaine County, Idaho

**Prepared by Idaho Department of Environmental Quality
Boise, Idaho**

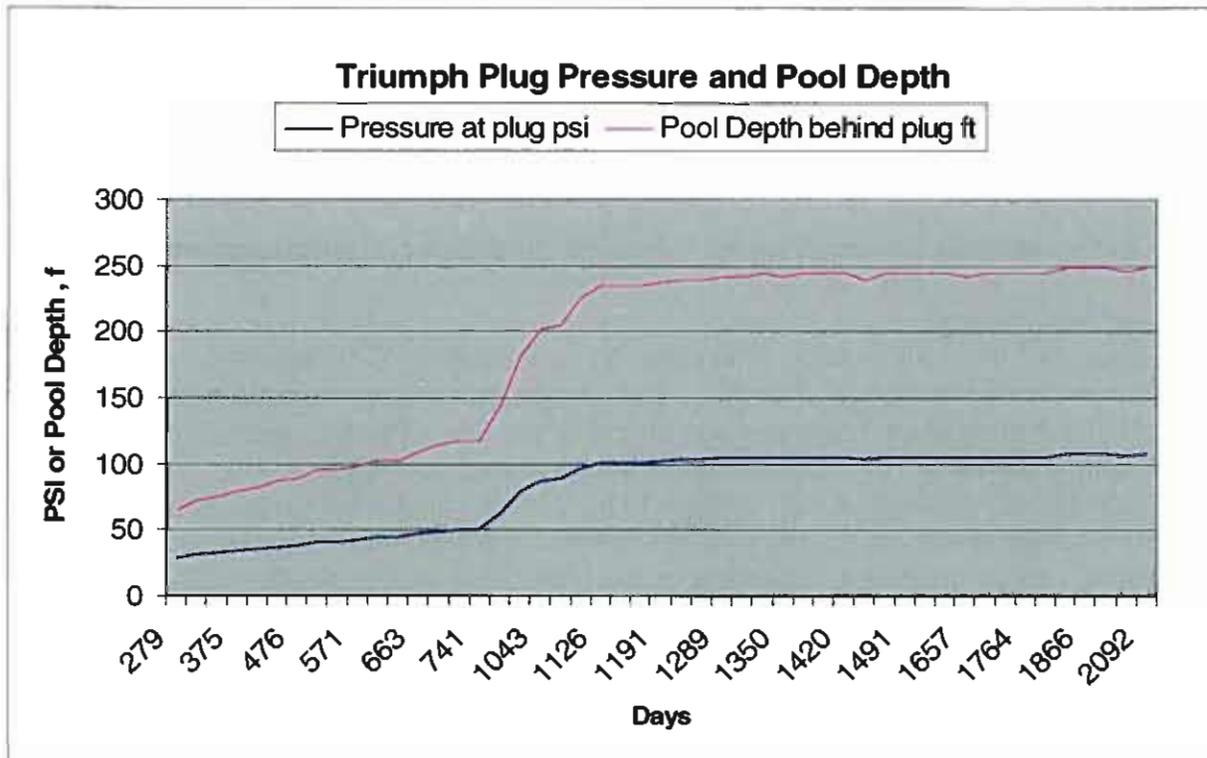
Figure 2. Triumph Mine Plug Pressure and Pool Depth Measurements.

Water pressure behind the mine plug continues to be monitored. Measurements taken from the date of plug installation (August 28, 2003) show that it took about 2 years (to July 2005 or 697 days after plugging) to reach about 50 pounds per square inch (psi) (Figure 2). The pressure stayed the same for about another half-year, and then began

a steady increase to a little over 100 psi in September 2006, 1,126 days after plugging. Since then, pressure has only slightly increased, to 110 psi, during the past two years. The mine water pool behind the plug seems to have stabilized, but will continue to be monitored. Seep surveys will also continue to be implemented. These are conducted in the late summer or early fall when green vegetation serves as an indicator for possible seeps.

The mine plug continues to limit water discharge volumes to about 4 gpm. This is compared to the pre-plug flows that ranged from 90 to 190 gpm. The quality of the post-plug water was tested September 24, 2003. The results showed that the concentration of total arsenic decreased from 0.648 (milligrams per liter (mg/l)) to 0.040 mg/l from November 20, 2002, to the September 2003 sample date. Data from October 8, 2008, show an increase in total arsenic to 0.454 mg/l compared to the 2003 data (Table 2). Total manganese decreased from 3.620 mg/l to 0.170 mg/l from November 20, 2002, to the September 2003. In the October 2008 sampling, total manganese increased above the 2002 and 2003 results with a level of 10.1 mg/l. Data from the ongoing IDL monitoring program show the same trends.

Mine Water. The remaining components of the Mine Water remedy need to be implemented. A mine plug expert will likely need to be called in to assess the overall effectiveness of the plug and recommend next steps for ongoing O&M. DEQ intends to use expected Asarco bankruptcy settlement funds to address this task.
