**FIRST FIVE-YEAR REVIEW REPORT FOR
TUCSON INTERNATIONAL AIRPORT AREA SUPERFUND SITE
PIMA COUNTY, ARIZONA**

US EPA Region 9

Executive Summary

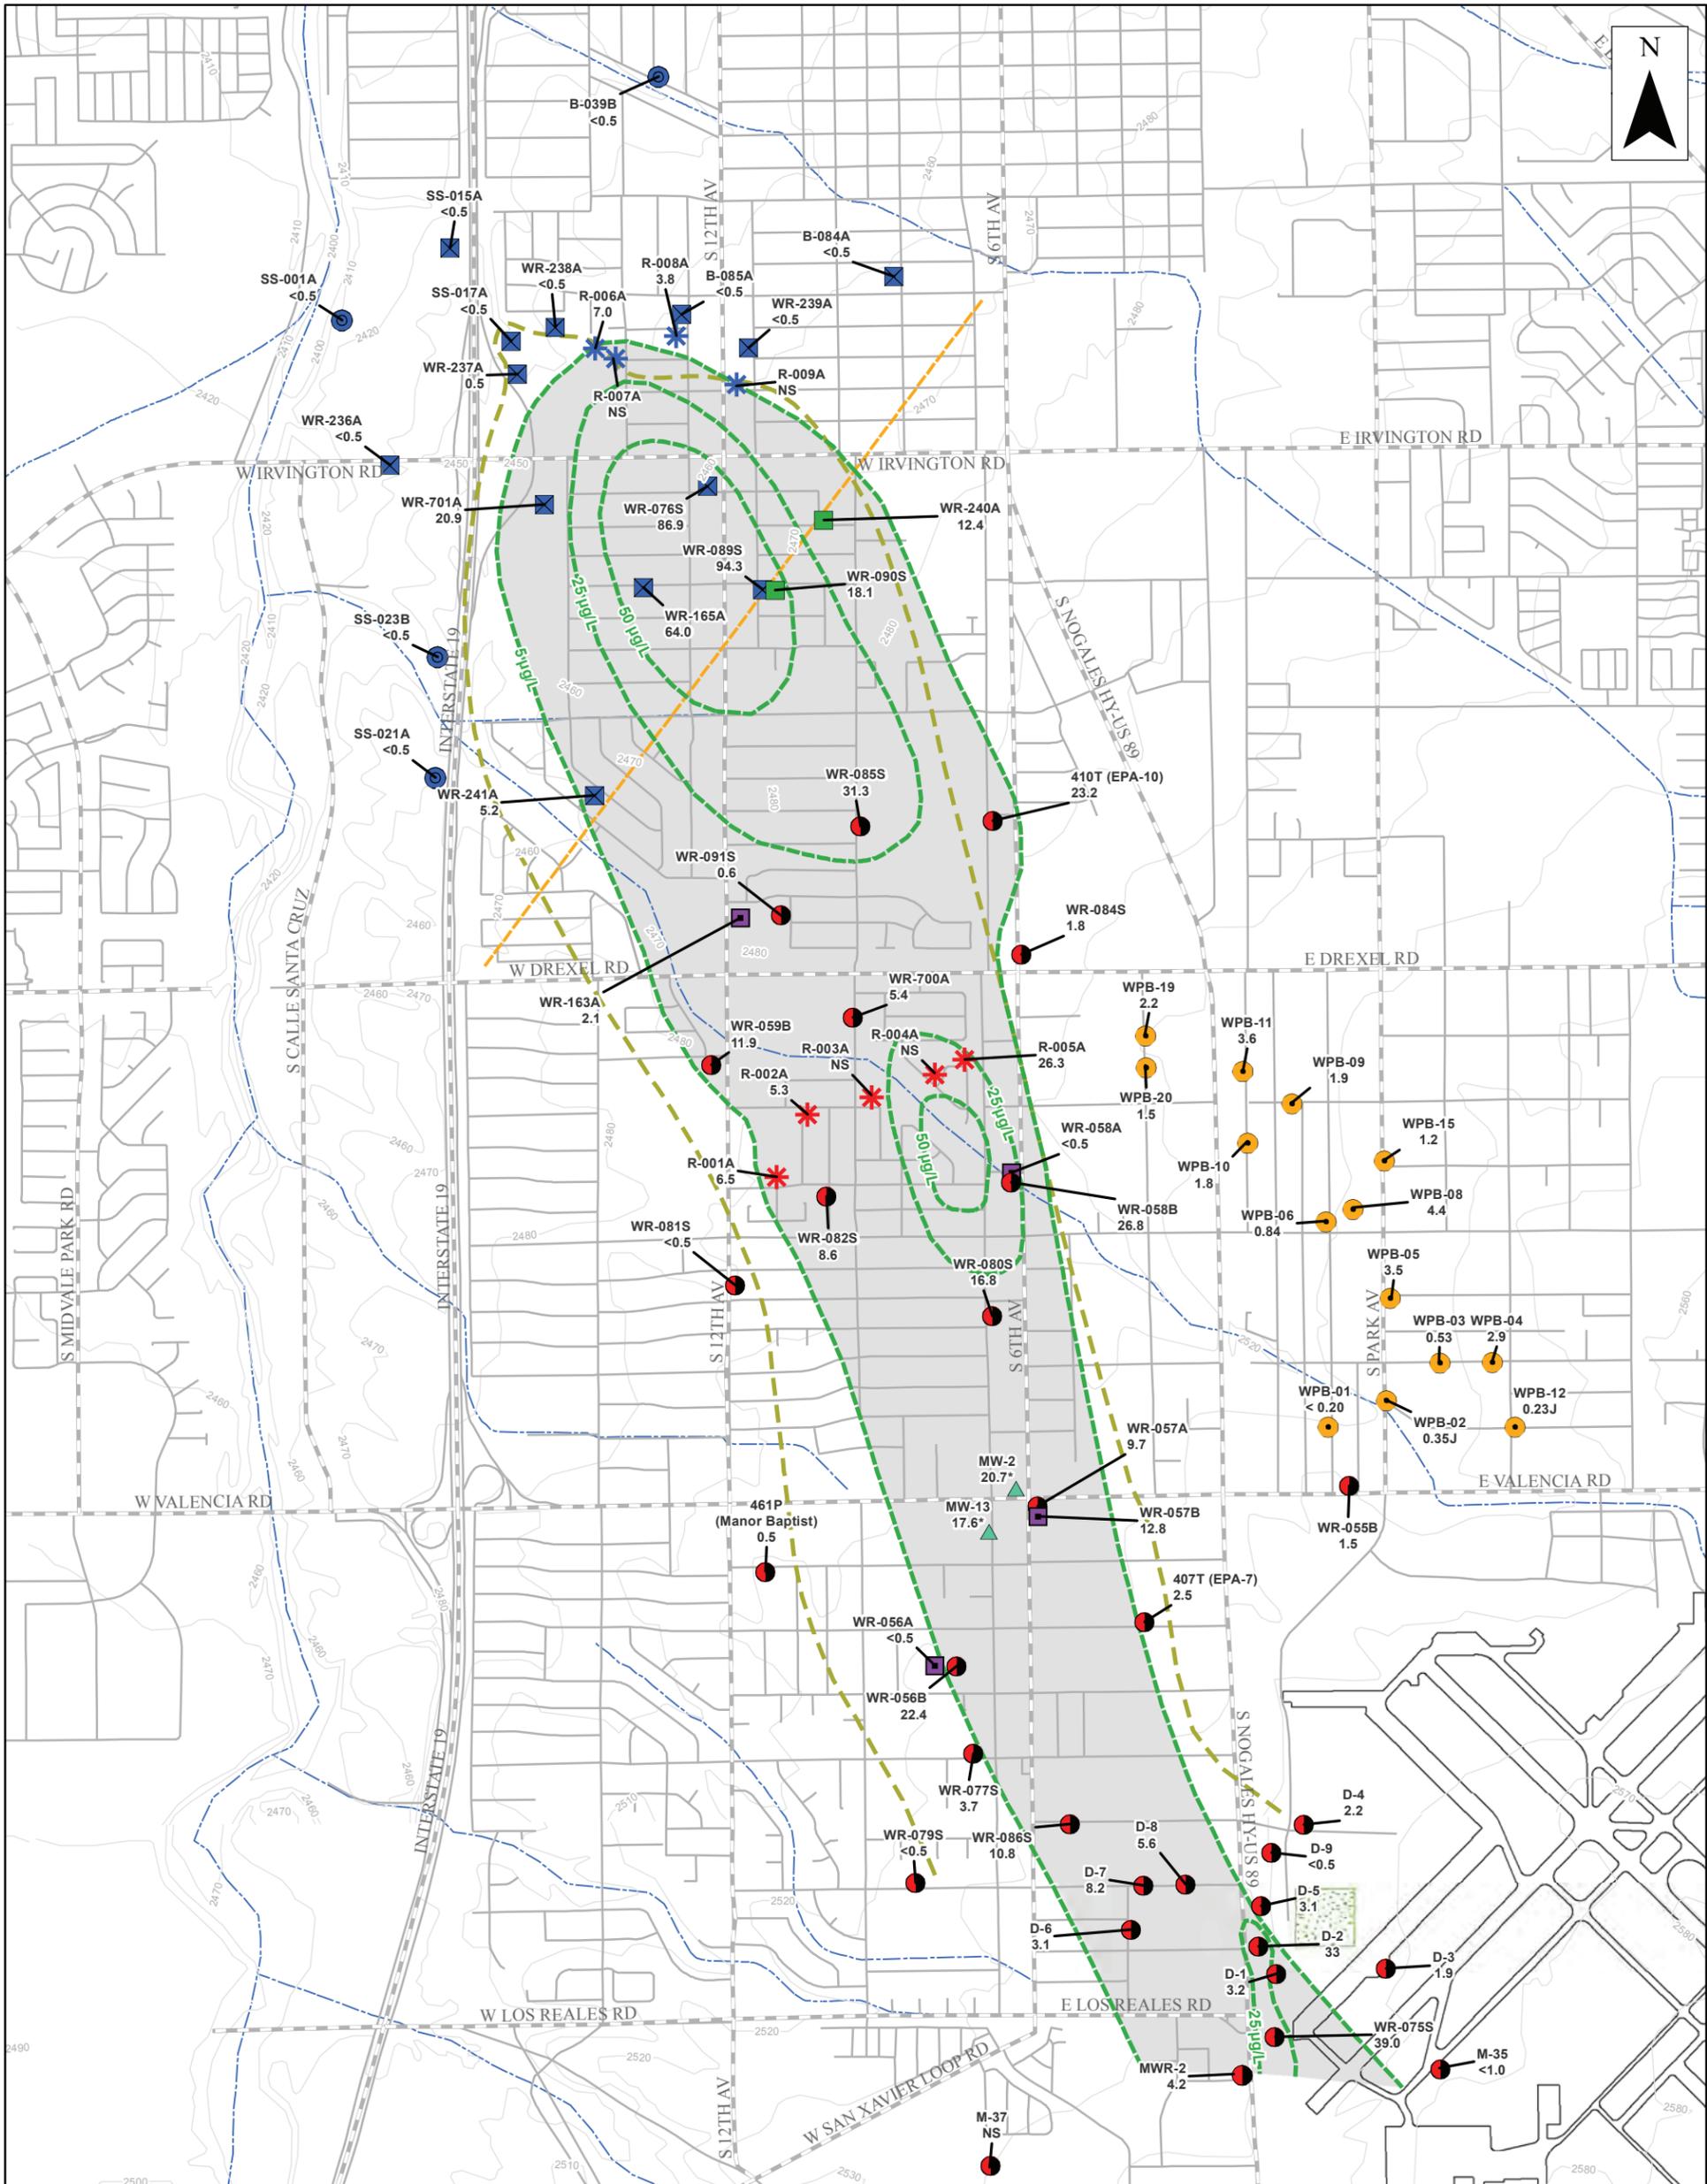
FIGURE 3
TCE Concentrations in the TARP Area,
February 2012
Tucson International Airport Area
Superfund Site
Tucson, Arizona

The North Well Field extraction wells of the TARP groundwater system have been successful in maintaining hydraulic capture of the TCE plume boundary of the regional aquifer in the TARP area. Figure 3 indicates that the TCE plume is decreasing in width along the western boundary. In addition, groundwater capture to the northwest is evidenced by the absence of TCE detected at sentinel wells WR-237A, WR-238A, and WR-239A. The highest TCE concentration at the North Well Field is observed at remediation well R-007A at 24 µg/L and the highest TCE concentration at the South Well Field is observed at remediation well R-004A at 47 µg/L.

Concentrations of TCE near well 410T, located on the eastern plume boundary, have been increasing since 1999. TCE concentrations in groundwater samples from monitoring well 410T have increased from approximately 2.9 µg/L (June 1999) to 23.2 µg/L (February 2012). The cause(s) of the increase has not yet been determined. Groundwater in this area appears to be captured by the extraction wells but the increase in TCE concentrations indicates that complete capture may not be occurring upgradient of this area in OU2. Other wells in the area (for example, wells WR-085S and the South Well Field extraction wells) show stable or declining concentrations of TCE.

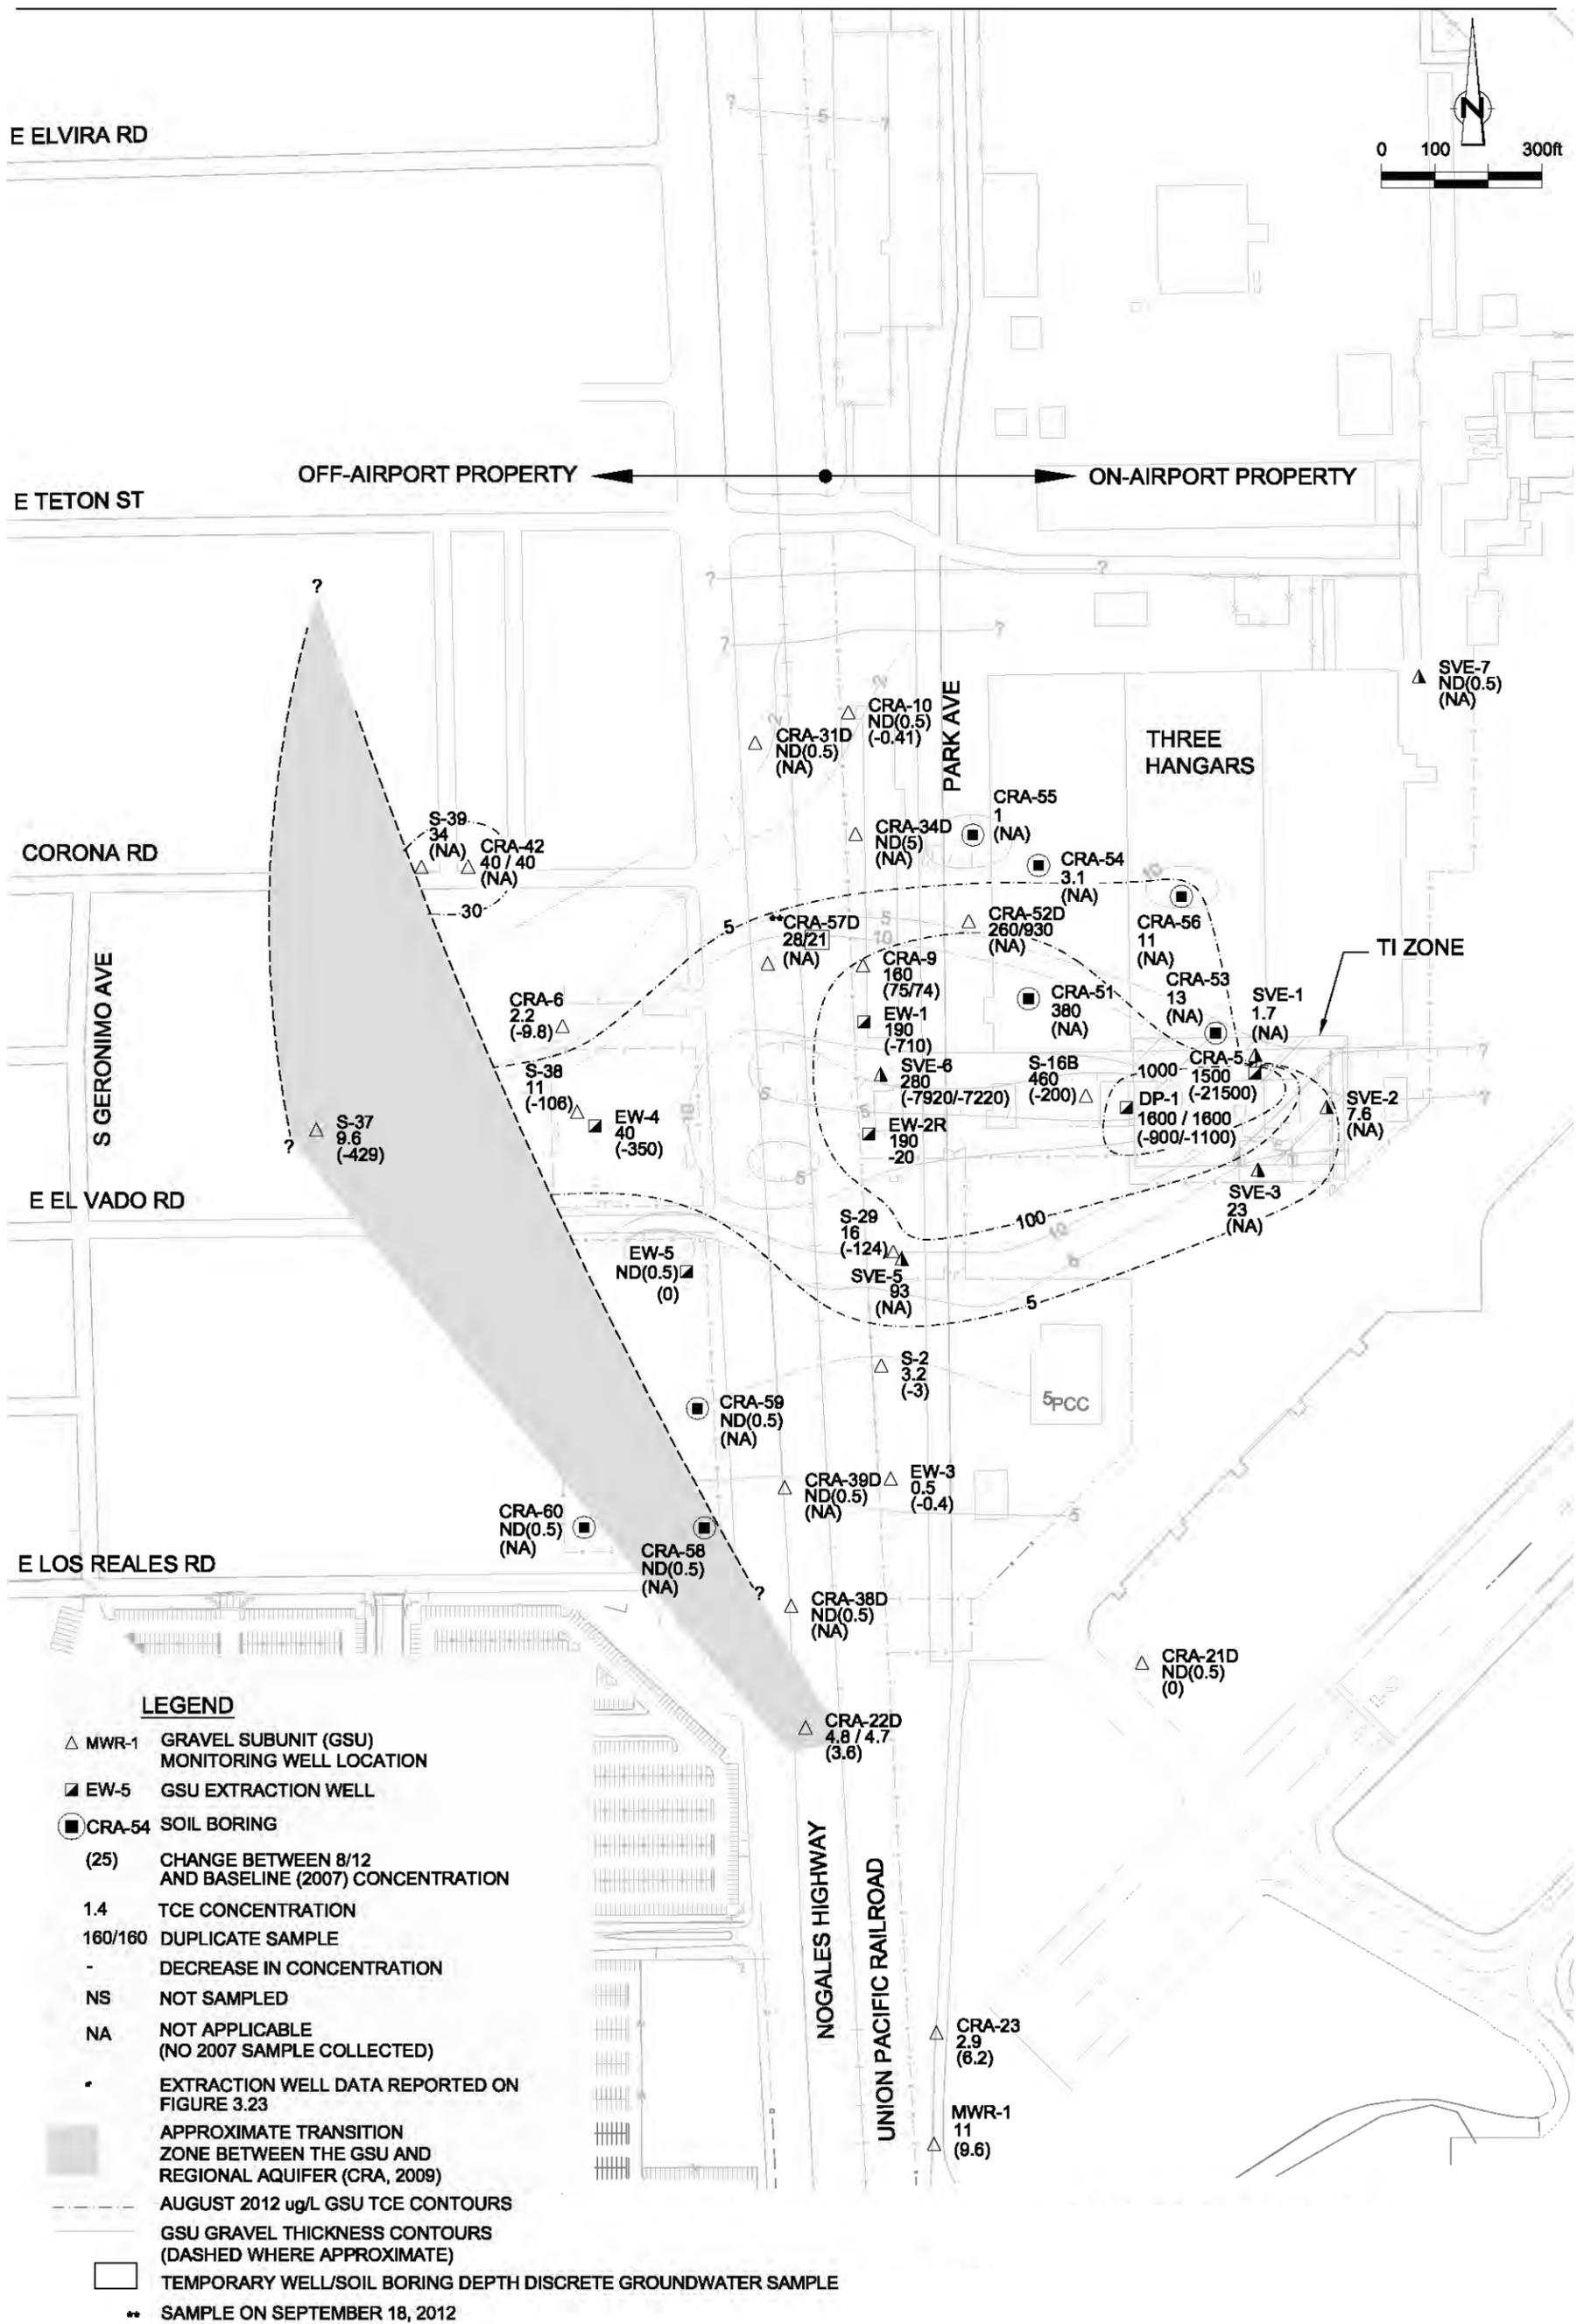
FIGURE 4
TCE Concentrations in the Airport Property GSU, August 2012
 Tucson International Airport Area Superfund Site
 Tucson, Arizona

Extraction well EW-4 exhibits localized TCE plume capture as evidenced by the decrease in TCE concentrations from baseline concentrations to August 2012 concentrations noted in monitoring wells S-37 (480 µg/L to 9.6 µg/L), S-38 (440 µg/L to 11 µg/L), and S-21B (370 µg/L to 13µg/L). However, the increasing TCE concentrations noted at monitoring wells S-39 (currently 34 µg/L) and CRA-42 (40 µg/L), located downgradient of the groundwater remedy capture zone suggest that the well may not be containing all of the TCE-impacted groundwater in the northwestern portion of the plume. Although there may not be capture at this location, any contamination that might migrate away would be captured by the TARP (OU1).
