OPERATIONS & MAINTENANCE SUMMARY REPORT

**BROWN & BRYANT, ARVIN FACILITY
SUPERFUND SITE, FIRST OPERABLE UNIT
REMEDIAL ACTION**

ARVIN, CALIFORNIA

May 2012

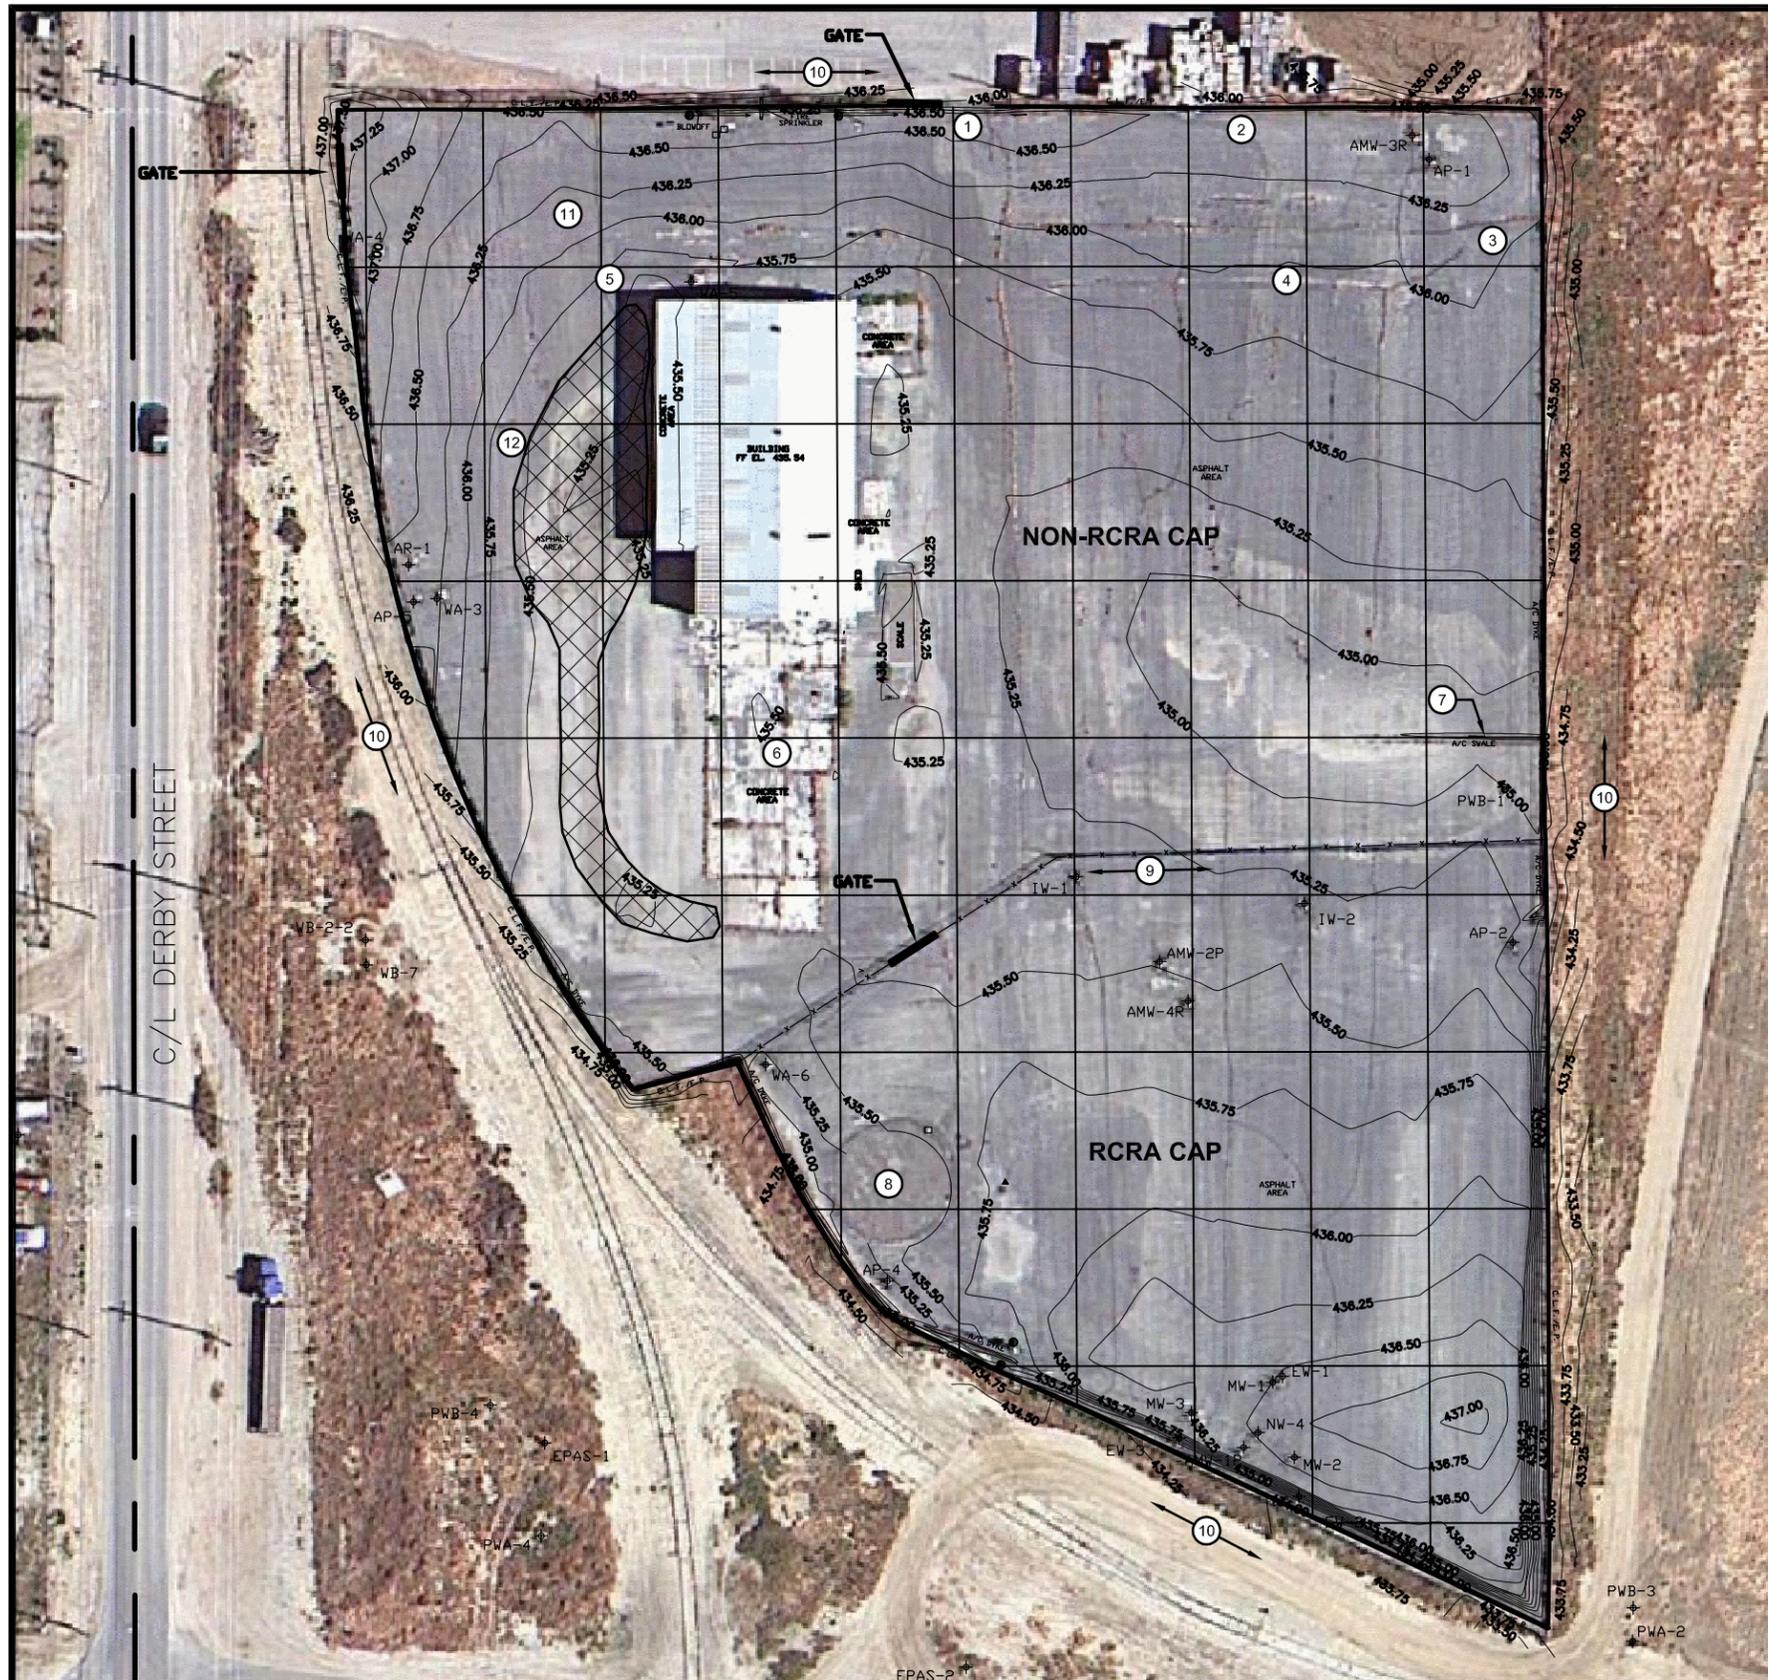
1. 2 SMALL HOLES, ABOUT 1-INCH IN DIAMETER, WERE IDENTIFIED IN THE FENCE FABRIC OF THE NORTH ACCESS GATE.
2. CRACK IN THE AC, ABOUT 1/4-INCH WIDE EXTENDING NORTH FROM PREVIOUS CRACK REPAIR TO NORTHERN EDGE OF NON-RCRA CAP.

3. 1/2-INCH WIDE CRACK IN AC APPROXIMATELY 50 FEET LONG THAT RUNS ALONG THE EDGE OF A PREVIOUS PATCH REPAIR.
4. SMALL WEEDS COMING UP ALONG EXISTING CRACKS NEXT TO THE PATCH REPAIR.

5. PONDING WATER ON CAP FROM RECENT STORM EVENT.
6. WEEDS IN CRACKS AT THE CONCRETE SLAB.
7. CRACK, APPROXIMATELY 1/2-INCH WIDE ON BOTH EDGES OF A 24-INCH WIDE SWALE. WEEDS GROWING OUT OF THE CRACK IN THE AC PAVEMENT. THE CRACK BECOMES MORE PRONOUNCED AS IT MOVES TO THE EDGE OF THE AC.

8. LOCATION OF THE FORMER TANK (UN-32 TANK) ON THE RCRA CAP. NO CRACKS OR DETERIORATION OBSERVED.
9. THE FENCING THAT DIVIDES THE NON-RCRA CAP AND THE RCRA CAP IS IN GOOD CONDITION AND THE ASPHALT CAP HAS NO SIGNS OF CRACKING.

10. FENCE POST, FABRIC AND STANCHIONS ARE IN GOOD SHAPE ALONG THE EXTERIOR SITE FENCING EXCEPT AS NOTED IN COMMENT 1 ABOVE.
11. SMALL CRACKS EXTENDING FROM RECENTLY REPAIRED CRACK REPAIRS.

12. SMALL CRACKS EXTENDING FROM RECENTLY REPAIRED CRACK REPAIRS.

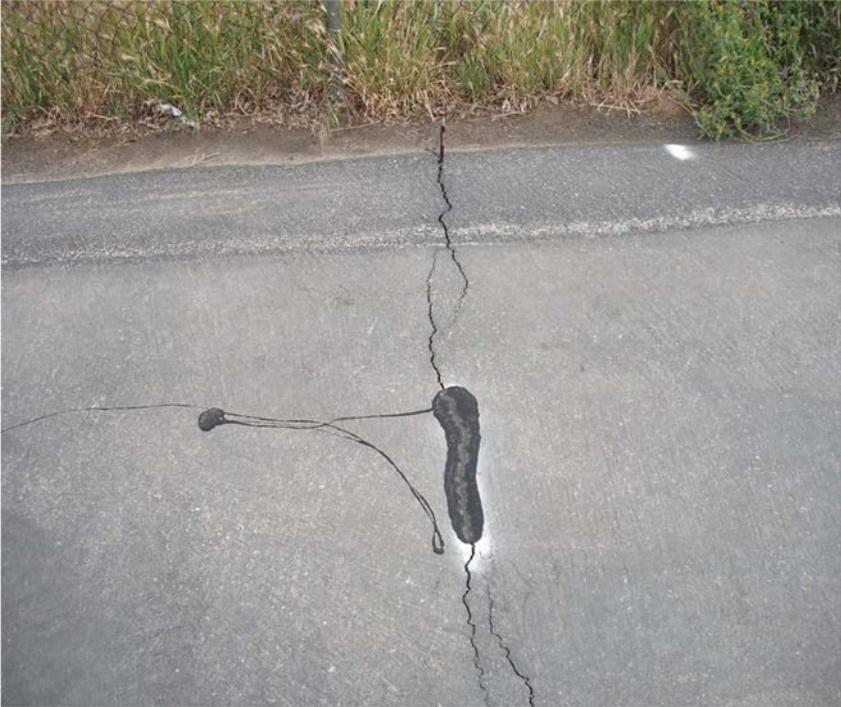
PHOTO NO: B&B-2012-01
		LOCATION: Non-RCRA Capped Area Map Location Number: 2
		DESCRIPTION: Crack in asphalt cap, approximately 0.25-inch wide, extending north from previous crack repair to northern edge of non- Resource Conservation and Recovery Act (RCRA) cap.

Finding Identifier	Description of Finding	Repair Recommendation
1	Two small holes, approximately 1-inch diameter, were identified in the fence fabric of the north access gate.	Repair chain-link fence fabric to eliminate holes.
2	Crack in asphalt cap, approximately 0.25 inch wide, extending north from previous crack repair to northern edge of non-Resource Conservation and Recovery Act (RCRA) cap (approximately 50 feet long).	Cracking is of low severity; recommend further monitoring.
3	0.5-inch-wide crack in asphalt cap, approximately 50 feet long running along the edge of a previous patch repair.	Cracks are of low to medium severity. Continue to monitor cracks less than 0.25 inch wide. For crack widths greater than 0.25 inch, recommend sealing the crack with a sealant that meets Caltrans specifications for crack treatment section 37-5 (Caltrans, 2010), or equivalent. The crack treatment material specifications from Caltrans Standard Specifications 37-5 are included in Attachment C for ease of reference.

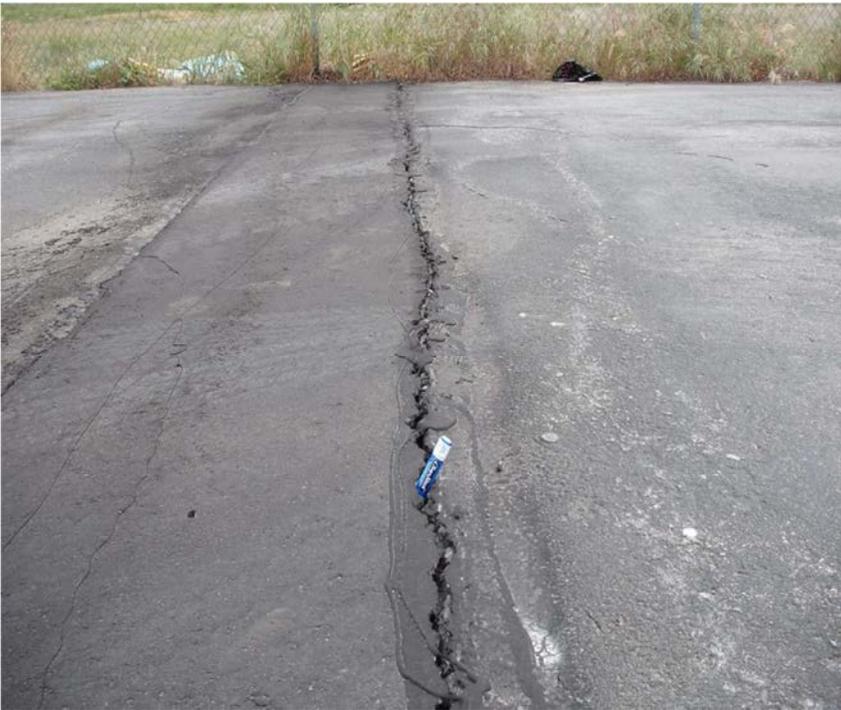
PHOTO NO: B&B-2012-02
		LOCATION: Non-RCRA Capped Area Map Location Number: 3
		DESCRIPTION: Close up of 0.5-inch-wide crack in asphalt cap, approximately 50 feet long, running along the edge of a previous patch repair; looking east in northeast area of non-RCRA cap.

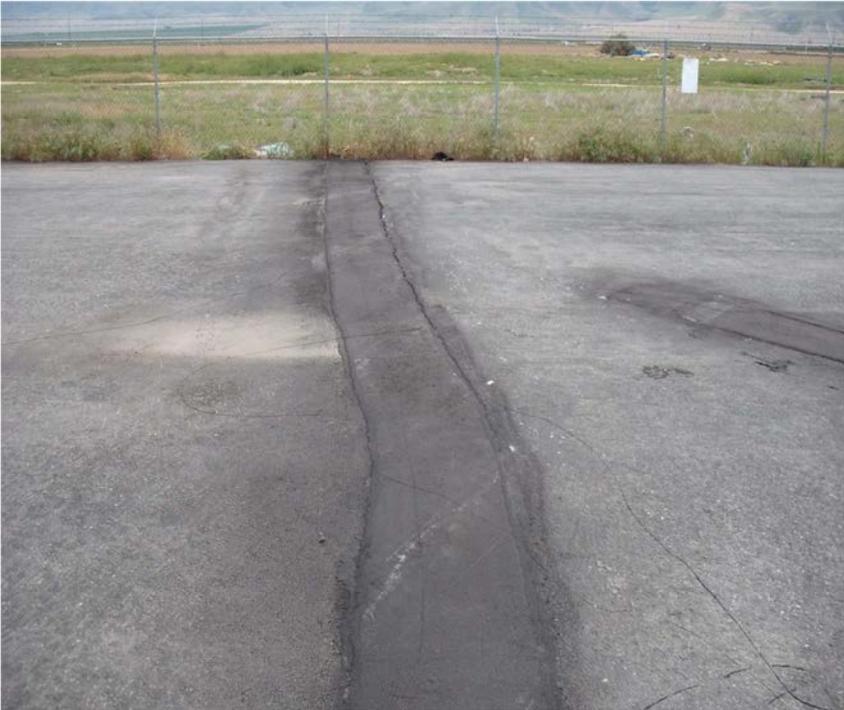
PHOTO NO: B&B-2012-03
		LOCATION: Non-RCRA Capped Area Map Location Number: 3
		DESCRIPTION: Full view of area of 0.5-inch-wide crack in asphalt cap, approximately 50 feet long, running along the edge of a previous patch repair; looking east in northeast area of non-RCRA cap.

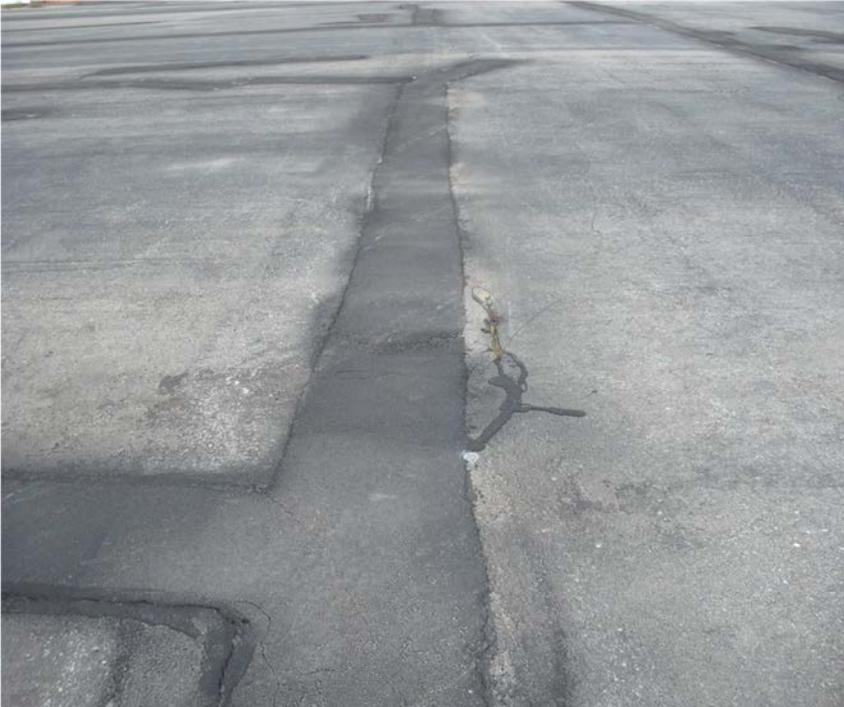
PHOTO NO: B&B-2012-04
		LOCATION: Non-RCRA Capped Area Map Location Number: 4
		DESCRIPTION: Small weeds growing along existing cracks next to the patch repair; looking west in northeast area of non-RCRA cap.

4	Small weeds growing from existing less than 0.25-inch-wide cracks next to the patch repair.	Remove weeds and seal cracks with a sealant that meets Caltrans specifications for crack treatment section 35-7 (Caltrans, 2010), or equivalent.
5	Ponding water on cap from recent storm event.	Continue to monitor quality of asphalt where ponding is occurring. If asphalt degrades, consider re-grading to sheet water from the non-RCRA cap.
6	Weeds growing from cracks of variable widths at the concrete slab.	Remove weeds and seal crack. The concrete slab failure is a divided slab of medium severity. Seal cracks with sealant that meets Caltrans specifications for concrete repair section 41 (Caltrans, 2010), or equivalent.
7	Crack, approximately 0.5 inch wide, on both edges of a 24-inch-wide swale. Weeds growing from crack in the asphalt cap pavement. The crack becomes more pronounced as it moves to edge of asphalt cap.	Remove weeds and seal crack. The joint along the swale has separated resulting in medium severity joint cracking. Seal cracks with a sealant that meets Caltrans specifications for crack treatment section 37-5 (Caltrans, 2010), or equivalent.

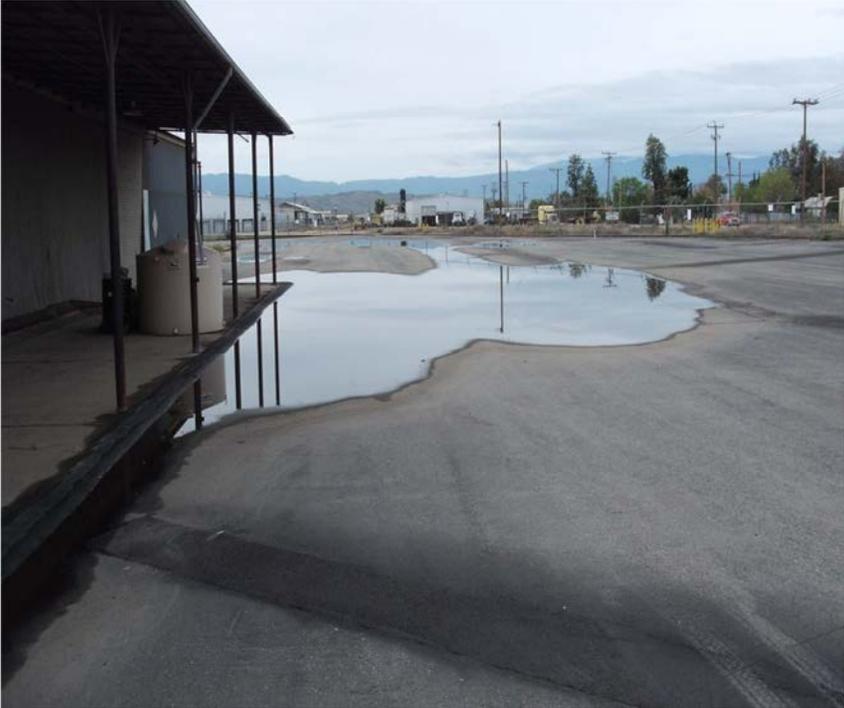
PHOTO NO: B&B-2012-05 LOCATION: Non-RCRA Capped Area Map Location Number: 5 DESCRIPTION: Ponding water on cap from recent storm event; looking south on western side of non-RCRA cap.

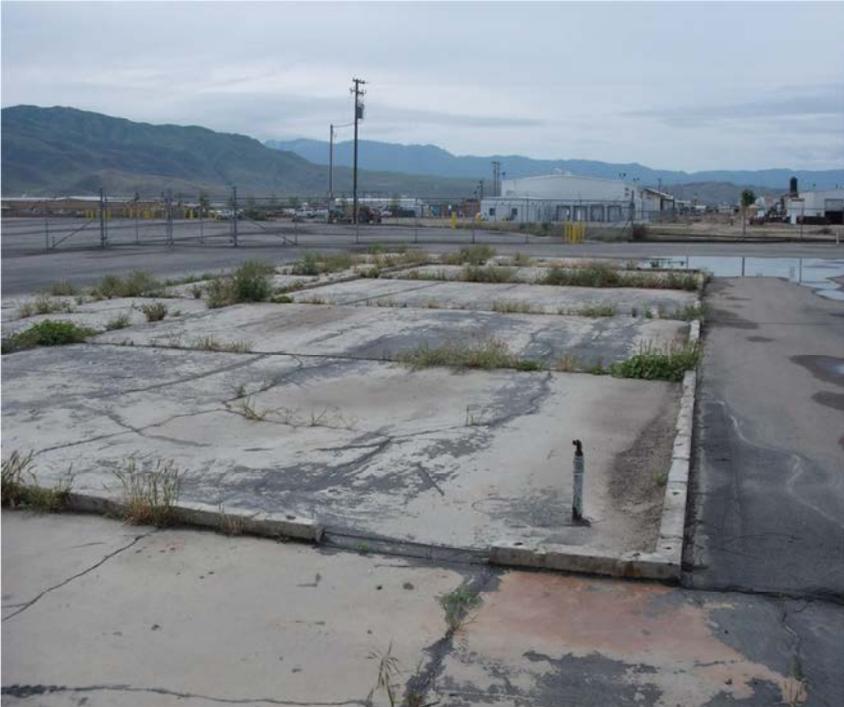
PHOTO NO: B&B-2012-06 LOCATION: Non-RCRA Capped Area Map Location Number: 6 DESCRIPTION: Weeds growing from cracks at the concrete slab just south of the building on the western side on non-RCRA cap.

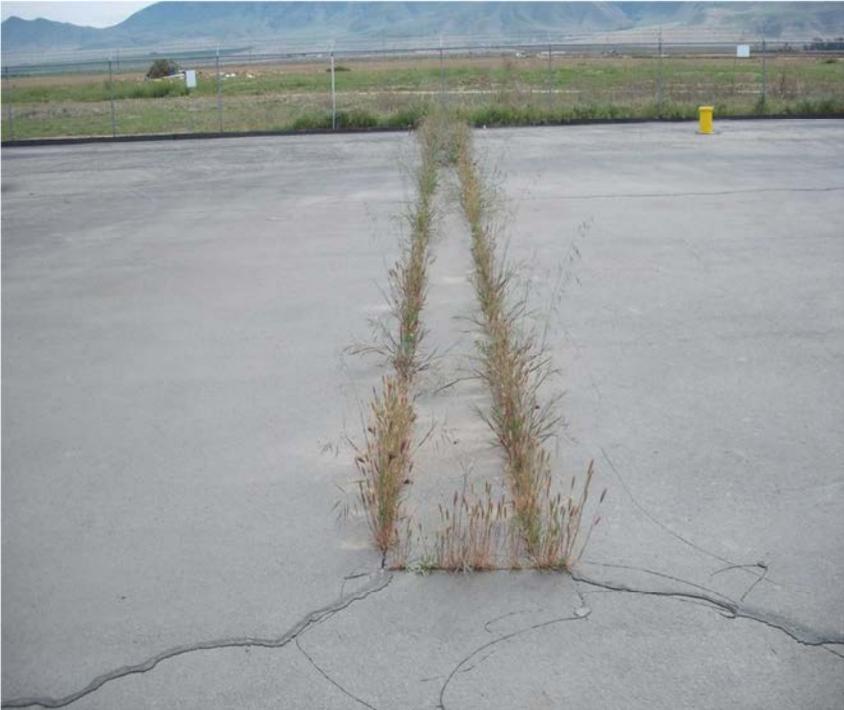
PHOTO NO: B&B-2012-07 LOCATION: Non-RCRA Capped Area Map Location Number: 7 DESCRIPTION: Crack, approximately 0.5 inch wide on both edges of a 24-inch-wide swale. Weeds growing from crack in the asphalt cap pavement. The crack becomes more pronounced as it moves to the edge of the asphalt cap. Located at the swale on the east side of the non-RCRA cap; looking east.

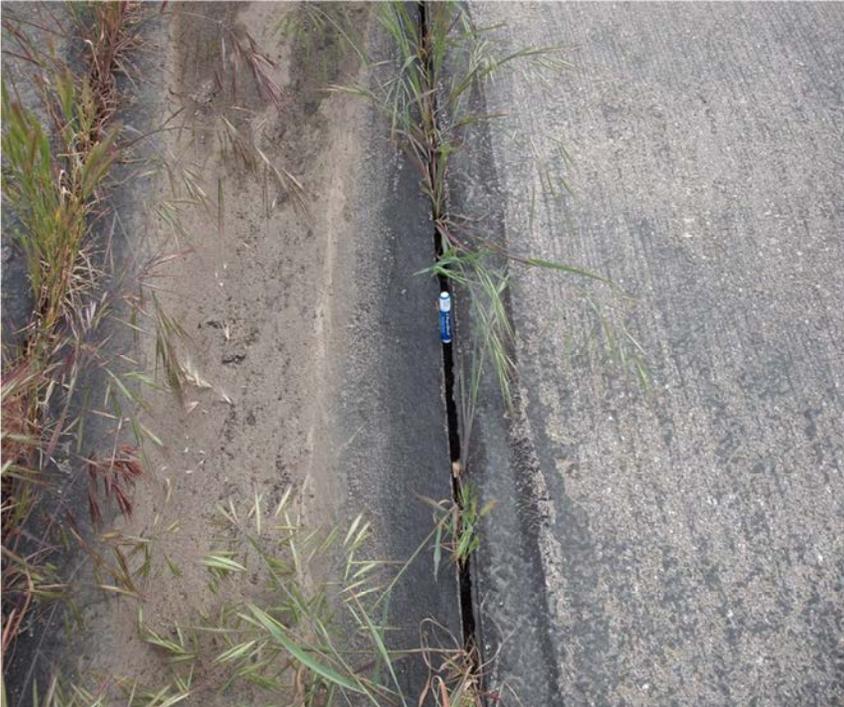
PHOTO NO: B&B-2012-08 LOCATION: Non-RCRA Capped Area Map Location Number: 7 DESCRIPTION: Close up of the crack on the edge of the swale. Crack is approximately 0.5 inch wide on both edges of a 24-inch-wide swale. Crack becomes more pronounced as it moves to the edge of the asphalt cap, located at the swale on the east side of the non-RCRA cap.

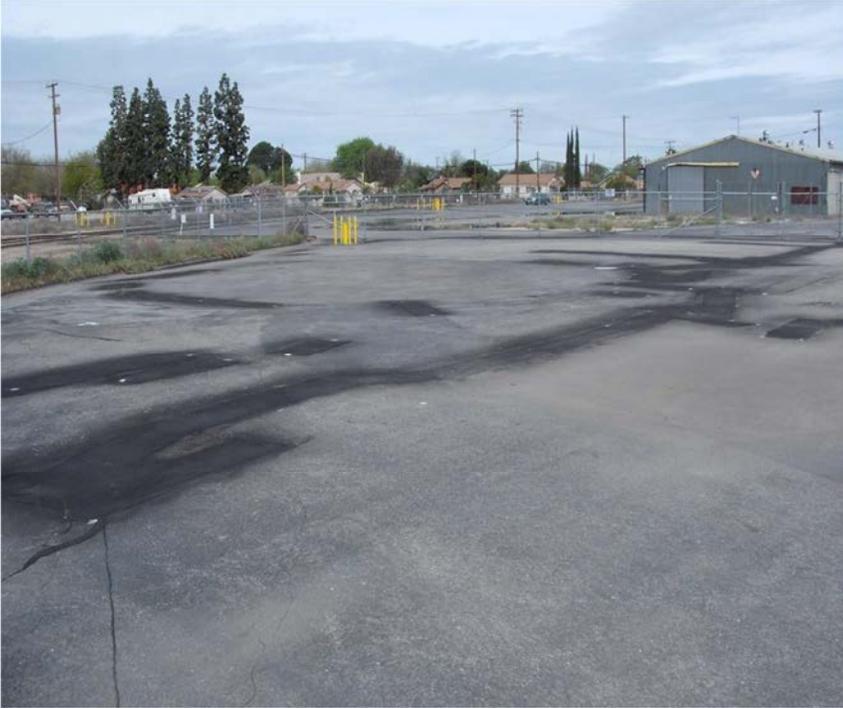
PHOTO NO: B&B-2012-09 LOCATION: Non-RCRA Capped Area Map Location Number: 8 DESCRIPTION: Location of the former tank (UN-32 Tank) on the RCRA cap. No cracks or deterioration observed.

Finding Identifier	Description of Finding	Repair Recommendation
8	Location of the former tank (UN-32 Tank) on the RCRA cap. No cracks or deterioration observed.	No repair recommendation required.
9	Fencing that divides the non-RCRA cap from RCRA cap is in good condition and asphalt cap has no signs of cracking.	No repair recommendation required.
10	Fence post, fabric, and stanchions are in good shape along the exterior site fencing, except as noted in item #1 above.	No repair recommendation required.
11	Small cracks extending from recently repaired crack repairs.	Cracking is low severity; recommend further monitoring.
12	Small cracks extending from recently repaired crack repairs.	Cracking is low severity; recommend further monitoring.

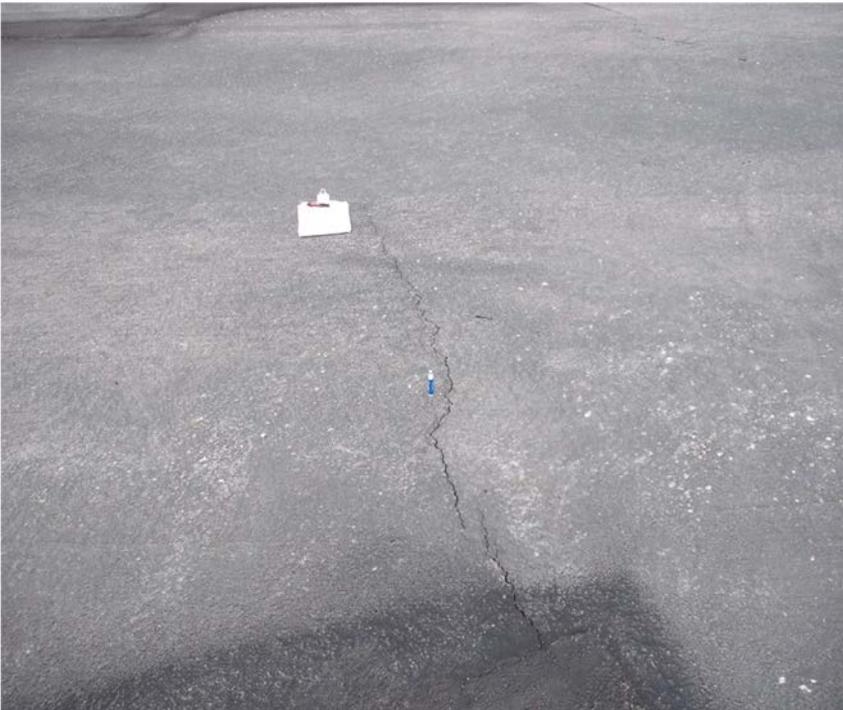
(11) Typical small crack extending from a previously repaired crack. See photos 10-12

PHOTO NO: B&B-2012-10 LOCATION: Non-RCRA Capped Area Map Location Number: 11 DESCRIPTION: Small cracks extending from recently repaired cracks. Cracks are located along west side of non-RCRA cap.

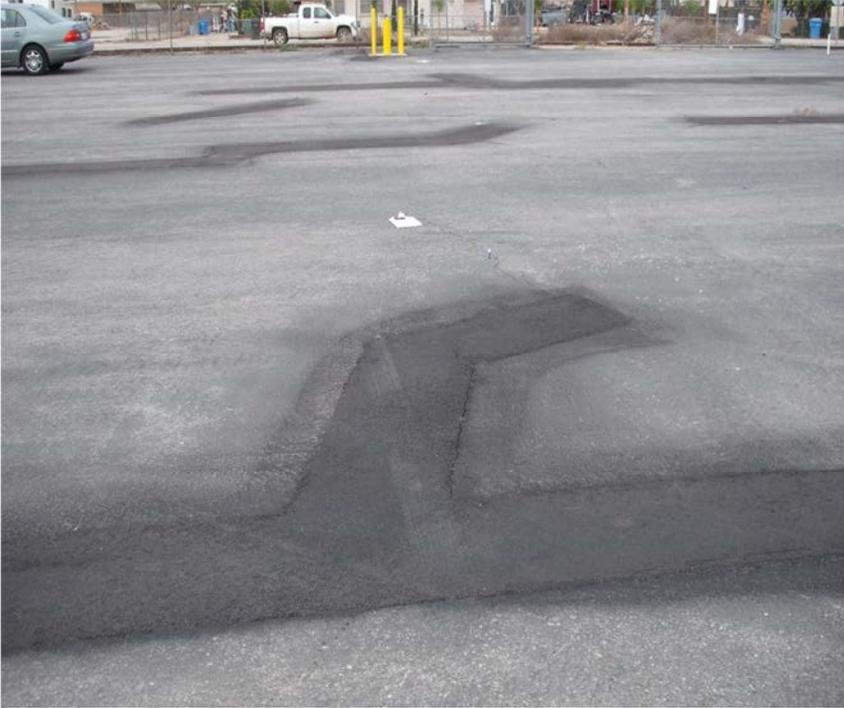
PHOTO NO: B&B-2012-11 LOCATION: Non-RCRA Capped Area. Map Location Number: 11 DESCRIPTION: Small cracks extending from recently repaired crack repairs. Cracks are located along west side of non-RCRA cap. This photo provides a larger field of view of photo B&B-2012-10 looking at the northwest corner of the non-RCRA cap.

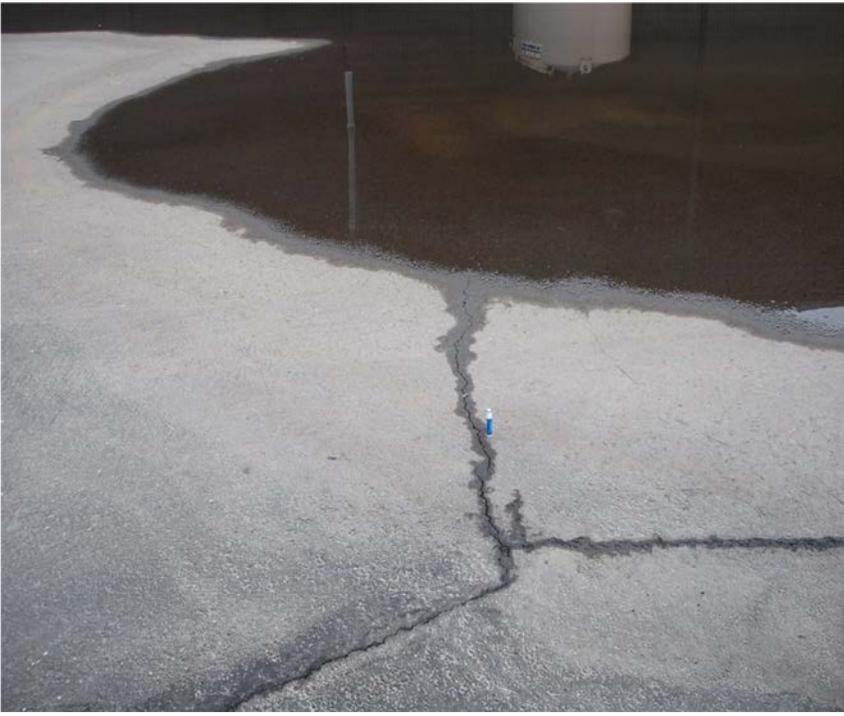
PHOTO NO: B&B-2012-12 LOCATION: Non-RCRA Capped Area. Map Location Number: 12 DESCRIPTION: Small cracks extending from recently repaired cracks. Cracks are located along west side of non-RCRA cap near the west side of the warehouse.
