Attachment 5
Site Inspection Checklist

Iron Mountain Mine Sitewide Inspection, April 3, 2008

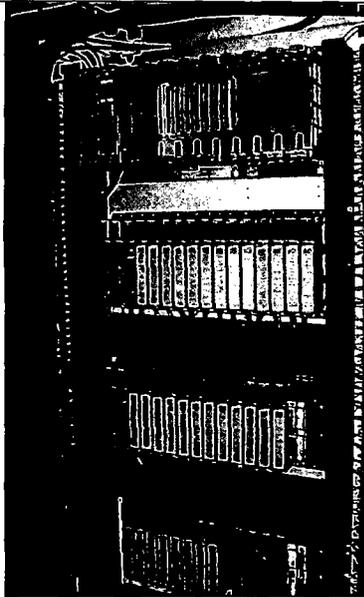
MFTP Control Center. Programmable logic controller (PLC) system updated in September 2007.

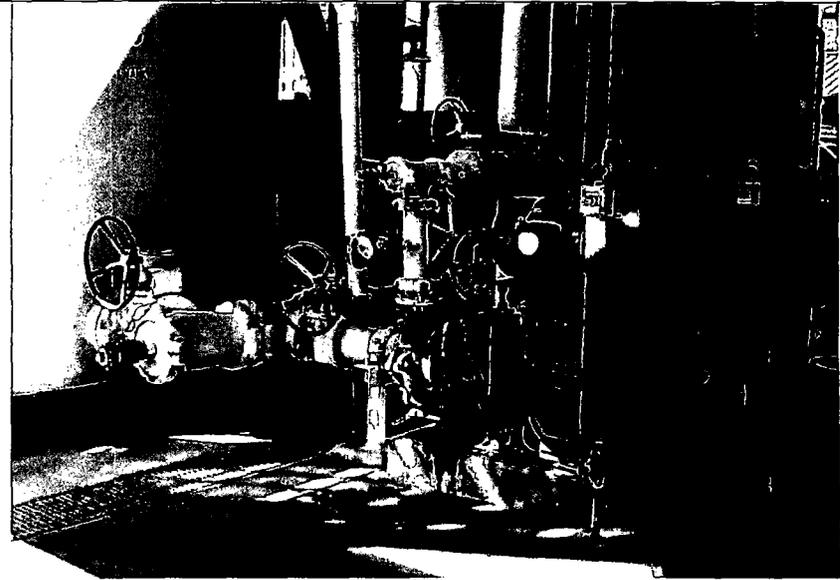
MFTP lime slurry pumps. All pumps and tanks, except the thickener, have redundancy.

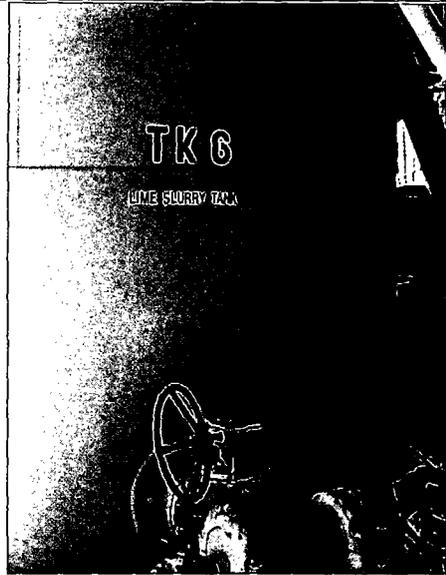
MFTP lime slurry tanks. The treatment plant has two lime slurry tanks for redundancy.

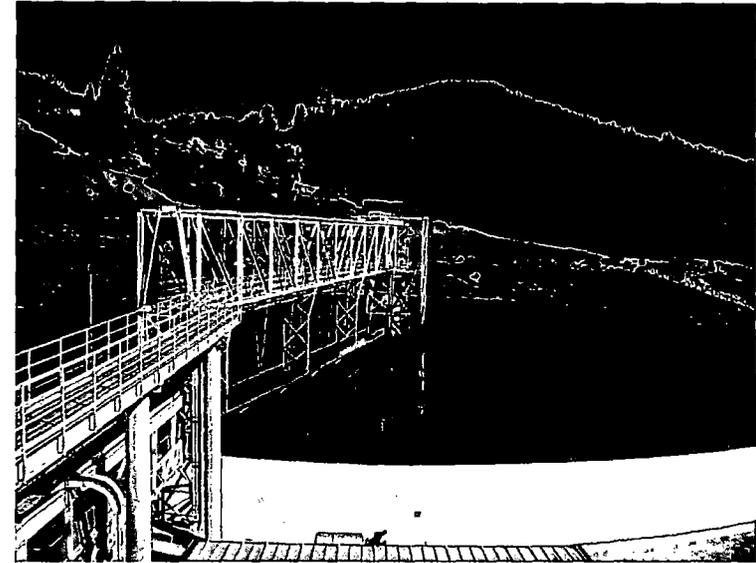
MFTP thickener. The thickener tank launder was recoated in 2007.

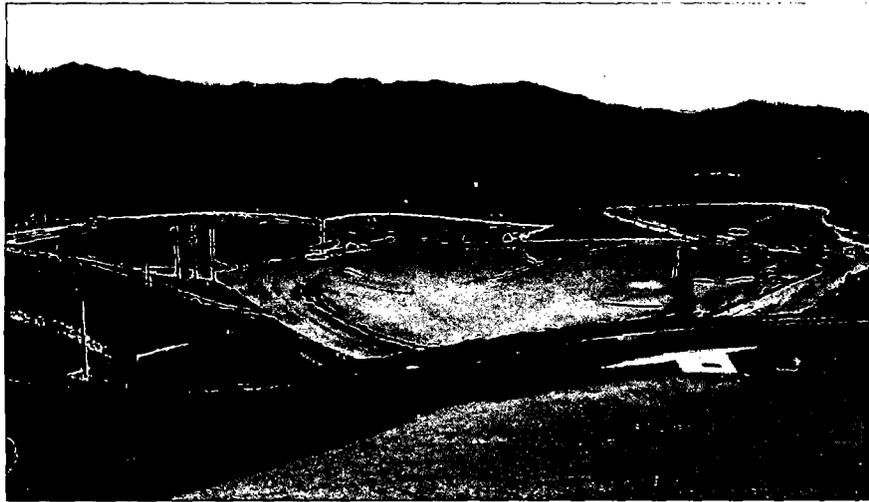
MFTP sludge drying beds. Pond # 4 was almost full and Pond # 3 was one third full, for a total sludge volume of about 20,000 yd³.

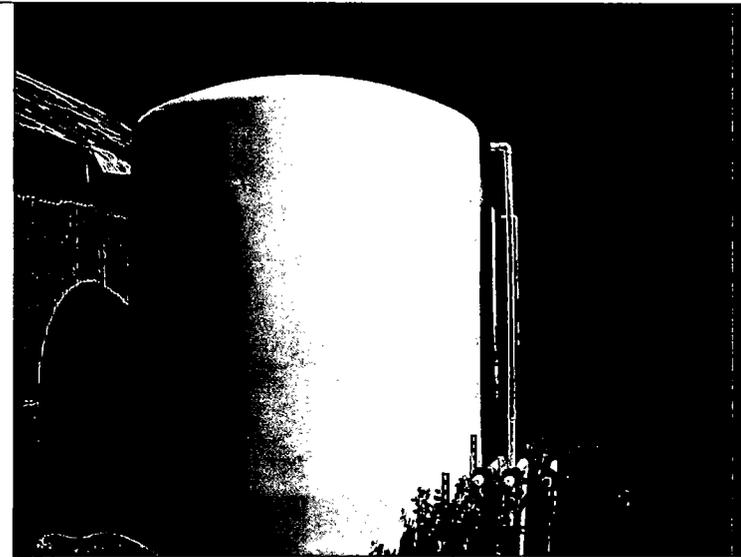
Three 6,500-gallon poly tanks are on the east side of the shed. Per IMO discussion with Ted Arman, the tanks contain raw Acid Mine Drainage, Sodium Silicate, and Ag-Gel fertilizer product.

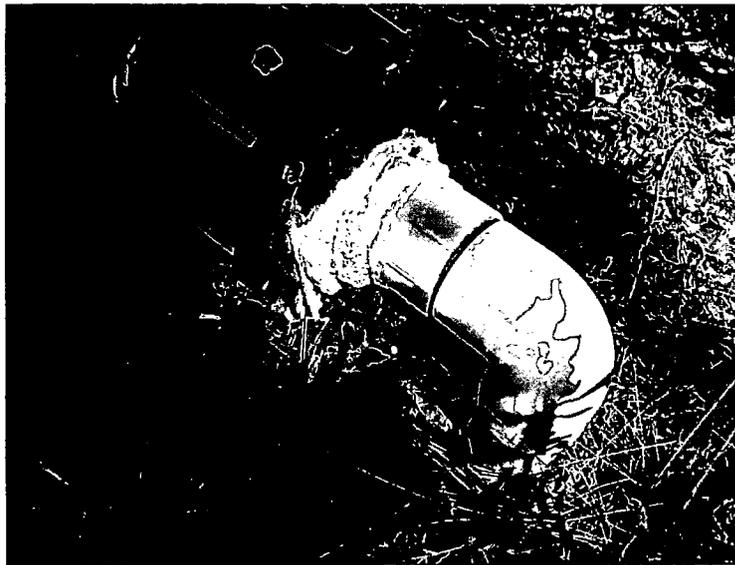
Precipitates on the pipe connection for the middle poly tank, located east of the shed, indicates a leak. There is no secondary containment.

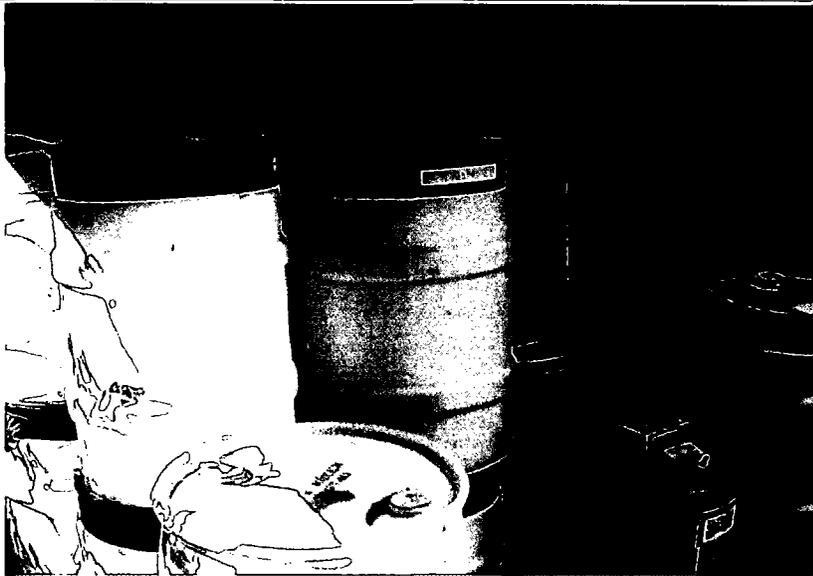
55-gallon drums stored on north side of warehouse. Many of the drums were empty.

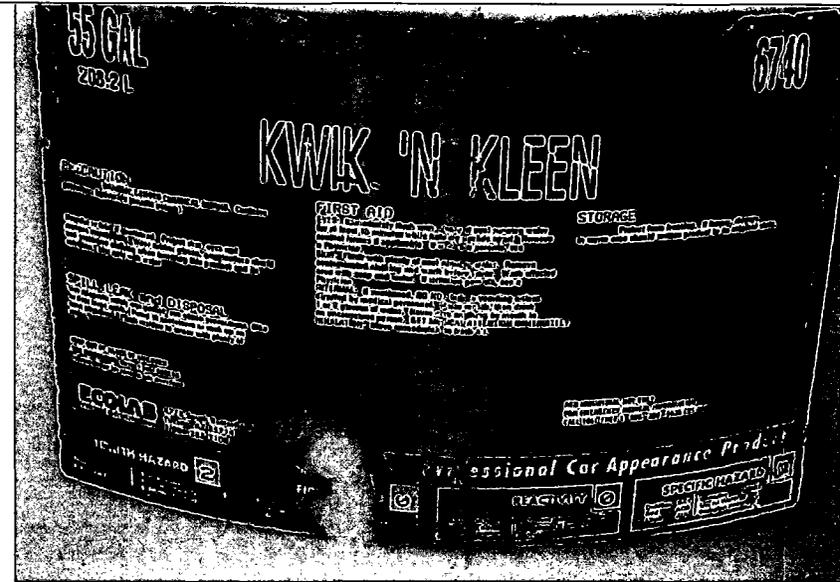
Label on one 55-gallon drum. Contains potassium hydroxide (caustic potash), which is listed as a corrosive health hazard.

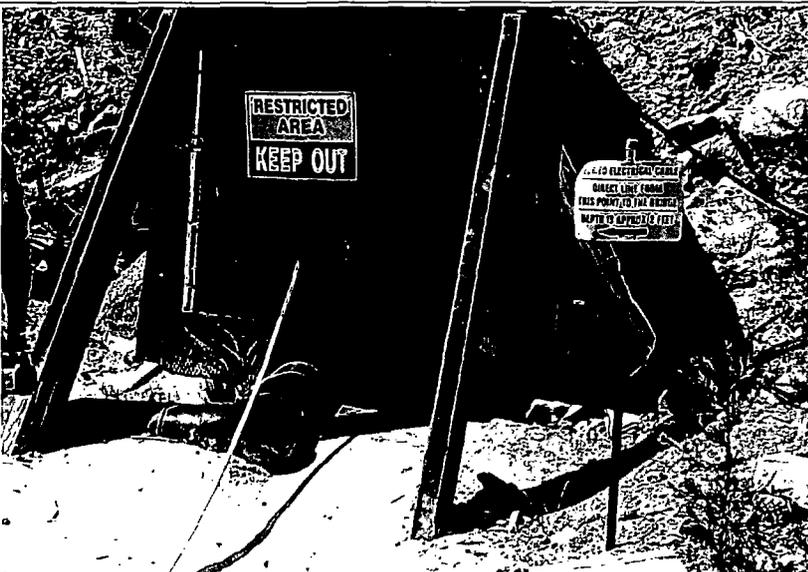
Lawson Portal. AMD pipeline was encased in concrete to protect the pipeline from falling rocks.

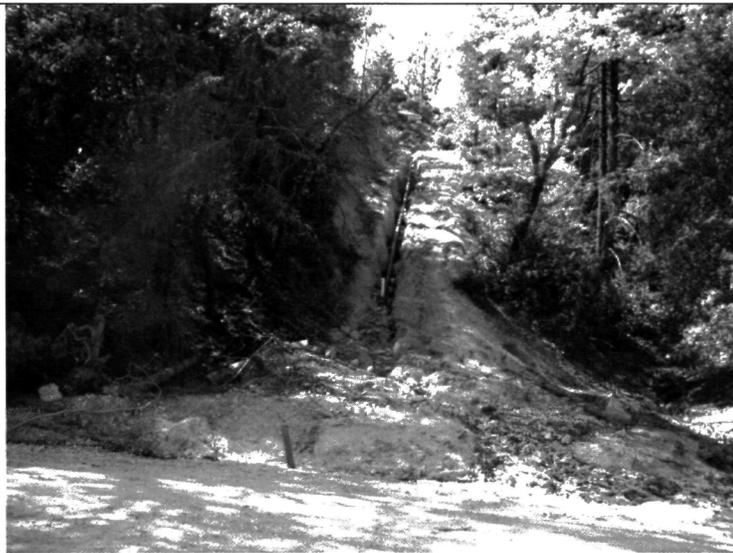
On December 18, 2007, a leak of the AMD pipeline occurred near Road Marker 16.5 near the intersection of the AMD pipeline and the filtrate pipeline that extends from the Mine Waste Disposal Cell. The pipeline was immediately shut down, and temporary repairs were made with rubber couplings so that the pipeline could be returned to service to handle the high flows from SCRR caused by heavy rains (IMO, 2008d). On January 4, 2008, during heavy rainfall, the temporary rubber coupling repair failed where the Mine Waste Disposal Cell filtrate pipeline enters the AMD pipeline. Due to the 4 inches of rainfall that occurred on that date, the leak could not be stopped until January 5, 2008. Permanent repairs were completed on the pipeline on January 8, 2008, when stainless steel band clamps arrived (IMO, 2008b).

On 12/18/07, a leak of the AMD pipeline occurred near Road Marker 16.5 near the intersection of the AMD pipeline and the filtrate pipeline that extends from the Mine Waste Disposal Cell. Pipeline was repaired.

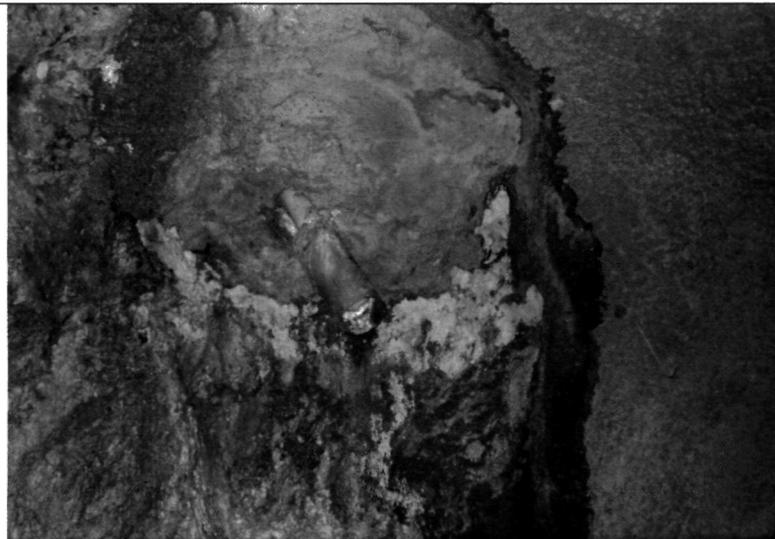
Richmond Mine. Shotcrete form has fallen off a portion of the plug. The pipe drain shown in the photo is blocked, and seepage is occurring around the edge of the chute plug.

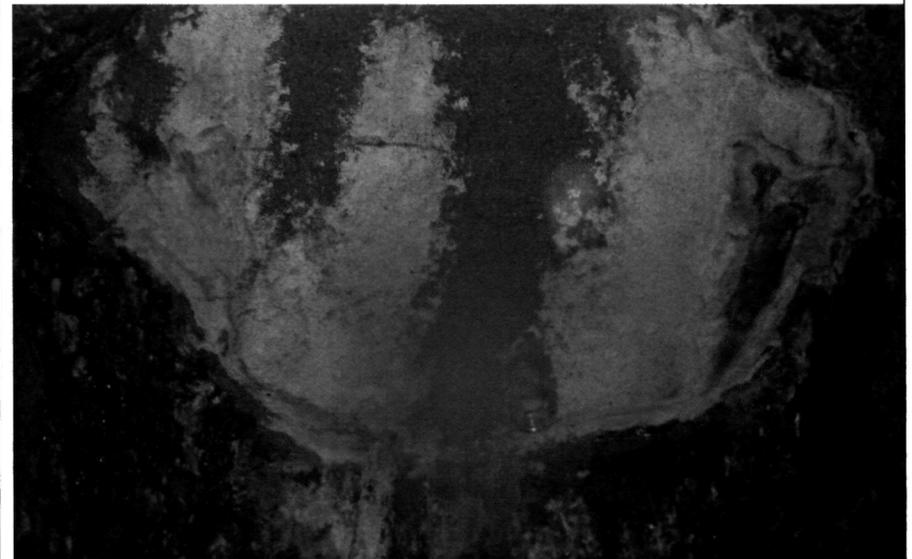
Richmond Mine. Seepage is occurring around the edge of the chute plug.

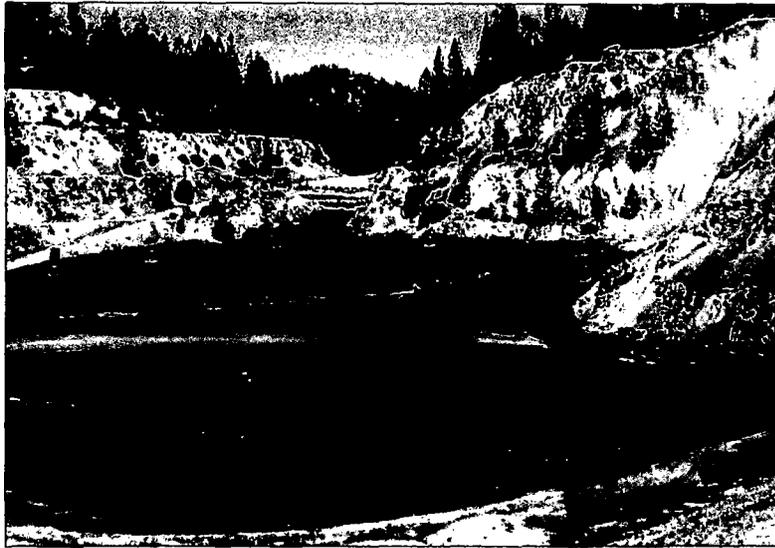
1. **Settlement (Low spots)** Location shown on site map Settlement not evident
 Areal extent _____ Depth _____
 Remarks: IMO identified a sinkhole between two of the filtrate riser pipes in Brick Flat Pit. No settlement areas were identified at the Matheson disposal cell. As part of ROD 1, EPA constructed partial caps in subsidence areas over the Richmond mineralized zone. IMO inspects, maintains, and repairs the capped subsidence areas. The annual survey of the subsidence areas and clay caps was completed on October 16, 2007. In the *October 2007 IMO Monthly Progress Report*, IMO reported that a comparison of the 2007 and 2006 surveys indicated minimal continuing vertical movement of the monitored areas.

Brick Flat Pit, looking NE. IMO will raise 4 filtrate riser pipes by 10 feet in 2008. Filtrate has decreased significantly and needs to be investigated.

4.	Leachate Extraction Wells <input type="checkbox"/> Properly secured/locked <input type="checkbox"/> Evidence of leakage at penetration	<input checked="" type="checkbox"/> Functioning <input checked="" type="checkbox"/> Needs Maintenance	<input type="checkbox"/> Routinely sampled <input type="checkbox"/> Good condition <input type="checkbox"/> N/A
Remarks: If flow occurs from the Brick Flat Pit Seep 8L, Filtrate 8R, or the spillway, the water is collected for treatment at MFTP and is monitored for pH, copper, and zinc. The amount of filtrate has decreased significantly at Brick Flat Pit. No water was collected from Brick Flat Pit during the 2007 or 2008 water years. Two possible reasons for reduced filtrate flow have been identified: (1) the filtrate piping has malfunctioned, or (2) the amount of filtrate has decreased as a result of the thickness of the overlying sludge, and the water is exiting through the unlined sidewalls of the pit. The location of Brick Flat Pit was determined to be an effective sludge disposal location because drainage, if not captured, would re-enter the ore body and be captured by the AMD treatment system (see ROD 1) or would be discharged to the Slickrock Creek drainage, which is currently captured for treatment by SCRR. IMO should continue evaluations to identify the reason for the reduced filtrate at Brick Flat Pit. IMO has scheduled 4 filtrate riser pipes at Brick Flat Pit to be extended by 10 feet during the 2008 dry season.

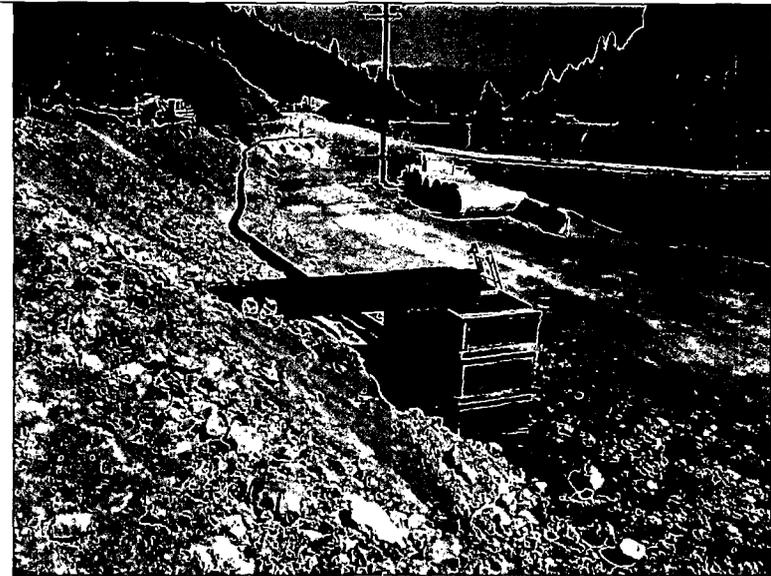
Old No. 8 gravity drain pipeline installed in March 2008. PW-3 was not being pumped at the time of the inspection.

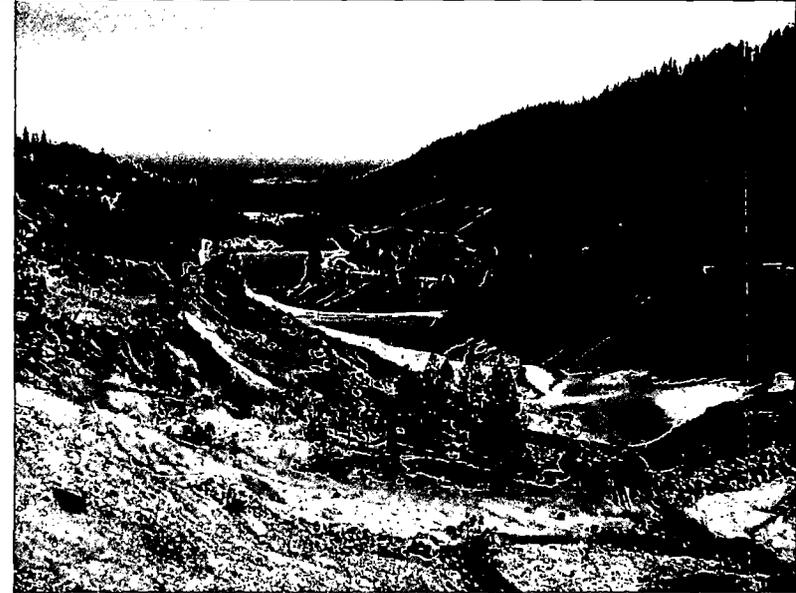
SCRR sedimentation basin and rock check dams, looking east. The rock check dams are performing well.

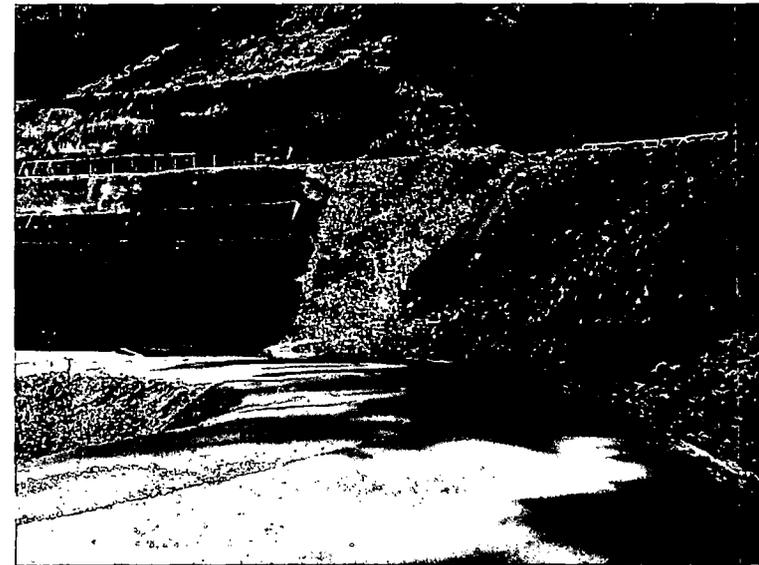
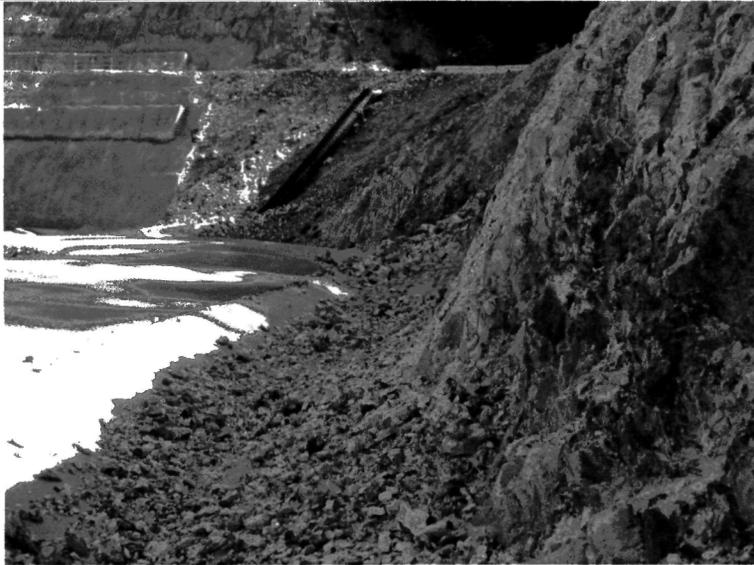
SCRR storm water channel. Rocks have accumulated in channel and need to be removed more frequently.

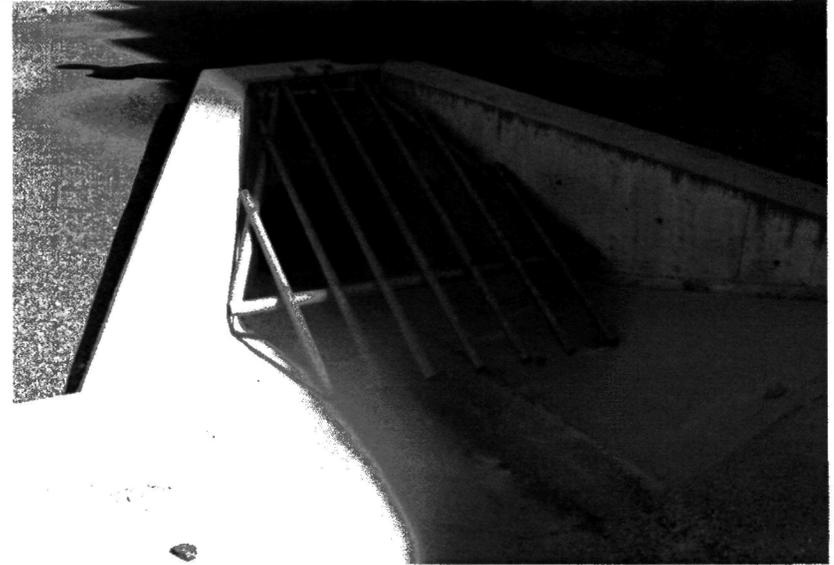
SCRR storm water channel. Gap between channel bottom and metal grate has allowed some rocks to enter spillway. Bars should be extended.

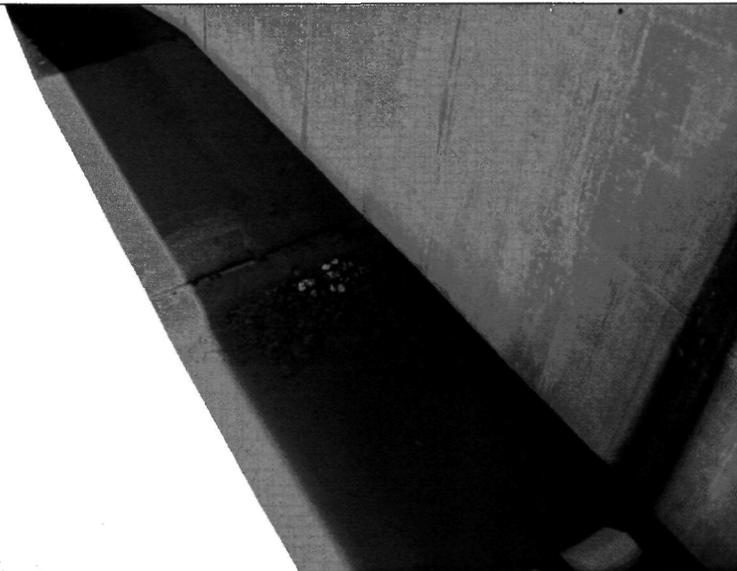
SCRR Spillway. Rocks and gravel have entered the spillway from the storm water channel.

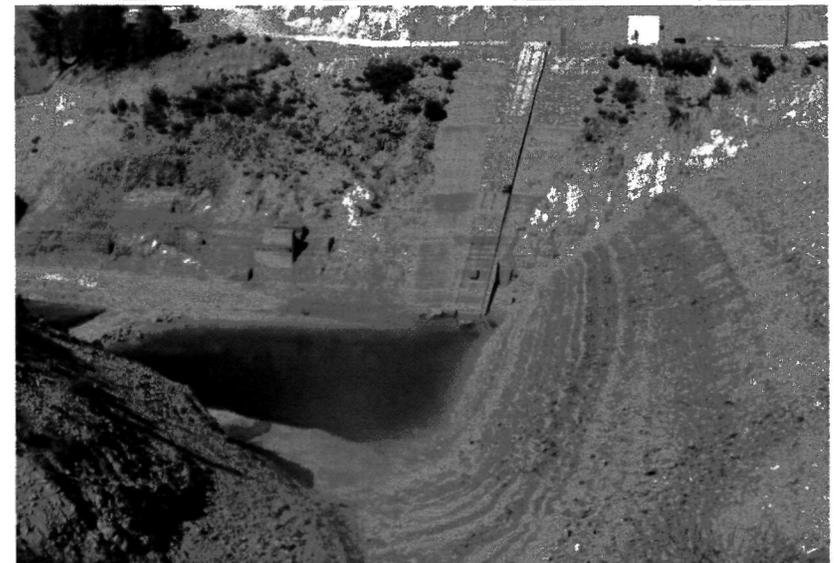
SCRR intake structure and dam. The water level this wet season came up to the second gate.
