**FIFTH FIVE-YEAR REVIEW REPORT FOR
COAST WOOD PRESERVING SUPERFUND SITE
MENDOCINO COUNTY, CALIFORNIA**

USACE, Seattle District

**U.S. Environmental Protection Agency
Region IX**

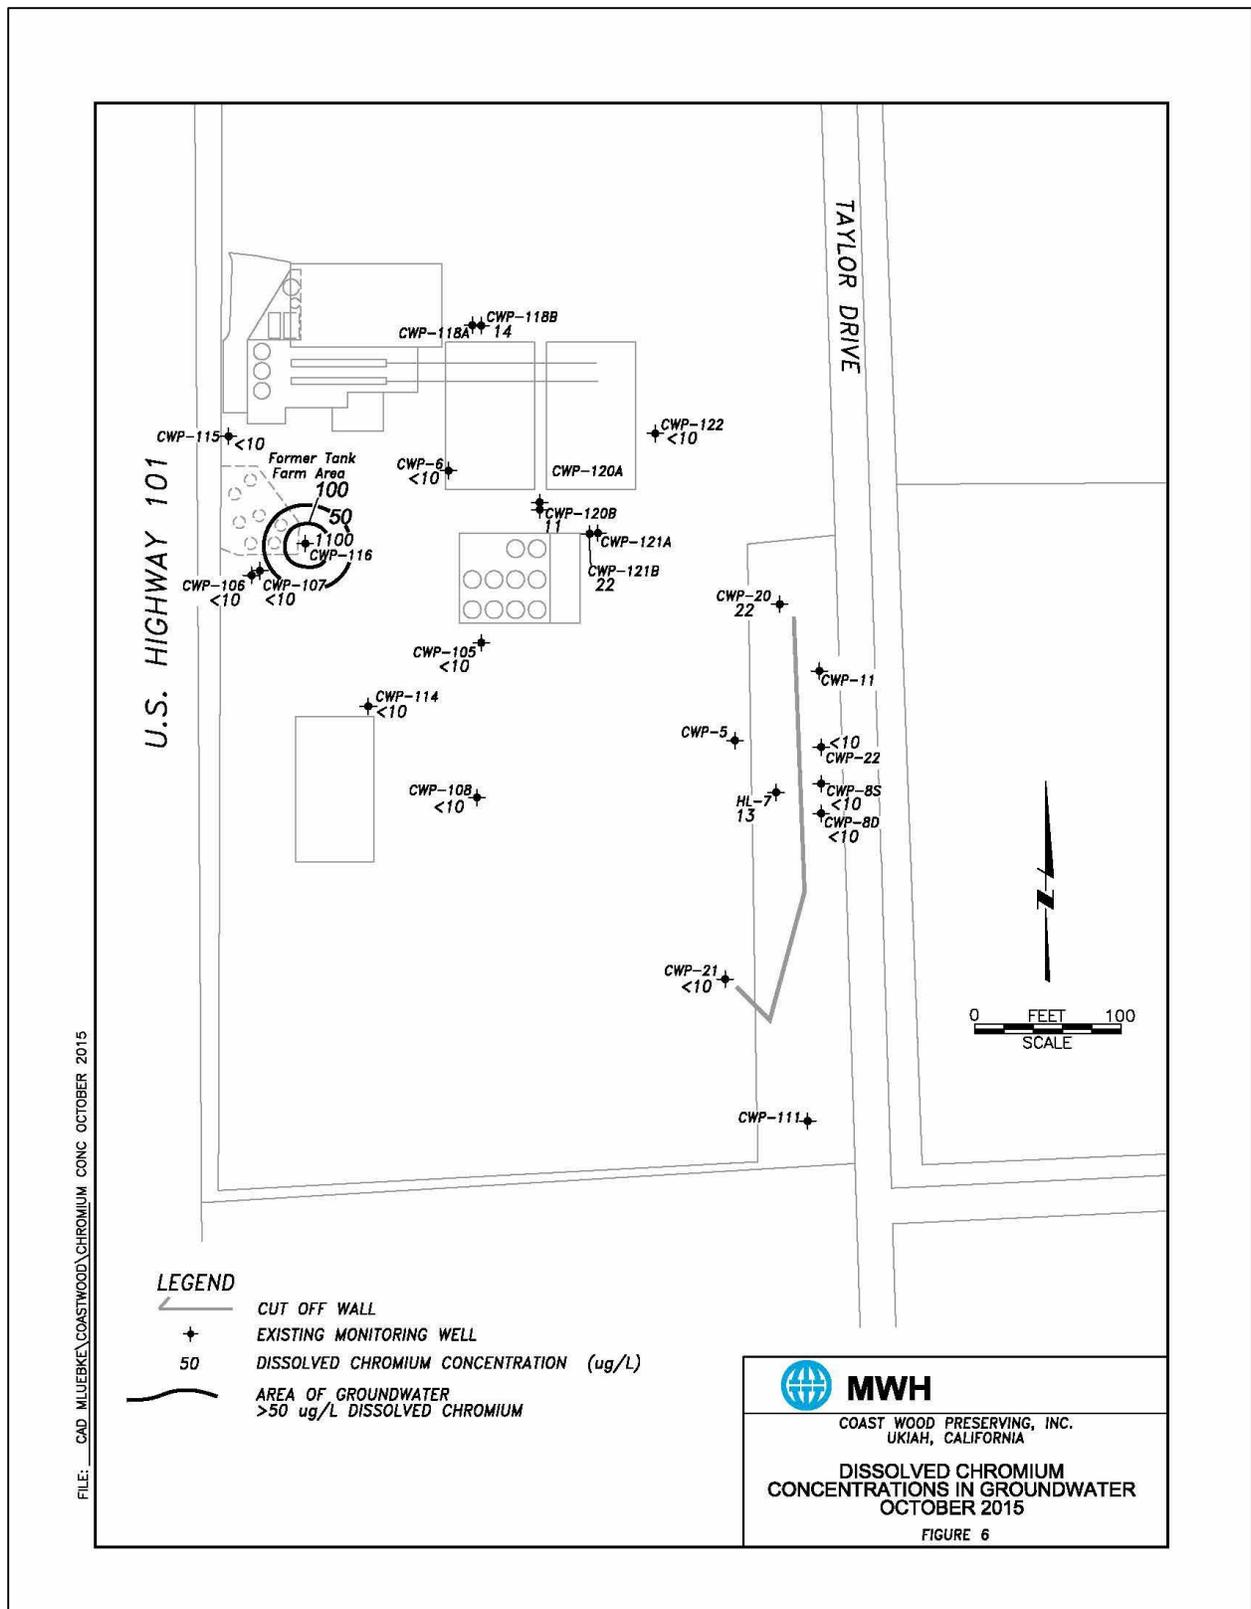
Figure 3 : Total Chromium Plume Map from October 2015

Hexavalent chromium and total chromium concentrations in groundwater currently remain above their respective clean up levels in a few isolated areas, and have fluctuated in concentration during this review period, possibly due to seasonal variation in groundwater levels. Only two wells have had arsenic concentrations exceeding cleanup levels during this review period. These wells are located near the most recent injection which occurred in 2010, and are expected to decline and not migrate off site as arsenic re-precipitates. Concentrations of contaminants are expected to decline over time as arsenic precipitates and as total chromium and hexavalent chromium continue to reduce from past injections.

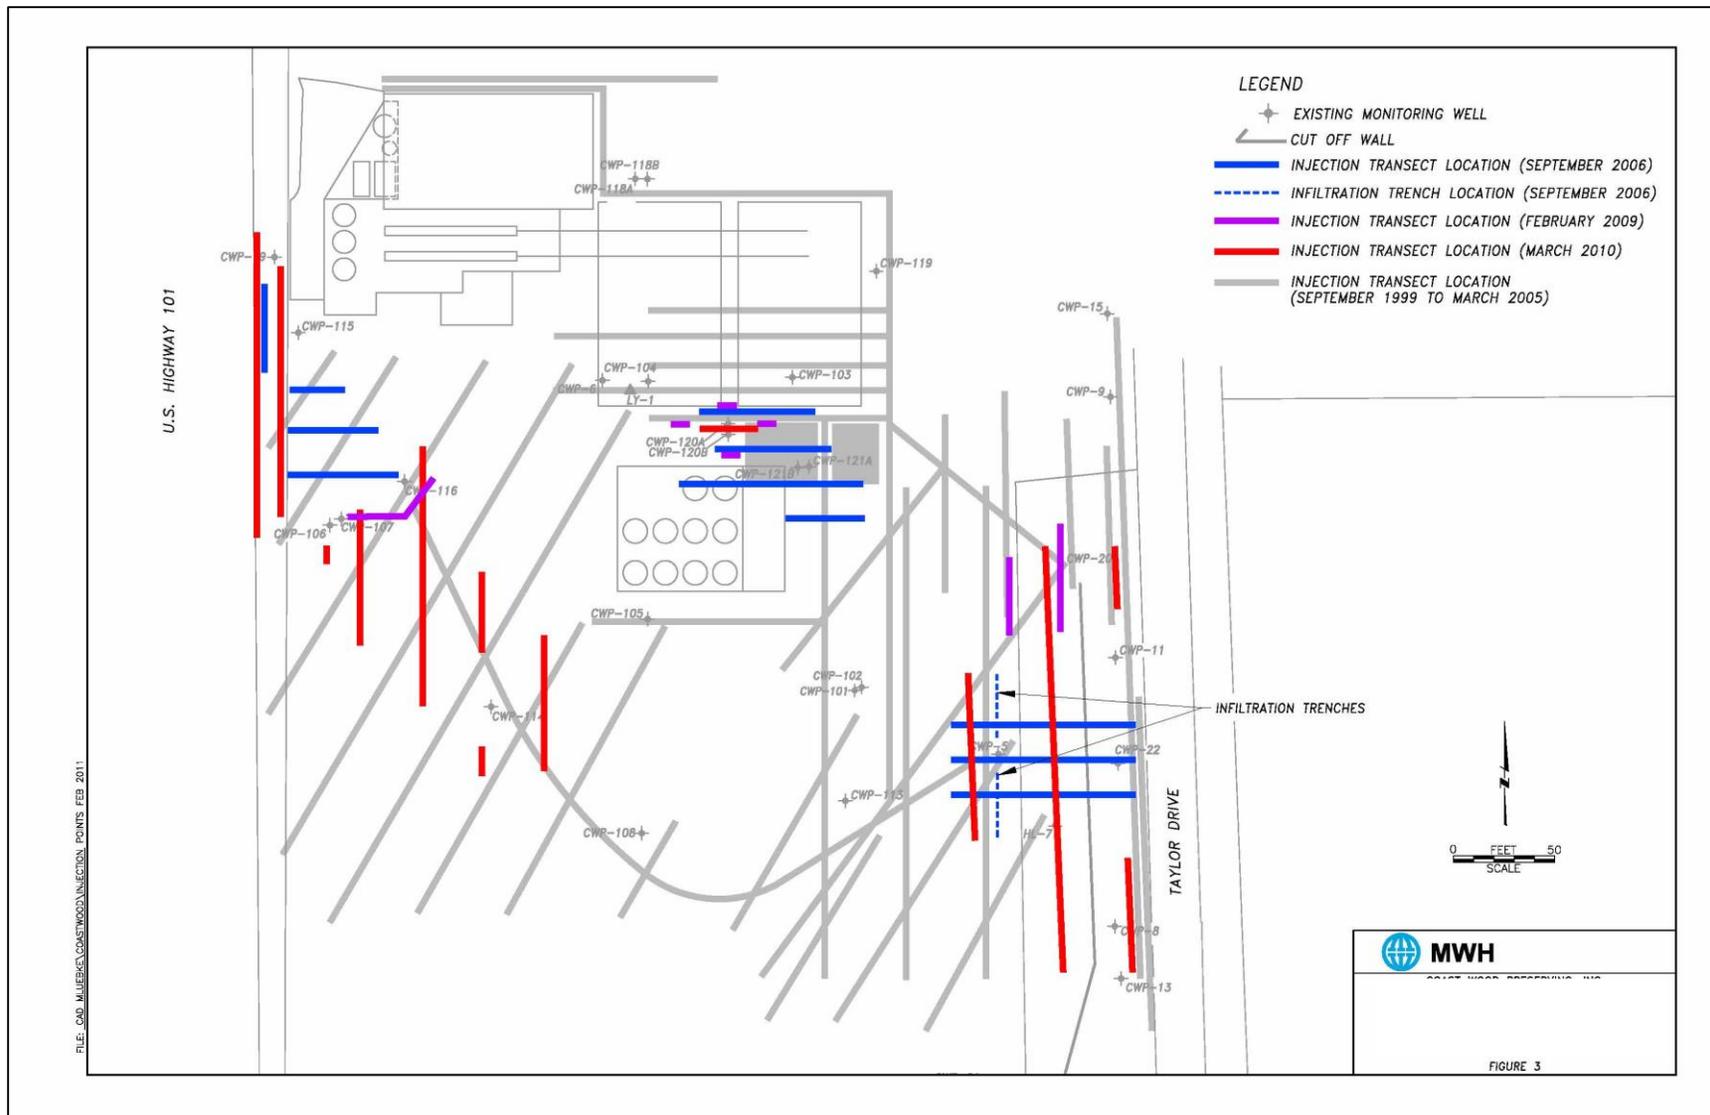
Figure B-5: In Situ Reduction Program Injection Transect Location from 1999-2010

Generation of reducing conditions by the injection of calcium polysulfide beginning in 1999 and ending in 2010 led to the temporary leaching of arsenic from Site soils. This condition has been noted at other sites and was anticipated at the time of the amendment to the remedial action plan. Locations of injections at the Site can be seen in Figure B-5.

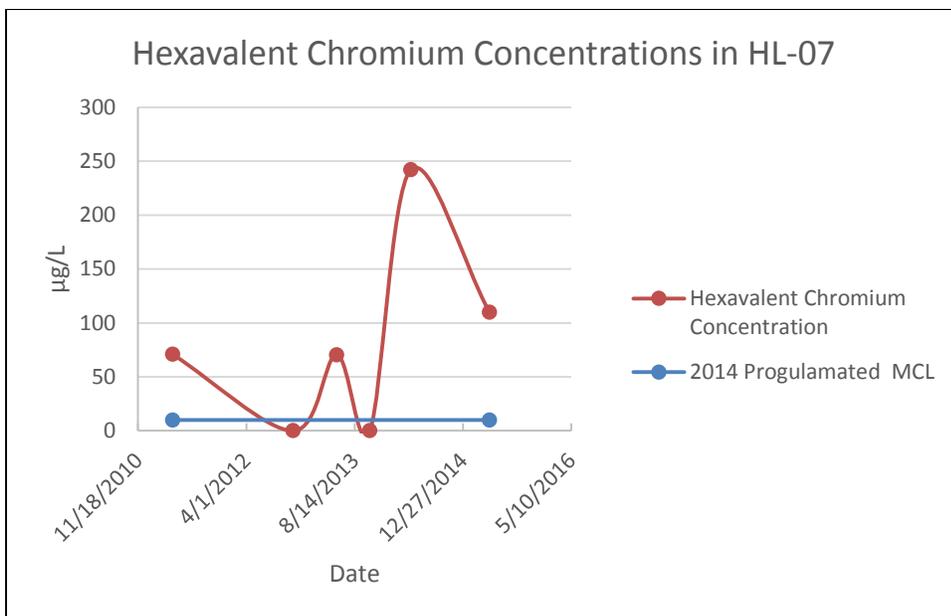
Figure B-9: Hexavalent Chromium Concentrations at HL-7 during the Review Period
 (Note: HL-07 = HL-7)

In April 2014, samples collected from trench HL-7 contained a concentration of 242 µg/L hexavalent chromium believed to be related to seasonally high groundwater contacting contaminated soils in the vadose zone and prompting the recommendation in the February 2014 annual groundwater monitoring report for an additional round of reductant infiltration. As was the case for prior infiltration activities, the purpose of the January 2015 infiltration event was to deliver a dilute solution of calcium polysulfide reductant into both the vadose and saturated zones into the trenches upgradient of HL-7, with groundwater extraction from HL-7 and re-infiltration of the extracted groundwater into the upgradient trenches. Immediate results after the infiltration and recirculation of the reductant indicated that dissolved chromium and arsenic were below levels of detection.

Though not enough data was available to conduct a trends analysis on hexavalent chromium, graphs of concentrations over time were generated (Figure B-6 through Figure B-9). Note that no data of hexavalent chromium exists for CWP prior to 2011. These graphs were generated for wells where sampling results showed hexavalent chromium concentrations above MCLs. The graphs indicate a possible pulse of untreated hexavalent chromium resulting from seasonal precipitation and higher groundwater levels in April of 2014. The concentrations then dip in 2015 due to the infiltration of reductant at the infiltration

In January 2015, due to the pulse of untreated hexavalent chromium, infiltration of the reductant solution was conducted using the infiltration trenches located in the Infiltration Trench Area upgradient of HL-7 (Figure B-2). The 2015 *Annual Groundwater Monitoring Report* (MWH, 2016) noted that the reductant solution injected into the infiltration trench upgradient of HL-7 was effective at reducing hexavalent chromium in HL-7, but concentrations increased during the 1 year time span between sampling events. Additional infiltration began on February 2, 2016, while water levels remain elevated from winter rainfall. In the future, sampling of the wells will be positioned around the cutoff wall to evaluate the presence or absence of potential leakage under or around the cutoff wall. Data generated from such sampling will be presented in the next annual report in 2017.

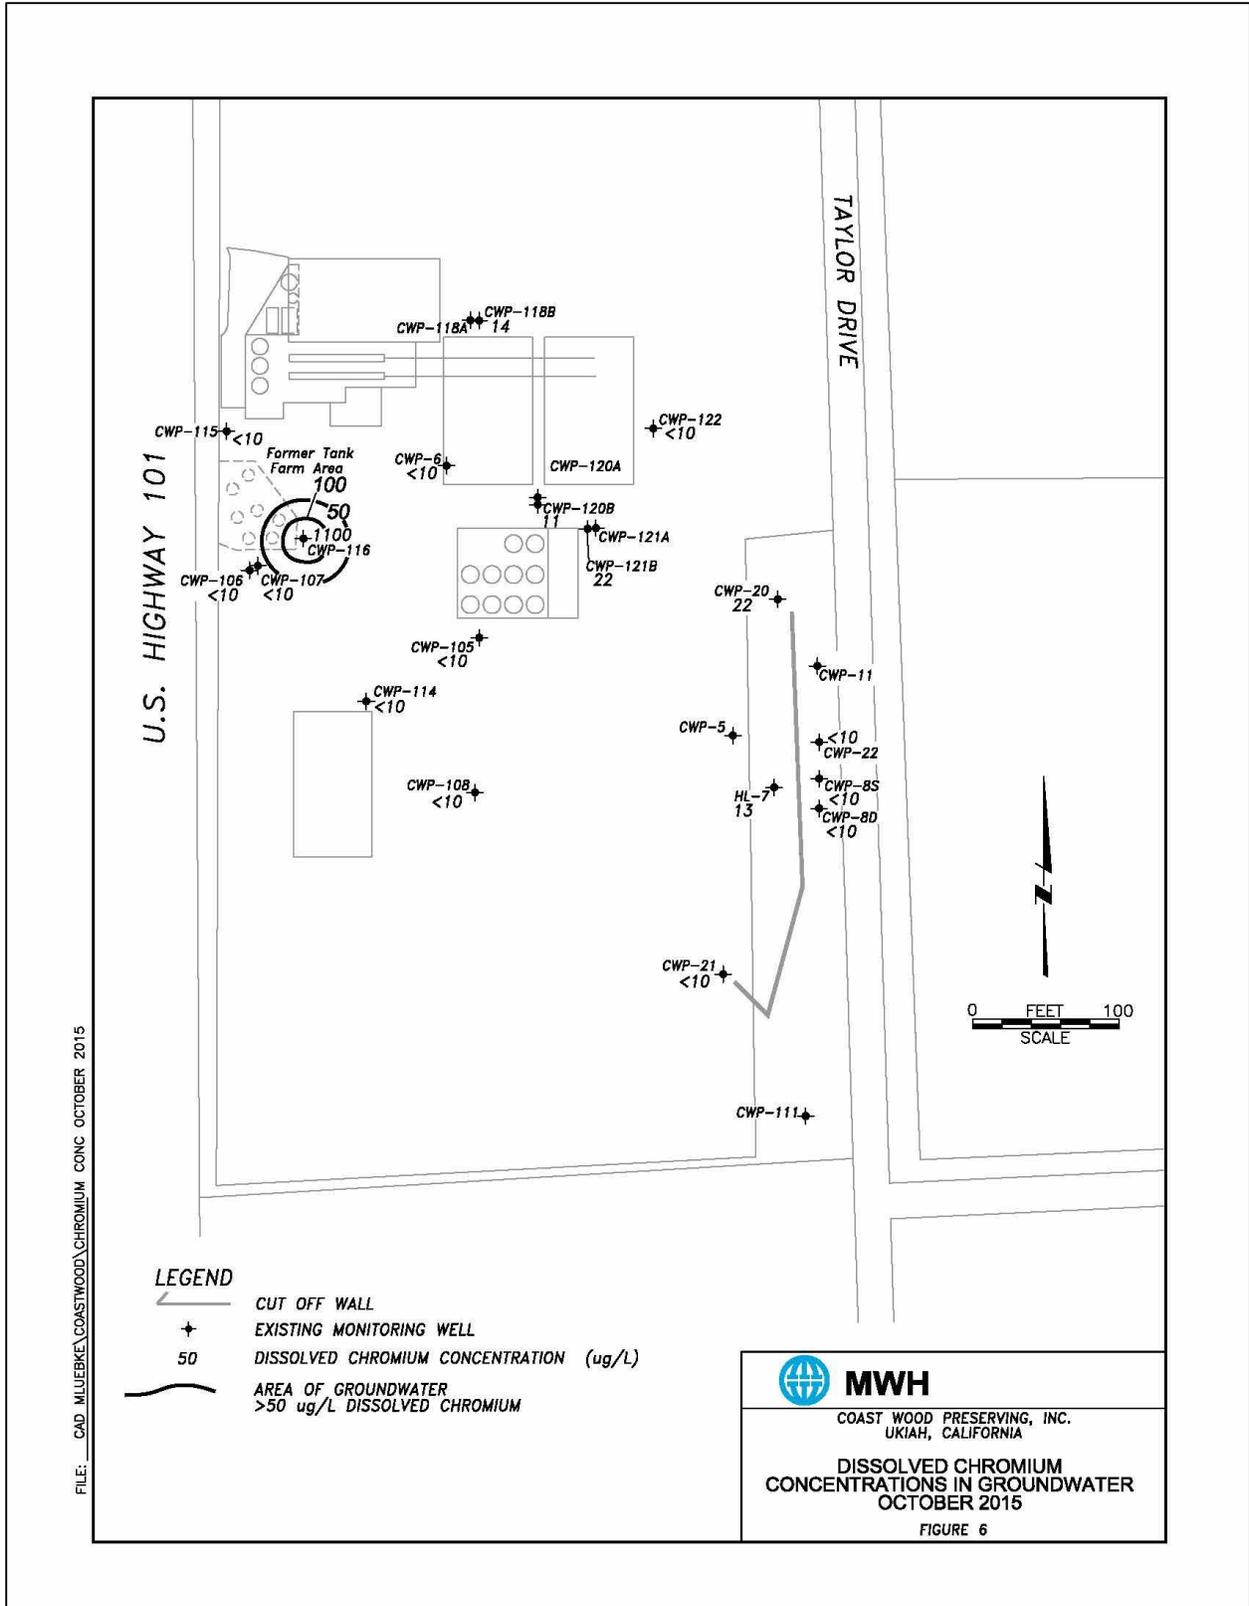
Figure B-14: Total Chromium Plume Map from October 2015

Data from October 2015 indicates that the total chromium plume at HL-7 had reduced below detection, as seen in Figure B-14, leaving only one area of concern for total chromium on site at CWP-116. However, until all contaminated soils have been removed, it is assumed that a pulse of untreated contaminated groundwater will be detected around the Infiltration Well Area again in the future as described in preceding paragraphs.

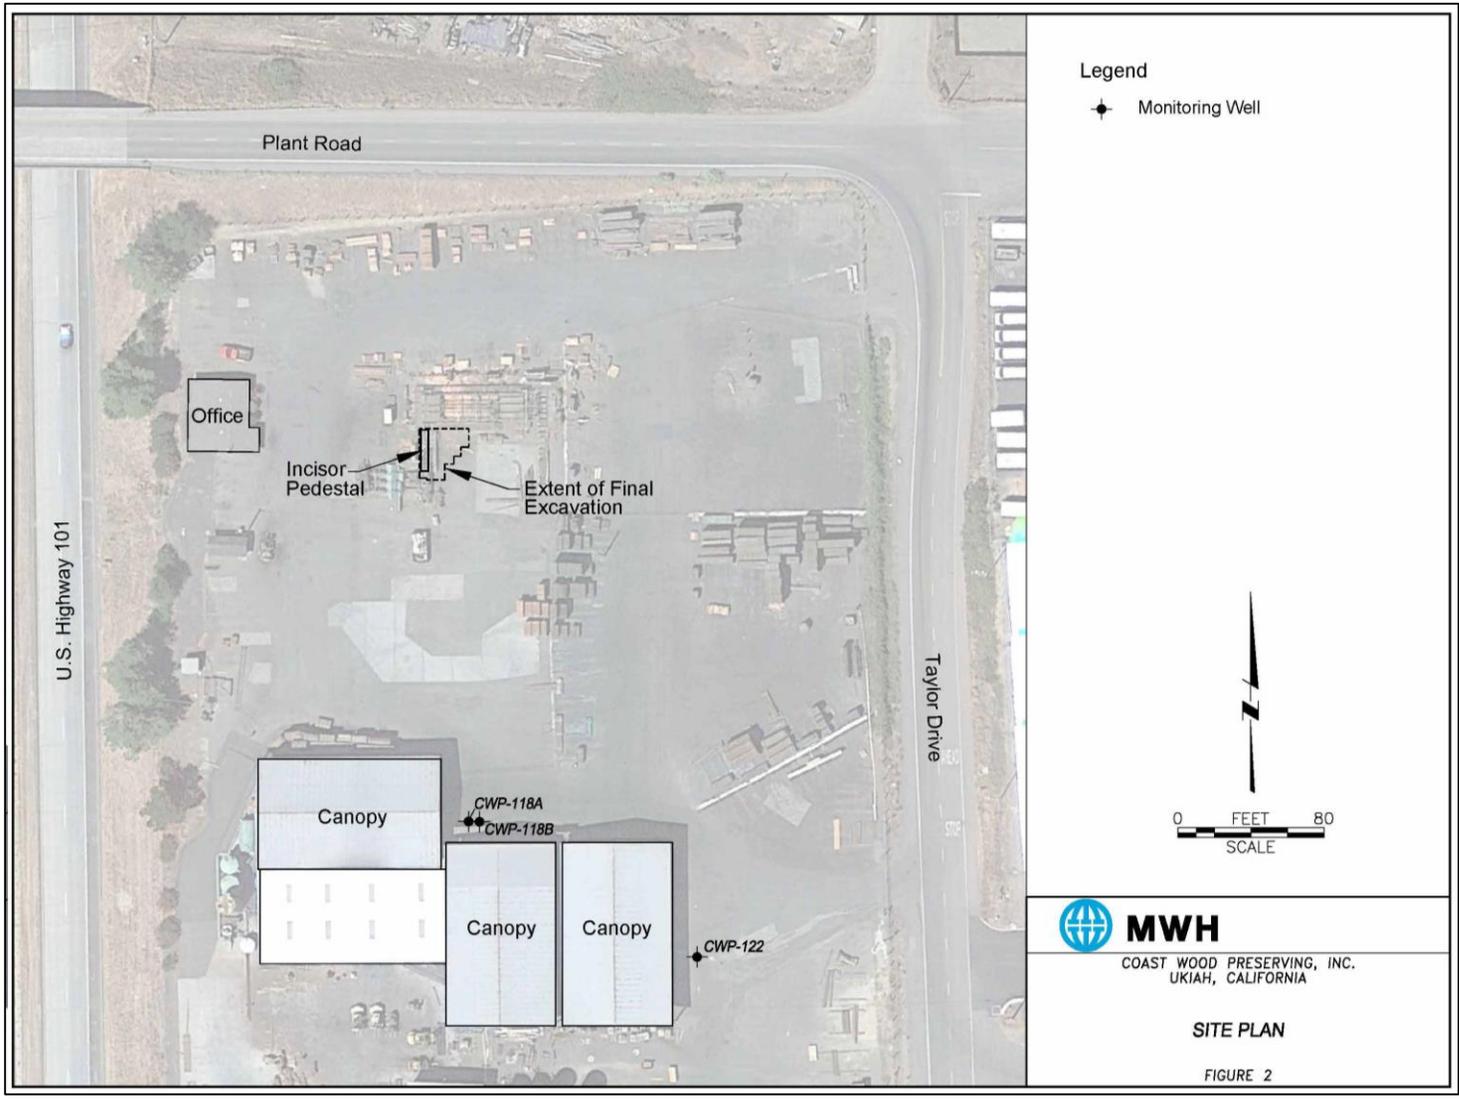
Figure B-16: Location of 2015 Incisor Pedestal Demolition and Soil Excavation at CWP

In 2015, approximately 42 cubic yards of contaminated soil was removed from the Site during the demolition of a concrete pedestal that once held a lumber incisor (Figure B-16 and Figure B-17). The soil was excavated to soil cleanup goals established for the Site as detailed in the 2003 Explanation of Significant Differences (DTSC, 2003).

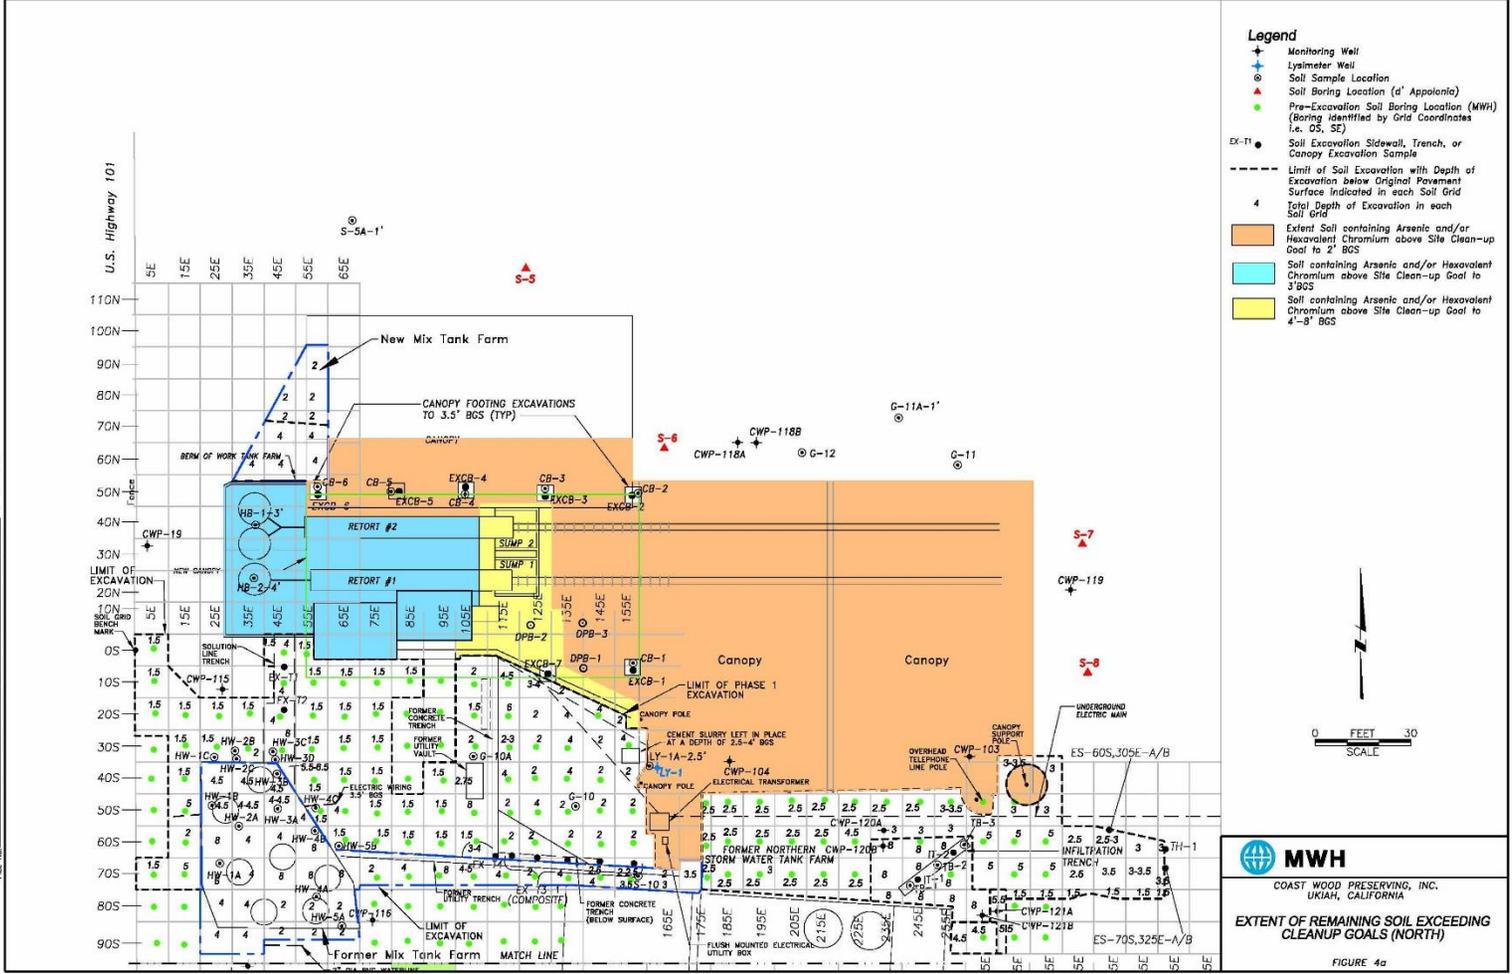
Figure B-18: Extent of Remaining Soil Exceeding Cleanup Goals (North)

Data from past FYRs have documented the nature and extent of COC contamination in the soil. It is estimated that currently 1,448 cubic yards of contaminated soil resides on site and will be excavated during the closeout of the Site. Figure B-18 and Figure B-19 present data on soil cleanup.
