Appendix D
Historical Spill Records

SUMMARY OF SPILL OF AUGUST 31, 1990

Arimetco/Copper Tek
107 Burch Drive
Yerington, NV 89447
(702) 463-3125

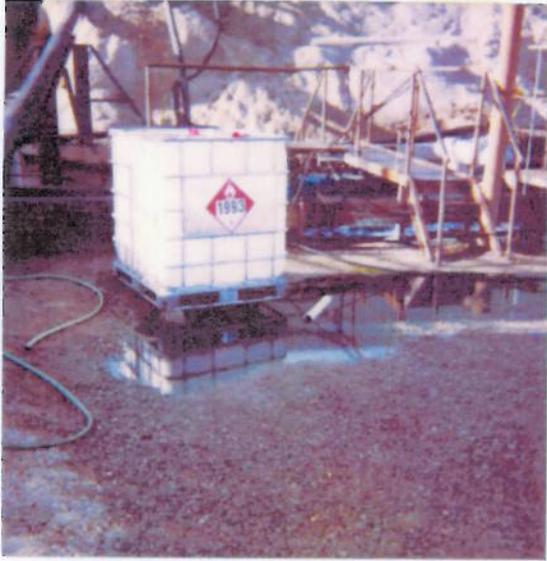
1-18-98
CLASS I SPILL FROM ELECTROLYTIC
POND
WASHED BACK INTO TANK

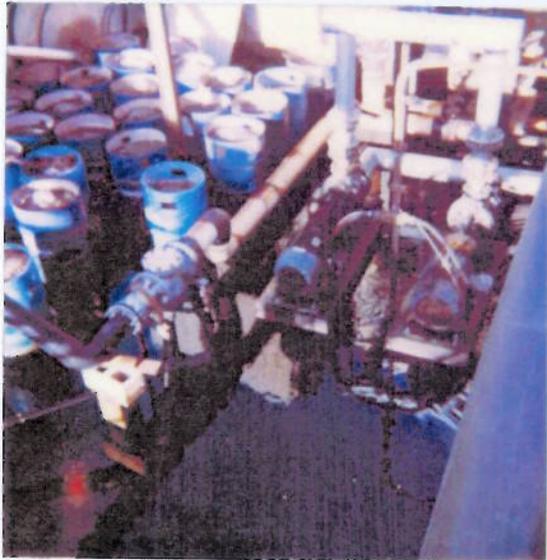
At 1930 hours on January 17, 1998, we had a power failure which resulted in a Class I spill around the big tank farm.

The power failure had caused some pumps and lights to shut down. Dennis Creedon saw what was happening and started shutting things down. During the shutdown one of the pumps to the Filter Feed Plant froze-up, causing the main breakers to trip in the Rectifier Room. This then required the plant to be shut down in various places by rapidly closing some crucial valves. In this case, critical time passed while wrenches were found with which to turn them off, since, the valves had no handles on them.

1-18-98
TANK FARM FLOODED

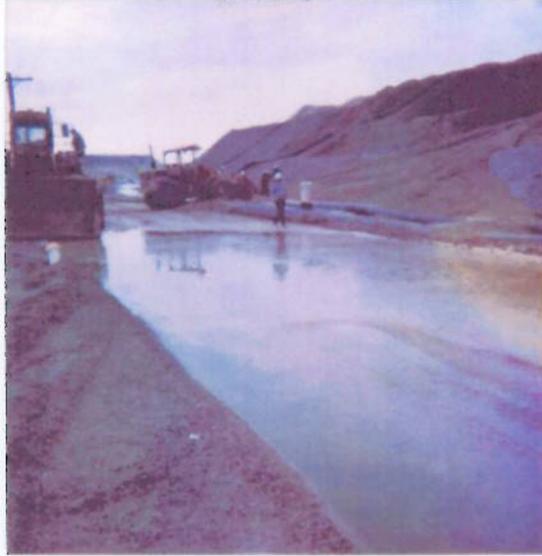
SLIDE BLOCKED PLS CH.

500 GALLON PLS
2-15-98 . VLT AREA

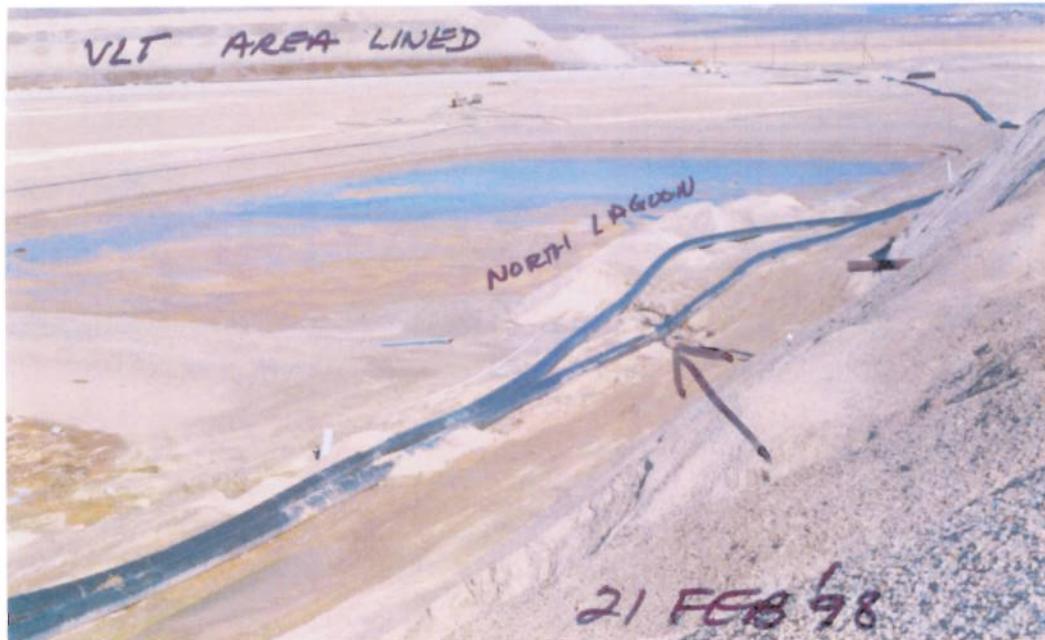
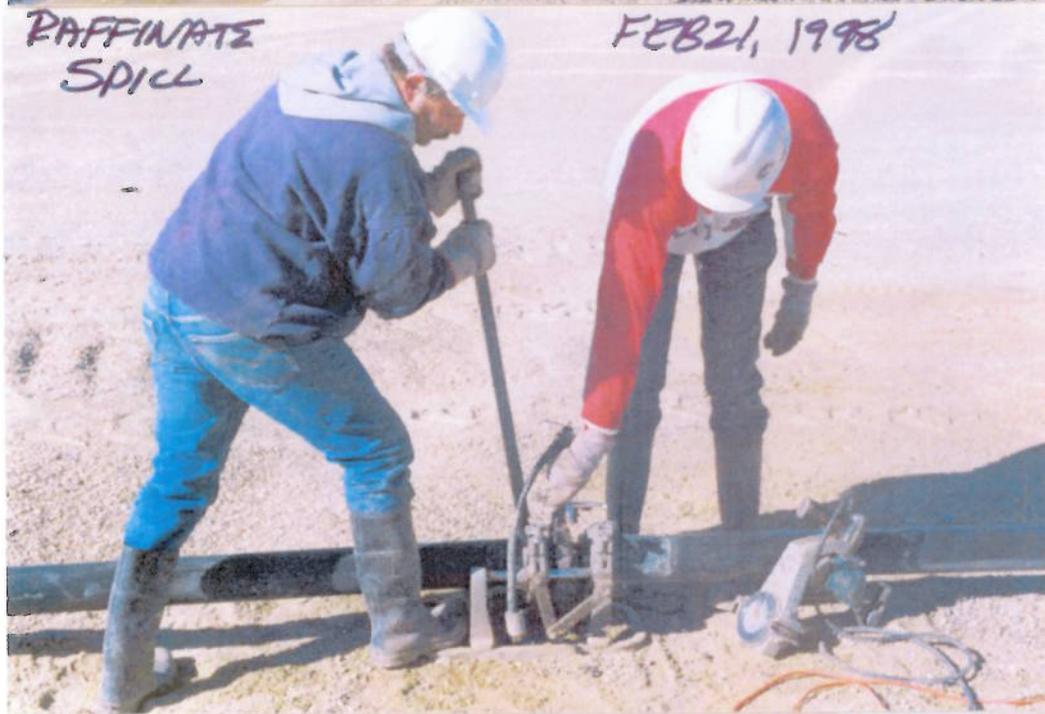
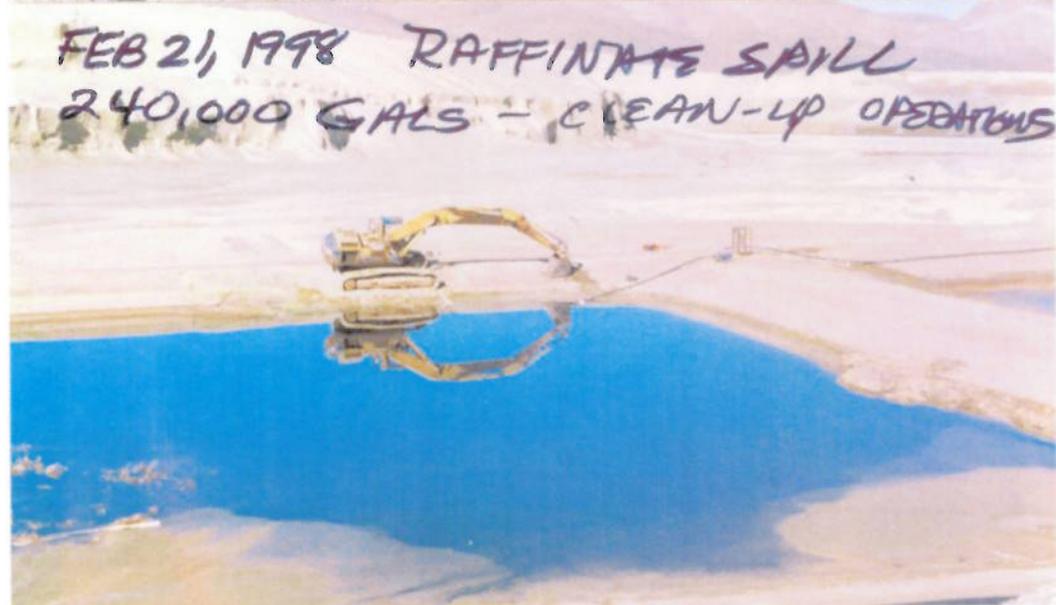
7. Remedial Actions taken in Response to Spill:
(attach analytical results supporting remediation)
The 16" Drisco pipe (Raffinate line) going to the VLT pads sprung a leak in a weld. A pit was dug with the backhoe to capture any spilled solution when the pipe was cut into to reweld. The spilled solution was then pumped into pad #11 on the VLT Pads. The hole was then excavated and contaminated soil was taken to heaps. The hole was then filled with clean tailings

8. Date Remedial Actions Completed:
Monday. 2-23-98
9. Name of Person Responsible for Spill Remediation:
Ray Minifie - Robert Schneider
10. Position:
Lead Miner Construction Foreman

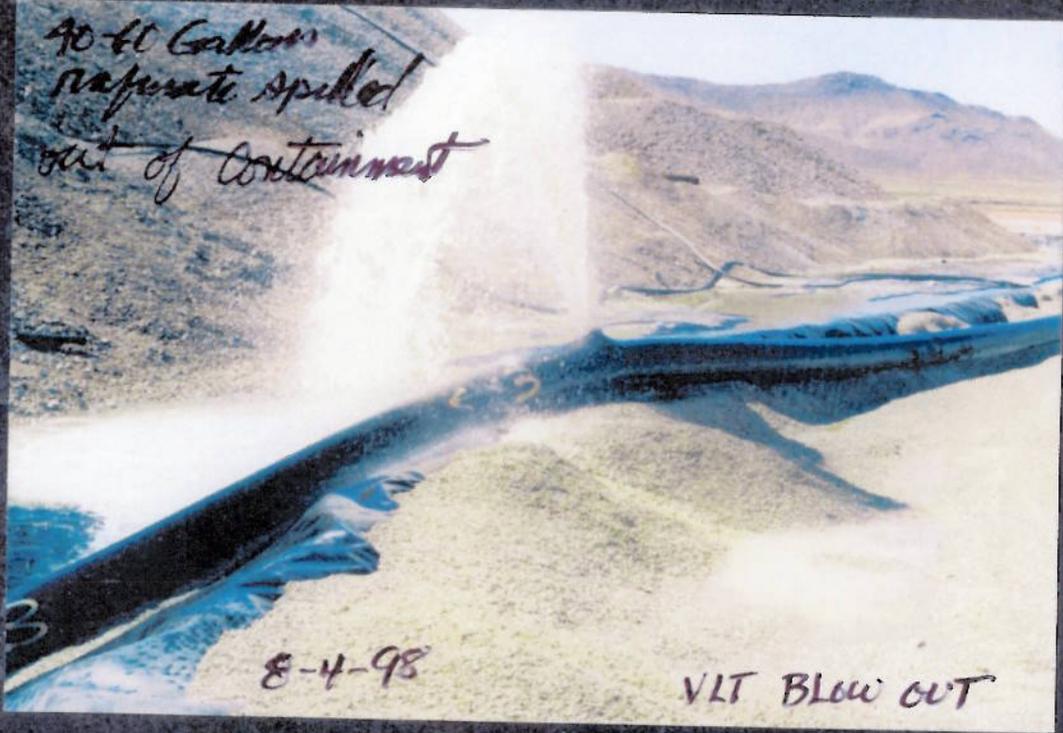
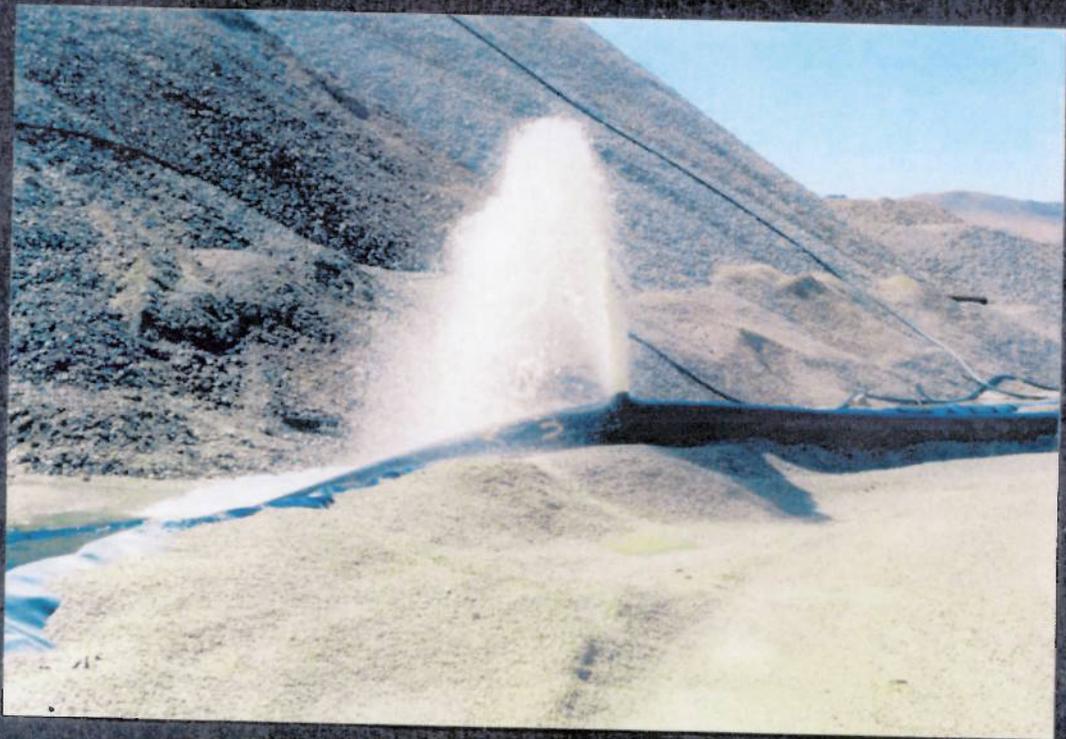
4. Location of Spill: VLT pond area. Southwest corner on berm.
5. Reason for Spill: Rupture in pipe
6. Material Contaminated: VLT tailings, which were removed and placed on lined heap leach at VLT.

7. Remedial Actions taken in Response to Spill: Response team called. Low (attach analytical results supporting remediation)
pressure alarm went off at 4:08 PM. At 4:10 project manager called in leak in containment at VLT Pond area. Raffinate to VLT Pond was already being shut down by SX crew. As pressure dropped in line the 50-60 gallon raffinate solution was released and immediately cleaned up and removed to the VLT heap leach lined pad. Environmental was immediately called and responded to initial call. Photo's were taken of release.
