January 18, 2008

**RE: 2007 HDPE Penetration Repair Documentation Report  
Casmalia Hazardous Waste Management Facility  
Casmalia, California  
URS Project No. 28906580**

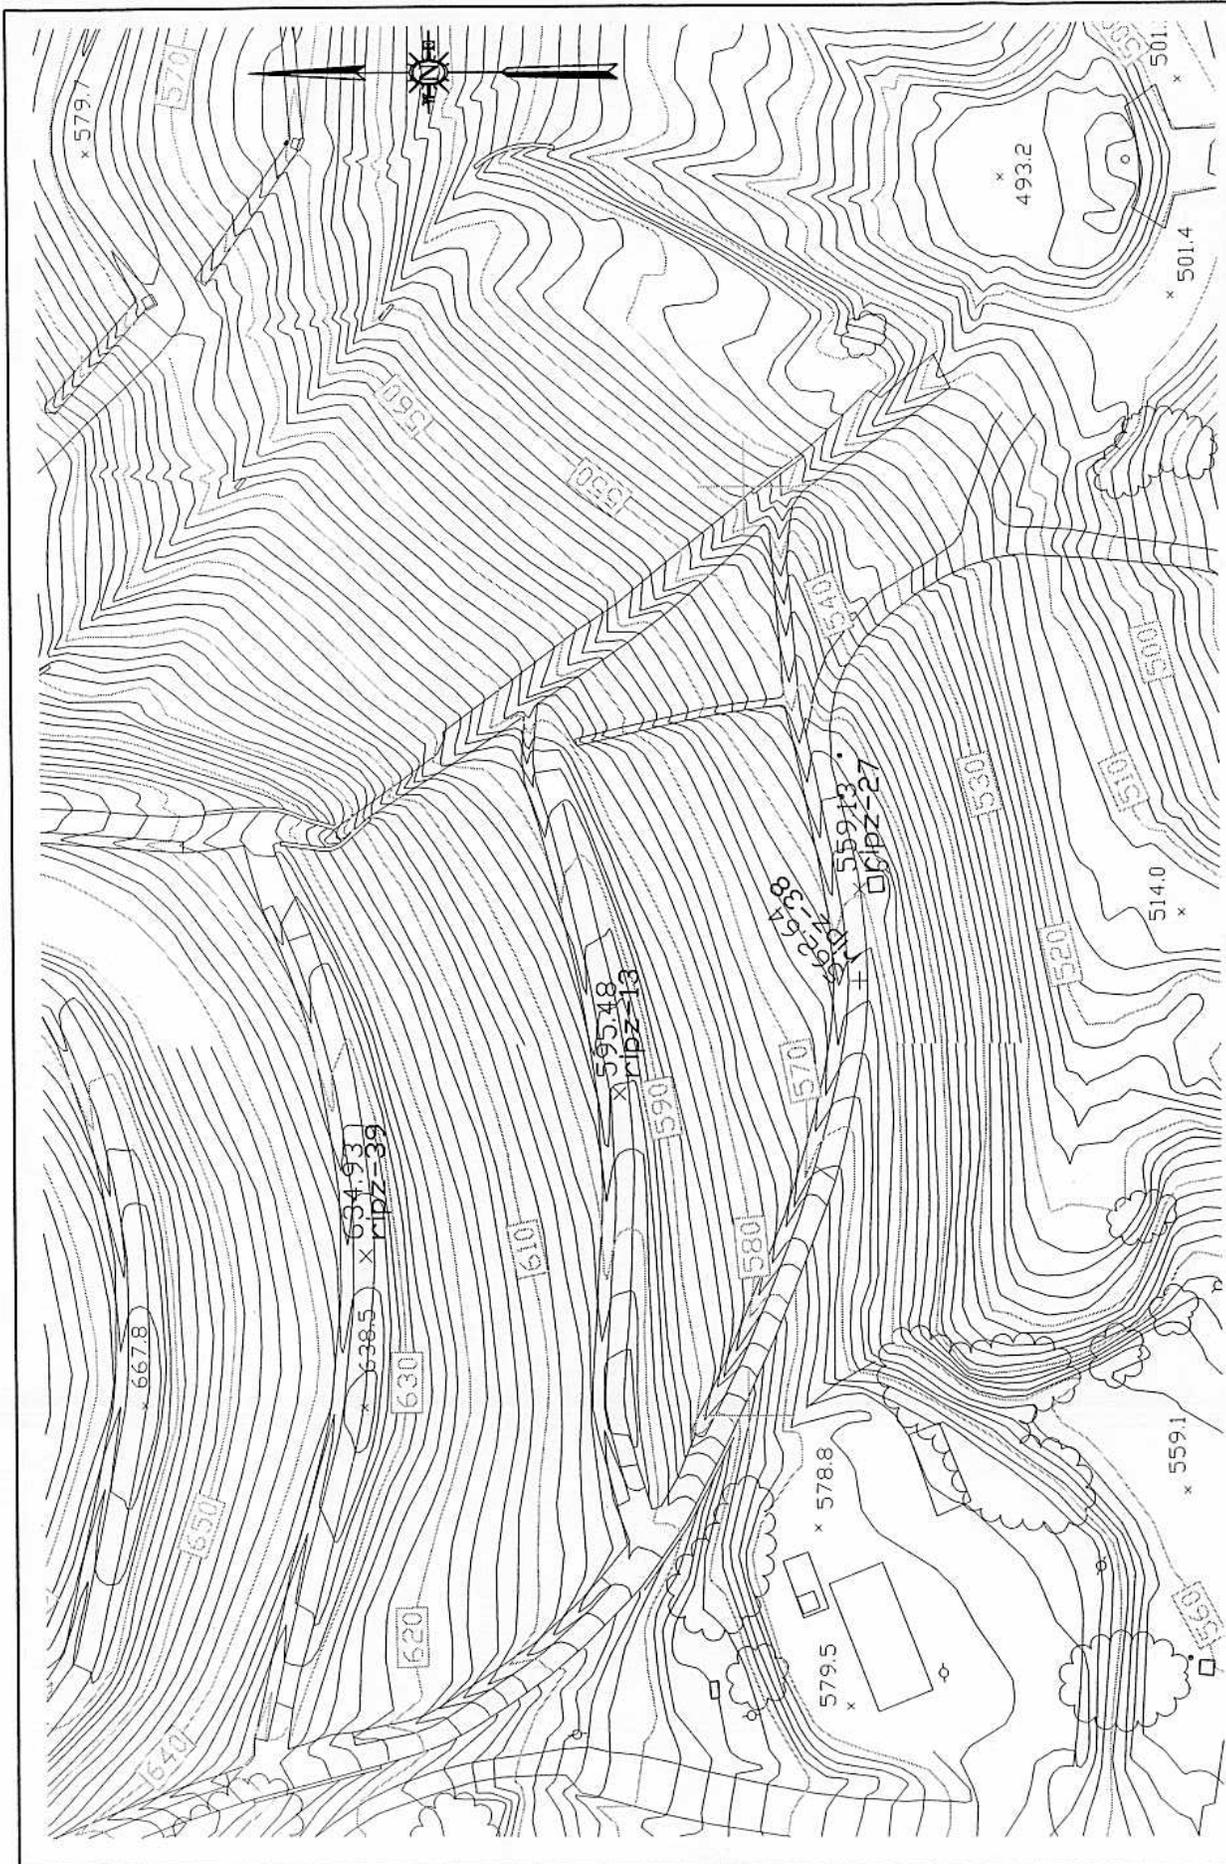
**NEW RI PIEZOMETER LOCATIONS  
 CASMALIA LANDFILL  
 COUNTY OF SANTA BARBARA, CALIFORNIA**

URS performed final cover repairs where cone penetration testing (CPT) and piezometer installation damaged the final cover during August 2007. This report documents repairs to the final cover system associated with the execution of the scope of work described in the above mentioned work plan. A total of eight repairs were completed. Four repairs were for successful piezometer installations and four were at areas where piezometer installations were ultimately decided to be properly abandoned in accordance with the work plan. Table 1 relates CPT and piezometer numbers to the repair number. Repair locations are illustrated on Figure 1.

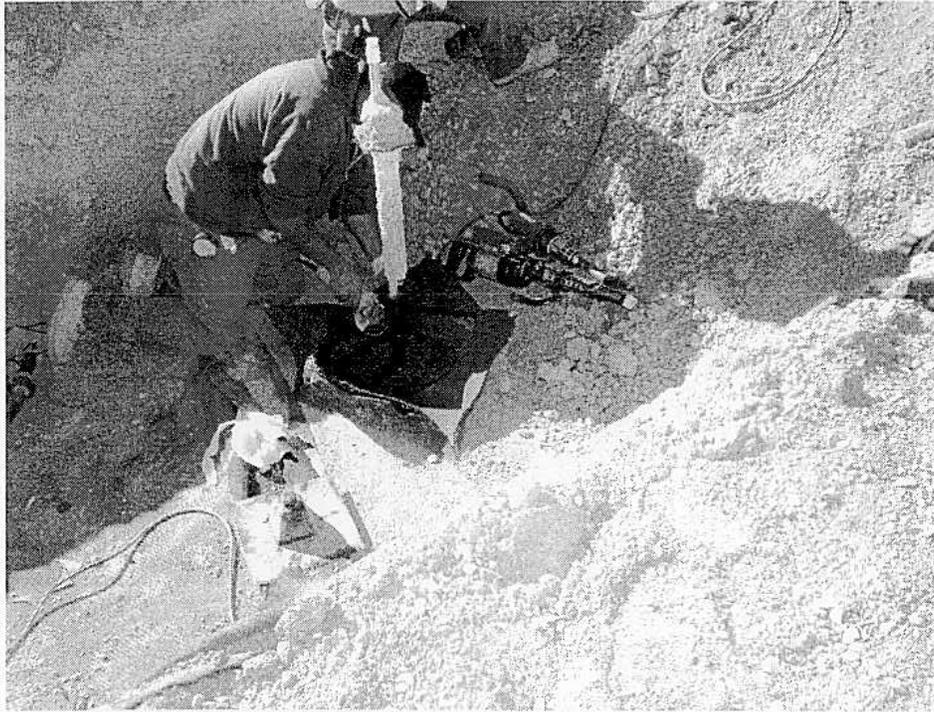
**Repair of RIPZ-39**  
Installation of Boot and Sleeve

TIME	DESCRIPTION/NOTES
0710	UNITED RENTALS ON SITE TO DELIVER SHORING MATERIALS.
0725	FLSI ONSITE: JOSE TORRES, R. JAVIERQUI, R. GARCIA, E. TORRES, J. TORRES JR.
0740	CONDUCT SITE ORIENTATION, DISCUSS HEALTH & SAFETY, REVIEW HAZARD EVALUATION. KEY POINTS INCLUDE HOT WORK (EXTRUSION WELDER) ON LANDFILL. VERIFY THAT ALL REPAIR AREAS HAVE A GOOD SEAL WITH GROUT. MONITOR AIR AT WORK FACE. WORKING IN EXCAVATION DEEPER THAN 4FT REQUIRES SHORING. USE LADDER FOR ENTERING AND EXITING EXCAVATIONS. MAINTAIN COMMUNICATION AND UTILIZE BUDDY SYSTEM.
0820	T. COLERA, O. CAMACHO & B. SHUMAKER SET-UP AND INSTALL SHORING AT RIPZ-27 AND RIPZ-39 EXCAVATIONS IN GALLERY WELL ROAD.
0835	FLSI CREW MEMBERS MOBILIZE EQUIPMENT TO RIPZ-39 EXCAVATION AREA. L. BAILEY ESTABLISH AIR MONITORING AT WORK AREA.
0910	SHORING INSTALLATION COMPLETED.
0920	FLSI START REPAIR OF LINER AT RIPZ-39 AND ADJACENT PUNCTURE. USED PRE-FABRICATED BOOT AROUND RIPZ-39. (BENCH 2)

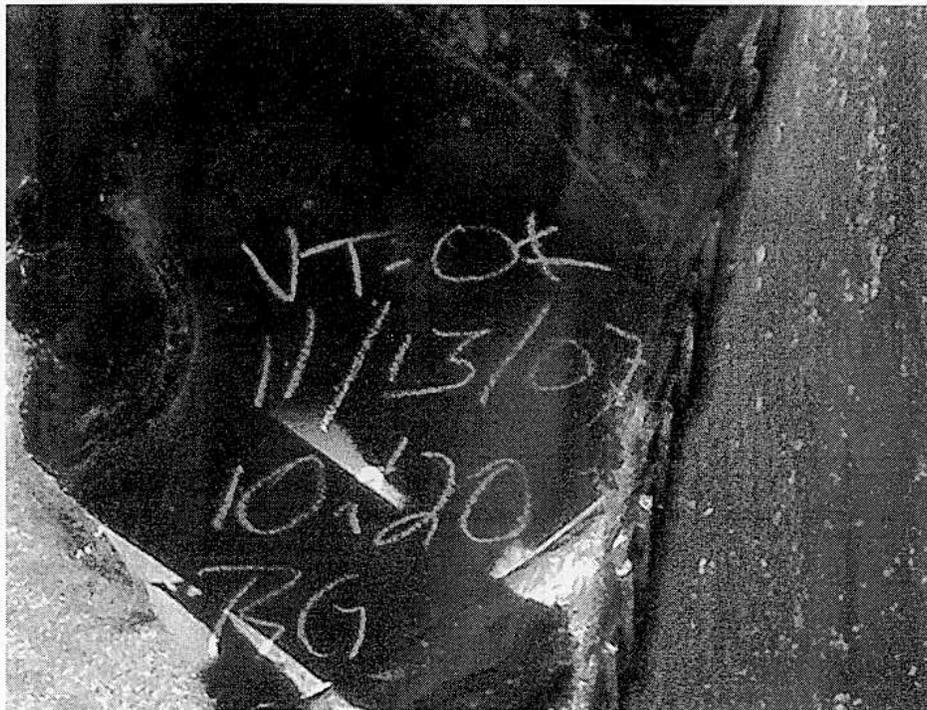
**Completion and Test Verification at RIPZ-39**  
Test Results of Boot Repair at RIPZ-39

1020	COMPLETED REPAIRS AT RIPZ-39 LOCATION AND PERFORMED SUCCESSFUL VACUUM TEST. RESTORE DRAINAGE MAT AND FILTER FABRIC.
1040	RELOCATE EQUIPMENT TO RIPZ-13 EXCAVATION AREA. L. BAILEY ESTABLISH AIR MONITORING AT WORK AREA.
1055	START REPAIR OF RIPZ-13 AND TWO ADJACENT PUNCTURE LOCATIONS. (BENCH 1)

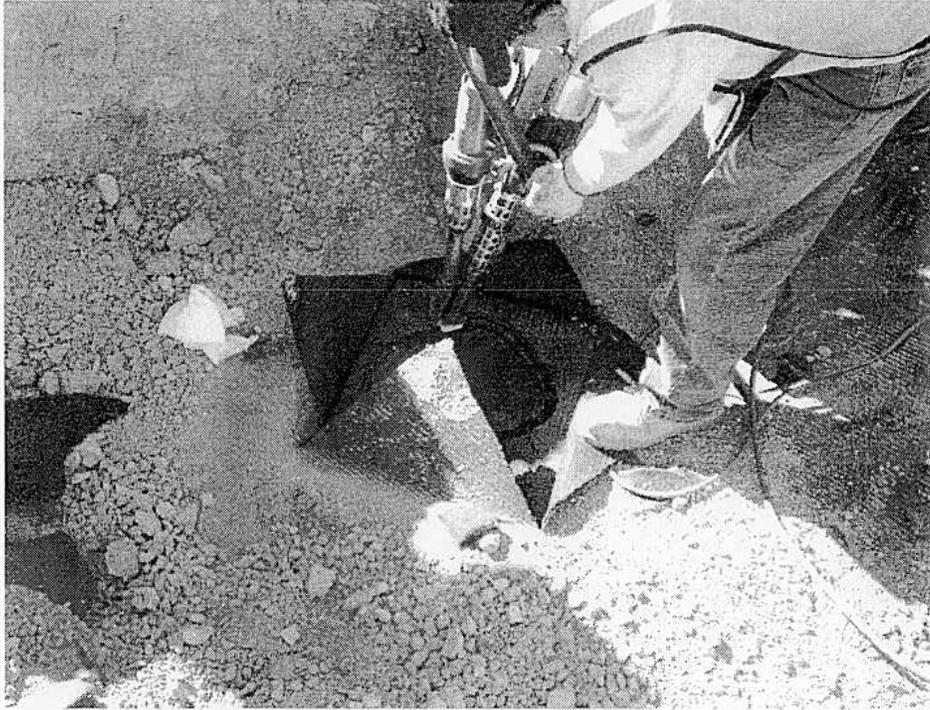
**Repair of 39A**  
Installation of Patch

Date	Repair No.	Repair Location	Repair Description	Vacuum Test			
				Date	Time	Pass/Fail	Name
11-13-07	39A	ADJACENT TO RIPZ-39 IN BENCH ED 2, APPROX 5.5ft SOUTH OF DRAINAGE DITCH.	12" X 12" PATCH	11-13-07	10:17 am	PASS	R.G.
11-13-07	RIPZ-39	WEST SIDE OF RIPZ-39 EXCAVATION IN BENCH ED 2, APPROX 5.5ft SOUTH OF DRAINAGE DITCH.	18" BOOT w/ 14" SLEEVE	11-13-07	10:20 am	PASS	R.G.
11-13-07	13B	EAST SIDE OF RIPZ-13 EXCAVATION, APPROX 10.5ft EAST OF RIPZ-13, APPROX 6.5ft SOUTH OF DITCH ON BENCH ED 1.	14" X 14" PATCH	11-13-07	11:40 am	PASS	R.G.
11-13-07	13A	CENTER OF RIPZ-13 EXCAVATION, APPROX 5.5ft EAST OF RIPZ-13, APPROX 6.5ft SOUTH OF DITCH ON BENCH ED 1.	18" X 18" PATCH	11-13-07	11:45 am	PASS	R.G.
11-13-07	RIPZ-13	WEST SIDE OF RIPZ-13 EXCAVATION, APPROX 6.5ft SOUTH OF DITCH ON BENCH ED 1.	18" BOOT w/ 14" SLEEVE	11-13-07	11:55 am	PASS	R.G.
11-13-07	38A	WEST EXCAVATION ON GALLERY WELL ED, APPROX 5.5ft SOUTH OF DRAINAGE DITCH.	16" X 16" PATCH	11-13-07	2:20 pm	PASS	R.G.

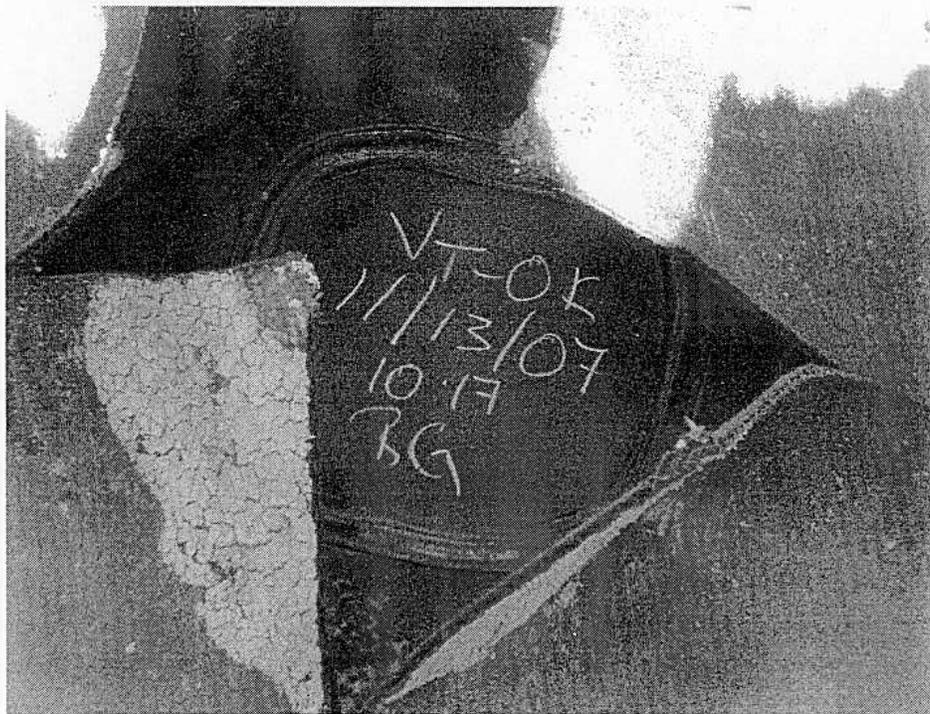
**Completion and Test Verification at 39A**  
Test Results of Patch Repair at 39A

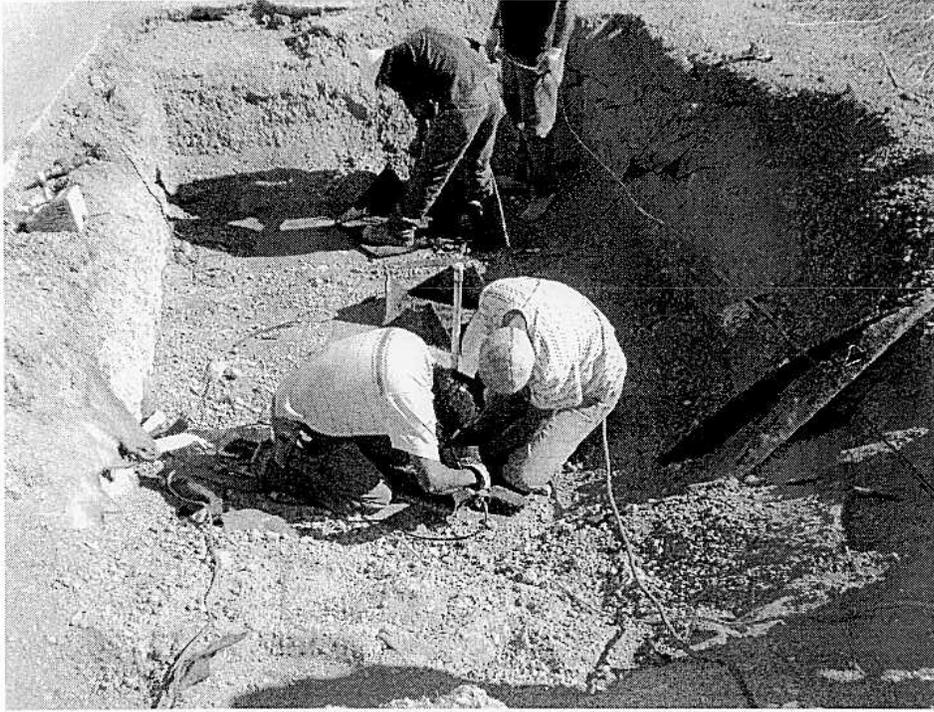
**Repair of RIPZ-13, 13A and 13B**  
Installation of Boot, Sleeve and Patches

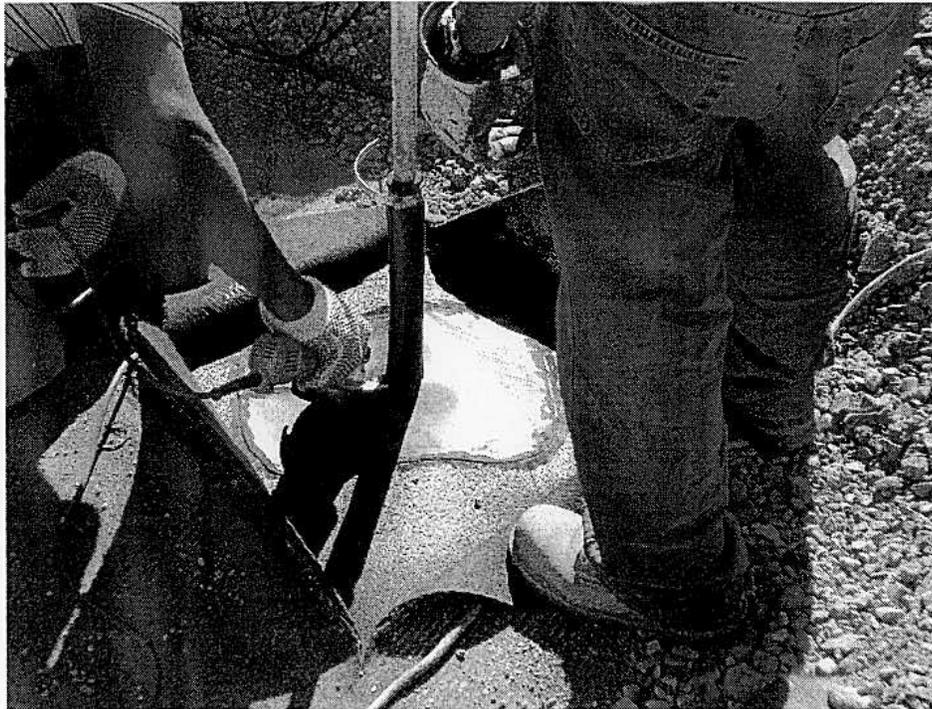
**Repair of RIPZ-13**  
Completion of Boot and Sleeve

TIME	DESCRIPTION/NOTES
<i>1135</i>	<i>COMPLETED BOOT AND PATCH REPAIRS AT RIPZ-13 EXCAVATION</i>
<i>1145</i>	<i>VACUUM TESTED EACH REPAIR AREA - PASSED.</i>
<i>1210</i>	<i>RESTORED DRAINAGE MAT AND GEOTEXTILE OVER REPAIR AREAS.</i>
<i>1220</i>	<i>LANCH BREAK</i>
<i>1320</i>	<i>RELOCATE EQUIPMENT TO RIPZ-38 AND RIPZ-38A EXCAVATIONS, RZ-38A IS THE WESTERN MOST EXCAVATION ON GALLERY WELL RD WHERE THE CPT PUNCTURED THE LINER BUT IT WAS DECIDED THAT THE PIEZOMETER SHOULD BE INSTALLED FURTHER EAST ON THE ROAD.</i>
<i>1325</i>	<i>START REPAIR OF RIPZ-38 AND 38A CONCURRENTLY.</i>
<i>1340</i>	<i>START REPAIR OF RIPZ-27 (ADJ TO GALLERY WELL)</i>
<i>1420</i>	<i>COMPLETED REPAIRS AT RIPZ-38, 38A AND 27.</i>
<i>1425</i>	<i>PERFORMED VACUUM TEST ON REPAIR LOCATIONS - ALL PASSED.</i>
<i>1435</i>	<i>RESTORED DRAINAGE MAT AND GEOTEXTILE OVER REPAIR AREAS</i>
<i>1500</i>	<i>DECONED EQUIPMENT AND STAGED IN FRONT PARKING LOT.</i>

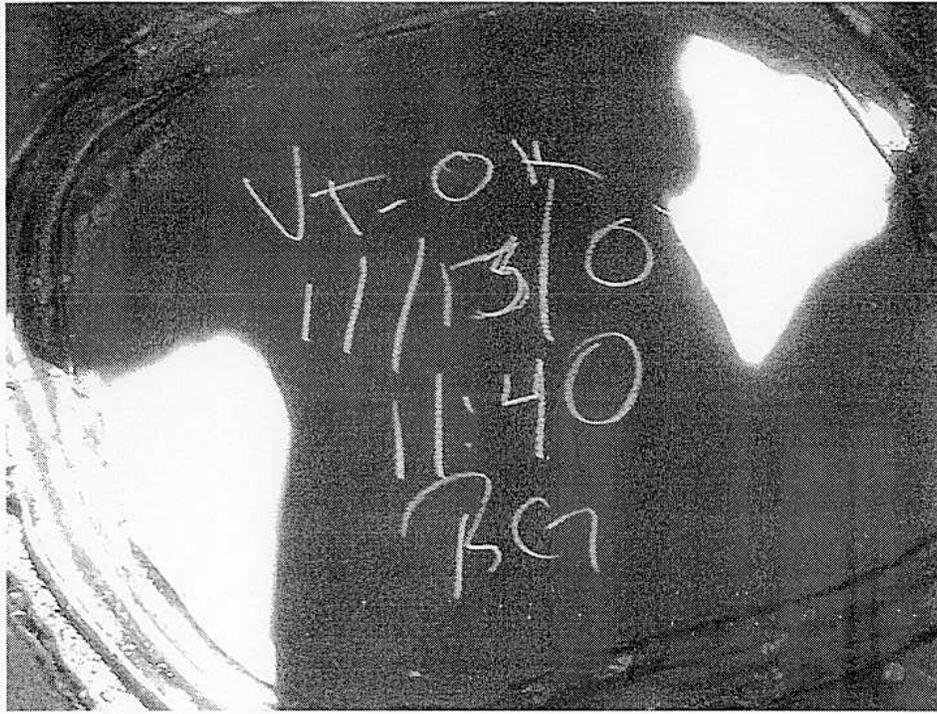
**Completion and Test Verification at 13B**  
Test Results of Patch Repair at 13B

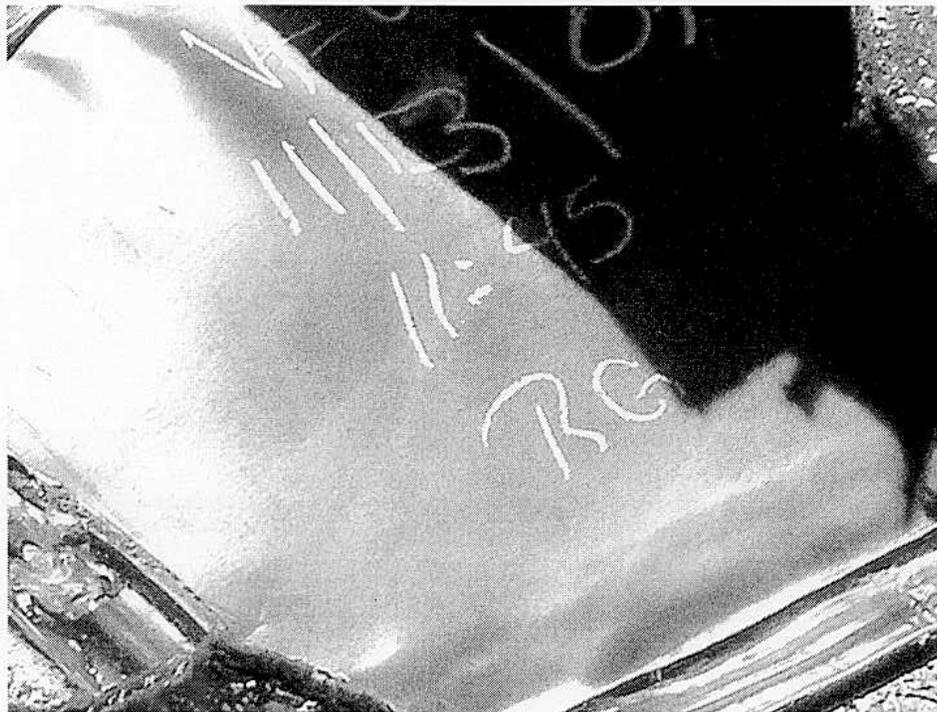
**Completion and Test Verification at 13A**  
Test Results of Patch Repair at 13A

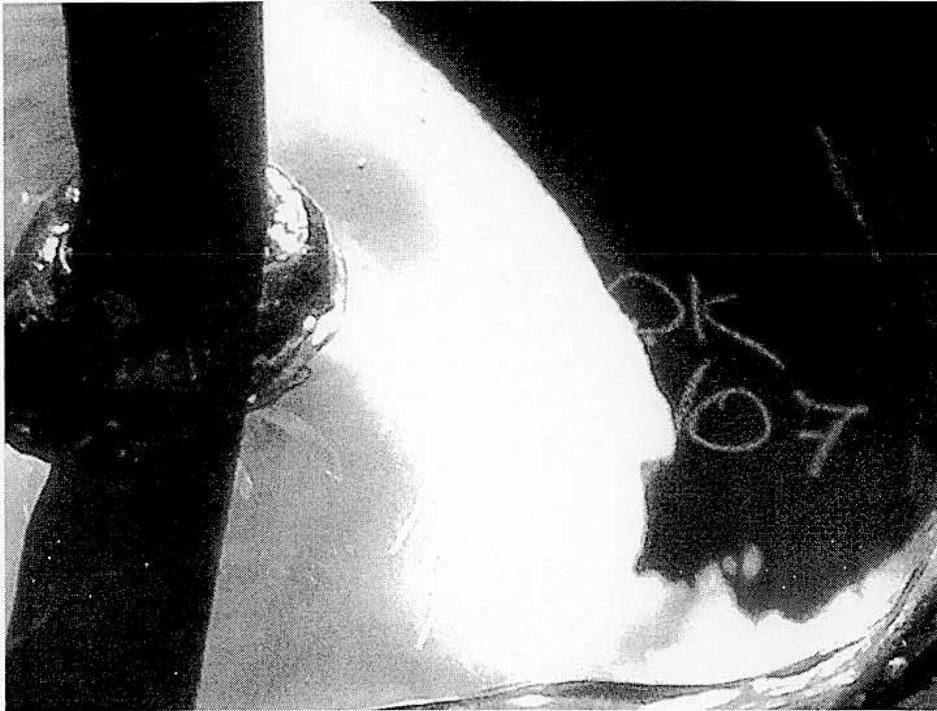
**Completion and Test Verification at RIPZ-13**  
Test Results of Repair at RIPZ-13

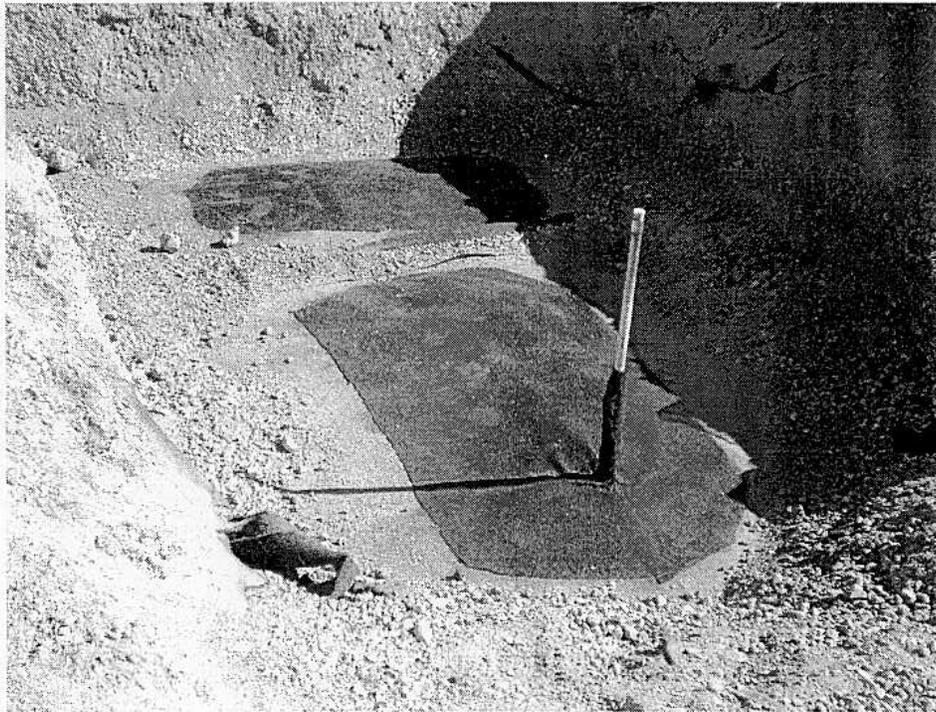
**Restoration at RIPZ-13. 13A and 13B**  
Repair and Restoration of Drainage Mat and Filter Fabric

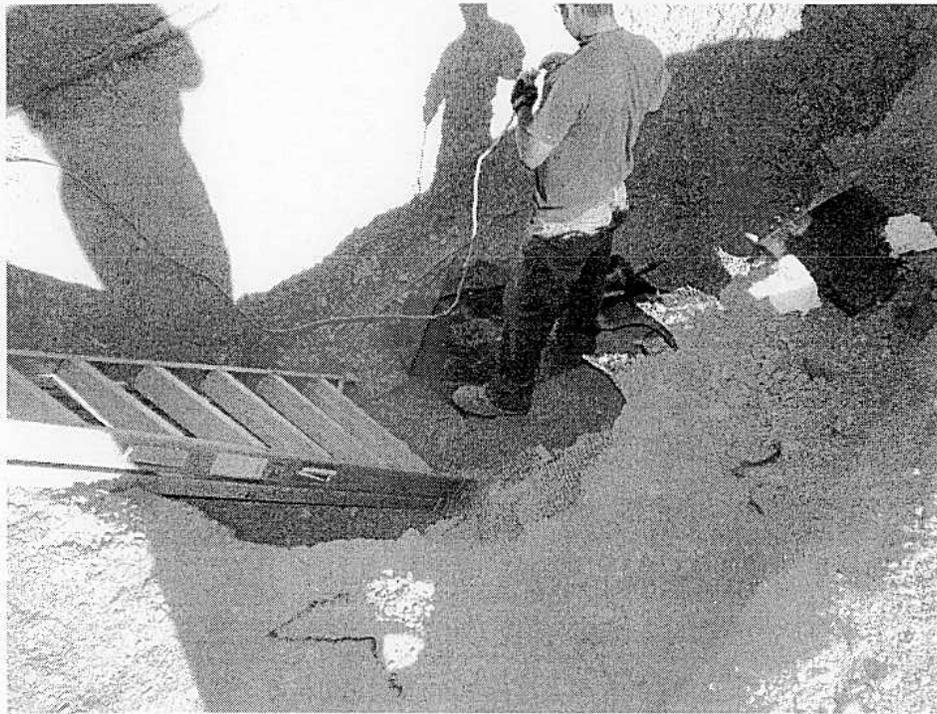
**Repair of 38A**  
Expose Work Surface Prior to Installation of Patch

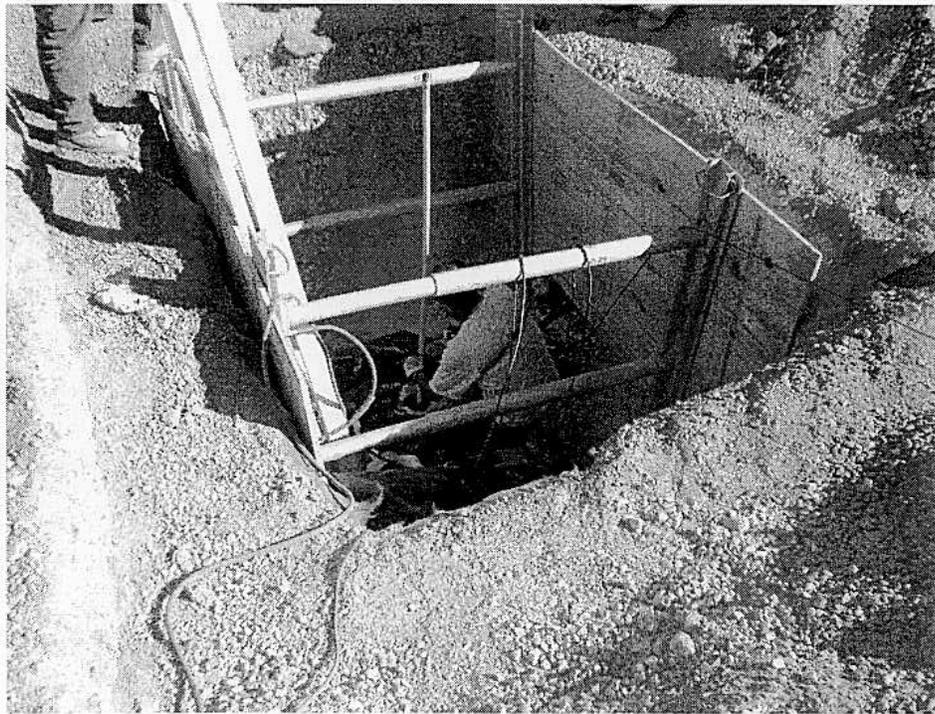
**Repair of RIPZ-38**  
Installation of Boot and Sleeve

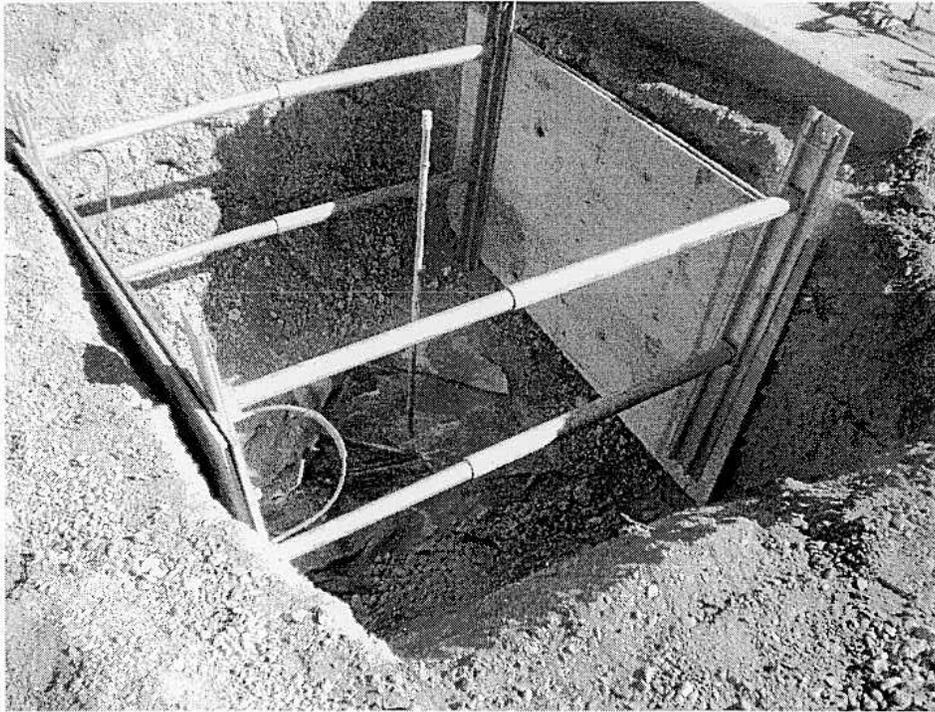
**Repair of RIPZ-27**  
Expose Work Surface Prior to Installation of Boot and Sleeve

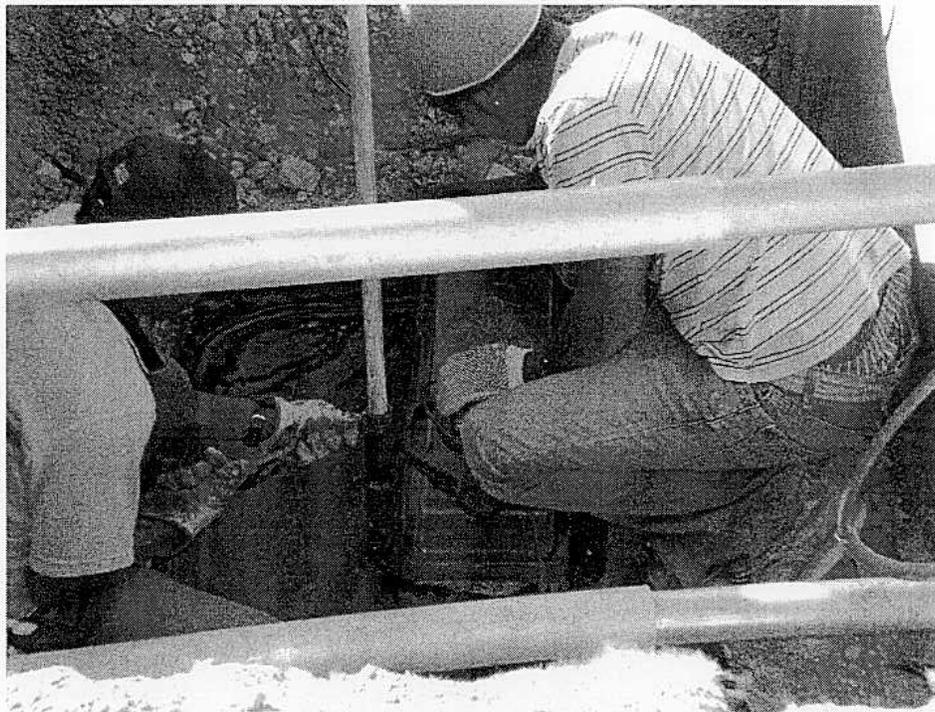
**Repair of RIPZ-27**  
Installation of Boot and Sleeve
